# **ANNUAL REVIEW**

**1 January 2023 – 31 December 2023**

**Jandra Quarry**

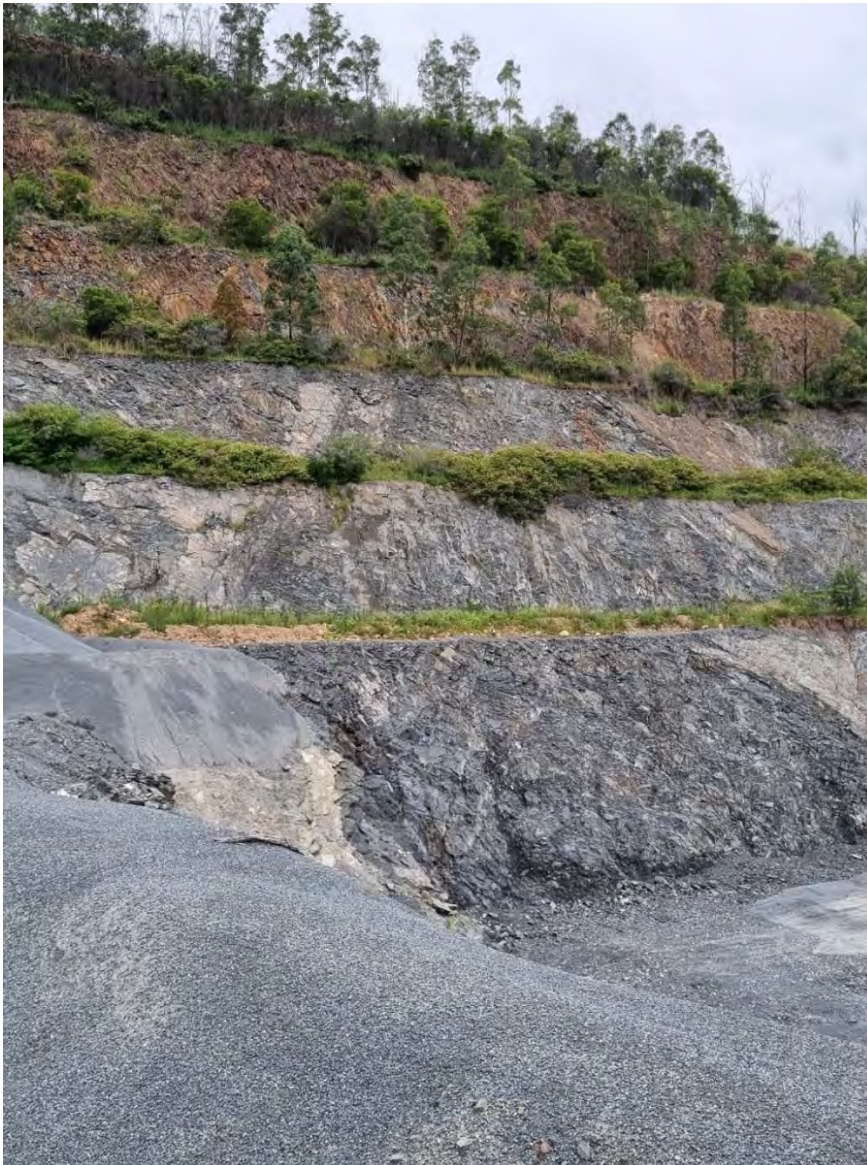
**Photo 1: Active Rehabilitation of benches at Jandra Quarry (2023)**

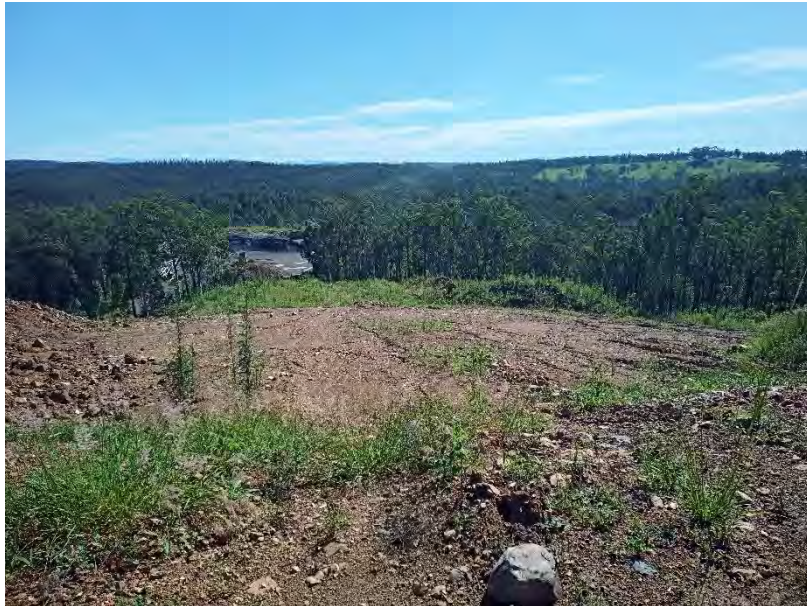
**Plate 5** Overburden Stockpile Area.

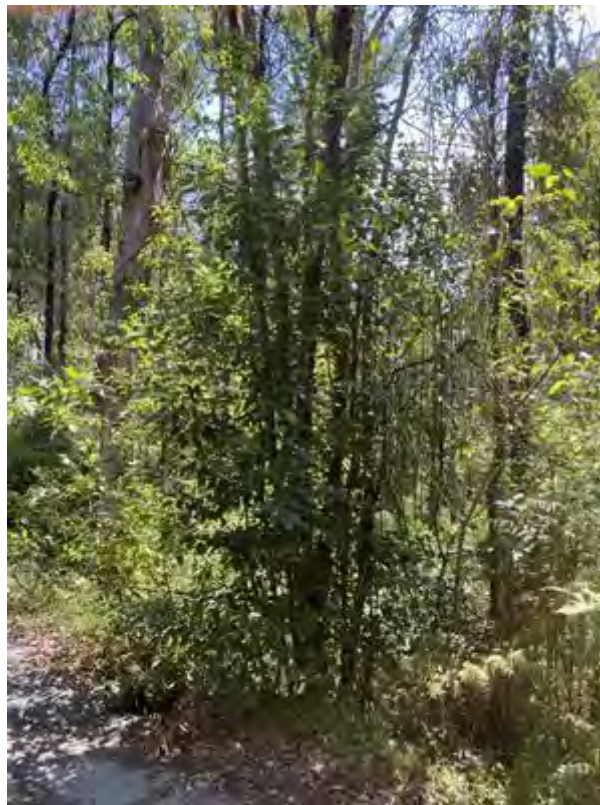
**Plate 6** Camphor Laurel found on creek line near Pacific Highway.

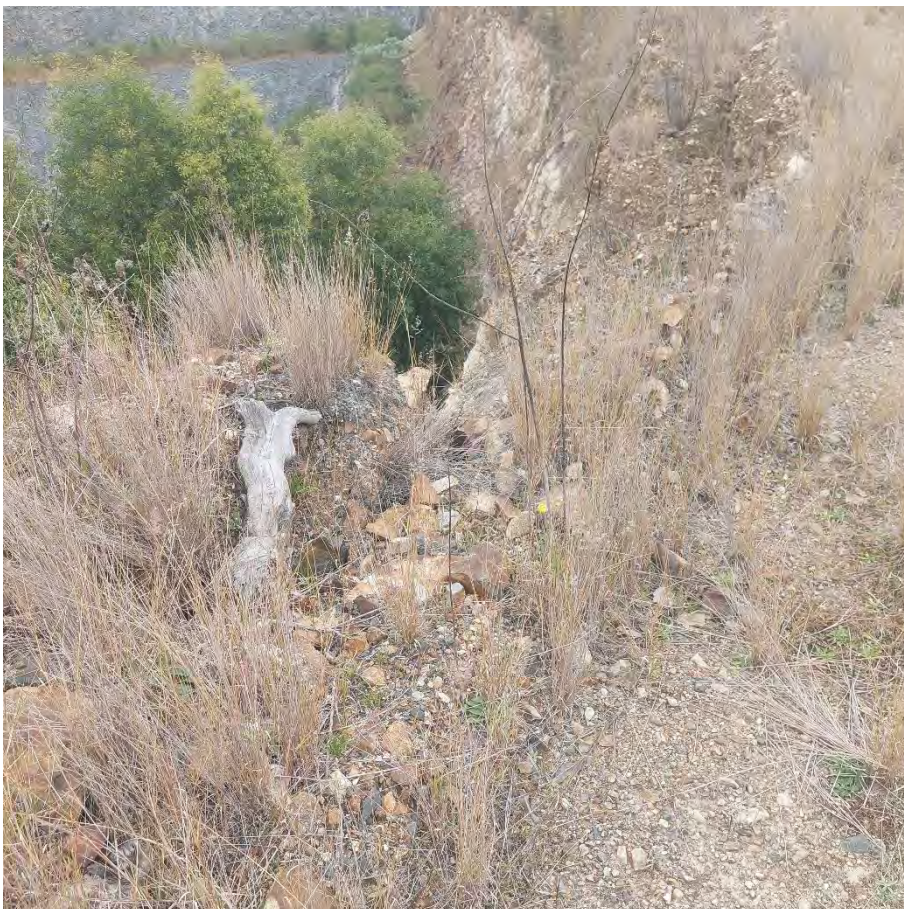
**Plate 6**      **Under-cut from erosion along the high-wall of the western AP area.**

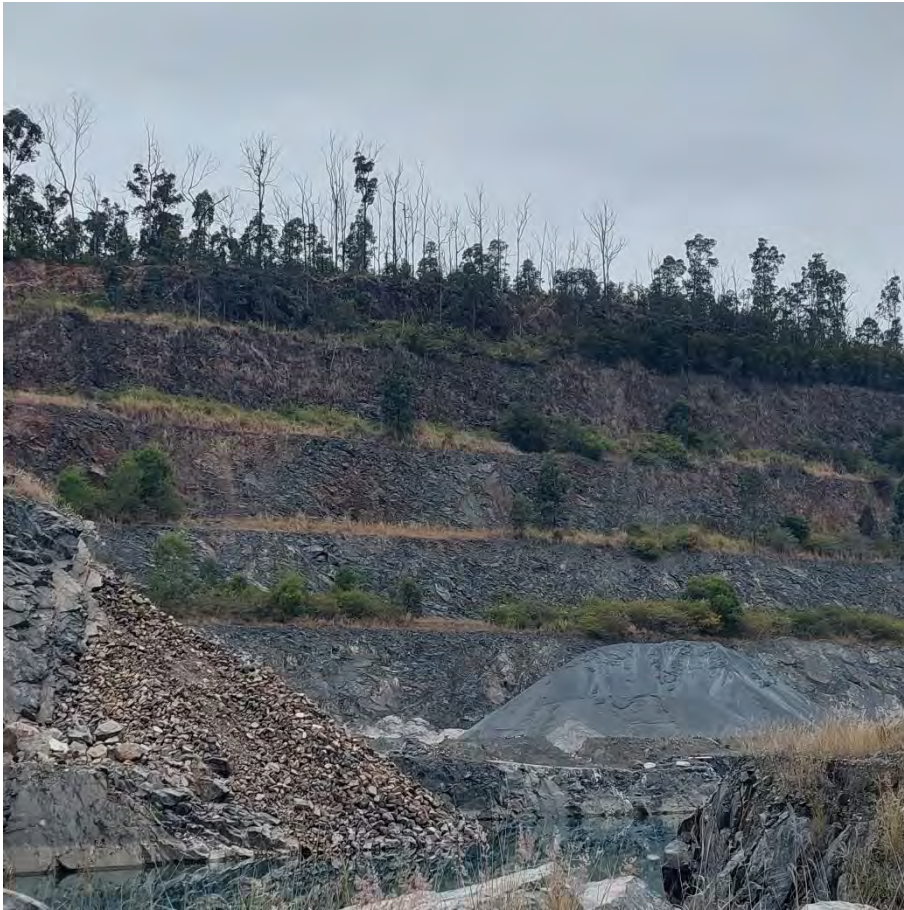
**Plate 7** Excavated material perched on edge of settlement dam in the AP area near the ROM (previously noted in 2022 as falling into dam).

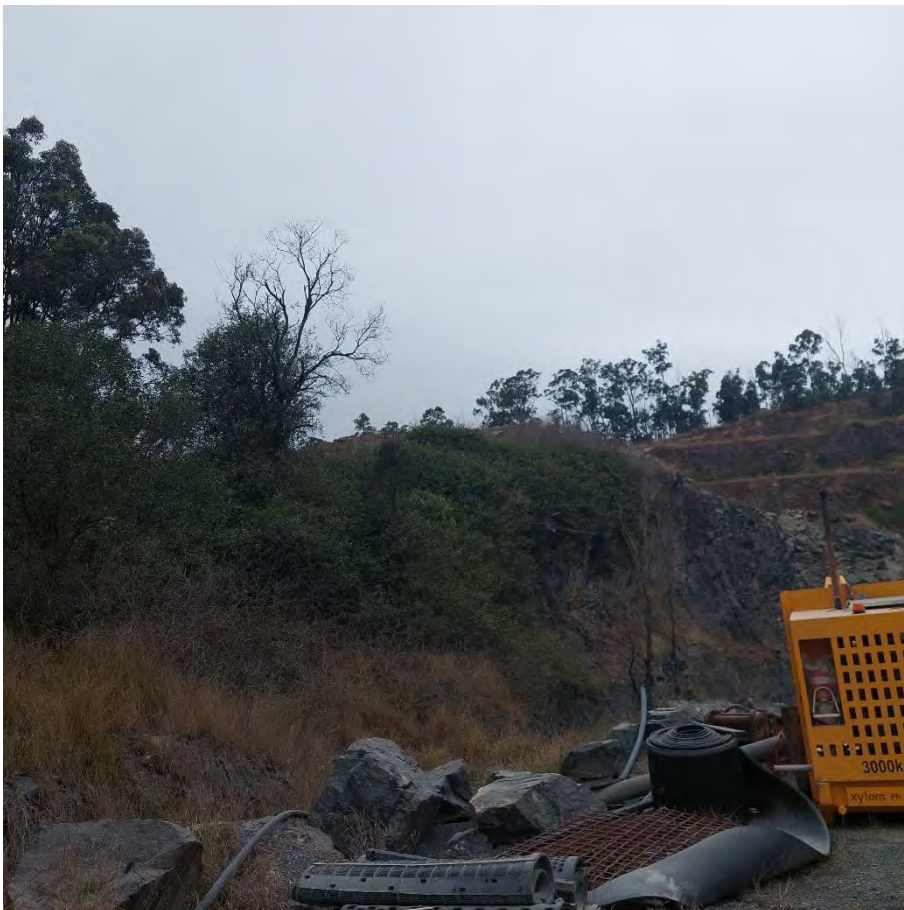
**Plate 8** Dense covering of Lantana along an area of the ROM (north-eastern side of the AP area).

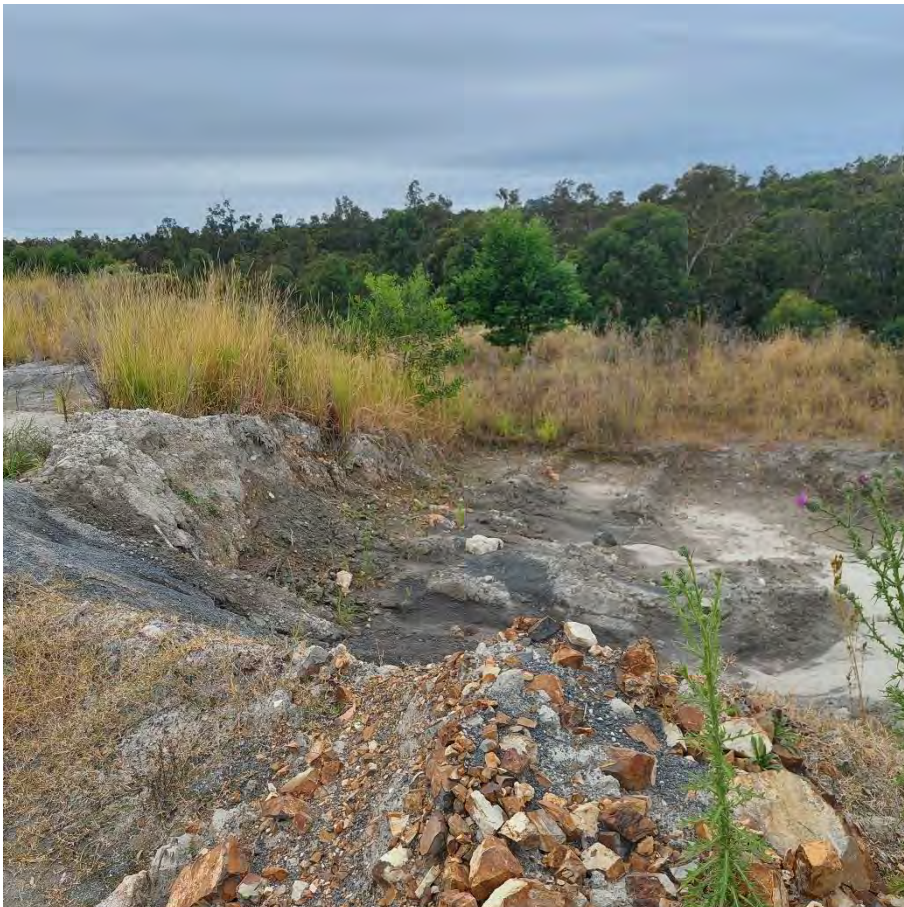
**Plate 10** Erosion control / point in Overburden Stockpile Area.

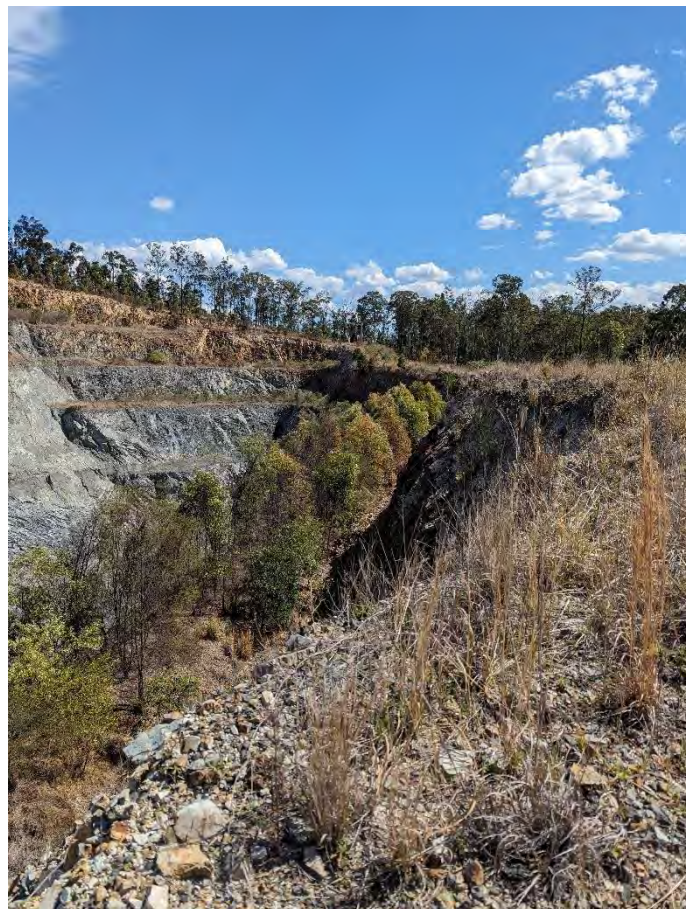
**Plate 6**      **Under-cut from erosion along the high-wall of the western AP area.**

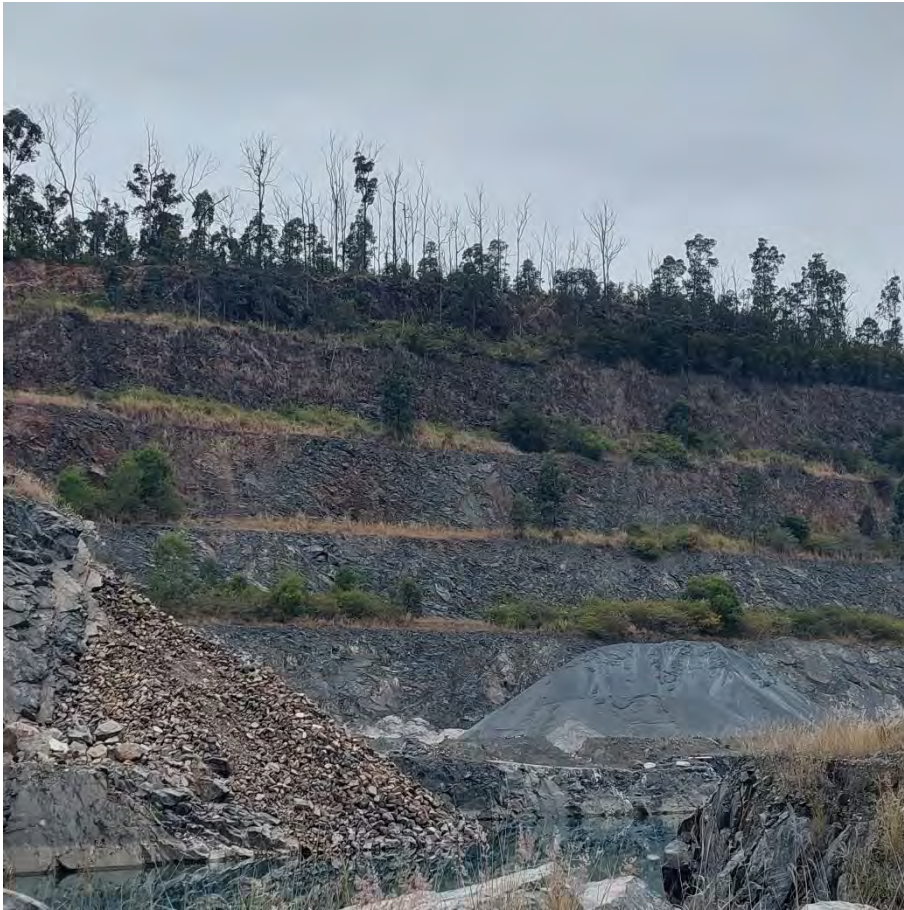
**Plate 7** Excavated material perched on edge of settlement dam in the AP area near the ROM 2023 (previously noted in 2022 as falling into dam).

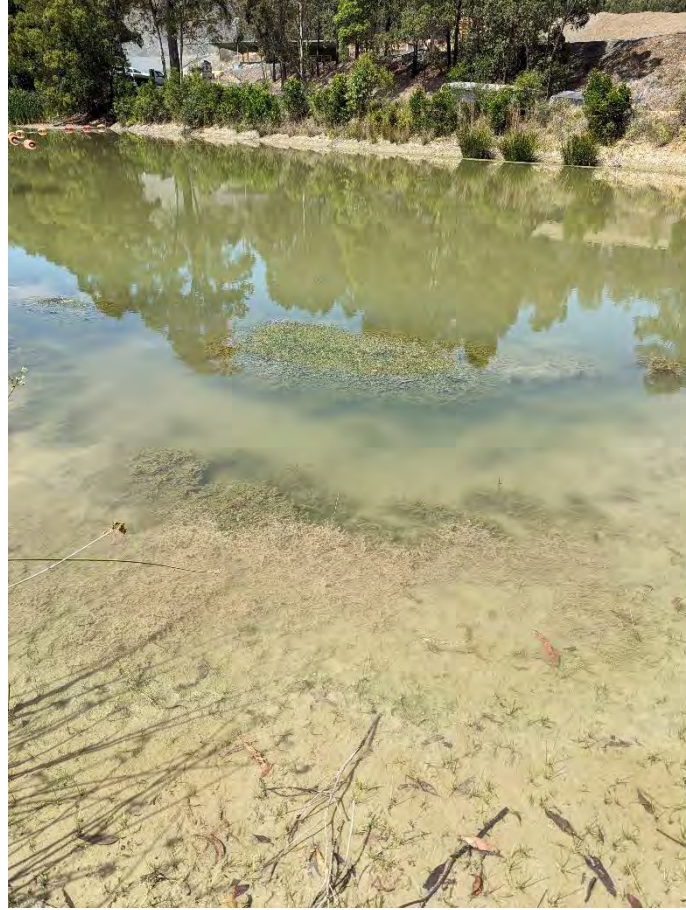
**Plate 9** Dam near office with high sediment water running in.
