ANNUAL REVIEW
1 April 2022 – 31 March 2023

Northern Dune Extension

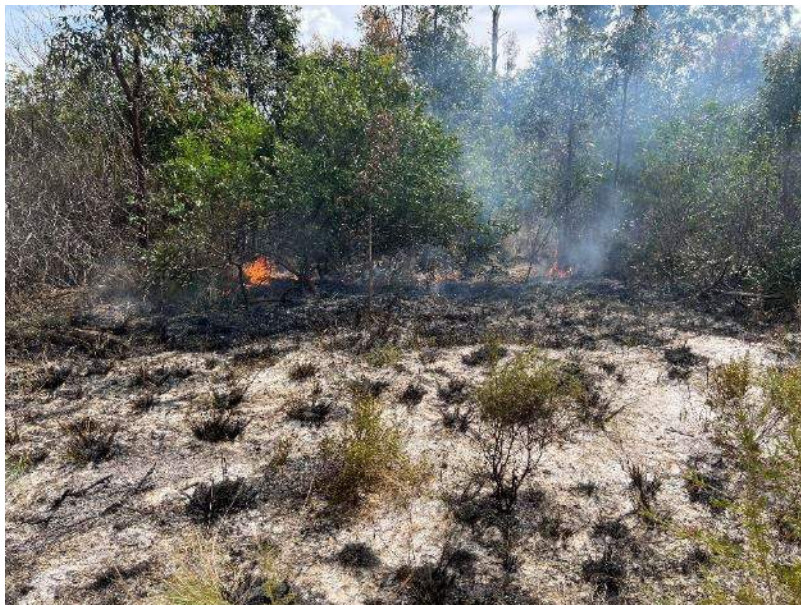
Plot data for this quadrat shows that almost all parameters have decreased since the previous survey, attributed to the controlled burn with many plants destroyed (**Plate 1**). The positive is the reduction in the number of exotic species and as mentioned above the reduction in cover of *E. curvula*. The next round of monitoring will determine the extent of recovery for this area.

Plate 1: Controlled burn occurring in the vicinity of Q46 on the day of monitoring. Note the reduction in plants – native and exotic in the ground cover stratum.

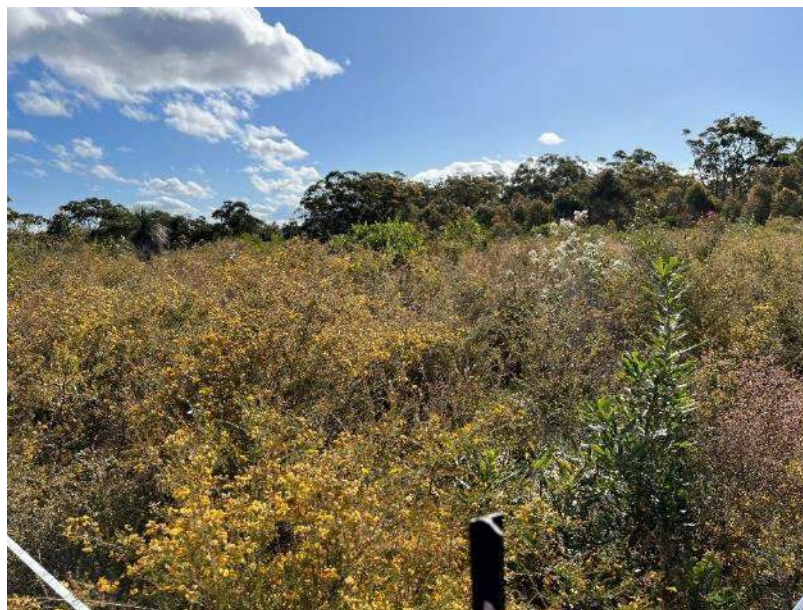
Plate 3: Quadrat Q49 in Block Q3 from the SE corner showing the excellent native species coverage and the prodigious flowering of multiple species.

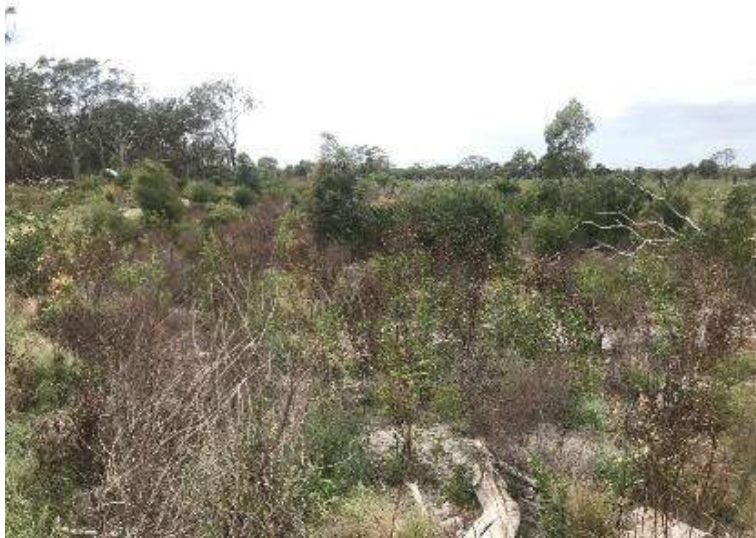
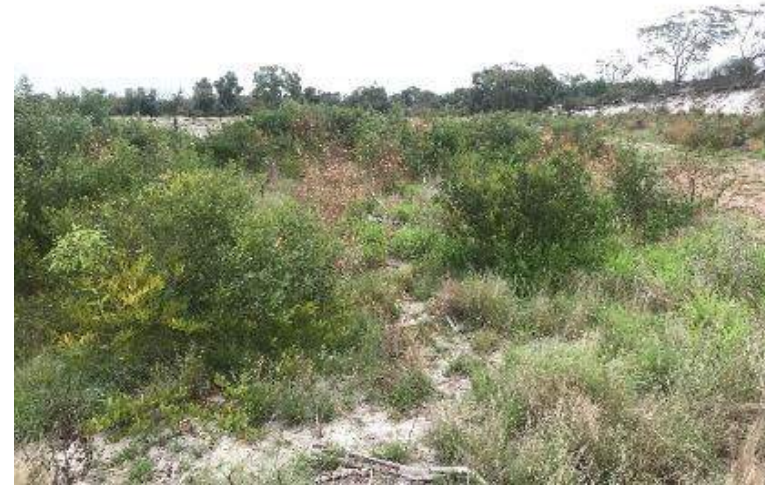
Plate 15: View of Block Q1 from PP1 looking East (left) and West (right) January 2020. Notice the dieback of shrub species and the height of the Eucalypt (left) and the prevalence of *Eragrostis curvula* (right)

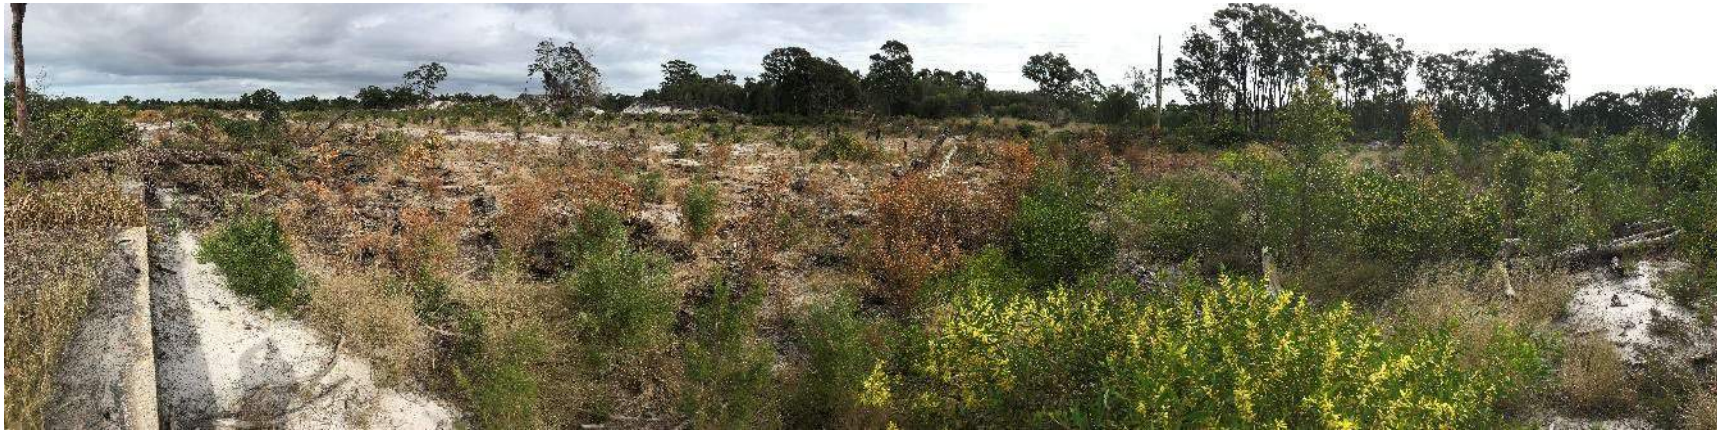
Plate 17: Block Q1 PP2 looking south - west – north, July 2020 just after controlled burns

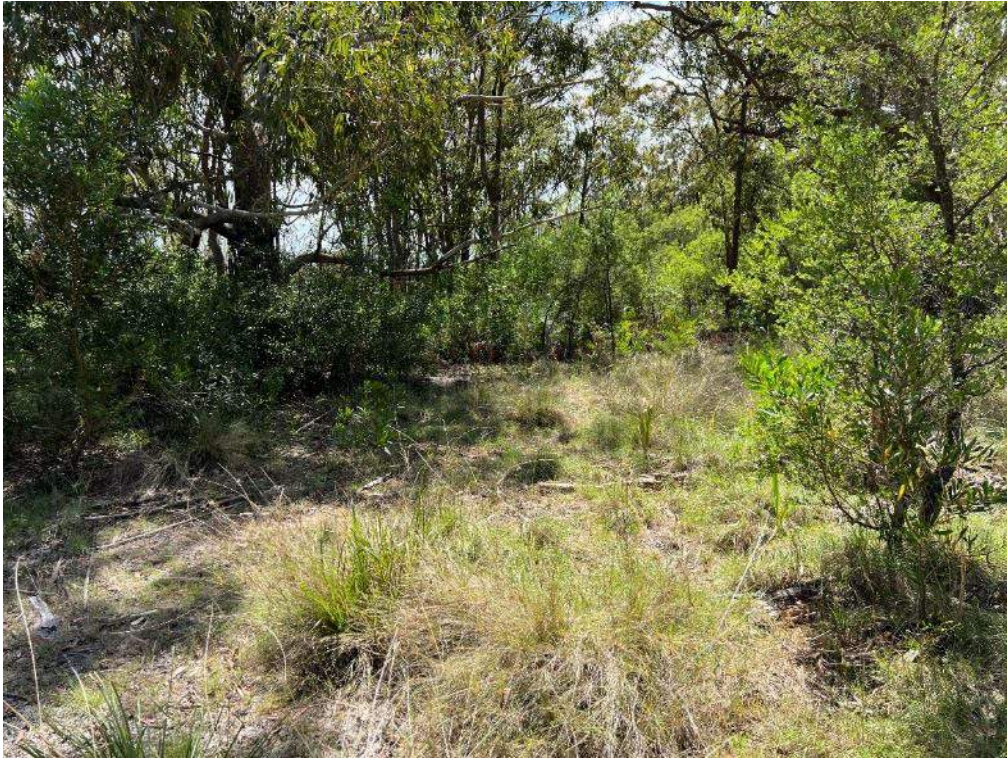
Plate 7: PP1 looking east showing poor condition (foreground) and better condition vegetation (background)

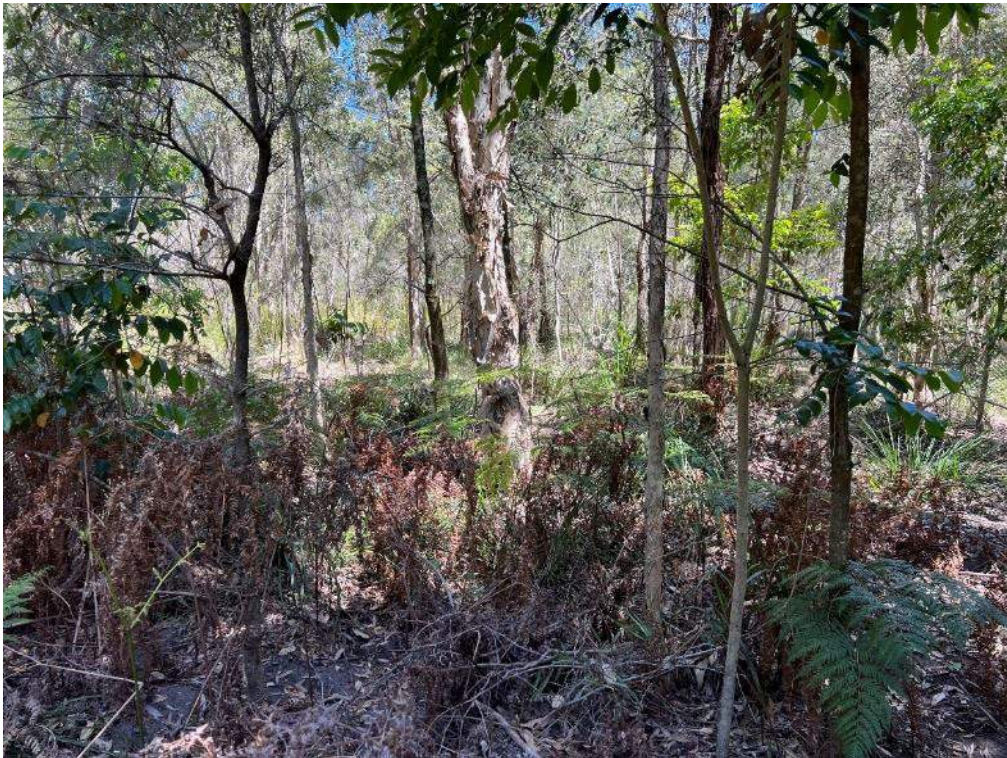
Plate 8: PP2 looking north showing dense Lantana and previous control works

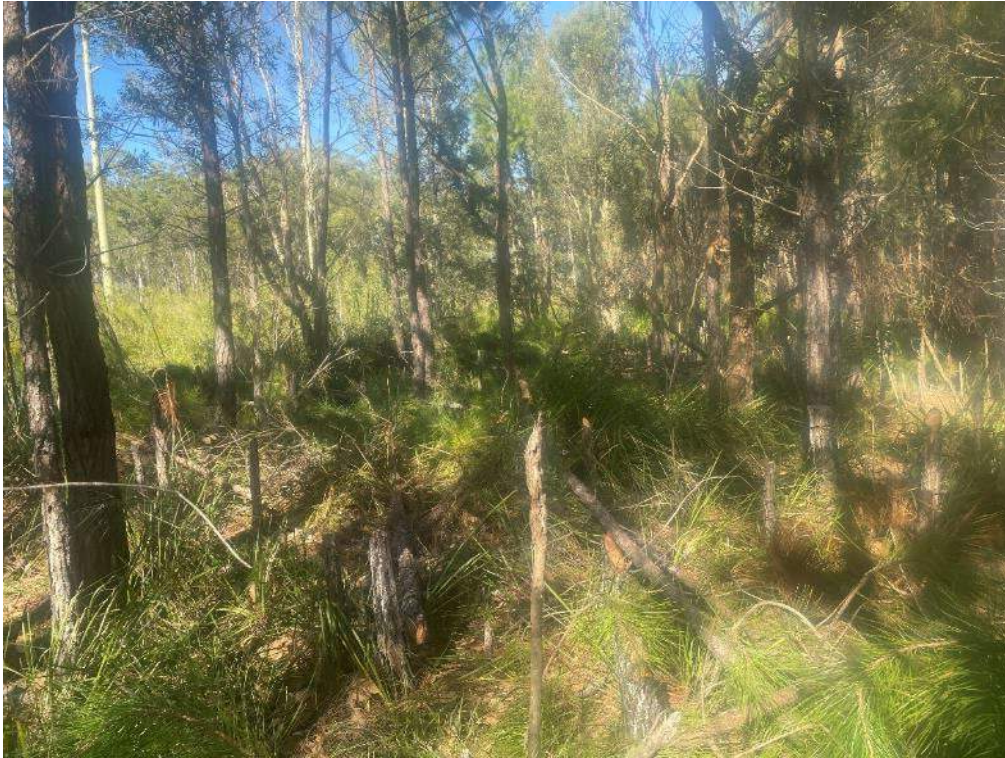
Plate 14: Slash Pine control efforts in the moderate to scattered density area of the NBOA. Note the stumps in the foreground.
