ANNUAL REVIEW

1 January 2022 – 31 December 2022 Jandra Quarry

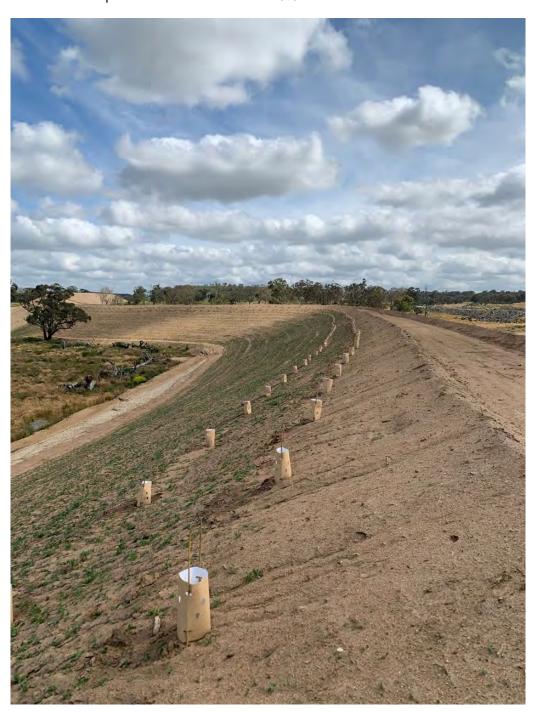
In the 2022 reporting, a total of 1035 trees have been planted out along the bund wall. Grass seeding has also occurred on top of the bund as shown in **Photo 1**.

Photo 1: Grass seeding, and trees planted on the bund wall.

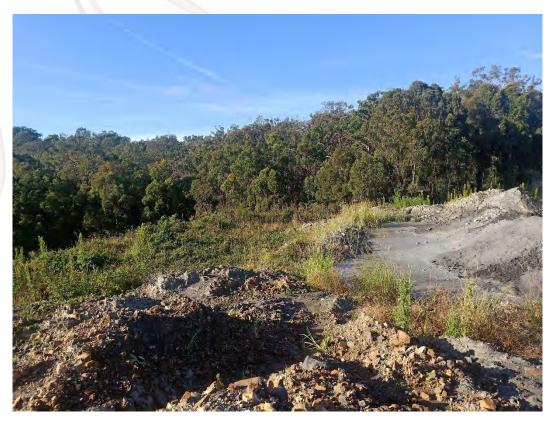
Plate 3 Dominance of weeds within the OSA

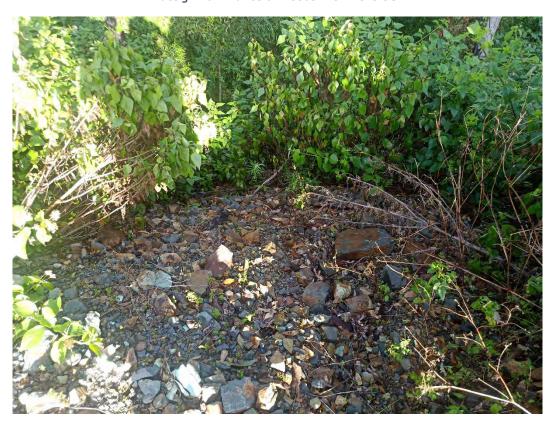
Plate 4 Exotic species growing within a constructed drainage channel.

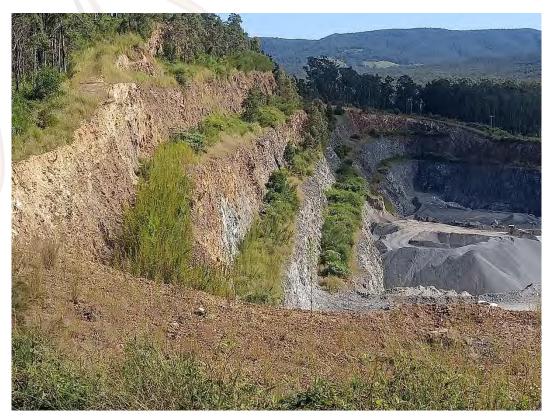
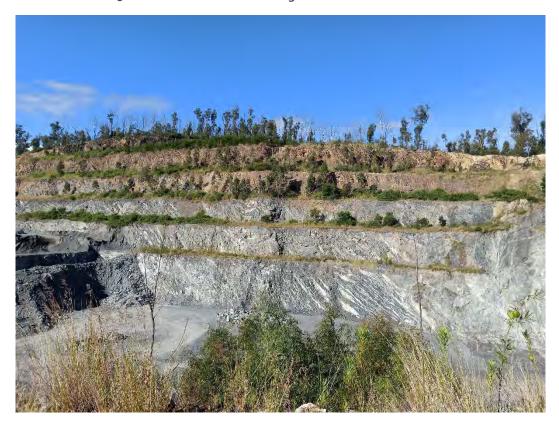
An inspection of the benches via drone was not conducted during this round of monitoring. Bench condition was interpreted as best as possible from a visual inspection at a safe distance, and via photos (**Plate 5 and Plate 6**). Areas of minor rill erosion identified in the previous monitoring round are still evident. A small amount of erosion was apparent along the north-eastern AP area (ROM) with excavated material falling into a Settlement Dam (**Plate 7**). Furthermore, this area contains a high cover of *Lantana camara* (Lantana) (**Plate 8**).

Plate 5 Rehabilitated benches along the eastern side of the AP area.

Plate 6 Rehabilitated benches along the eastern side of the AP area.

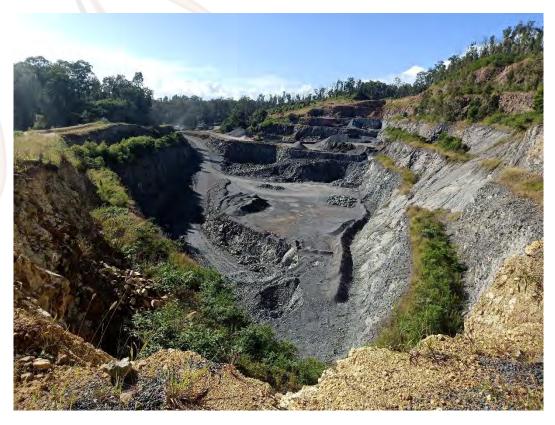
Plate 7 Rehabilitated benches along both sides of the AP benches and material falling into AP dam.

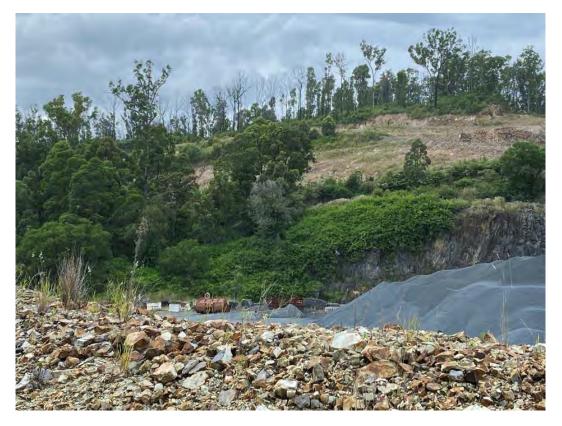
Plate 8 Dense covering of Lantana along an area of the ROM (north-eastern side of the AP area).

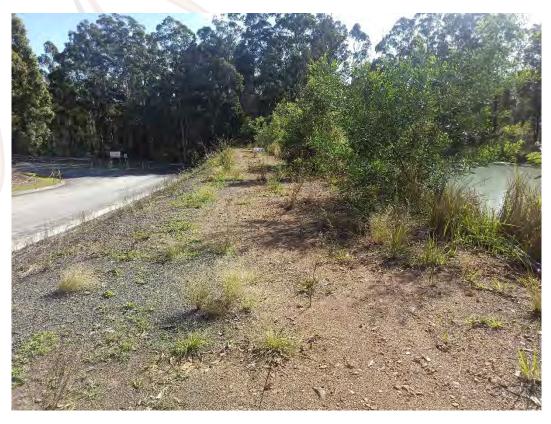
Plate 9 Native species growth (*Acacia longifolia* and *Eucalyptus spp.*) with exotic grasses dominating the ground layer.

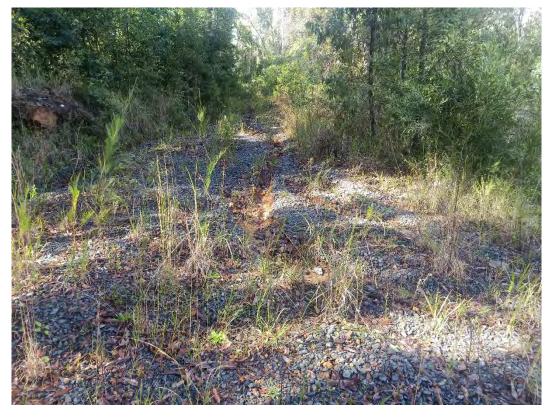
A walkover of the edge of the Settlement Dam revealed good vegetation coverage along the dam walls and no areas of erosion or unintended water leakage were apparent. Some exotic species, such as *L. camara* (Lantana), *S. mauritianum* (Tobacco Bush), *Paspalum* spp., *M. repens* (Red Natal Grass), *A. adenophora* (Crofton Weed) and *Andropogon virginicus* (Whisky Grass) have established themselves along the dam walls. Despite this, there is still good native species coverage, with species such as *Acacia longifolia*, *Acacia maidenii* and *Eucalyptus spp.* being the most common (**Plate 9**). To the North East of the settlement dam there is a small amount of rill erosion along an existing track that leads to the OSA (**Plate 10**).

Plate 10 Minor rill erosion north-east of settlement dam.

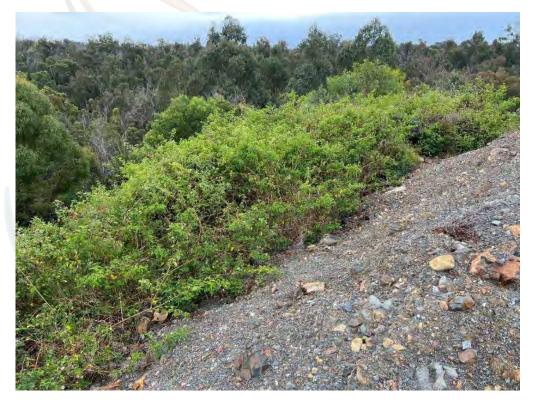
Plate 3: W2 on the Overburden Stockpile Area showing dense thicket of Lantana

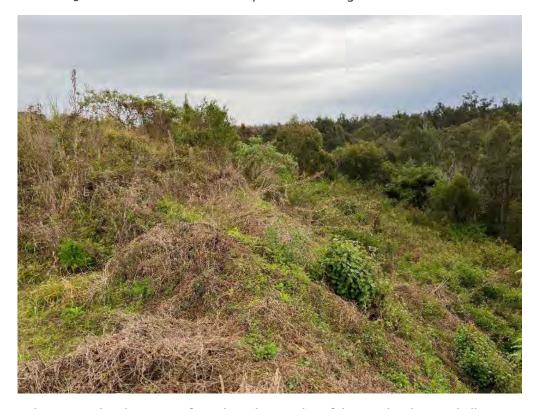
Plate 4: W₃ showing range of weed species on edge of the Overburden Stockpile Area

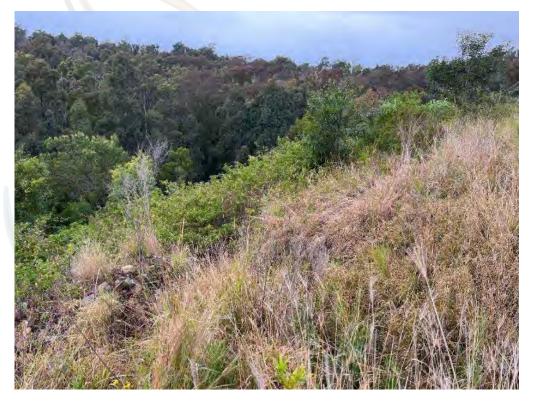
Plate 5: W1 on the Overburden Stockpile Area showing establishment of exotic grasses and woody weeds

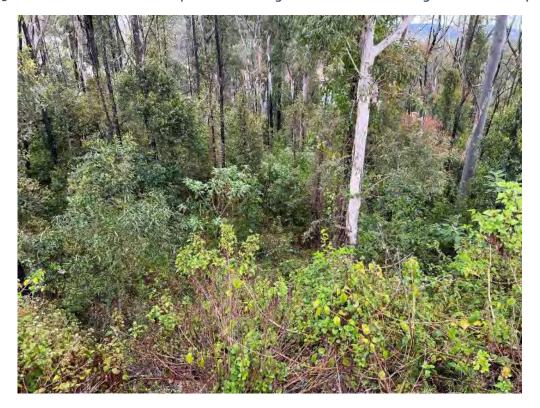
Plate 6: W₅ Scattered Wild Tobacco in the vegetation island to the west of the Overburden Stockpile Area

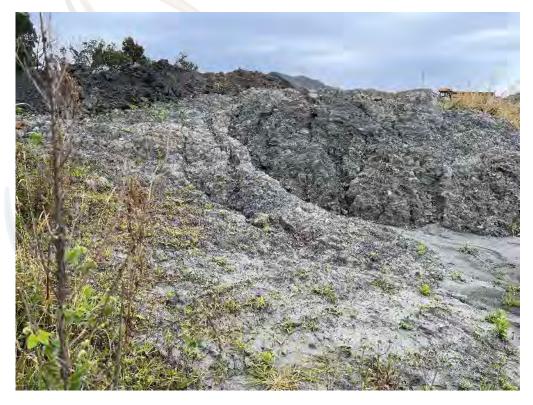
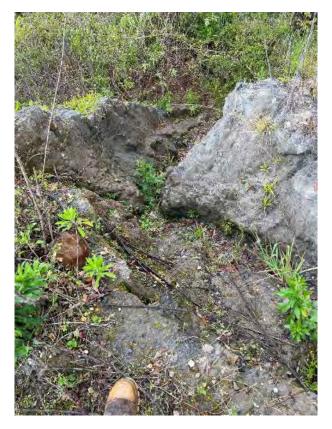
A single point pf erosion was observed (OB1 Plate 7 and Plate 8), where unconsolidated material is eroding into a channel and then downslope, presumably into a drainage channel below the OSA. While a constructed bund exists along the edges of the OSA, no other sediment control structures were observed.

Plate 7: OB1 showing erosion of unconsolidated material on the Overburden Stockpile Area

Plate 8: OB1 showing erosion and drainage of material into vegetation adjacent to the Overburden Stockpile

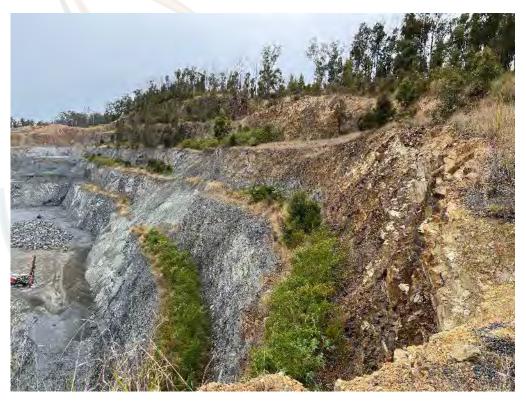
Plate 9: OB4 showing the eastern Active Pit Area Benches. Note the unstable rock face at the right

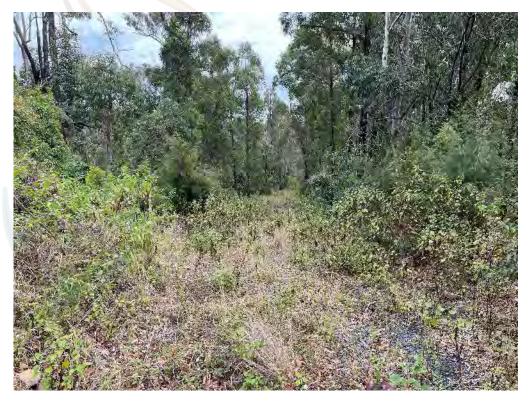
Plate 13: OB6 showing the access road to the OBA from the Settlement Dam. Minor rilling is visible bottom right, note the proliferation of weeds

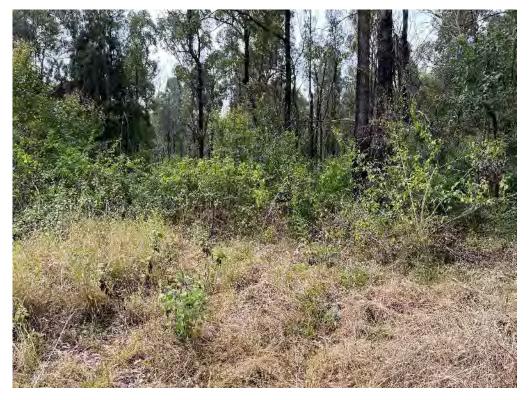
Plate 14: W11 showing wood weeds around the open area near the Settlement Dam

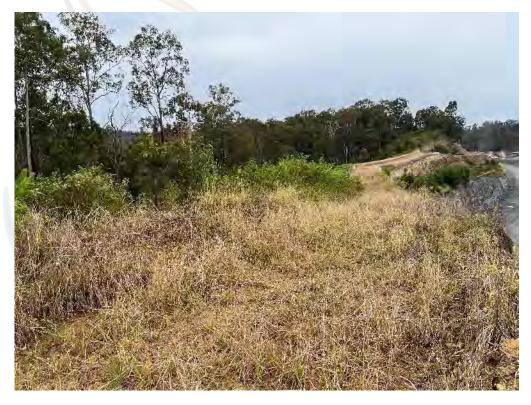
Plate 15: W7 showing extent of Lantana and Wild Tobacco along Whiteside track

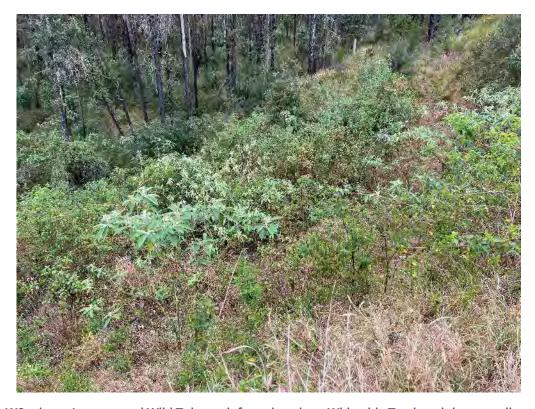
Plate 16: W8 - dense Lantana and Wild Tobacco infestation along Whiteside Track and the powerline easement

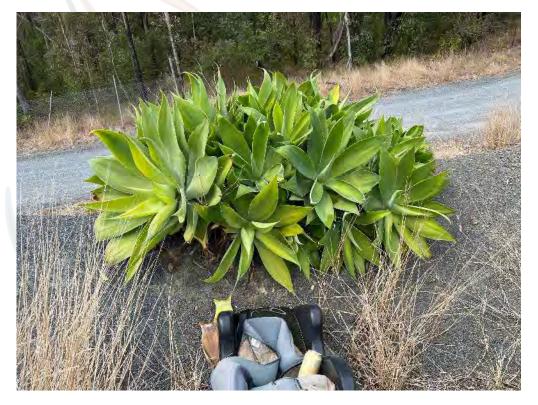
Plate 17: W12 - Agave attenuata plant and rubbish on the truck parking pad

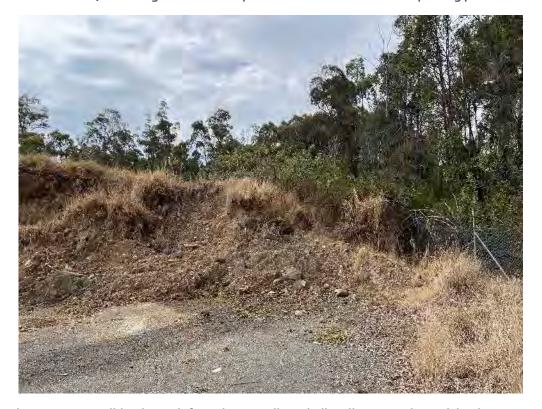
Plate 18: W13 - Wild Tobacco infestation on soil stockpile adjacent to the tank laydown area

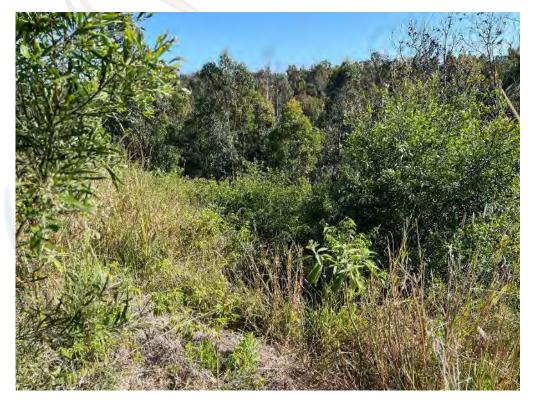
Plate 3: OB1 on the Overburden Stockpile Area showing proliferation of weed species

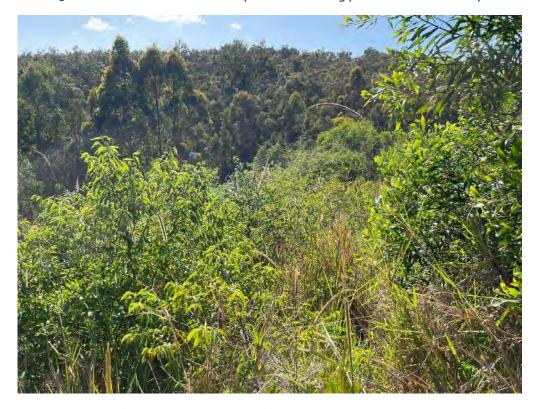
Plate 4: OB1 showing range of weed species on edge of the Overburden Stockpile Area and into the gully below – note the Jacaranda mimosifolia flowering below Eucalypts centre left.

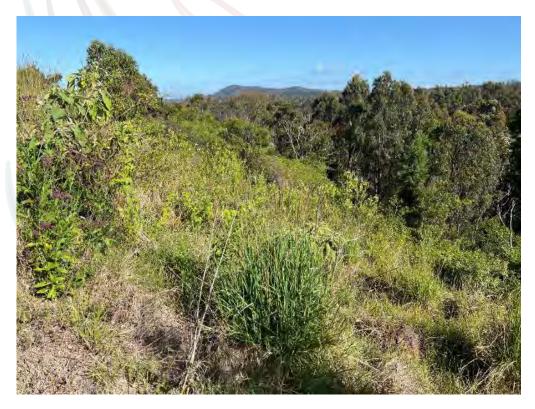
Plate 5: W1 on the Overburden Stockpile Area showing establishment of exotic grasses and woody weed species

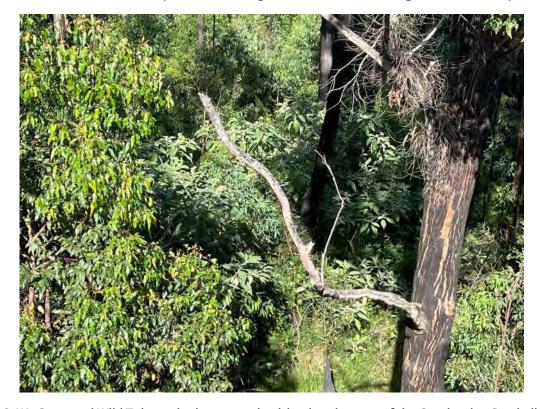
Plate 6: W₃ Scattered Wild Tobacco in the vegetation island to the west of the Overburden Stockpile Area

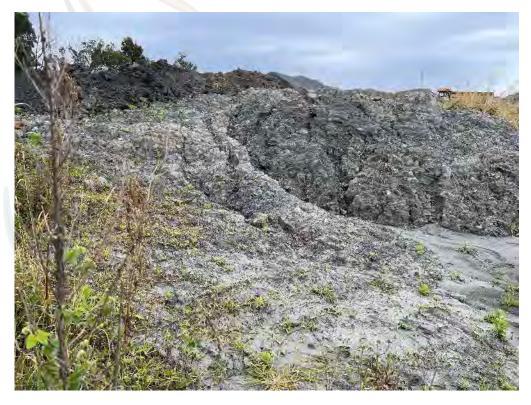
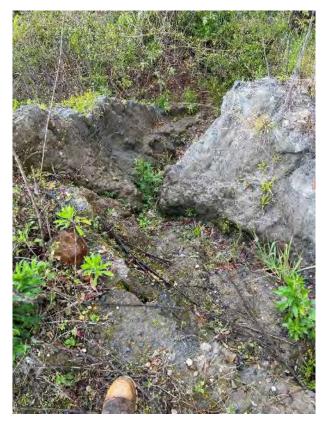
No active of erosion was observed. The September survey noted a small area of unconsolidated material and a drainage channel (W4 Plate 7 and Plate 8). This appears to have stabilised, and the drainage feature is not active at the time of this survey. Another drainage feature was observed at OB3 taking water off the OSA into the central "vegetation island". This has been temporarily bunded and is presumably used only during extreme rainfall events (Plate 9).

Plate 7: W4 showing erosion of unconsolidated material on the Overburden Stockpile Area – photo from September survey

Plate 8: W4 showing erosion and drainage of material into vegetation adjacent to the Overburden Stockpile

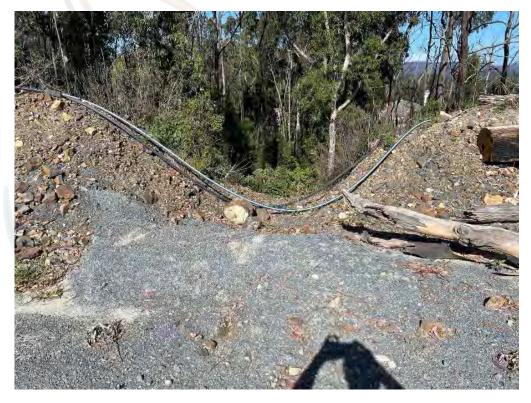
Plate 9: Drainage feature at OB3 -note the temporary bund

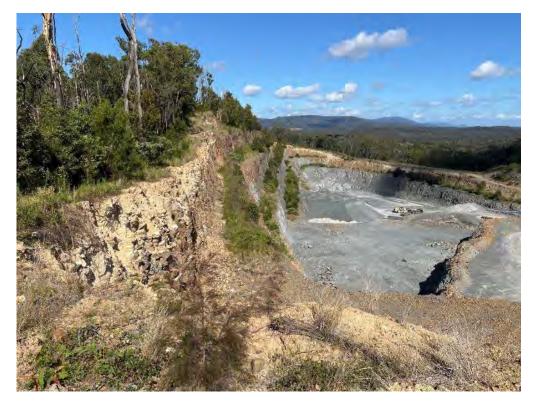
Plate 10: OB4 showing the eastern Active Pit Area Benches. Note the unstable rock face at the left and the narrow benches

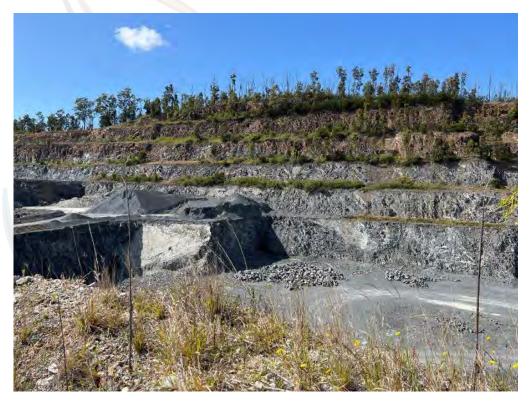
Plate 11: OB5 showing the revegetation of the southern benches in the Active Pit Area. Note the decrease in native woody vegetation from the upper benches to the lower benches

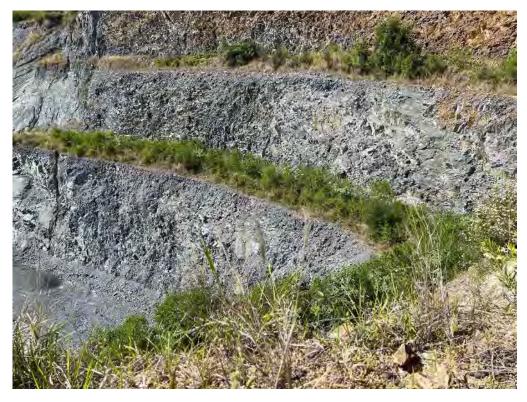
Plate 12: OB6 showing the revegetation of the southern benches in the Active Pit area. Note the lack of taller Eucalyptus species, proliferation of Acacias and exotic grasses

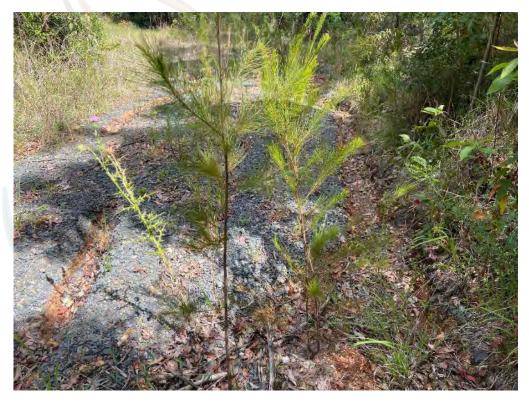
Plate 13: OB11 – rill erosion on access track (not active) in background and self-regenerating *Allocasuarina spp.* in foreground

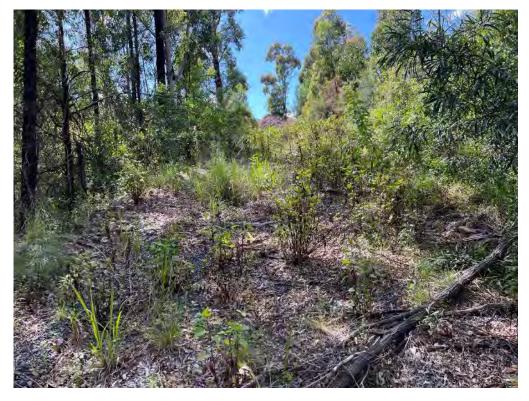
Plate 14: OB10 showing the access road to the OSA from the Settlement Dam. Minor rilling is visible bottom left, note the proliferation of weeds

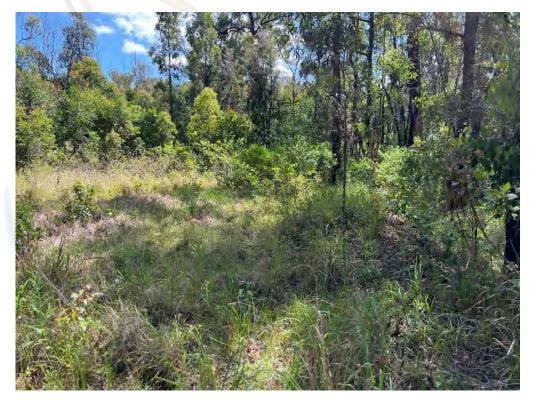
Plate 15: OB9 showing woody herbaceous weeds around the open area near the Settlement Dam

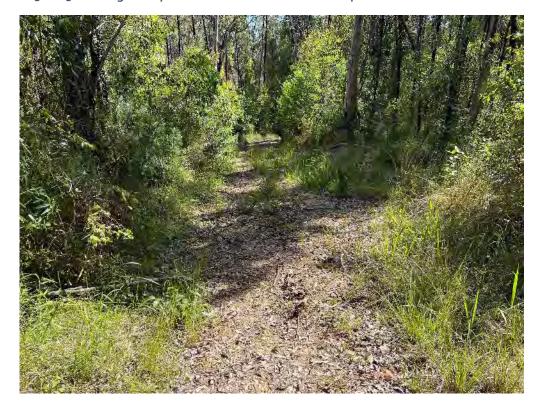
Plate 16: Access track at O7 showing native vegetation starting to close the track and reducing its utility as a fire break and access for firefighting

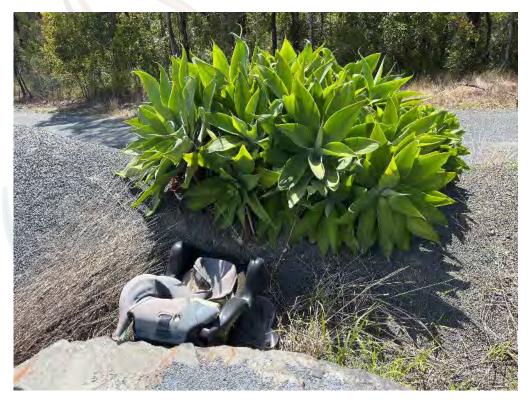
Plate 17: W12 - Agave attenuata plant and rubbish on the truck parking pad

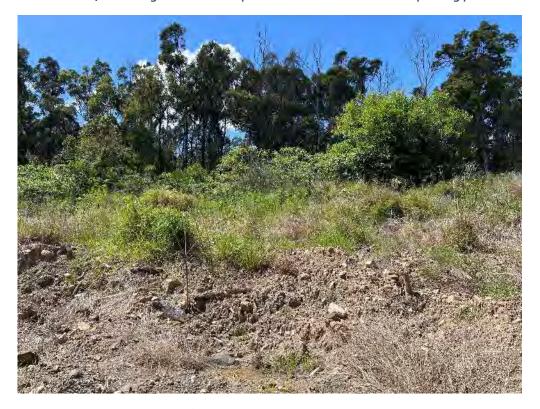
Plate 18: OB12 - Wild Tobacco infestation on soil stockpile adjacent to the tank laydown area

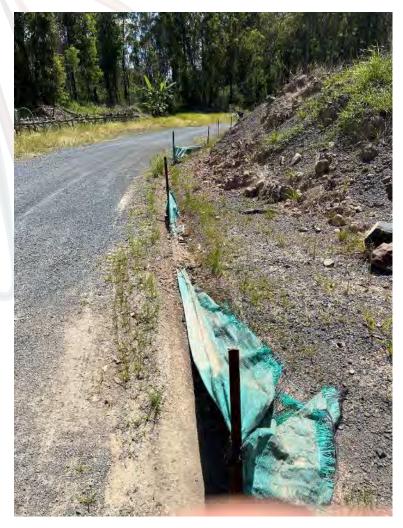
Plate 19: OB12 - Sediment fence in disrepair below topsoil stockpile

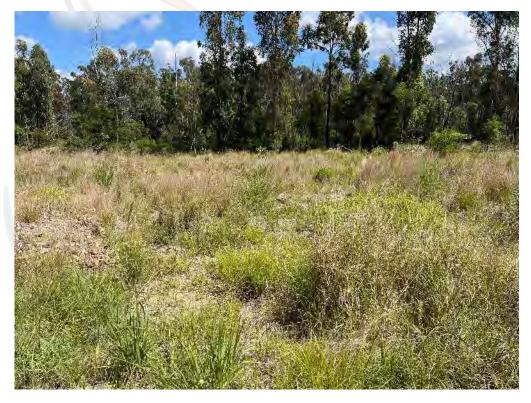
Plate 20: W9 - Grassy paddock below truck parking pad is beginning to be colonised by woody weeds

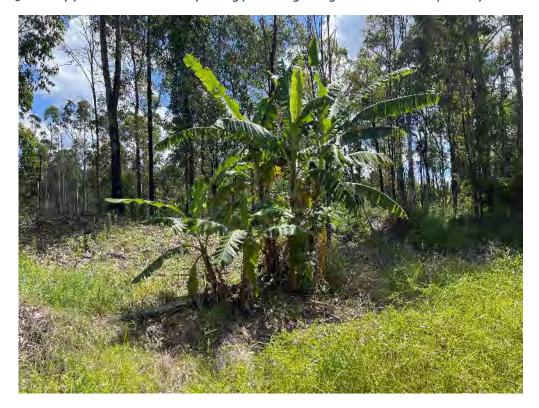
Plate 21: W10 - Feral bananas requiring control to prevent becoming an infestation

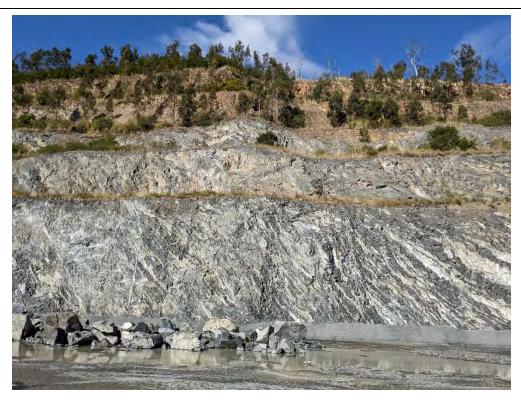
Current level in main pit and benching rehabilitation progress

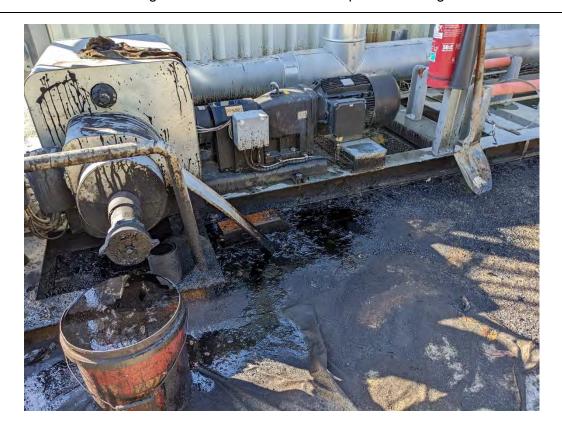
Minor hydrocarbon leakage, primarily on to geofabric, within the Downer plant area
