Electrical Safety - Bushfire Mitigation Plan (BFMP)

Oaklands Junction Quarry 2023-2024

Revision 6

HOLCIM QUARRY OAKLANDS JUNCTION 2021

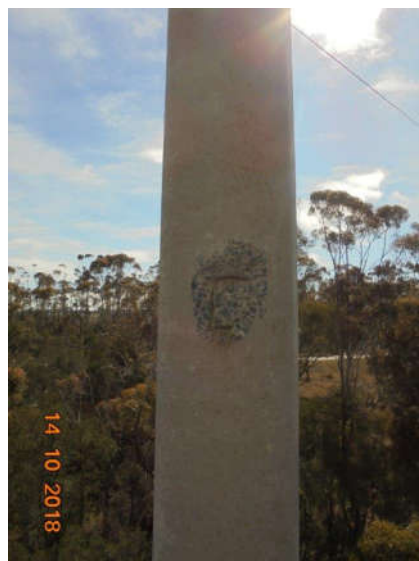
- Pole 6 (P33453) has a hole in the concrete pole at the top, is considered serviceable and given a medium maintenance priority

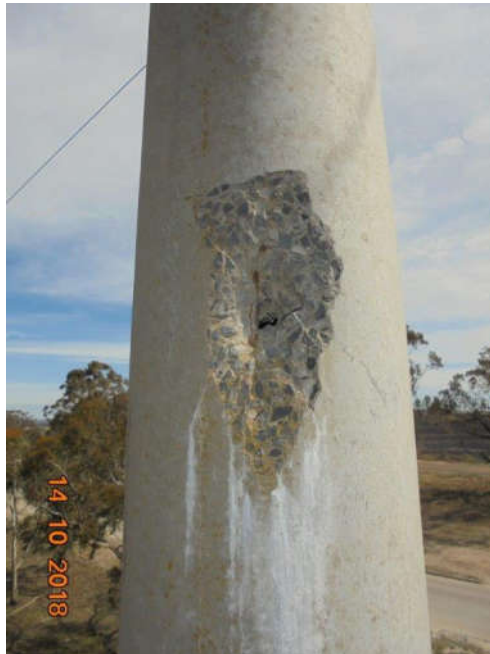
- Pole 8 (P33455) has a hole at the top of the pole, is considered serviceable and given a medium maintenance priority.

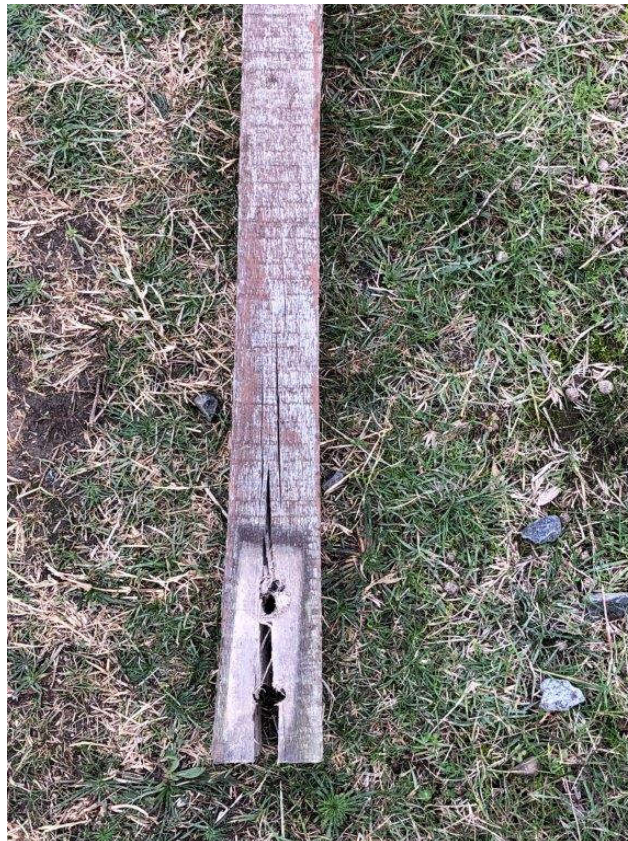
Pole 14 associated airbrake switch operator handle was split through and was replaced by a fibreglass version.

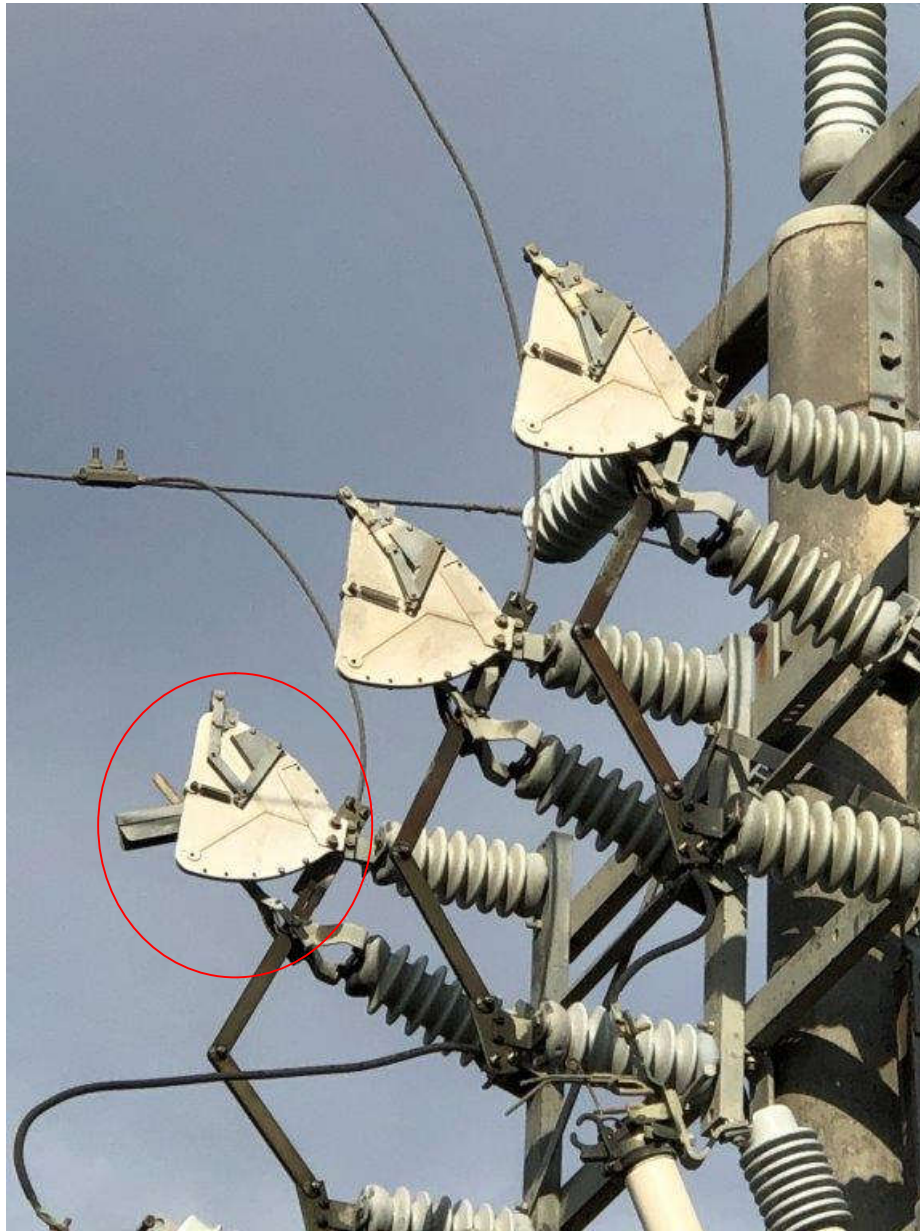
Airbrake switches on Poles 14 and 17 still suffer from alignment issues and took several attempts to close all three switches (Phases) at the same time. Picture below shows the distant phase not aligning properly.

These airbrake switches must not be operated live.

All parties (ARA, OHMS and PCS) involved recommend replacing these airbrake switches with pole mounted gas switches purely from a safety perspective which would also provide individual isolation for each transformer without having to isolate the entire site before operating one of the airbrake switches (Open or close).

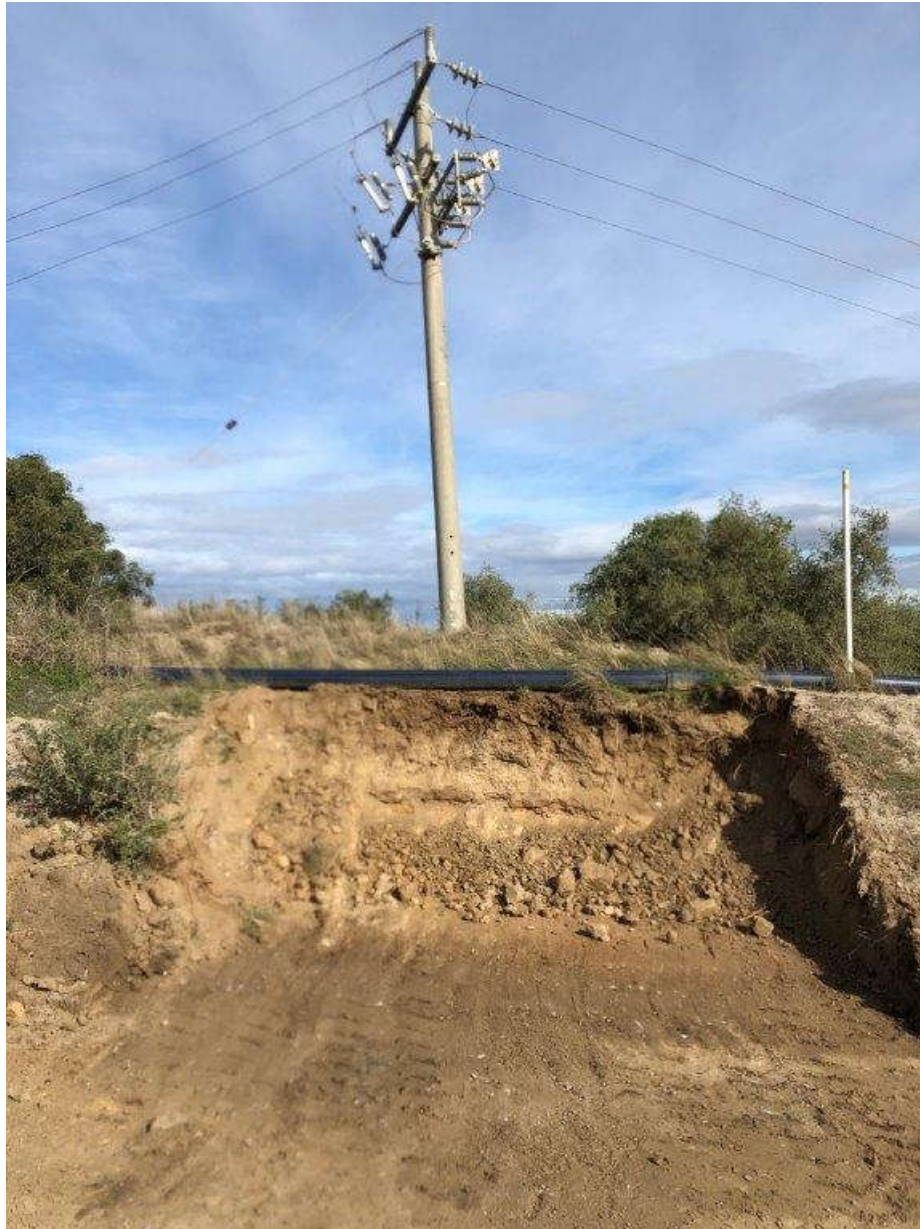
Pole 22 (P33471) access was provided by the removal of the road embankment via a front-end loader, however this only provided access to the near side of the pole mounted equipment for cleaning and servicing. Refer photo.
