#### Review and Amendments Schedule - PLANIT CONSULTING PTY LTD

Development consent for Ramtech Pty Ltd's (Ramtech) proposal to construct and operate a sand quarry at Lot 1 in DP 755721 & Lots 1 & 2 in DP 780199 Pottsville Mooball Road, Mooball was granted by the Minister for Planning on 24th November 2008. Schedule 3 of the development consent requires that individual management plans for the key environmental issues be prepared and that environmental management and monitoring conditions be fulfilled. To this end, an EMP was approved by the Department of Planning which integrates the prescribed environmental monitoring programs in accordance with Condition 2 of Schedule 5 into a planning and operations framework.

This report represents a six monthly report for presentation to the CCC and for presentation to the DOP. This will be incorporated in to the formal 12 monthly report when appropriate.

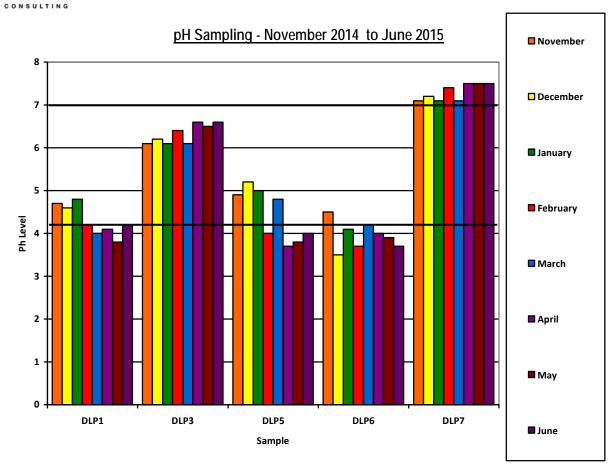
Figure 1: Dunloe Sands - Ground Water - Chemical (pH Test) Results November 2014 to June 2015

The EMP provides the interim target range regarding the pH levels of ground water sampling. The majority of the results displayed are between the minimum of 4.2pH and maximum of 7.0pH (shown as black lines). DLP 7 shows all samples outside of the maximum interim target levels by between 0.1 and 0.6pH. This presents a more alkaline pH level than the target range. These minimal exceedances of pH at DLP7 are not considered to be of any significance as small fluctuations in groundwater pH is common within regions which experience both high and low levels of rainfall and are consistent with background levels which were consistently acidic before operations commenced.

DLP1, 5 and 6 record samples below the 4.2pH interim target. This presents a more acidic pH level than the target range. This is considered to have been caused by significantly high levels of rainfall following dry periods and generally low lying environments conducive to acidic soils (<4m AHD). It is probable in this regard that organic acidity has leached in to the shallow ground water from surrounding low lying soils during rainfall events. The majority of results present within the target range and therefore the sampling for the year in considered to be generally consistent with the EMP requirements and background readings.

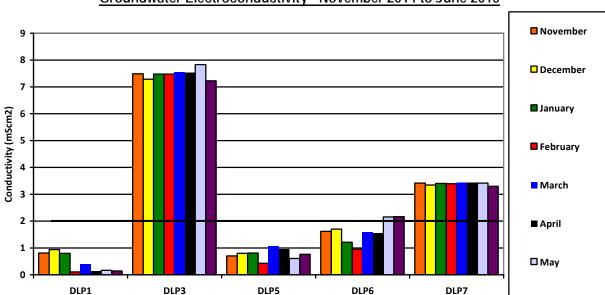
Figure 2: Dunloe Sands - Ground Water - Chemical (EC Test) Results November 2014 to June 2015

The majority of the samples taken produce considerably low EC levels when compared to the EMP maximum interim target of 2.00mS/cm2. However, two samples sites; DLP3 and DLP7 present conductivity levels above the maximum interim target of 2.00mS/cm2 stated within the EMP (shown as a black line). These sites have also expressed similar levels of EC within background testing. This can be explained by the sampling wells being installed in the low-lying portion of the floodplain. The wells are adjacent to sections of Mooball Creek and the main agricultural drainage line which can be subject to tidal influences. It is therefore considered likely that some localised salinisation of surficial groundwater has occurred within the vicinity of monitoring locations DLP3 and DLP7, albeit at levels consistent with background readings.

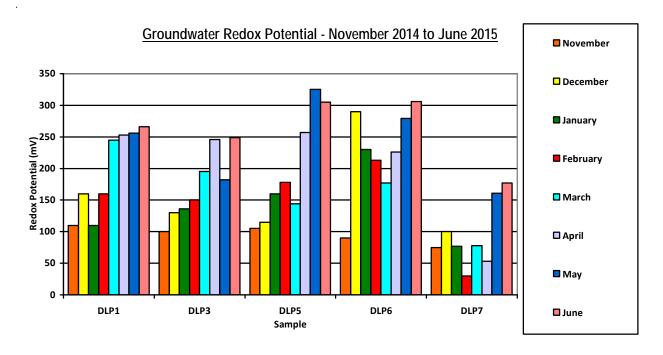
Figure 3: Dunloe Sands - Ground Water - Chemical (Redox Potential Test) Results November 2014 to June 2015

The EMP does not provide an interim target level for Redox Potential but instead states that results should be monitored for outlier samples. All samples present in a uniform manner, with no outliers present. High levels generally correspond with higher than normal periods of rainfall.

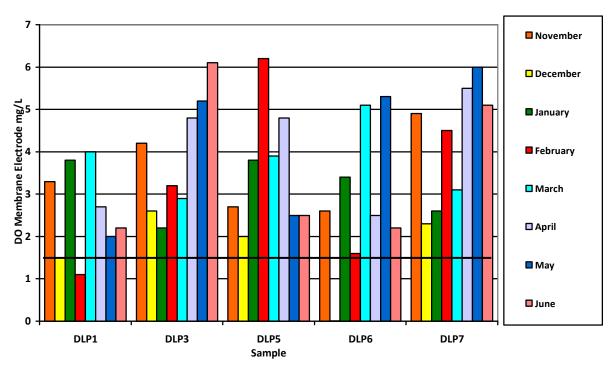
Figure 4: Dunloe Sands - Ground Water - Chemical (DO Test) Results November 2014 to June 2015

The minimum DO level provided within the EMP is 1.5mg/mL (shown as a black line). The results vary in DO levels considerably with the majority not presenting or conforming to a pattern over the monitoring period. The majority of the groundwater samples that were collected are above the minimum interim target however one sample collected from DLP 1 presented levels below the target. The improvements in DLP 7 & 3 continue to be pleasing and reverse the trend from the previous periods.

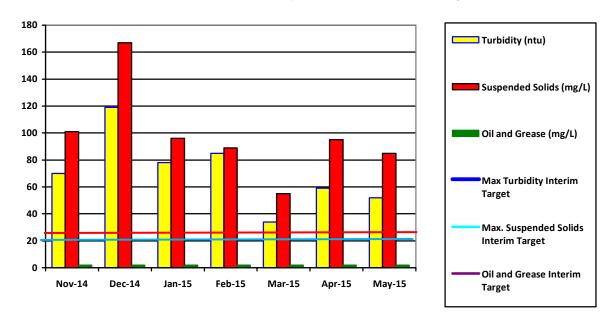
Figure 5: Dunloe Sands - Lake - Chemical Results - November 2014 to May 2015

Interim target levels for turbidity present a maximum level of 20ntu within the EMP. The levels recorded over the monitoring period show levels above the maximum levels during the majority of samples, primarily it is considered due to the presence of the dredging apparatus on site which would understandably increase turbidity levels. In this regard, the site does not have a permanent dredge on site, rather it relies upon the hire of a suitable machine after which stockpiles are created. It is also noted that well over 1000mm of rain has been recorded in the monitoring period corresponding with high turbidity readings. This is entirely expected given both high rainfall and active dredging.

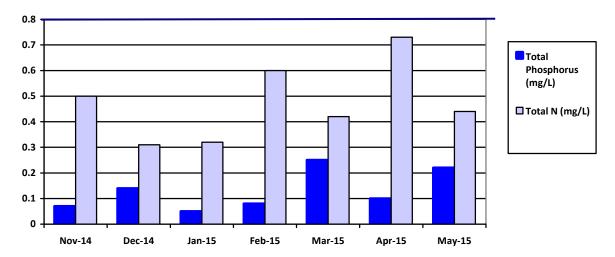
Figure 6: Dunloe Sands - Lake - Chemical Results - November 2014 to May 2015

Total phosphorus levels have a maximum interim target of 0.8mg/L (shown as red line). All sample data results in levels of below the maximum interim target levels contained within the EMP.
