Donazzan's Dam- Pakenham Quarry

Intermediate Inspection

Client: Holcim (Australia) Pty Ltd

08-Jan-2021

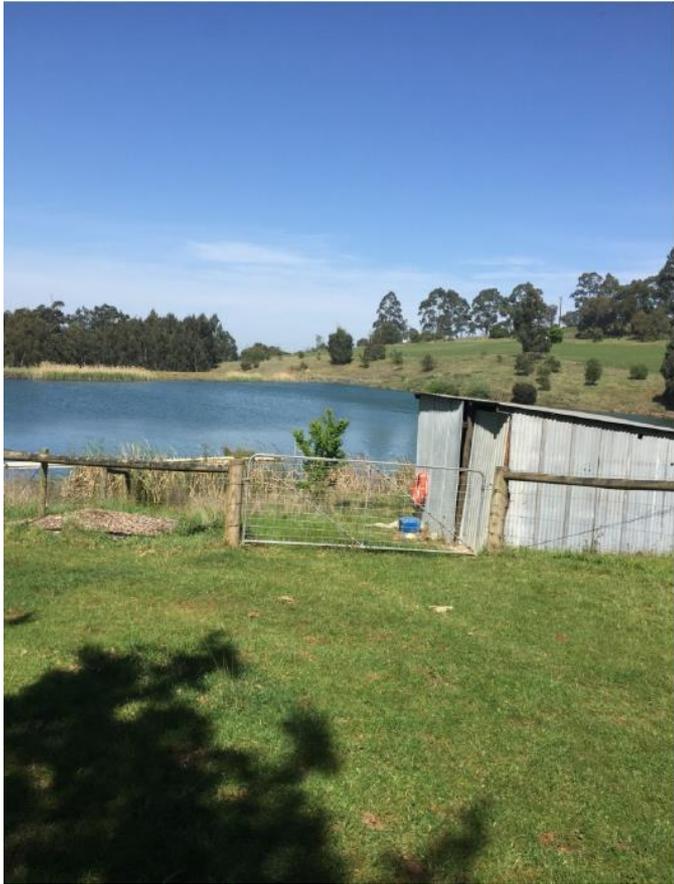
Photo A-1 is a general view of the Donazzan's Dam taking from the south end. It shows the vegetation has ground along the perimeter of the water reservoir. At the left hand of the photo we see the old inlet pipe that has been left in place to serve as a bird perch.

a) 2015 – General View of Donazzan's Dam
(Coffey, 2015)

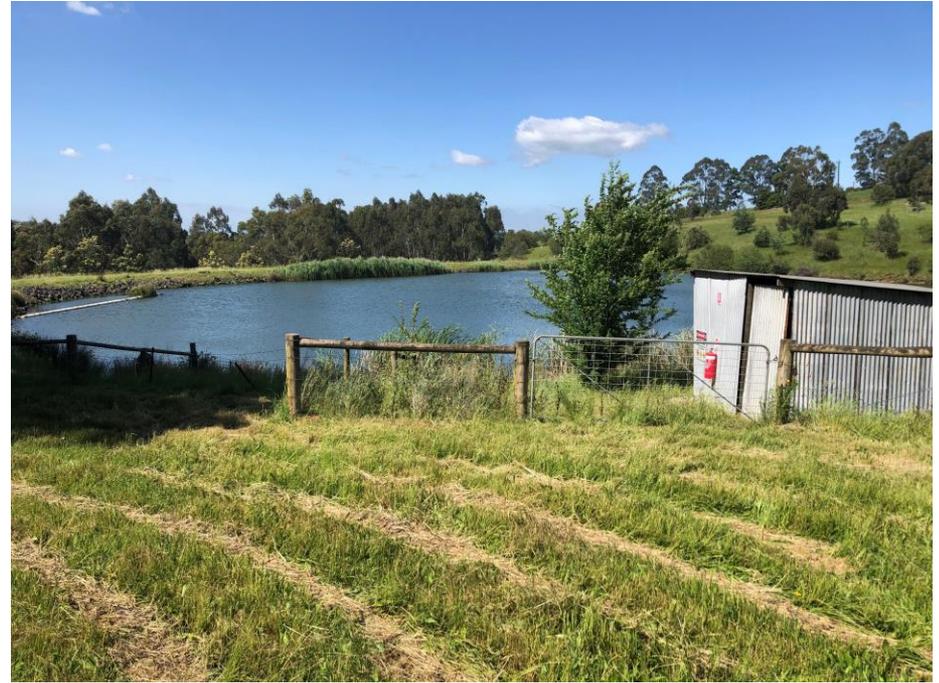
b) 2020 – General View of Donazzan's Dam

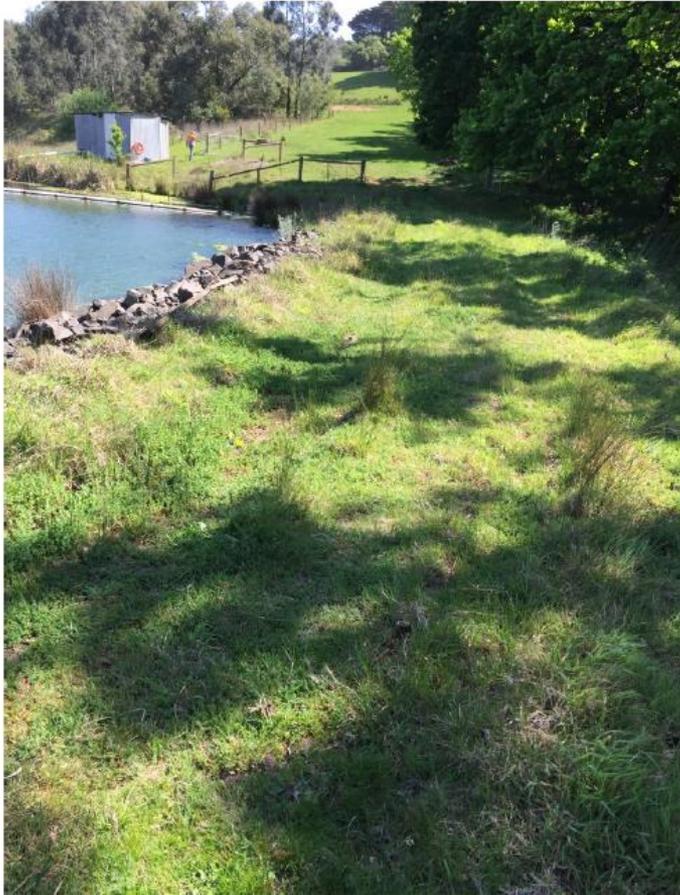
During the AECOM 2020 inspection, the Quarry Manager indicated us that they had backfilled the wheels ruts in the dam crest that were identified during previous inspection. These works were observed during the inspection and the Dam crest shows less sign of wheels ruts as seen when comparing Photos A-2a and A-2b respectively taken in 2015 and 2020.

a) 2015 – Wheels Ruts in the Crest Dam

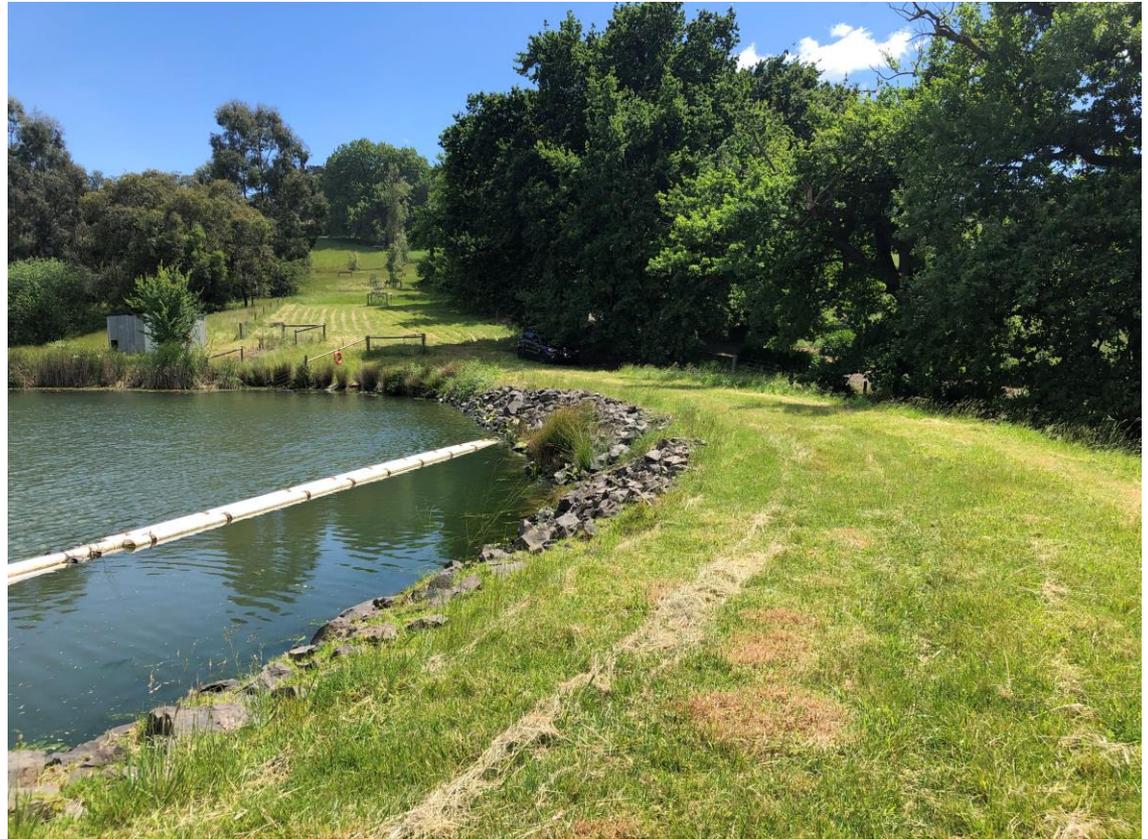
b) 2020 – Crest Dam

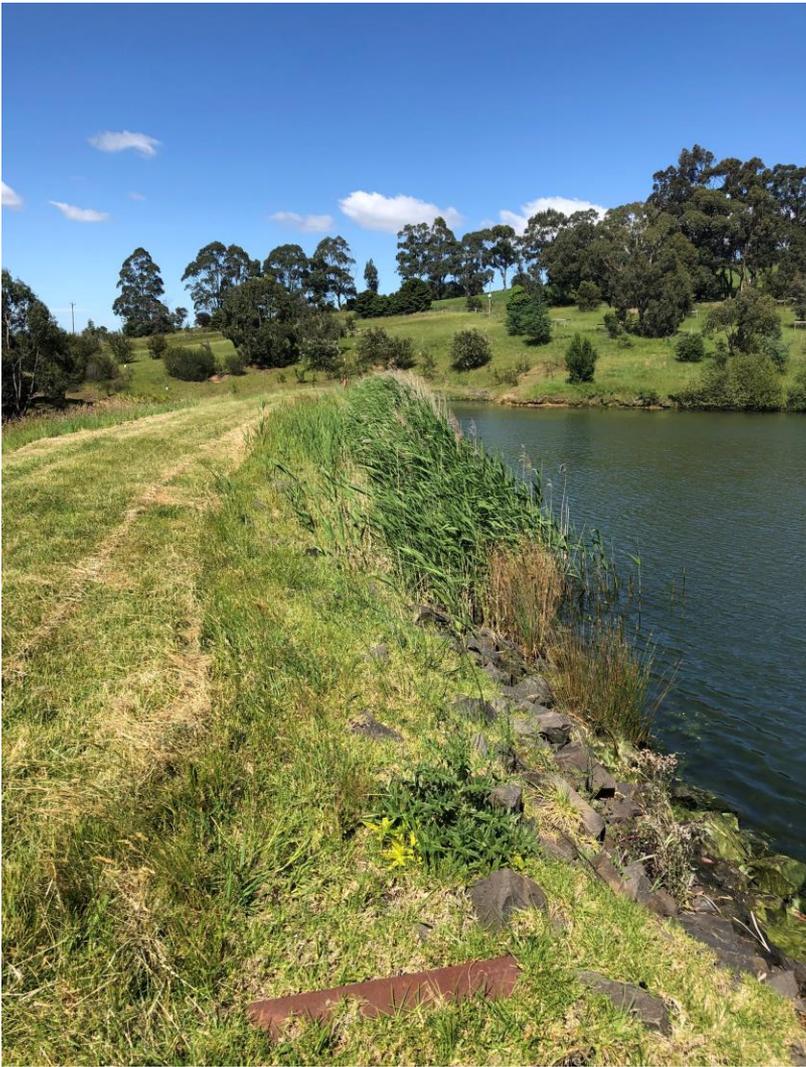
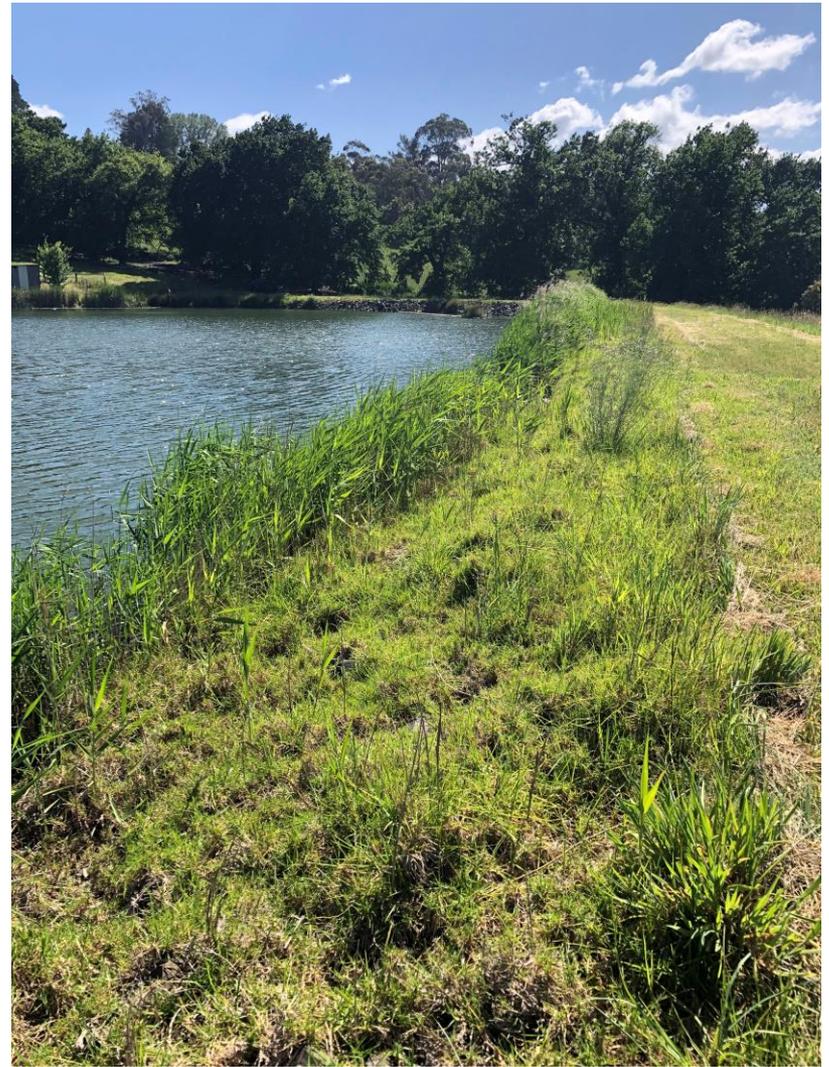
Figure A-3 shows the presence of reed along the upstream edge of the embankment, limited in area and consistent with the 2015 inspection.

We have noted, and it was confirmed by the quarry manager, that additional beaching material has been placed on the upstream slope of the dam over an extent of about 20 m starting at mouth of the emergency spillway as shown in Figure A-5 in Appendix A.

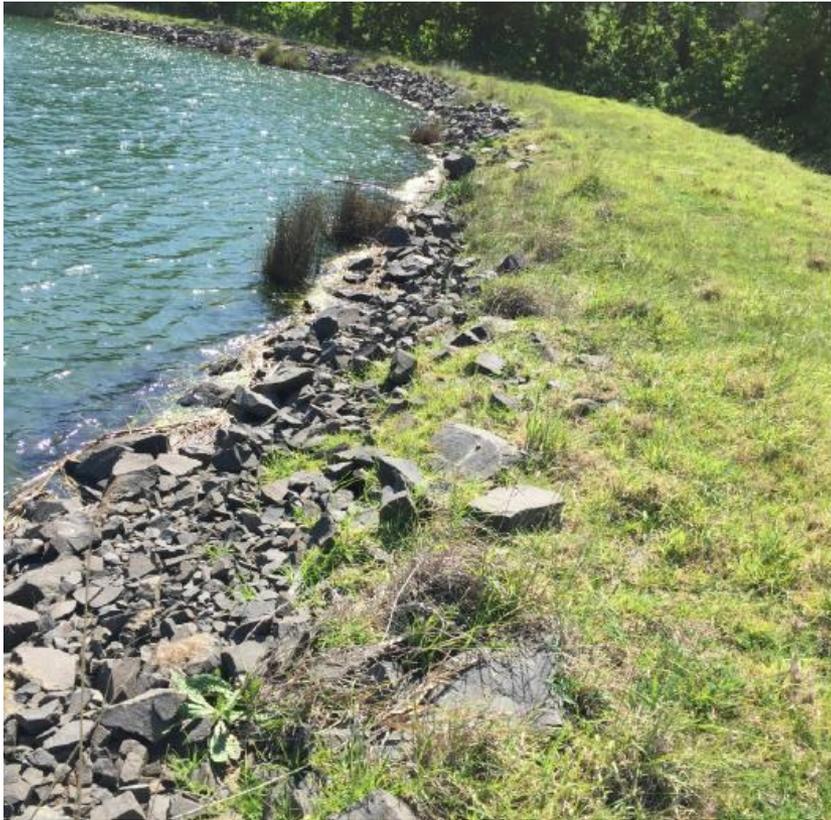
Beaching, comprising 50 to 150mm diameter crushed rock, is present along the south-eastern edge of the dam, to reduce erosion of the embankment due to wave action. Photo A-4a and A-4b show the beaching condition in 2015 and 2020 respectively, and we note that it is in good condition.

a) 2015 – Beaching in the Downstream Slope
(Coffey, 2015)

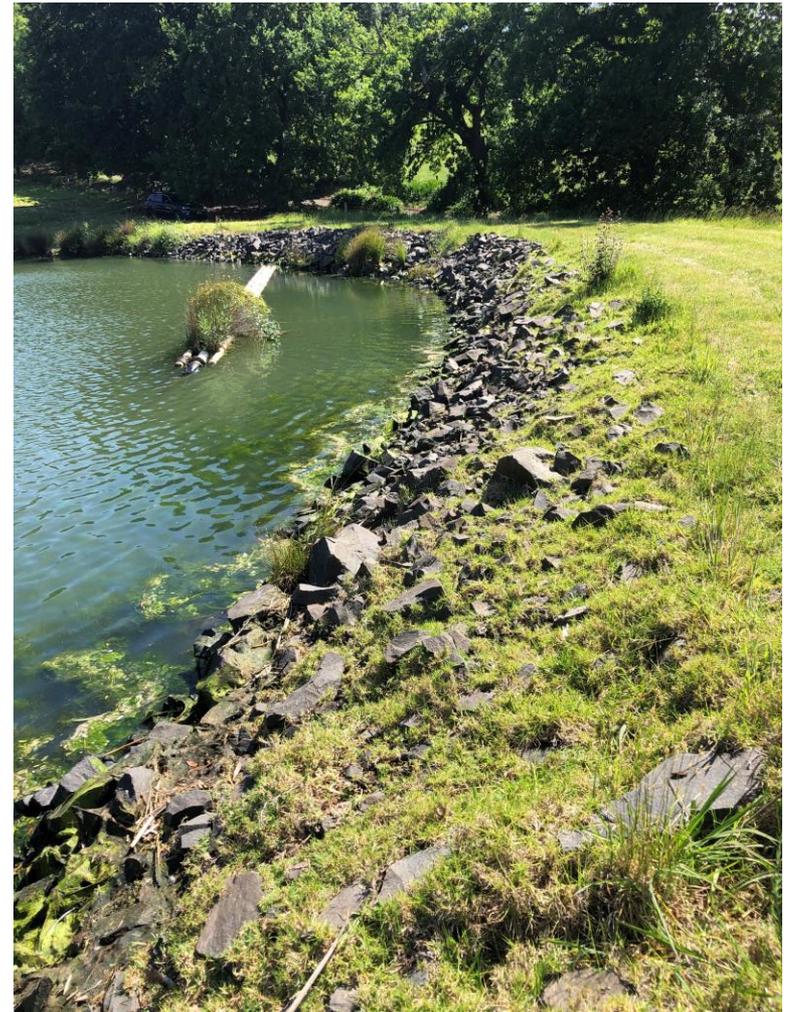
b) 2020 – Beaching in the Downstream Slope

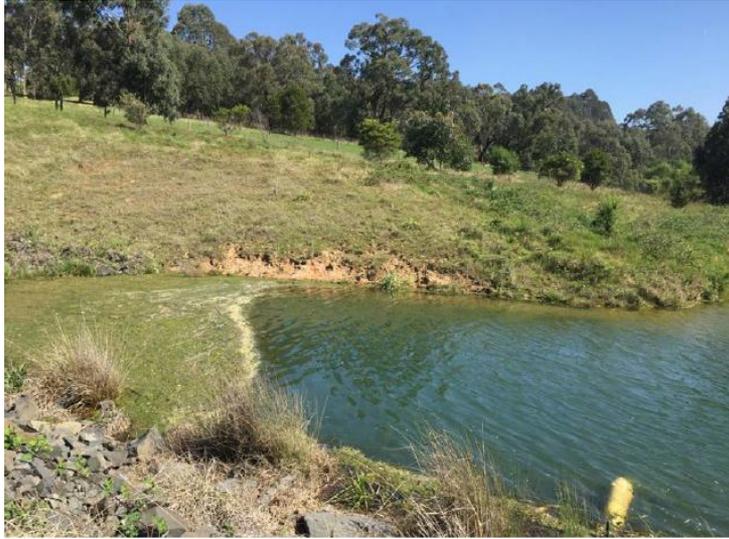
During the AECOM 2020 inspection, erosion of the upstream reservoir banks within the natural hillslopes close to the spillway inlet has been noted. This was also noted in previous inspection. Photo A-6a and A-6b taken in 2015 and 2020 respectively show that erosion has continued in the past year with increase areas of sandy beaches. Photo A-7a and A-7b show that erosion also occurs in the slope upstream of the spillway. Vegetation has been implemented in these areas to help minimise erosion in the slope.

a) 2015 – Erosion of the Banks (Coffey, 2015)

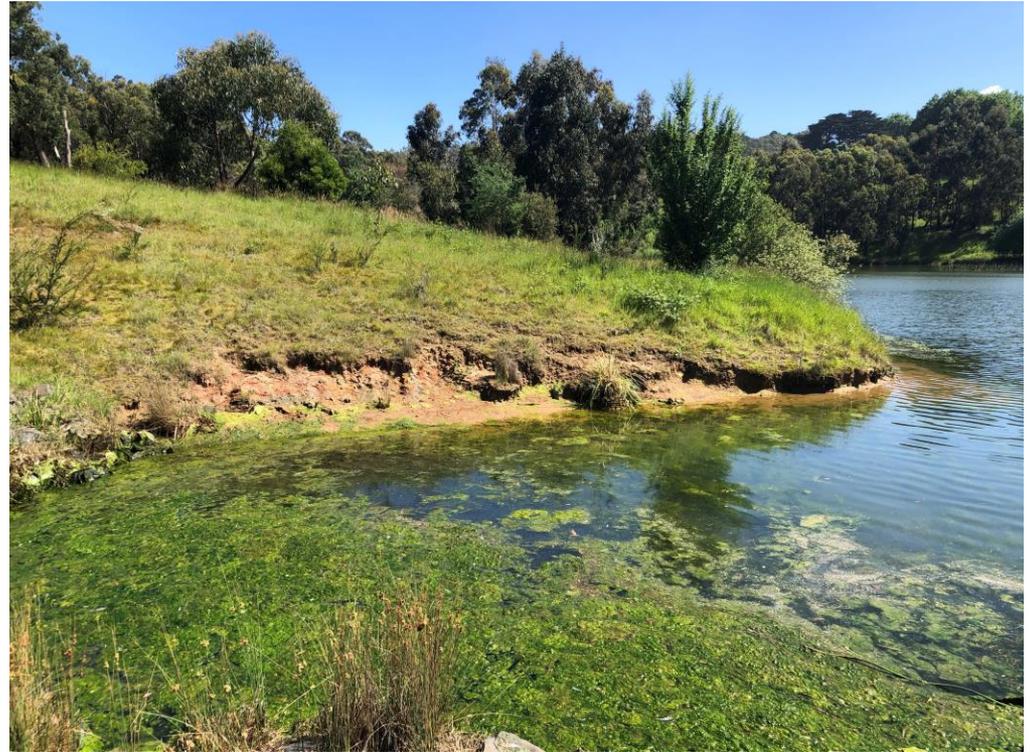
b) 2020 – Erosion of the Banks

We recommend that the erosion of the spillway channel and side walls be monitored following each spill event and major rainfall events.

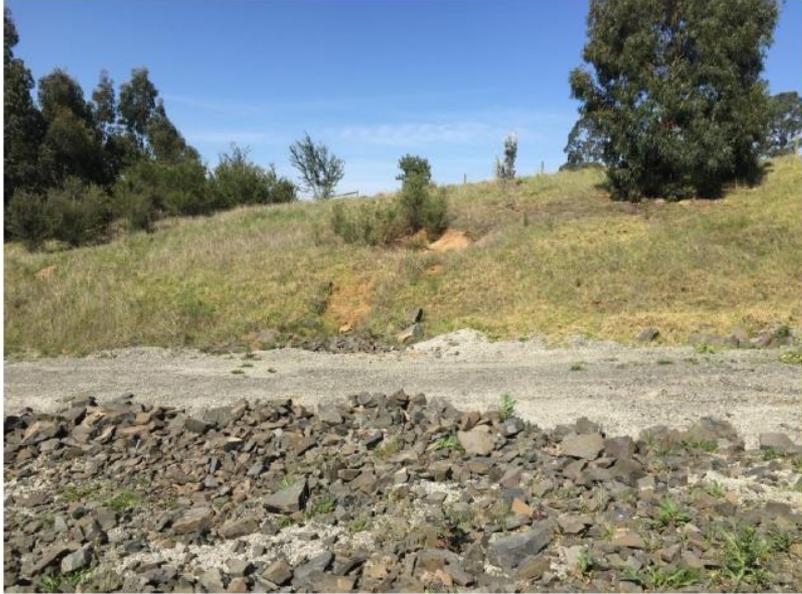
a) 2015 – Erosion in the Slope Upstream of the Spillway (Coffey, 2015)

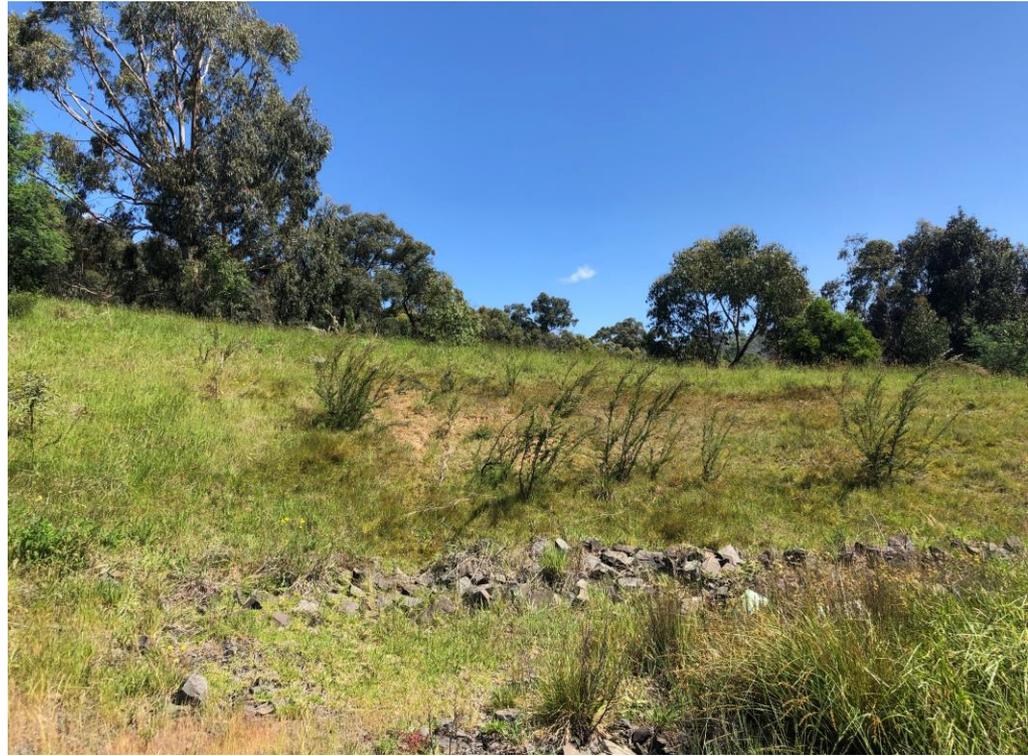
b) 2020 – Erosion in the Slope Upstream of the Spillway

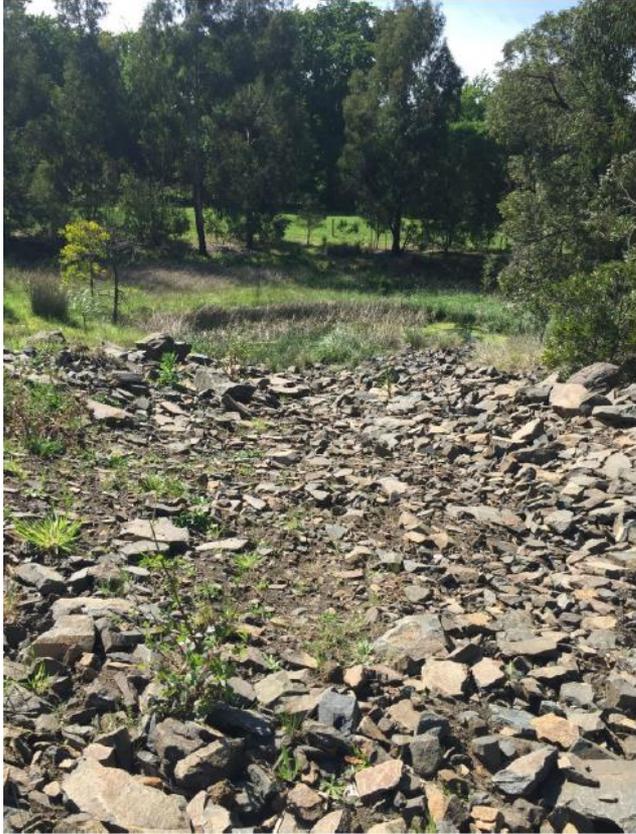
Additional rip-rap was placed within the emergency spillway extent following a flood event that occurred in 2019 and washed away an important part of the rip-rap (see Photo A-8a and A-8b).

a) 2015 – Emergency Spillway (Coffey, 2015)

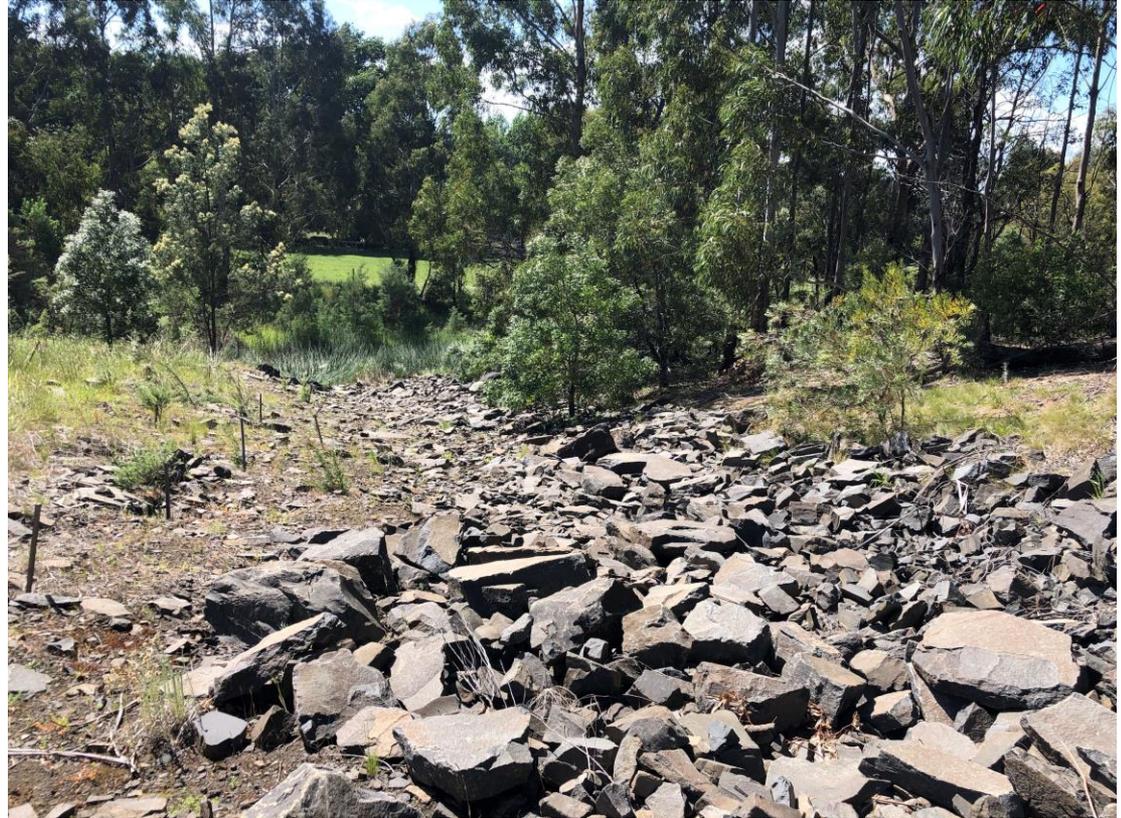
b) 2020 – Emergency Spillway

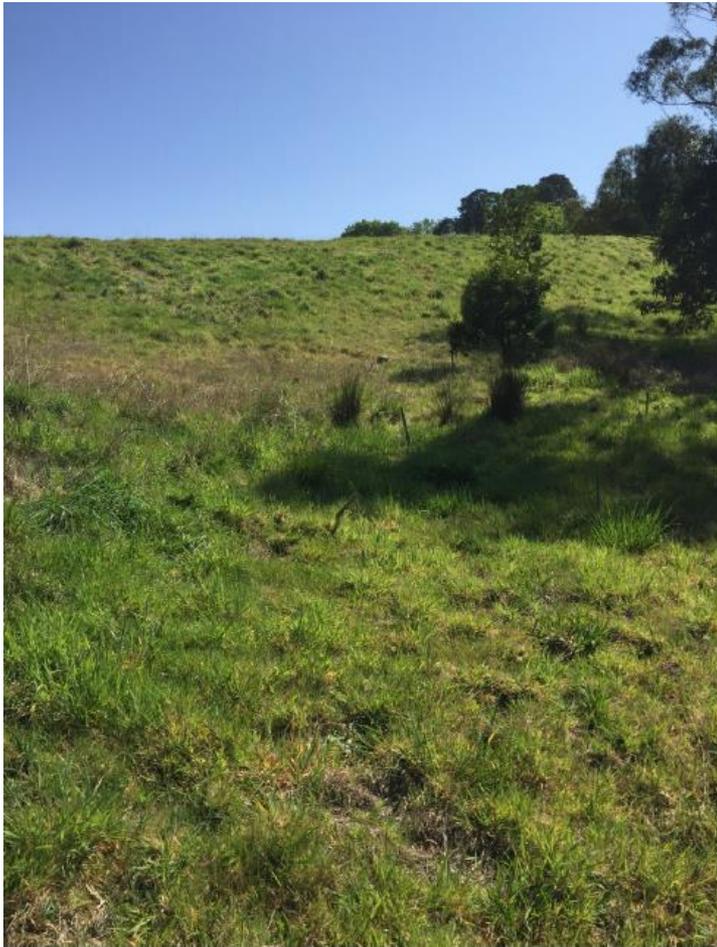
Vegetation and tall grass are present in the downstream slope and at the toe of the Dam which makes it harder to identify movements of material and seepage areas in the slope and at the toe of the dam. During the site inspection no abnormalities were identified. It was noted that planting of vegetation is carried out at the toe of the dam close to the spillway. No toe drain is present at the Donazzan's Dam. Photo A-9a and A-9b taken in 2015 and 2020 respectively show the downstream toe.

a) 2015 – downstream slope view from the toe (Coffey (2015))

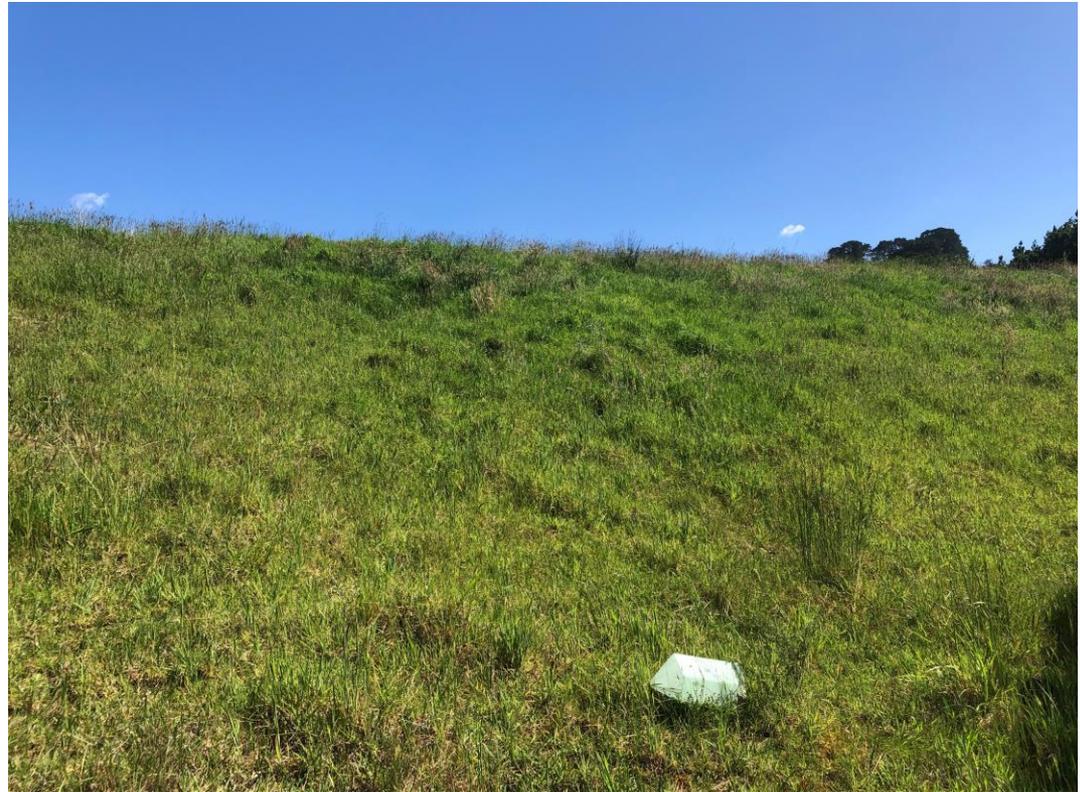
AECOM Imagine it. Delivered.	Client : Holcim Pty Ltd	Project : Donnazan's Dam Intermediate Inspection
	Photo A - 9 : Downstream Slope View from the Toe

b) 2020 – downstream slope view from the toe

We recommend that any trees/shrubs growing on the embankment or within the spillway chute to be removed. No trees or shrubs should be planted on the embankment.

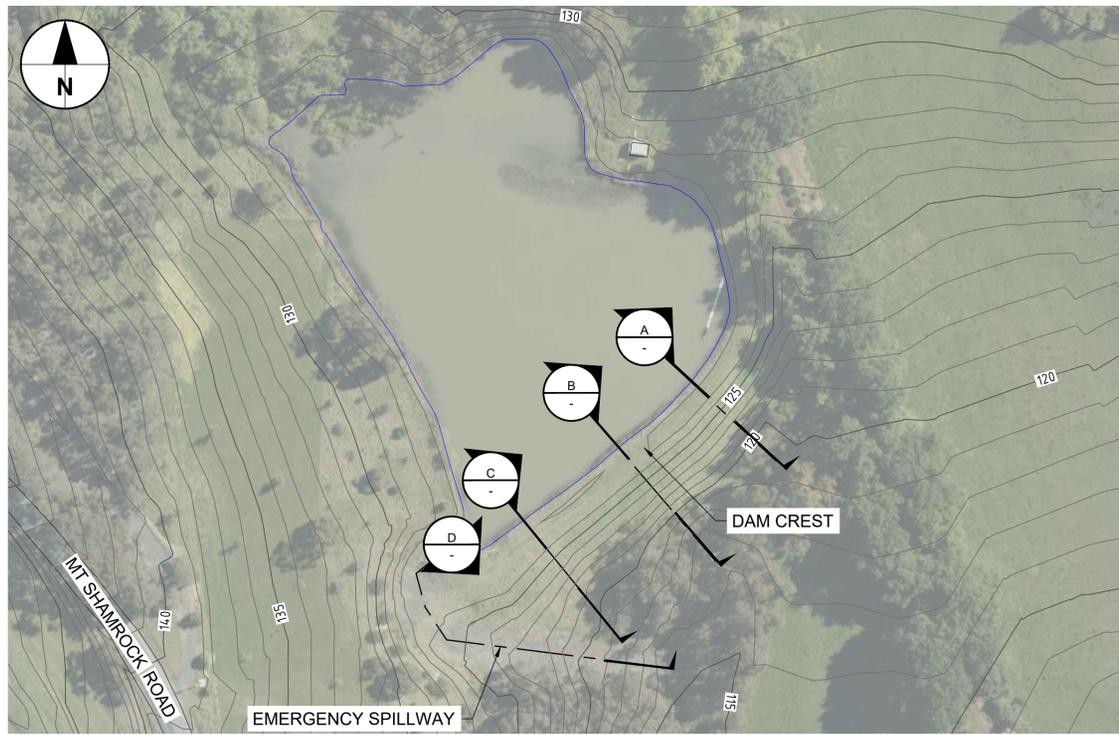
PLAN
Scale 1:1000

- Dam Cross-section B indicates that the crest is lower than in 2015, and the crest elevation is inconsistent along the crest with the lowest point at about RL 127.0 m. The plan-view also indicates that the western part of the dam is below RL 127.0m. In the initial design, the crest elevation was at RL 127.4 m and was used to determine the FSL (1m below the crest elevation). It would be important to confirm the current elevation of the crest and review the FSL accordingly. We recommend that the crest elevation is built up to be made consistent along the length of the crest at RL 127.4 m to maintain the design freeboard allowance.

- The survey provided should be updated with the following and the drawing in Appendix B updated to include:
 - the location of the existing standpipe piezometers

- Extent of riprap within the spillway
 - The location of inlet and outlet pipes.

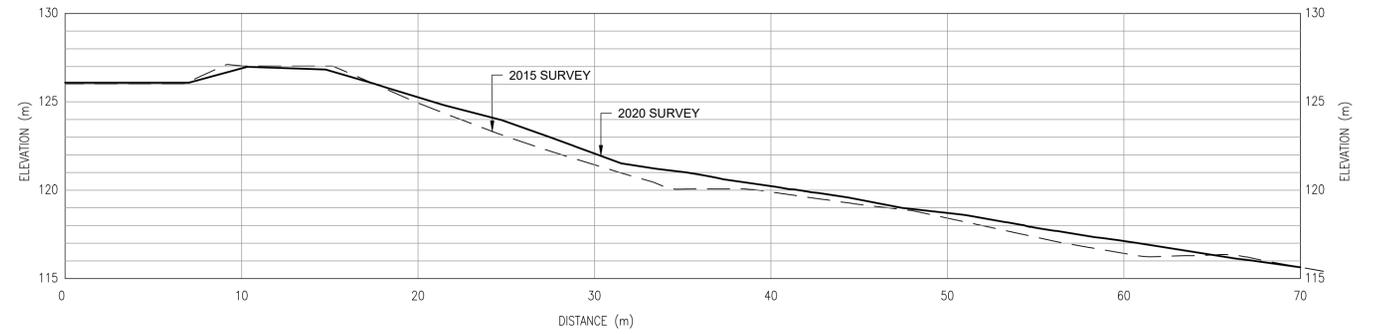
C | DAM CROSS-SECTION
SCALE 1:200

- Dam Cross-section C shows modifications have been made to the crest of the dam with reduction in width to approximately about 5 m wide.
- The longitudinal section of the emergency spillway confirms that it has been backfilled with riprap material in the slope and at the mouth of the spillway.
