Matt Dodd
Quarry Manager- Pakenham
Holcim (Australia) Pty Ltd
95 Mount Shamrock Road, Pakenham

2019 Groundwater and Spring Review, Pakenham Quarry

AECOM Services Pty Ltd (AECOM) was engaged by Holcim (Australia) Pty Ltd (Holcim) to conduct annual monitoring and review of groundwater levels and spring flow/quality at the Mt Shamrock Quarry (WA174) in Pakenham, Victoria (the site) (see **Attachment 1- Figure 1**).

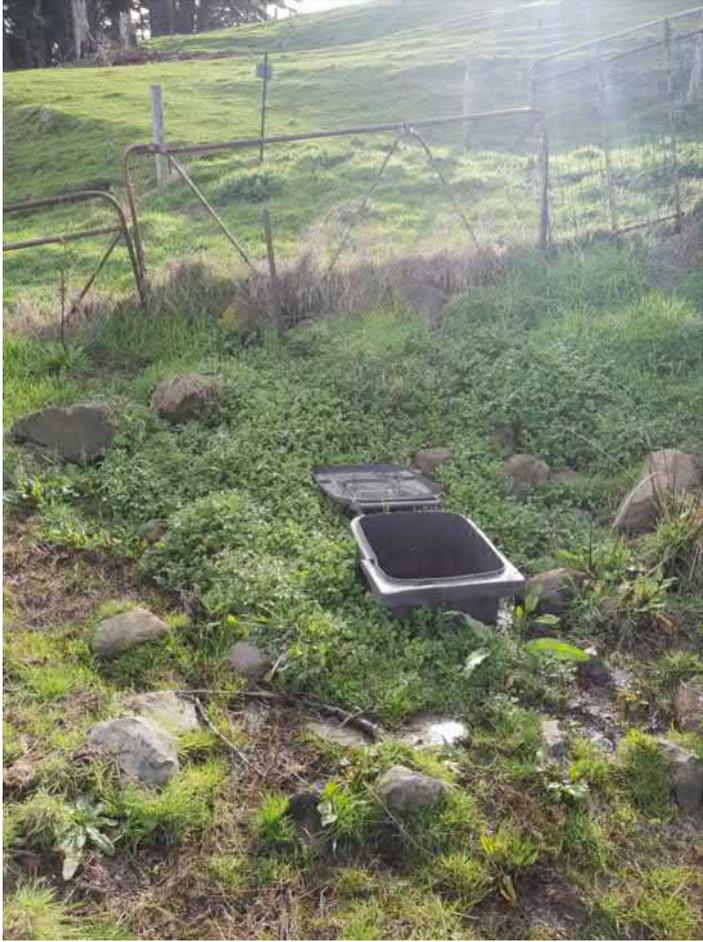
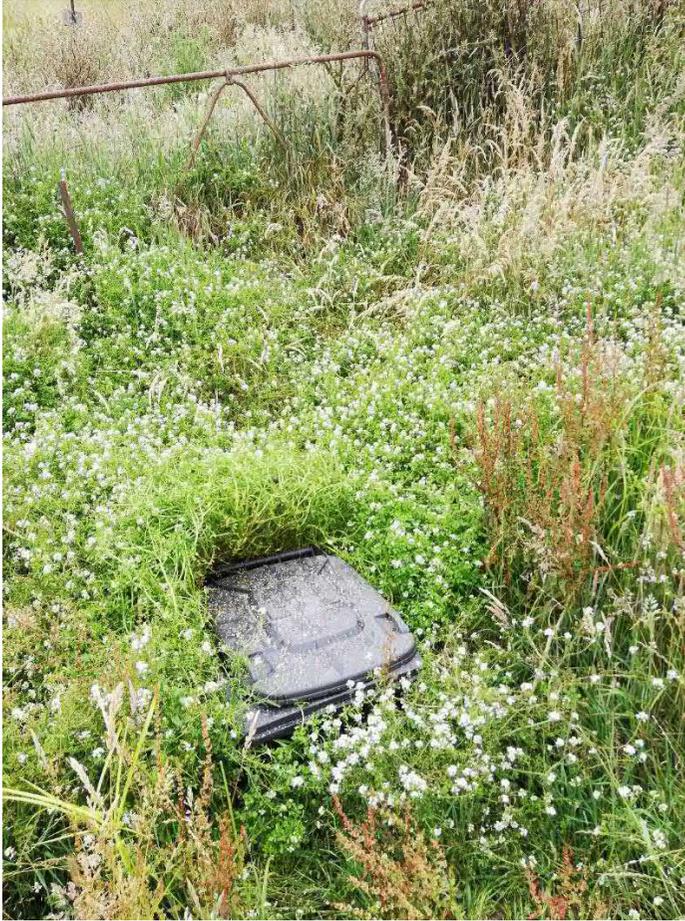
<p>Plate 1 Spring 1</p>

SP01 located to the west of the quarry site, provides irrigation and stock water to a number of properties in the local area. In December 2019 the area was observed to be boggy and vegetation in good health.

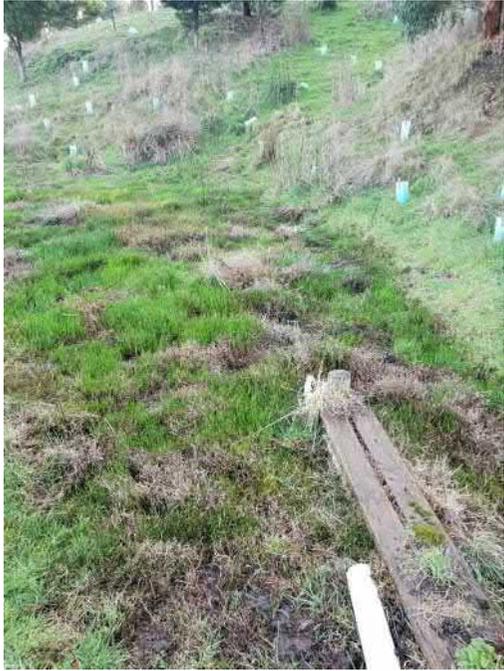
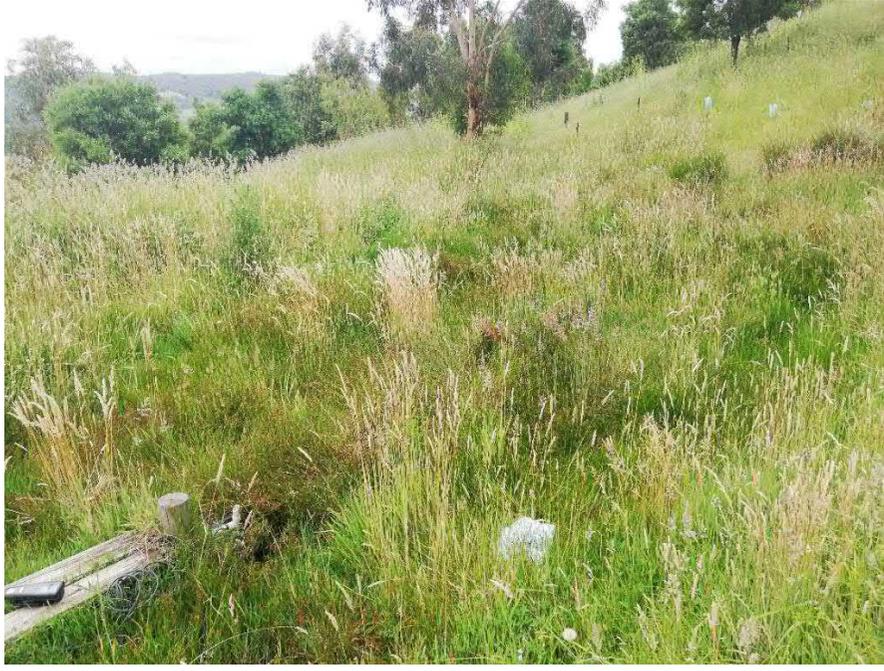
Plate 2 Spring 2

SP02 located to the west of the quarry, was observed to be a small dam feed by groundwater and surface water runoff from a relatively steep slope above. The area was fenced, with no flow measured.

The dam exhibits instability on the downslope face. It was previously understood that under heavy rainfall, the pond overtops resulting in erosion and instability on the face of the dam. The spring was noted to have the potential to break free of the wall constructed at the location to reduce flow down the slope. A tank is apparently planned to be constructed downgradient from which water is fed to, to reduce stress on the wall.

In December 2019 the spring was noted to be a deep pond with a large amount of overgrown grass. Water was not visible from a distance but when examined closely clear standing water was visible within grass. Although no flow was observed, troughs and tanks in the area were full.

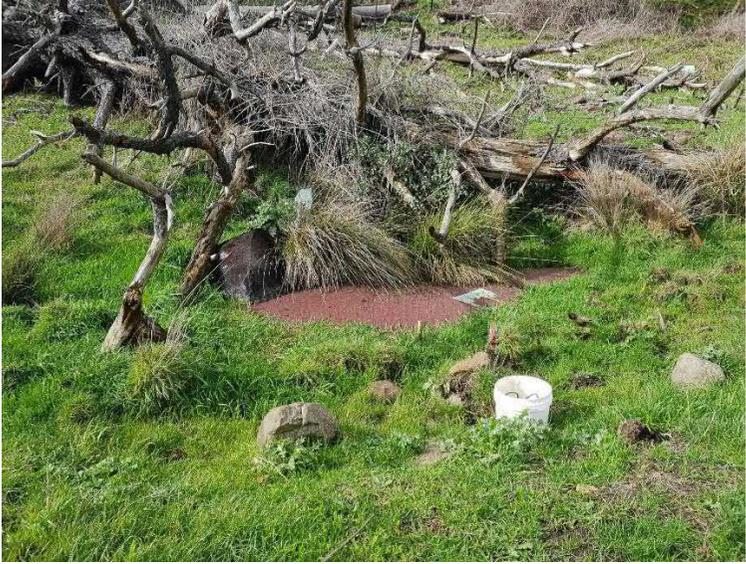
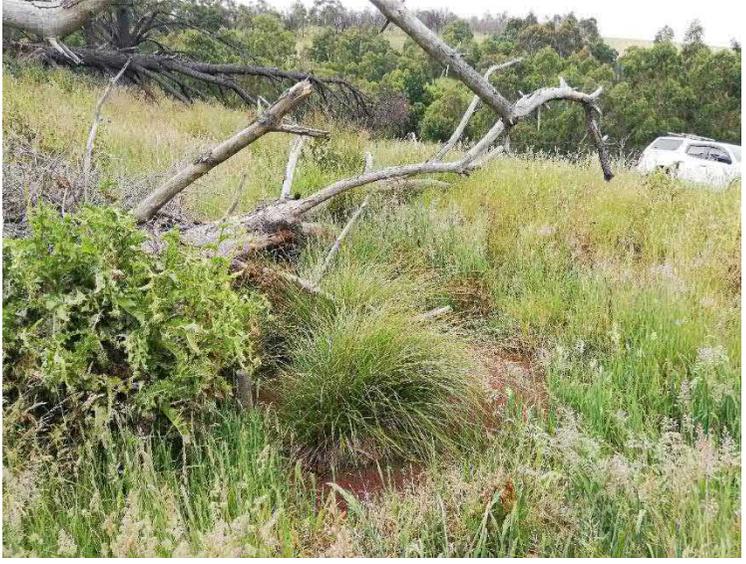
<p>Plate 3 Spring 3</p>

Vegetation in December 2019 was very healthy and the surrounding area boggy. Water was covered in floating vegetation. Flow was not observed.

Measured EC (812 $\mu\text{S}/\text{cm}$) values were within those historically reported (540-1,022 $\mu\text{S}/\text{cm}$). Following an observed spike in EC in 2016 values have stabilised at a lower level since then.

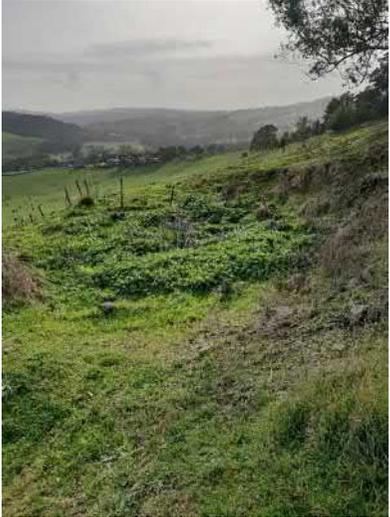
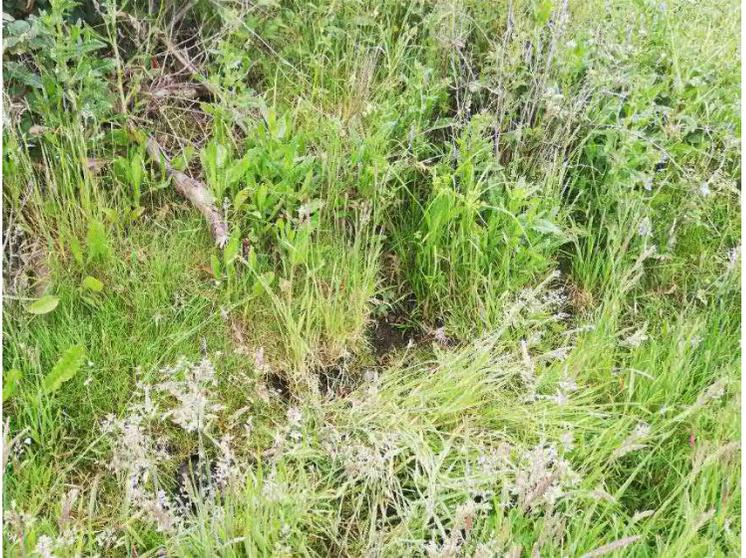
<p>Plate 4 Spring 4</p>

SP04 located to the north west of the quarry was noted to be overgrown in places. A small depression was observed down topographic gradient of the spring line and slope. The area has been fenced off, preventing livestock access.

In December 2019 a damp seep in exposed soil was observed. No standing or flowing water was present and water quality measurements could not be collected. Vegetation was thicker and greener than the surrounding area.

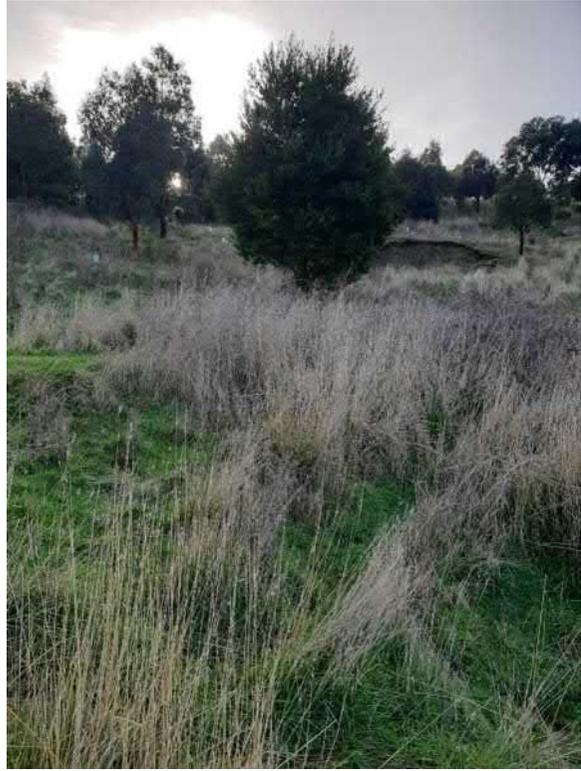
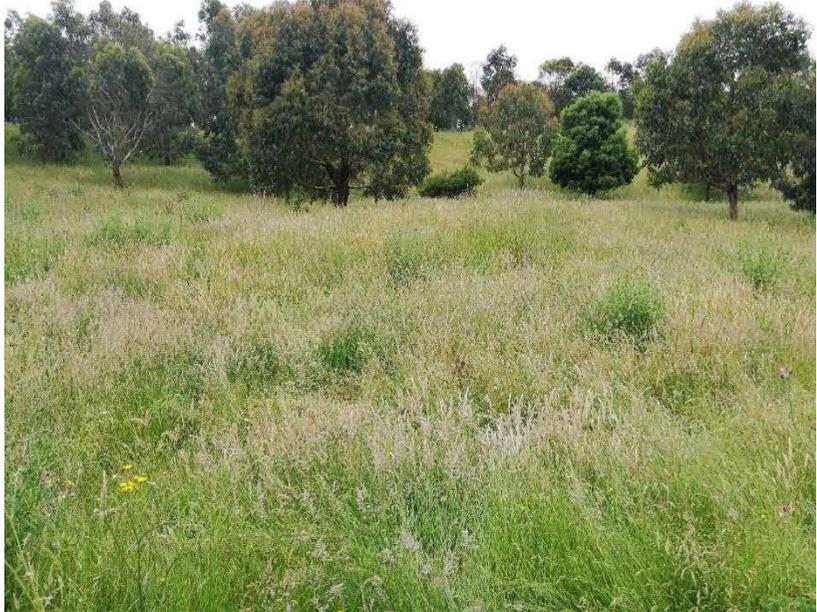
Plate 5 Spring 5

In December 2019 the spring was observed to be dry, as it has been since 2009, and water quality measurements could not be collected. Vegetation was taller and thicker than the immediately surrounding area.

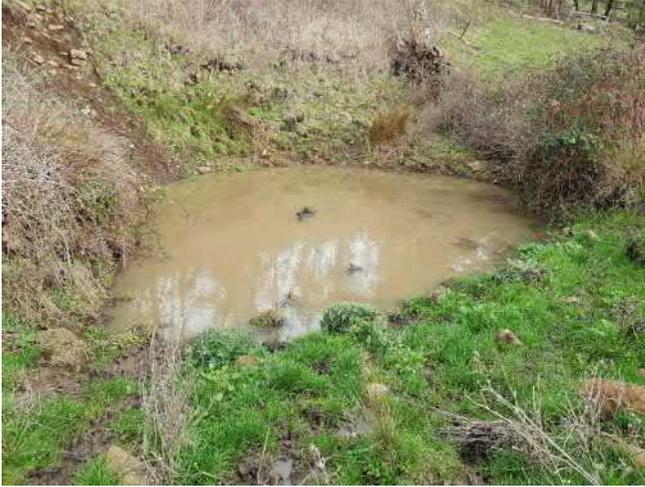
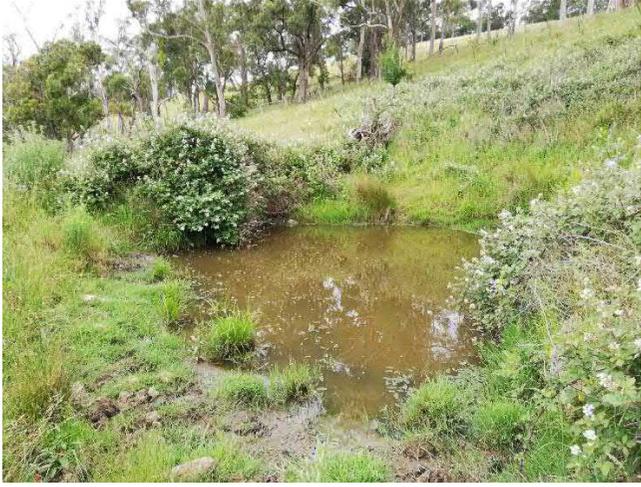
<p>Plate 6 Spring 6</p>

Spring water at SP06 accumulates in a collection pond accessible to livestock, with cattle prints observed. Pool at spring was noted to be stagnant and very boggy. The pool is approximately 15-20m² and up to 0.5m deep. EC was measured as 437.5 $\mu\text{S}/\text{cm}$, within the historical range.

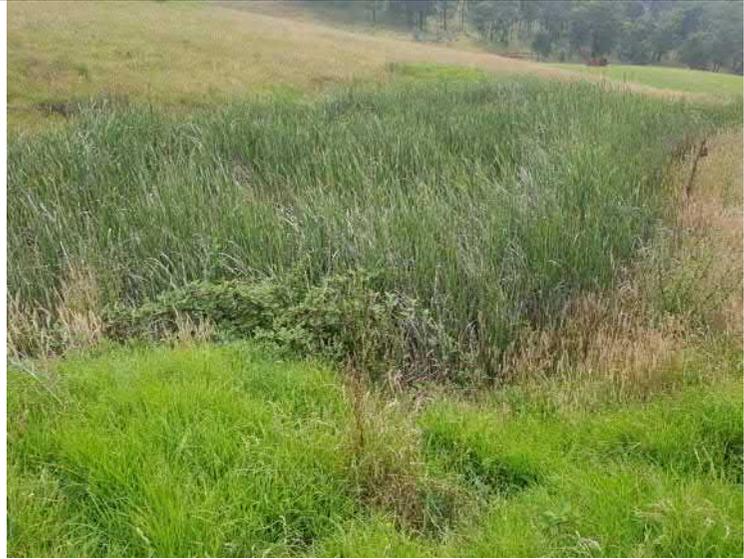
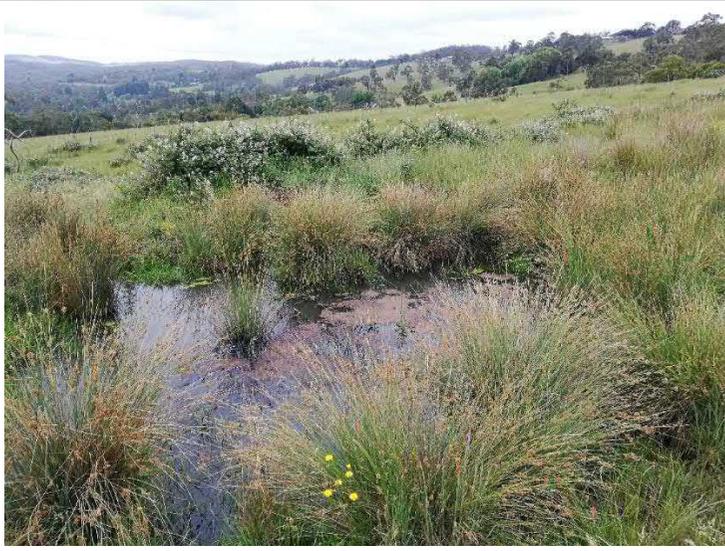
<p>Plate 8 Spring 8</p>

Spring is a wetland with a lot of reeds. EC was measured at 631 $\mu\text{S}/\text{cm}$, within the historic range but the EC at this spring shows high variability since observations began in 2001. A low amount of flow was observed down the slope from the wetland and oxidised orange precipitate was present.

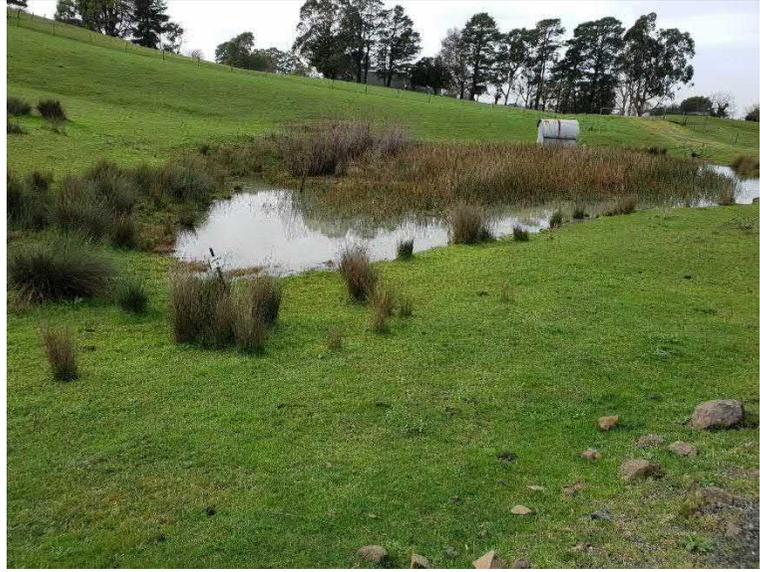
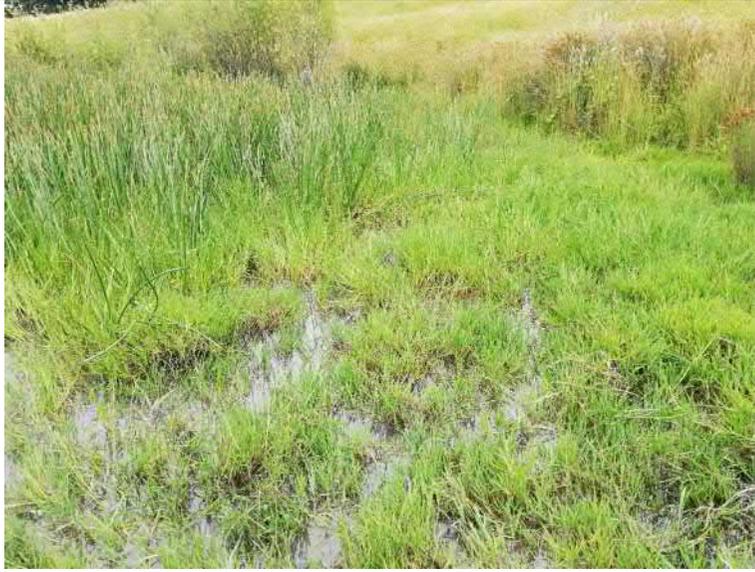
<p>Plate 9 Spring 9</p>

An access road was constructed in the vicinity of SP09 in 2014 and the access road includes a culvert installed underneath that diverts water away from the quarry. The topography of the area was noted to be slightly altered during the construction.

A pond of water was observed down gradient of the former SP09 location that is most likely a combination of seepage and surface water run-off, and is unlikely to have a significant groundwater contribution at the location observed.

In December 2019 the wetland was observed to have standing water and vegetation was thick and healthy. EC was measured as 1,231 $\mu\text{S}/\text{cm}$, within the historic range.

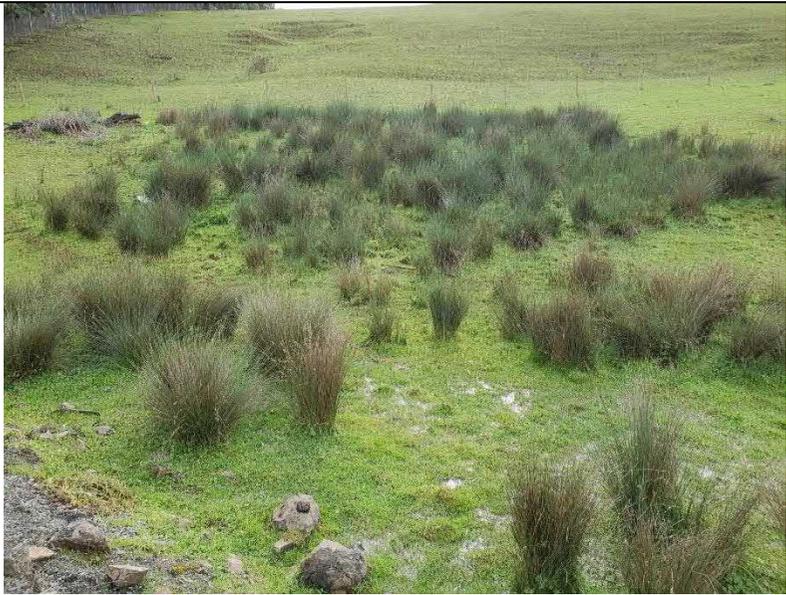
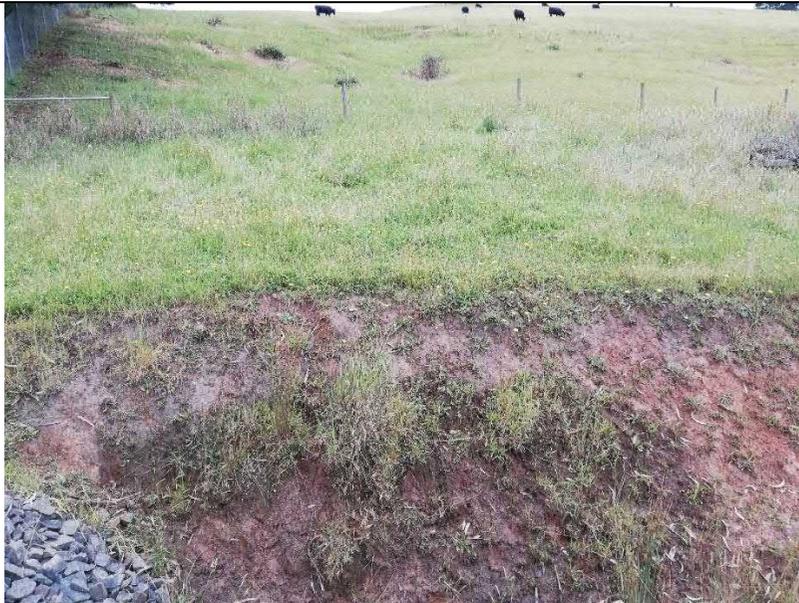
Plate 10 Spring 10

Similar to SP09, the monitoring point, SP10, was noted to be changed by the previous construction of an access road and culvert.

Monitoring has continued and the area has been recorded as dry since 2014, including in the recent December 2019 monitoring event when only a damp seep in the exposed embankment was observed.

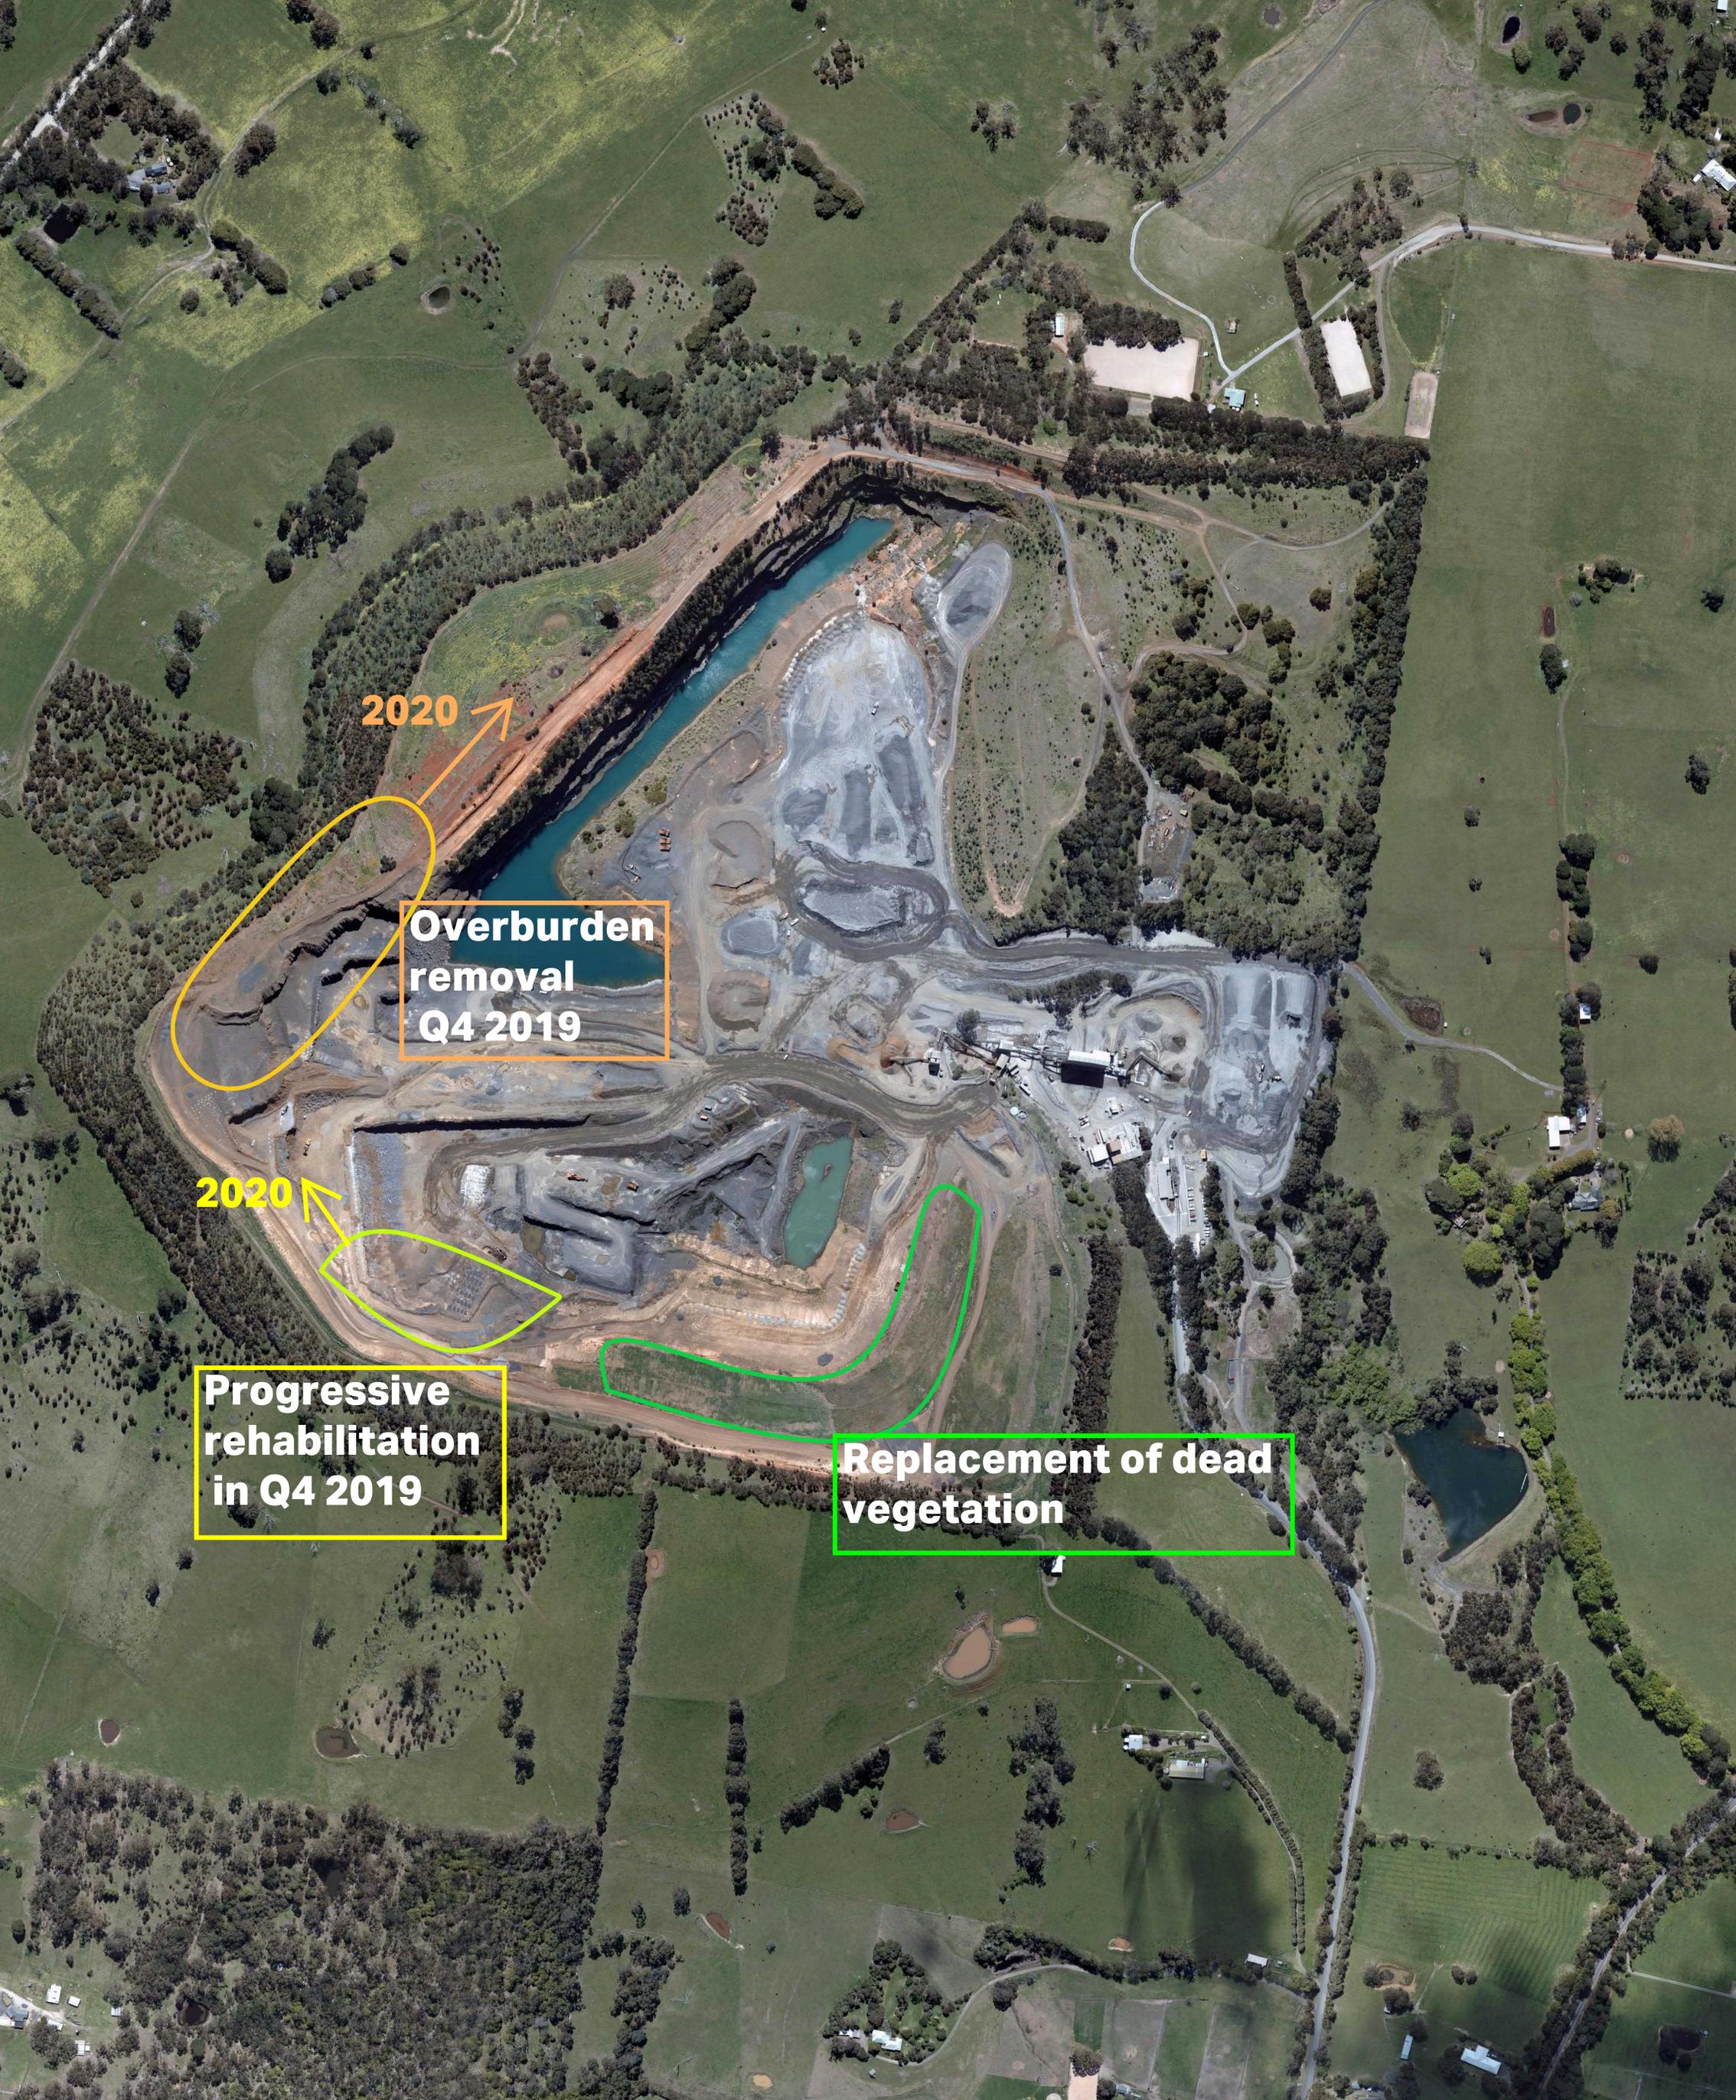
Areas of Progressive
Stripping and
Revegetation

Holcim continued rehabilitation works at the quarry in 2019. Previous revegetation efforts in the south east of the quarry were supported with dead vegetation replaced in this area (highlighted in green the aerial photograph in **Attachment 5**).

Overburden placement as part of the rehabilitation works will likely decrease infiltration and recharge and the shaping of the overburden will likely re-direct runoff. Although rehabilitated areas are comparably minor in relation to the overall quarry footprint, as rehabilitation continues the effect may become more apparent.
