27 January 2021

Matt Dodd
Quarry Manager- Pakenham
Holcim (Australia) Pty Ltd
95 Mount Shamrock Road, Pakenham

2020 Groundwater and Spring Review, Pakenham Quarry

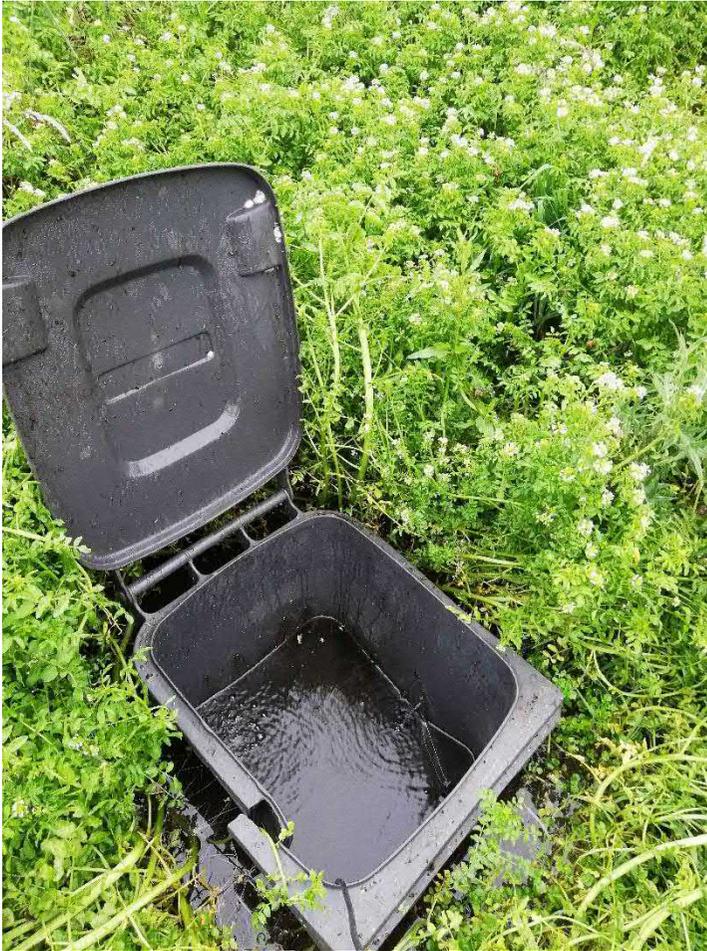
SP01 located to the west of the quarry site, provides irrigation and stock water to a number of properties in the local area. In December 2019 the area was observed to be boggy and vegetation in good health.

A black plastic container, possibly a rainwater collection bucket or a sample container, is shown with its lid open. The container is filled with dark, still water. It is placed in a field of lush green vegetation, including various grasses and small white flowers. The container is slightly tilted, and the water surface shows some ripples.	Plate 1 Spring 1

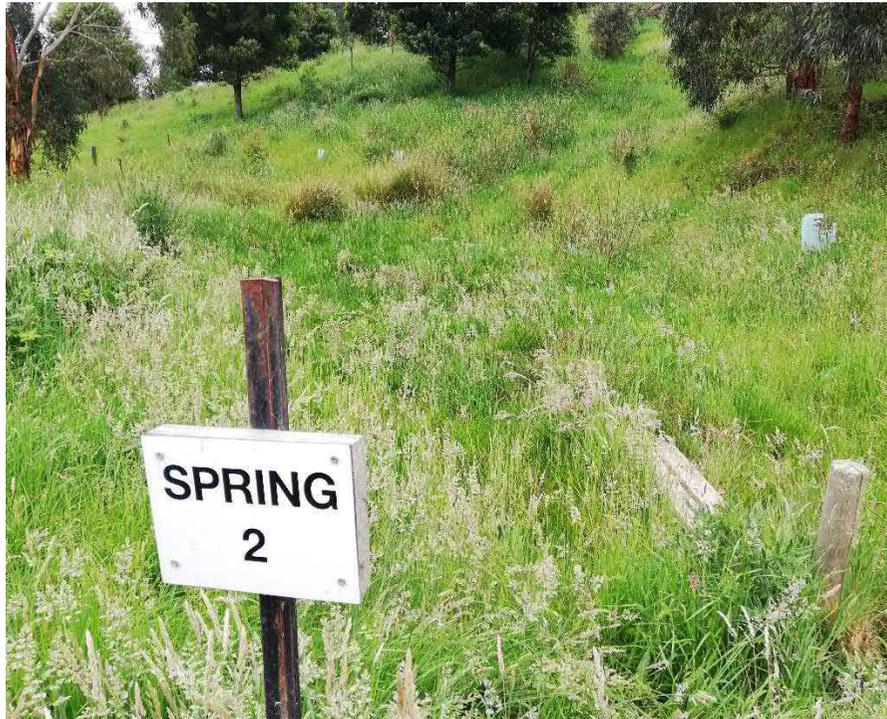
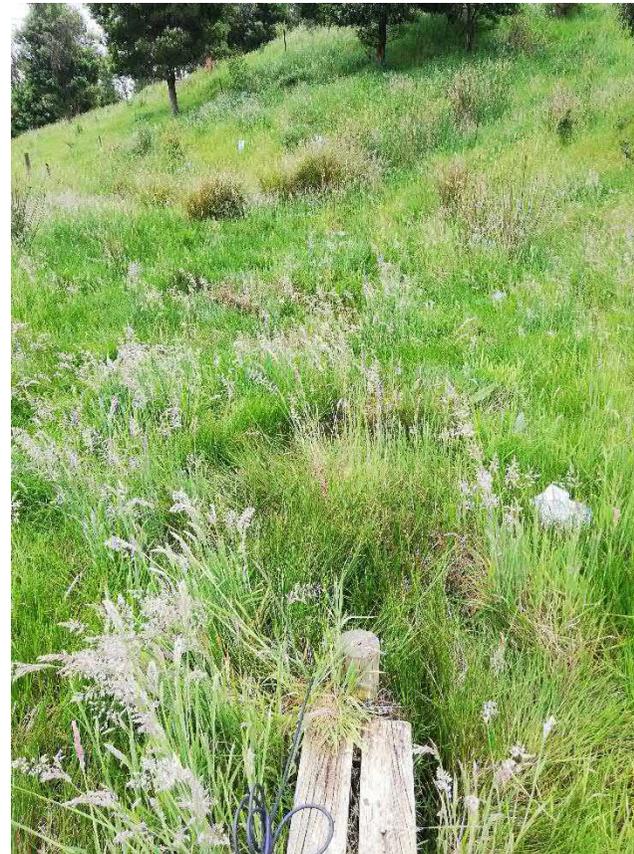
Plate 2
Spring 2

SP02 located to the west of the quarry, was observed to be a small dam fed by groundwater and surface water runoff from a relatively steep slope above. The area was fenced, with no flow measured.

The dam exhibits instability on the downslope face. It was previously understood that under heavy rainfall, the pond overtops resulting in erosion and instability on the face of the dam. The spring was noted to have the potential to break free of the wall constructed at the location to reduce flow down the slope. A tank is apparently planned to be constructed downgradient from which water is fed to, to reduce stress on the wall. This has not yet been constructed.

In November 2020 the spring was noted to be a have standing water with a large amount of overgrown grass. Water was not visible from a distance but when examined closely clear standing water was visible within grass. Although no flow was observed, troughs and tanks in the area were full.

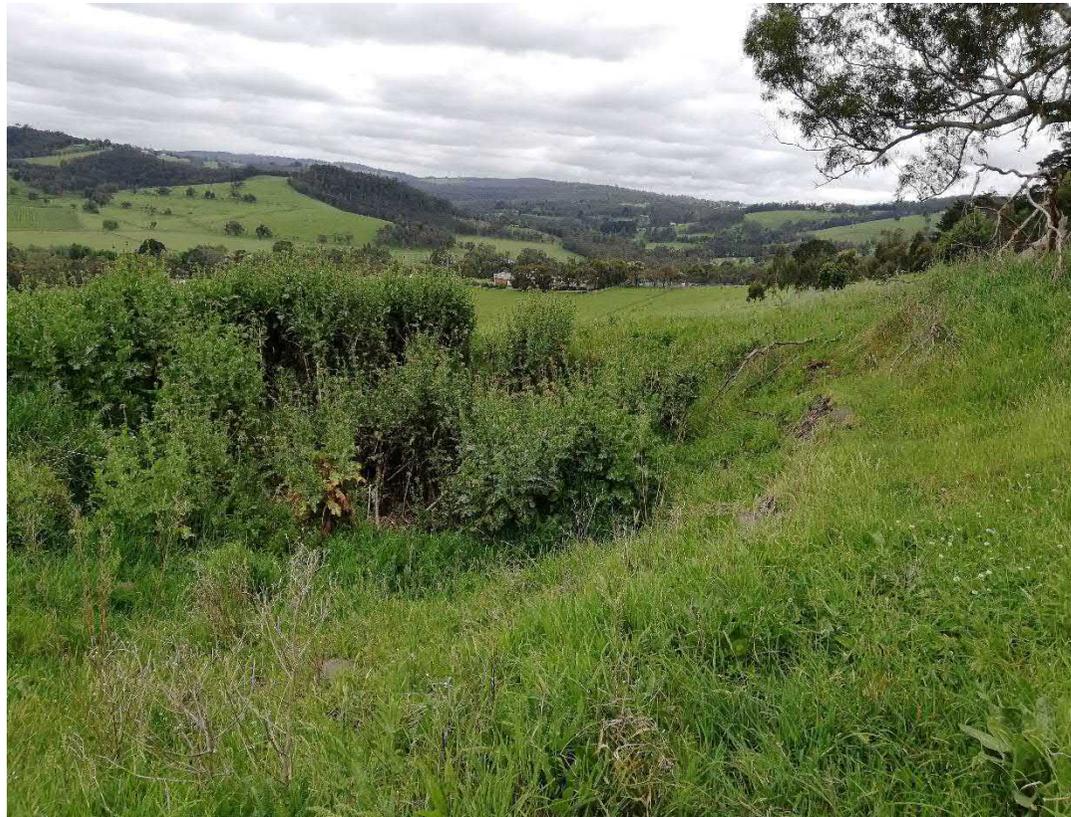
Plate 3
Spring 3

Vegetation in November 2020 was very healthy and the surrounding area boggy. Water was observed to be seeping down the slope.

Measured EC (697 $\mu\text{S}/\text{cm}$) values were within those historically reported (540-1,022 $\mu\text{S}/\text{cm}$). Following an observed spike in EC in 2016 values have stabilised at a lower level since then.

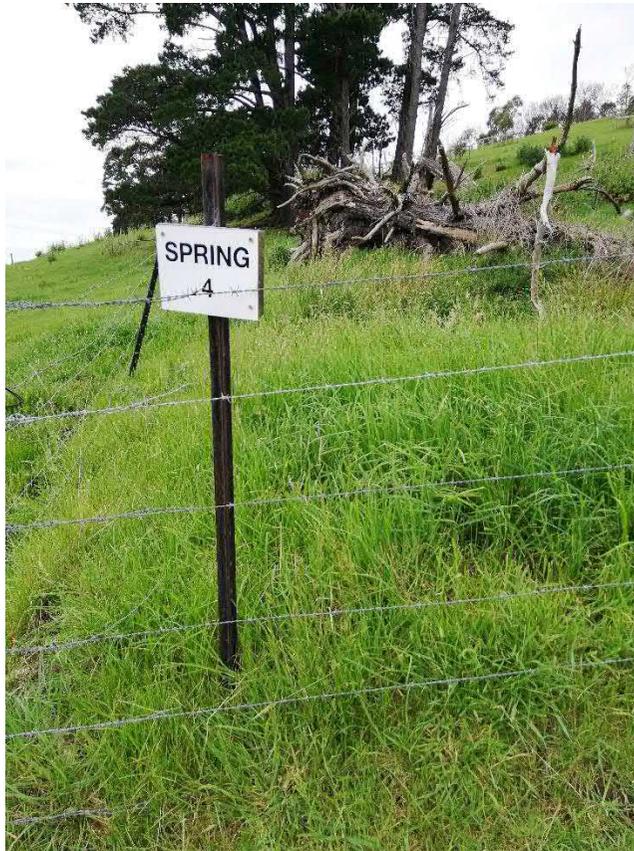
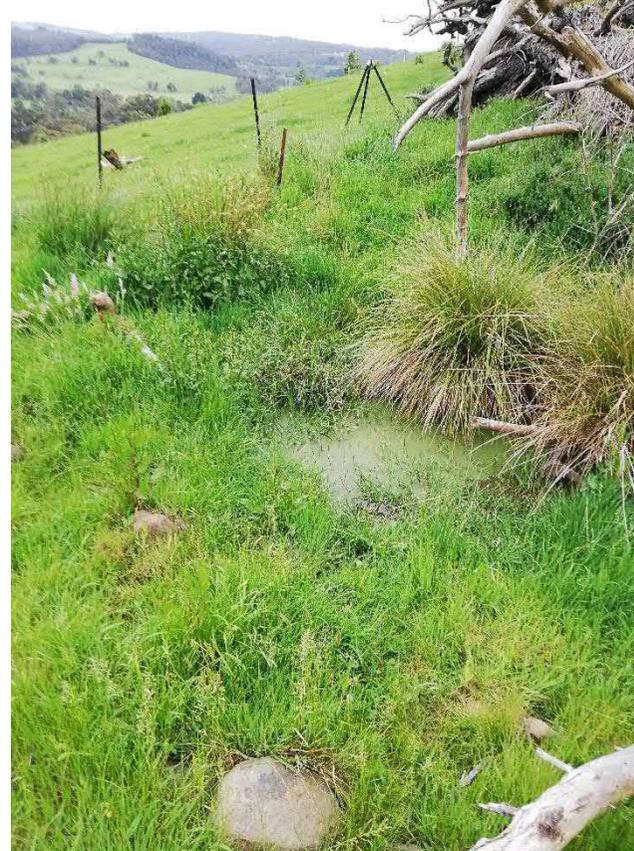
Plate 4
Spring 4

SP04 located to the north west of the quarry was noted to be overgrown in places. A small depression was observed down topographic gradient of the spring line and slope. The area has been fenced off, preventing livestock access.

In November 2020 a damp seep in thick vegetation was noted. No standing or flowing water was present and water quality measurements could not be collected. Vegetation was thicker and greener than the surrounding area.

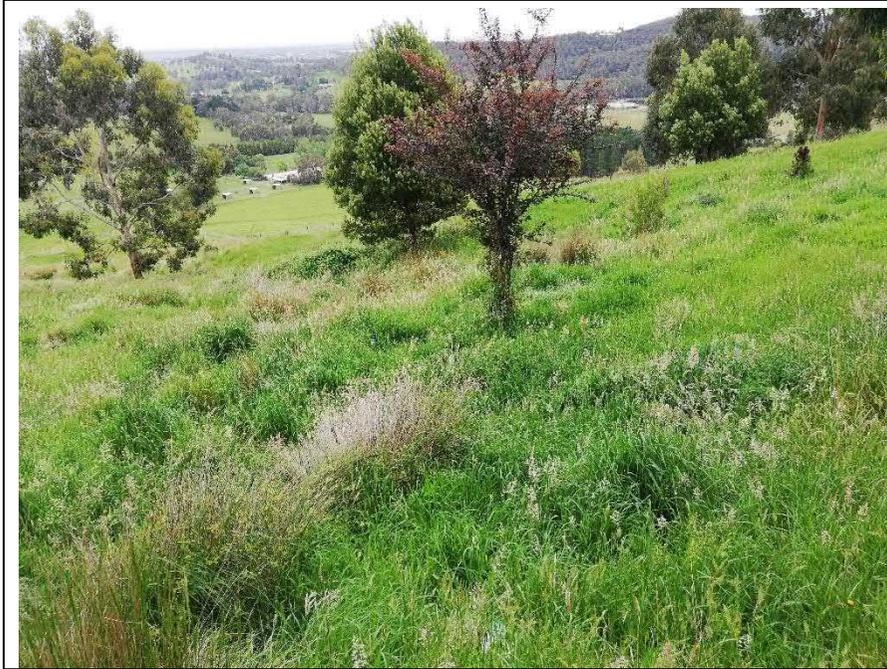
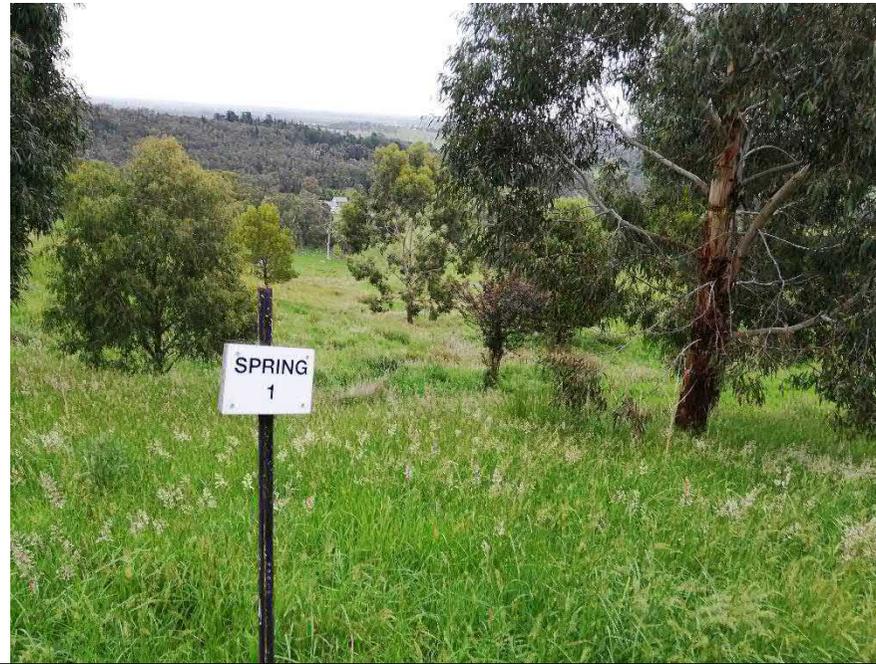
Plate 5
Spring 5

In November 2020 the spring was observed to be dry, as it has been since 2009, and water quality measurements could not be collected. Vegetation was taller and thicker than the immediately surrounding area.

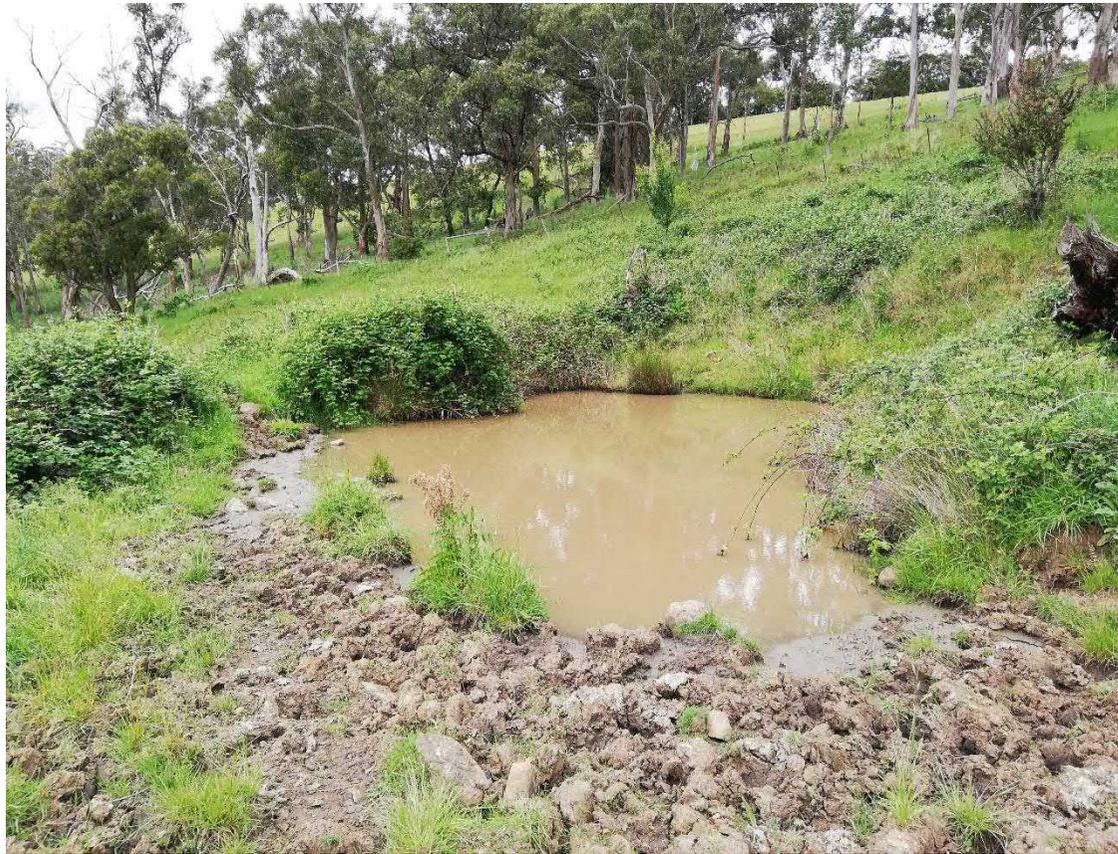
Plate 6
Spring 6

Spring water at SP06 accumulates in a collection pond accessible to livestock, with cattle prints observed. Pool at spring was noted to be stagnant and very boggy. The pool is approximately 15-20m² and up to 0.5m deep. EC was measured as 386 $\mu\text{S}/\text{cm}$, within the historical range.

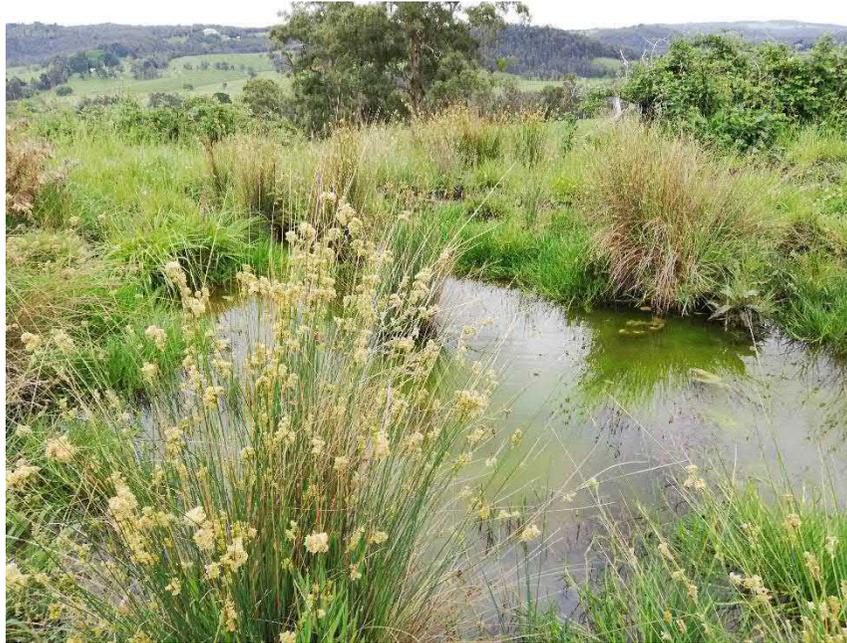
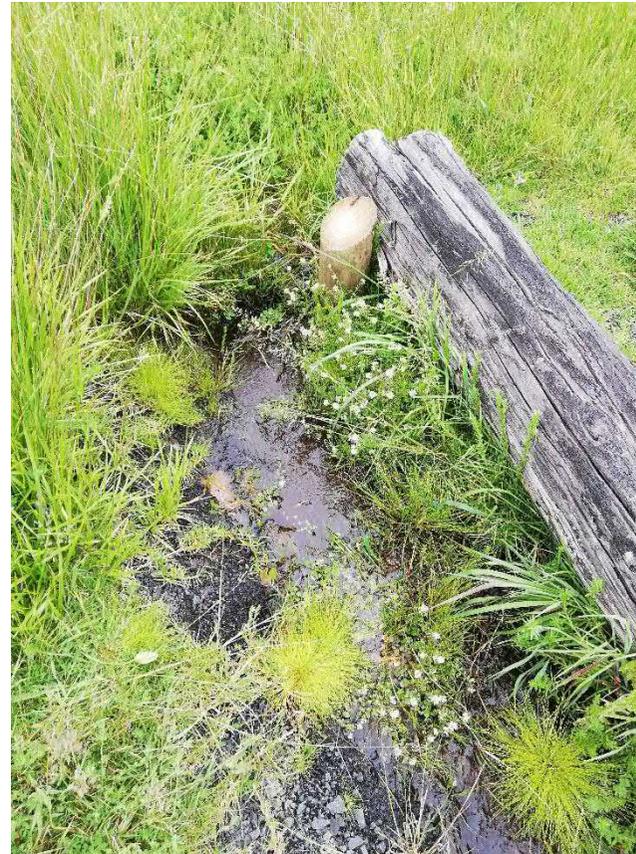
Plate 8
Spring 8

Spring is a wetland with a lot of reeds. EC was measured at 655 $\mu\text{S}/\text{cm}$, within the historic range but the EC at this spring shows high variability since observations began in 2001. A low amount of flow was observed down the slope from the wetland.

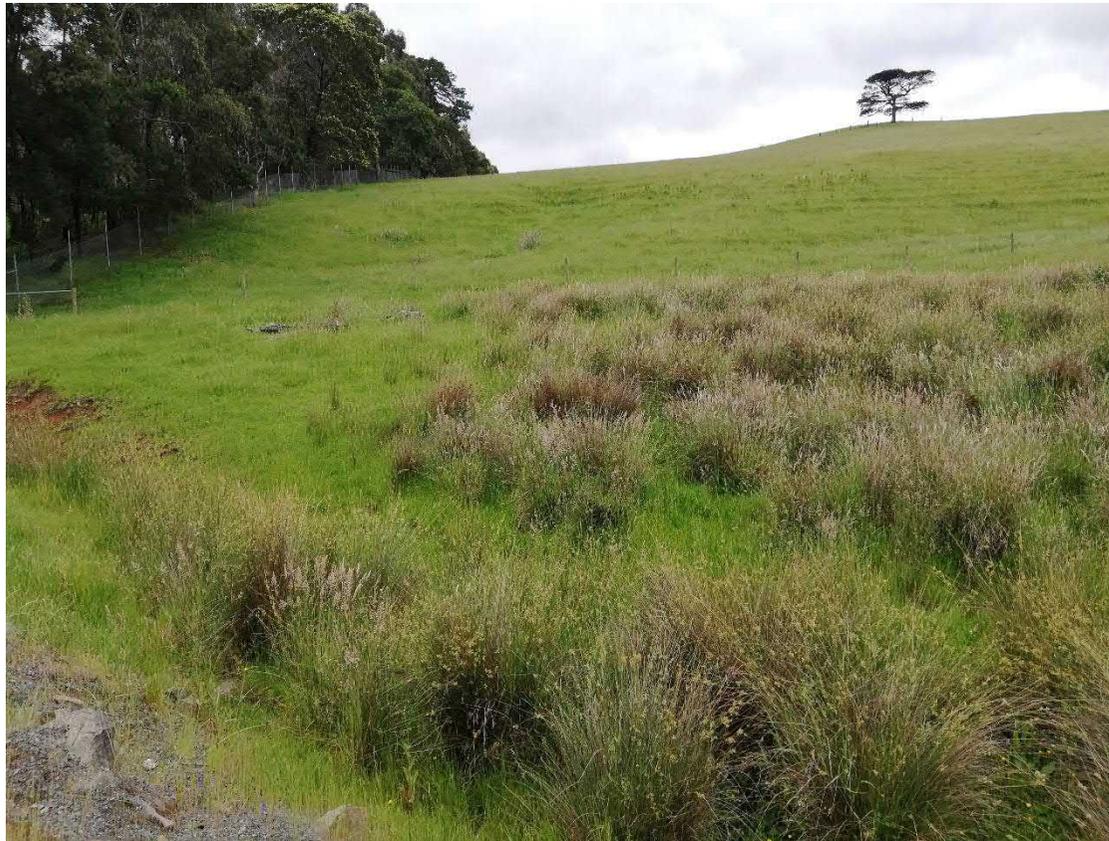
Plate 9
Spring 9

An access road was constructed in the vicinity of SP09 in 2014 and the access road includes a culvert installed underneath that diverts water away from the quarry. The topography of the area was noted to be slightly altered during the construction.

A pond of water was observed down gradient of the former SP09 location that is most likely a combination of seepage and surface water run-off, and is unlikely to have a significant groundwater contribution at the location observed.

In November 2020 the wetland was observed to have standing water and vegetation was thick and healthy. EC was measured as 556 $\mu\text{S}/\text{cm}$, within the historic range.

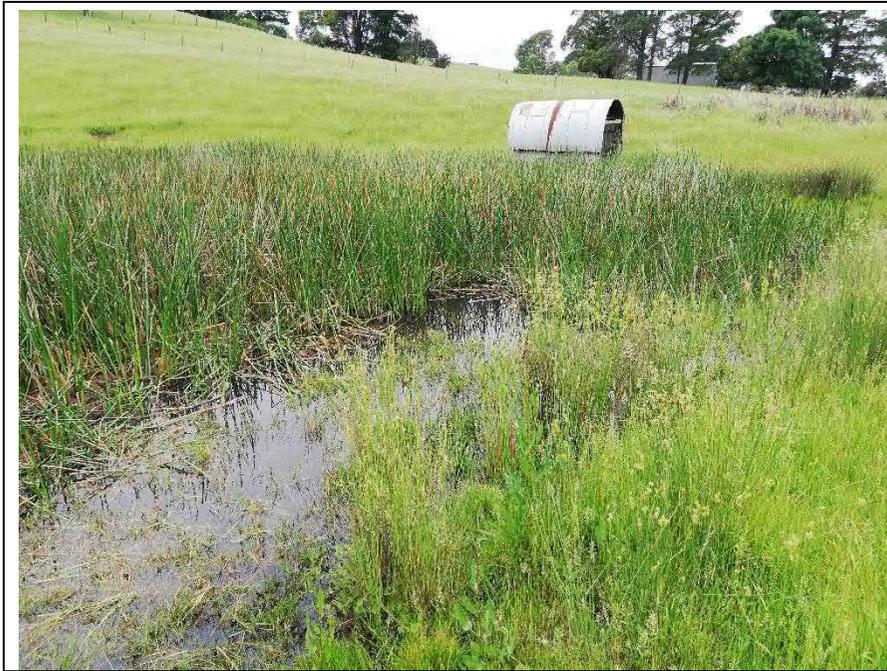
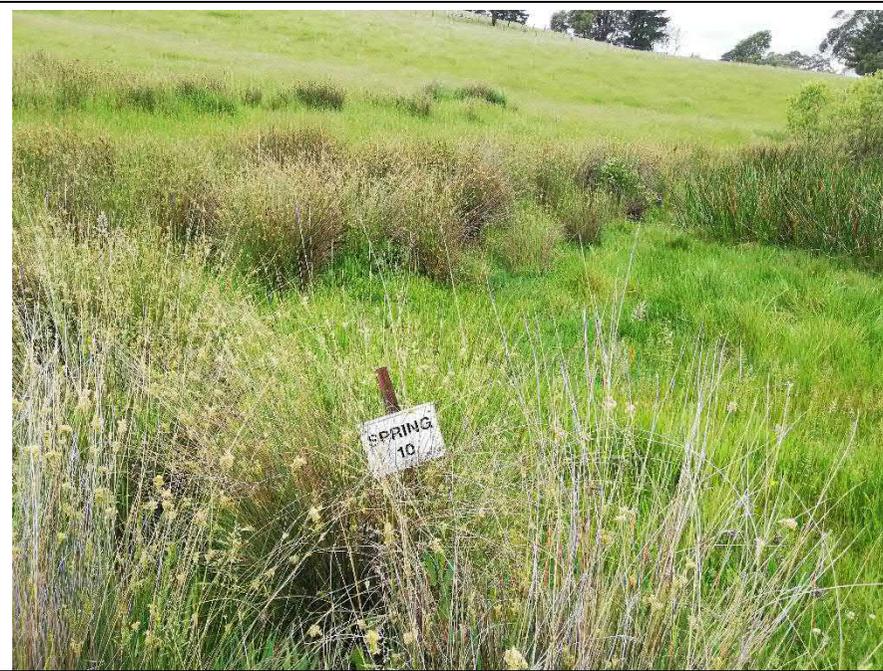
Plate 10
Spring 10

Similar to SP09, the monitoring point, SP10, was noted to be changed by the previous construction of an access road and culvert.

Monitoring has continued and the area has been recorded as dry since 2014, including in the recent November 2020 monitoring event when only a damp seep in the exposed embankment was observed.
