3 March 2022

Leigh Elliott
Quarry Manager- Pakenham
Holcim (Australia) Pty Ltd
95 Mount Shamrock Road, Pakenham

2021 Groundwater and Spring Review, Pakenham Quarry

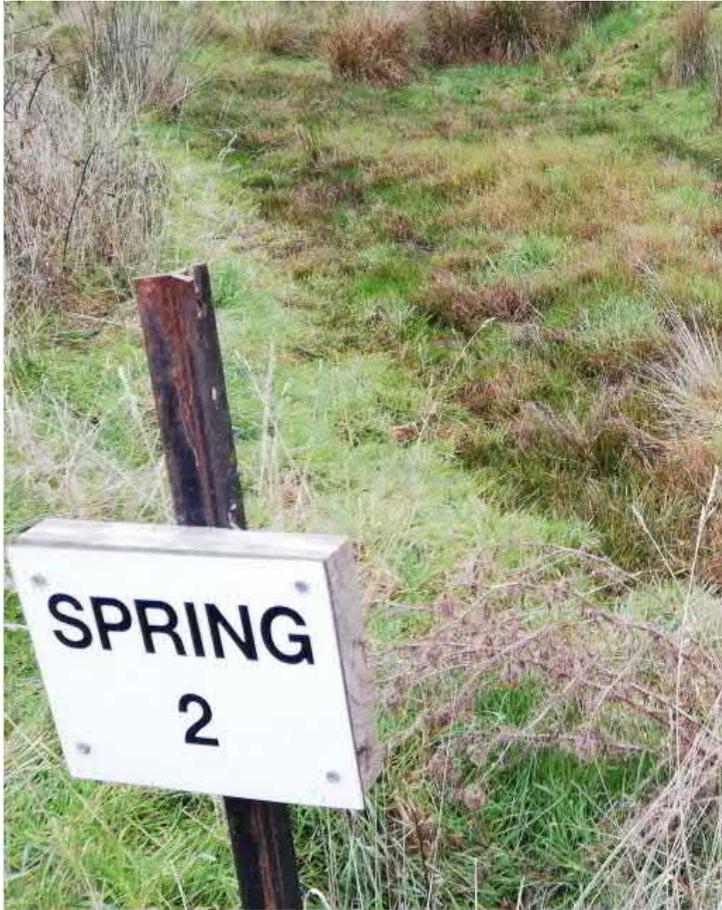
**Plate 2 Spring 2
June 2021**

SP02 located to the west of the quarry, has historically been observed to be a small dam fed by groundwater and surface water runoff from a relatively steep slope above. In June 2021, the area was fenced off, with no flow observed from the groundwater but flow was observed on the slope above.

The dam exhibits instability on the downslope face. It was previously understood that under heavy rainfall, the pond overtops resulting in erosion and instability on the face of the dam. The spring was noted to have the potential to break free of the wall constructed at the location to reduce flow down the slope. A tank is apparently planned to be constructed downgradient from which water is fed to, to reduce stress on the wall. This has not yet been constructed.

In June 2021 the spring was noted to be a have thick vegetation. The water EC (2,259 $\mu\text{S}/\text{cm}$) was within the historical range of EC values reported at SP02, with EC continuously higher at SP02 than other spring locations.

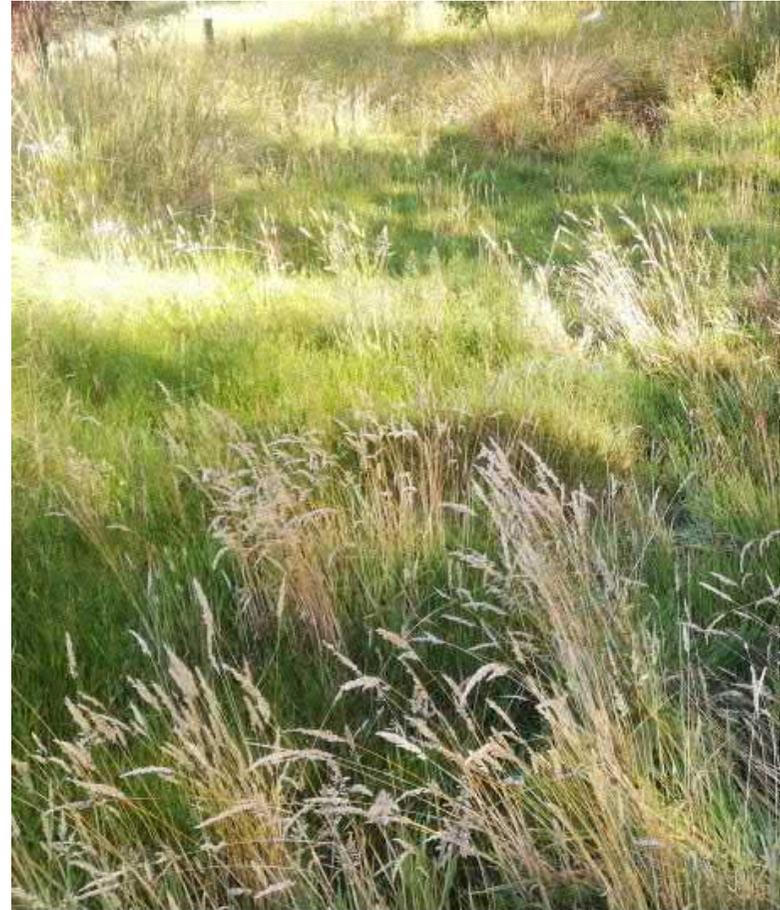
**Plate 2 Spring 2
December 2021**

In December 2021 the spring was noted to be a have healthy vegetation. The water EC (2,420 $\mu\text{S}/\text{cm}$) was within the historical range of EC values reported at SP02, with EC continuously higher at SP02 than other spring locations.

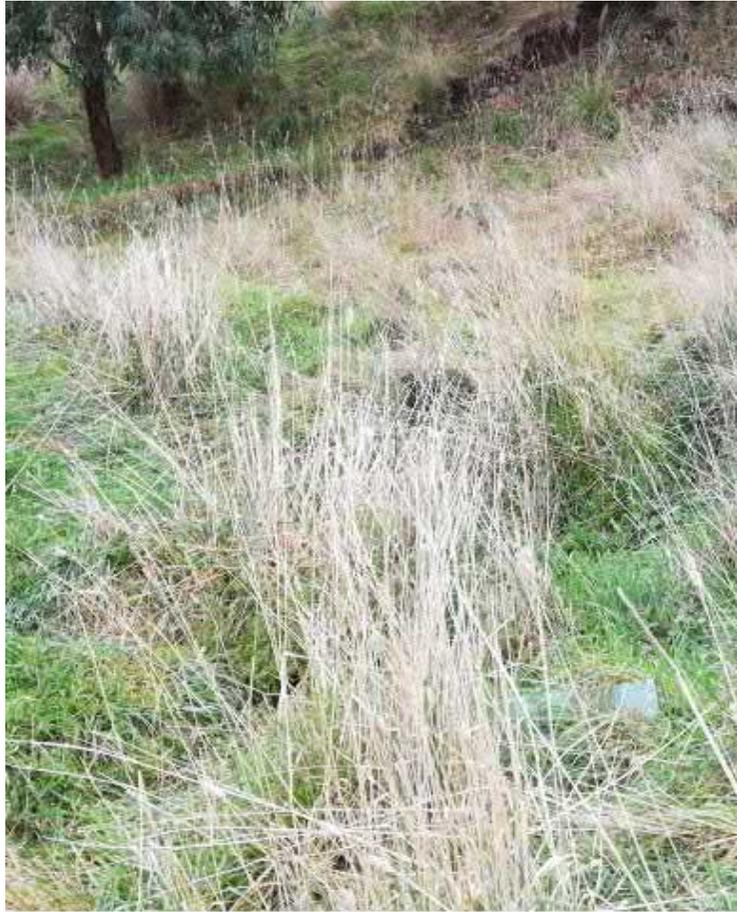
**Plate 5 Spring 5
June 2021**

In June 2021 the spring was observed to be dry, as it has been since 2009, and water quality measurements could not be collected. Vegetation was observed to be healthy. The sign was reported to incorrectly refer to Spring 1.

- During the June and December 2021 spring survey, it was noted that signage for the labels at spring locations SP01 and SP05, located on the southern and western sides of the quarry, were incorrectly labelled. This should be investigated to confirm the correct signage is in place.
- Decrease the number of spring surveys to one event per annual review period. The spring survey should be completed during the same season to capture late spring and summer conditions, when springs are likely not affected by significant periods of rainfall (such as during winter conditions).
- Remove spring locations from the monitoring program where the ground considerations have changed, such as at SP09 and SP10 due to the fire track construction.

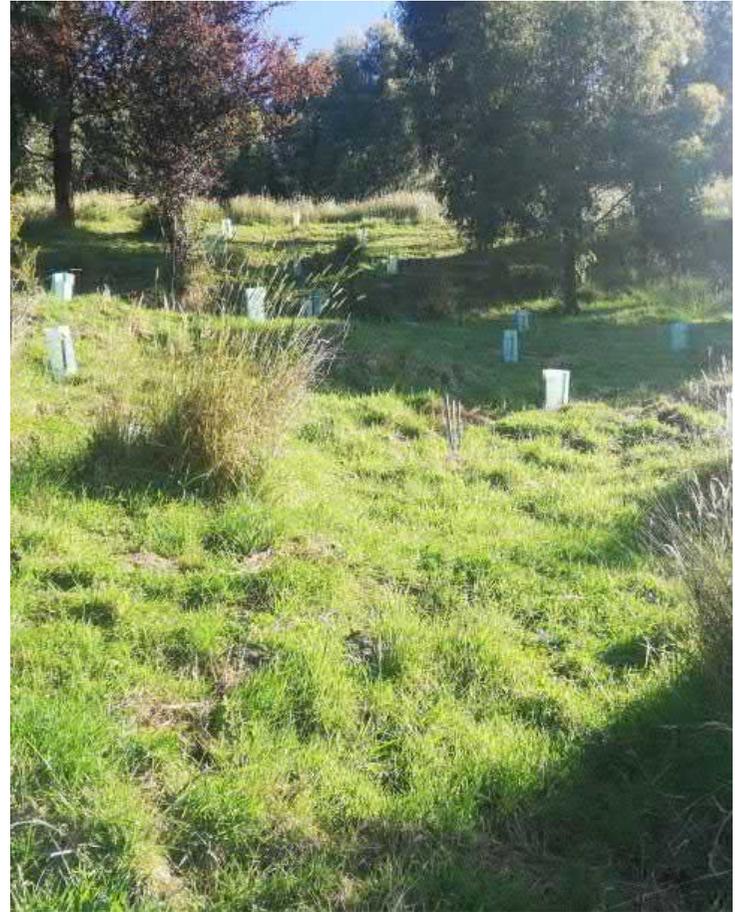
**Plate 5 Spring 5
December 2021**

In December 2021 the spring was still observed to be dry, as it has been since 2009, and water quality measurements could not be collected. Vegetation was observed to be healthy. The sign was still reported to incorrectly refer to Spring 1.

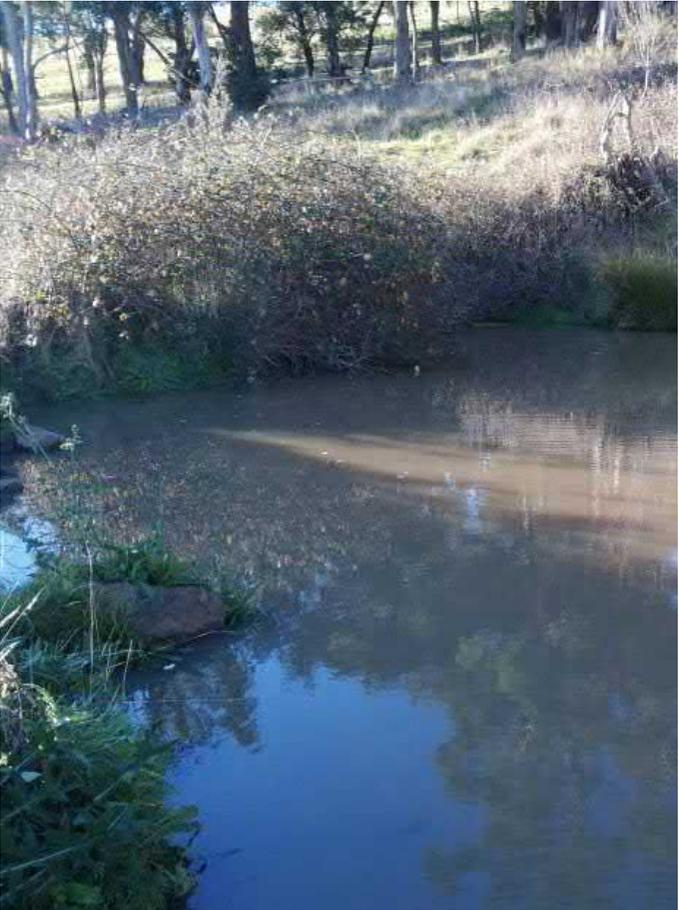
Spring water at SP06 accumulates in a collection pond accessible to livestock. Cows were observed to be entering the water in June 2021. The water was observed to be light brown. EC was measured as 512 $\mu\text{S}/\text{cm}$, which was within the historical range.

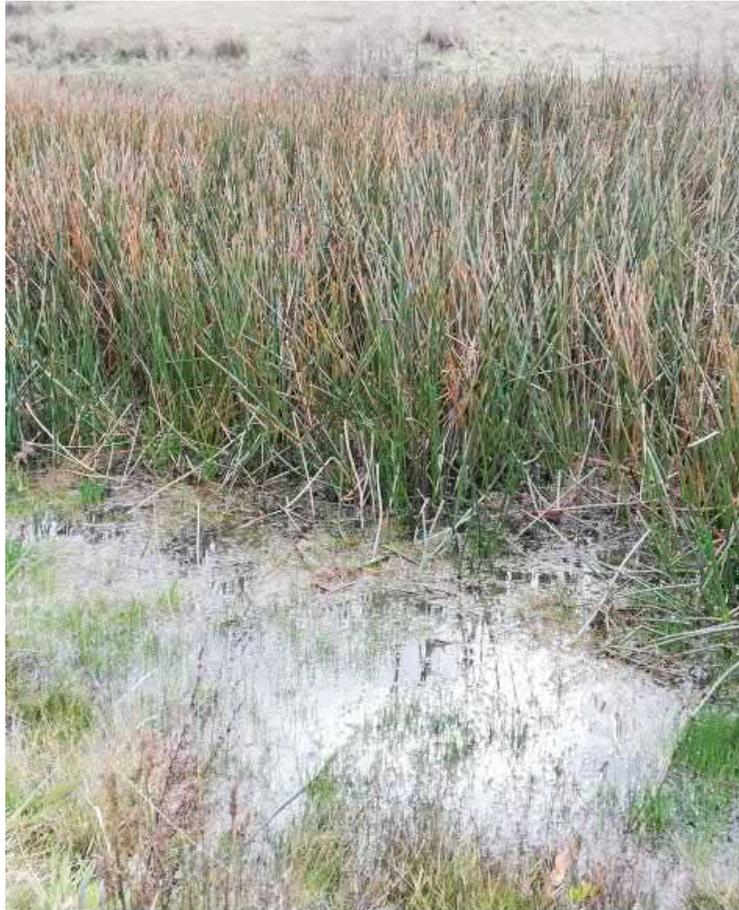
**Plate 9 Spring 9
June 2021**

An access road was constructed in the vicinity of SP09 in 2014 and the access road includes a culvert installed underneath that diverts water away from the quarry. The topography of the area was noted to be slightly altered during the construction.

A pond of water was observed down gradient of the former SP09 location that is most likely a combination of seepage and surface water run-off, and is unlikely to have a significant groundwater contribution at the location observed.

In June 2021 the wetland was observed to have water. EC was measured as 675 $\mu\text{S}/\text{cm}$ which is within the historic range.

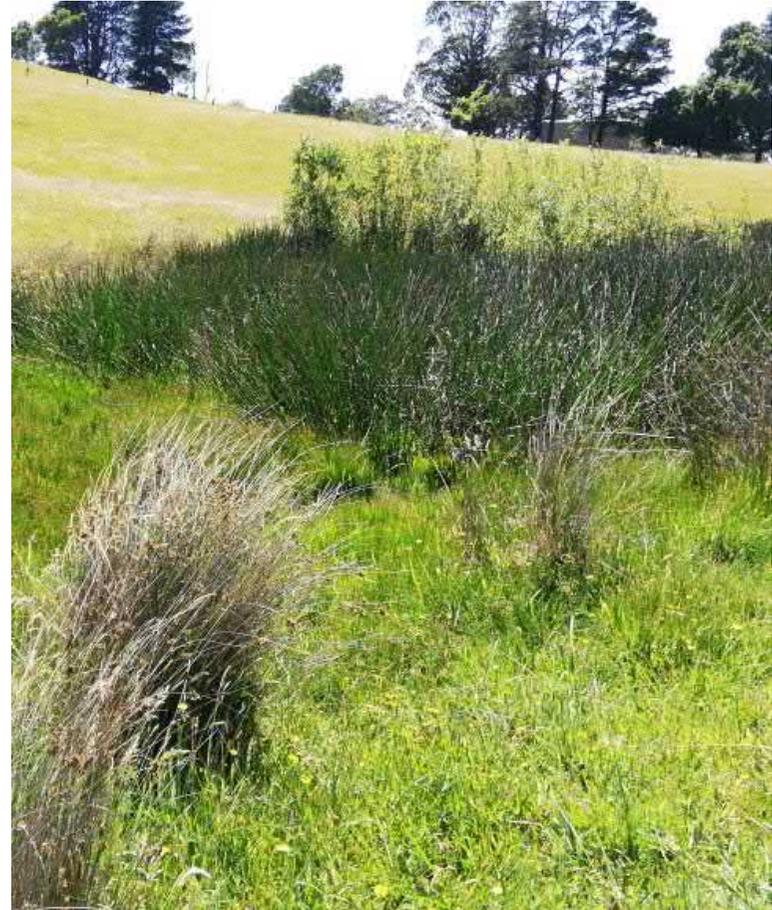
**Plate 9 Spring 9
December 2021**

In December 2021 the wetland was observed to have water. EC was measured as 957 $\mu\text{S}/\text{cm}$ which is within the historic range.

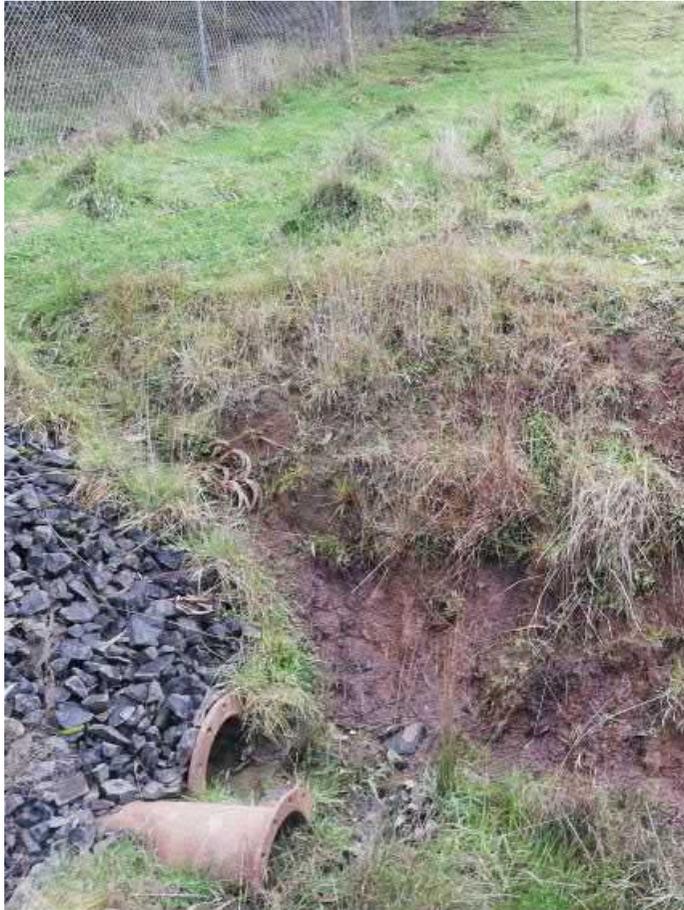
Plate 10 Spring 10
June 2021

Similar to SP09, the monitoring point, SP10, was noted to be changed by the previous construction of an access road and culvert.

Monitoring has continued and the area has been recorded as dry since 2014, including in the recent June 2021 monitoring event when only a damp seep in the exposed embankment was observed.

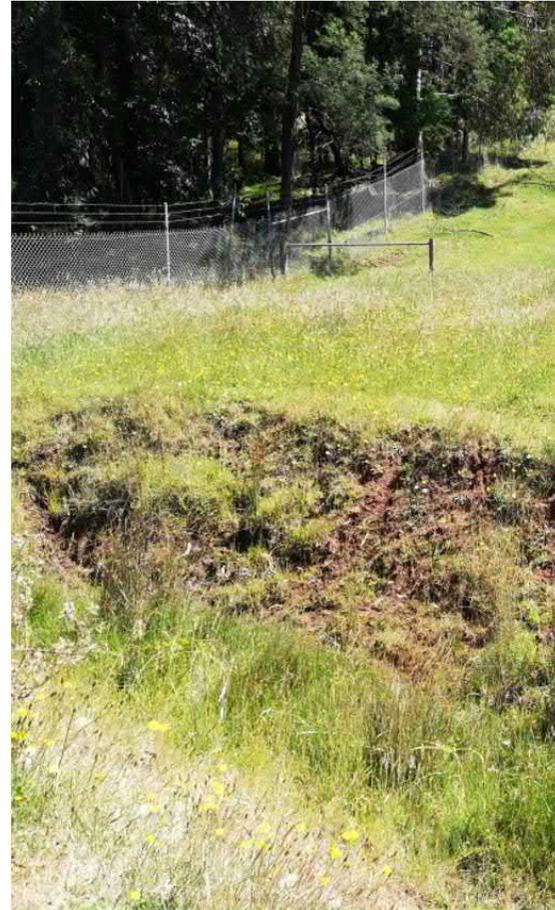
Plate 10 Spring 10
December 2021

As for June, a damp seep in the exposed embankment was observed.
