15 February 2023

Leigh Elliott  
Quarry Manager- Pakenham  
Holcim (Australia) Pty Ltd  
95 Mount Shamrock Road, Pakenham

## **2022 Groundwater and Spring Review, Pakenham Quarry**

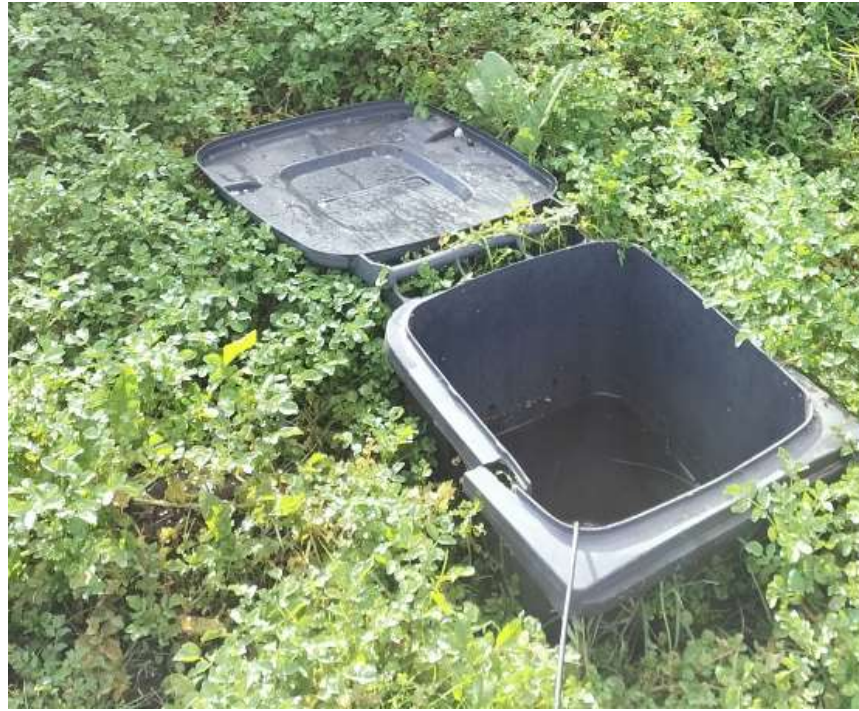
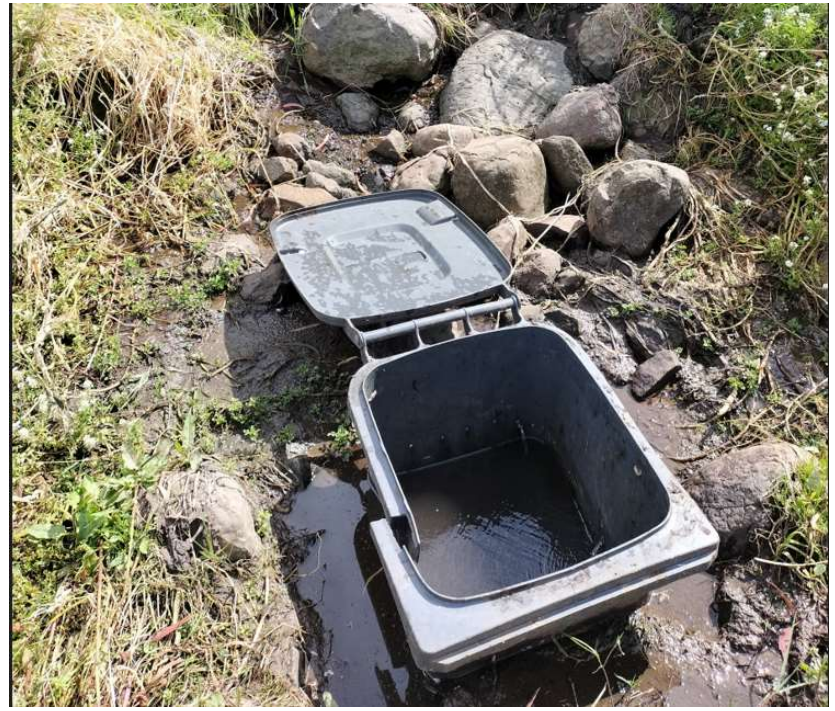
SPRING ID/Use (if any)	Location/history/use/changes	EC (µS/cm) June 2022	EC (µS/cm) December 2022	Observations June 2022	Observations December 2022
SP01	West of quarry Provides irrigation and stock water to a number of properties in the local area	928	753	113mL/s flowing from spring (9.8m <sup>3</sup> /day)	Water flowing into bin, losing some water which misses the capture system. Flow rate = 19m <sup>3</sup> /day
SP02	West of the quarry historically been observed to be a small dam fed by groundwater and surface water runoff from a relatively steep slope above  Previous rounds underestimated flow at the bore due to the addition of a pipe to divert flow from the spring to the tank which was not taken into account. Flow is	1995	2265	Thick vegetation. Flow measured at tank downhill – 0.027L/s (2.3m <sup>3</sup> /day)	Flow rate 5L/171 secs from second trough outflow, thick veg around spring (2.5m <sup>3</sup> /day)

Plate 1 Spring 1  
June 2022

Plate 1 Spring 1  
December 2022

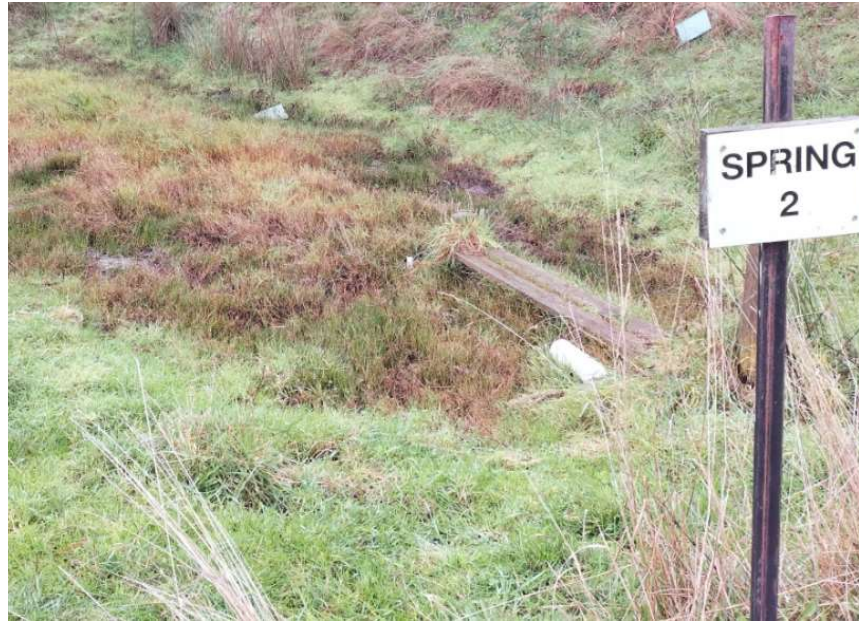
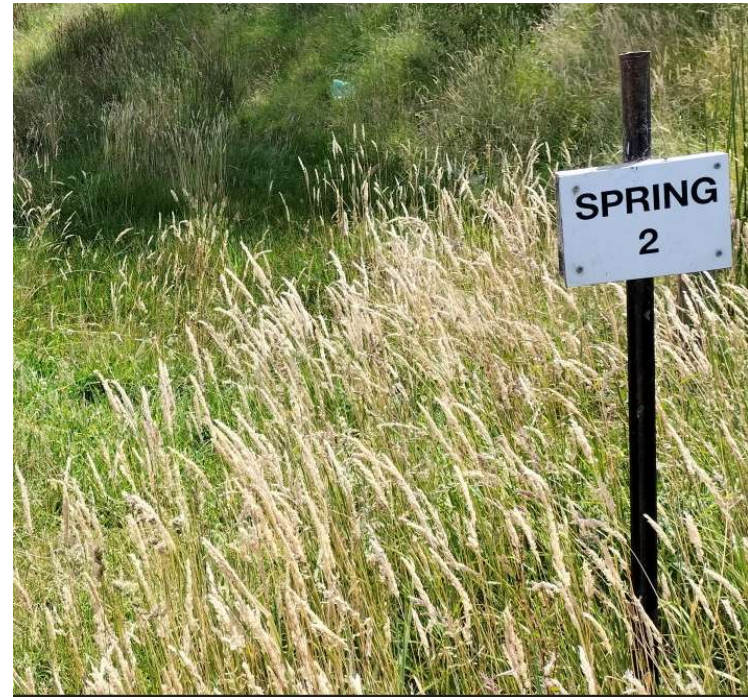
Plate 2 Spring 2  
June 2022

Plate 2 Spring 2  
December 2022

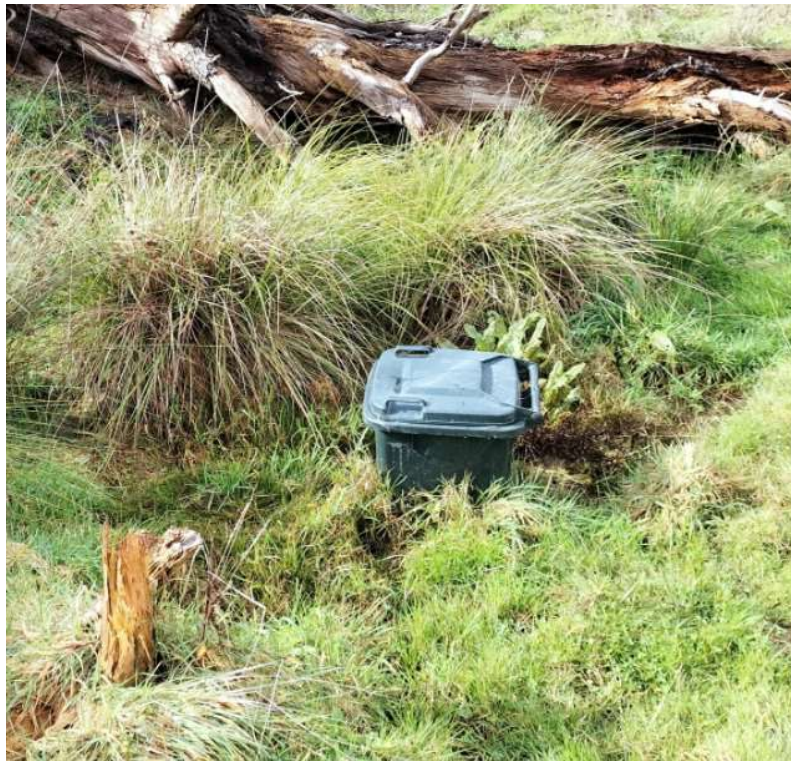
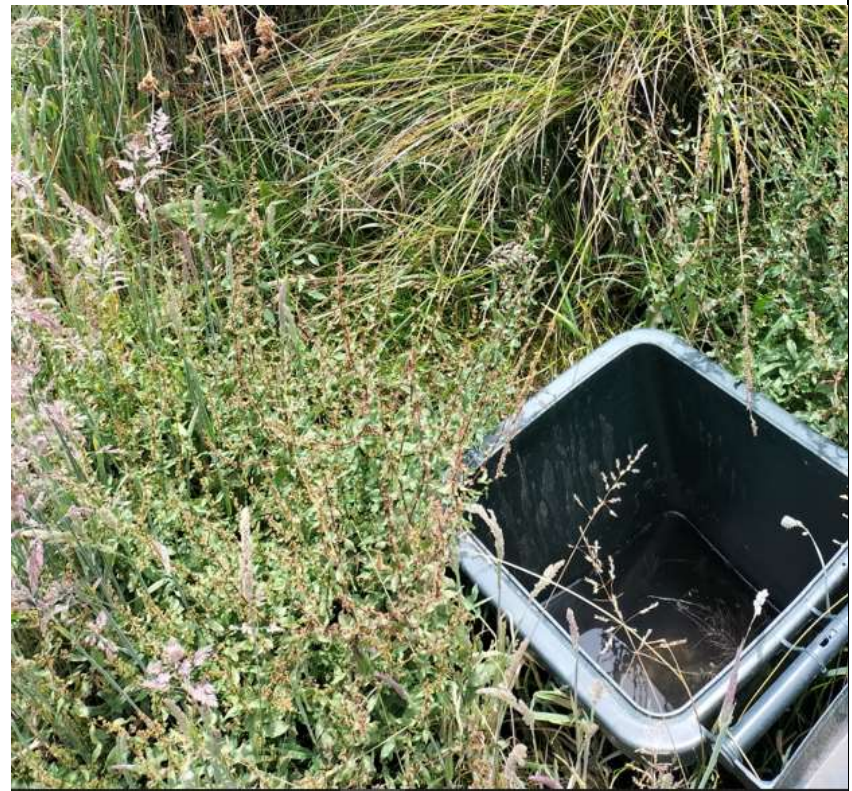
Plate 3 Spring 3  
June 2022

Plate 3 Spring 3  
December 2022

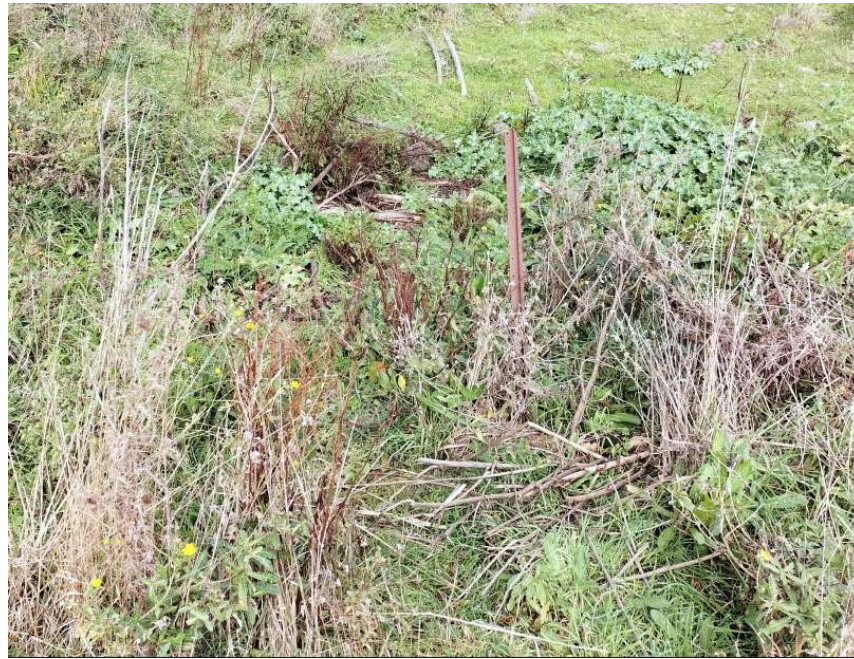
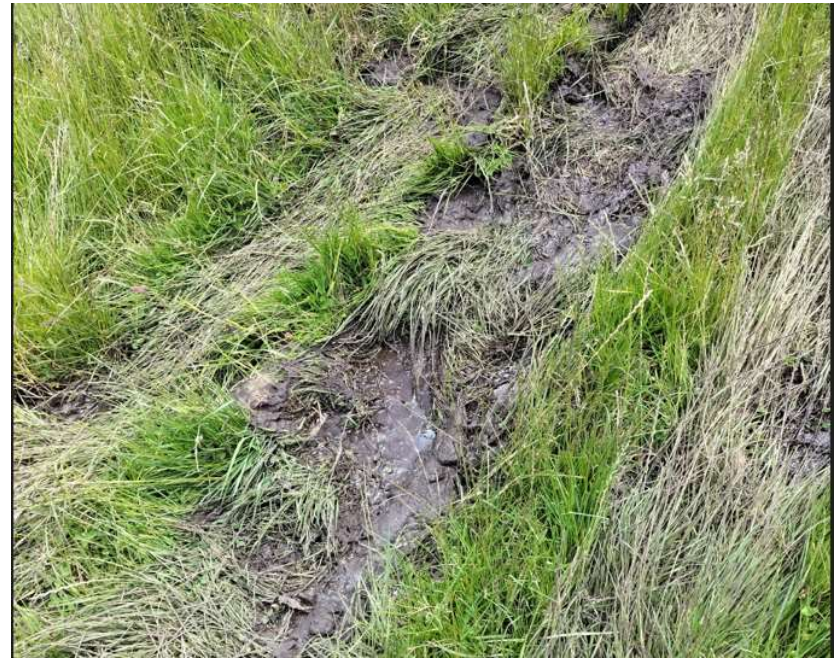
Wet conditions in the preceding months up to December 2022 appear to have influenced SP04 and SP06. Standing water was observed in December 2022 at SP04 for the first time since October 2017 and flow observed for the first time since June 2010. SP06 has typically been observed to contain standing water, however, flow has not been observed historically and so assumed to be subsurface. In December 2022 flow was observed on the surface down slope from the bore. At both SP04 and SP06 flow was diffuse beneath vegetation and unable to be recorded without extensive soil disturbance.

**Plate 4 Spring 4**  
**June 2022**

**Plate 4 Spring 4**  
**December 2022**

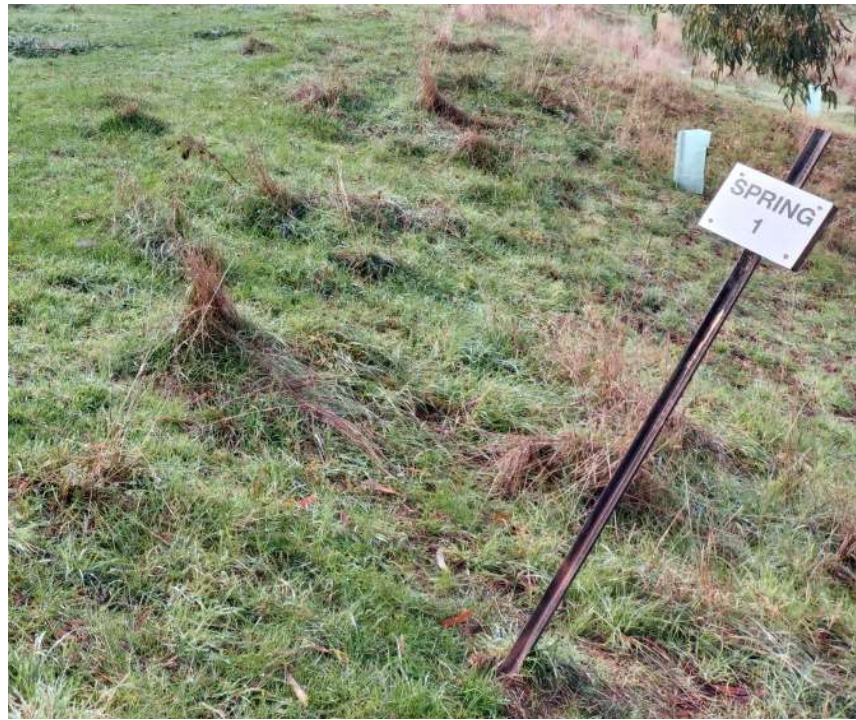
**Plate 5 Spring 5**  
**June 2022 (note that the spring is mislabelled as Spring 1)**

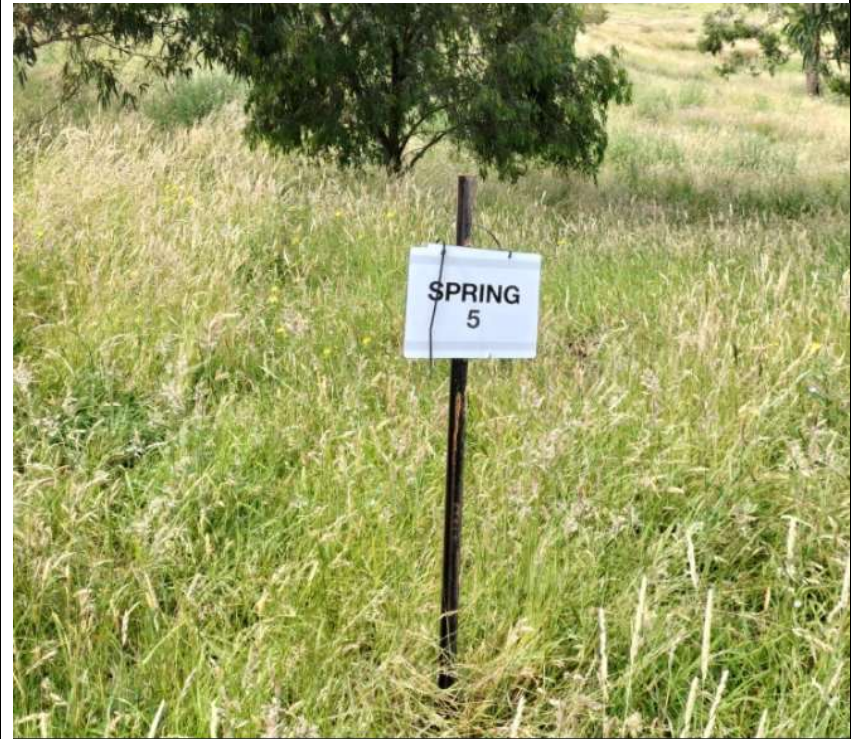
**Plate 5 Spring 5**  
**December 2022 (is now correctly labelled)**

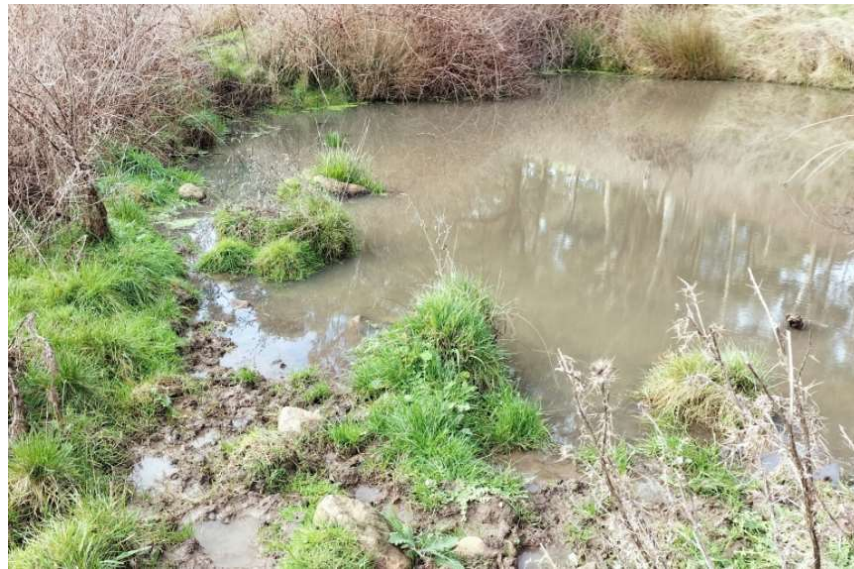
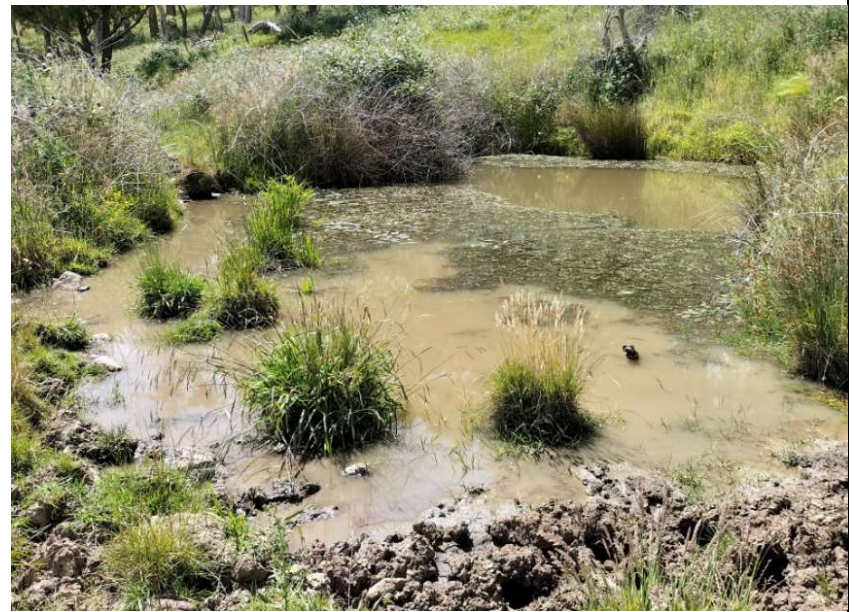
Plate 6 Spring 6  
June 2022

Plate 6 Spring 6  
December 2022

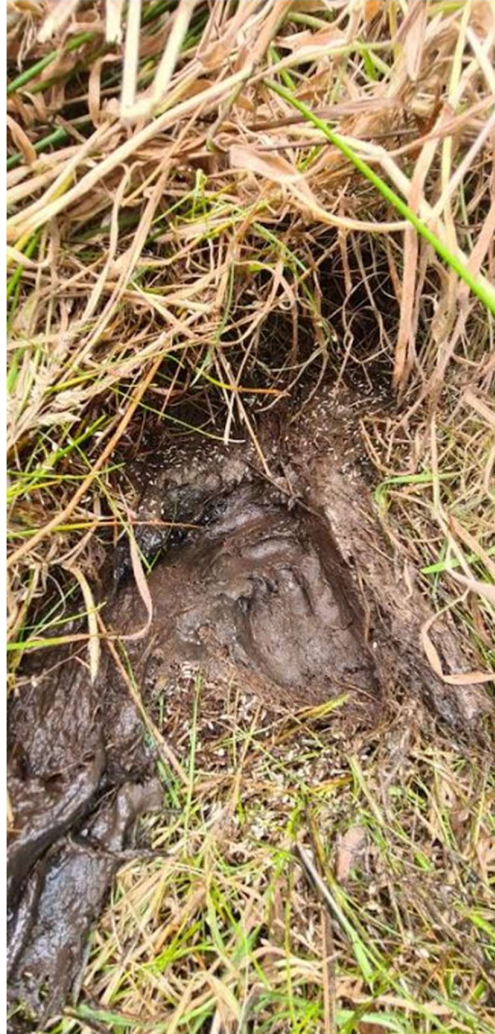
**Plate 6 Spring 6 Seepage down slope from spring**

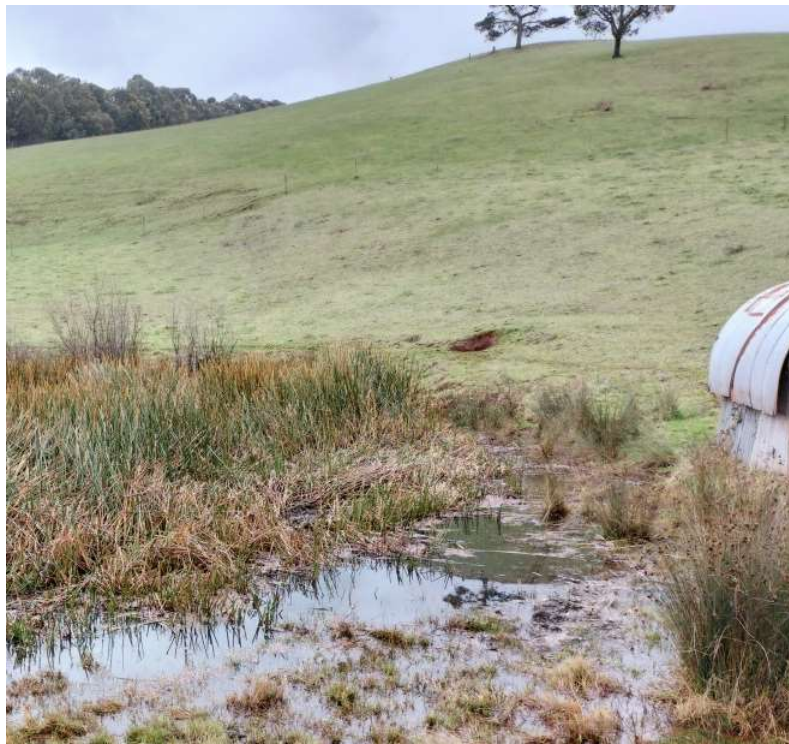
**Plate 9 Spring 9**  
**June 2022 (mislabelled as SP10)**

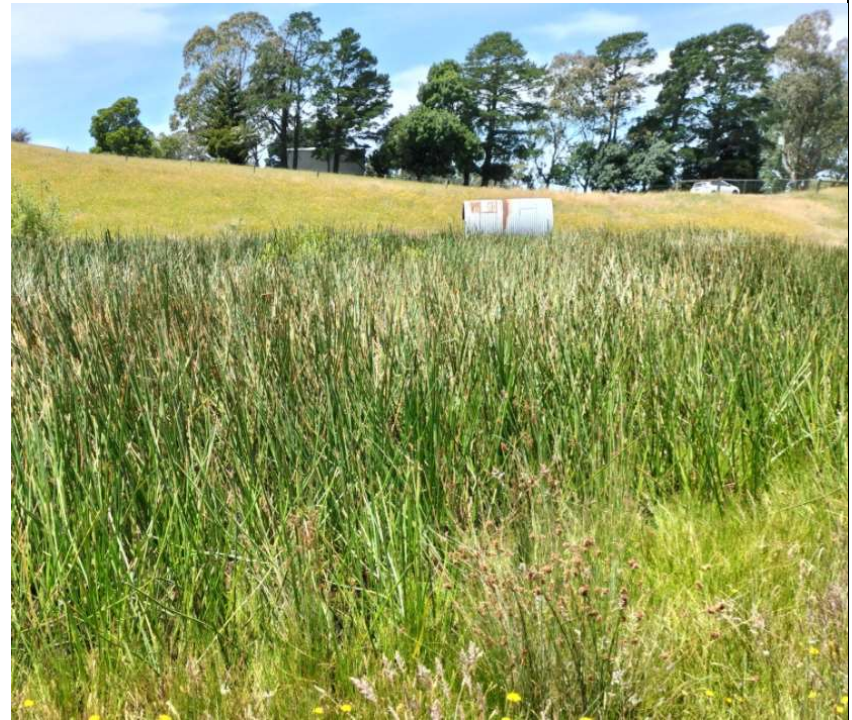
**Plate 9 Spring 9**  
**December 2022 (now correctly labelled as SP09)**

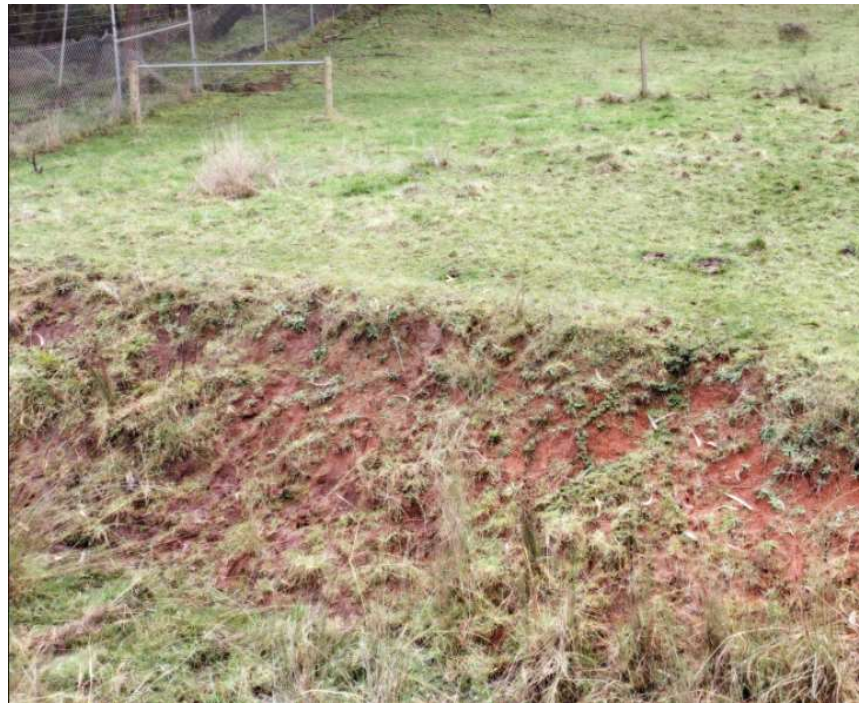
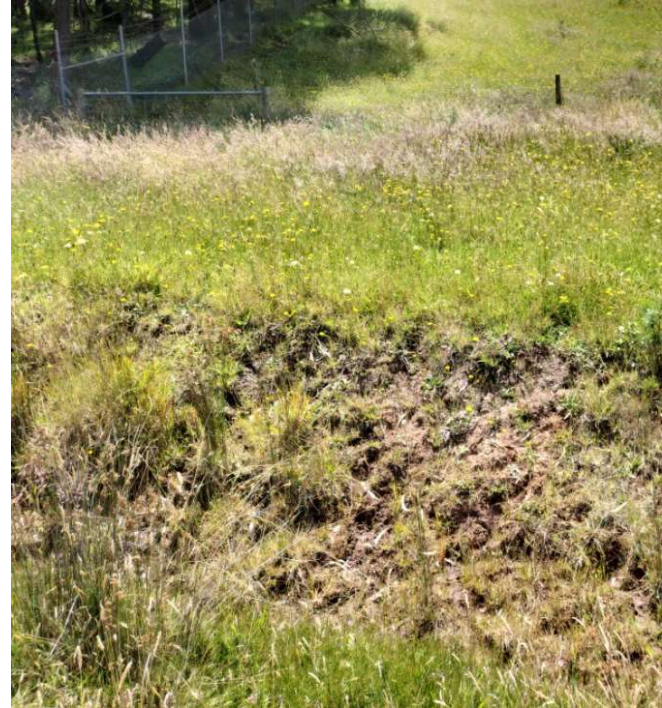
SP10	East of the quarry, close to Spring 9. area has been recorded as dry since 2014, including in the recent December 2022 monitoring event when only a damp seep in the exposed embankment was observed. Was reclassified as a seep in 2005	Not taken	Not taken	Damp seep in embankment	Damp seep in embankment. Reclassified as seep.

Plate 10 Spring (Seep) 10  
June 2022

Plate 10 Spring (Seep) 10  
December 2022

- Decrease the number of spring surveys to one event per annual review period. The spring survey should be completed during the same season to capture late spring and summer conditions, when springs are likely not affected by significant periods of rainfall.
- Remove SP10 from ongoing monitoring where ground disturbance associated with the 2014 construction of the fire access track has stopped this seep from being a discrete groundwater discharge point separate from SP09.
