Quarterly Report

Mt Shamrock

Environmental Management Plan

3 Monthly Progress Update

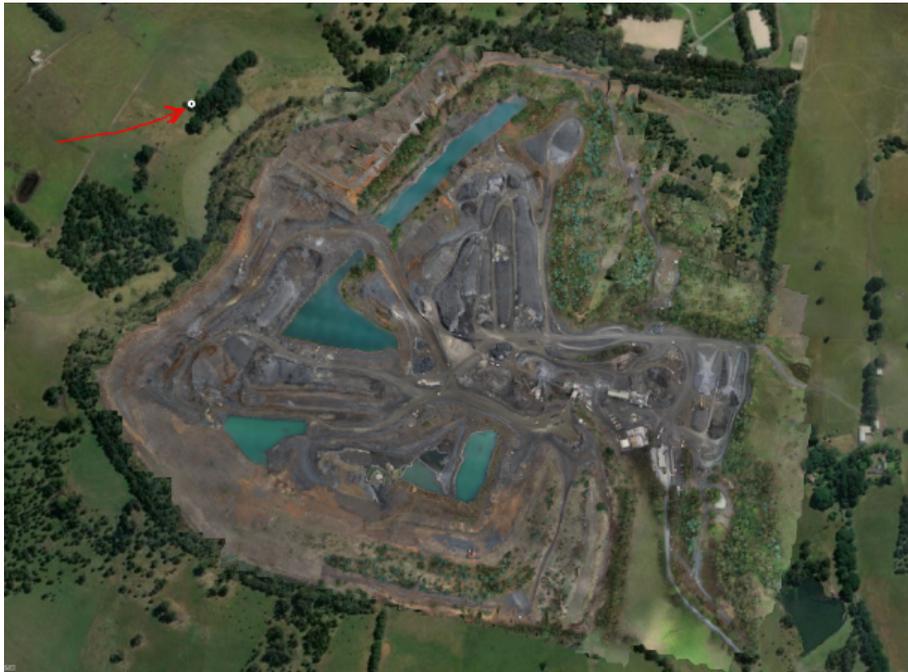
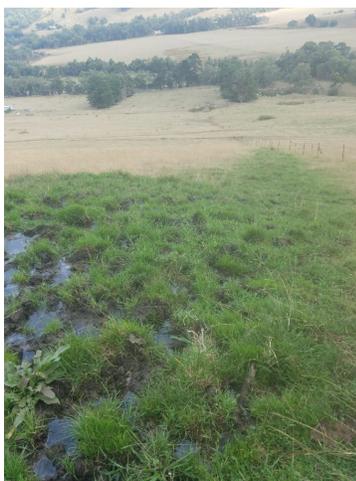
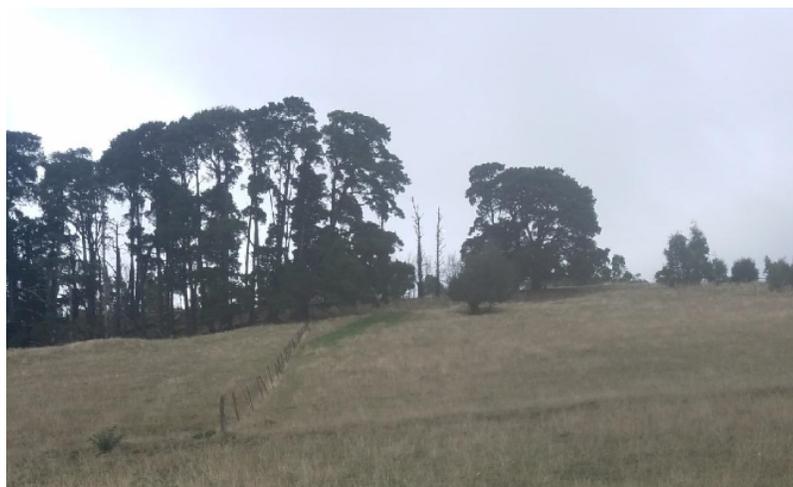
Figures 1,2 and 3 - A new spring observed in March 2023
