17 February 2020

Matthew Dodd  
Quarry Manager  
Holcim (Australia) Pty Ltd  
Mt. Shamrock Road

## **Mt. Shamrock Quarry - Toomuc Valley Slope Inspection, January 2019**

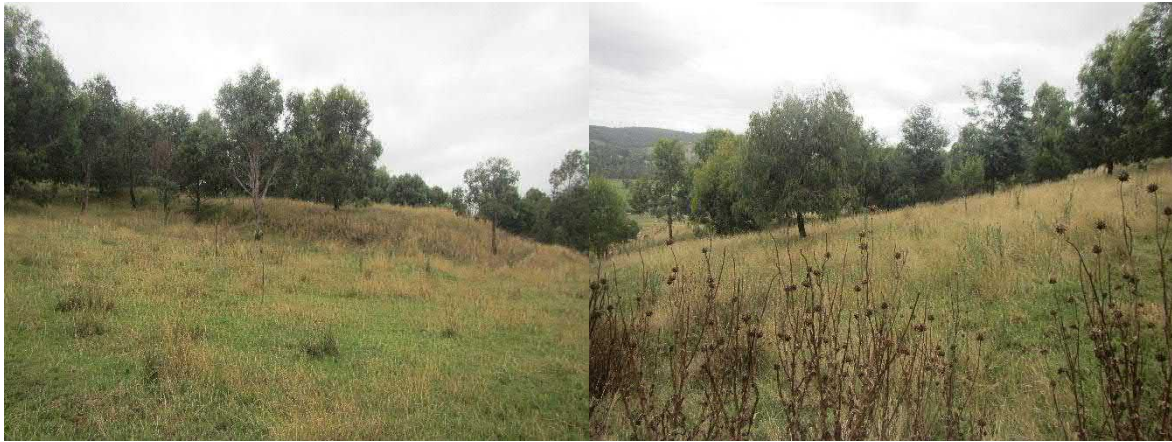
**Mass03**

Mass03	<ul style="list-style-type: none"> <li>Overall the area is well vegetated with dense grass cover and small to medium shrubs and trees throughout.</li> <li>Whilst the slope surface is hummocky, this appears to be associated with historical major landslips and no evidence of recent or ongoing instability was observed.</li> <li>Holcim representative indicated that there is no known slope movement in this area over the review period and in general the area is considered to have remained stable over the last 7 years.</li> </ul>

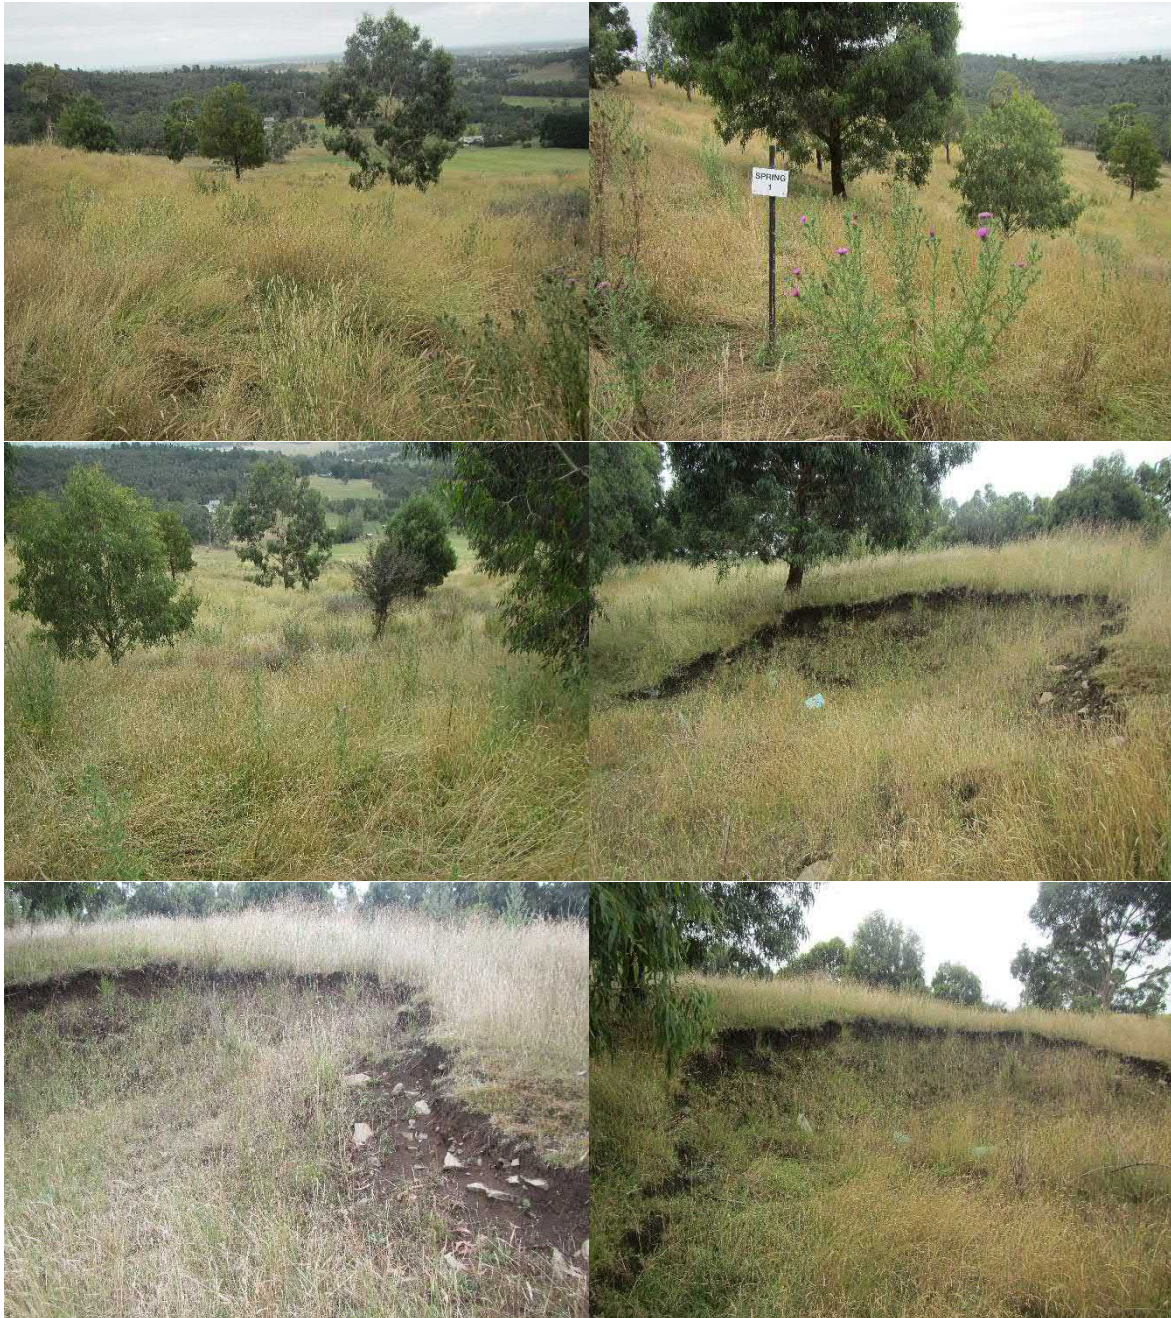
**Mass04**

Landslide Reference ID	2019 Visual Observation
Mass04	<p>General Slope Stability of Mass04 Area</p> <ul style="list-style-type: none"> <li>Overall the area is well vegetated with dense grass cover and small to medium shrubs and trees throughout.</li> <li>Whilst the slope surface is hummocky, this appears to be associated with historical major landslips and no evidence of recent or ongoing instability was observed.</li> <li>Holcim representative indicated that there is no known slope movement in this area over the review period and in general the area is considered to have remained stable over the last 5 years.</li> </ul> <p>Localised Small Circular Failure of Old Backscarp (refer Attachment 2)</p> <ul style="list-style-type: none"> <li>During review period a small, shallow circular failure of an old backscarp from the larger historical landslide has occurred. The slope behind the failure is relatively flat, appeared dry and is vegetated with grass and bushes. There is no evidence of tension cracks behind the failure.</li> <li>The failure measures about 5 m in width and ~1.5 m in height. The slope below slump is damp, likely associated with a spring. Surface water was not able to be observed based on moist conditions from recent rainfall.</li> <li>The circular failure is small in volume and, given that the location is isolated from any downhill infrastructure, is not considered to be a significant geological risk.</li> </ul> <p><b>Remedial Solution Treatments</b></p> <p>The following remedial options have been implemented during the previous review period:</p> <ol style="list-style-type: none"> <li>Construct a barricade to prevent animal access to the area to allow vegetation to establish, it is currently fenced on all sides at approximately a 50m radius.</li> <li>Revegetate behind the failure / old backscarp with deep root (but small canopy) shrubs / bushes and grasses</li> <li>Revegetate in the saturated area below the failure with wet tolerant species, ie swampy gums, river gum, boobias</li> <li>Revegetate the slump surface with grasses.</li> <li>Maintain regular documented inspections and if conditions deteriorate notify suitably qualified geotechnical engineer for further direction.</li> </ol> <p>It is deemed important to continue to monitor the vegetation of this scarp to ensure that washouts do not inhibit the progress. Some vegetation regrowth (likely to be as a result of previous remedial treatments and revegetation) was observed at the toe of the scarp area.</p>

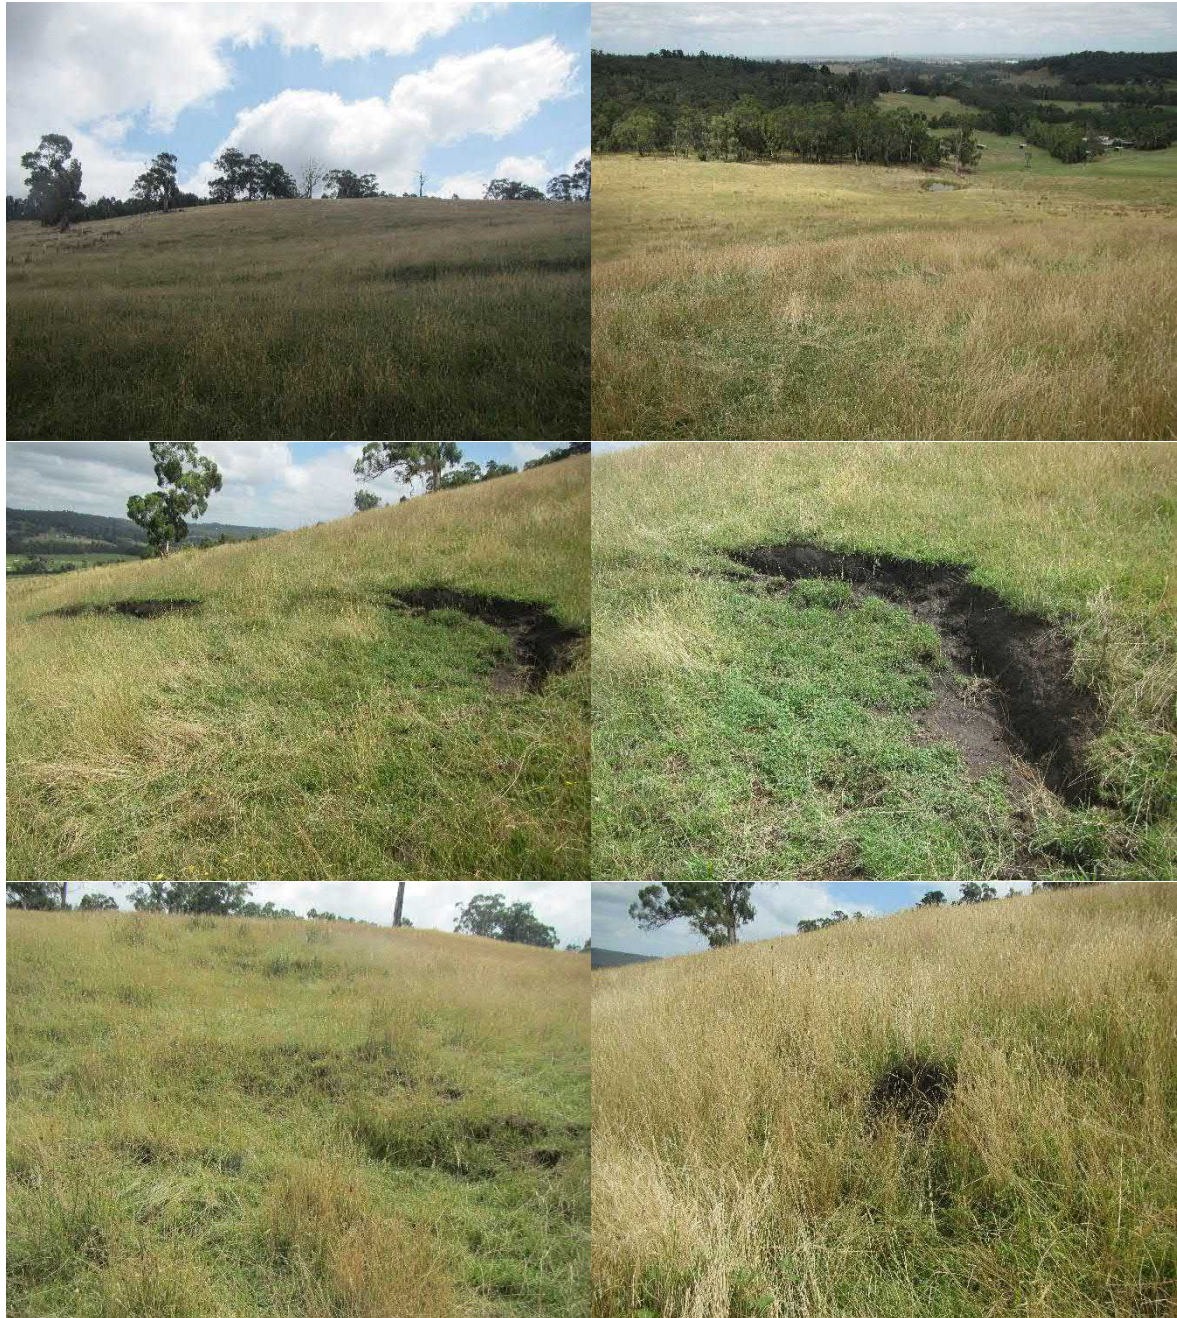
**Mass05**

Mass05	<ul style="list-style-type: none"> <li>Overall the area is well vegetated with dense grass cover throughout.</li> <li>Holcim representative indicated that there is no known slope movement in this area over the review period and in general the area is considered to have remained stable over the last 7 years.</li> <li>Minor historical circular failures were observed in four locations: these failures were observed to be associated with exposed (bare) scarps and a change in the natural topography locally downslope with remnant mobilised material. A natural drain has formed through this material to avoid the local high. It is recommended that the bare scarp areas are grassed to mitigate potential of further erosion.</li> <li>The mobilised material is well vegetated. Observation of the exposed scarp suggests that the material is weakly structured, near-surface soil possibly associated with the Werribee Formation (Attachment 1 for geological map and Attachment 2 for photo of scarp).</li> </ul>

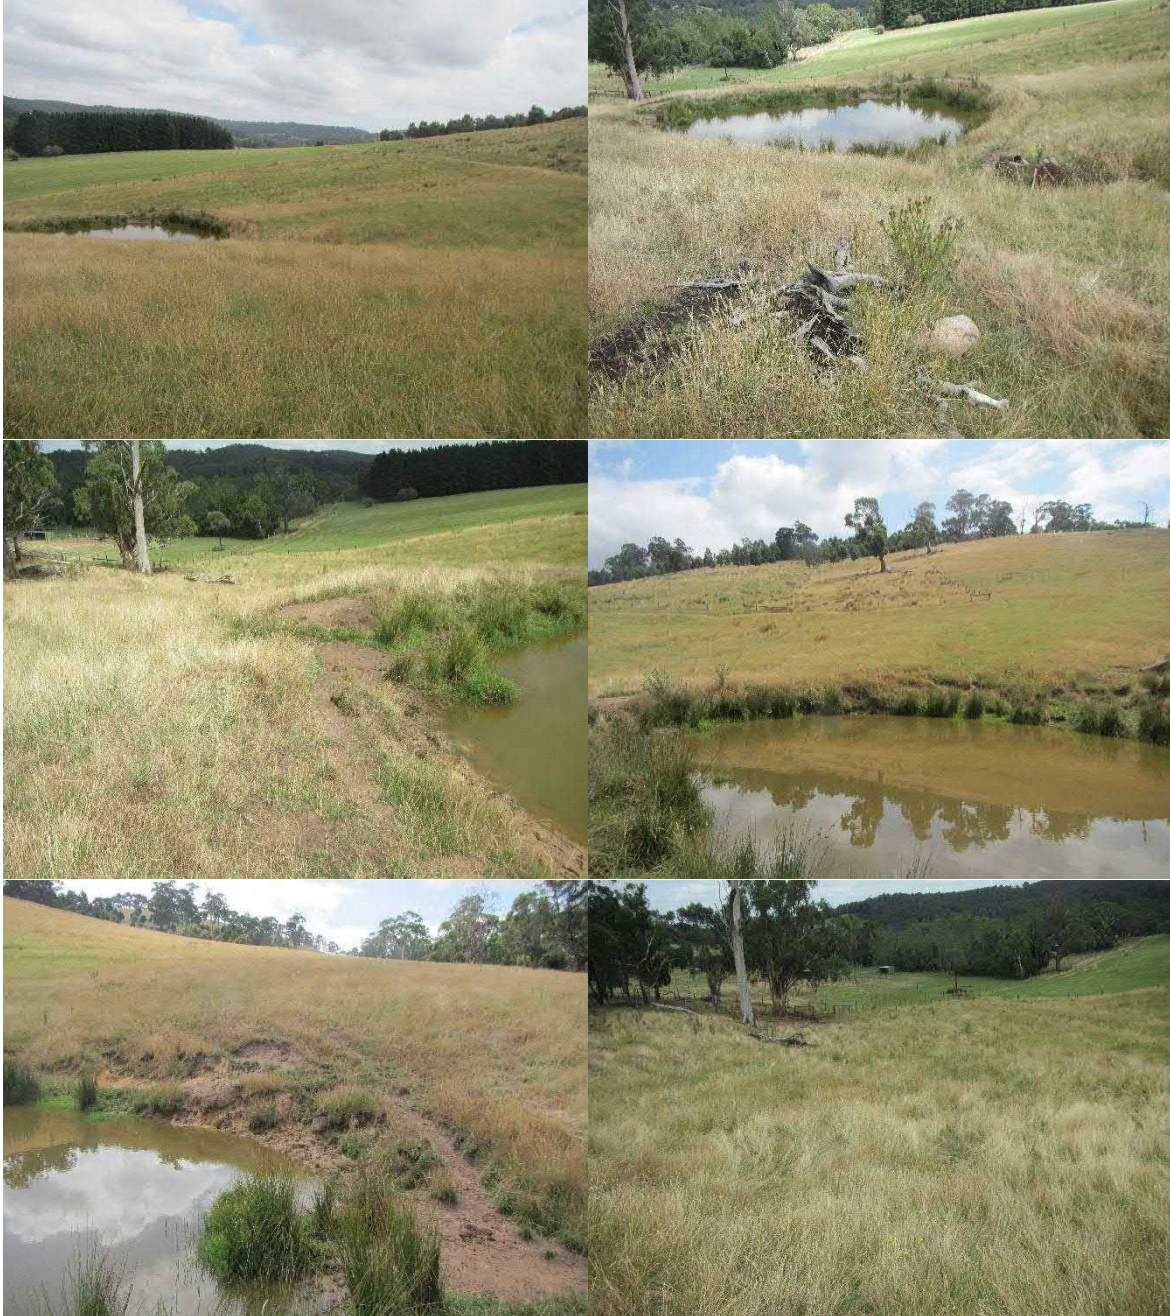
## Mass05 Dam

Mass05 Dam	<ul style="list-style-type: none"> <li>Upstream drainage channel/ catchment from Mass05 is unobstructed. Embankments are vegetated. Eastern side is bare, with an observed retreating crest. There is waste (rubbish) blocking the upstream channel to the east. This is recommended to be monitored but is not anticipated to comprise significant risk at this stage.</li> <li>A downstream spillway has formed naturally.</li> <li>Water was observed 500mm below the crest of the dam, with the crest material softened by cattle traffic. There is a low risk for this structure in terms of both likelihood and consequence</li> </ul>
Mass06	<ul style="list-style-type: none"> <li>Overall the area is well vegetated with dense grass cover throughout.</li> <li>Holcim representative indicated that there is no known slope movement in this area over the review period and in general the area is considered to have remained stable over the last 7 years.</li> </ul>

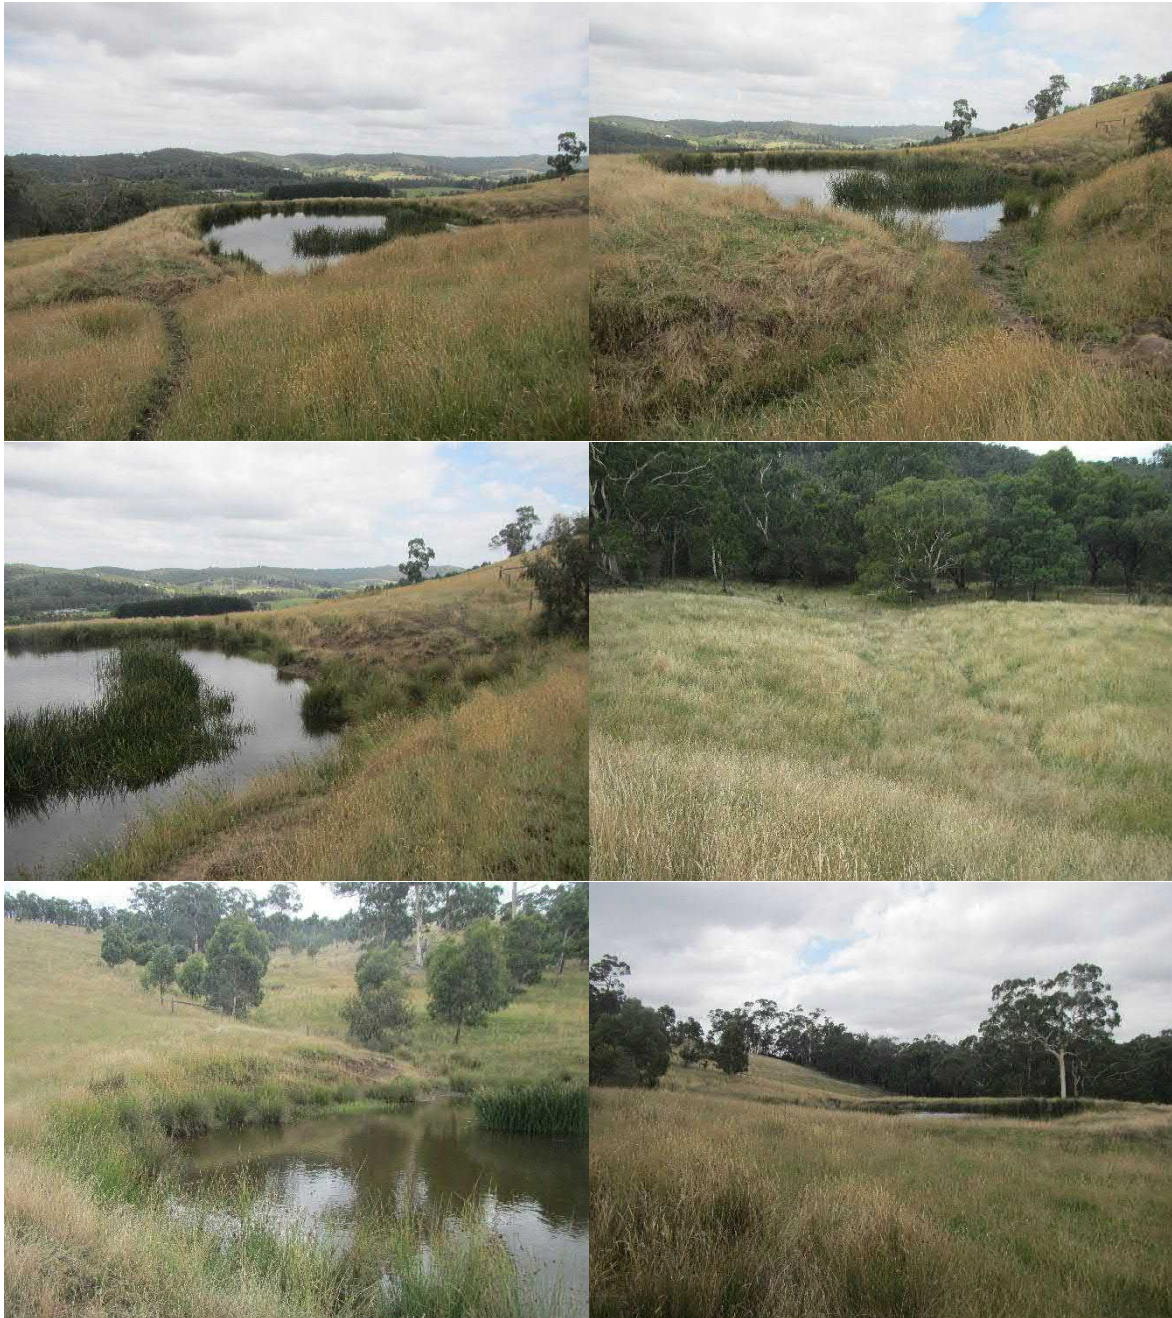
## Mass06 Dam

Mass06 Dam	<ul style="list-style-type: none"> <li>This dam contains a comparatively large volume of water to other dams (surface area 45 m<sup>2</sup>, total depth unknown). The water level was observed at 500mm below the crest.</li> <li>A natural overflow to east has been identified, which directs water to a dam on an adjacent property downstream.</li> <li>The dam crests are retreating, predominantly due to fauna traffic, with characteristically erosive material. A visual assessment indicates a low risk of failure.</li> <li>Risk to cattle adjacent to dam, where in some places a 1.5-2m vertical difference was observed due to the retreating crest.</li> </ul>
Mass07	<ul style="list-style-type: none"> <li>Tree planting has been undertaken upslope.</li> <li>There is a minor scarp adjacent to the worn cattle track on the eastern side, suggested erosive driver being the cattle traffic but reiterating the poor structure of the soils.</li> <li>Historical scarp has been vegetated with no exposed ground or evidence of movement. Overall the area is well vegetated with dense grass cover throughout.</li> <li>Holcim representative indicated that there is no known slope movement in this area over the review period and in general the area is considered to have remained stable over the last 7 years</li> </ul>

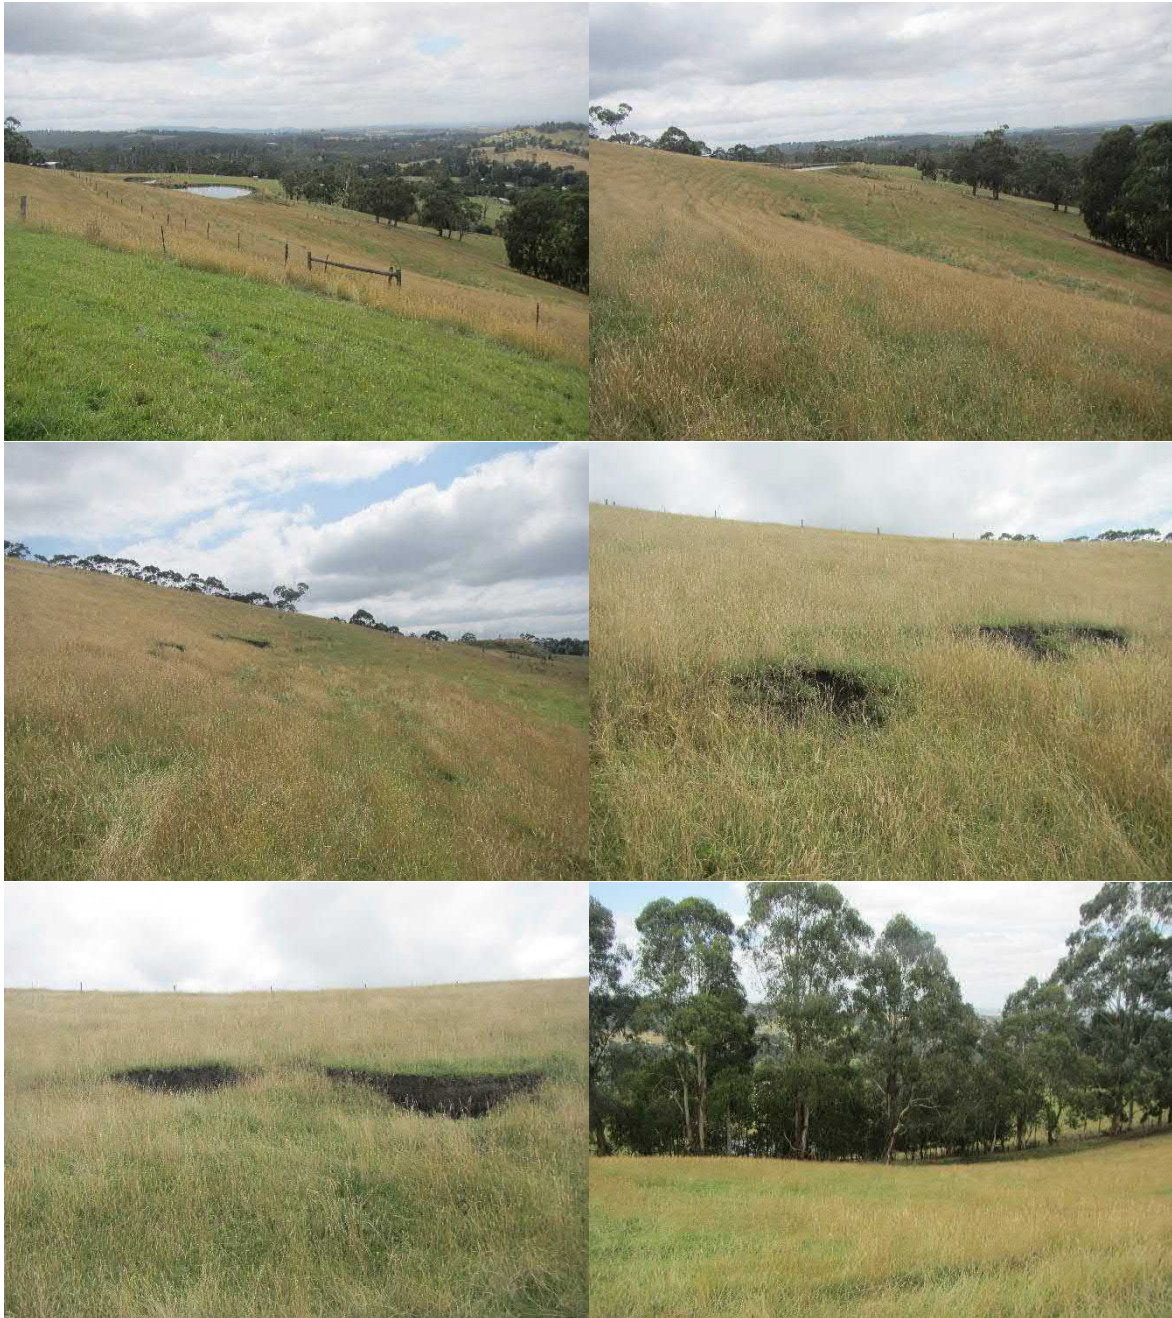
**Mass08**

Mass08	<ul style="list-style-type: none"> <li>Overall the area is well vegetated with dense grass cover throughout.</li> <li>There are some historical scarps up to 1m height. These demonstrate weak soil structure, with anticipated minor failures in rain events.</li> <li>The local area immediately below scarp is poorly to moderately vegetated. Bare ground was observed for approximately 500mm laterally at the toe of the scarp.</li> <li>A minor, unrelated scarp was observed upstream.</li> </ul> <p><b>Proposed Remedial Solution Treatments</b></p> <ol style="list-style-type: none"> <li>Revegetate the scarp surface with grasses; and</li> <li>Maintain regular documented inspections and if conditions deteriorate notify suitably qualified geotechnical engineer for further direction.</li> </ol>

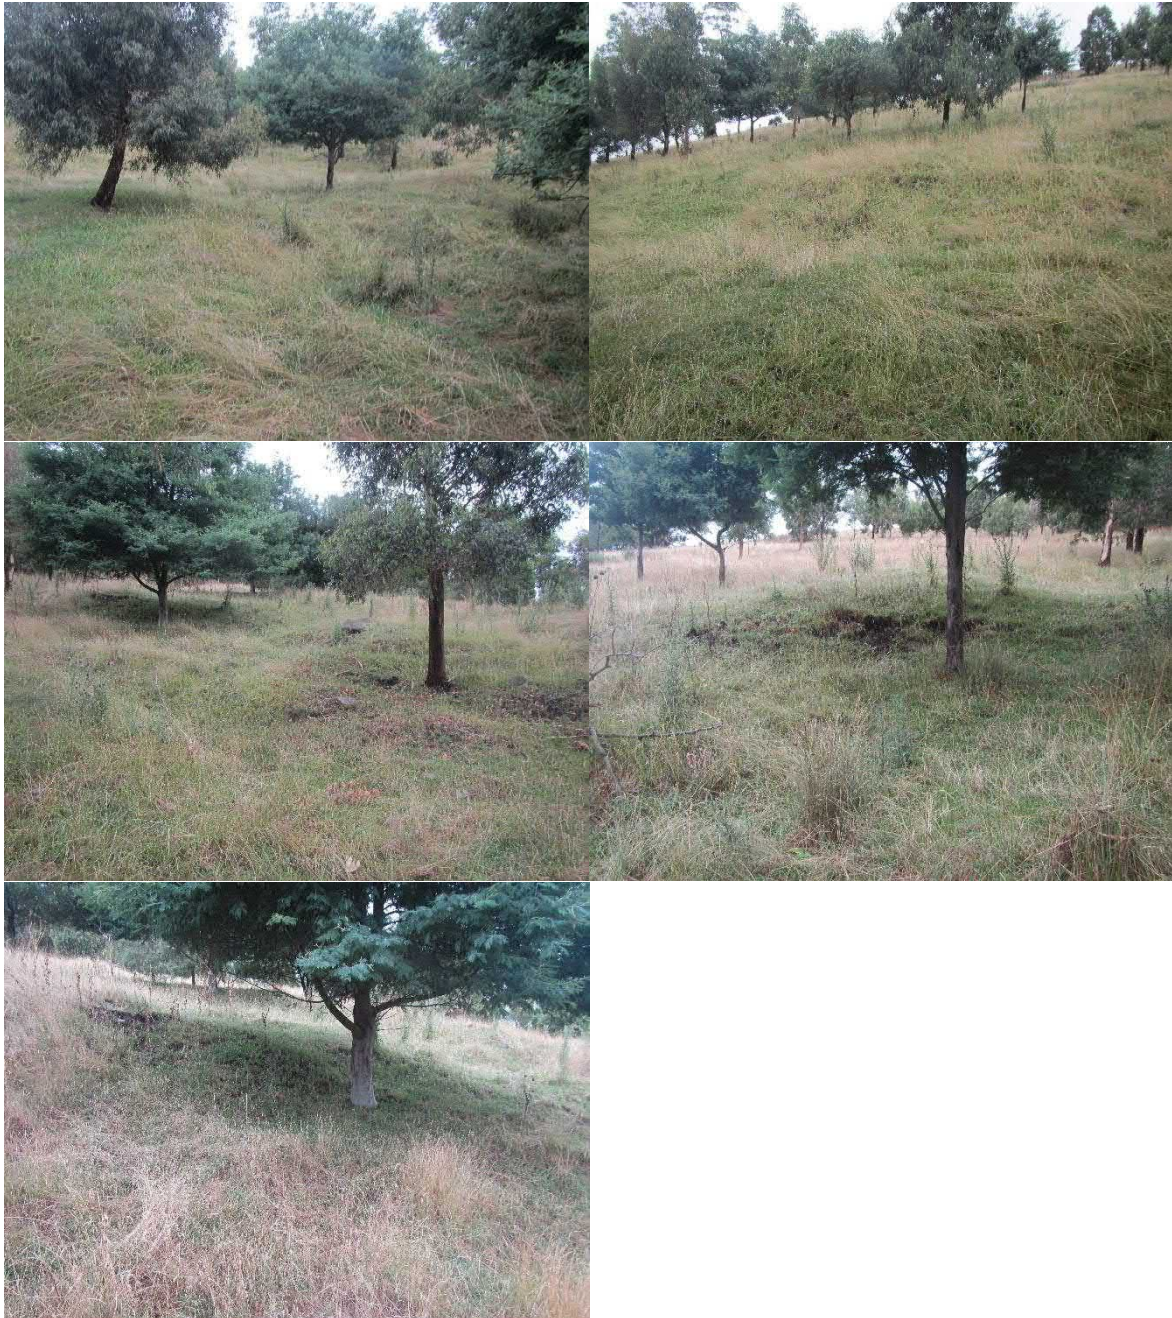
**Mass09**

Landslide Reference ID	2019 Visual Observation
Mass09	<ul style="list-style-type: none"> <li>Overall the area is well vegetated with dense grass cover and small to medium shrubs and trees throughout.</li> <li>Whilst the slope surface is hummocky, this appears to be associated with historical major landslips and no evidence of recent or ongoing instability was observed. Minor scarp erosion was observed but it is not anticipated to pose significant geotechnical risk.</li> <li>Holcim representative indicated that there is no known slope movement in this area over the review period and in general the area is considered to have remained stable over the last 7 years.</li> </ul>
Mass10	<ul style="list-style-type: none"> <li>Overall the area is well vegetated with dense grass cover and medium shrubs and trees throughout.</li> <li>Whilst the slope surface is hummocky, this appears to be associated with historical major landslips and no evidence of recent or ongoing instability was observed.</li> <li>Holcim representative indicated that there is no known slope movement in this area over the review period and in general the area is considered to have remained stable over the last 7 years.</li> <li>Minor grass cover has been removed with bare earth exposed – surficial erosion only.</li> <li>Minor downstream surficial erosion.</li> <li>A drain was observed under road to the south of the mass. No blockage observed at entry/ exit.</li> </ul>

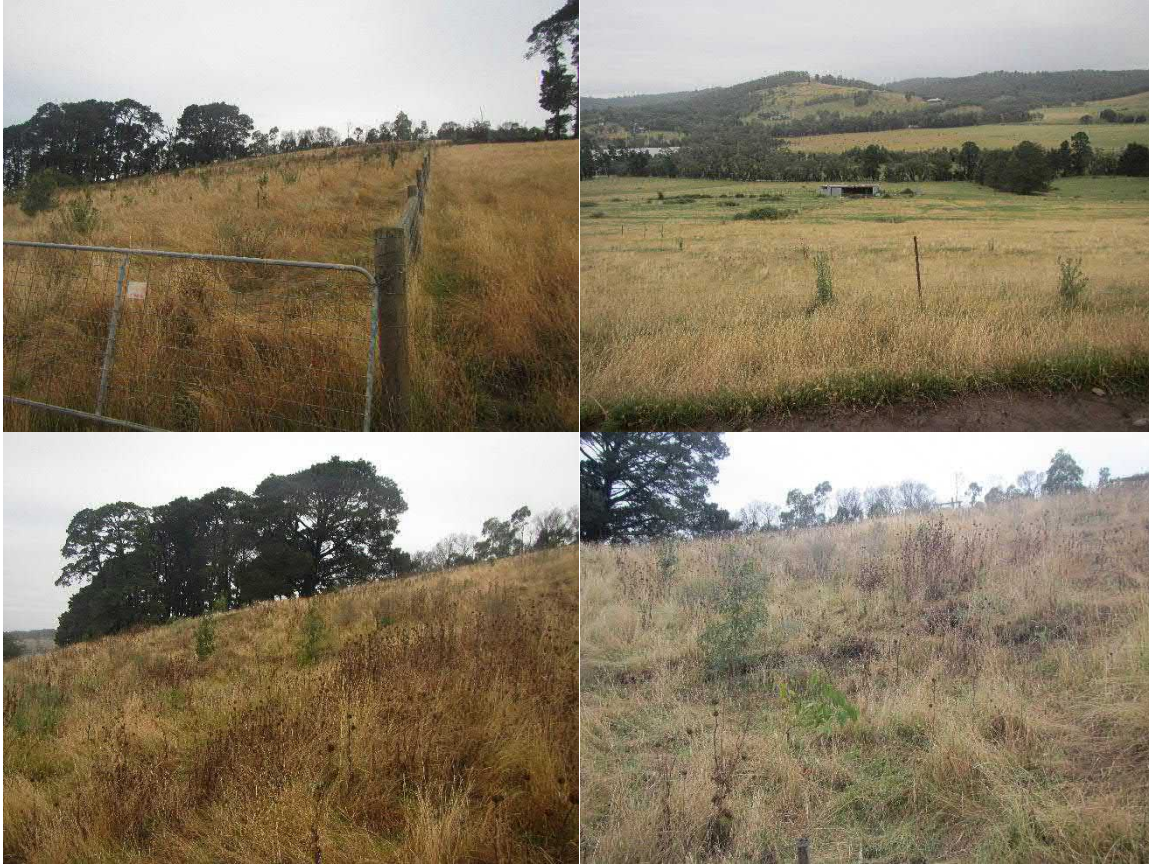
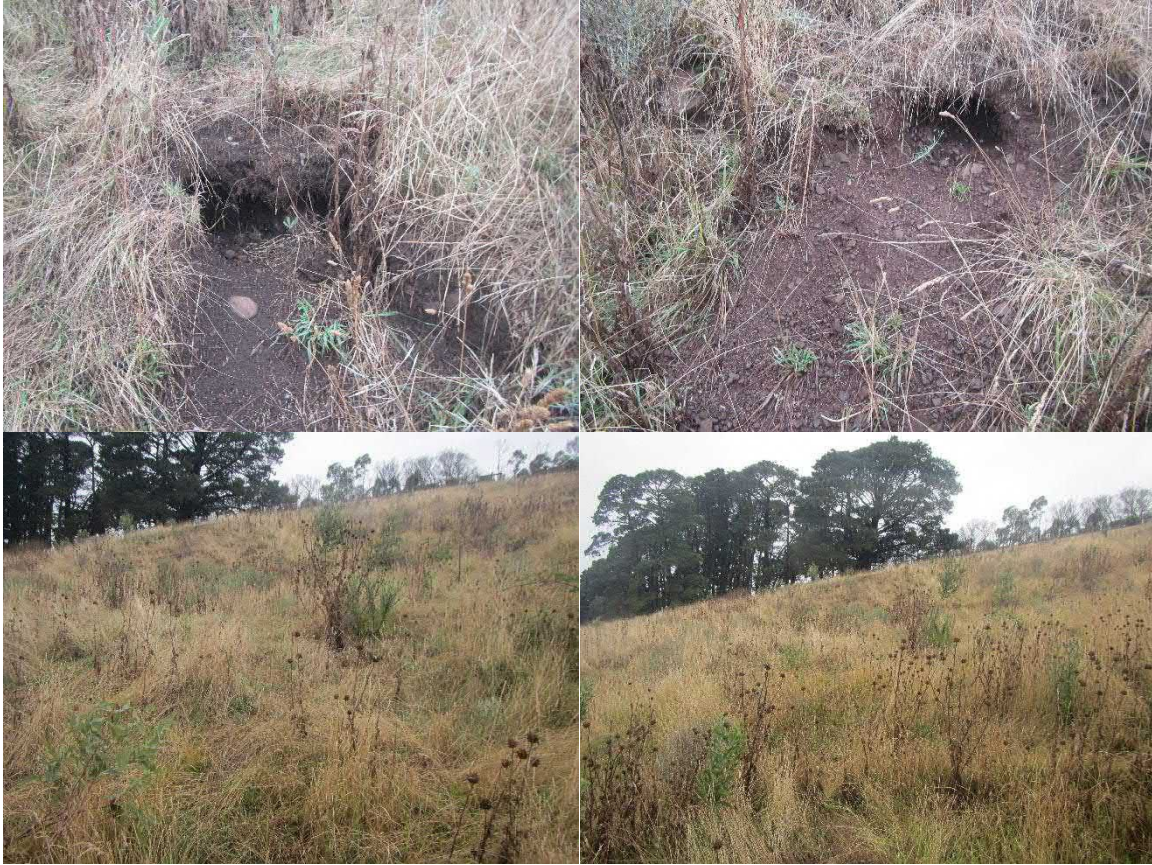
**Mass11**

Mass11	<ul style="list-style-type: none"> <li>Overall the area is well vegetated with dense grass cover and shrub and tree planting program, on a tight grid, has been established (refer Attachment 2). During the inspection period, the vegetation guards have been removed. Some vegetation as part of the program has also died off, which was reported by Holcim to be because of drought conditions.</li> <li>Whilst the slope surface is hummocky, this appears to be associated with historical major landslips and no evidence of recent or ongoing instability was observed.</li> <li>The small area in the top north corner of the Mass previously observed to be bare of grass cover was observed to have some vegetation growth albeit still comprising relatively less vegetation than surrounding areas. This area is coincident with a historical slump, as evidenced by a heaved mass in front of the area. At the area of the scarp of this slump, the slope remains bare and animal burrowing was observed to be undercutting the slope.</li> <li>Holcim representative indicated that there is no known slope movement in this area over the review period and in general the area is considered to have remained stable over the last 7 years.</li> </ul> <p><b>Proposed Remedial Solution Treatments</b></p> <ol style="list-style-type: none"> <li>1. Fill/ remediate burrowing so that the undercutting risk is mitigated;</li> <li>2. Construct a barricade to prevent animal access to the area to allow vegetation to establish;</li> <li>3. Revegetate the scarp surface with grasses; and</li> <li>4. Maintain regular documented inspections and if conditions deteriorate notify suitably qualified geotechnical engineer for further direction.</li> </ol>

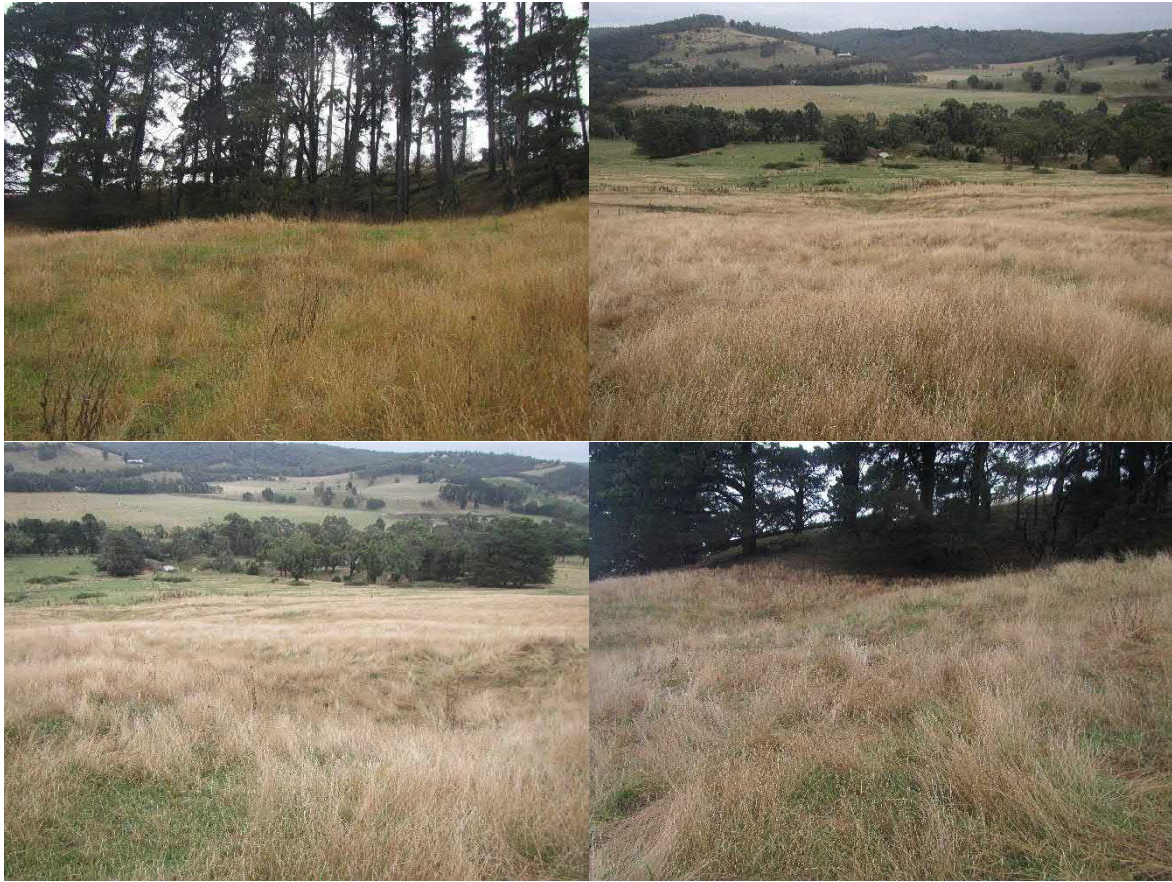
**Mass12**

Mass12	<ul style="list-style-type: none"> <li>Overall the area is well vegetated with dense grass cover and medium shrubs and trees throughout.</li> <li>Whilst the slope surface is hummocky, this appears to be associated with historical major landslips and no evidence of recent or ongoing instability was observed.</li> <li>Holcim representative indicated that there is no known slope movement in this area over the review period and in general the area is considered to have remained stable over the last 7 years.</li> </ul>
Mass13	<ul style="list-style-type: none"> <li>Overall the area is well vegetated with dense grass cover and medium shrubs and trees throughout.</li> <li>Whilst the slope surface is hummocky, this appears to be associated with historical major landslips and no evidence of recent or ongoing instability was observed.</li> <li>Holcim representative indicated that there is no known slope movement in this area over the review period and in general the area is considered to have remained stable over the last 7 years.</li> <li>Pipe under road. No blockage observed at entry. The exit of the pipe was observed to have some silt and sediment build-up (anticipated to be as a result of recent rainfall), which is damming the pipe exit.</li> <li>Minor scarp erosion approximately halfway between the access road and the dam was observed to have enlarged slightly during the inspection period. It is noted that there is negligible immediate risk, however there may be value in revegetating this area to mitigate further erosion.</li> </ul> <p><b>Proposed Remedial Solution Treatments</b></p> <ol style="list-style-type: none"> <li>1. Revegetate the scarp surface with grasses; and</li> <li>2. Maintain regular documented inspections and if conditions deteriorate notify suitably qualified geotechnical engineer for further direction.</li> </ol>

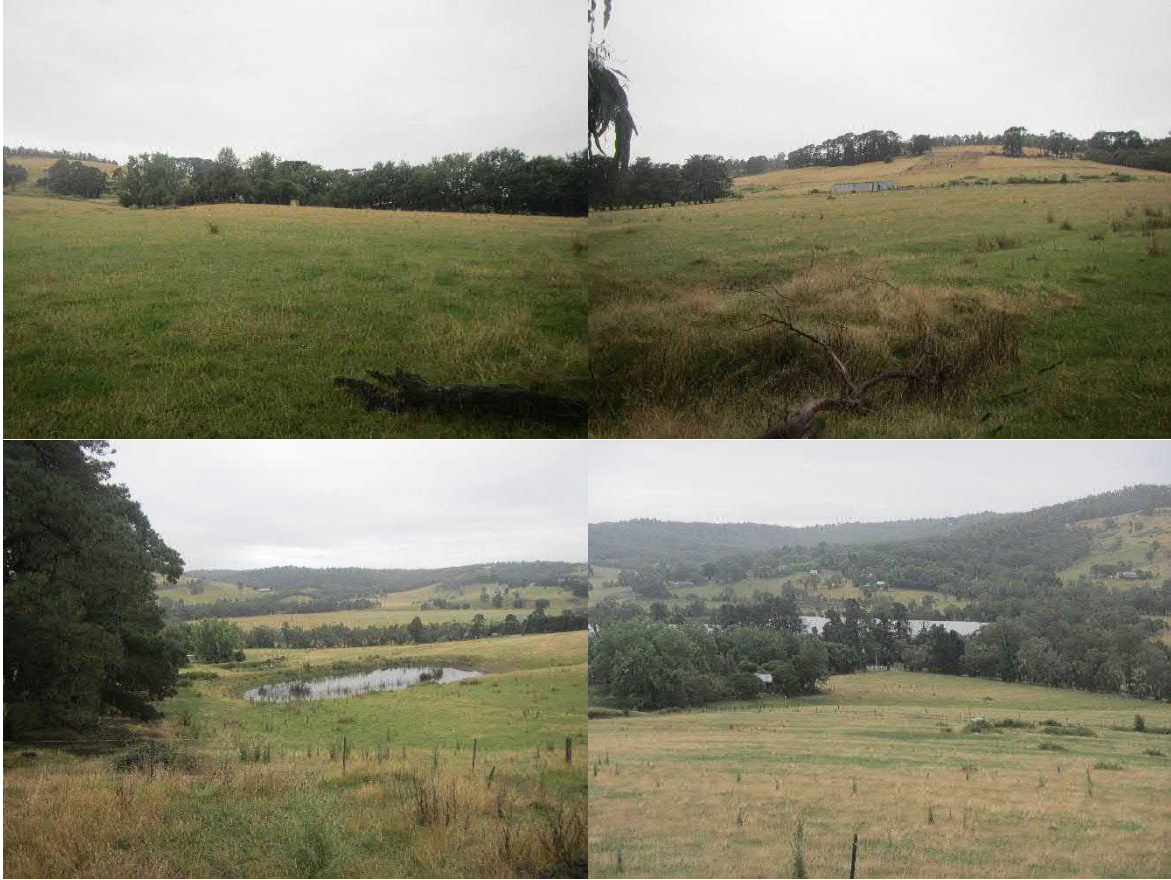
**Mass14**

Mass14	<ul style="list-style-type: none"> <li>Overall the area is well vegetated with dense grass cover and medium shrubs and trees throughout.</li> <li>Whilst the slope surface is hummocky, this appears to be associated with historical major landslips and no evidence of recent or ongoing instability was observed.</li> <li>Holcim representative indicated that there is no known slope movement in this area over the review period and in general the area is considered to have remained stable over the last 7 years.</li> </ul>
Mass15	<ul style="list-style-type: none"> <li>Overall the area is well vegetated with dense grass cover and medium shrubs and trees throughout.</li> <li>Whilst the slope surface is hummocky, this appears to be associated with historical major landslips and no evidence of recent or ongoing instability was observed.</li> <li>Holcim representative indicated that there is no known slope movement in this area over the review period and in general the area is considered to have remained stable over the last 7 years.</li> <li>Minor side-road scarps were observed, anticipated due to cattle traffic.</li> <li>Holcim representatives previously and anecdotally shared that there is a spring present under the large tree at the elevated east of this mass.</li> </ul>

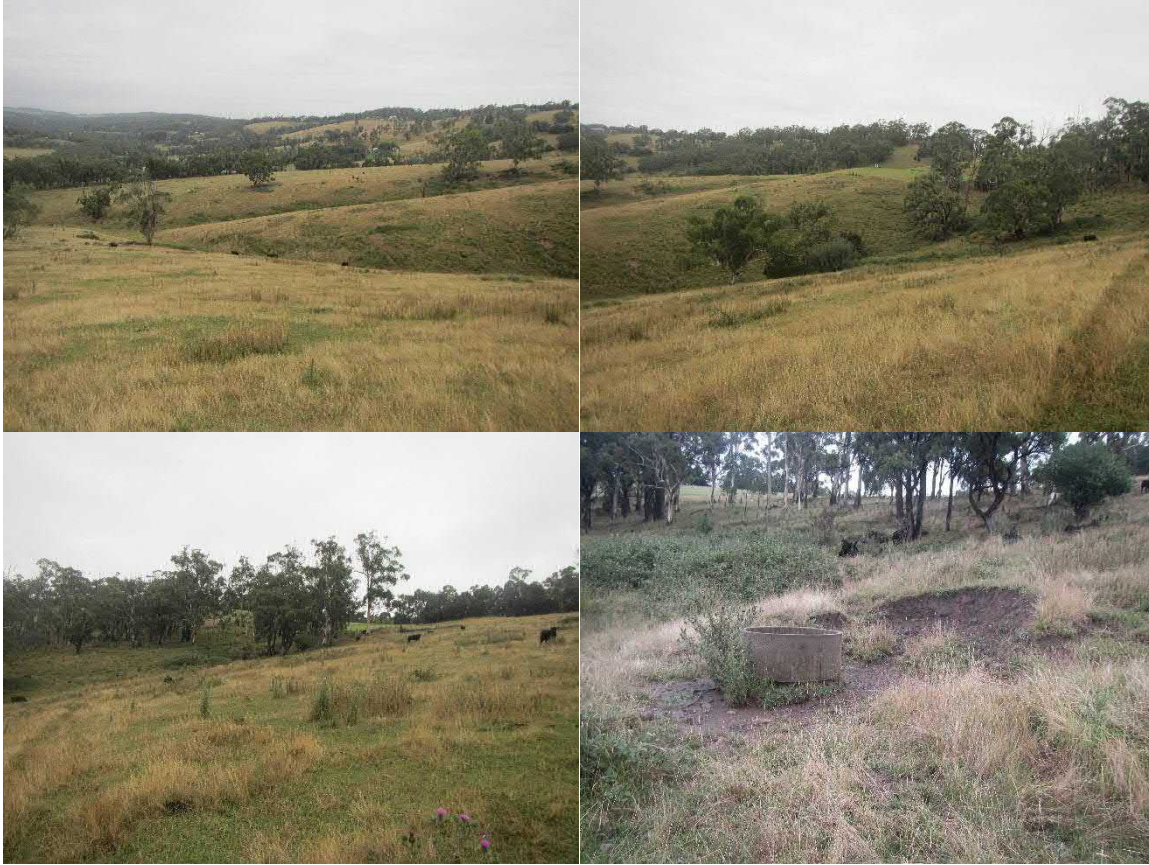
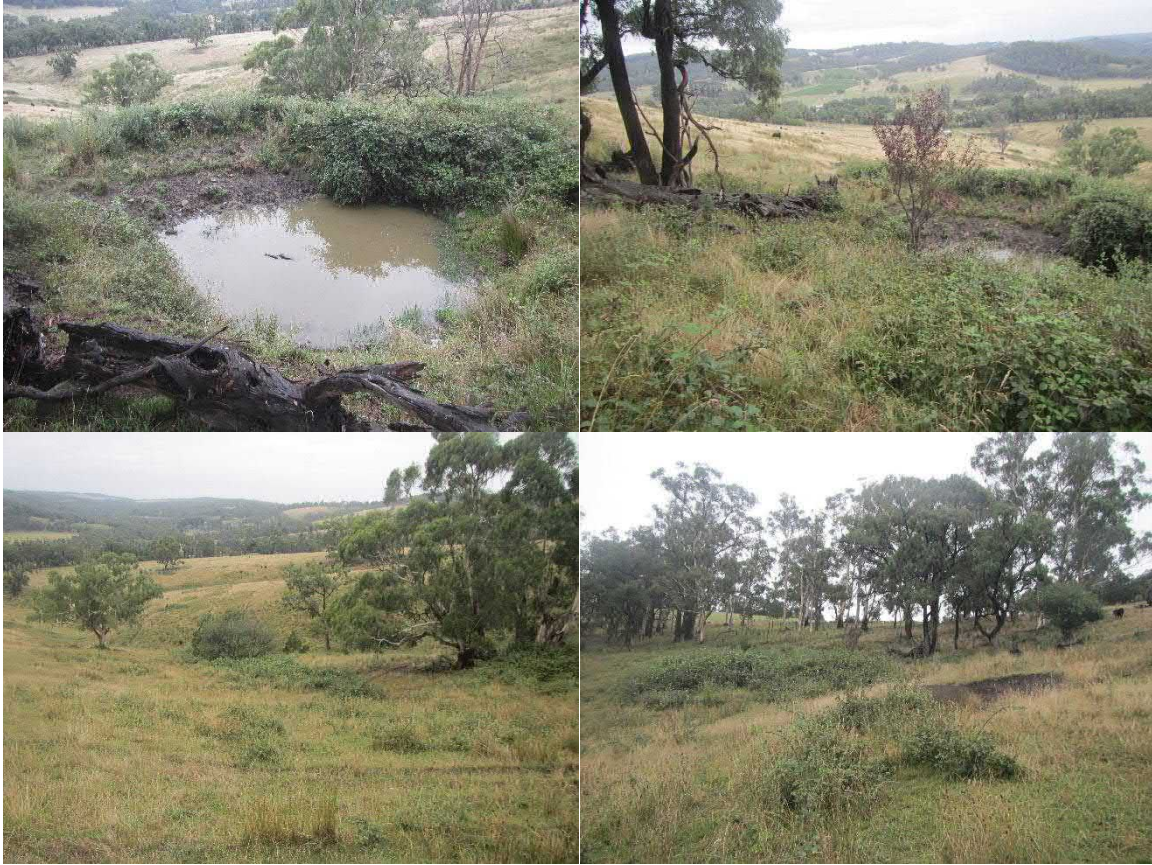
**Mass16**

Mass16	<ul style="list-style-type: none"> <li>Access gained to site but noted that it is important to contact landowner prior to entering.</li> <li>Heavy vegetation in the northern area, predominantly trees and shrubs. There is minor side slope erosion visible but anticipated to be related to traffic (both vehicles and cattle).</li> <li>A minor farm dam was observed approximately halfway up the mass. The vegetation on the dam bank has decreased, anticipated to be as a result of fauna traffic. The water level was observed 1.5m from crest of the dam with minor cattle tracks observed on the crest.</li> </ul>
Mass17	<ul style="list-style-type: none"> <li>Area is well vegetated with dense grass cover.</li> <li>Whilst the slope surface is hummocky, this appears to be associated with historical major landslips and no evidence of recent or ongoing instability was observed.</li> <li>Holcim representative indicated that there is no known slope movement in this area over the review period and in general the area is considered to have remained stable over the last 7 years.</li> </ul>

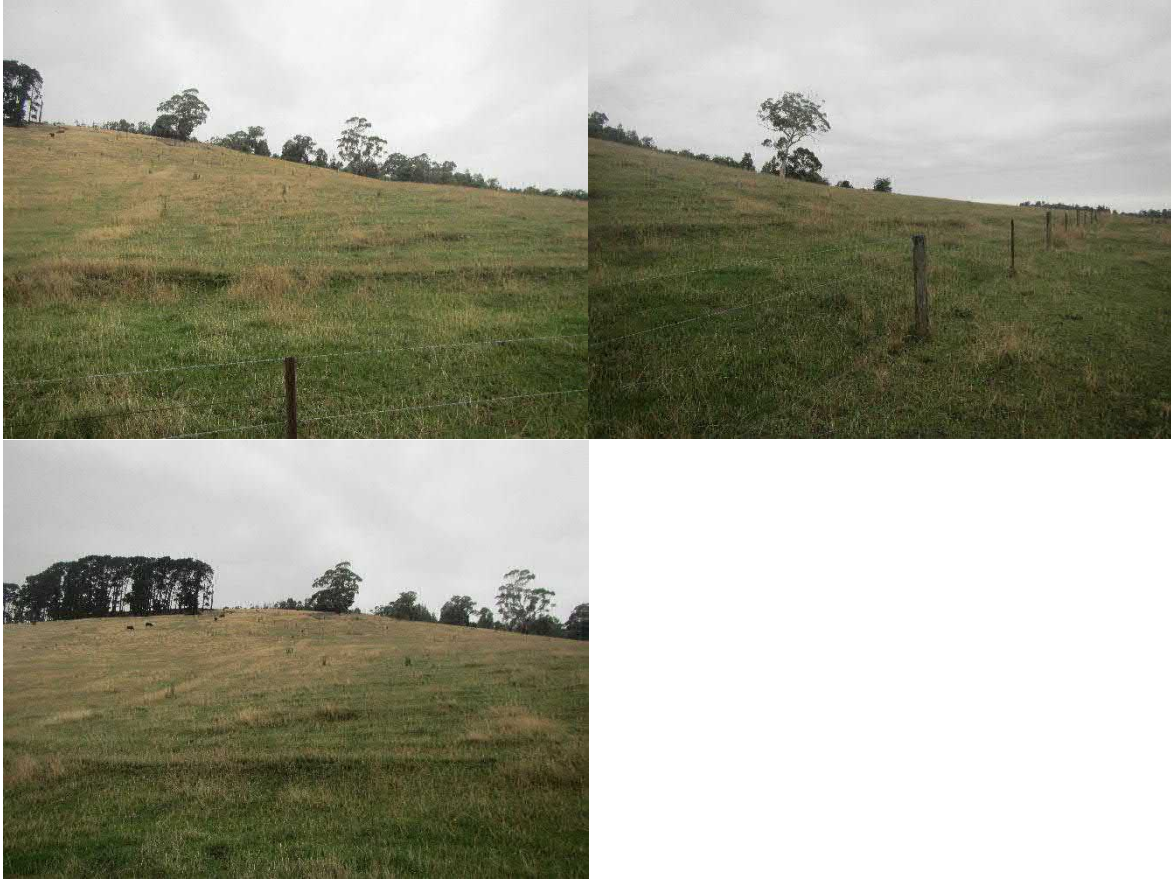
**Mass18**

Mass18	<ul style="list-style-type: none"> <li>Overall the area is well vegetated with dense grass cover and medium shrubs and trees throughout.</li> <li>Whilst the slope surface is hummocky, this appears to be associated with historical major landslips and no evidence of recent or ongoing instability was observed.</li> <li>Holcim representative indicated that there is no known slope movement in this area over the review period and in general the area is considered to have remained stable over the last 7 years.</li> <li>Mass 19 was observed to have localised surface erosion, evidenced by exposed (bare) earth &lt; 0.5m<sup>2</sup>.</li> </ul>
Mass19	
Mass20
