17 February 2020

Matthew Dodd  
Quarry Manager  
Holcim (Australia) Pty Ltd  
Mt. Shamrock Road

## **Mt. Shamrock Quarry - Toomuc Valley Slope Inspection, January 2019**

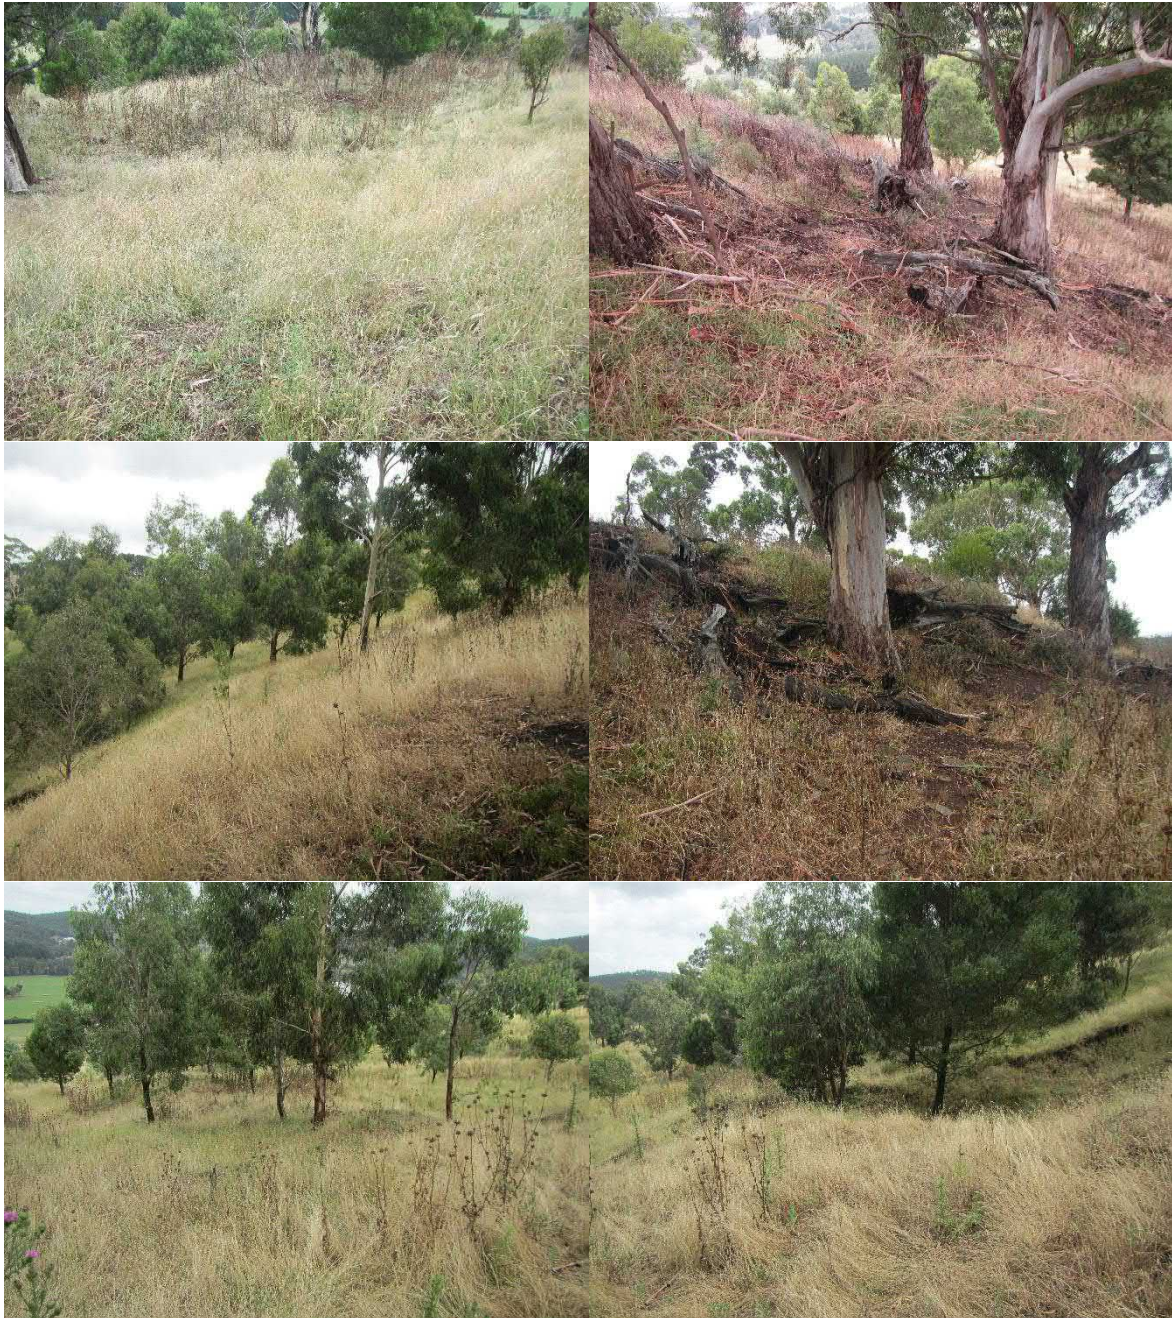
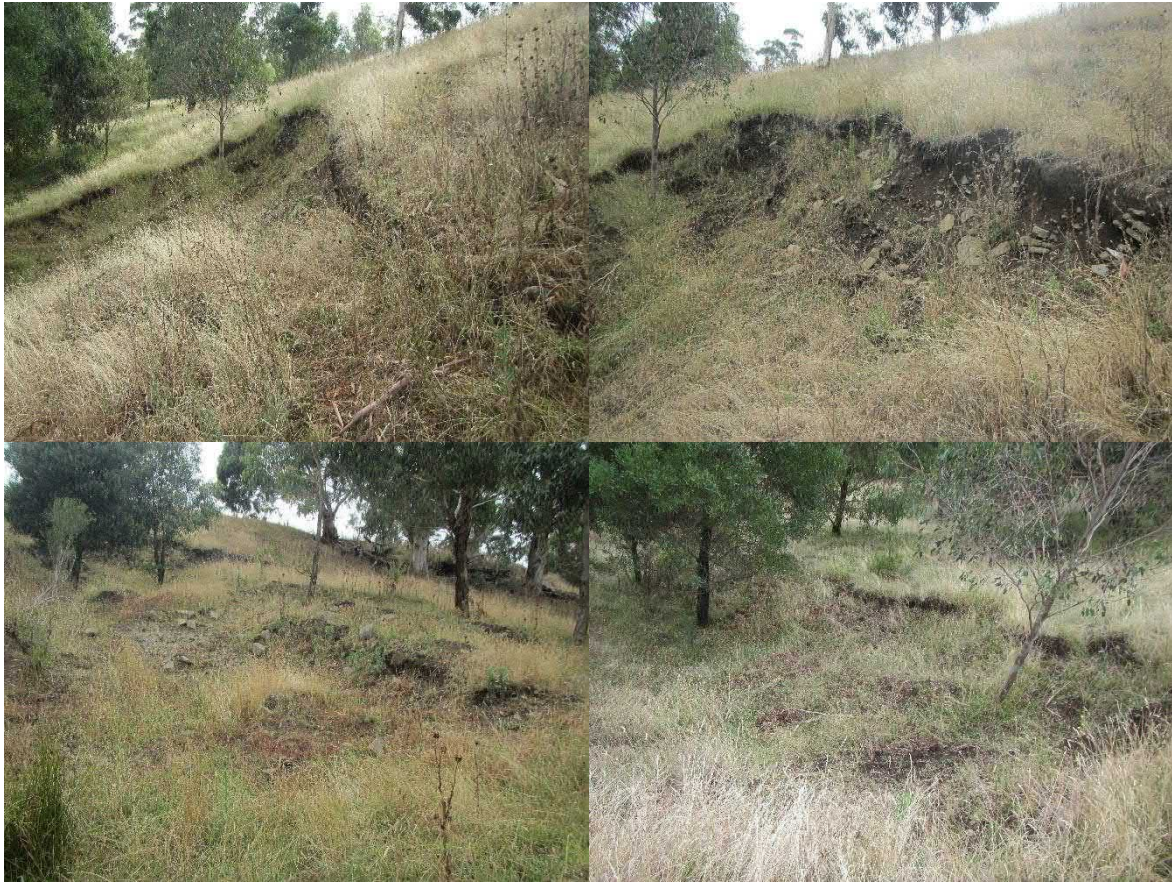
**Back scarp of Large Historical Landslide comprising Masses 1, 2, 3, 9 and 17**

Landslide Reference ID	2019 Visual Observation
Other Areas Visited	
Back scarp of Large Historical Landslide comprising Masses 1, 2, 3, 9 and 17	<ul style="list-style-type: none"><li>The crest of the backscarp was observed to be relatively fresh (recently eroded), and suggests retreating of the crest is occurring. At time of inspection, this retreat was anticipated to be &lt;100mm laterally.</li><li>The downslope area of the backscarp is well vegetated with grasses and trees.</li><li>Slope erosion was observed on adjacent slopes, in particular around larger gum trees but is anticipated to be historical and of no significant geotechnical risk.</li></ul> <p><b>Proposed Remedial Solution Treatments</b></p> <ol style="list-style-type: none"><li>Construct a barricade to prevent animal access to the area to allow vegetation to establish;</li><li>Revegetate behind the failure / old backscarp with deep root (but small canopy) shrubs / bushes and grasses; and</li><li>Maintain regular documented inspections and if conditions deteriorate notify suitably qualified geotechnical engineer for further direction.</li></ol>

1. Introduce additional vegetation at the crest of a scarp at “Back scarp of large historical landslide” (refer Attachment 1), as it appeared to be freshly eroded and retreating;
2. Fill animal burrowing holes and revegetate scarps at Mass11;
3. Revegetation of scarp surfaces with grasses proposed at Mass08 and Mass13; and
4. Remedial treatments previously proposed for Mass13 Dam remain, as this has not yet been undertaken. These are aimed at establishing a permanent freeboard and reinstating the dam embankment. Whilst the dams are typically located remotely to existing downslope infrastructure, should failure occur, the potential for downslope damage exists. In the case of the dam at Mass13, more detailed assessment of runout paths should be undertaken to assess the risk, if any, to infrastructure.
