20 January 2021

Matthew Dodd
Quarry Manager
Holcim (Australia) Pty Ltd
Mt. Shamrock Road
Pakenham, Victoria 3810

Mt. Shamrock Quarry - Toomuc Valley Slope Inspection, January 2020**1.0 Introduction and Background**

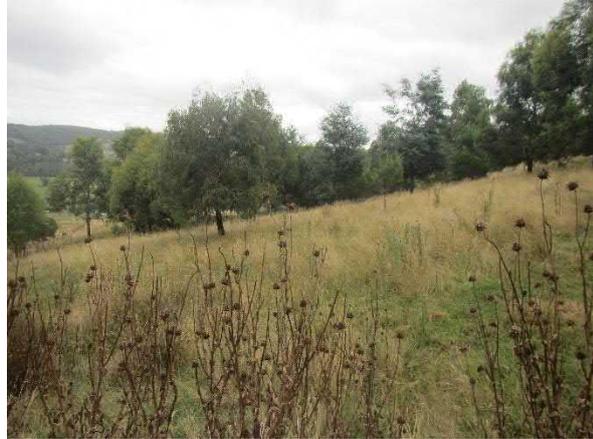
Mass03	<ul style="list-style-type: none"> Overall the area is well vegetated with dense grass cover and small to medium shrubs and trees throughout. Whilst the slope surface is hummocky, this appears to be associated with historical major landslips and no evidence of recent or ongoing instability was observed. Holcim representative indicated that there is no known slope movement in this area over the review period and in general the area is considered to have remained stable over the last 7 years.

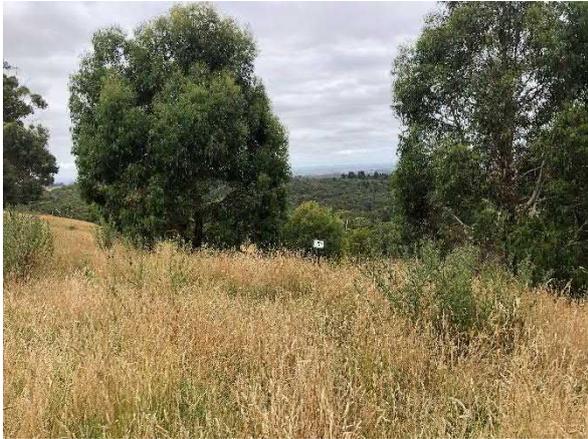
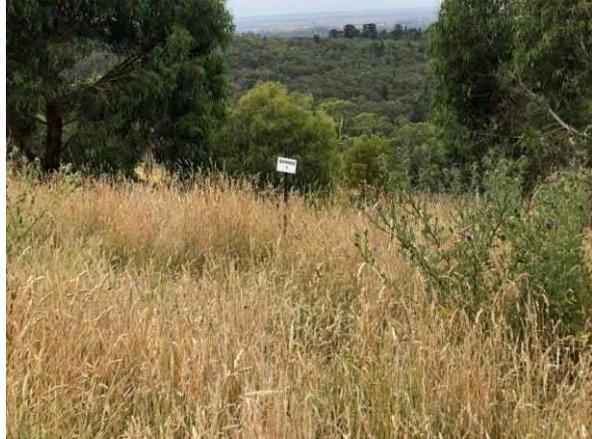
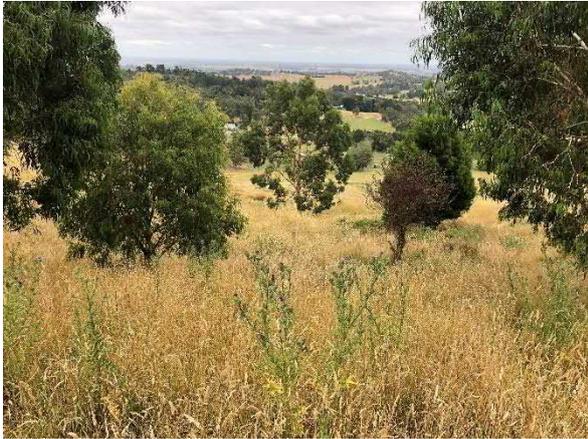
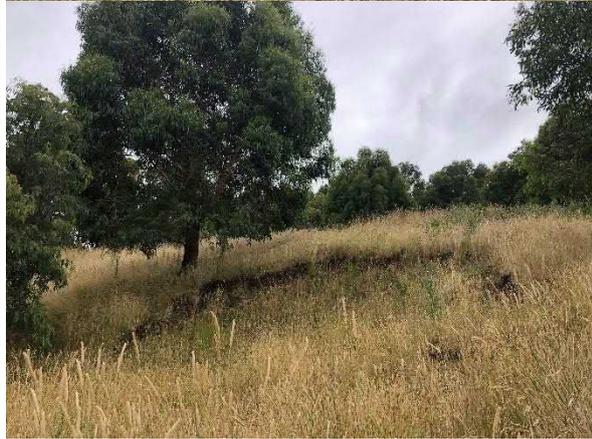
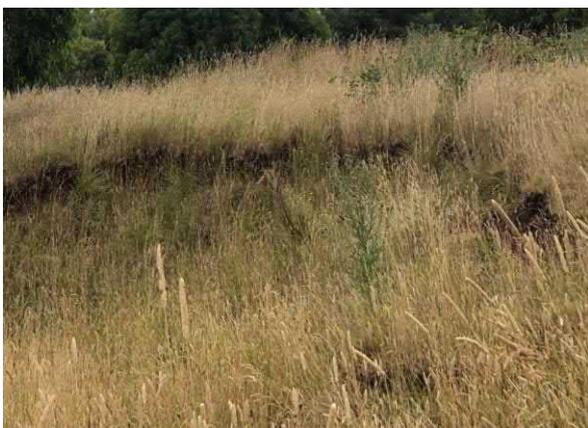
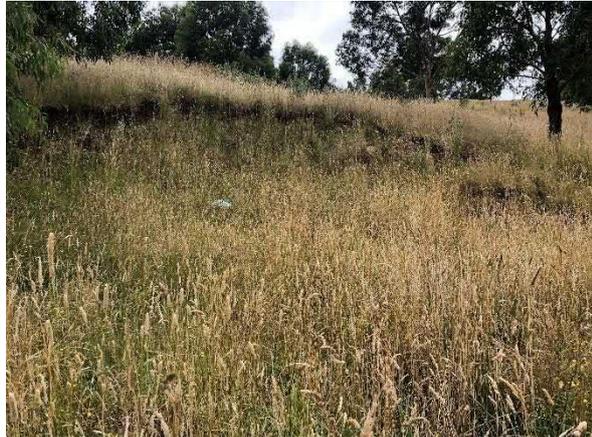
Landslide Reference ID	2020 Visual Observation
Mass04	<p>General Slope Stability of Mass04 Area</p> <ul style="list-style-type: none"> Overall the area is well vegetated with dense grass cover and small to medium shrubs and trees throughout. Whilst the slope surface is hummocky, this appears to be associated with historical major landslips and no evidence of recent or ongoing instability was observed. Holcim representative indicated that there is no known slope movement in this area over the review period and in general the area is considered to have remained stable over the last 6 years. <p>Localised Small Circular Failure of Old Backscarp (refer Attachment 2)</p> <ul style="list-style-type: none"> During previous review period a small, shallow circular failure of an old backscarp from the larger historical landslide has occurred. Evidence suggest it has been triggered ~9 years ago. The slope behind the failure is relatively flat, appeared dry and is vegetated with grass and bushes. There is no evidence of tension cracks behind the failure. The failure measures about 5 m in width and ~1.5 m in height. The slope below slump is damp, likely associated with a spring. Surface water was not able to be observed based on moist conditions from recent rainfall. The circular failure is small in volume and, given that the location is isolated from any downhill infrastructure, is not considered to be a significant geological risk. <p>Remedial Solution Treatments</p> <p>The following remedial options have been implemented during the previous review period:</p> <ol style="list-style-type: none"> Construct a barricade to prevent animal access to the area to allow vegetation to establish, it is currently fenced on all sides at approximately a 50m radius. Revegetate behind the failure / old backscarp with deep root (but small canopy) shrubs / bushes and grasses Revegetate in the saturated area below the failure with wet tolerant species, ie swampy gums, river gum, boobias Revegetate the slump surface with grasses. Maintain regular documented inspections and if conditions deteriorate notify suitably qualified geotechnical engineer for further direction. <p>It is deemed important to continue to monitor the vegetation of this scarp to ensure that washouts do not inhibit the progress. Some vegetation regrowth (likely to be as a result of previous remedial treatments and revegetation) was observed at the toe of and within the scarp area.</p>

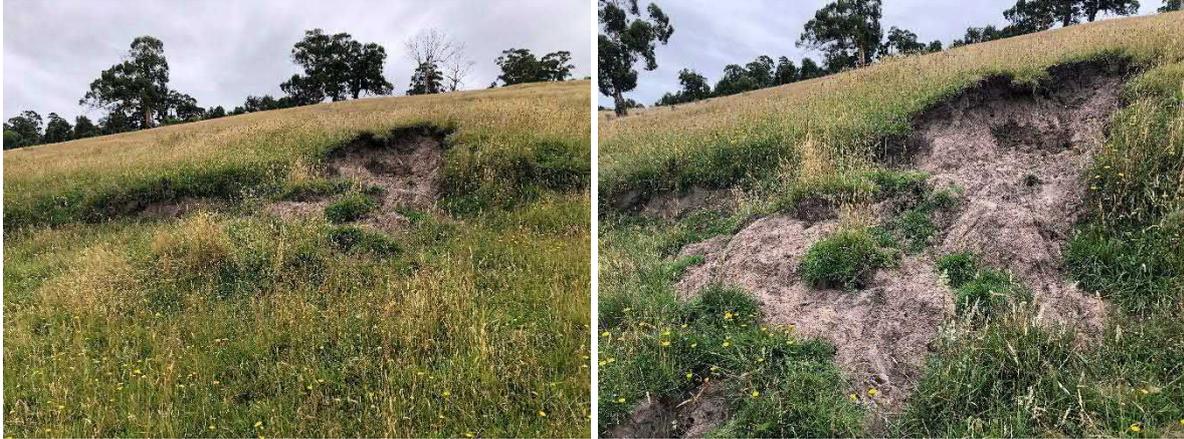
- Mass05 shows signs of additional movements with a localised small failure within an existing backscarp due to cattle traffic and circular slope failure within an existing backscarp that extent over about 15 m. Both failures are small in volume and, given that the location is isolated from any downhill infrastructure, is not considered to be a significant geological risk.

Mass05	<ol style="list-style-type: none"> Overall the area is well vegetated with dense grass cover throughout. Holcim representative indicated that there is no known slope movement in this area over the review period and in general the area is considered to have remained stable over the last 8 years. Minor historical circular failures were observed in four locations: these failures were observed to be associated with exposed (bare) scarps and a change in the natural topography locally downslope with remnant mobilised material. A natural drain has formed through this material to avoid the local high. It is recommended that the bare scarp areas are grassed to mitigate potential of further erosion. The mobilised material is well vegetated. Observation of the exposed scarp suggests that the material is weakly structured, near-surface soil possibly associated with the Werribee Formation (Attachment 1 for geological map and Attachment 2 for photo of scarp). <p>Localised Failure of Old Backscarps (see figure for Mass 5)</p> <ul style="list-style-type: none"> During the 2020 Inspection, a localised small failure of old backscarp was noted due to cattle traffic. The failure measures about ~2 m in width and ~2m in height. The failure is small in volume and, given that the location is isolated from any downhill infrastructure, is not considered to be a significant geological risk. During the inspection a shallow circular failure of an old backscarp from the larger historical landslide has occurred. There is no evidence of tension cracks behind the failure. The failure measures about 15 m in width and ~1.5 m in height. The circular failure is small in volume and, given that the location is isolated from any downhill infrastructure, is not considered to be a significant geological risk. <p>Remedial Solution Treatments</p> <p>The following remedial options are recommended:</p> <ol style="list-style-type: none"> Revegetate behind the failure / old backscarp with deep root (but small canopy) shrubs / bushes and grasses Revegetate the scarp surface with grasses; and Maintain regular documented inspections and if conditions deteriorate notify suitably qualified geotechnical engineer for further direction. <p>It is deemed important to continue to monitor the vegetation of this scarp to ensure that washouts do not inhibit the progress.</p>

Failure due to Cattle Traffic

1. Fill animal burrowing holes and revegetate scarps at Mass11;
2. Revegetation of scarp surfaces with grasses proposed at Mass05, Mass08 and Mass13; and

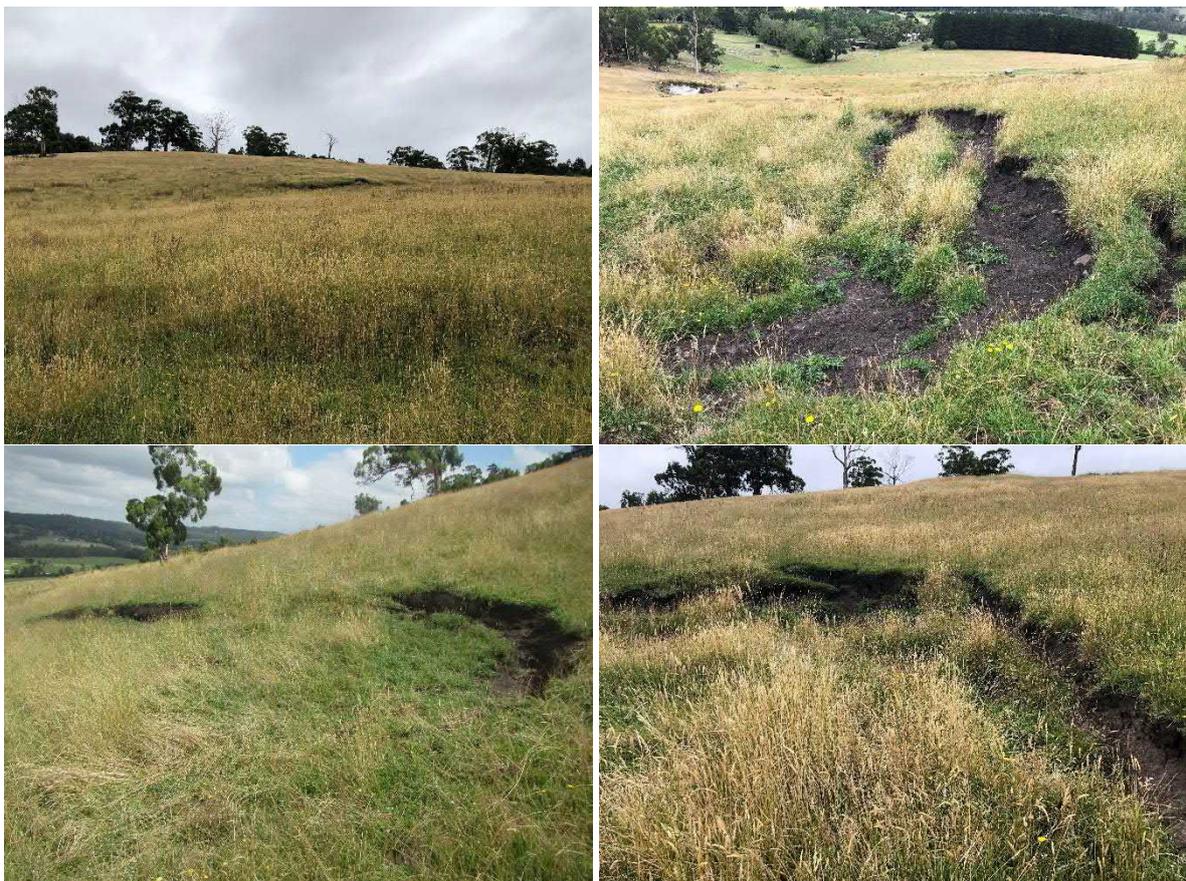
- Mass 05 shows new areas of instability with a local failure due to cattle traffic and a circular slope failure of an existing backscarp extending over 15 m.
- No sign of new areas of instability were identified on the other Masses located within slopes surrounding the quarry.
- the Mass06 Dam Crest has deteriorated due to cattle traffic and in some section, the crest is locally reduced to a 1.2 - 1.5 m width compared to 2.5 – 3.0 m elsewhere.
- Significant seepage has been noted at the toe of the Dam located upstream of Mass 14. This dam is not within Holcim Land.

Circular Failure of an Existing Old Backscrap

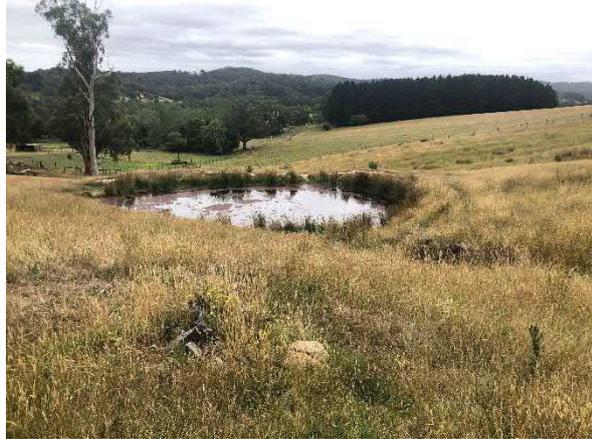
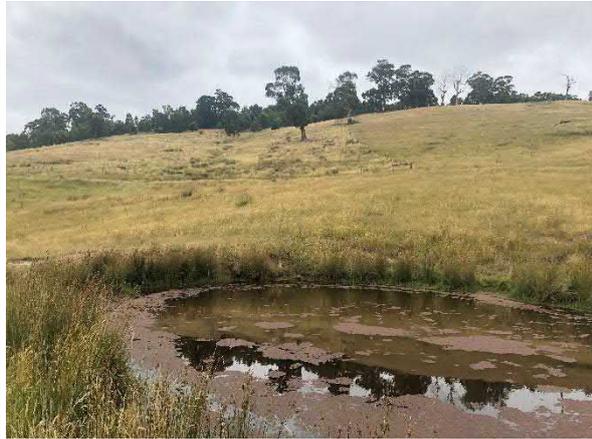
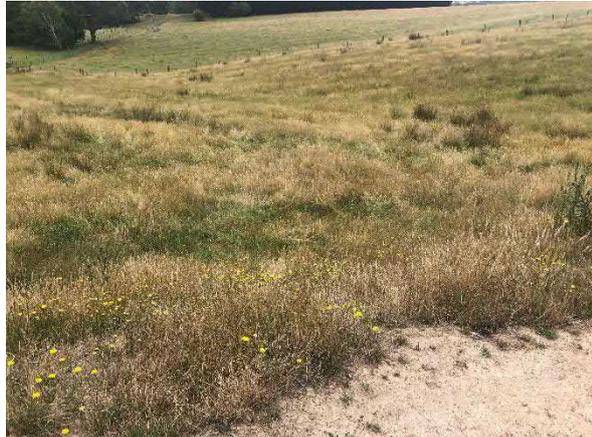
Mass05 Dam	<ul style="list-style-type: none"> Upstream drainage channel/ catchment from Mass05 is unobstructed. Embankments are vegetated. Eastern side is bare, with an observed retreating crest. There is waste (rubbish) blocking the upstream channel to the east. This is recommended to be monitored but is not anticipated the comprise significant risk at this stage. A downstream spillway has formed naturally. Water was observed 800mm below the crest of the dam, with the crest material softened by cattle traffic. There is a low risk for this structure in terms of both likelihood and consequence
Mass06	<ul style="list-style-type: none"> Overall the area is well vegetated with dense grass cover throughout. Holcim representative indicated that there is no known slope movement in this area over the review period and in general the area is considered to have remained stable over the last 8 years.

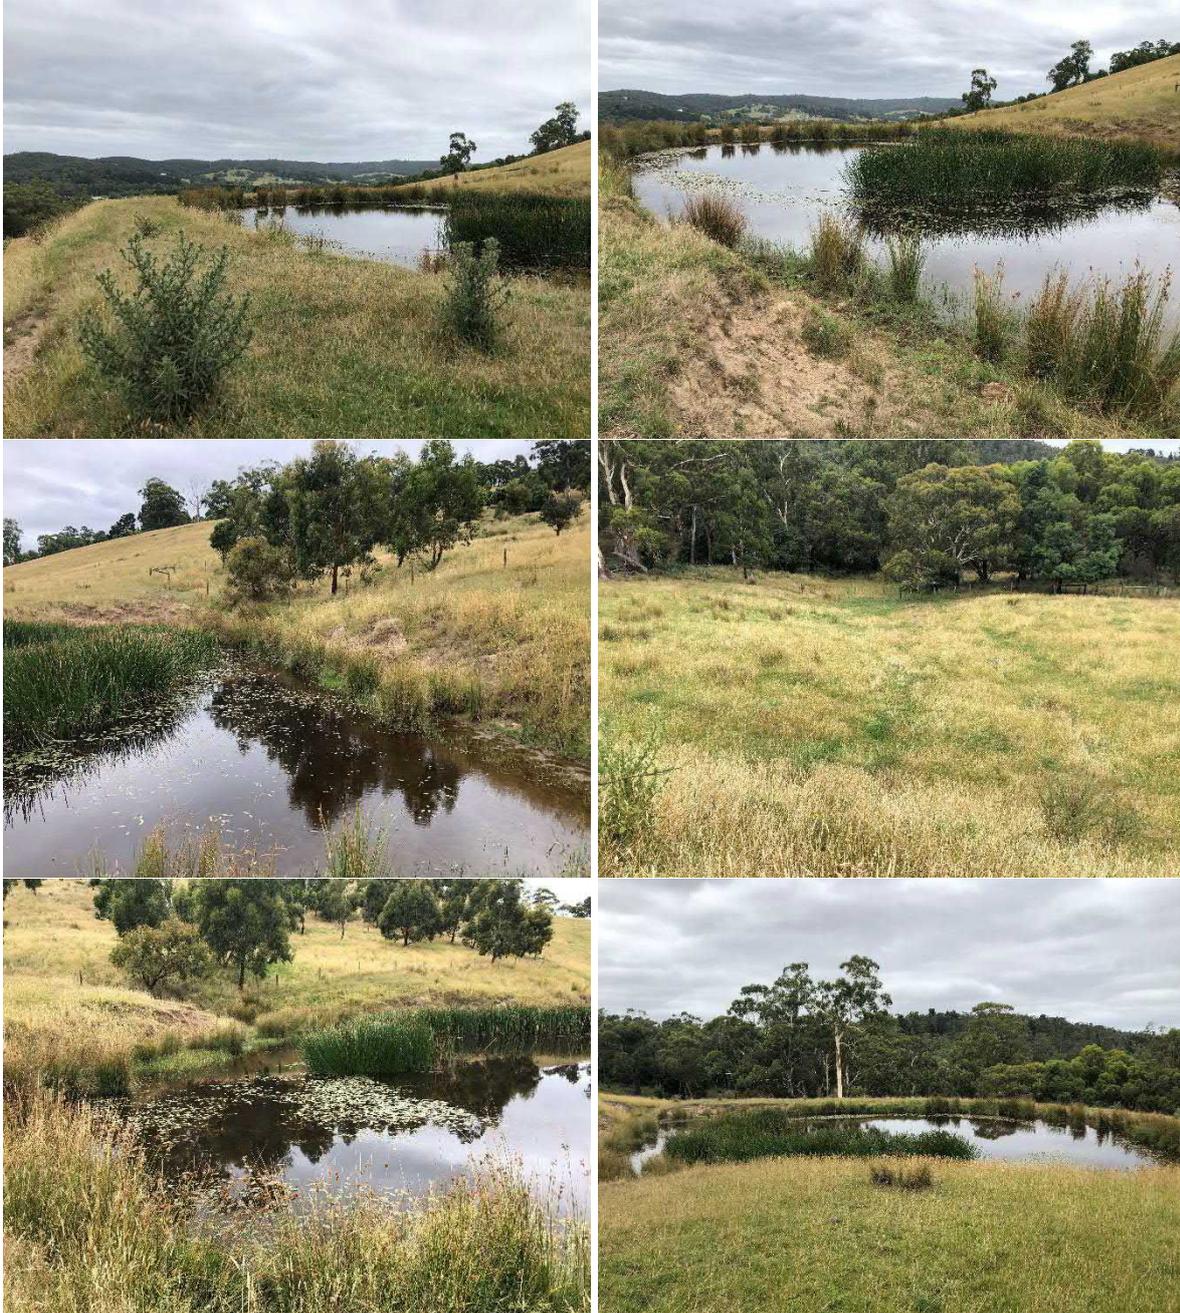
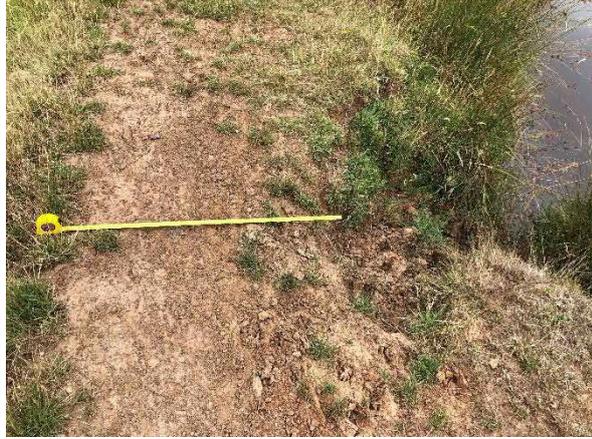
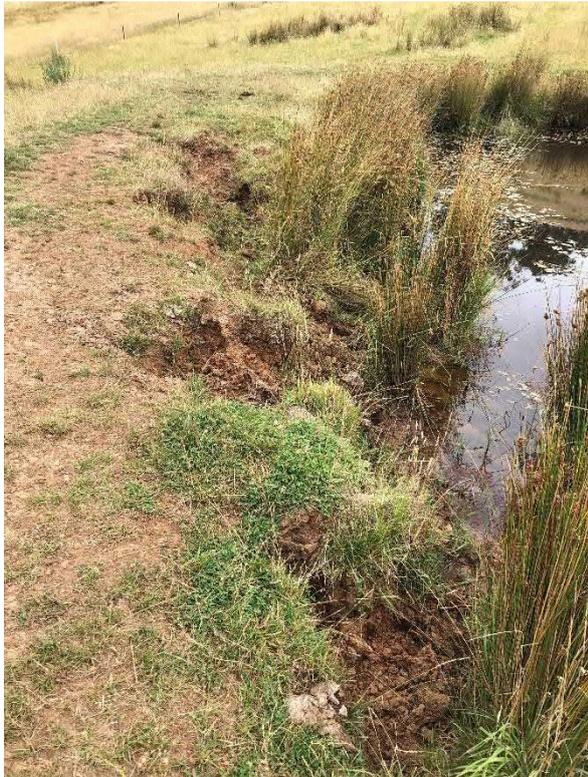
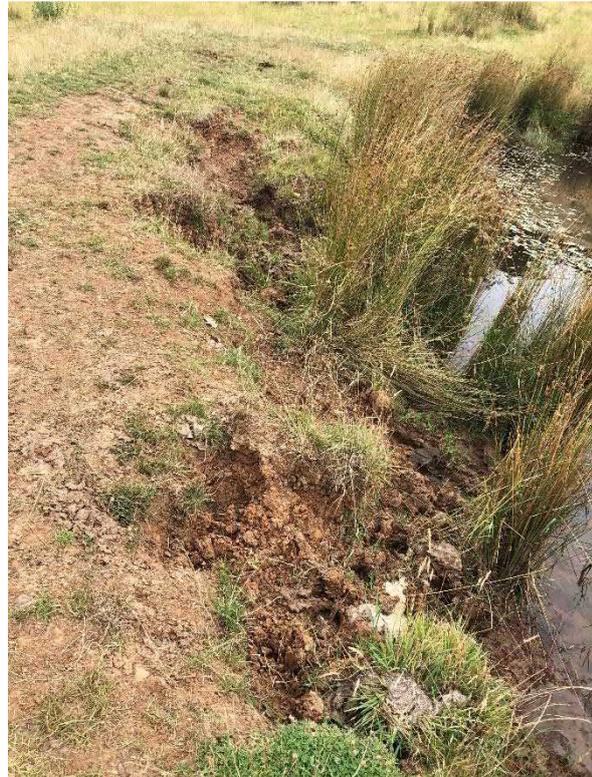
- The other masses show no sign of movements.
- The upstream shoulder of Mass 06 Dam crest has deteriorated due to cattle traffic and in some part, the width crest is locally reduced to a 1.2 - 1.5 m width compared to 2.5 – 3.0 m elsewhere. At the time of the inspection the water level was 900 mm below the crest and risk of overflow were low. Repairs of the crest and construction of a fence to prevent cattle traffic on the crest are recommended to mitigate any risk of Dam failure and prevent further degradation.

Landslide Reference ID	2020 Visual Observation
Mass06 Dam	<ul style="list-style-type: none"> This dam contains a comparatively large volume of water to other dams (surface area 45 m², total depth unknown). The water level was observed at 900mm below the crest. A natural overflow to east has been identified, which directs water to a dam on an adjacent property downstream. Risk to cattle adjacent to dam, where in some places a 1.5 - 2 m vertical difference was observed due to the retreating crest The Mass 06 Dam crest is narrowing, predominantly due to fauna traffic on the upstream crest and in some part, the width crest is locally reduced to a 1.2 - 1.5 m width compared to 2.5 – 3.0 m elsewhere. Failure risk is considered low. Continued uncontrolled discharged of water from an over full dam could result in erosion and scour of the dam wall and whilst the consequences of dam failure would be moderate as the asset is isolated from infrastructure such as dwellings, public roads etc. A visual assessment of the dam surface area and anticipated (albeit unknown) depth indicates that should water runoff, this would saturate the ground however is not anticipated to detrimentally influence the downstream property. A full failure would result in rapid discharge of a not insignificant volume of water and mud which likely would severely damage vegetation and could trigger other remobilisation landslips further down slope. Another consequence would be loss of stock drinking water. To maintain the integrity of the dam and prevent damage to the dam wall due to uncontrolled discharged and possible overtopping possible remedial solutions are suggested below. <p>Remedial Solution Treatments</p> <p>The following remedial options have been suggested on the basis that, at this point, only small earthmoving plant is considered feasible to mobilise to the area</p> <ul style="list-style-type: none"> Construct a barricade to prevent animal access to the dam crest. Reinstate the scoured dam crest with locally won clays (keyed in, placed and compacted in accordance with good dam construction practice. <p>*Note: works should be carried out under the direction of an appropriately experienced and qualified dams or geotechnical engineer.</p> <ul style="list-style-type: none"> Maintain regular documented inspections of the dam and if conditions deteriorate notify suitably qualified geotechnical engineer for further direction.

4. Remedial treatment of Mass06 Dam with reinstatement of the dam crest and construction of a barricade to prevent animal access to the dam crest.
5. Holcim should notify the landowner of the dam located upstream of Mass 14 of the important seepage observed and recommend the dam be inspected by an experienced and qualified dams or geotechnical engineer.

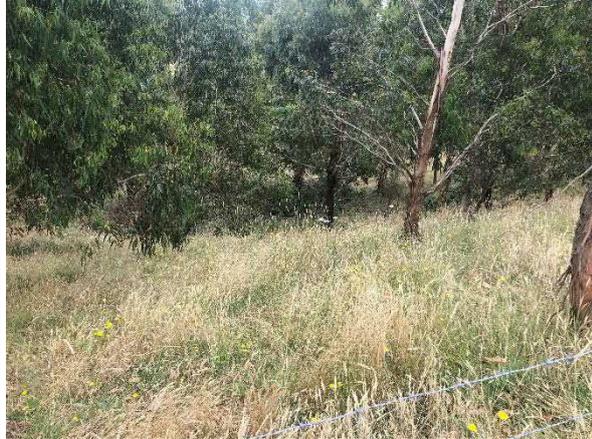
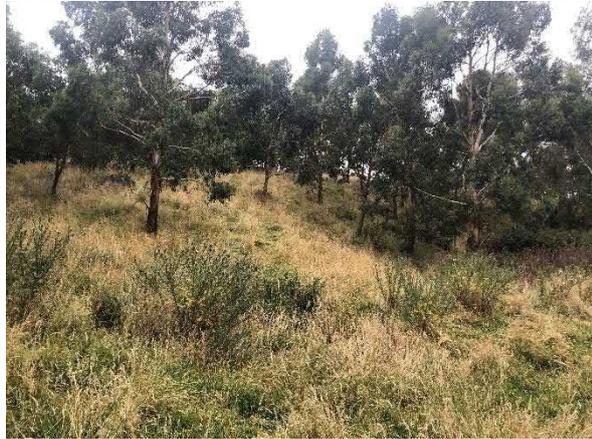
Mass07	<ul style="list-style-type: none"> Tree planting has been undertaken upslope. There is a minor scarp adjacent to the worn cattle track on the eastern side, suggested erosive driver being the cattle traffic but reiterating the poor structure of the soils. Historical scarp has been vegetated with no exposed ground or evidence of movement. Overall the area is well vegetated with dense grass cover throughout. Holcim representative indicated that there is no known slope movement in this area over the review period and in general the area is considered to have remained stable over the last 8 years
Mass08	<ul style="list-style-type: none"> Overall the area is well vegetated with dense grass cover throughout. There are some historical scarps up to 1m height. These demonstrate weak soil structure, with anticipated minor failures in rain events. The local area immediately below scarp is poorly to moderately vegetated. Bare ground was observed for approximately 500mm laterally at the toe of the scarp. <p>Proposed Remedial Solution Treatments</p> <ol style="list-style-type: none"> Revegetate the scarp surface with grasses; and Maintain regular documented inspections and if conditions deteriorate notify suitably qualified geotechnical engineer for further direction.

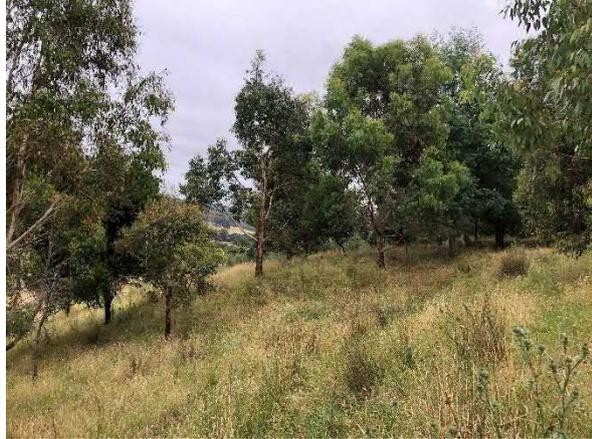
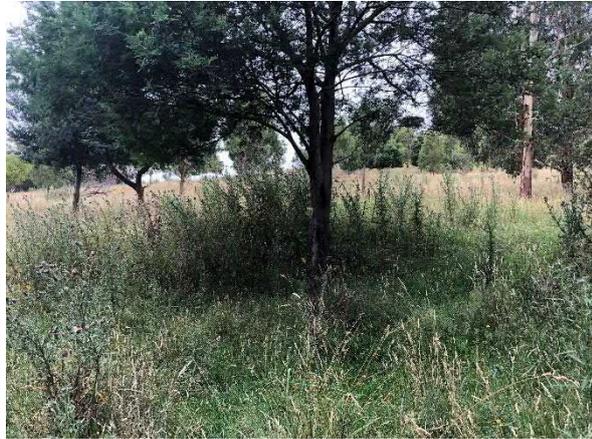
Mass09	<ul style="list-style-type: none"> Overall the area is well vegetated with dense grass cover and small to medium shrubs and trees throughout. Whilst the slope surface is hummocky, this appears to be associated with historical major landslips and no evidence of recent or ongoing instability was observed. Minor scarp erosion was observed but it is not anticipated to pose significant geotechnical risk. Holcim representative indicated that there is no known slope movement in this area over the review period and in general the area is considered to have remained stable over the last 8 years.
Mass10	<ul style="list-style-type: none"> Overall the area is well vegetated with dense grass cover and medium shrubs and trees throughout. Whilst the slope surface is hummocky, this appears to be associated with historical major landslips and no evidence of recent or ongoing instability was observed. Holcim representative indicated that there is no known slope movement in this area over the review period and in general the area is considered to have remained stable over the last 8 years. Minor grass cover has been removed with bare earth exposed – surficial erosion only. Minor downstream surficial erosion. A drain was observed under road to the south of the mass. No blockage observed at entry/ exit.

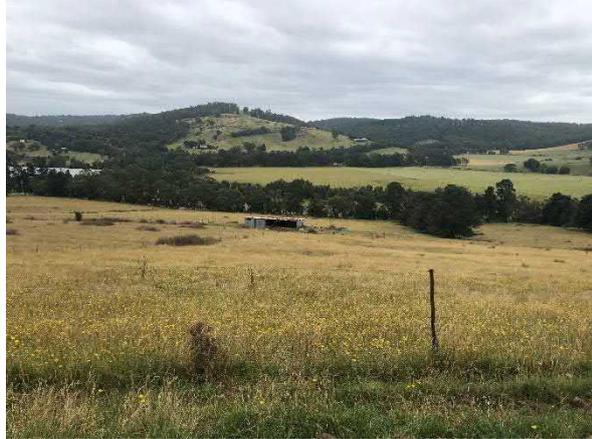
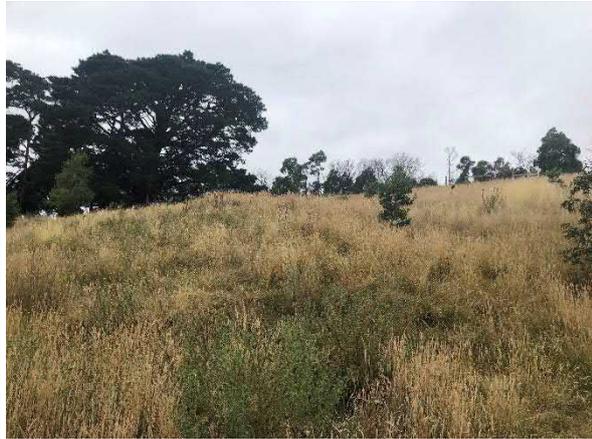
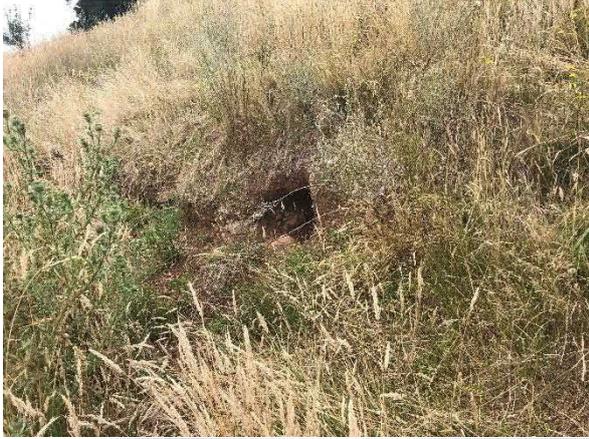
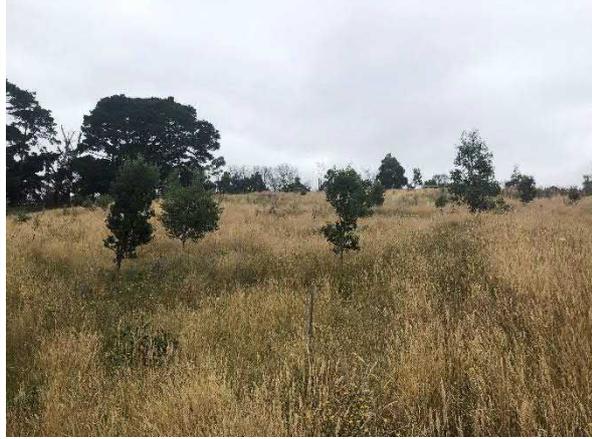
- Some minor animal burrowing was observed to have occurred in landslip scarps during the inspection period. These burrows introduce the risk of undercutting the slope and progressing crest retreat. At the time of inspection, the animal burrowing was observed to be at maximum 500mm deep into the slope (laterally) and was not expected to be of sufficient size to collapse the overlying material. However, to mitigate any potential future degradation of the slope, these areas are proposed to be filled and revegetated, where possible.

Landslide Reference ID	2020 Visual Observation
Mass11	<ul style="list-style-type: none"> • Overall the area is well vegetated with dense grass cover and shrub and tree planting program, on a tight grid, has been established (refer Attachment 2). The area is fenced. • Whilst the slope surface is hummocky, this appears to be associated with historical major landslips and no evidence of recent or ongoing instability was observed. • The small area in the top north corner of the Mass previously observed to be bare of grass cover was observed to have vegetation growth albeit still comprising relatively less vegetation than surrounding areas. This area is coincident with a historical slump, as evidenced by a heaved mass in front of the area. At the area of the scarp of this slump, the slope remains bare and animal burrowing was observed to be undercutting the slope. • Holcim representative indicated that there is no known slope movement in this area over the review period and in general the area is considered to have remained stable over the last 8 years. <p>Proposed Remedial Solution Treatments</p> <ol style="list-style-type: none"> 1. Fill/ remediate burrowing so that the undercutting risk is mitigated; 2. Construct a barricade to prevent animal access to the area to allow vegetation to establish; 3. Revegetate the scarp surface with grasses; and 4. Maintain regular documented inspections and if conditions deteriorate notify suitably qualified geotechnical engineer for further direction.

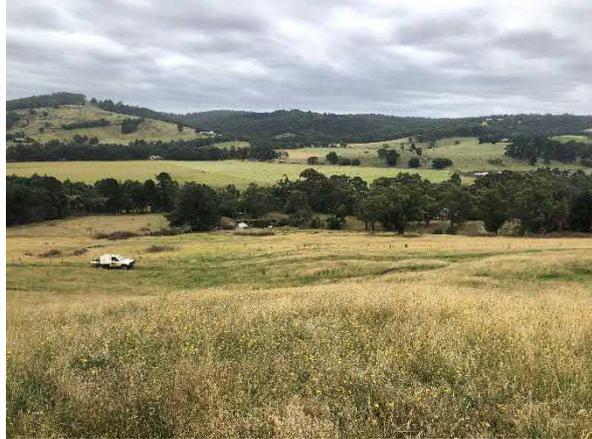
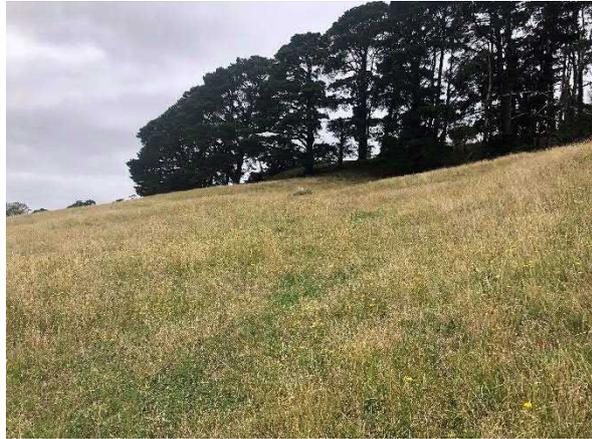
Mass12	<ul style="list-style-type: none"> • Overall the area is well vegetated with dense grass cover and medium shrubs and trees throughout. • Whilst the slope surface is hummocky, this appears to be associated with historical major landslips and no evidence of recent or ongoing instability was observed. • Holcim representative indicated that there is no known slope movement in this area over the review period and in general the area is considered to have remained stable over the last 8 years.
Mass13	<ul style="list-style-type: none"> • Overall the area is well vegetated with dense grass cover and medium shrubs and trees throughout. • Whilst the slope surface is hummocky, this appears to be associated with historical major landslips and no evidence of recent or ongoing instability was observed. • Holcim representative indicated that there is no known slope movement in this area over the review period and in general the area is considered to have remained stable over the last 8 years. • Pipe under road. No blockage observed at entry. The exit of the pipe was observed to have some silt and sediment build-up (anticipated to be as a result of recent rainfall), which is damming the pipe exit. • Minor scarp erosion approximately halfway between the access road and the dam was observed to have enlarged slightly during previous inspection but since has not deteriorated. It is noted that there is negligible immediate risk, however there may be value in revegetating this area to mitigate further erosion. <p>Proposed Remedial Solution Treatments</p> <ol style="list-style-type: none"> 1. Revegetate the scarp surface with grasses; and 2. Maintain regular documented inspections and if conditions deteriorate notify suitably qualified geotechnical engineer for further direction.

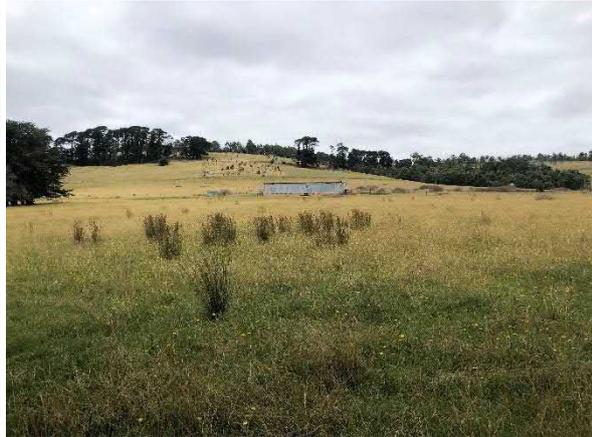
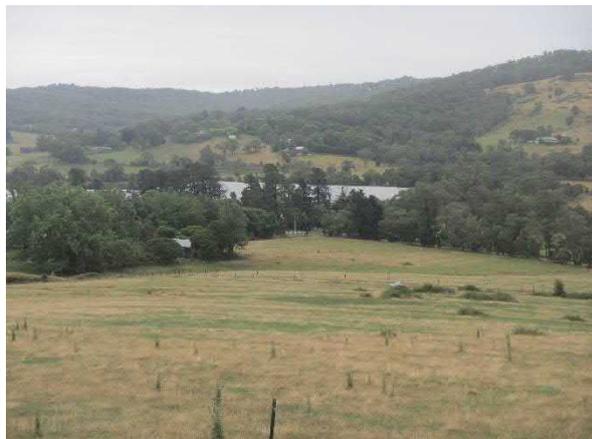
Mass14	<ul style="list-style-type: none"> Overall the area is well vegetated with dense grass cover and medium shrubs and trees throughout. Whilst the slope surface is hummocky, this appears to be associated with historical major landslips and no evidence of recent or ongoing instability was observed. Holcim representative indicated that there is no known slope movement in this area over the review period and in general the area is considered to have remained stable over the last 8 years. <p>Upstream of Mass 14</p> <p>Upstream of Mass 14, between the pond and the Farm Dam the soil surface is very wet with water ponding. This is a possible indication that water is seeping from the Farm Dam. This area is not located within Holcim Land but the information should be conveyed to the land owner and a more detailed inspection should be carried out to understand the source of this ponding water and assess the integrity of the dam. This inspection should be carried out by an experienced and qualified dams or geotechnical engineer.</p> <ul style="list-style-type: none"> A visual assessment of the dam surface area and anticipated (albeit unknown) depth indicates that should water runout, this would be in part stored in the pond downstream and possibly have a detrimentally impact on the downstream property. A full failure would result in rapid discharge of a significant volume of water and mud which likely would damage the dwellings located less than 150 m downstream and the road located further downstream.

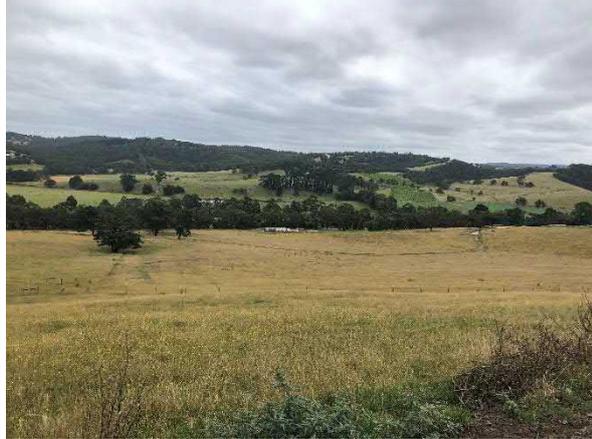
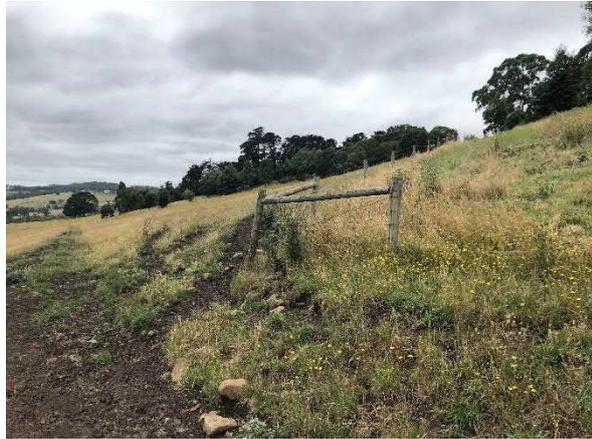
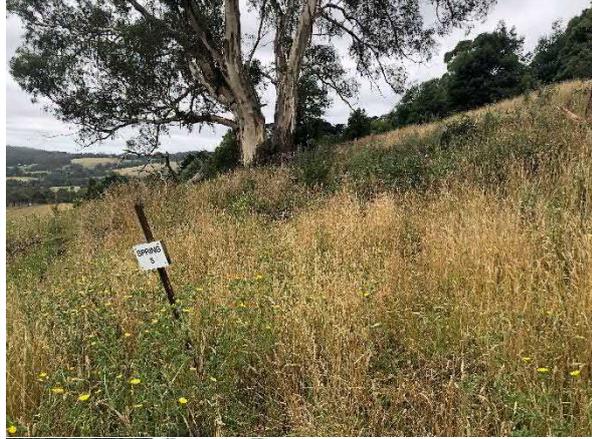
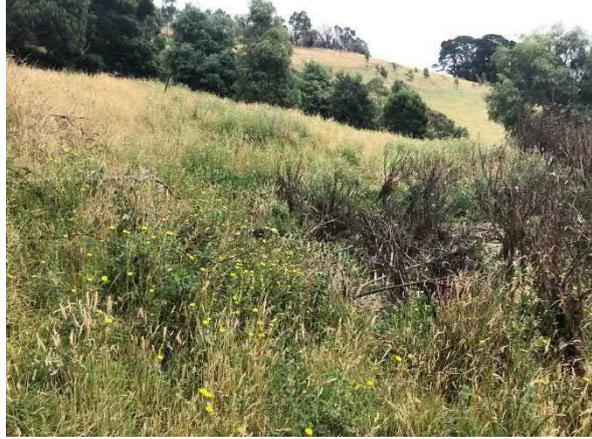
Mass15	<ul style="list-style-type: none"> Overall the area is well vegetated with dense grass cover and medium shrubs and trees throughout. Whilst the slope surface is hummocky, this appears to be associated with historical major landslips and no evidence of recent or ongoing instability was observed. Holcim representative indicated that there is no known slope movement in this area over the review period and in general the area is considered to have remained stable over the last 8 years. Minor side-road scarps were observed, anticipated due to cattle traffic. Holcim representatives previously and anecdotally shared that there is a spring present under the large tree at the elevated east of this mass.
Mass16	<ul style="list-style-type: none"> Access gained to site but noted that it is important to contact landowner prior to entering. Heavy vegetation in the northern area, predominantly trees and shrubs. There is minor side slope erosion visible but anticipated to be related to traffic (both vehicles and cattle). A minor farm dam was observed approximately halfway up the mass. The vegetation on the dam bank has decreased, anticipated to be as a result of fauna traffic. The water level was observed 1 m from crest of the dam with minor cattle tracks observed on the crest.

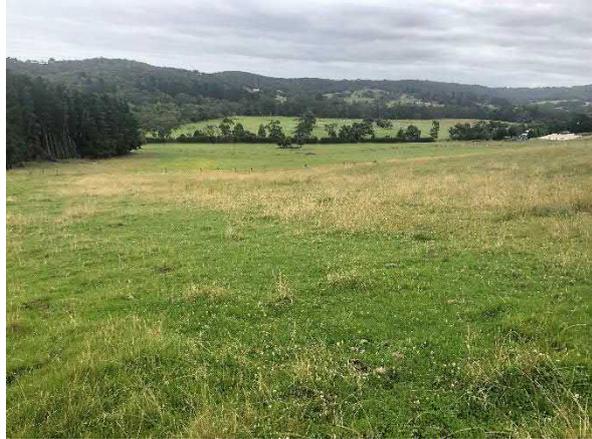
Landslide Reference ID	2020 Visual Observation
Mass17	<ul style="list-style-type: none"> Area is well vegetated with dense grass cover. Whilst the slope surface is hummocky, this appears to be associated with historical major landslips and no evidence of recent or ongoing instability was observed. Holcim representative indicated that there is no known slope movement in this area over the review period and in general the area is considered to have remained stable over the last 8 years.
Mass18	<ul style="list-style-type: none"> Overall the area is well vegetated with dense grass cover and medium shrubs and trees throughout. Whilst the slope surface is hummocky, this appears to be associated with historical major landslips and no evidence of recent or ongoing instability was observed.
Mass19	<ul style="list-style-type: none"> Holcim representative indicated that there is no known slope movement in this area over the review period and in general the area is considered to have remained stable over the last 8 years.

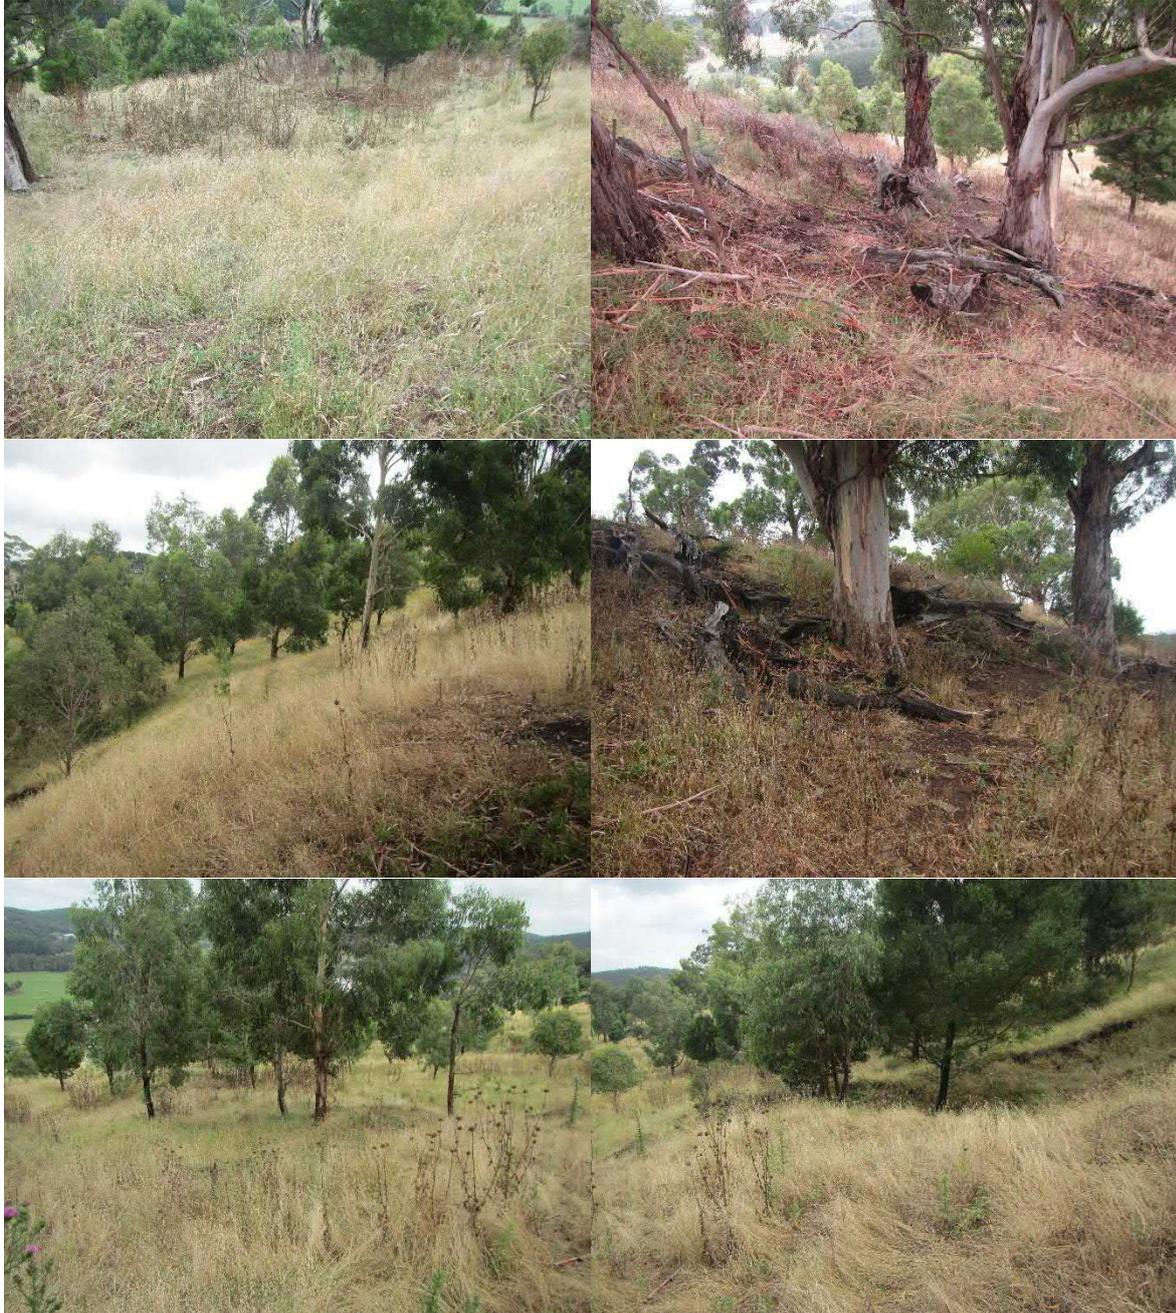
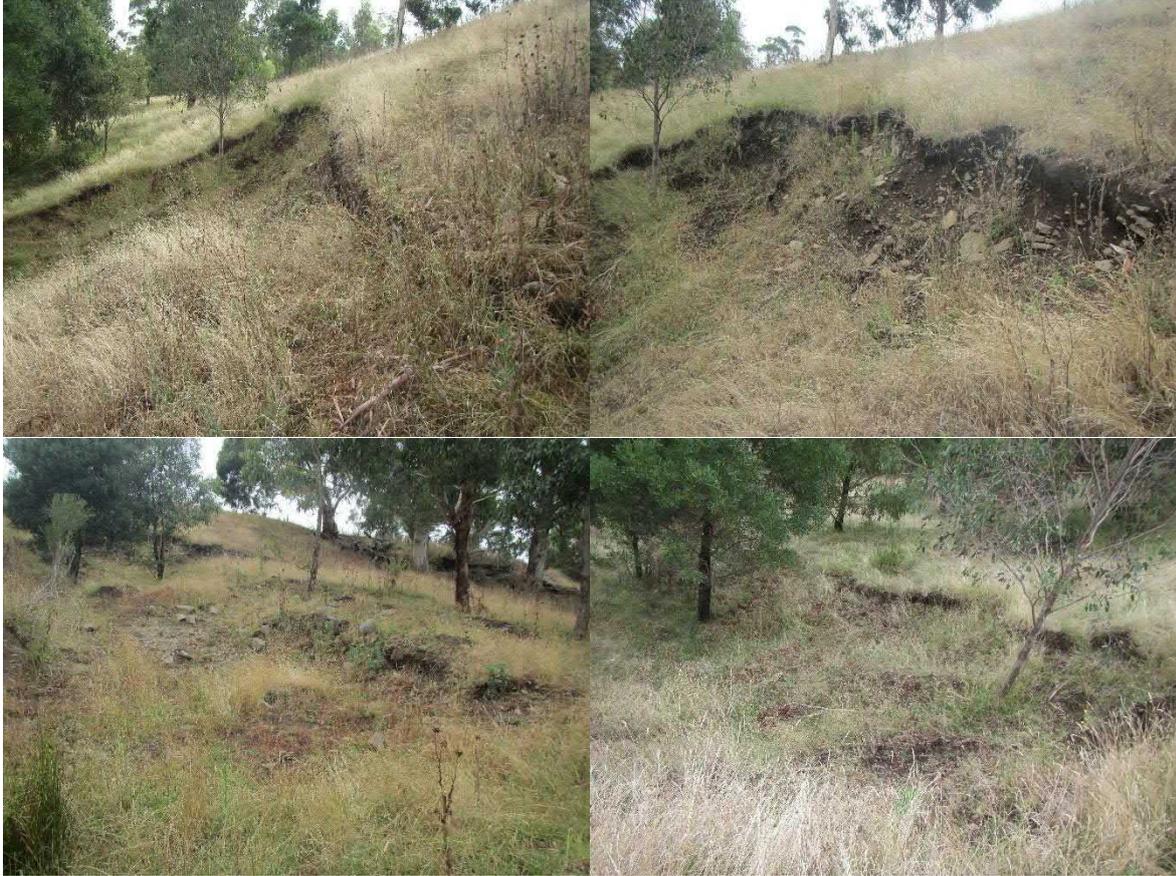
Mass20	<ul style="list-style-type: none">
Other Areas Visited	
Back scarp of Large Historical Landslide comprising Masses 1, 2, 3, 9 and 17	<ul style="list-style-type: none"> The crest of the backscarp was observed to be relatively fresh (recently eroded), and suggests retreating of the crest is occurring. At time of the 2019 inspection, this retreat was anticipated to be <100mm laterally. The downslope area of the backscarp is well vegetated with grasses and trees. Slope erosion was observed on adjacent slopes, in particular around larger gum trees but is anticipated to be historical and of no significant geotechnical risk. <p>Proposed Remedial Solution Treatments</p> <ol style="list-style-type: none"> Construct a barricade to prevent animal access to the area to allow vegetation to establish; Revegetate behind the failure / old backscarp with deep root (but small canopy) shrubs / bushes and grasses; and Maintain regular documented inspections and if conditions deteriorate notify suitably qualified geotechnical engineer for further direction.
