2 December 2021

Matthew Dodd
Quarry Manager
Holcim (Australia) Pty Ltd
Mt. Shamrock Road
Pakenham, Victoria 3810

Mt. Shamrock Quarry - Toomuc Valley Slope Inspection, December 2021

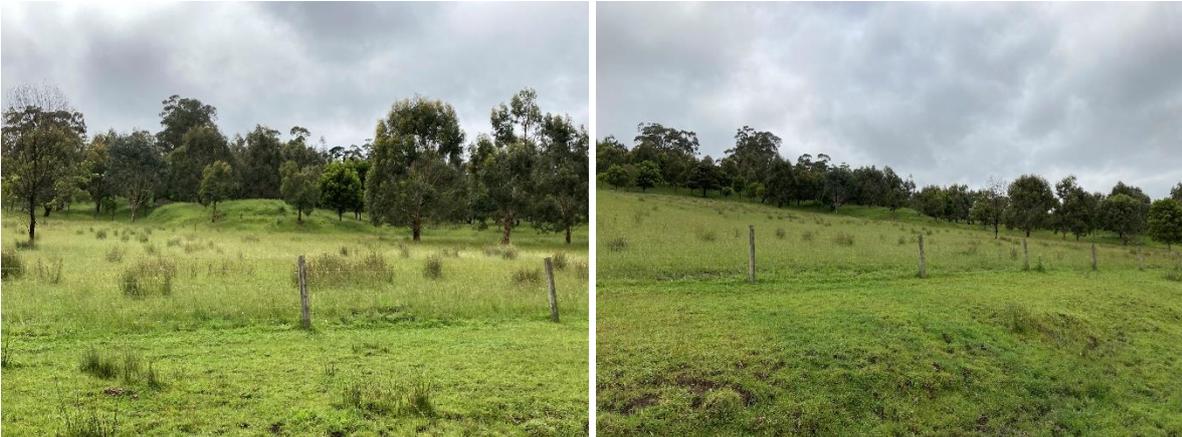
Mass03	<ul style="list-style-type: none"> Overall the area is well vegetated with dense grass cover and small to medium shrubs and trees throughout. Whilst the slope surface is hummocky, this appears to be associated with historical major landslips and no evidence of recent or ongoing instability was observed. Holcim representative indicated that there is no known slope movement in this area over the review period and in general the area is considered to have remained stable over the last 8 years.

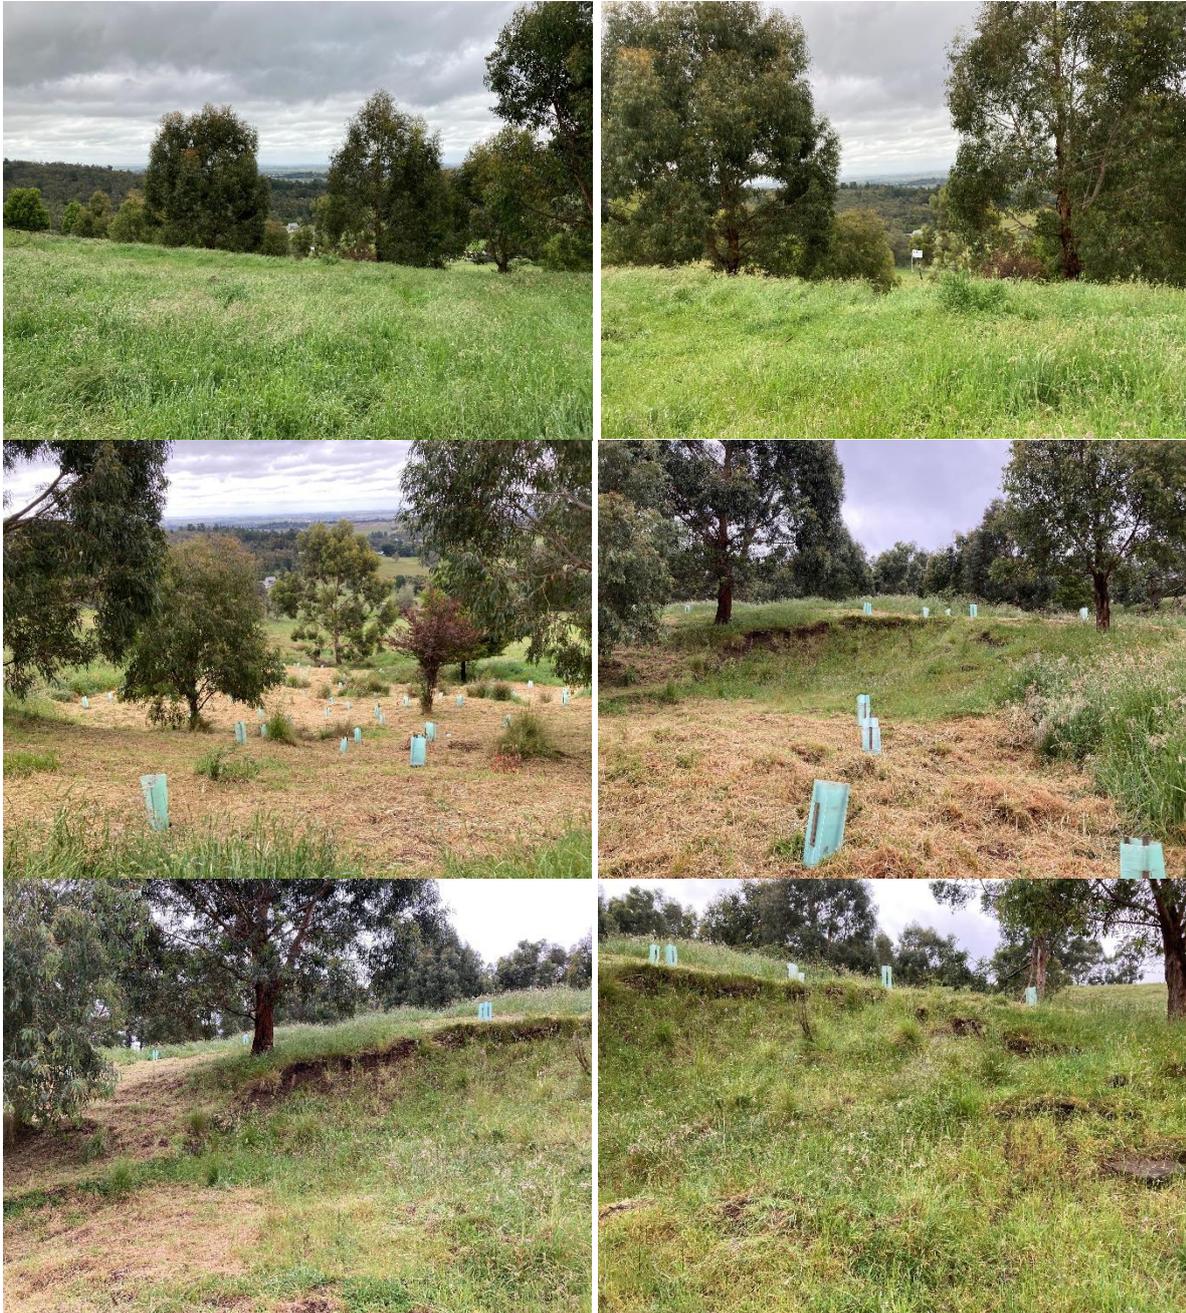
Landslide Reference ID	2021 Visual Observation
Mass04	<p>General Slope Stability of Mass04 Area</p> <ul style="list-style-type: none"> • Overall the area is well vegetated with dense grass cover and small to medium shrubs and trees throughout. • Whilst the slope surface is hummocky, this appears to be associated with historical major landslips and no evidence of recent or ongoing instability was observed. • Holcim representative indicated that there is no known slope movement in this area over the review period and in general the area is considered to have remained stable over the last 7 years. <p>Localised Small Circular Failure of Old Backscarp (refer Attachment 2)</p> <ul style="list-style-type: none"> • During previous review period a small, shallow circular failure of an old backscarp from the larger historical landslide has occurred. Evidence suggest it has been triggered ~9 years ago. The slope behind the failure is relatively flat, appeared dry and is vegetated with grass and bushes. There is no evidence of tension cracks behind the failure. • The failure measures about 5 m in width and ~1.5 m in height. The slope below slump is damp, likely associated with a spring. Surface water was not able to be observed based on moist conditions from recent rainfall. • The circular failure is small in volume and, given that the location is isolated from any downhill infrastructure, is not considered to be a significant geological risk. <p>Remedial Solution Treatments</p> <p>The following remedial options have been suggested during previous review period:</p> <ol style="list-style-type: none"> 1. Construct a barricade to prevent animal access to the area to allow vegetation to establish 2. Revegetate behind the failure / old backscarp with deep root (but small canopy) shrubs / bushes and grasses 3. Revegetate on the slump surface with grasses 4. Revegetate in the saturated area below the failure with wet tolerant species, ie swampy gums, river gum, boobiellas <p>Maintain regular documented inspections of the dam and if conditions deteriorate notify suitably qualified geotechnical engineer for further direction.</p>

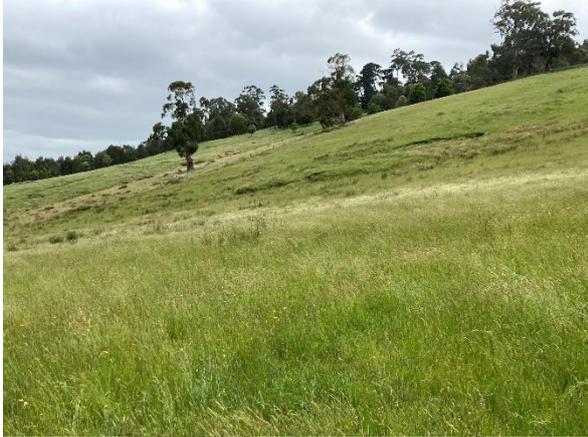
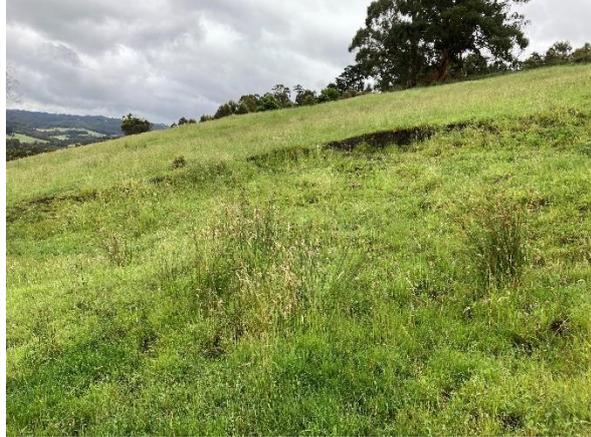
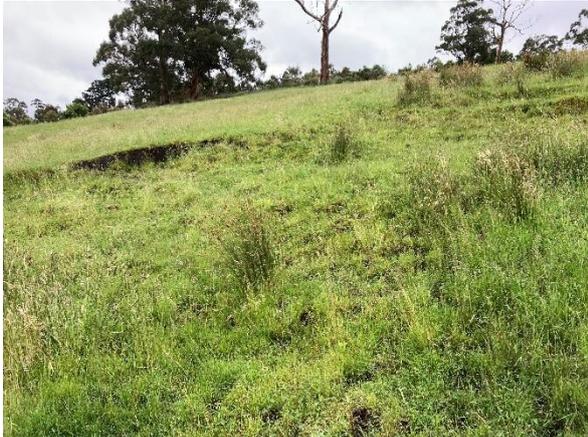
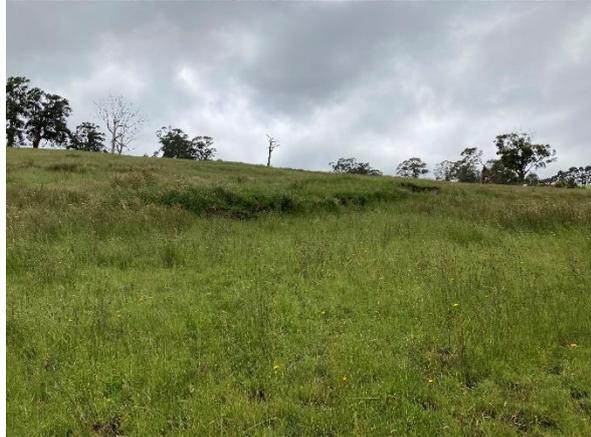
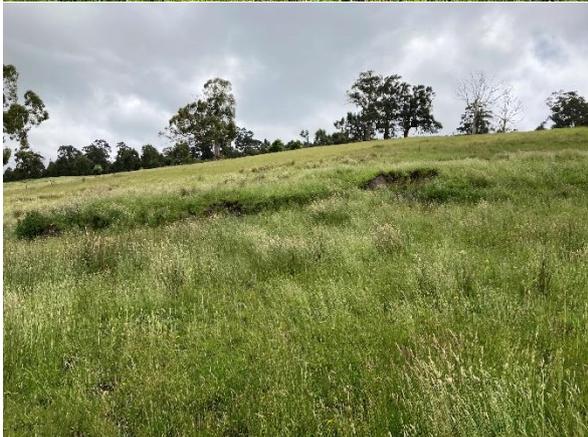
- Mass05 shows signs of additional movements with a localised small failure within an existing backscarp due to cattle traffic and circular slope failure within an existing backscarp that extent over about 15 m. Both failures are small in volume and, given that the location is isolated from any downhill infrastructure, is not considered to be a significant geological risk.

Mass05	<ol style="list-style-type: none"> 1. Overall the area is well vegetated with dense grass cover throughout. 2. Holcim representative indicated that there is no known slope movement in this area over the review period and in general the area is considered to have remained stable over the last 9 years. 3. Minor historical circular failures were observed in four locations: these failures were observed to be associated with exposed (bare) scarps and a change in the natural topography locally downslope with remnant mobilised material. A natural drain has formed through this material to avoid the local high. It is recommended that the bare scarp areas are grassed to mitigate potential of further erosion. 4. The mobilised material is well vegetated. Observation of the exposed scarp suggests that the material is weakly structured, near-surface soil possibly associated with the Werribee Formation (Attachment 1 for geological map and Attachment 2 for photo of scarp). <p>Localised Failure of Old Backscarps (see figure for Mass 5)</p> <ul style="list-style-type: none"> • During the inspection a shallow circular failure of an old backscarp from the larger historical landslide has occurred. There is no evidence of tension cracks behind the failure. The failure measures about 15 m in width and ~1.5 m in height. The circular failure is small in volume and, given that the location is isolated from any downhill infrastructure, is not considered to be a significant geological risk. <p>Remedial Solution Treatments</p> <p>The following remedial options are recommended:</p> <ol style="list-style-type: none"> 1. Revegetate behind the failure / old backscarp with deep root (but small canopy) shrubs / bushes and grasses 2. Revegetate the scarp surface with grasses; and 3. Maintain regular documented inspections and if conditions deteriorate notify suitably qualified geotechnical engineer for further direction. <p>It is deemed important to continue to monitor the vegetation of this scarp to ensure that washouts do not inhibit the progress.</p>

Circular Failure of an Existing Old Backscrap

1. Fill animal burrowing holes and revegetate scarps at Mass11;
2. Revegetation of scarp surfaces with grasses proposed at Mass05, Mass08 and Mass13; and

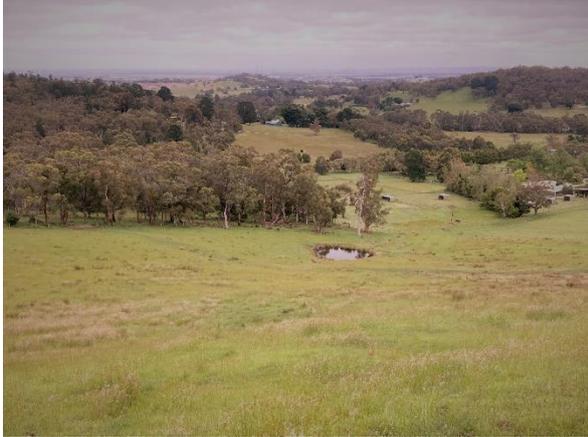
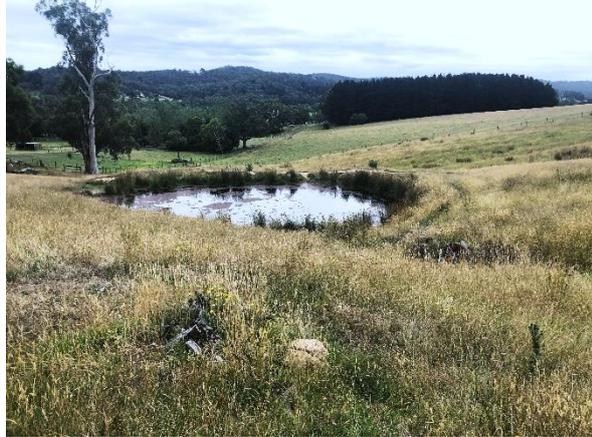
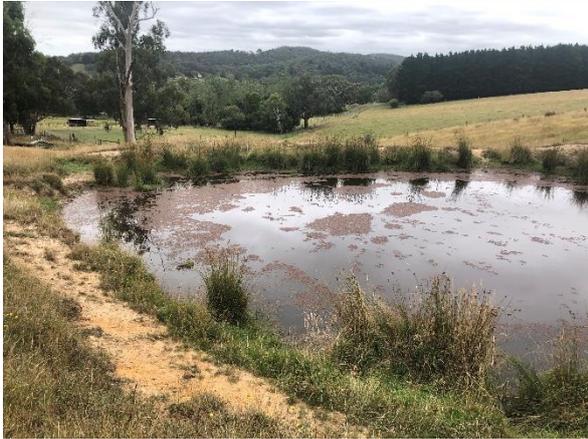
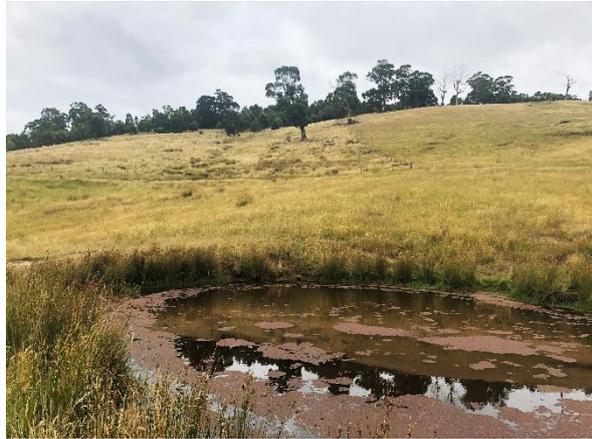
Mass05 Dam	<ul style="list-style-type: none"> • Upstream drainage channel/ catchment from Mass05 is unobstructed. Embankments are vegetated. Eastern side is bare, with an observed retreating crest. • A downstream spillway has formed naturally. • Water was observed 800mm below the crest of the dam, with the crest material softened by cattle traffic. There is a low risk for this structure in terms of both likelihood and consequence
Mass06	<ul style="list-style-type: none"> • Overall the area is well vegetated with dense grass cover throughout. • Holcim representative indicated that there is no known slope movement in this area over the review period and in general the area is considered to have remained stable over the last 8 years.

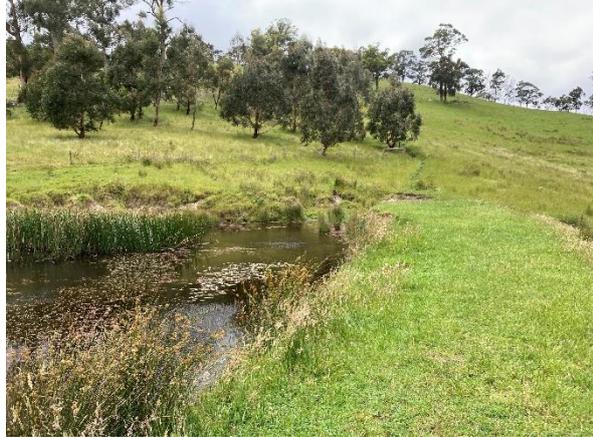
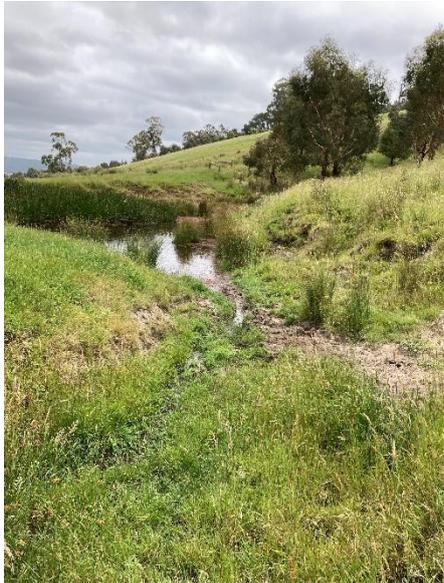
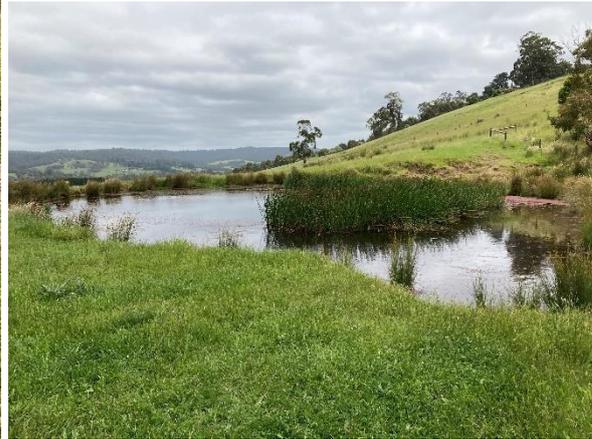
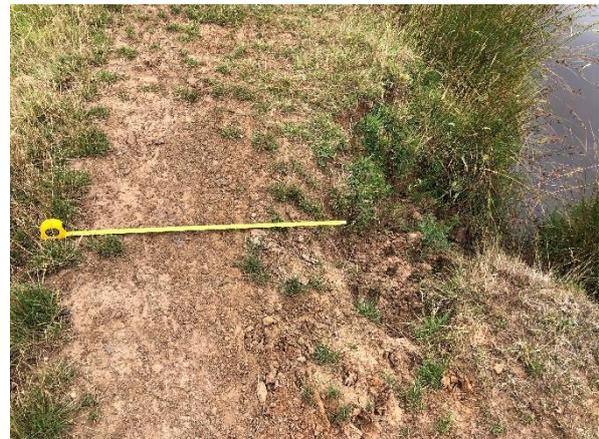
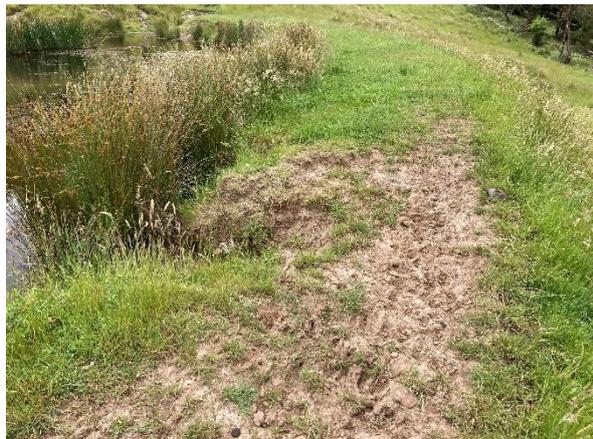
- The masses show no new sign of movements.
- The upstream shoulder of Mass 06 Dam crest is not showing additional deterioration from what was observed in 2020 due to cattle traffic. In some part, the width crest is locally reduced to a 1.2 - 1.5 m width compared to 2.5 – 3.0 m elsewhere. Repairs of the crest and construction of a fence to prevent cattle traffic on the crest are recommended to mitigate any risk of Dam failure and prevent further degradation.

Landslide Reference ID	2021 Visual Observation
Mass06 Dam	<ul style="list-style-type: none"> This dam contains a comparatively large volume of water to other dams (surface area 45 m², total depth unknown). The water level was observed at 500mm below the crest. A natural overflow to east has been identified, which directs water to a dam on an adjacent property downstream. Risk to cattle adjacent to dam, where in some places a 1.5 - 2 m vertical difference was observed due to the retreating crest The Mass 06 Dam crest is narrowing, predominantly due to fauna traffic on the upstream crest and in some part, the width crest is locally reduced to a 1.2 - 1.5 m width compared to 2.5 – 3.0 m elsewhere. Failure risk is considered low. Continued uncontrolled discharged of water from an over full dam could result in erosion and scour of the dam wall and whilst the consequences of dam failure would be moderate as the asset is isolated from infrastructure such as dwellings, public roads etc. A visual assessment of the dam surface area and anticipated (albeit unknown) depth indicates that should water runoff, this would saturate the ground however is not anticipated to detrimentally influence the downstream property. A full failure would result in rapid discharge of a not insignificant volume of water and mud which likely would severely damage vegetation and could trigger other remobilisation landslips further down slope. Another consequence would be loss of stock drinking water. To maintain the integrity of the dam and prevent damage to the dam wall due to uncontrolled discharged and possible overtopping possible remedial solutions are suggested below. <p>Remedial Solution Treatments</p> <p>The following remedial options have been suggested on the basis that, at this point, only small earthmoving plant is considered feasible to mobilise to the area:</p> <ul style="list-style-type: none"> Construct a barricade to prevent animal access to the dam crest. Reinstate the scoured dam crest with locally won clays (keyed in, placed and compacted in accordance with good dam construction practice. <p>*Note: works should be carried out under the direction of an appropriately experienced and qualified dams or geotechnical engineer.</p> <ul style="list-style-type: none"> Maintain regular documented inspections of the dam and if conditions deteriorate notify suitably qualified geotechnical engineer for further direction.

- No sign of new areas of instability were identified on the Masses located within slopes surrounding the quarry.
- Mass06 Dam Crest has deteriorated due to cattle traffic and in some section, the crest is locally reduced to a 1.2 - 1.5 m width compared to 2.5 – 3.0 m elsewhere.
- Significant seepage has been noted at the toe of the Dam located upstream of Mass 14. This dam is not within Holcim Land.

4. Remedial treatment of Mass06 Dam with reinstatement of the dam crest and construction of a barricade to prevent animal access to the dam crest.
5. Holcim should notify the landowner of the dam located upstream of Mass 14 of the important seepage observed and recommend the dam be inspected by an experienced and qualified dams or geotechnical engineer.

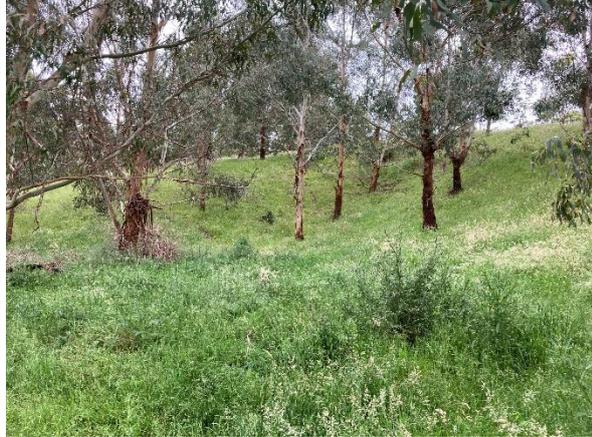
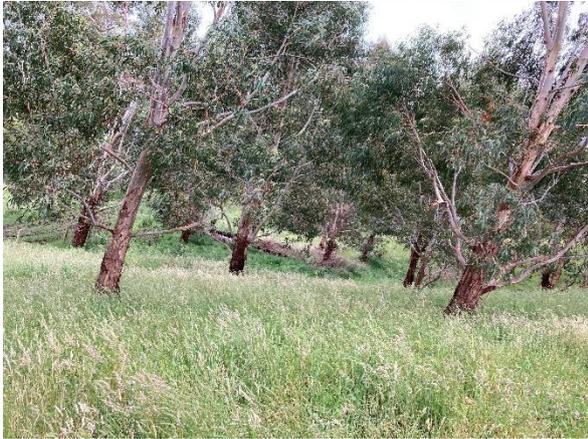
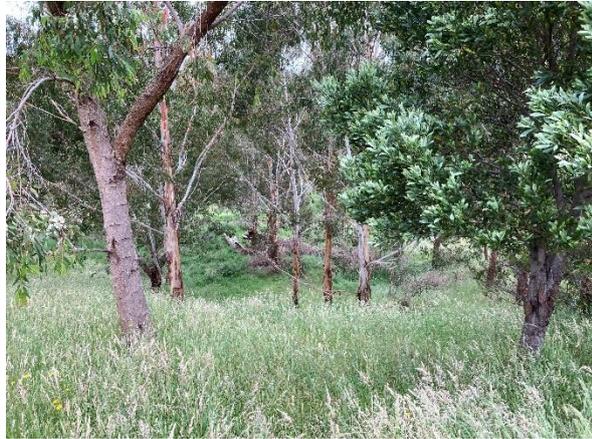
Mass07	<ul style="list-style-type: none"> Tree planting has been undertaken upslope. There is a minor scarp adjacent to the worn cattle track on the eastern side, suggested erosive driver being the cattle traffic but reiterating the poor structure of the soils. Historical scarp has been vegetated with no exposed ground or evidence of movement. Overall the area is well vegetated with dense grass cover throughout. Holcim representative indicated that there is no known slope movement in this area over the review period and in general the area is considered to have remained stable over the last 8 years
Mass08	<ul style="list-style-type: none"> Overall the area is well vegetated with dense grass cover throughout. There are some historical scarps up to 1m height. These demonstrate weak soil structure, with anticipated minor failures in rain events. The local area immediately below scarp is poorly to moderately vegetated. Bare ground was observed for approximately 500mm laterally at the toe of the scarp. <p>Proposed Remedial Solution Treatments</p> <ol style="list-style-type: none"> Revegetate the scarp surface with grasses; and Maintain regular documented inspections and if conditions deteriorate notify suitably qualified geotechnical engineer for further direction.

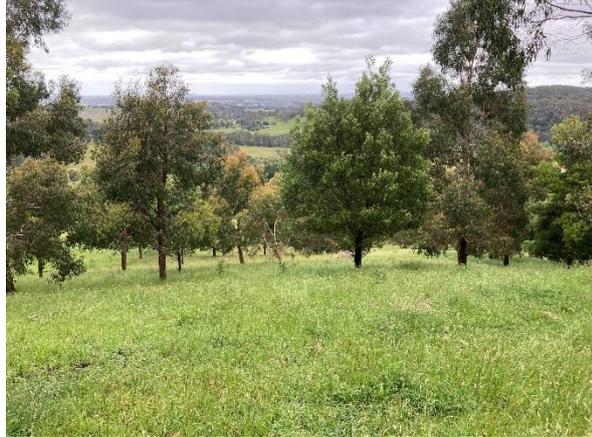
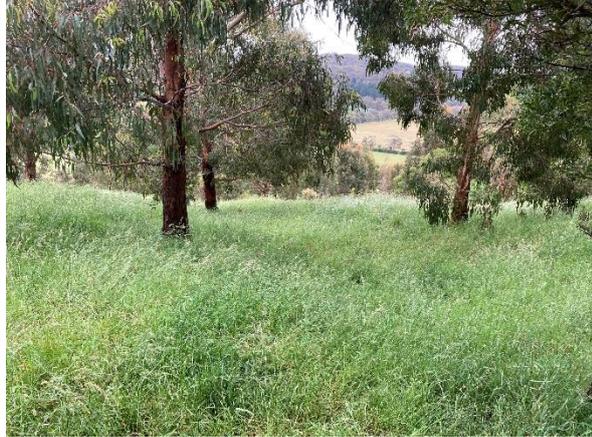
Mass09	<ul style="list-style-type: none"> Overall the area is well vegetated with dense grass cover and small to medium shrubs and trees throughout. Whilst the slope surface is hummocky, this appears to be associated with historical major landslips and no evidence of recent or ongoing instability was observed. Minor scarp erosion was observed but it is not anticipated to pose significant geotechnical risk. Holcim representative indicated that there is no known slope movement in this area over the review period and in general the area is considered to have remained stable over the last 8 years.
Mass10	<ul style="list-style-type: none"> Overall the area is well vegetated with dense grass cover and medium shrubs and trees throughout. Whilst the slope surface is hummocky, this appears to be associated with historical major landslips and no evidence of recent or ongoing instability was observed. Holcim representative indicated that there is no known slope movement in this area over the review period and in general the area is considered to have remained stable over the last 8 years. Minor grass cover has been removed with bare earth exposed – surficial erosion only. Minor downstream surficial erosion. A drain was observed under road to the south of the mass. No blockage observed at entry/ exit.

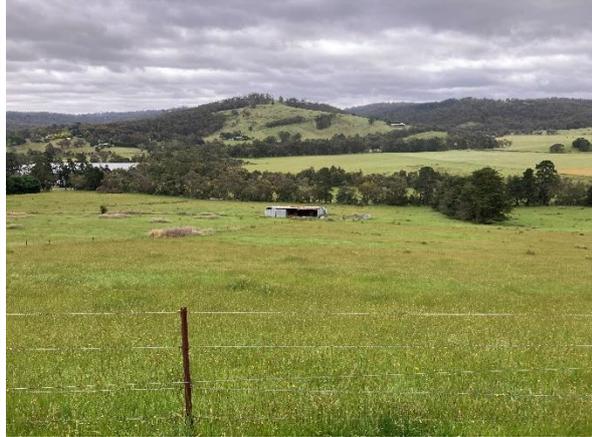
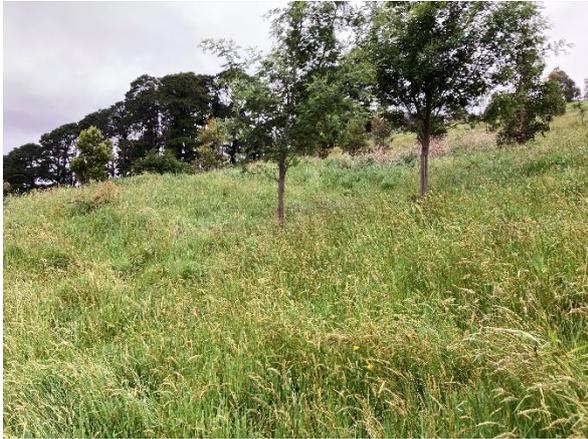
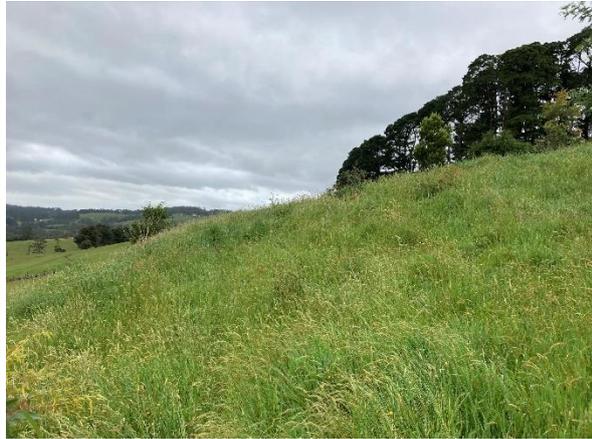
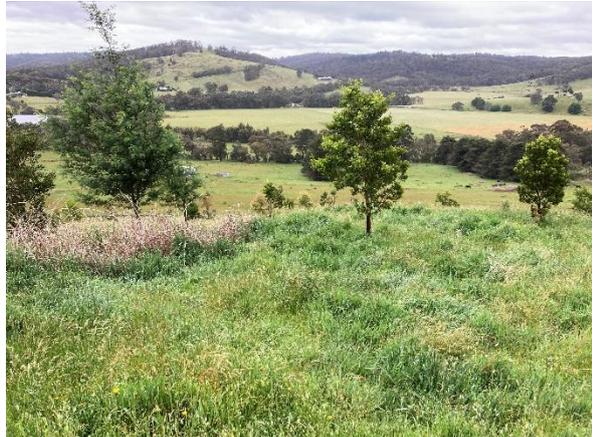
Landslide Reference ID	2021 Visual Observation
Mass11	<ul style="list-style-type: none"> • Overall the area is well vegetated with dense grass cover and shrub and tree planting program, on a tight grid, has been established (refer Attachment 2). The area is fenced. • Whilst the slope surface is hummocky, this appears to be associated with historical major landslips and no evidence of recent or ongoing instability was observed. • The small area in the top north corner of the Mass previously observed to be bare of grass cover was observed to have vegetation growth albeit still comprising relatively less vegetation than surrounding areas. This area is coincident with a historical slump, as evidenced by a heaved mass in front of the area. At the area of the scarp of this slump, the slope remains bare and animal burrowing was observed to be undercutting the slope. • Holcim representative indicated that there is no known slope movement in this area over the review period and in general the area is considered to have remained stable over the last 8 years. <p>Proposed Remedial Solution Treatments</p> <ol style="list-style-type: none"> 1. Fill/ remediate burrowing so that the undercutting risk is mitigated; 2. Construct a barricade to prevent animal access to the area to allow vegetation to establish; 3. Revegetate the scarp surface with grasses; and 4. Maintain regular documented inspections and if conditions deteriorate notify suitably qualified geotechnical engineer for further direction.

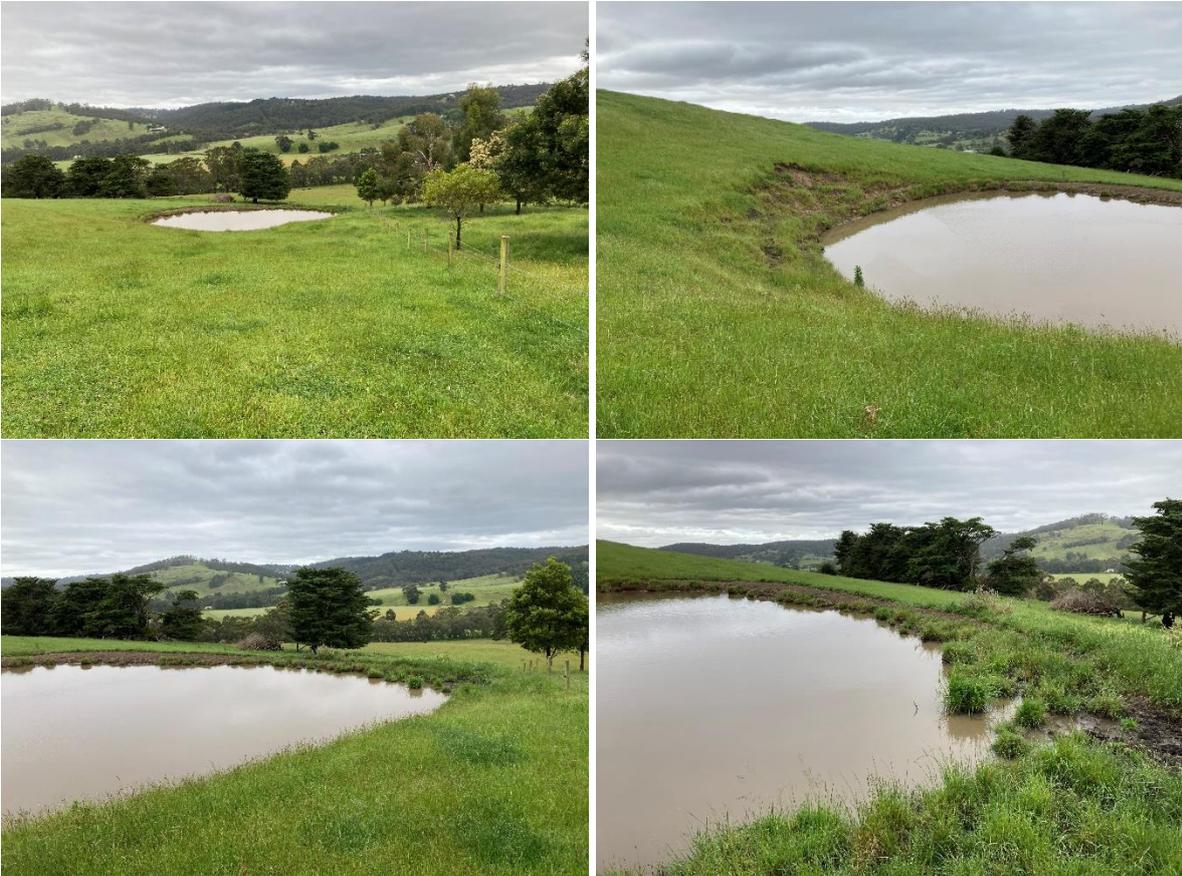
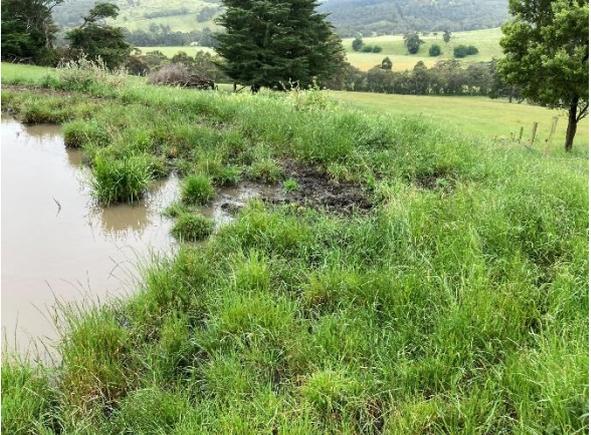
Landslide Reference ID	2021 Visual Observation
Mass13 Dam	<p>Existing Dam</p> <ul style="list-style-type: none"> Current water level observed to be 200mm below dam embankment crest. Dam embankment appears to be in good condition and where water level has exceeded embankment crest it discharges naturally at the northern end of the embankment. The point of discharge has been softened by animal traffic with minor desiccation cracking at crest. Continued uncontrolled discharged of water from an over full dam could result in erosion and scour of the dam wall and whilst the consequences of dam failure would be moderate as the asset is isolated from infrastructure such as dwellings, public roads etc. A more detailed assessment should be considered as there is property potentially in line with the dam albeit some distance away. A visual assessment of the dam surface area and anticipated (albeit unknown) depth indicates that should water runout, this would saturate the ground however is not anticipated to detrimentally influence the downstream property. A full failure would result in rapid discharge of a not insignificant volume of water and mud which likely would severely damage vegetation and could trigger other remobilisation landslips further down slope. Another consequence would be loss of stock drinking water. The natural slope at the back of the dam which has experienced a shallow surficial slump has the potential to continue moving and may result in causing an overtopping of the dam if this is to occur. The same mechanism was observed to be beginning to form on the northern side of the dam. The upstream embankment is steepening/ eroding. Many areas appear to fail locally and deposit material into the dam. The pressure of water does not visually appear great enough to destabilise downstream embankment. The primary risk would be degradation of embankment stability as a result of cattle/ ongoing erosion. To maintain the integrity of the dam and prevent damage to the dam wall due to uncontrolled discharged and possible overtopping possible remedial solutions are suggested below. <p>Remedial Solution Treatments</p> <p>The following remedial options have been suggested on the basis that, at this point, only small earthmoving plant is considered feasible to mobilise to the area</p> <ol style="list-style-type: none"> Construct a barricade to prevent animal access to the dam crest and northern area which appears to have been disturbed by stock. Lower the full supply level to be at least 0.5m below the dam crest and maintain as the full supply level, by construction of a rock lined emergency spillway chute with floor level at design full supply level. The most suitable location is likely towards the north where water appears to be naturally discharging. An engineered solution would ensure that the chute is aligned away from the dam wall (in natural material) so that if discharging water cannot work back and erode / scour the dam embankment). The chute would require rock lining and the outlet would have to be designed so water is dispersed in a manner that does not cause slope instability at or below the point of discharge. A small (say 8t) backhoe would be suitable for this task. A hydrological assessment should be undertaken in order to determine required pipe size / or chute size. Remove / trim the failure cutting slope back to undisturbed ground and vegetate with deep-rooted grasses so the excavated surface is stabilised. Install a cut-off swale behind the cut batter on the upslope side of the dam to intercept any slope wash and direct it either around the dam or into the dam in a controlled manner. <p>*Note: works should be carried out under the direction of an appropriately experienced and qualified dams or geotechnical engineer.</p> <ul style="list-style-type: none"> Maintain regular documented inspections of the dam and if conditions deteriorate notify suitably qualified geotechnical engineer for further direction.

3. Remedial treatments previously proposed for Mass 02, Mass04 and Mass13 Dam remain, as this has not yet been undertaken. These are aimed at establishing a permanent freeboard and reinstating the dam embankment. Whilst the dams are typically located remotely to existing downslope infrastructure, should failure occur, the potential for downslope damage exists. In the case of the dam at Mass13, more detailed assessment of runout paths should be undertaken to assess the risk, if any, to infrastructure.

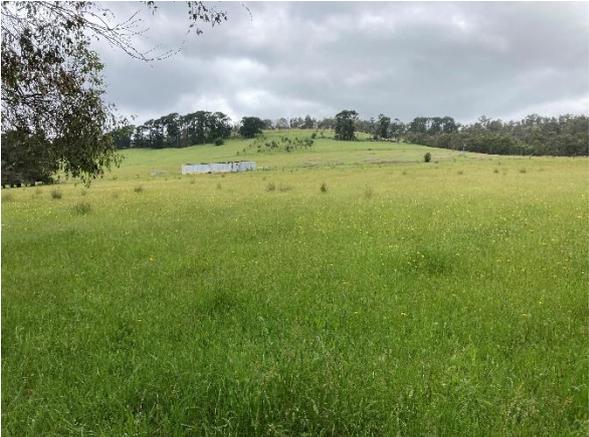
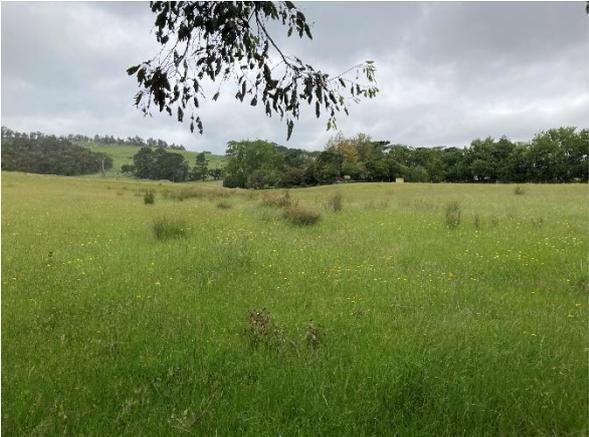
Mass14	<ul style="list-style-type: none"> Overall the area is well vegetated with dense grass cover and medium shrubs and trees throughout. Whilst the slope surface is hummocky, this appears to be associated with historical major landslips and no evidence of recent or ongoing instability was observed. Holcim representative indicated that there is no known slope movement in this area over the review period and in general the area is considered to have remained stable over the last 8 years. <p>Upstream of Mass 14</p> <p>In 2020, upstream of Mass 14, between the pond and the Farm Dam, it was noted that the soil surface is very wet with water ponding. This is a possible indication that water is seeping from the Farm Dam. This area is not located within Holcim Land and was not inspected in 2021. The information should be conveyed to the land owner and a more detailed inspection should be carried out to understand the source of this ponding water and assess the integrity of the dam. This inspection should be carried out by an experienced and qualified dams or geotechnical engineer.</p>

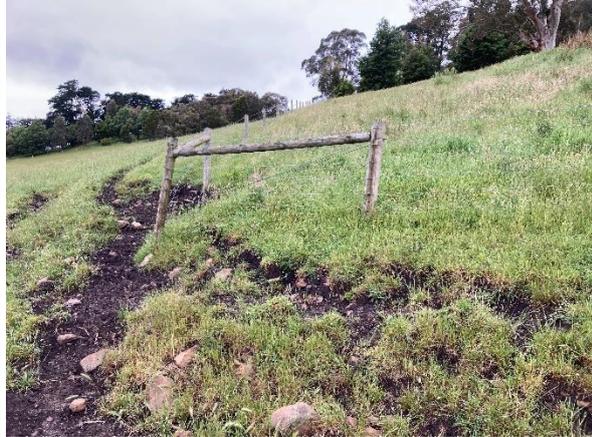
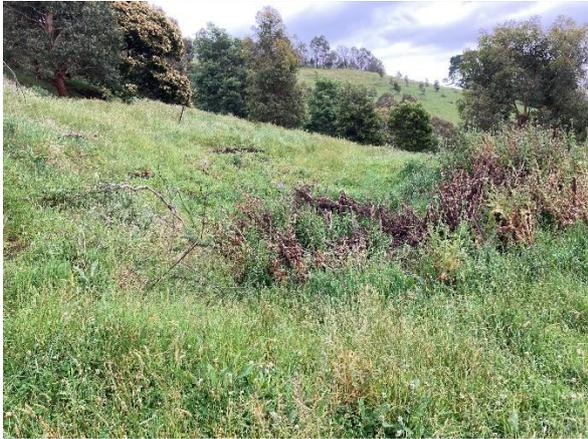
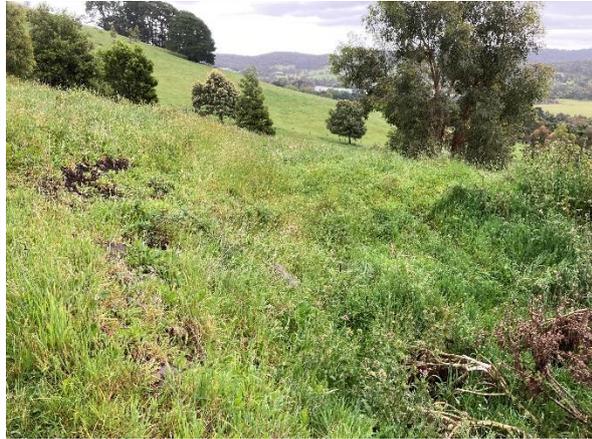
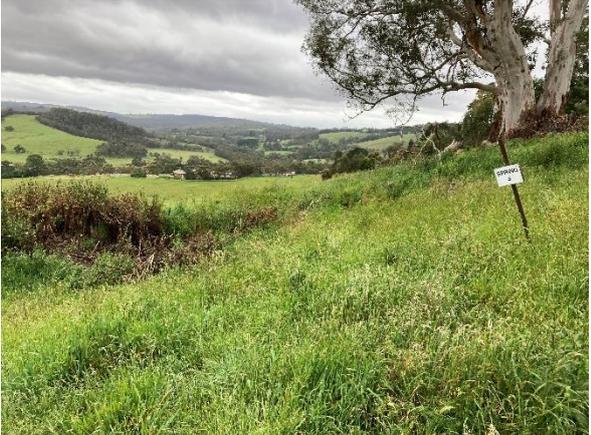
Mass15	<ul style="list-style-type: none"> Overall the area is well vegetated with dense grass cover and medium shrubs and trees throughout. Whilst the slope surface is hummocky, this appears to be associated with historical major landslips and no evidence of recent or ongoing instability was observed. Holcim representative indicated that there is no known slope movement in this area over the review period and in general the area is considered to have remained stable over the last 9 years. Minor side-road scarps were observed, anticipated due to cattle traffic. Holcim representatives previously and anecdotally shared that there is a spring present under the large tree at the elevated east of this mass.
Mass16	<ul style="list-style-type: none"> Access gained to site but noted that it is important to contact landowner prior to entering. Heavy vegetation in the northern area, predominantly trees and shrubs. There is minor side slope erosion visible but anticipated to be related to traffic (both vehicles and cattle). A minor farm dam was observed approximately halfway up the mass. The vegetation on the dam bank has decreased, anticipated to be as a result of fauna traffic. The water level was observed 500 mm from crest of the dam with minor cattle tracks observed on the crest.

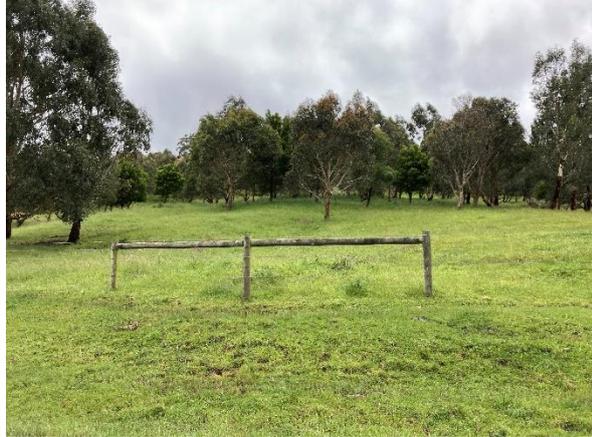
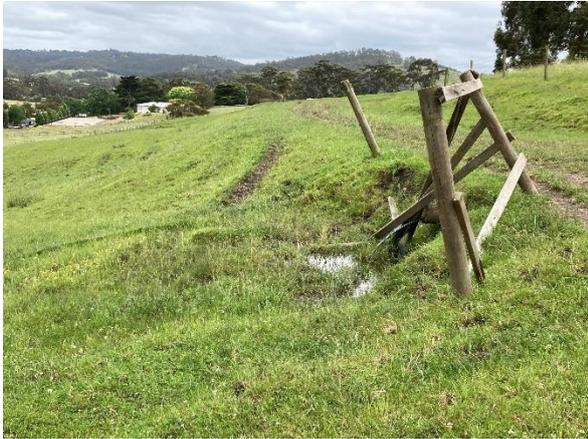
Mass17	<ul style="list-style-type: none"> Area is well vegetated with dense grass cover. Whilst the slope surface is hummocky, this appears to be associated with historical major landslips and no evidence of recent or ongoing instability was observed. Holcim representative indicated that there is no known slope movement in this area over the review period and in general the area is considered to have remained stable over the last 9 years.

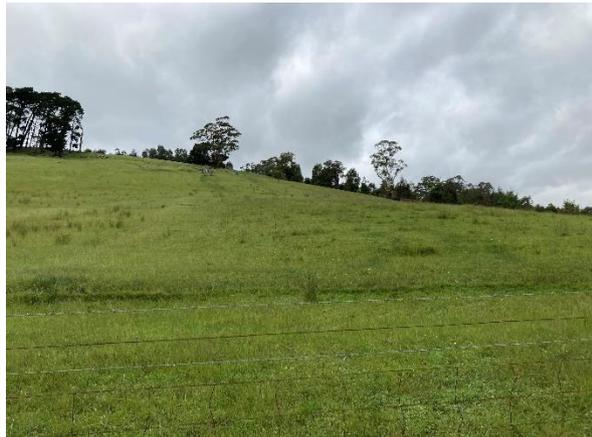
Landslide Reference ID	2021 Visual Observation
Mass18	<ul style="list-style-type: none"> Overall the area is well vegetated with dense grass cover and medium shrubs and trees throughout. Whilst the slope surface is hummocky, this appears to be associated with historical major landslips and no evidence of recent or ongoing instability was observed.
Mass19	<ul style="list-style-type: none"> Holcim representative indicated that there is no known slope movement in this area over the review period and in general the area is considered to have remained stable over the last 9 years.
Mass20	<ul style="list-style-type: none"> Holcim, has informed us that Spring was frequently overtopping and a pipe was added to convey water downstream of the spring and prevent overtopping. Since the installation of the pipe no overflow has been observed.
Other Areas Visited	
Back scarp of Large Historical Landslide comprising Masses 1, 2, 3, 9 and 17	<ul style="list-style-type: none"> The crest of the backscarp was observed to be relatively fresh (recently eroded), and suggests retreating of the crest is occurring. At time of the 2019 inspection, this retreat was anticipated to be <100mm laterally. Presence of dense vegetation did not allow us to observe the downstream slope of the backscarp. The downslope area of the backscarp is well vegetated with grasses and trees. Slope erosion was observed on adjacent slopes, in particular around larger gum trees but is anticipated to be historical and of no significant geotechnical risk. <p>Proposed Remedial Solution Treatments</p> <ol style="list-style-type: none"> Construct a barricade to prevent animal access to the area to allow vegetation to establish; Revegetate behind the failure / old backscarp with deep root (but small canopy) shrubs / bushes and grasses; and Maintain regular documented inspections and if conditions deteriorate notify suitably qualified geotechnical engineer for further direction.

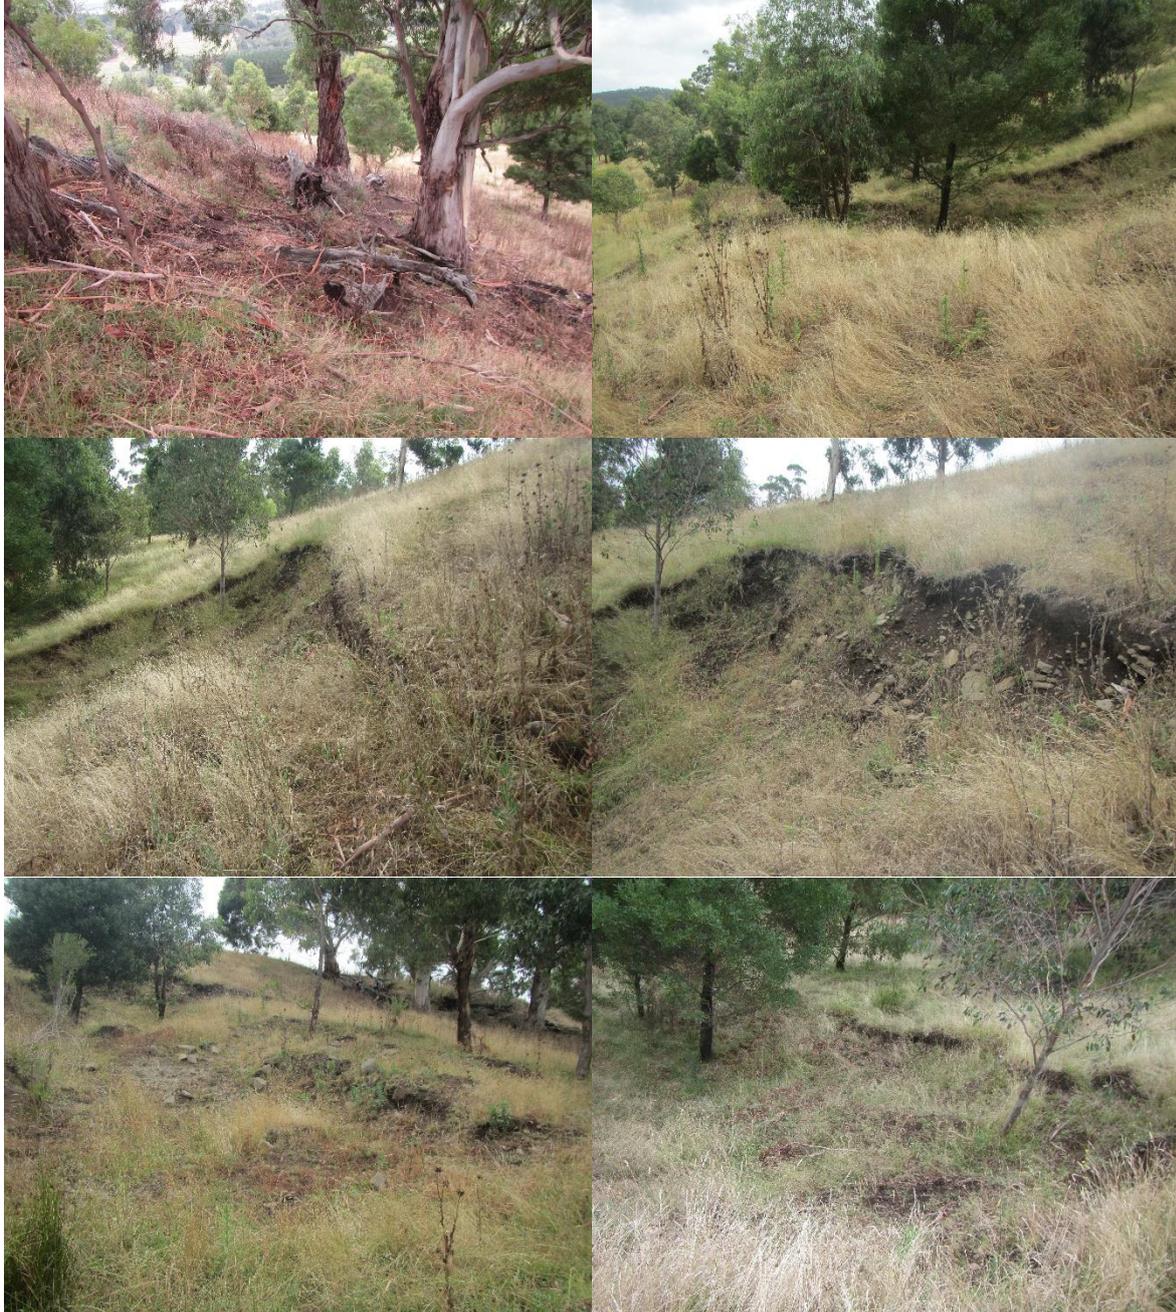
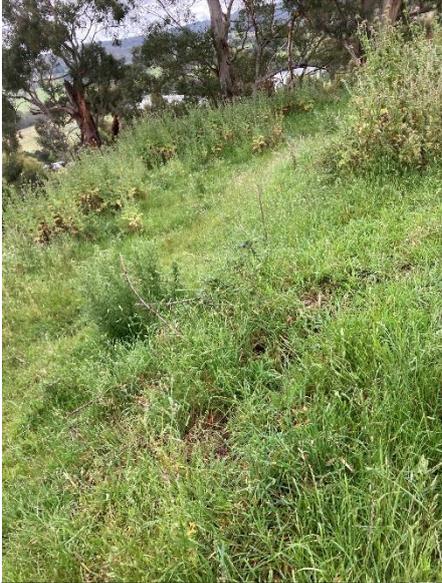
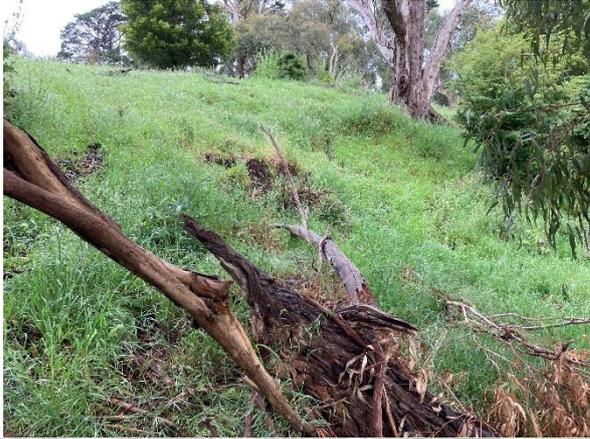
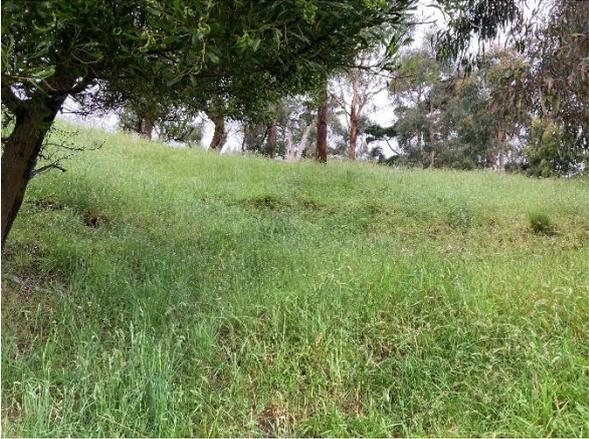
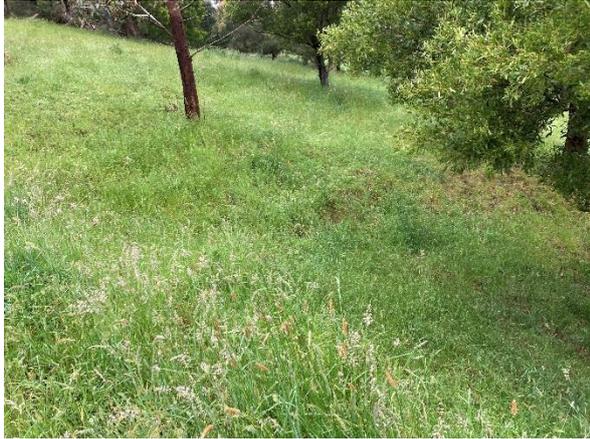
- With the benefit of reduced vegetation cover in 2001 it is possible to see that a number of the EMP masses are in fact either:
 - Smaller recent remobilisation of much larger historical landslips that encompass a number of the EMP masses (ie Mass 1, 2, 3, 9 and 17); or

Back scarp of Large Historical Landslide comprising Masses 1, 2, 3, 9 and 17 (photos of 2019 and 2021)
