26 February 2024

Leigh Elliott  
Quarry Manager  
Holcim (Australia) Pty Ltd  
Mt. Shamrock Road

**Mt. Shamrock Quarry - Toomuc Valley Slope Inspection, January 2024**

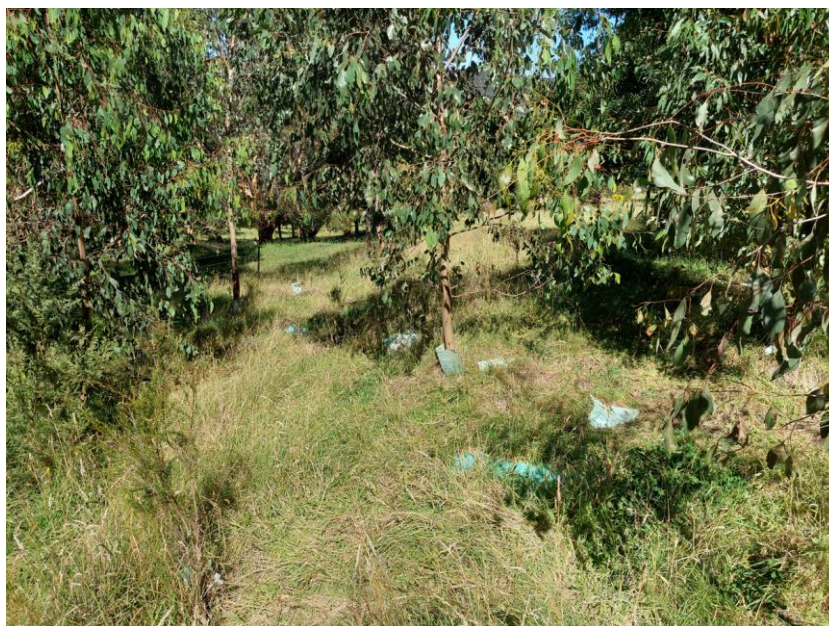
**Figure 1: Planted trees – Mass 2.**

On-site, tree saplings were protected with tree guards. At locations where the trees appeared to be more matured, such as shown in Figure 1 (Mass 2), they were generally of small to medium size.

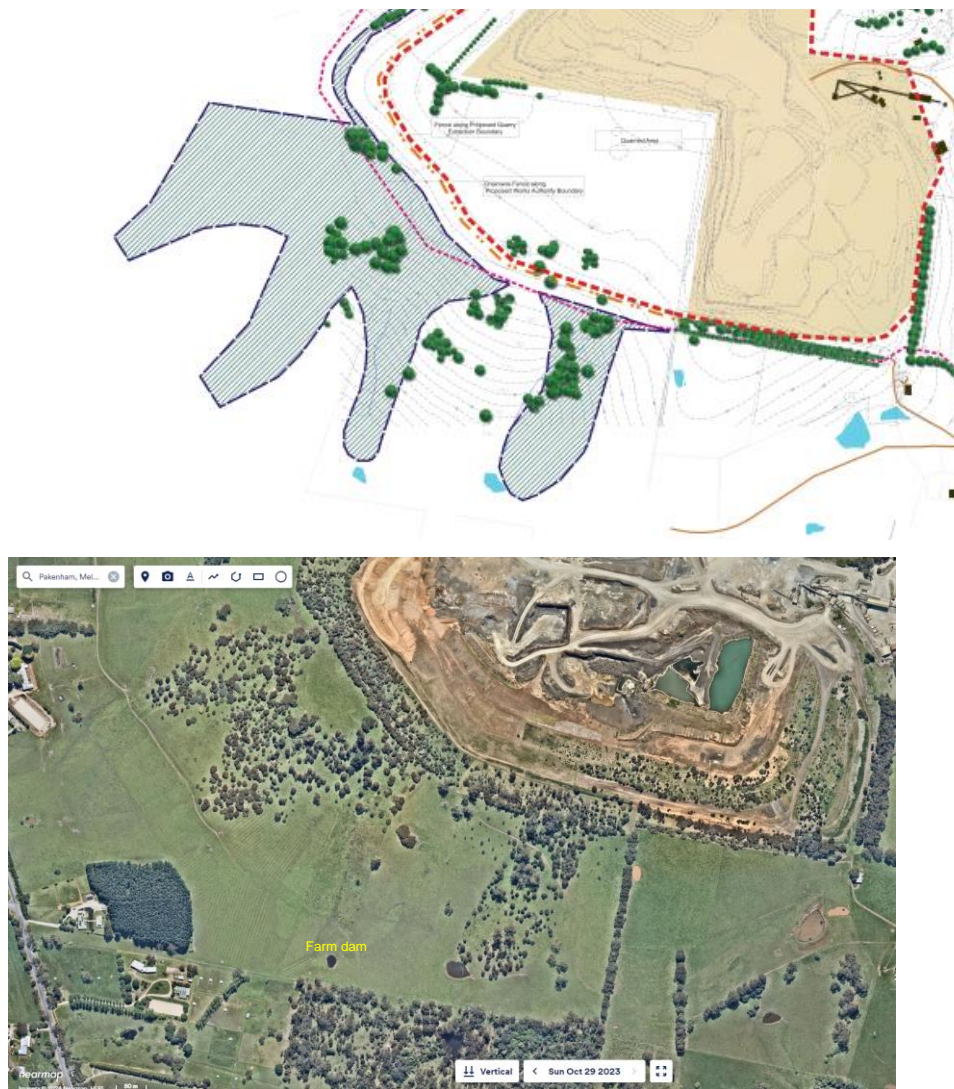
**Figure 2: (Top – Drawing L3a (EMP, Appendix 6), Bottom – Nearthmap, 2023). Southern slopes.**

Figure 2 shows that whilst there is good vegetation planting progress made, parts of the slope remain unvegetated. These include the slope to the north of the farm dam shown on Figure 2 and the upper area near the southwestern boundary of the quarry site.

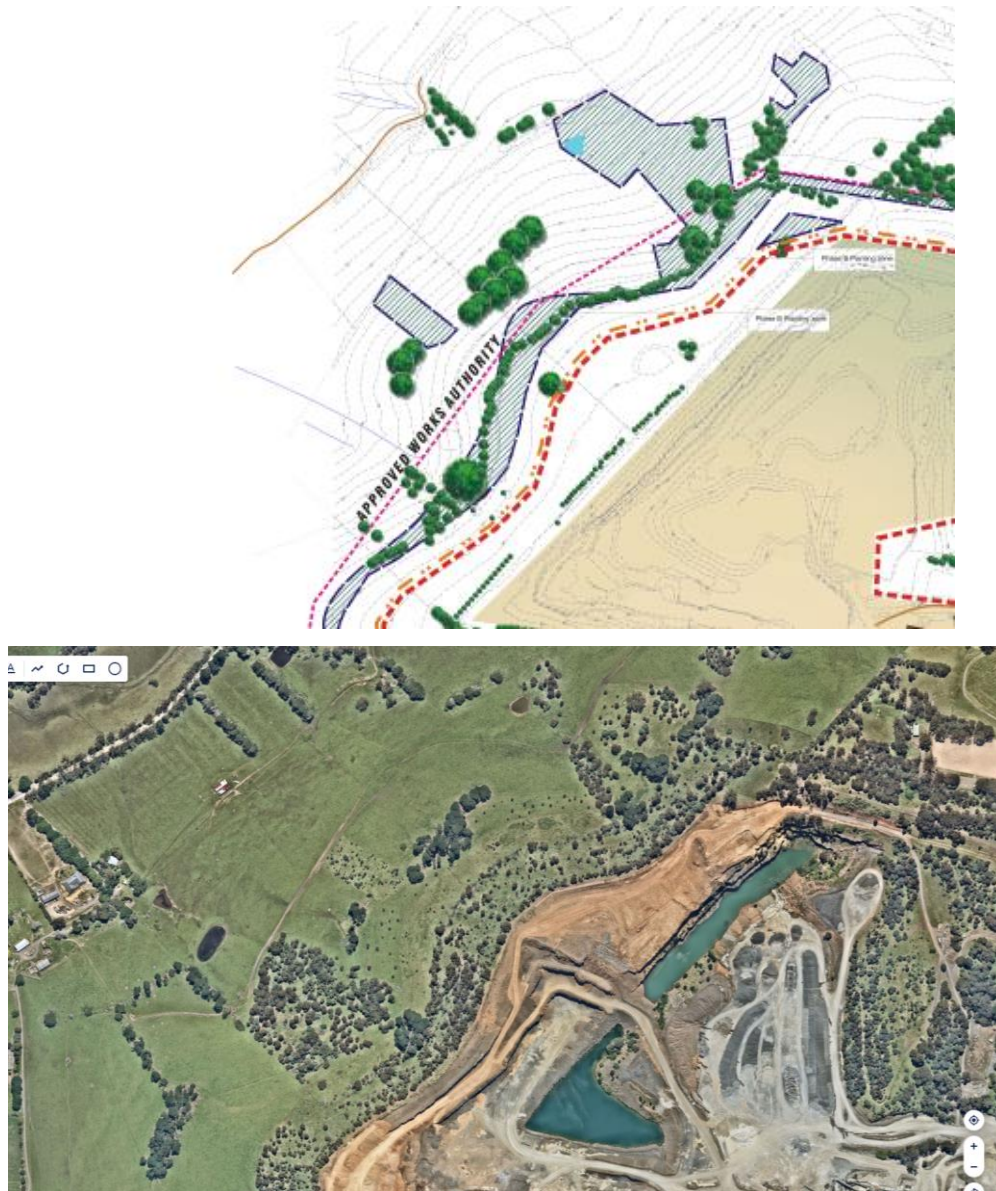
Figure 3: (Top – Drawing L3a (EMP, Appendix 6), Bottom – Nearmap, 2023). Western slopes.

Figure 3 shows substantial planting progress in the corresponding areas of Drawing L3a.

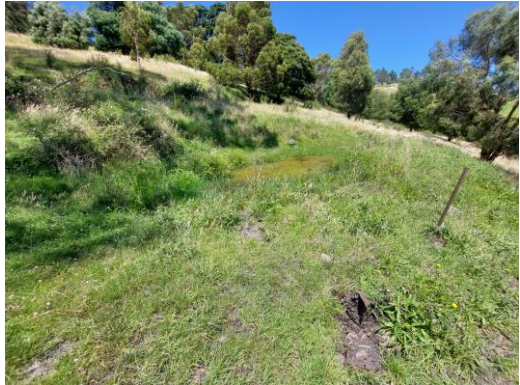
Spring 04	Spring water impounded by embankment.  Refer "Mass 15" entry in Attachment 1.	Within Mass 15, upslope.

On this basis, it is recommended that Holcim investigates alternative ways to manage surface water from the springs at the locations where standing water is considered to present a risk to the slope. A primary consideration of this will be to establish good surface drainage to avoid standing water.

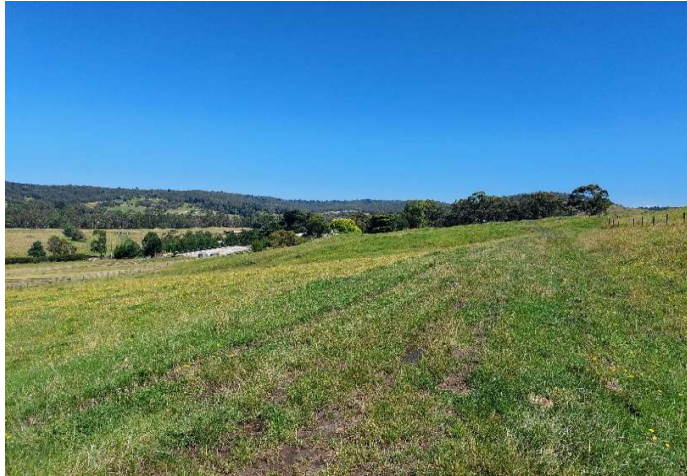
**Plate M01-A**

Reference	January 2024 Inspection – Observations
<b>Mass 1</b>	<p>Overall, the land surface in this area is hummocky but well vegetated with dense grass cover and small to medium shrubs (Plate M01-A). Within the upslope area of the mass, medium to large trees are present (Plate M01-D).</p> <p>The trunks of multiple trees are rotated (Plate M01-B). Attachment 3 shows the location where this has been observed. The trunks are rotated generally in the west to southwest direction, by amounts up to about 10° (estimated visually).</p> <p>Fence posts along the existing informal access track appeared to stand upright (Plate M01-B).</p>
<b>Mass 2</b>	<p>Overall, the land surface in this area is hummocky but well vegetated with dense grass cover (often overgrown) and medium to large trees (Plates M02-B and M02-D).</p> <p>Spring 02 was observed within the mass (Plate M02-A). Standing water at the spring location was impounded by an earth embankment, which was heavily grass-covered.</p> <p>The water depth within the impoundment was estimated to be one to two feet deep where it could be sighted.</p> <p>Anecdotal information by Holcim indicate that an in-take pipe had been installed within the spring impoundment to supply water to an above-ground tank located downslope along Mass 2.</p> <p>A PVC pipe was present and served to divert overflows from the spring impoundment to a point about 2 – 3 m to the east of the adjoining fence line (Plate M02-C). The area around the pipe discharge point was dry and grass covered.</p> <p>A shallow backscarp was present upslope of the overflow pipe (Plate M02-C), estimated less than 1.5 – 2 m in length. The scarp surface was poorly vegetated, though grass roots were starting to develop.</p>

Standing midslope and looking west towards existing structure

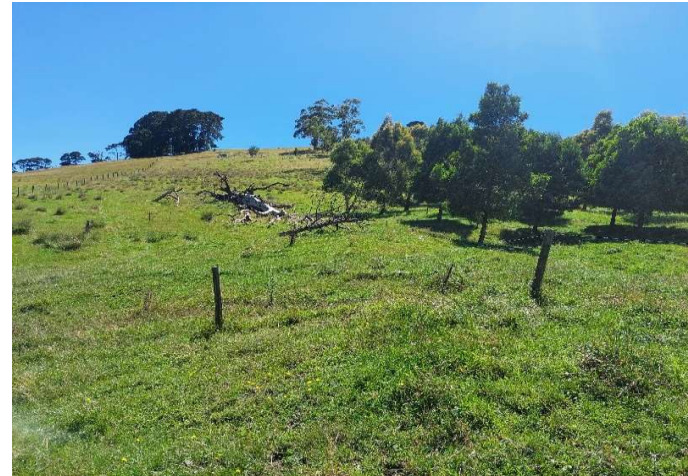
**Plate M01-B**

Standing midslope and looking north. Rotated trees

As such, our present recommendation is to continue to maintain regular documented inspections of all slope masses in accordance with the requirements of Sub-section 2.5.4 of the EMP.

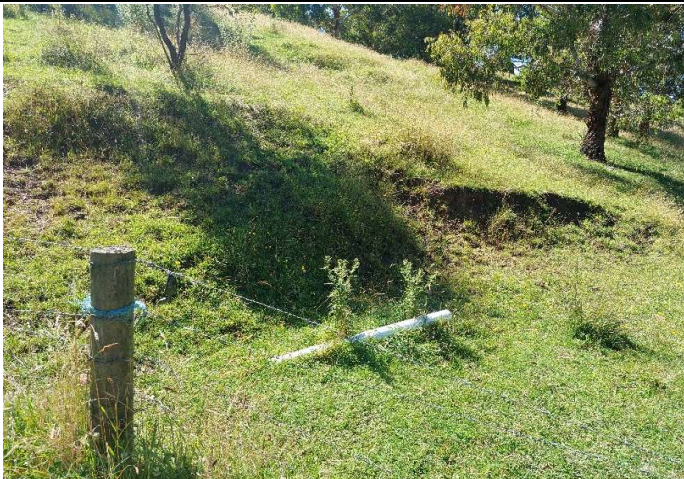
**Plate M02-C**  
PVC overflow line from Spring 02 and slump above

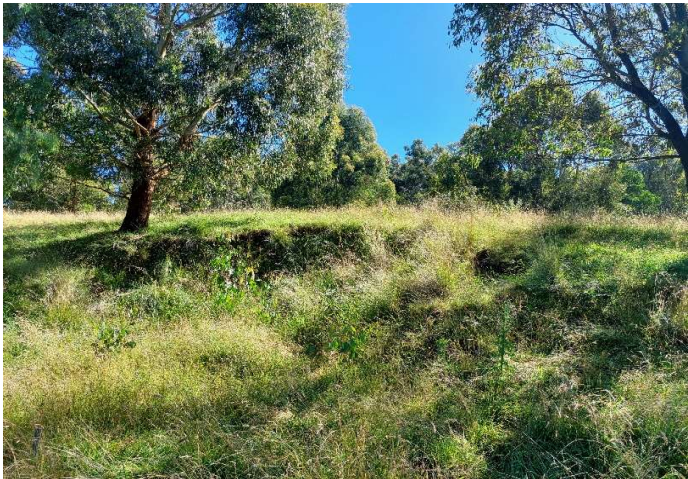
**Plate M04-A**  
Grass covered scarp

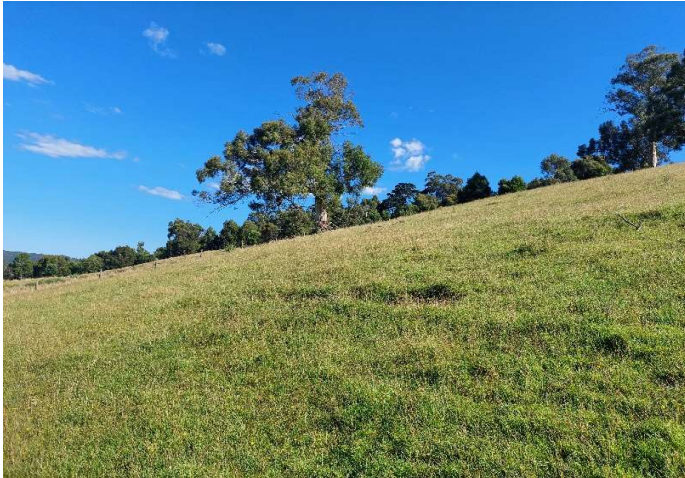
**Plate M05-A**

Looking west. Hummocky ground

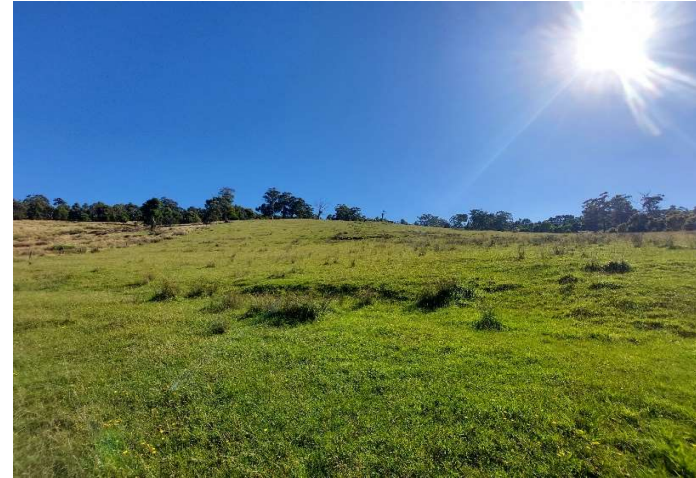
**Plate M05-B**

Looking upslope. Hummocky ground

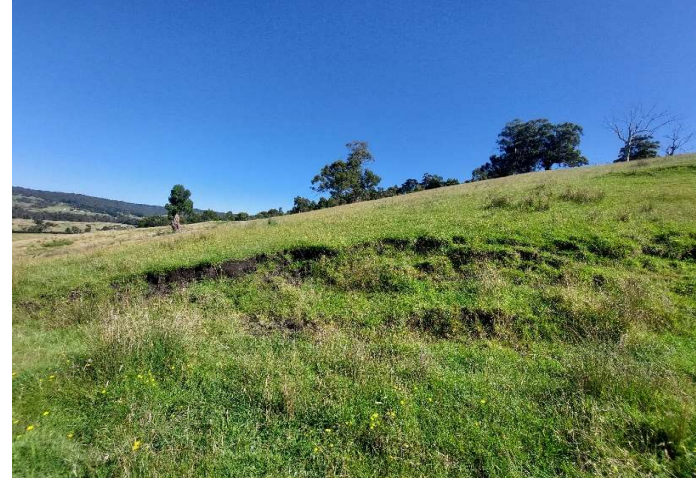
**Plate M05-D**

<b>Mass 3</b>	<p>Overall, the land surface in this area is hummocky but well vegetated with dense grass and dense tree cover (medium to large trees) (Plate M03-A).</p> <p>The trunks of multiple trees are rotated (Plates M03-A and M03-C). Attachment 3 shows the location where this has been observed. The trunks are rotated generally towards the downslope direction, by amounts less 5° (estimated visually)</p>
<b>Mass 4</b>	<p>Overall, the land surface in this area is hummocky but well vegetated with dense grass cover, small to medium shrubs and medium to large trees (mostly within the downslope area).</p> <p>The backscarp of an old slump was observed and was densely vegetated (Plate M04-A). Immediately overlying the scarp, a medium-sized tree was present with roots protruding into the scarp.</p>
<b>Mass 5</b>	<p>Overall, the land surface in this area is hummocky but well vegetated with dense grass cover and scattered medium to large trees (Plates M05-A and M05-B).</p> <p>At a location south (downslope) from Mass 5, backscarps of up to 1 – 1.5 m height were observed, which appeared to be associated with a localised area of historical slumping. Attachment 3 shows the location of where this has been observed.</p> <p>The backscarps were either bare or poorly vegetated.</p> <p>In some parts, mostly along the western flank of the slump, the backscarps were flattened and covered with dense grass (Plates M05-C and M05-D).</p>

Scarp flattened along western flank. Looking west

Relating to the observed backscarps within Mass 8 and south of Mass 5, it is recommended to re-vegetate the backscarps to provide increased surface resistance to erosion by water, as follows:

- Revegetate behind the observed backscarps with deep root (but small canopy) shrubs/bushes and grasses.
- Revegetate the backscarps surface with grasses.

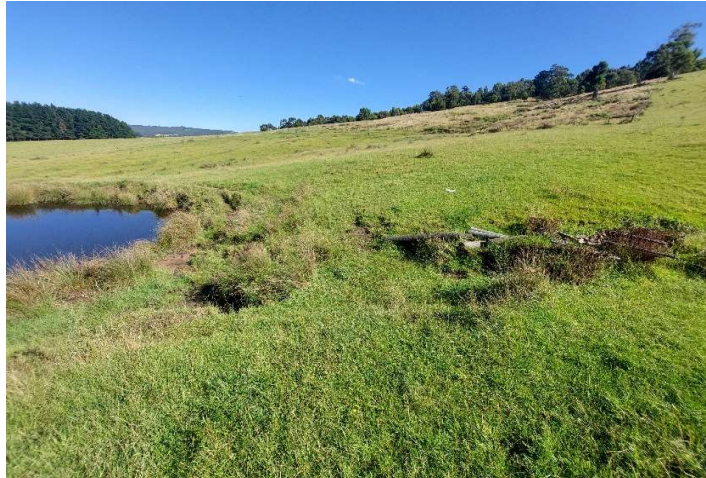
**Plate M05DAM-A**

Reference	January 2024 Inspection – Observations
<b>Farm Dam South of Mass 5</b>	<p>Water was observed about 300 – 500 mm below the crest of the dam.</p> <p>The dam was on the verge of overflowing through a point at roughly where the embankment abuts the natural ground surface on the south (Plate M05DAM-D).</p> <p>The ground surface at the spill point was mostly grass covered.</p> <p>The upstream gully which drains into the dam is partially obstructed with building rubble (comprising fence posts and pipes) (Plate M05DAM-A).</p> <p>The crest of the dam was mostly grass covered. A trail of bare ground had formed on the crest, likely demarcating the path taken by animals.</p> <p>The downstream face of the embankment is well-vegetated. The northern and eastern sides of the dam (both upslope from the dam) were also well-vegetated.</p> <p>At the location of Plate M05DAM-C, animal movement appeared to have caused localised damage to the embankment.</p>

Upstream depression partially obstructed with rubble

The risks associated with the impacts of dam failure should be investigated by Holcim. We draw your attention to the DELWP publication “Your dam: Your responsibility. A guide to managing the safety of small dams” for further details ([https://www.water.vic.gov.au/\\_data/assets/pdf\\_file/0027/668610/your-dam-your-responsibility.pdf](https://www.water.vic.gov.au/_data/assets/pdf_file/0027/668610/your-dam-your-responsibility.pdf)).

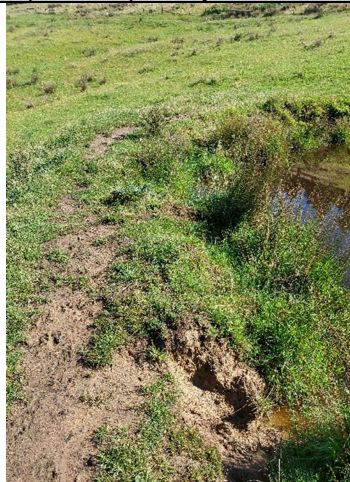
**Plate M05DAM-C**

Parts of embankment crest. Damage (right of photo)

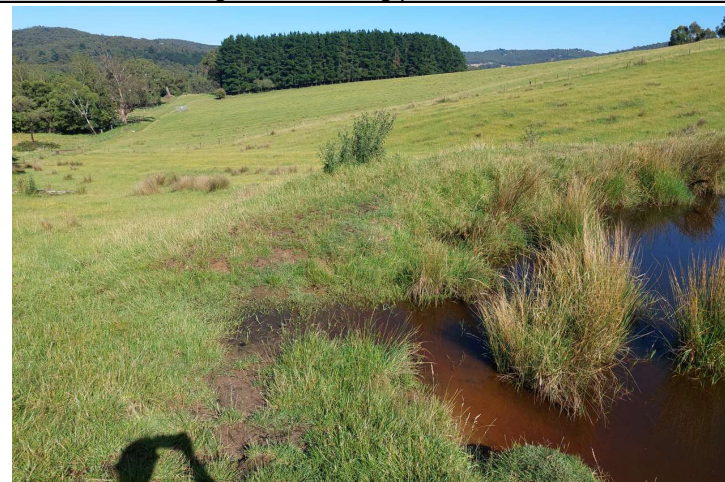
**Plate M05DAM-D**

Looking downstream. Dam on brink of overflowing.

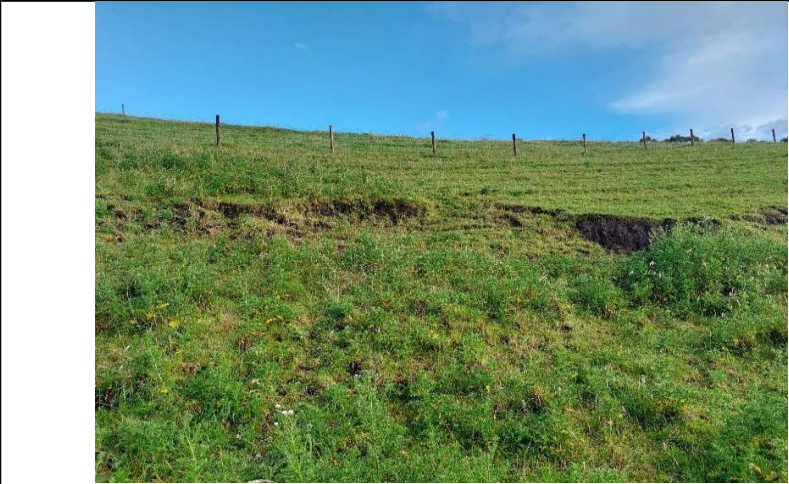
- **Masses 2, 4, 6, 7, 9, 11 – 13, 15 and 17 – 19:** no visual signs that could indicate recent ground movement were observed.
- **Mass 8:** backscarps were observed, which appeared to be associated with a localised area of historical slumping. In the remaining areas, no visual signs that could indicate recent ground movement were observed.
- **South (downslope) of Mass 5:** backscarps were observed within an area south of Mass 5 (outside of the Mass 5 extent, refer Attachment 3), which appeared to be associated with a localised area of historical slumping.
- **Masses 1, 3 and 10:** visual signs suggesting that recent ground movement has occurred were observed, which included:
  - **Mass 1:** rotated tree trunks.
  - **Mass 3:** rotated tree trunks.
  - **Mass 10:** rotated tree trunks and rotated fence line.

**Plate M08-A**  
Exposed scarp

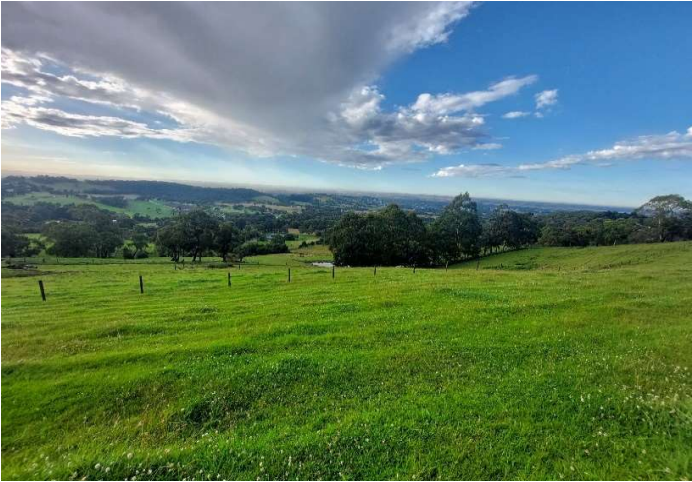
**Plate M08-D**  
Looking south. Hummocky ground

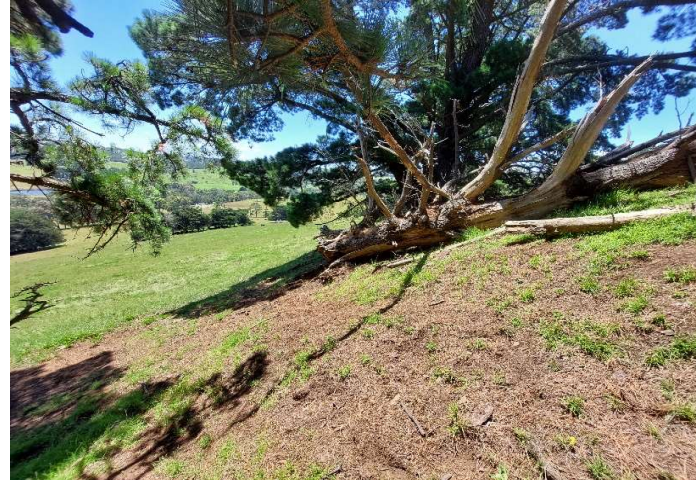
**Plate M12-B**  
Toppled tree

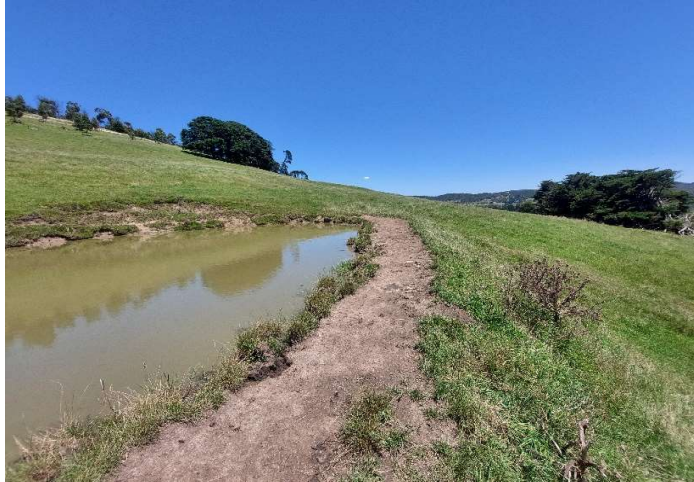
<b>Farm Dam West of Mass 13</b>	<p>The dam water level was observed to be some 250 – 500 mm below the embankment crest. The crest surface was mostly bare (Plate M13DAM-A).</p> <p>The dam was on the verge of overflowing through a point at roughly where the embankment abuts the natural ground surface on the northeastern side.</p> <p>The ground surface at the point of discharge was rugged and wet.</p> <p>A shallow slump on the southern (upslope) side was present (Plate M13DAM-B). The slump surface was poorly vegetated.</p> <p>On the northeastern (upslope) side of the dam, a shallow slump in topsoil was present. Its scarp did not exceed 200 mm in height (Plate M13DAM-C).</p> <p>The dam crest appeared narrower in localised sections of the embankment, but by amounts not exceeding about 300 mm (Plate M13DAM-A).</p> <p>The downstream face of the embankment was well-vegetated with grass (Plate M13DAM-D).</p>

**Plate M13DAM-A**  
Looking west

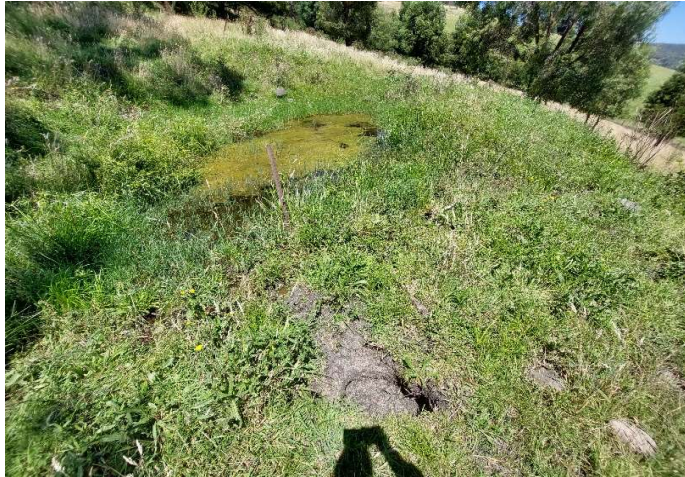
**Plate M15-A**  
Spring 04
