ENCOMPASS
MINING SOLUTIONS

TOOMUC VALLEY 2024 SLOPE INSPECTION

PAKENHAM QUARRY

Date: 22nd January 2025

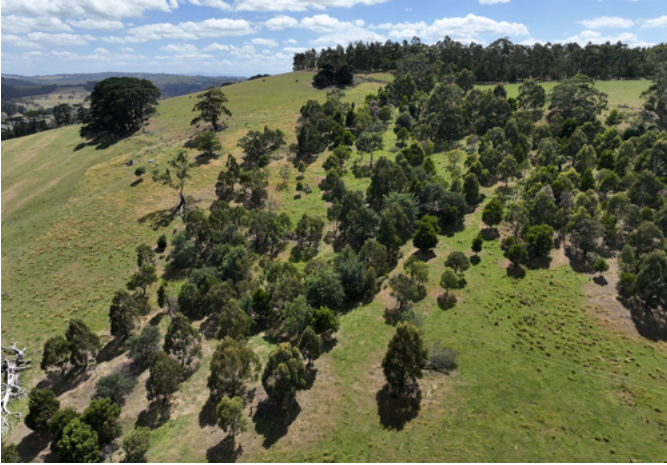
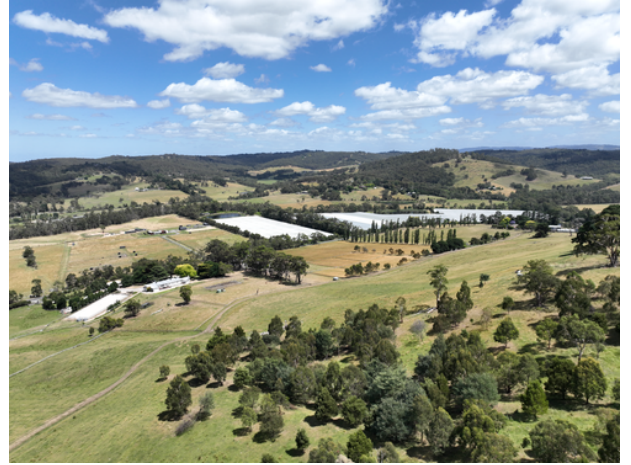
| REFERENCE | INSPECTION NOTES |
|---|---|
| | Established vegetation consisting of dense grass, and medium to large trees. |
| | The slope surface is hummocky, this appears to be associated with historical major landslips and no evidence of recent or ongoing instability was observed. |

Mass 01 - looking north

Mass 01 - looking southwest

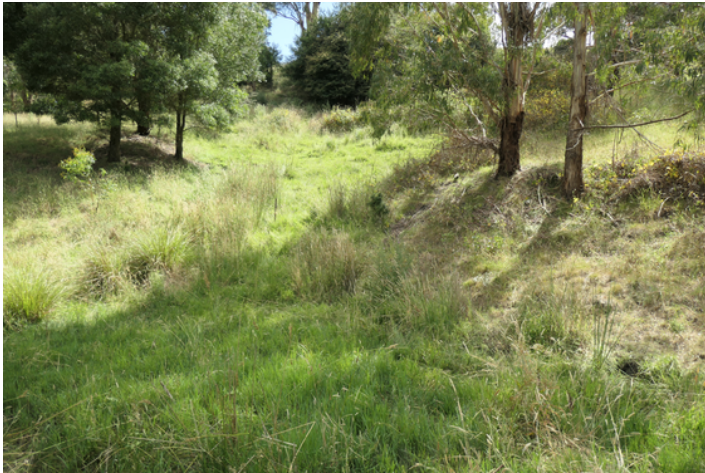
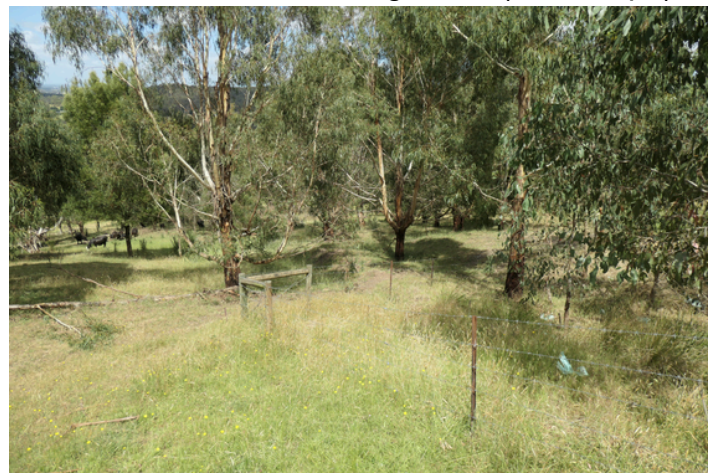
| | Recommendation |
| | - |
| | Overall the area is well vegetated with dense grass cover and small to medium shrubs and large trees throughout. |
| | The slope surface is hummocky, this appears to be associated with historical major landslips and no evidence of recent or ongoing instability was observed. |
| | Spring 02 was observed within the mass with standing water at the spring location contained by an earth embankment, which was heavily grass-covered. |
| | The water depth within the spring area was estimated to be 300-500 mm deep. |

Mass 02 - looking north

Mass 02 - looking south (downslope)

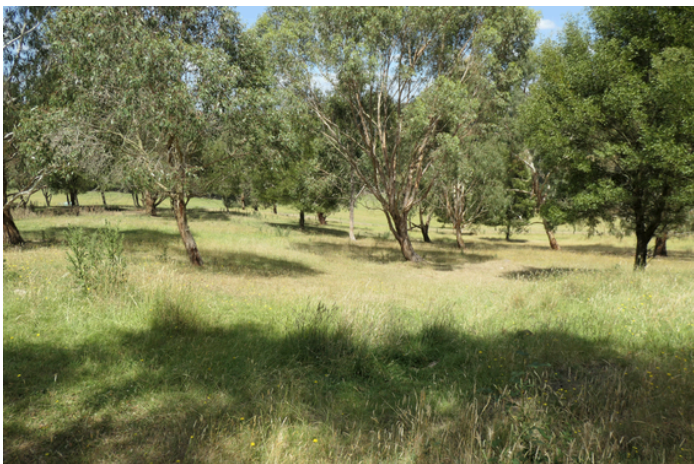
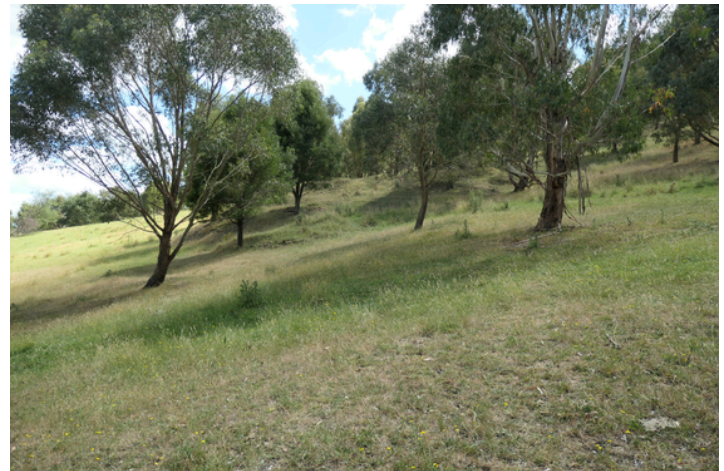
| | Recommendation |
| | - |
| | Overall, the land surface in this area is hummocky but well vegetated with dense grass and dense tree cover (medium to large trees). |
| | The trunks of a few random trees are rotated which appear in isolation and not grouped together. |
| | No evidence of recent or ongoing instability was observed. |

Mass 03 - looking south (downslope)

Mass 03 - looking west

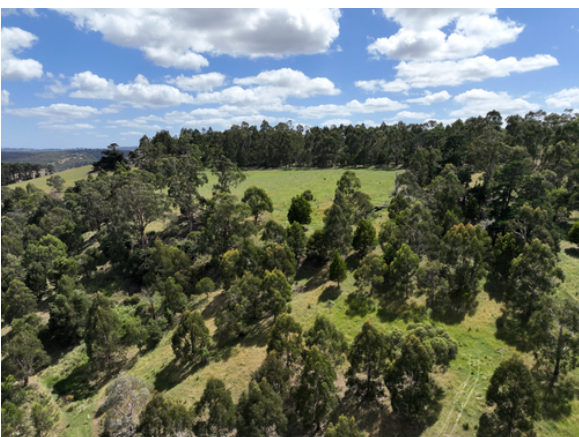
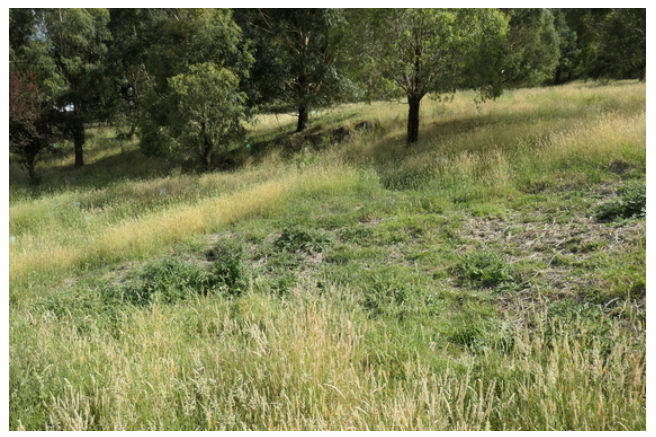
| REFERENCE | INSPECTION NOTES |
|---|--|
| | Overall, the land surface in this area is hummocky but well vegetated with dense grass cover, small to medium shrubs and medium to large trees (mostly within the downslope area). |
| | No evidence of recent or ongoing instability was observed. |

Mass 04 - looking north

Mass 04 - looking northwest

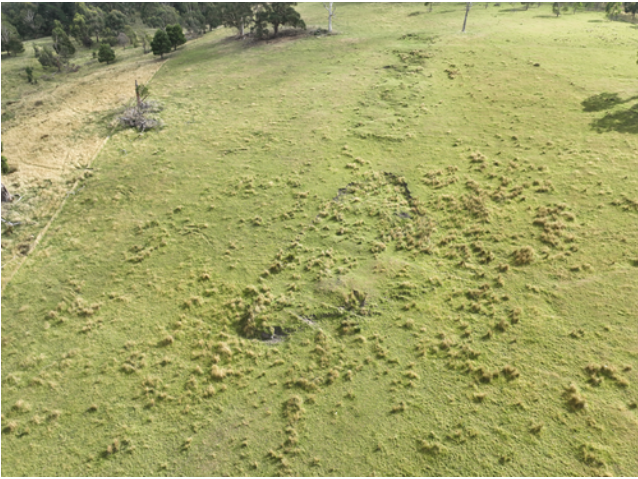
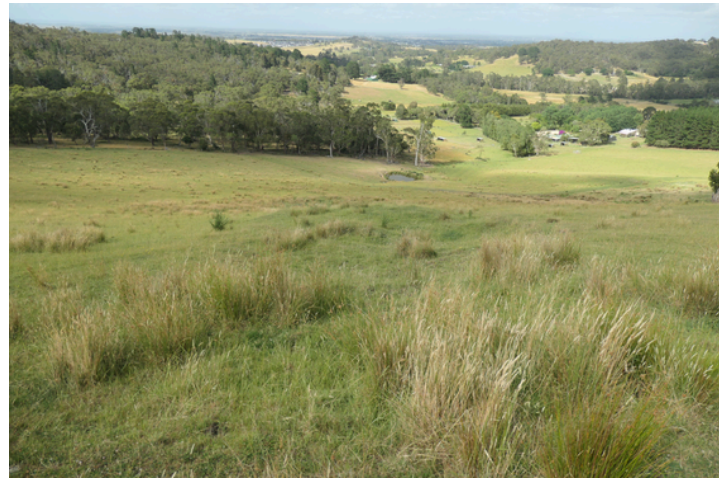
- South (downslope) of Mass 05: backscarps were observed within an area south of Mass 05 (outside of the historically mapped Mass 05 extent). Movement zone is small in volume and given that the location is isolated from any downhill infrastructure, it is not considered to be a significant geological risk.
- All other masses, no visual signs that could indicate recent ground movement were observed.

| | Recommendation |
| | - |
| | Overall the area is well vegetated with dense grass cover throughout. |
| | Minor historical circular failures were observed in four locations: these failures were observed to be associated with exposed (bare) scarps and a change in the natural topography locally downslope with remnant mobilised material. The mobilised material is well vegetated whereas the backscarps were either bare or poorly vegetated. |
| | The most recent failure (downslope) measures about 15 m in width and ~1.0 m in height. The circular failure is small in volume and given that the location is isolated from any downhill infrastructure is not considered to be a significant geological risk. |

Mass 05 - looking north

Mass 05 - midslope, looking south

| | Recommendation |
| | - |
| Mass 06 | Revegetation of scarp surfaces with grasses. Maintain regular documented inspections and if conditions deteriorate notify suitably qualified geotechnical engineer for further direction. |

- Remedial treatment of Farmers Dam 13 with revegetation of the small failure surface with grasses/shrubs to limit the ongoing rilling and erosion.
- Remedial treatment of lower Mass 05 backscarp areas with revegetation of grasses/shrubs to limit the ongoing erosion.

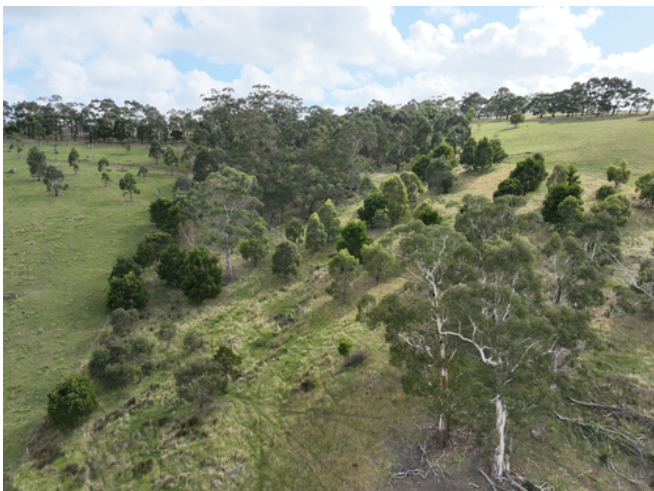
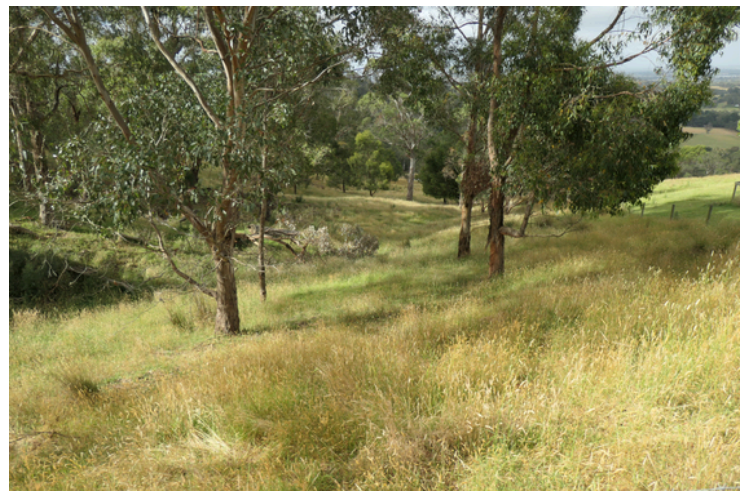
| | Recommendation |
| | - |
| | Overall, the land surface in this area is hummocky but well vegetated with dense grass cover and medium to large trees throughout. |
| | No evidence of recent or ongoing instability was observed. |

Mass 06 - looking north

Mass 06 - midslope, looking south

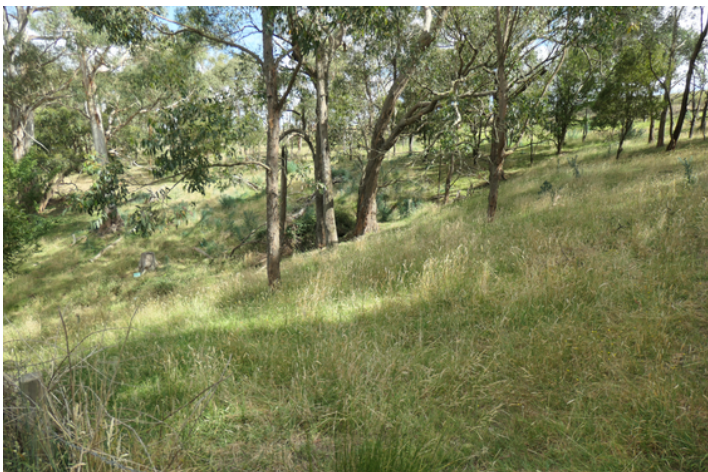
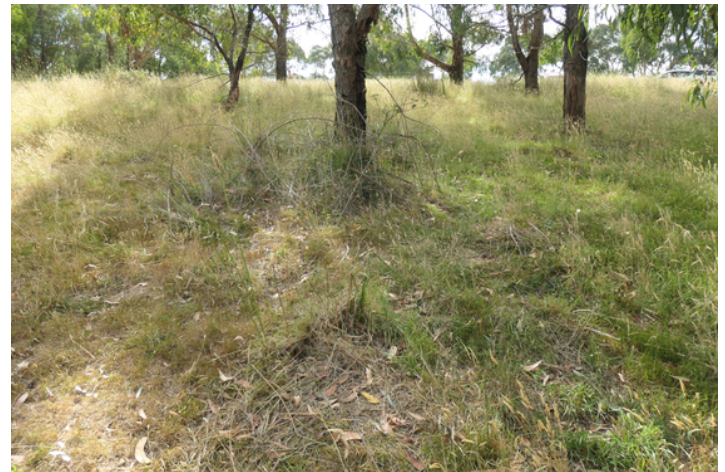
| | Recommendation |
| | - |
| | Overall, the land surface in this area is hummocky but well vegetated with dense grass cover and medium to large trees throughout. |
| | No evidence of recent or ongoing instability was observed. |

Mass 07 - looking northwest

Mass 07 - looking north

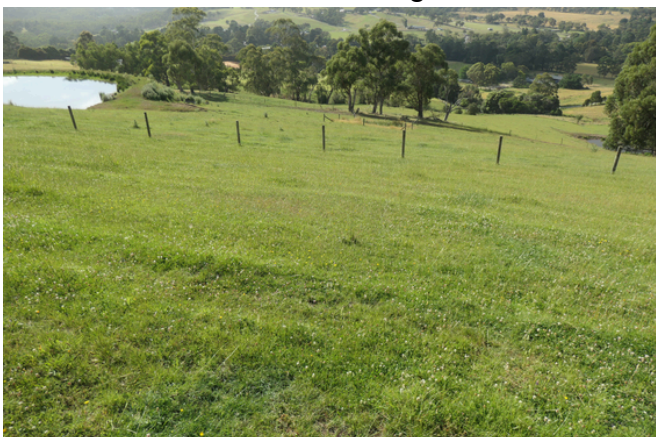
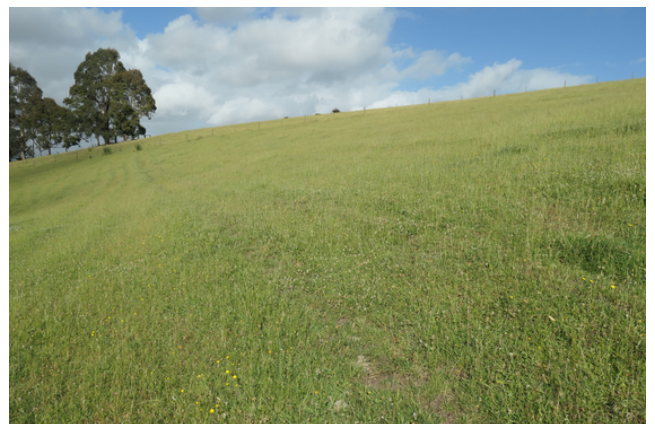
| REFERENCE | INSPECTION NOTES |
|---|--|
| | Overall the area is well vegetated with dense grass cover throughout. There are some historical scarps up to 1m height. |
| | The local area immediately below scarp is poorly to moderately vegetated. Bare ground was observed at the toe of the scarp |
| | No evidence of recent or ongoing instability was observed. |

Mass 08 - looking south

Mass 08 - looking southwest

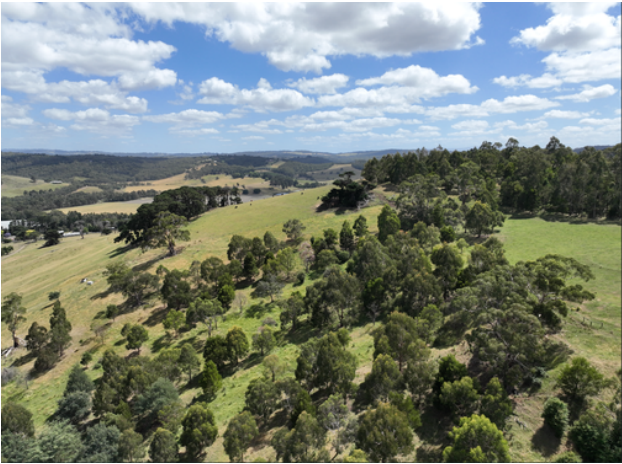
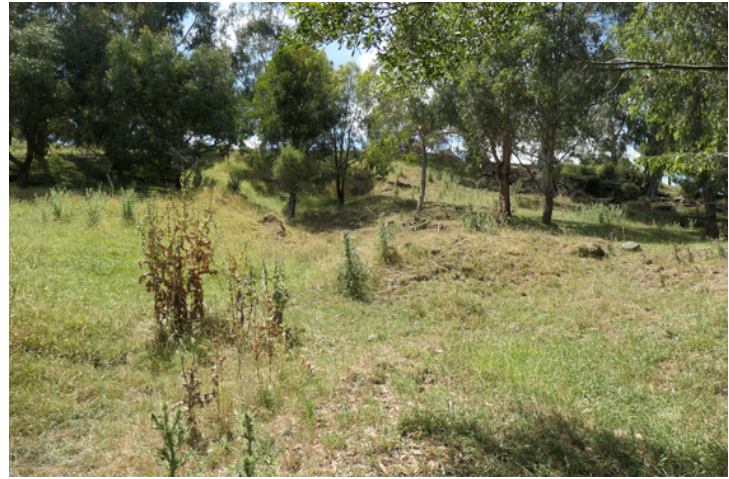
| | Recommendation |
| | - |
| | Overall the area is well vegetated with dense grass cover and small to medium shrubs and trees throughout. |
| | No evidence of recent or ongoing instability was observed. |

Mass 09 - looking west

Mass 09 - midslope, looking north

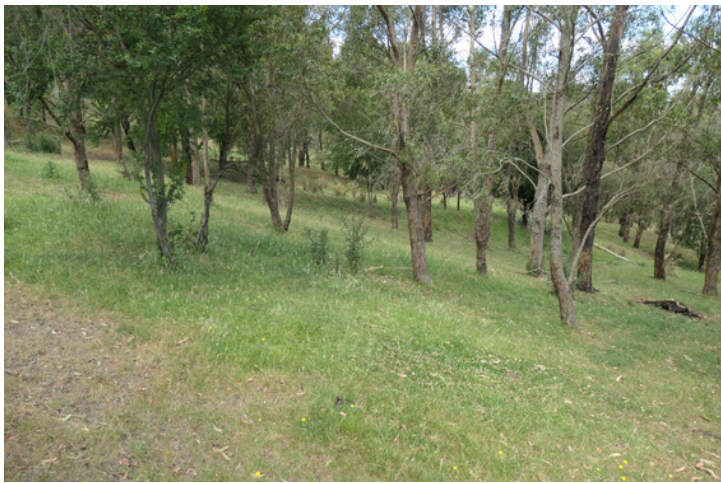
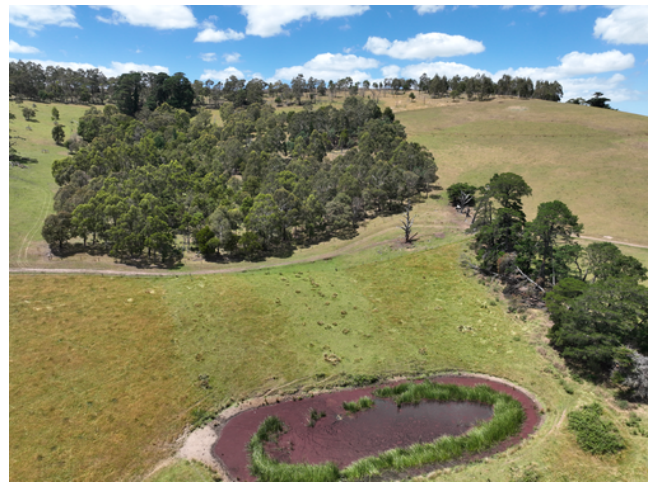
| | Recommendation |
| | - |
| | Overall, the land surface in this area is hummocky but well vegetated with dense grass and dense tree cover (medium to large trees). |
| | The trunks of a few random trees are rotated which appear in isolation and not grouped together. |
| | No evidence of recent or ongoing instability was observed. |

Mass 10 - looking south

Mass 10 - looking east

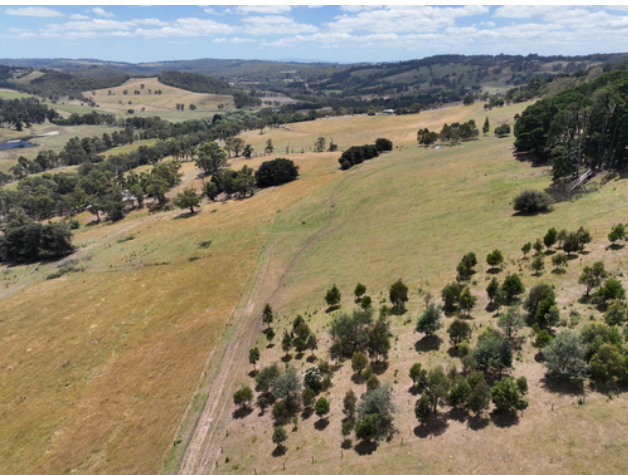
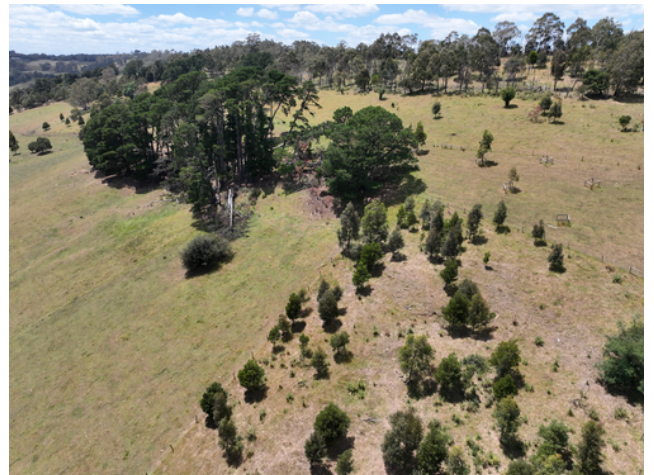
| | Recommendation |
| | - |
| | Overall, the land surface in this area is hummocky but well vegetated with dense grass cover and medium to large trees. |
| | No evidence of recent or ongoing instability was observed. |

Mass 11 - looking north

Mass 11 - looking northeast

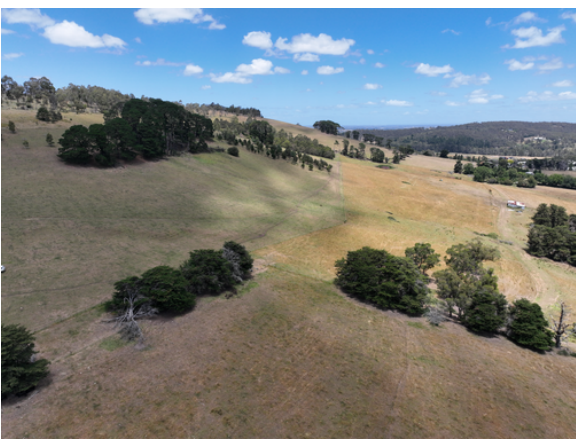
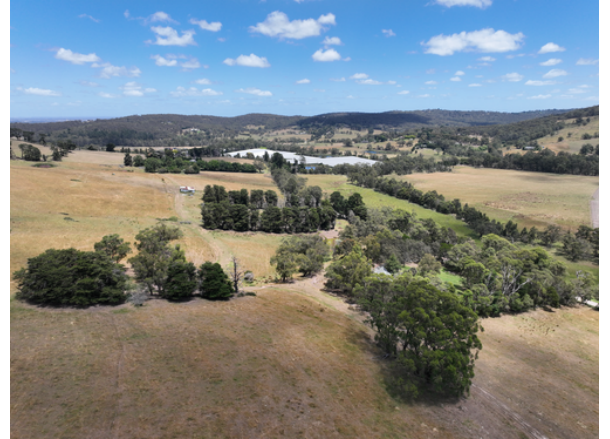
| REFERENCE | INSPECTION NOTES |
|---|---|
| | Overall the area is well vegetated with dense grass cover and medium shrubs and trees throughout. |
| | The slope surface is hummocky, this appears to be associated with historical major landslips and no evidence of recent or ongoing instability was observed. |

Mass 12 - looking south

Mass 12 - looking southwest

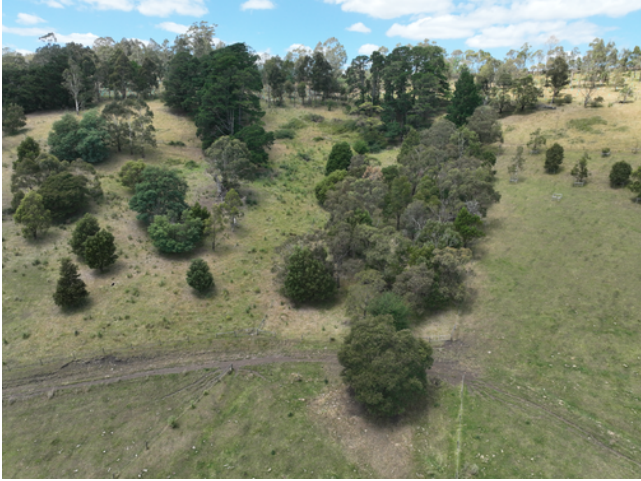
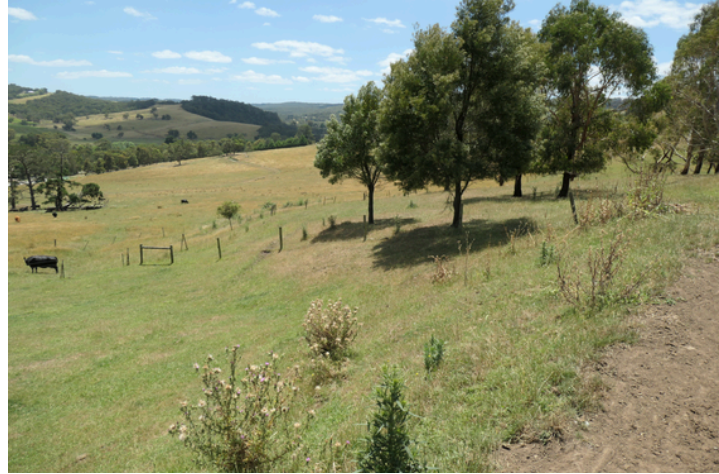
| | Recommendation |
| | - |
| | Overall the area is well vegetated with dense grass cover and medium shrubs and trees throughout. |
| | The slope surface is hummocky, this appears to be associated with historical major landslips and no evidence of recent or ongoing instability was observed. |

Mass 13 - looking east

Mass 13 - looking northwest

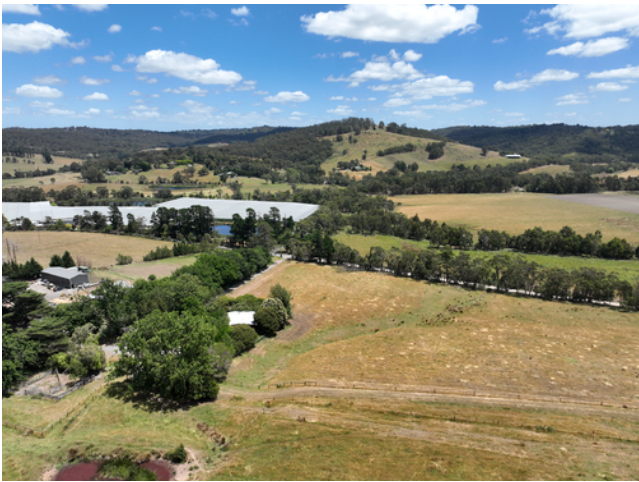
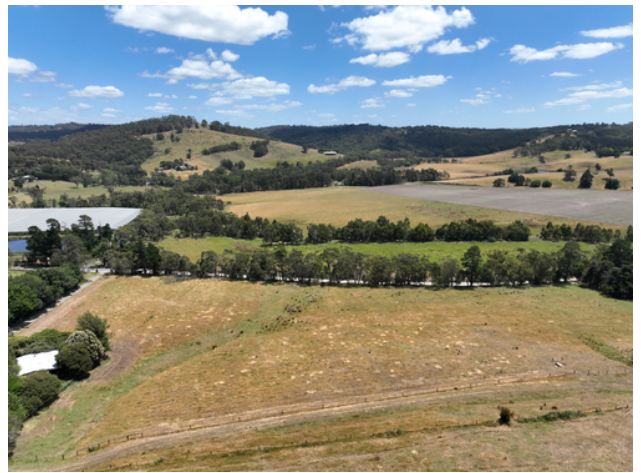
| | Recommendation |
| | - |
| | Overall the area is well vegetated with dense grass cover. |
| | No evidence of recent or ongoing instability was observed. |

Mass 14 - looking west

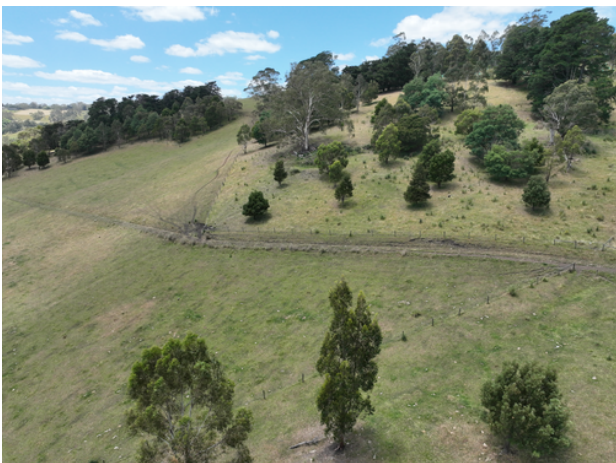
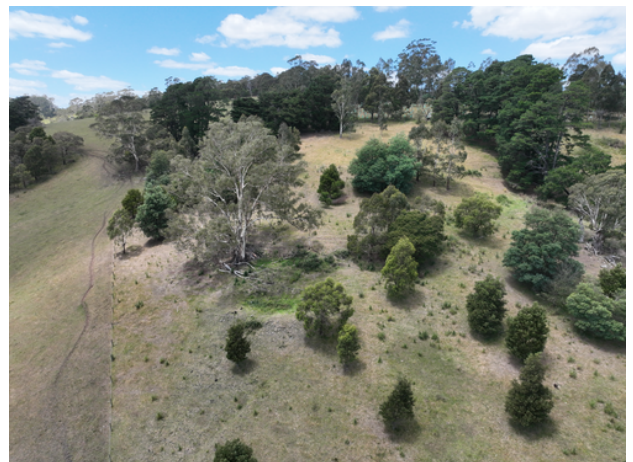
| | Recommendation |
| | - |
| | Overall the area is well vegetated with dense grass cover and medium shrubs and trees throughout. Spring 04 within the mass zone was not inspected but was reported as dry during the time of the inspection. |
| | The slope surface is hummocky, this appears to be associated with historical major landslips and no evidence of recent or ongoing instability was observed. |

Mass 15 - looking north

Mass 15 - looking northeast

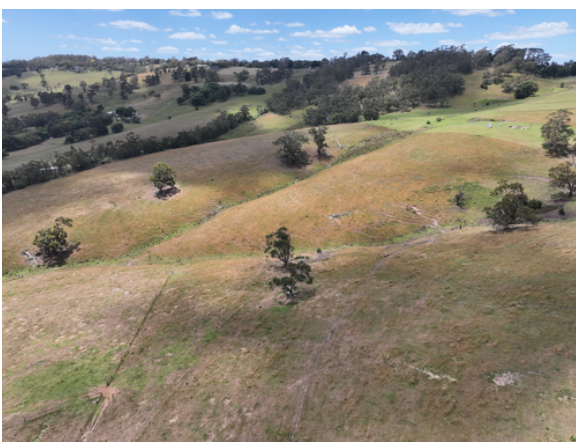
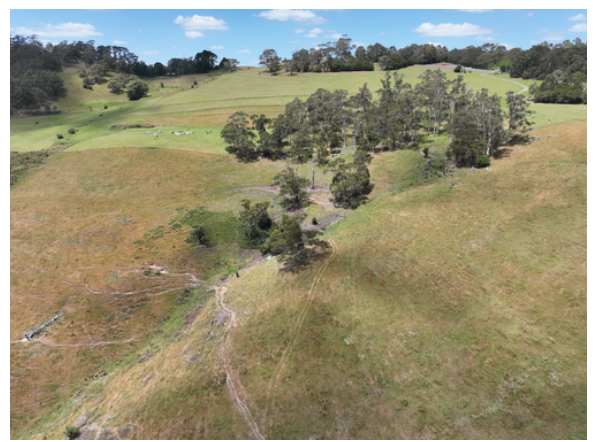
| | Recommendation |
| | - |
| | Overall the area is well vegetated with dense grass cover. |
| | No evidence of recent or ongoing instability was observed. |

Mass 16 - looking east

Mass 16 - looking southeast

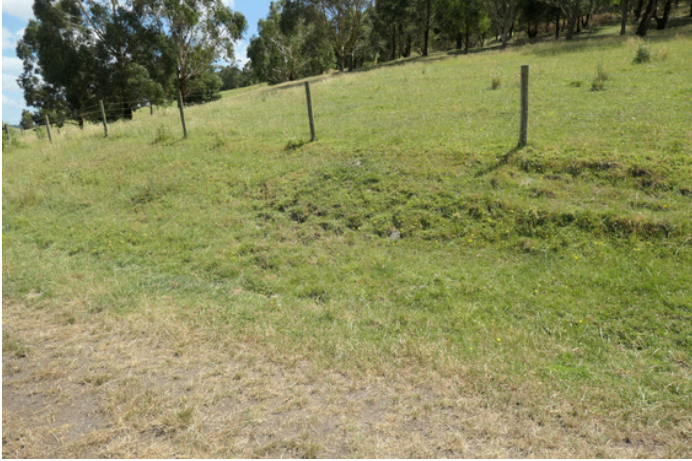
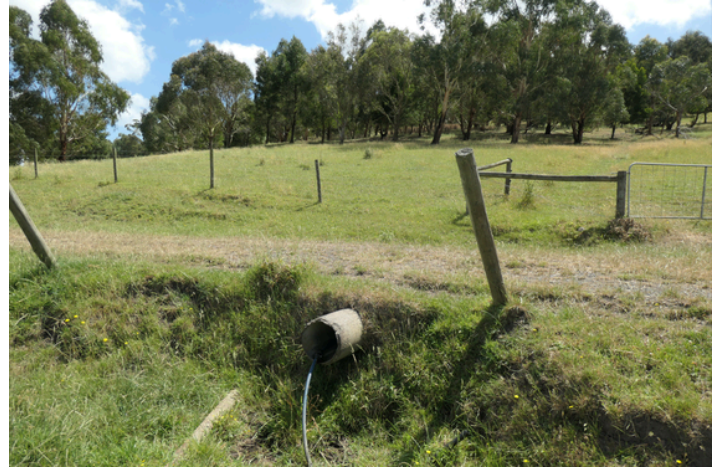
| REFERENCE | INSPECTION NOTES |
|---|---|
| | Area is well vegetated with dense grass cover. |
| | The slope surface is hummocky, this appears to be associated with historical major landslips and no evidence of recent or ongoing instability was observed. |

Mass 17 - looking northwest

Mass 17 - looking north

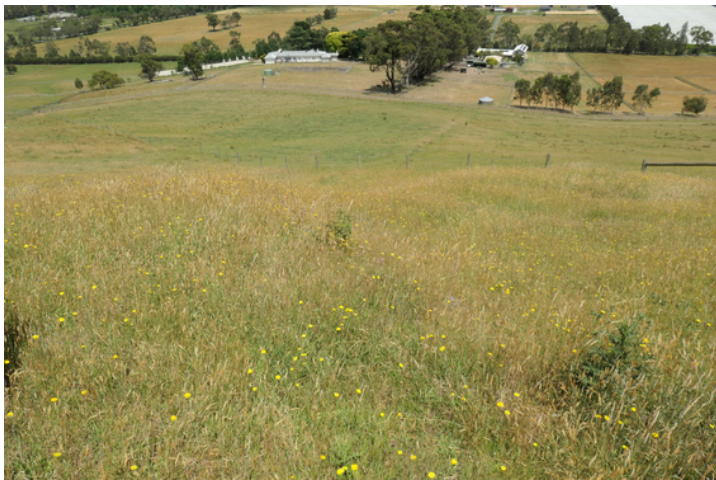
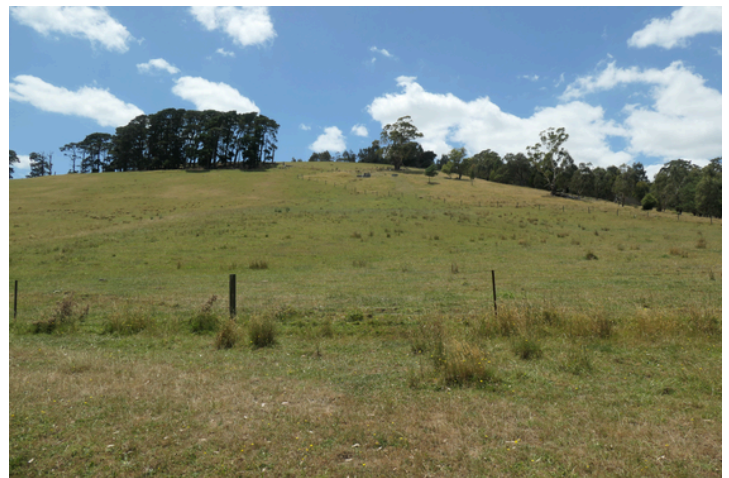
| | Recommendation |
| | - |
| | Overall the area is well vegetated with dense grass cover and medium shrubs throughout. Spring 01 flowing into bin area. |
| | The slope surface is hummocky, this appears to be associated with historical major landslips and no evidence of recent or ongoing instability was observed. |

Mass 18 - looking southwest

Mass 18 - looking northeast

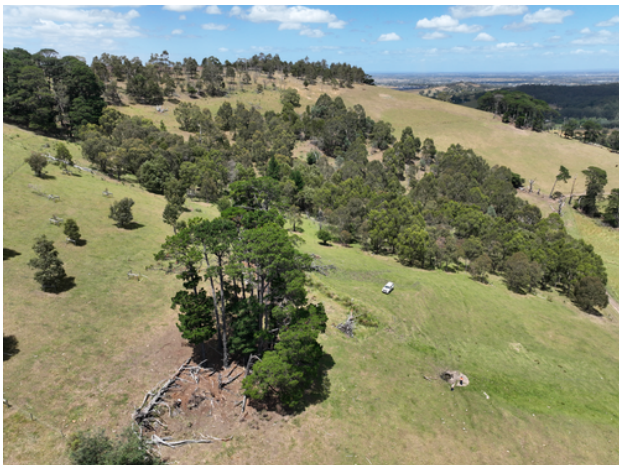
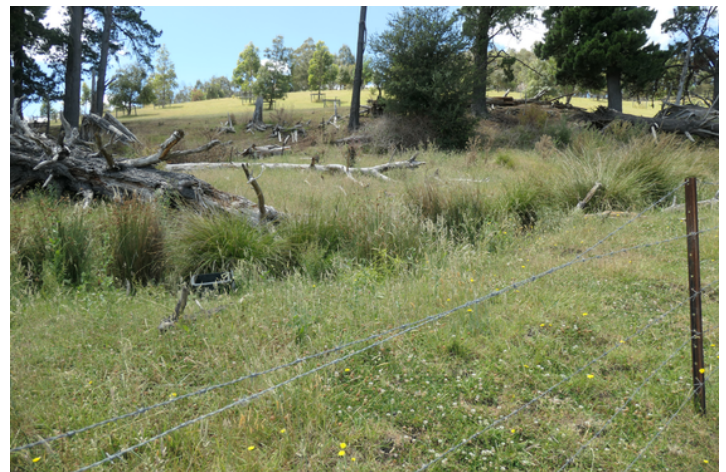
| | Recommendation |
| | - |
| | Overall the area is well vegetated with dense grass cover and medium shrubs and trees throughout. Water flowing from Spring 03. |
| | The slope surface is hummocky, this appears to be associated with historical major landslips and no evidence of recent or ongoing instability was observed. |

Mass 19 - looking south

Mass 19 - looking northwest

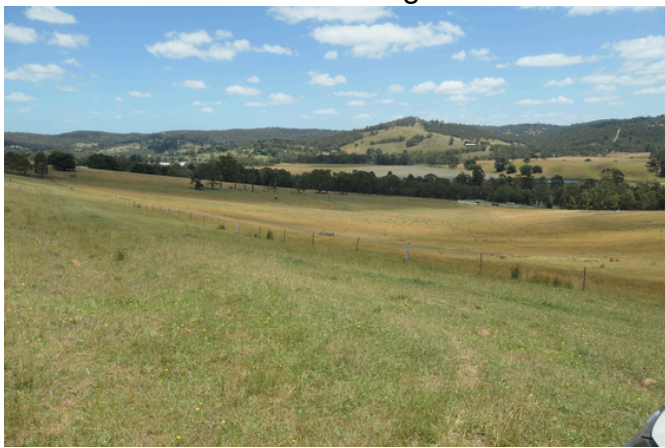
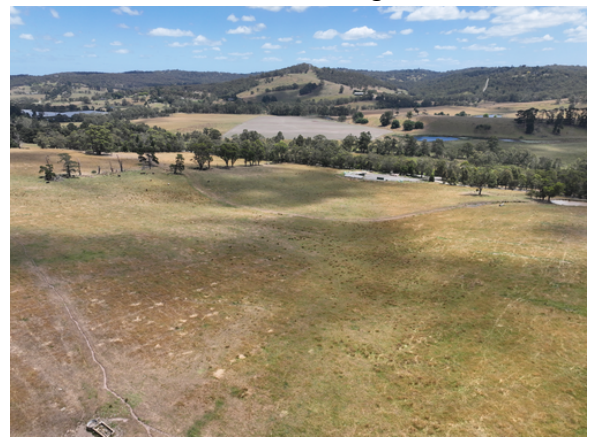
| | Recommendation |
| | - |
| | Area is well vegetated with dense grass cover. |
| | The slope surface is hummocky, this appears to be associated with historical major landslips and no evidence of recent or ongoing instability was observed. |

Mass 20 - looking southwest

Mass 20 - looking west

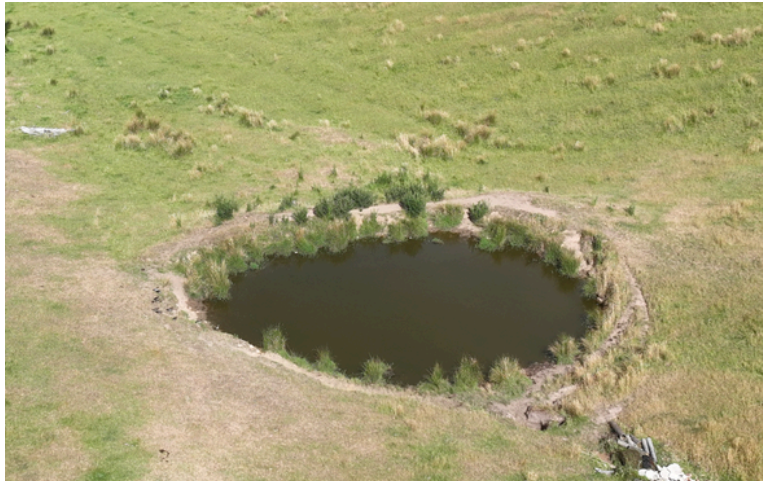
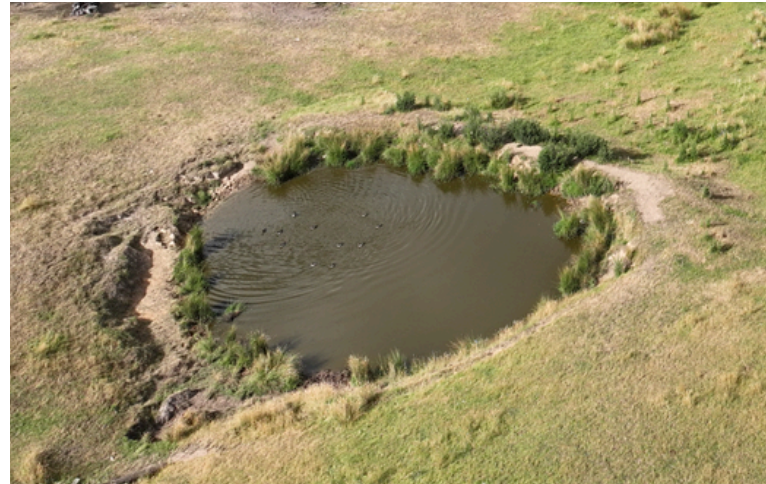
| REFERENCE | INSPECTION NOTES |
|---|--|
| | The water level within the dam was 400-600 mm below the crest, dam size approx. 310 m ² (0.03 ha), holding approx. 310 m ³ (0.31 ML), maximum storage capacity 500m ³ (0.5 ML). |
| | The crest of the dam was mostly covered with grass. A trail of bare ground had formed on the crest caused by livestock. The upstream face (southwest) of the embankment is also partially bare and eroded from livestock activity. The western and eastern downstream sides of the dam are well vegetated with grasses. |
| | The upstream gully which drains into the dam is partially obstructed with building rubble. |

Dam 05 - looking west

Dam 05 - looking south

| REFERENCE | INSPECTION NOTES |
|---|--|
| | The dam is in satisfactory condition. Holcim to maintain regular documented inspections and if conditions deteriorate notify suitably qualified geotechnical engineer for further direction. |

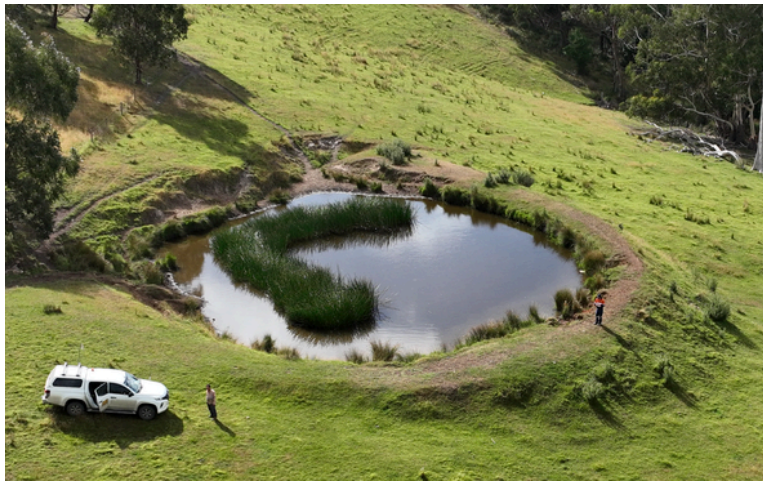
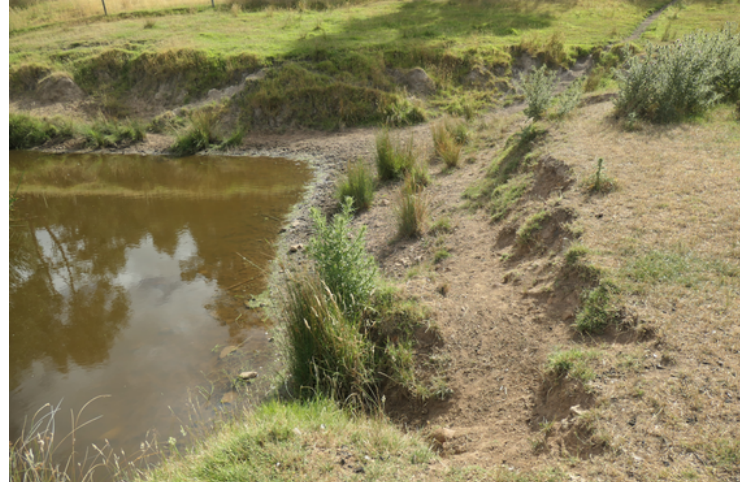
| REFERENCE | INSPECTION NOTES |
|---|--|
| | The water level within the dam was 600-800 mm below the crest, dam size approx. 900 m ² (0.09 ha), holding approx. 540 m ³ (0.54 ML), maximum storage capacity 900m ³ (0.9 ML). |
| | The crest of the dam was mostly covered with grass. A trail of bare ground had formed on the crest caused by livestock. The downstream (south) and western sides of the dam are well vegetated with grasses, some minor erosion caused by livestock. The upstream face (north) is partially bare and eroded from livestock activity. |
| | A natural overflow channel flows northeast and then south, this low point is also partially eroded by livestock with bare soil around the current water level. |

Dam 06 - looking east

Dam 06 - looking north

| REFERENCE | INSPECTION NOTES |
|---|--|
| | The dam is in satisfactory condition. Holcim to maintain regular documented inspections and if conditions deteriorate notify suitably qualified geotechnical engineer for further direction. |

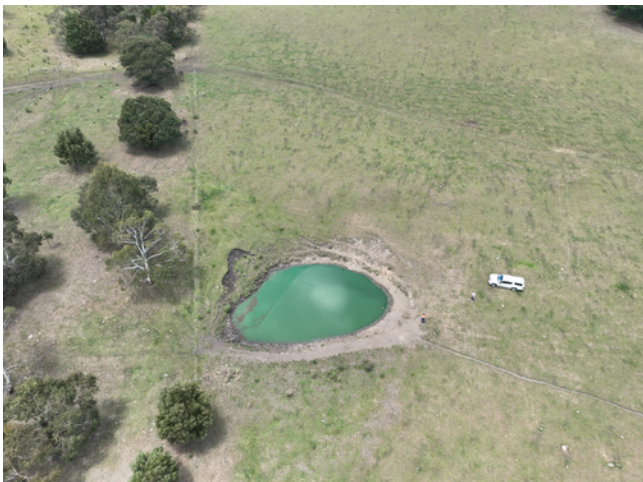
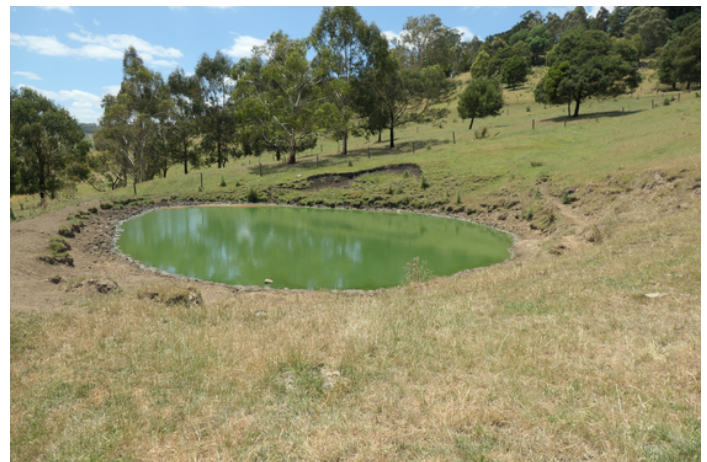
| REFERENCE | INSPECTION NOTES |
|---|--|
| | The water level within the dam was 200-400 mm below the crest, dam size approx. 400 m ² (0.04 ha), holding approx. 320 m ³ (0.32 ML), maximum storage capacity 480m ³ (0.48 ML). |
| | The crest of the dam is mostly bare. The downstream (west) and southern sides of the dam are well vegetated with grasses, extensive minor erosion caused by livestock. The upstream face (east) is partially bare and eroded from livestock activity. |
| | A natural overflow channel flows northwest, this low point is also eroded by livestock with bare soil around the current water level. |
| | A small shallow slump on the upstream (northern) side was observed. This area has been previously identified during the annual inspections with only minor changes in deterioration and condition of the slumping. |

Dam 13 - looking east

Dam 13 - looking north

| REFERENCE | INSPECTION NOTES |
|---|--|
| | The dam is in satisfactory condition. Revegetation of small failure surface with grasses/shrubs if possible. Holcim to maintain regular documented inspections and if conditions deteriorate notify suitably qualified geotechnical engineer for further direction. |
