**2025 TOOMUC VALLEY
SLOPE INSPECTION**

PAKENHAM QUARRY

Date: 14th January 2026

File Name	2025 Toomuc Valley Slope Inspection
Last Edited	14/01/2026
Report Status	Final

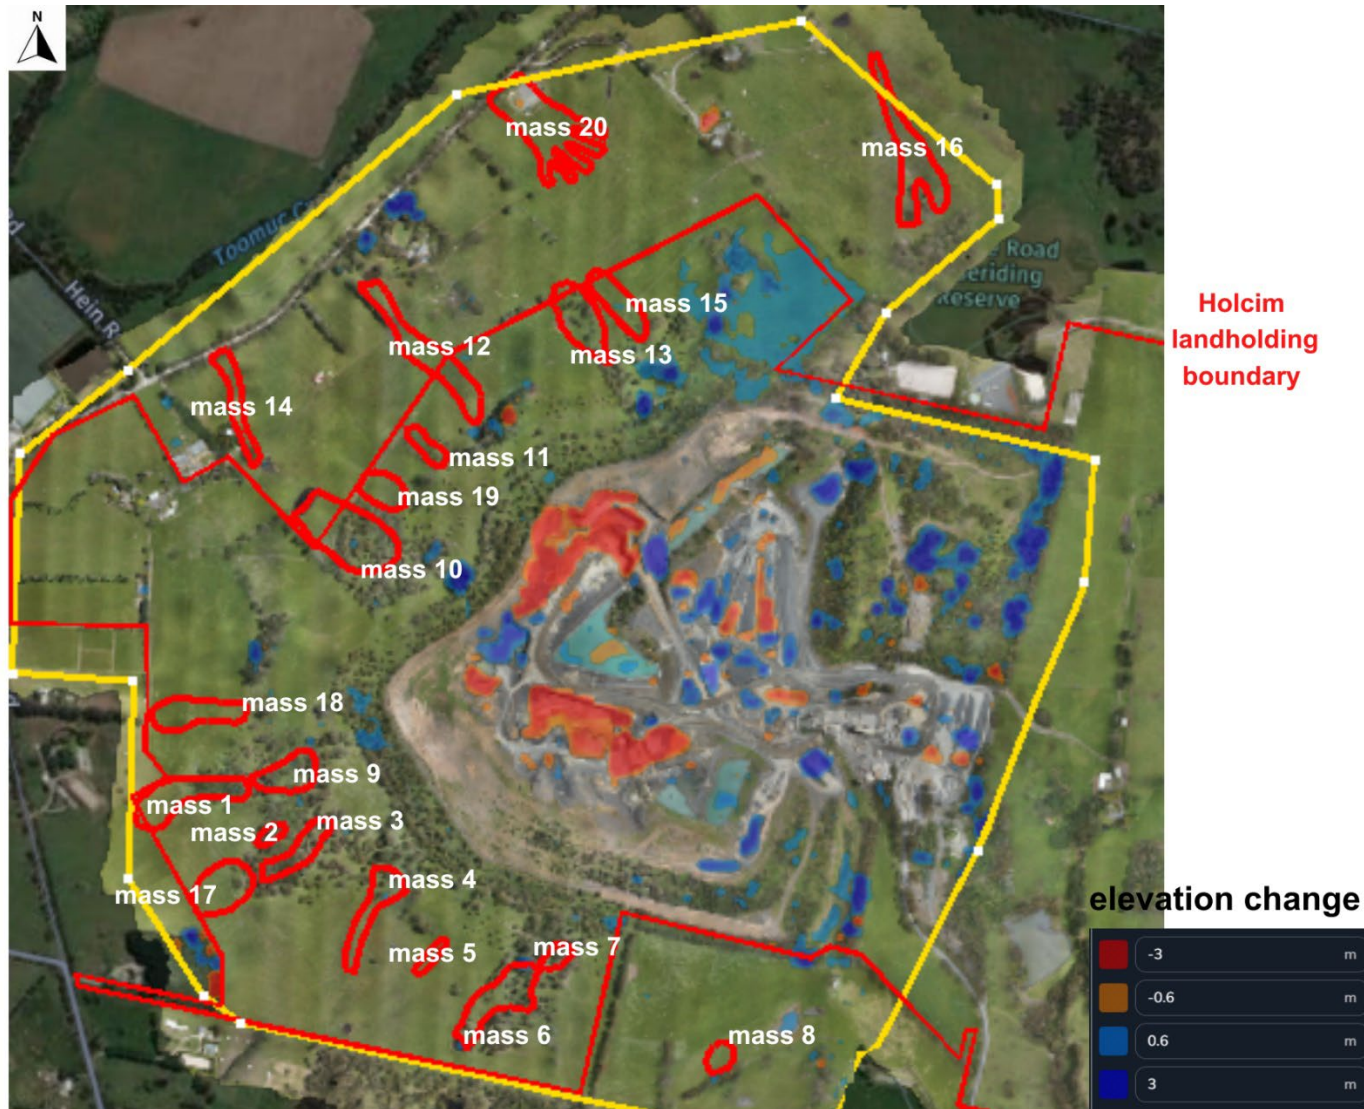
APPENDIX B. AERIAL IMAGE ASSESSMENT

A comparison of aerial images acquired between March and December 2025 was undertaken. No observable trends or changes in elevation around any of the mass locations.

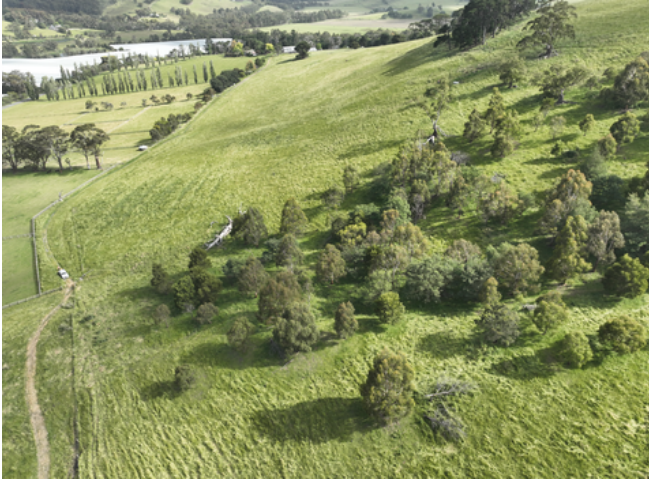
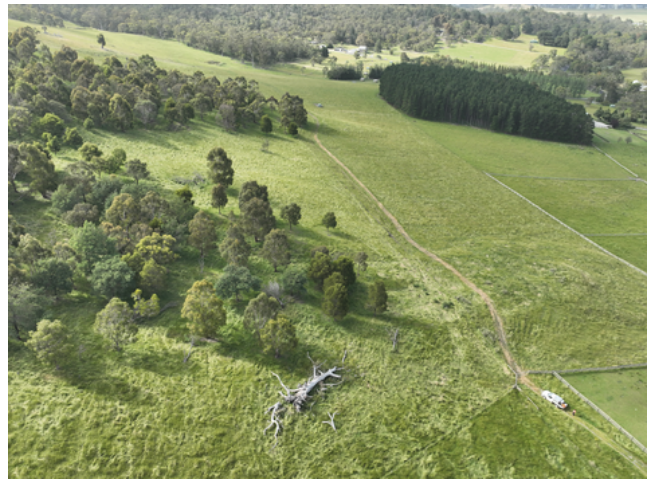
REFERENCE	INSPECTION NOTES
Mass 01	Observation
	Established vegetation consisting of dense grass, and medium to large trees.
	The slope surface is hummocky, this appears to be associated with historical major landslips and no evidence of recent or ongoing instability was observed.
	Recommendation
	-
Mass 02	Observation
	Overall the area is well vegetated with dense grass cover and small to medium shrubs and large trees throughout.
	The slope surface is hummocky, this appears to be associated with historical major landslips and no evidence of recent or ongoing instability was observed.
	Spring 02 was observed within the mass with standing water at the spring location contained by an earth embankment, which was heavily grass-covered.
	The water depth within the spring area was estimated to be 200-300 mm deep, which is lower than the previous year.
Recommendation	
	-
Mass 03	Observation
	Overall, the land surface in this area is hummocky but well vegetated with dense grass and dense tree cover (medium to large trees).

Mass 01 - looking northwest

Mass 01 - looking southeast

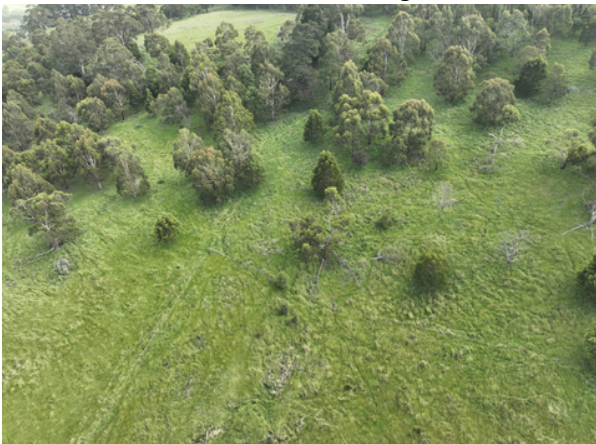
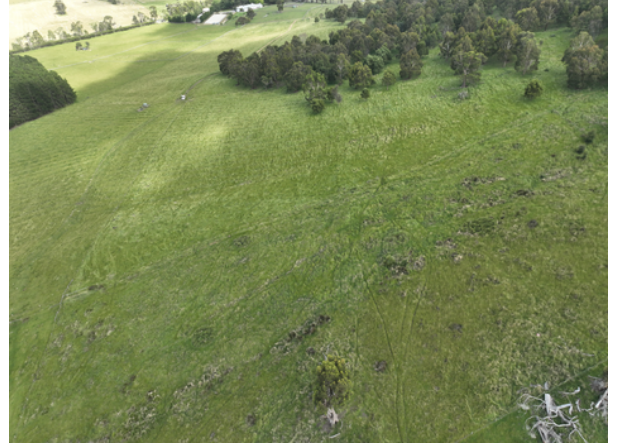
REFERENCE	INSPECTION NOTES
Mass 04	Observation
	Overall, the land surface in this area is hummocky but well vegetated with dense grass cover, small to medium shrubs and medium to large trees (mostly within the downslope area).
	No evidence of recent or ongoing instability was observed.
	Recommendation
	-
Mass 05	Observation
	Overall the area is well vegetated with dense grass cover throughout.
	Minor historical circular failures were observed in four locations: these failures were observed to be associated with exposed (bare) scarps and a change in the natural topography locally downslope with remnant mobilised material. The mobilised material is well vegetated whereas the backscarps were either bare or poorly vegetated. There has been some planting around Mass 5 which has improved the erosion around the failed areas.
	The most recent failure (downslope) measures about 15 m in width and ~1.0 m in height. The circular failure is small in volume and given that the location is isolated from any downhill infrastructure it is not considered to be of significant geological risk. No observable change in instability conditions since previous geotechnical inspection.

Mass 04 - looking north

Mass 04 - looking west

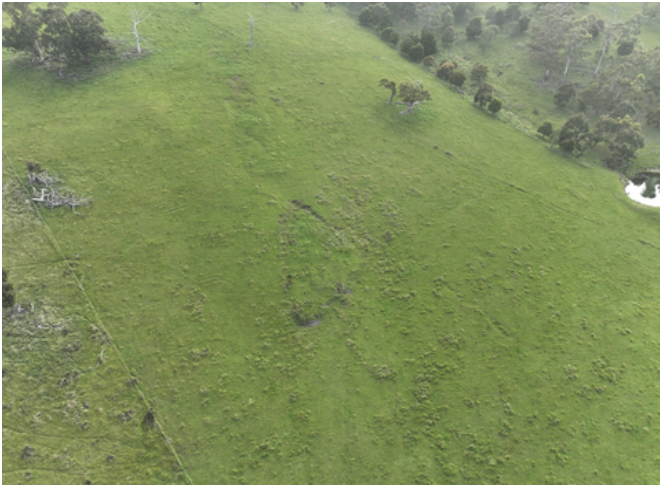
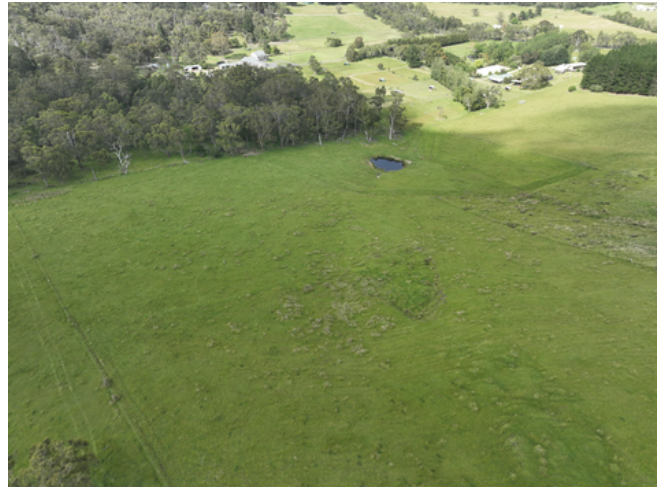
- South (downslope) of Mass 05: backscarps were observed within an area south of Mass 05 (outside of the historically mapped Mass 05 extent). Movement zone is small in volume and given that the location is isolated from any downhill infrastructure, it is not considered to be a significant geological risk.
- All other masses, no visual signs that could indicate recent ground movement were observed.

Mass 05 - looking north

Mass 05 - looking southwest

Recommendation
	Continued revegetation of scarp surfaces with grasses.
Mass 06	Observation
	Overall, the land surface in this area is hummocky but well vegetated with dense grass cover and medium to large trees throughout.
	No evidence of recent or ongoing instability was observed.
	Recommendation
	-
Mass 07	Observation
	Overall, the land surface in this area is hummocky but well vegetated with dense grass cover and medium to large trees throughout.
	No evidence of recent or ongoing instability was observed.
	Recommendation
	-

- Remedial treatment of Farmers Dam 13 with revegetation of the small failure surface with grasses/shrubs to limit the ongoing rilling and erosion.
- Continued remedial treatment of lower Mass 05 backscarp areas with revegetation of grasses/shrubs to limit the ongoing erosion.

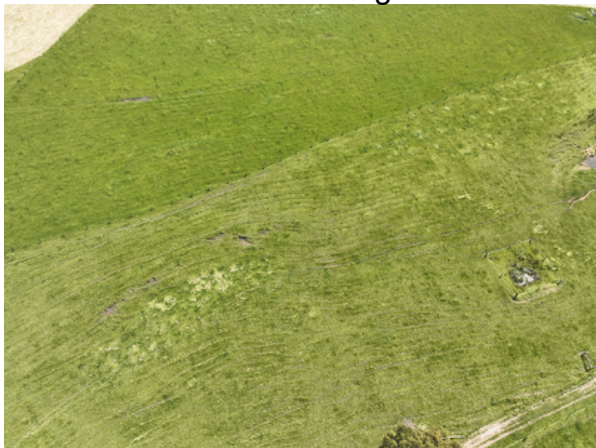
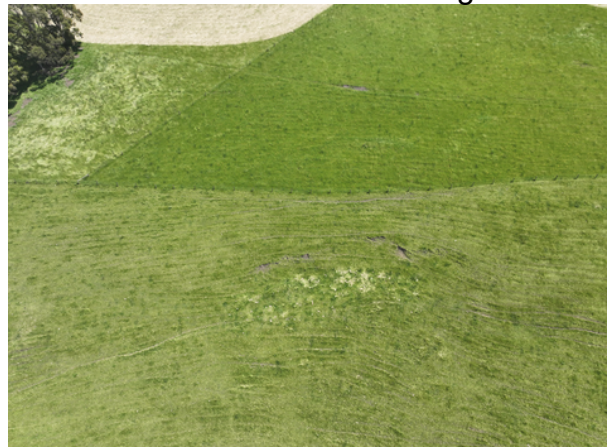
REFERENCE	INSPECTION NOTES
Mass 08	Observation
	Overall the area is well vegetated with dense grass cover throughout. There are some historical scarps up to 1m height.
	The local area immediately below scarp is poorly to moderately vegetated. Bare ground was observed at the toe of the scarp
	No evidence of recent or ongoing instability was observed.
	Recommendation
Mass 09	Observation
	Overall the area is well vegetated with dense grass cover and small to medium shrubs and trees throughout.
	No evidence of recent or ongoing instability was observed.
	Recommendation
	-
Mass 10	Observation
	Overall, the land surface in this area is hummocky but well vegetated with dense grass and dense tree cover (medium to large trees).
	The trunks of a few random trees are rotated which appear in isolation and not grouped together.
	No evidence of recent or ongoing instability was observed.
	Recommendation
Mass 11	Observation

Mass 08 - looking northeast

Mass 08 - looking north

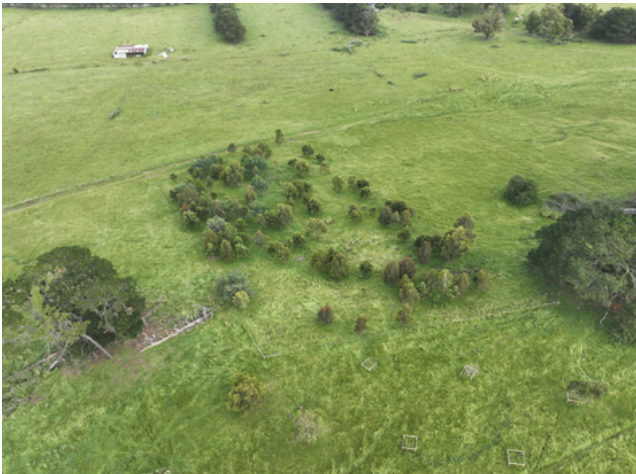
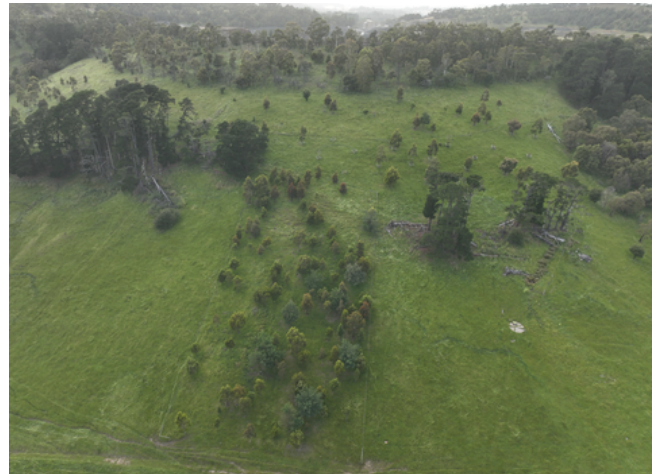
Overall, the land surface in this area is hummocky but well vegetated with dense grass cover and medium to large trees.
	No evidence of recent or ongoing instability was observed.
	Recommendation
	-

Mass 11 - looking northwest

Mass 11 - looking east

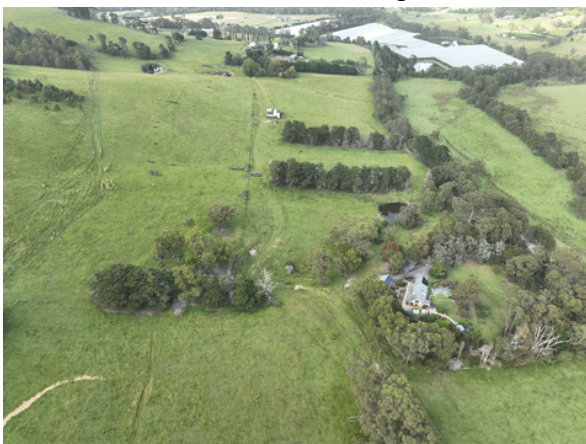
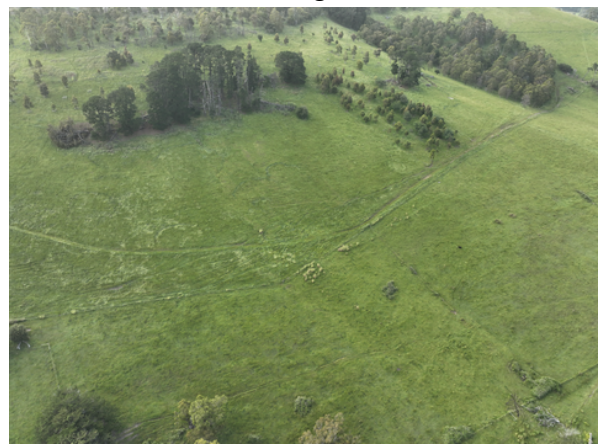
REFERENCE	INSPECTION NOTES
Mass 12	Observation
	Overall the area is well vegetated with dense grass cover and medium shrubs and trees throughout.
	The slope surface is hummocky, this appears to be associated with historical major landslips and no evidence of recent or ongoing instability was observed.
	Recommendation
	-
Mass 13	Observation
	Overall the area is well vegetated with dense grass cover and medium shrubs and trees throughout.
	The slope surface is hummocky, this appears to be associated with historical major landslips and no evidence of recent or ongoing instability was observed.
	Recommendation
	-
Mass 14	Observation
	Overall the area is well vegetated with dense grass cover.
	No evidence of recent or ongoing instability was observed.
	Recommendation
	-
Mass 15	Observation
	Overall the area is well vegetated with dense grass cover and medium shrubs and trees throughout.
	The slope surface is hummocky, this appears to be associated with historical major landslips and no evidence of recent or ongoing instability was observed.

Mass 12 - looking south

Mass 12 - looking southeast

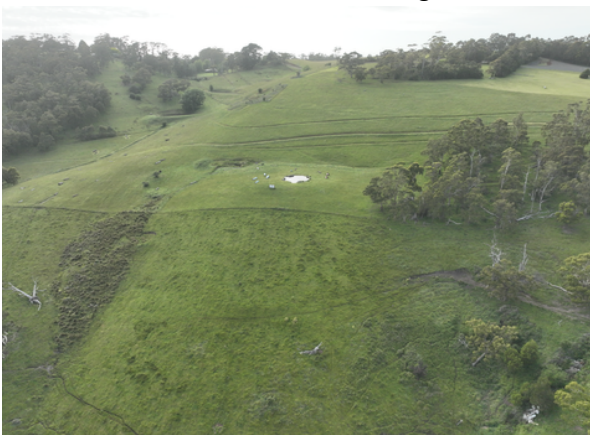
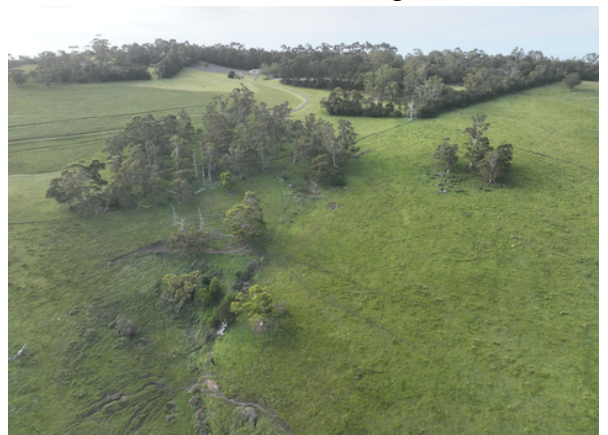
Recommendation
	-
Mass 16	Observation
	Overall the area is well vegetated with dense grass cover.
	No evidence of recent or ongoing instability was observed.
	Recommendation
	-

Mass 16 - looking east

Mass 16 - looking southeast

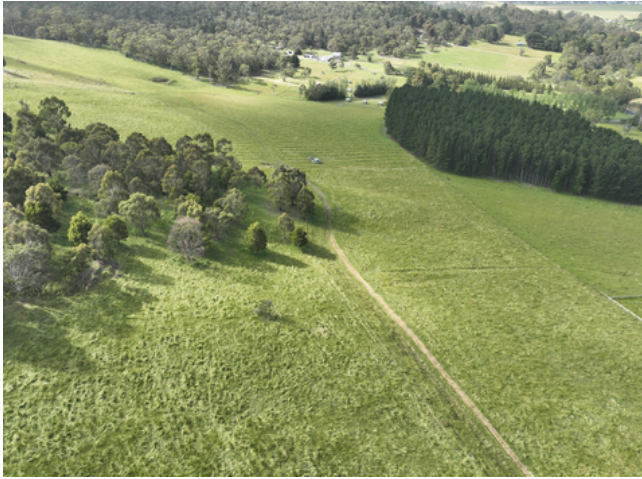
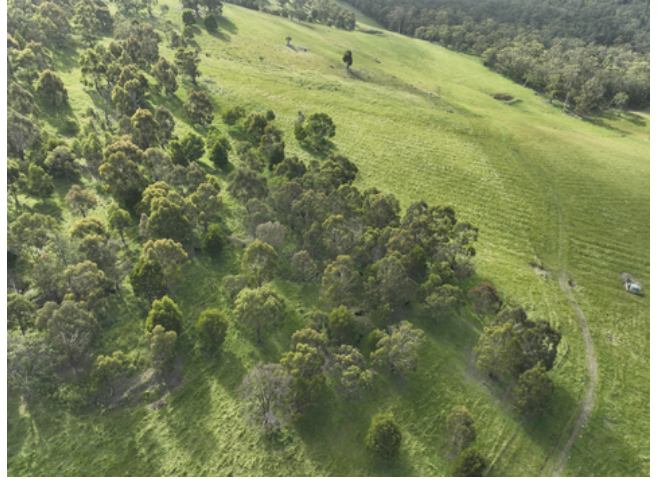
REFERENCE	INSPECTION NOTES
Mass 17	Observation
	Area is well vegetated with dense grass cover.
	The slope surface is hummocky, this appears to be associated with historical major landslips and no evidence of recent or ongoing instability was observed.
	Recommendation
Mass 18	-
	Observation
	Overall the area is well vegetated with dense grass cover and medium shrubs throughout. Spring 01 flowing into bin area.
	The slope surface is hummocky, this appears to be associated with historical major landslips and no evidence of recent or ongoing instability was observed.
Mass 19	Recommendation
	-
	Observation
	Overall the area is well vegetated with dense grass cover and medium shrubs and trees throughout. Water flowing from Spring 03.
Mass 20	The slope surface is hummocky, this appears to be associated with historical major landslips and no evidence of recent or ongoing instability was observed.
	Recommendation

Mass 17 - looking southeast

Mass 17 - looking east

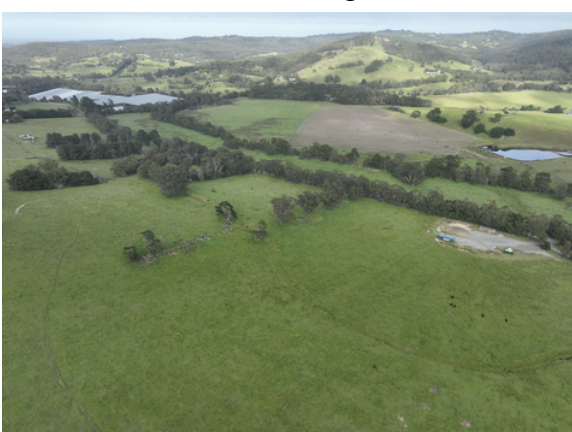
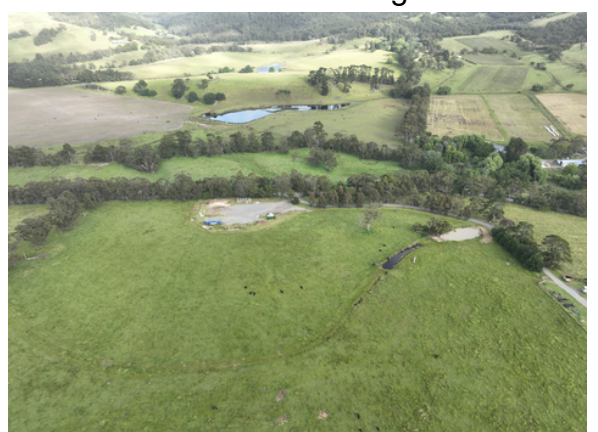
-
	Observation
Mass 20	Area is well vegetated with dense grass cover.
	The slope surface is hummocky, this appears to be associated with historical major landslips and no evidence of recent or ongoing instability was observed.
	Recommendation
	-

Mass 20 - looking southwest

Mass 20 - looking west

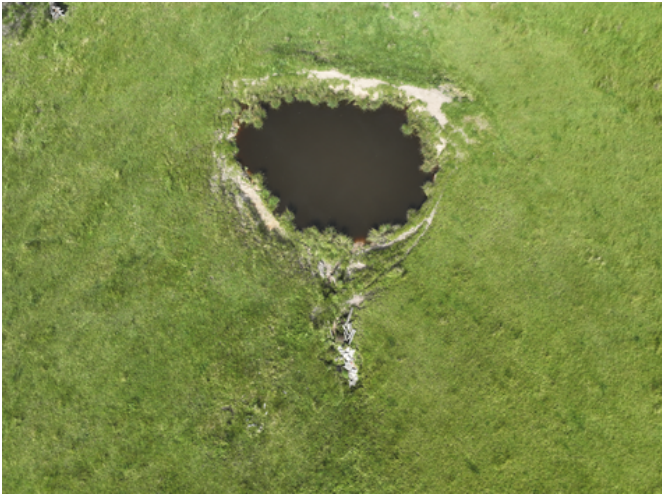
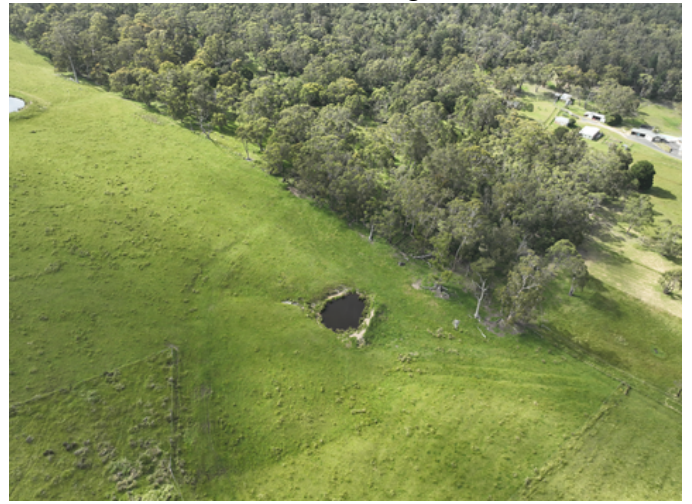
REFERENCE	INSPECTION NOTES
Farmers Dam 05	Observation
	The water level within the dam was 200-400 mm below the crest, dam size approx. 310 m ² (0.03 ha), holding approx. 400 m ³ (0.40 ML), maximum storage capacity 500m ³ (0.5 ML).
	The crest of the dam was mostly bare due to livestock activity. The upstream face (southwest) of the embankment is also partially bare and eroded from livestock activity. The western and eastern downstream sides of the dam are well vegetated with grasses.
	The upstream gully which drains into the dam is partially obstructed with building rubble and the natural overflow channel flows south.
	Recommendation
The dam is in satisfactory condition. Holcim to maintain regular documented inspections and if conditions deteriorate notify suitably qualified geotechnical engineer for further direction.	
Farmers Dam 06	Observation
	The water level within the dam was 400-600 mm below the crest, dam size approx. 900 m ² (0.09 ha), holding approx. 450 m ³ (0.45 ML), maximum storage capacity 1300m ³ (1.3 ML).

Dam 05 - looking southwest

Dam 05 - looking south

Additionally, the site inspection observed three Farmers Dams (05 / 06 / 13) exhibiting varying levels of degradation. This is an active farm therefore there will always be stock damage around the dam locations. If possible, construction of a fence to exclude stock around the bare soil / eroded areas to allow the grass to re-establish some cover. The best alternative is to provide stock water from a trough or install a fenced walkway to a restricted area of the stored water.

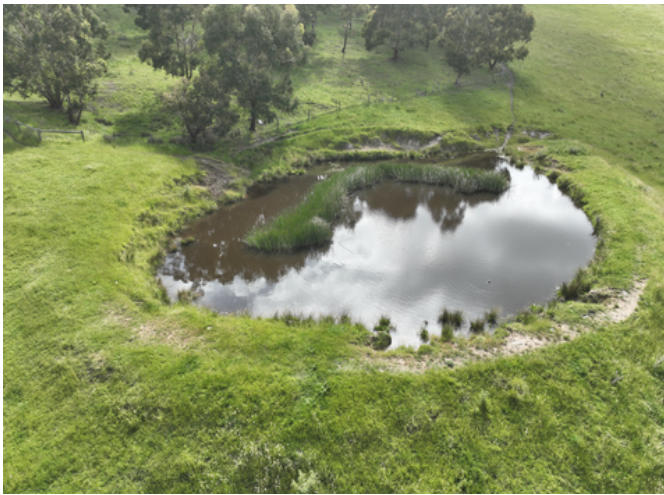
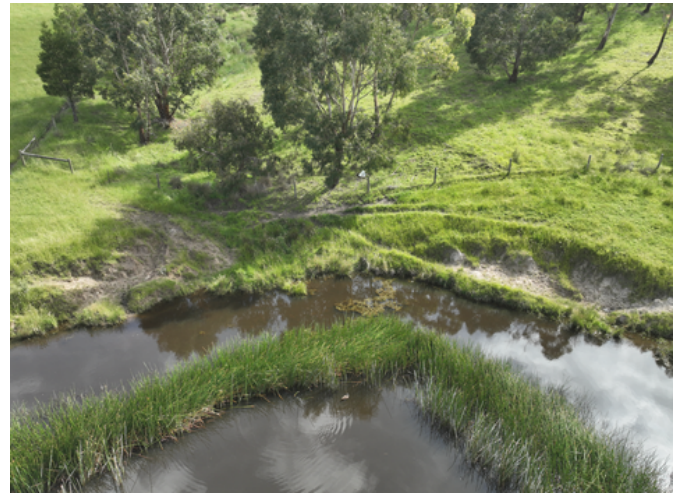
The crest of the dam was mostly covered with grass. A trail of bare ground had formed on the crest caused by livestock. The downstream (south) and western sides of the dam are well vegetated with grasses, some minor erosion caused by livestock. The upstream face (north) is partially bare and eroded from livestock activity.
	A natural overflow channel flows northeast and then south, this low point is also partially eroded by livestock with bare soil around the current water level.
	Recommendation
The dam is in satisfactory condition. Holcim to maintain regular documented inspections and if conditions deteriorate notify suitably qualified geotechnical engineer for further direction.	
Farmers Dam 13	Observation
	The water level within the dam was 400-600 mm below the crest, dam size approx. 400 m ² (0.04 ha), holding approx. 280 m ³ (0.28 ML), maximum storage capacity 480m ³ (0.48 ML).
	The crest of the dam is mostly bare. The downstream (west) and southern sides of the dam are well vegetated with grasses, extensive minor erosion caused by livestock. The upstream face (east) is partially bare and eroded from livestock activity.

Dam 06 - looking northeast

Dam 06 - looking north

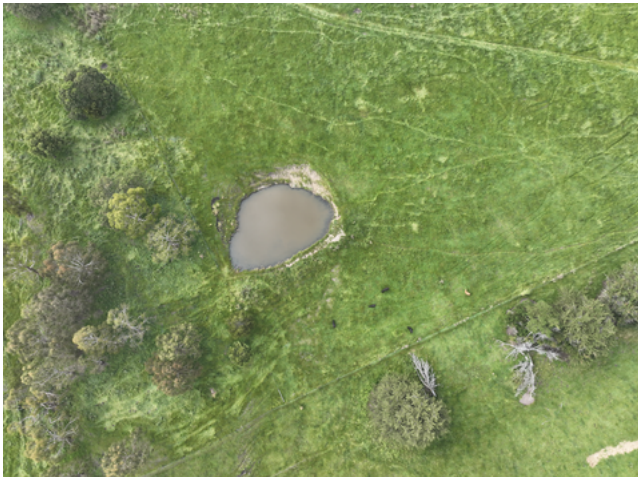
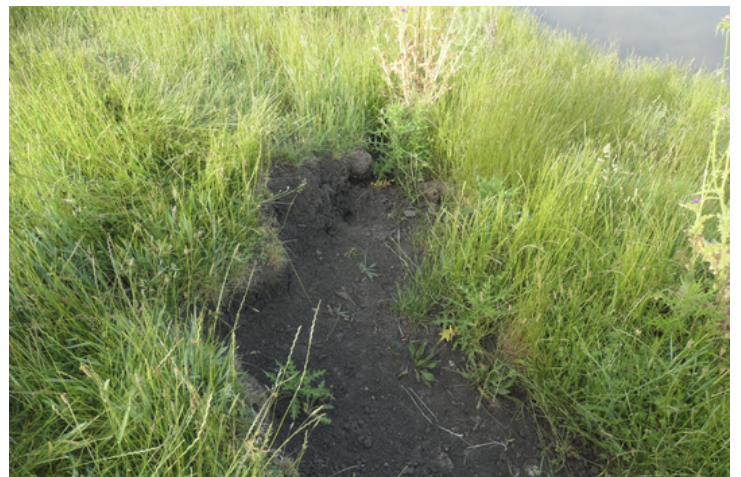
A natural overflow channel flows northwest; this low point is also eroded by livestock with bare soil around the current water level.
	A small shallow slump on the upstream (northern) side was observed. This area has been previously identified during the annual inspections with no real change in deterioration and condition of the slumping.
Recommendation	
The dam is in satisfactory condition. Revegetation of small failure surface with grasses/shrubs if possible. Holcim to maintain regular documented inspections and if conditions deteriorate notify suitably qualified geotechnical engineer for further direction.

Dam 13 - looking east

Dam 13 - looking east (erosion)
