Electrical Safety - Bushfire Mitigation Plan (BFMP)

Oaklands Junction Quarry 2024-2025

Revision 7

HOLCIM QUARRY OAKLANDS JUNCTION 2024

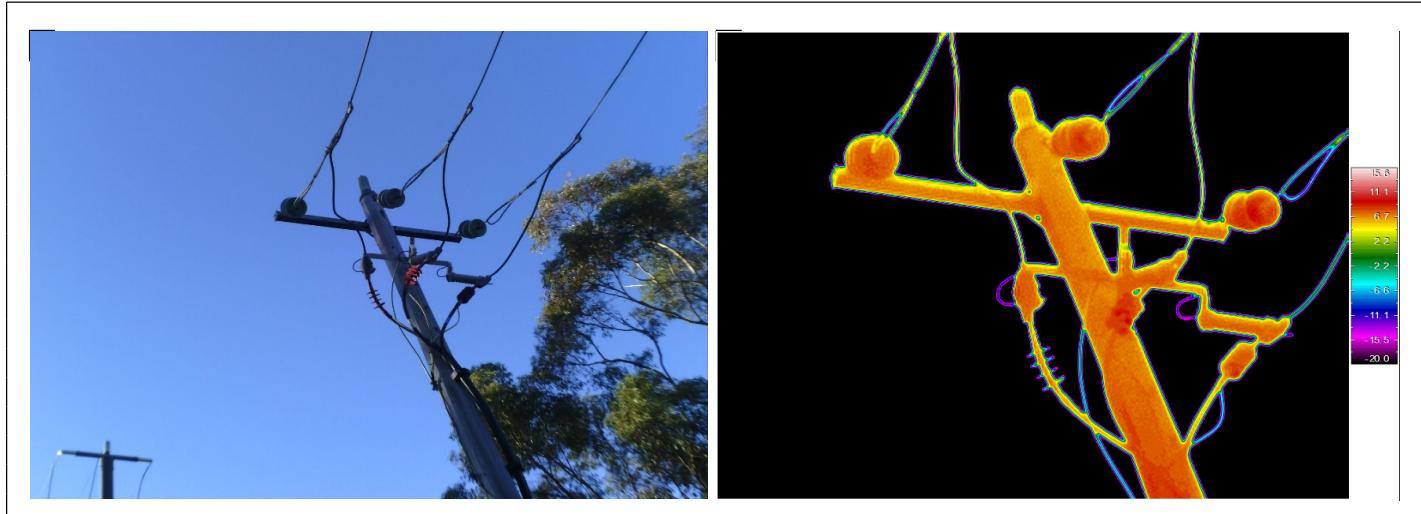
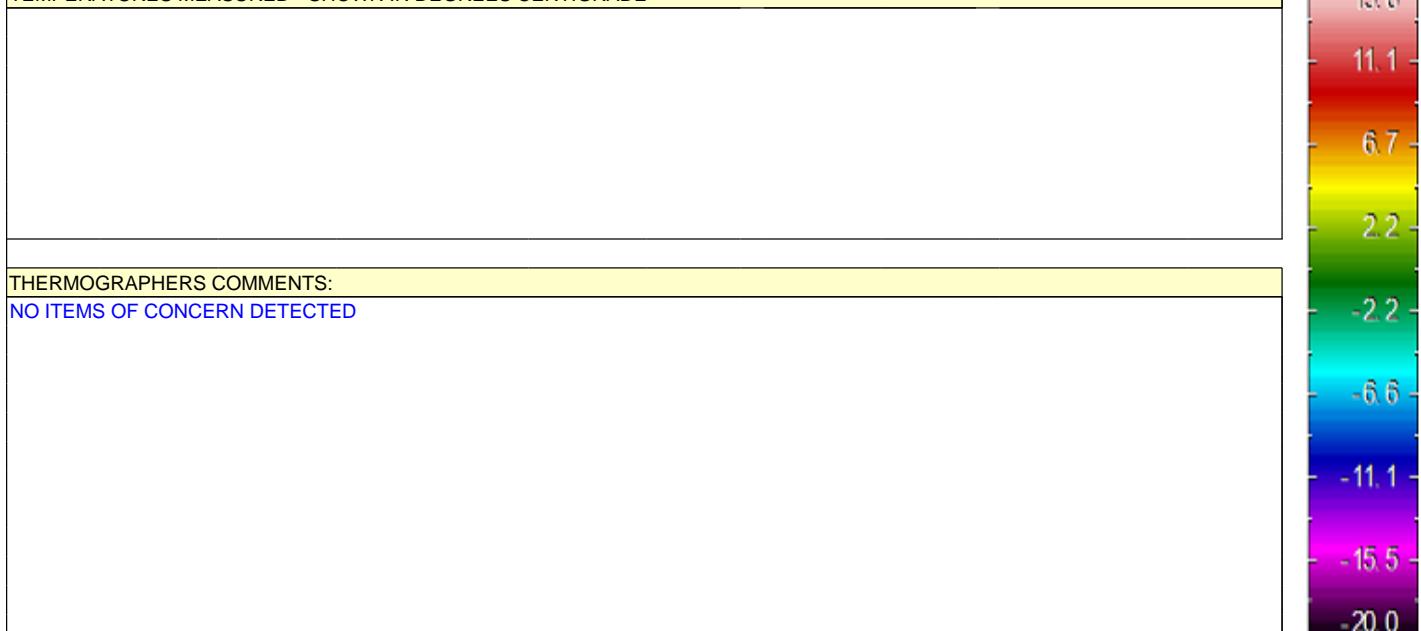
1058

NO ITEMS OF CONCERN DETECTED

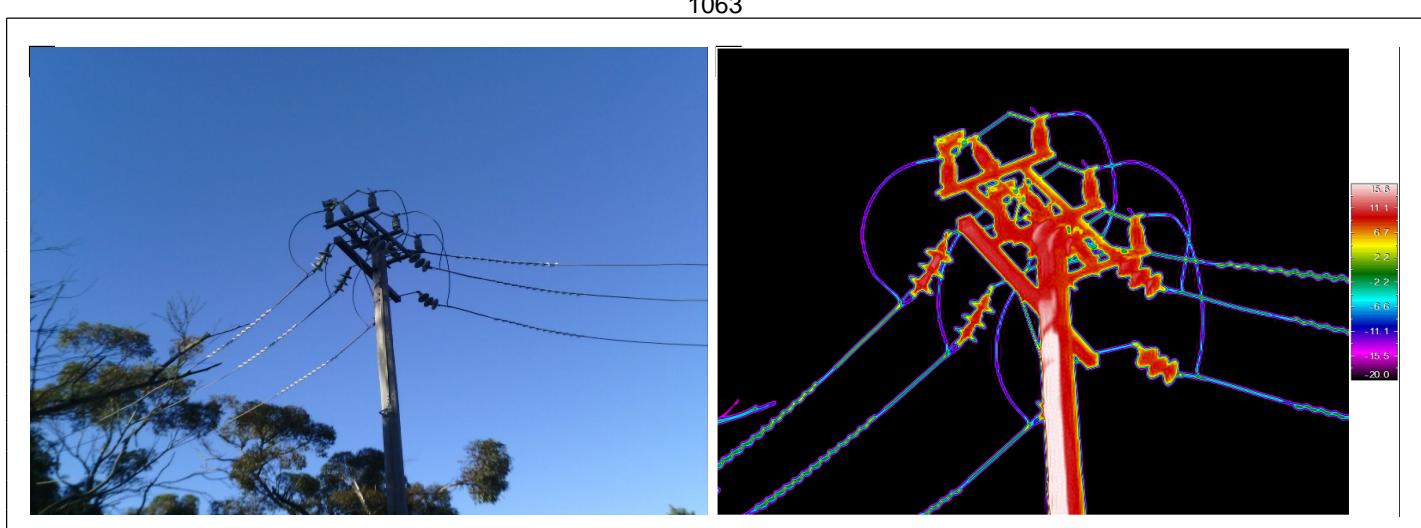
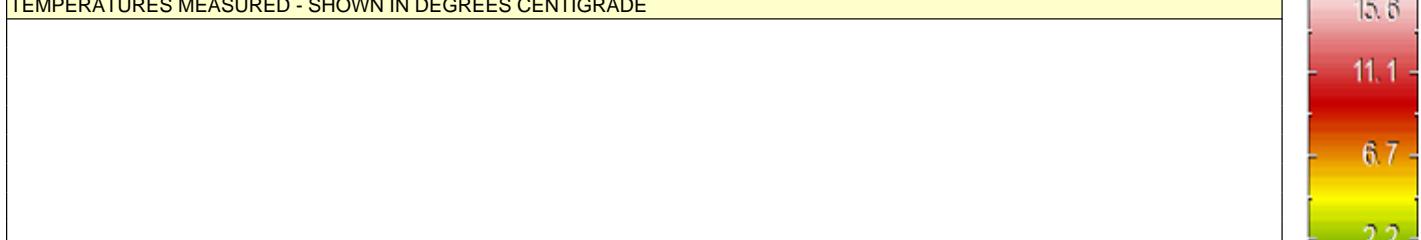
NO ITEMS OF CONCERN DETECTED

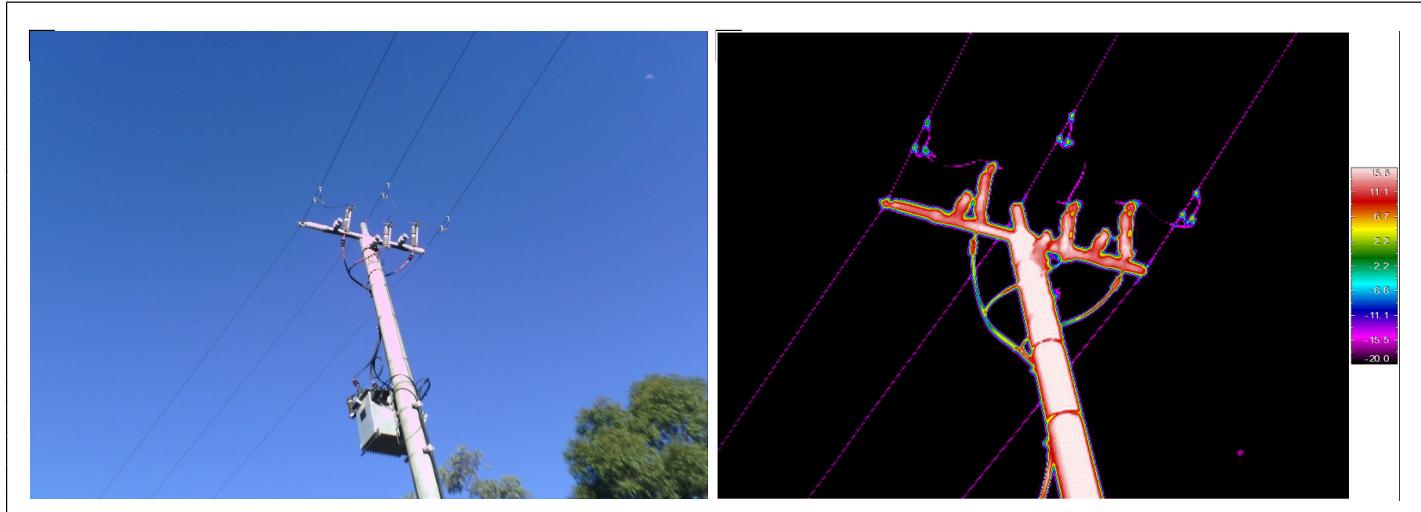
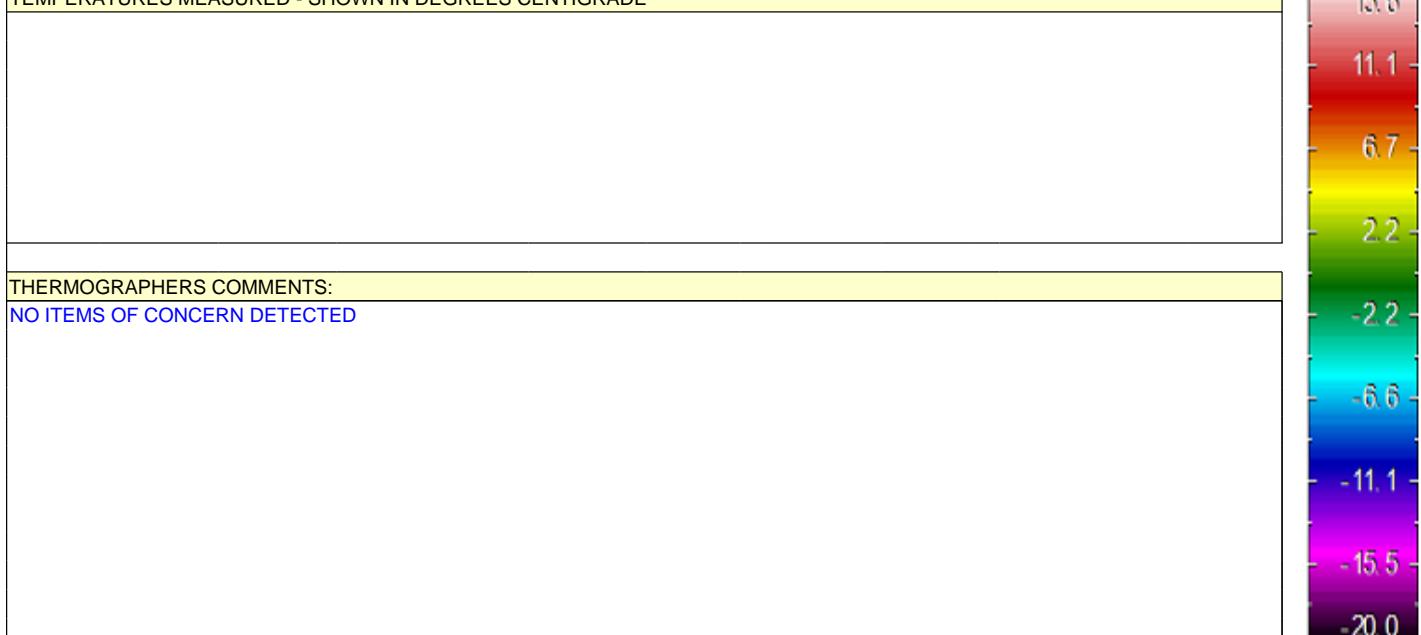
1066

NO ITEMS OF CONCERN DETECTED

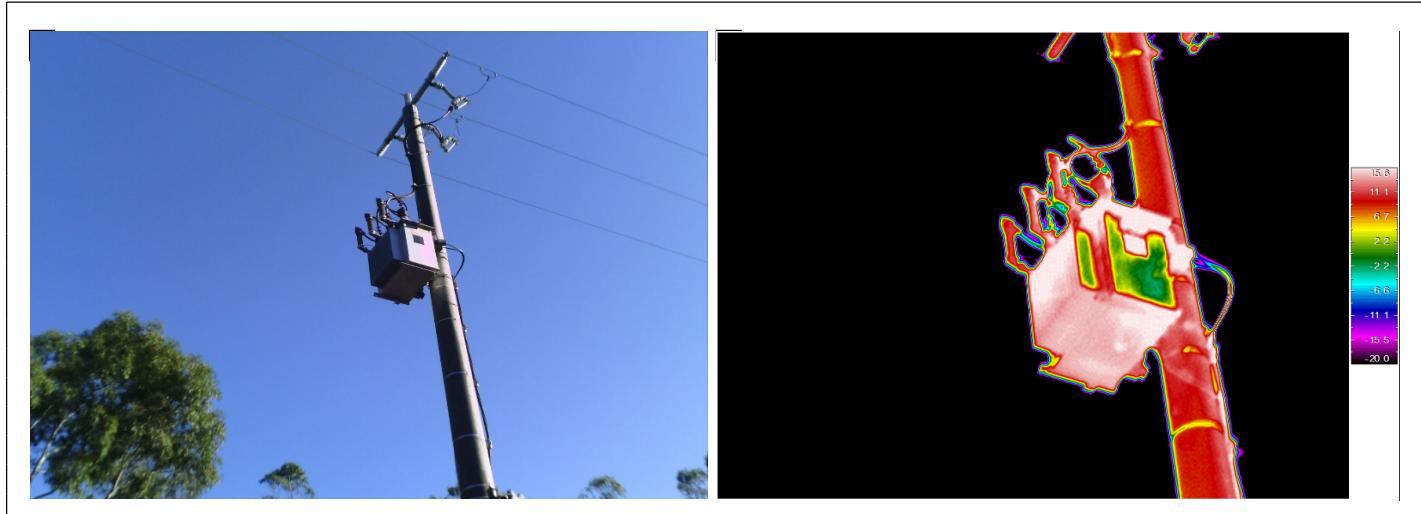
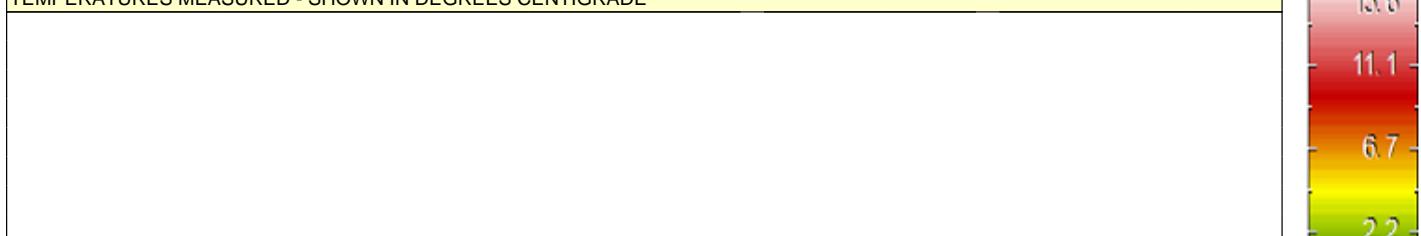
1067

NO ITEMS OF CONCERN DETECTED

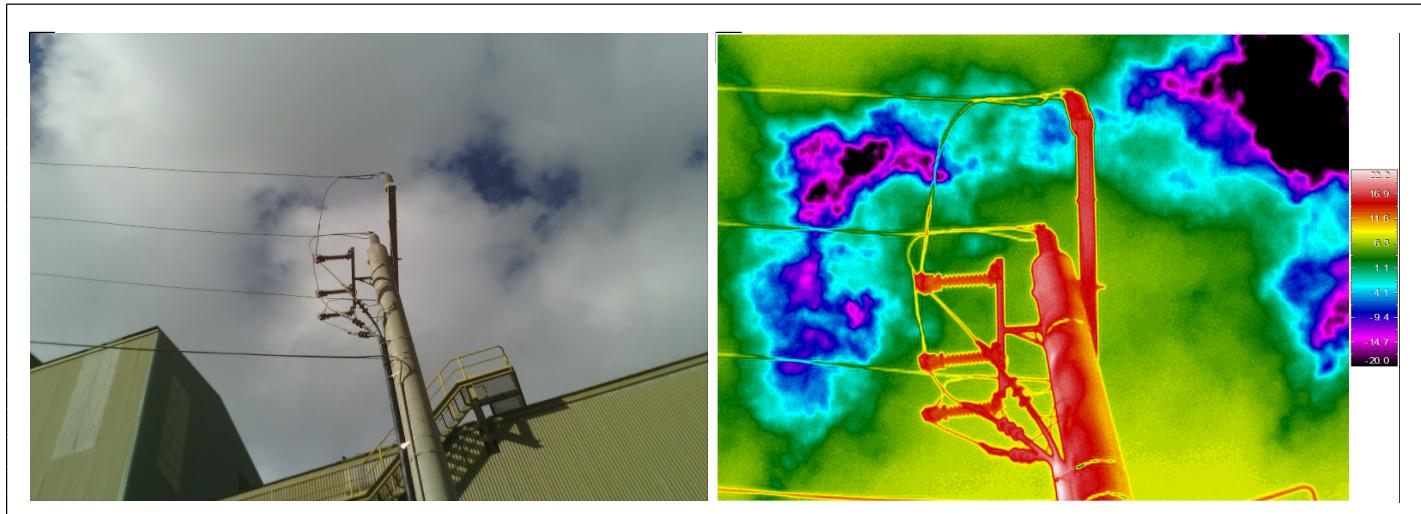
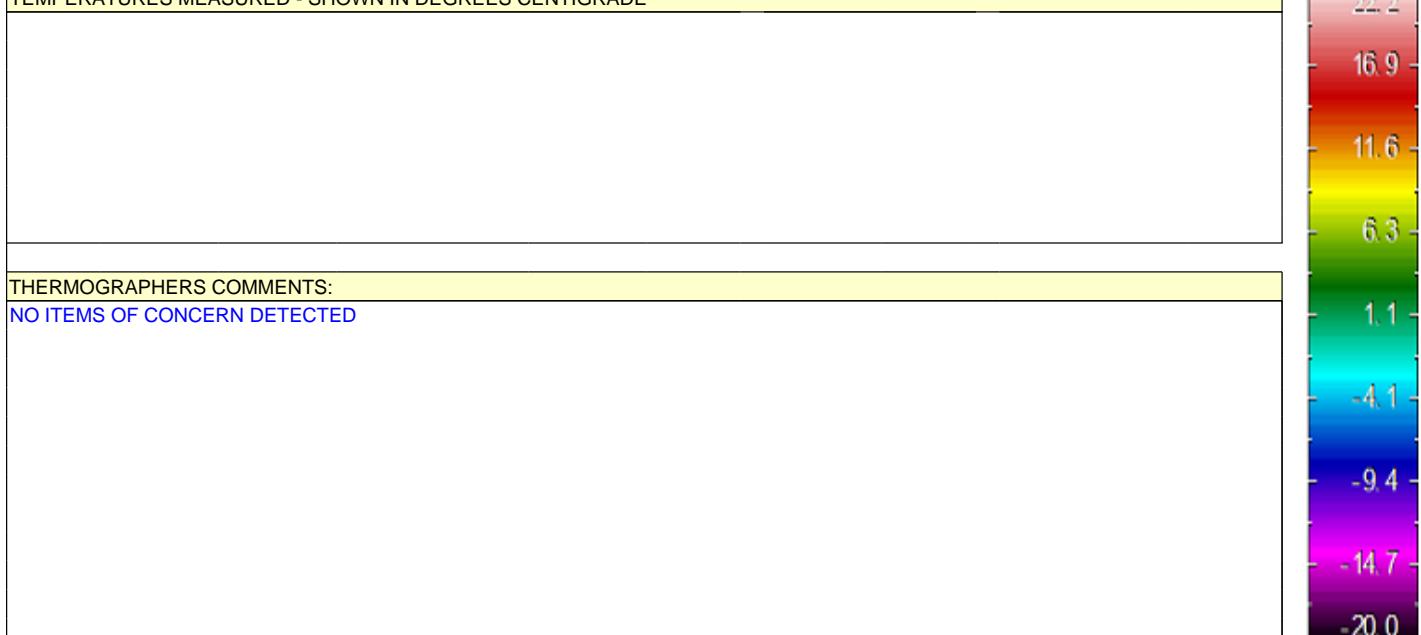
1071

NO ITEMS OF CONCERN DETECTED

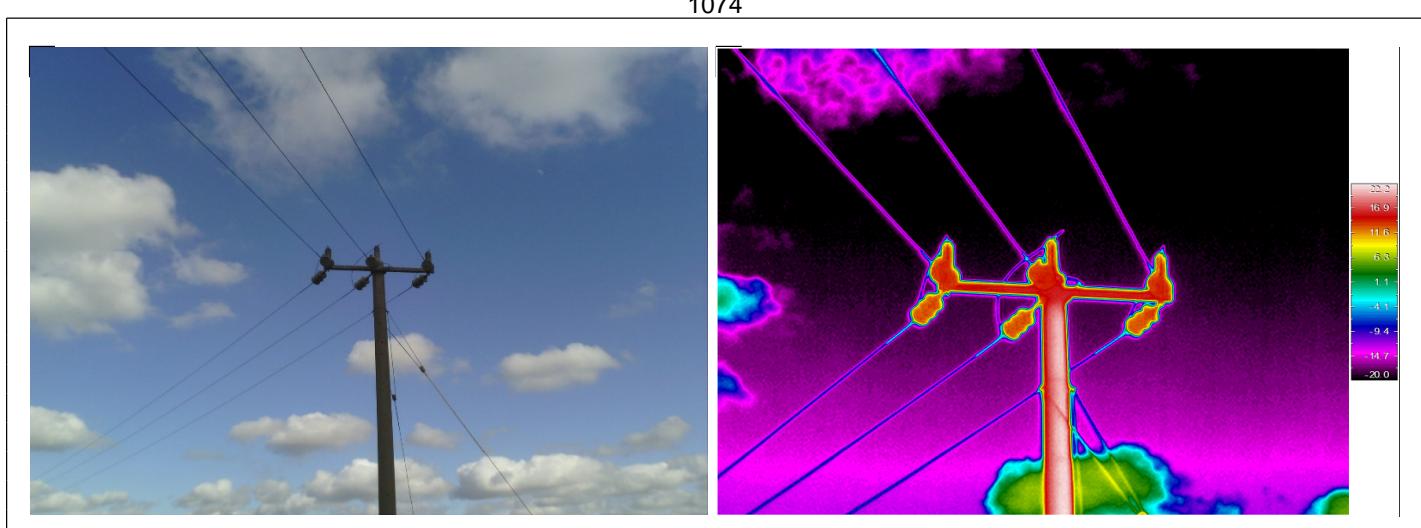
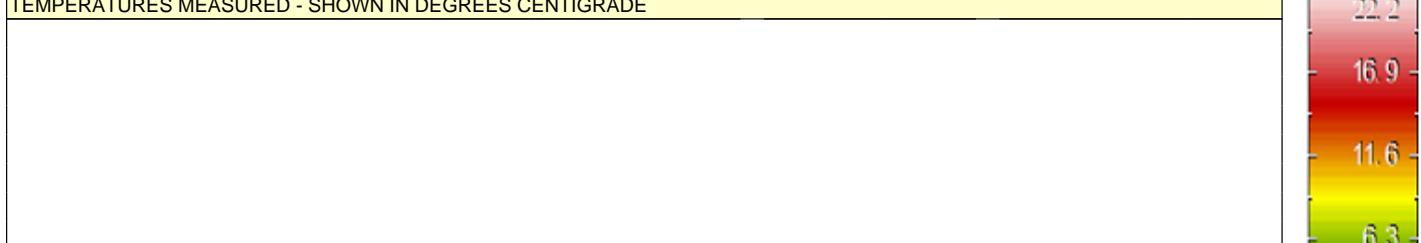
NO ITEMS OF CONCERN DETECTED

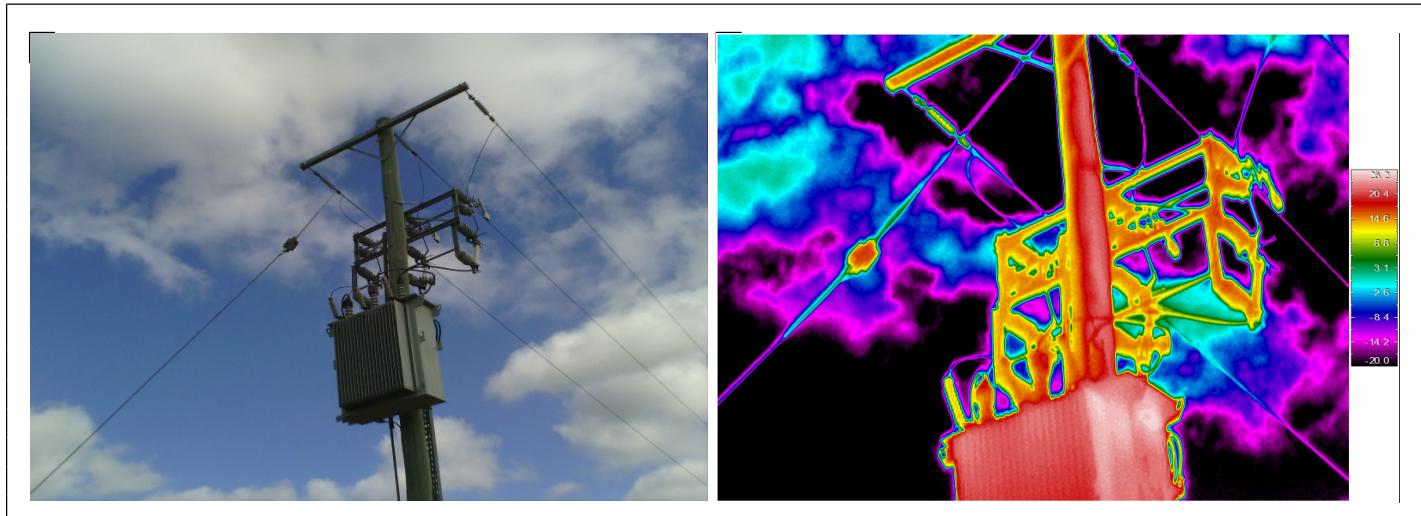
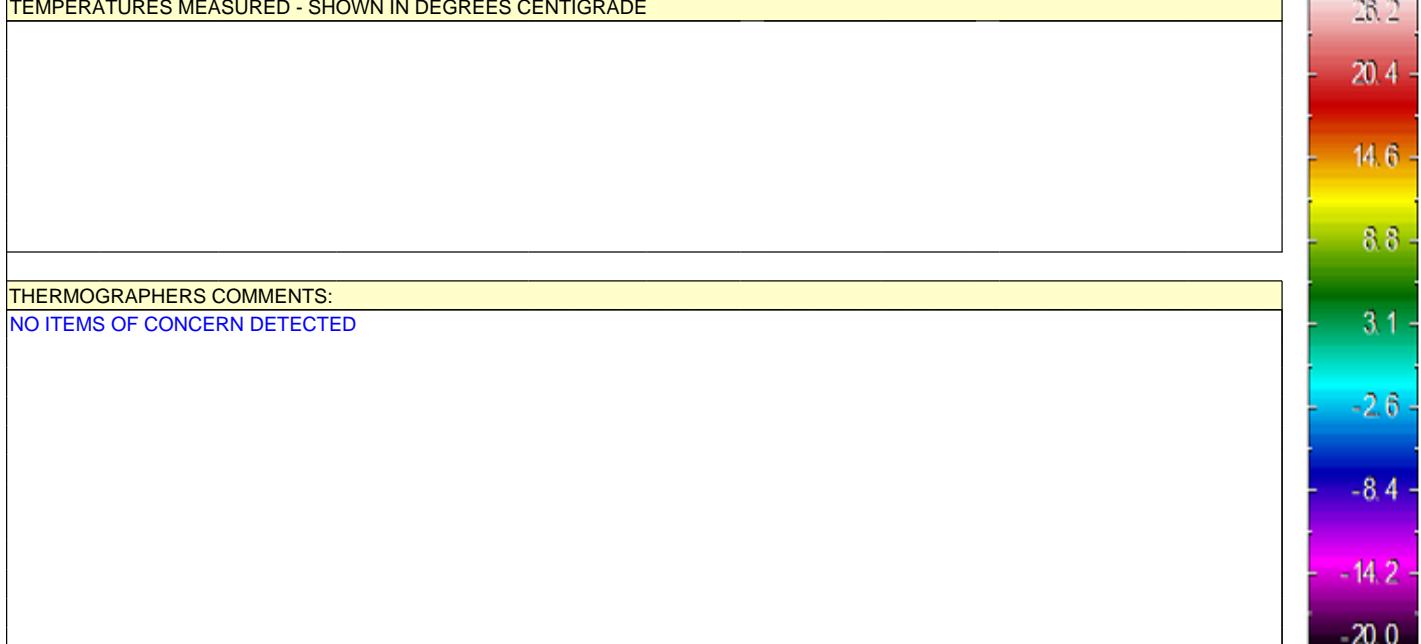
1078

NO ITEMS OF CONCERN DETECTED

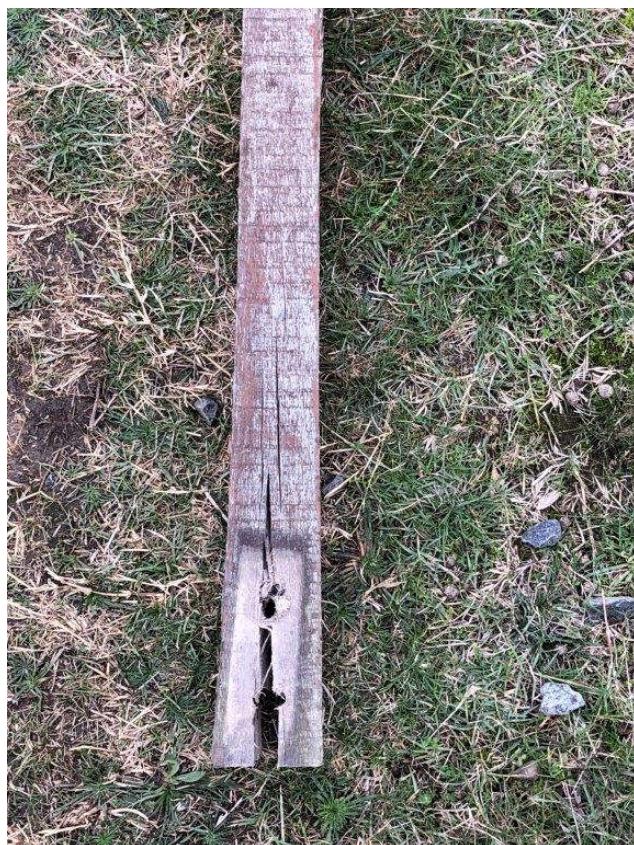
Pole 14 associated airbrake switch operator handle was split through and was replaced by a fibreglass version.

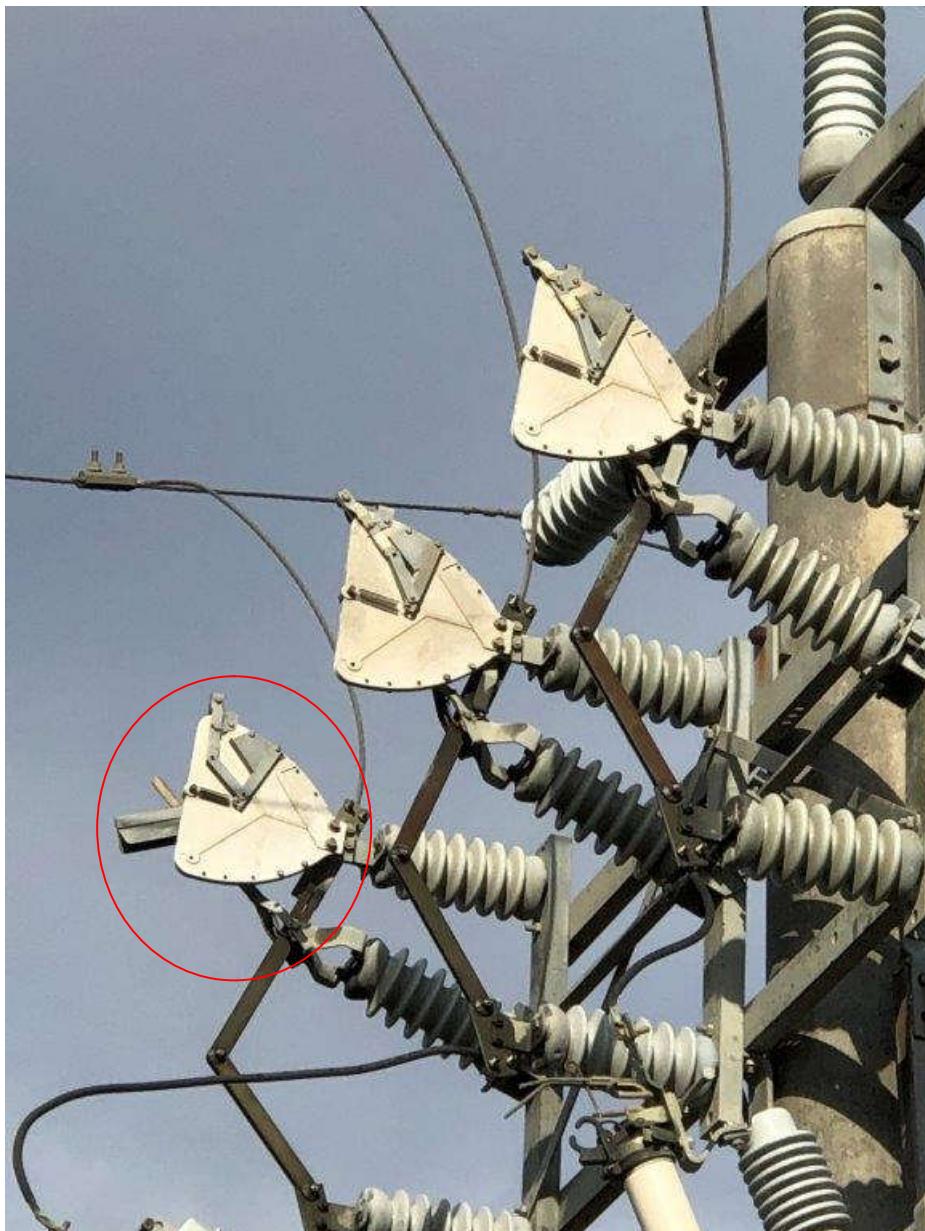
Airbrake switches on Poles 14 and 17 still suffer from alignment issues and took several attempts to close all three switches (Phases) at the same time. Picture below shows the distant phase not aligning properly.

These airbrake switches must not be operated live.

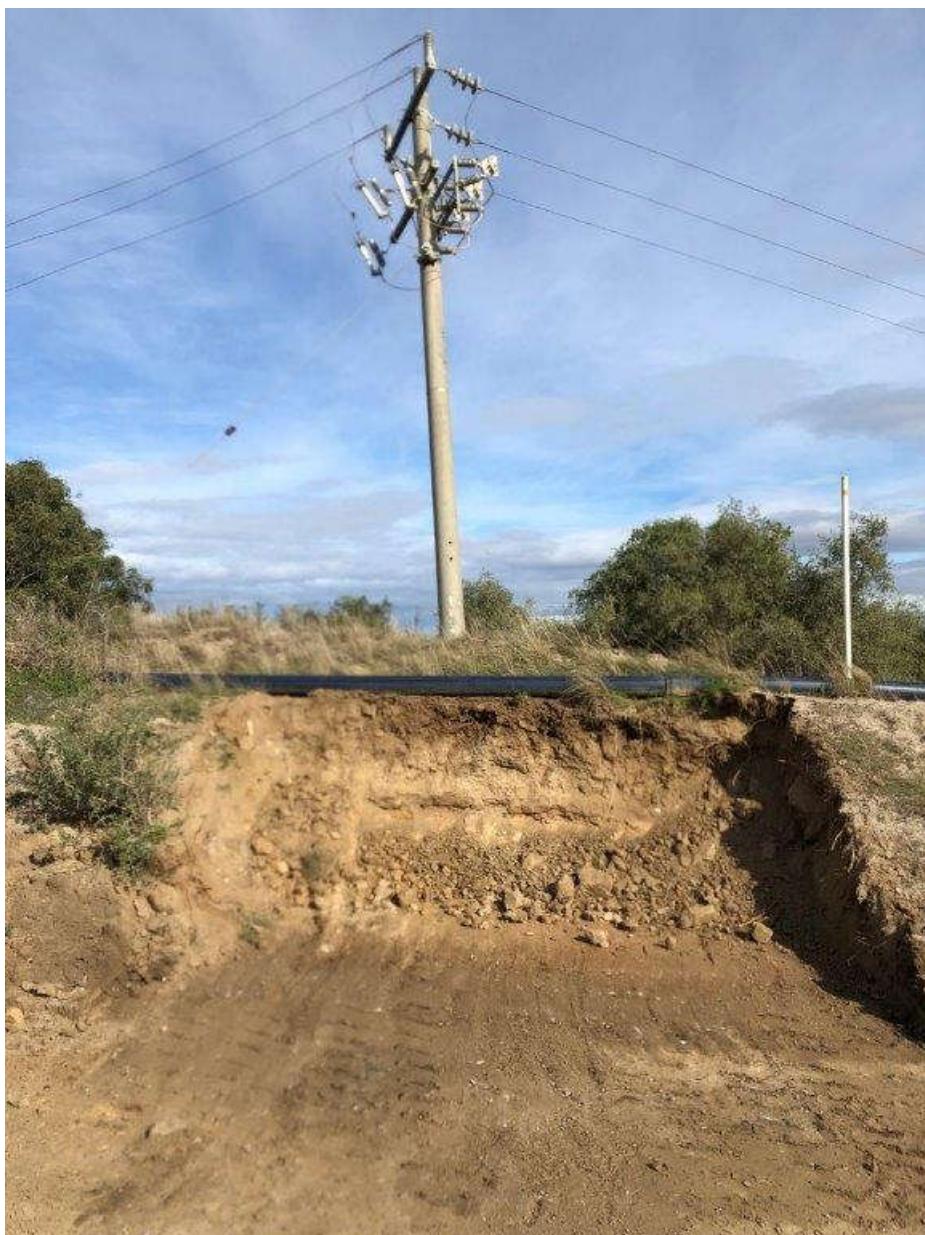
Pole 22 (P33471) access was provided by the removal of the road embankment via a front-end loader, however this only provided access to the near side of the pole mounted equipment for cleaning and servicing. Refer photo.
