ANNUAL REVIEW
1 April 2023 – 31 March 2024
Northern Dune Extension

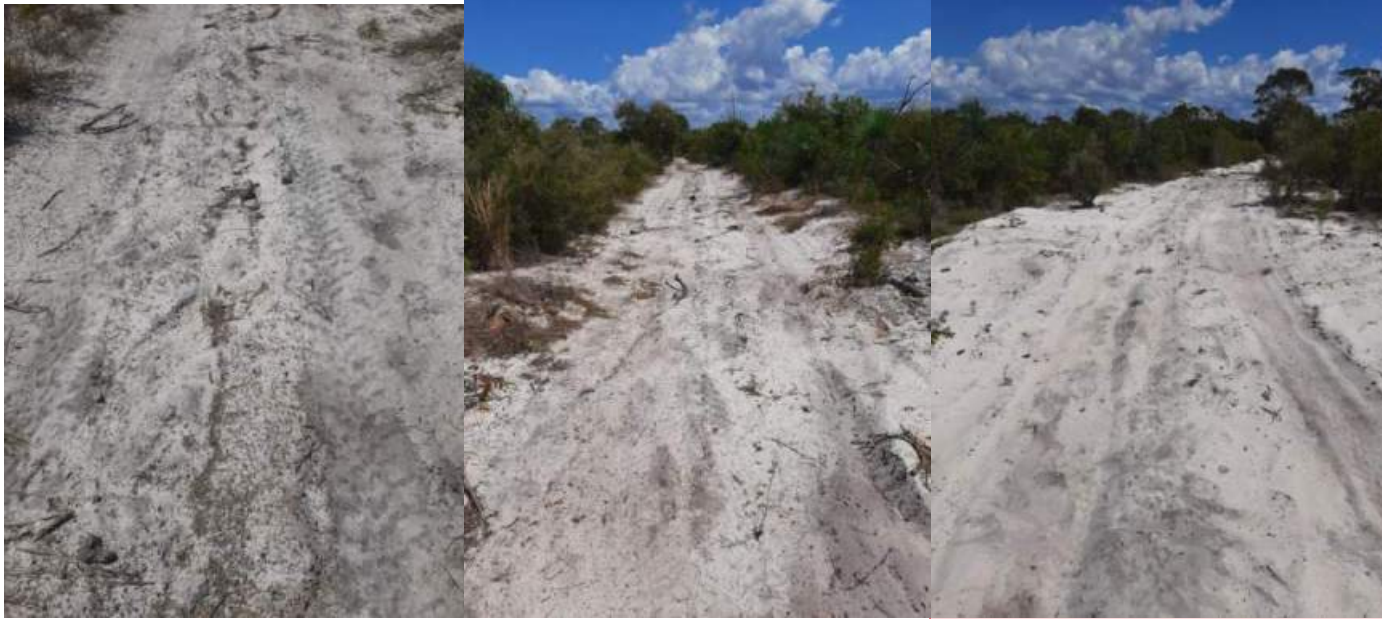
Commented [1]: Vehicles driving through rehabilitated area.

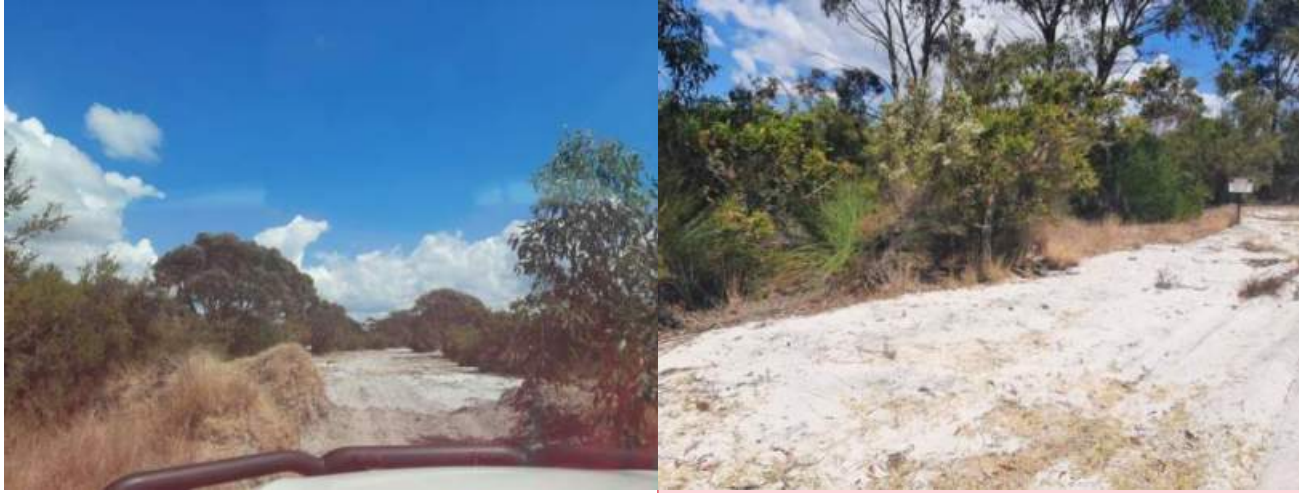
Commented [2]: Grass Dying from weed spraying

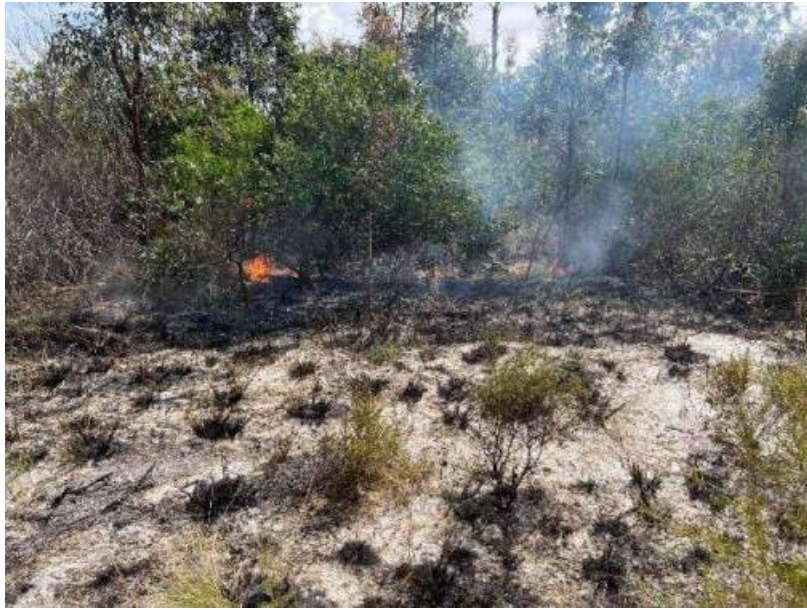
Controlled burn efforts in the area had destroyed most shrub and ground stratum species however, had successfully reduced exotic species within the plot. Species diversity remains satisfactory, with the survival of key species. The quadrat would benefit from continued revegetation efforts to improve diversity.

Plate 1: Controlled burn occurring in the vicinity of Q46 on the day of monitoring. Note the reduction in plants – native and exotic in the ground cover stratum.

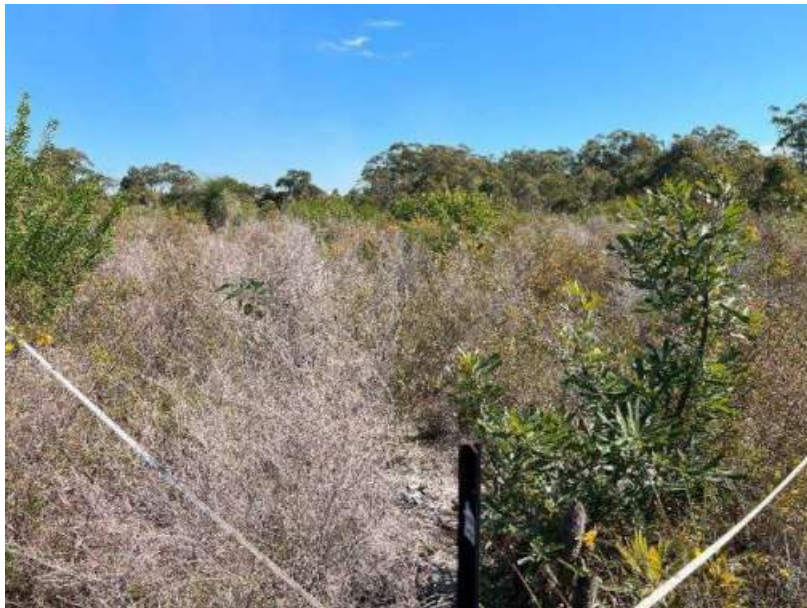
Plate 3: Quadrat Q49 in Block Q3 from the SE corner showing the senescence of native species, (left) but growth of the Banksia (right).

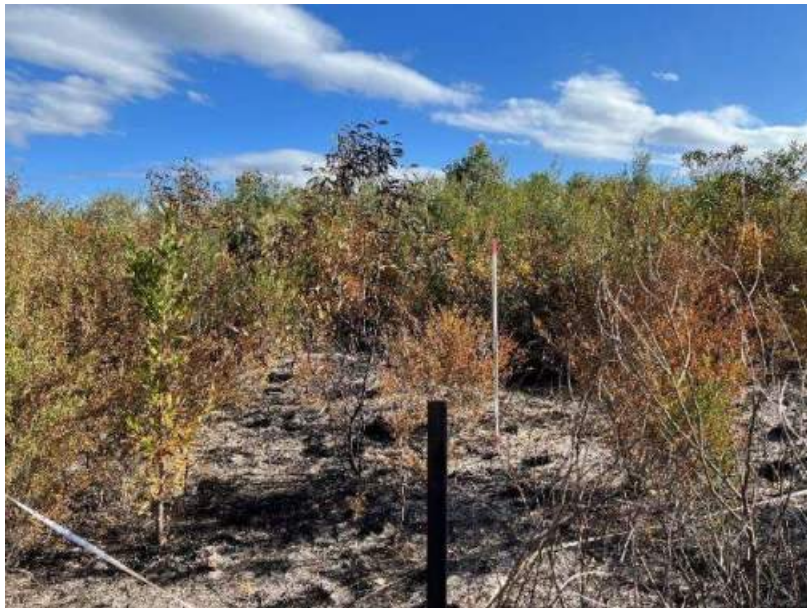
Plate 6: Block Q5, Quadrat 52 from the NW corner showing the effect of the weed reduction burn.

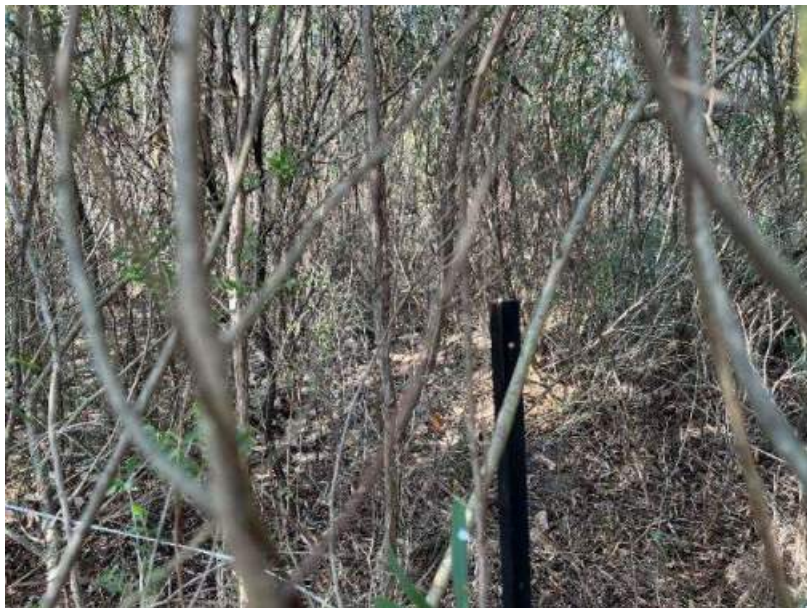
Plate 7: View of Q51 from the SE corner showing the lack of growth under the dense *L. laevigatum*.

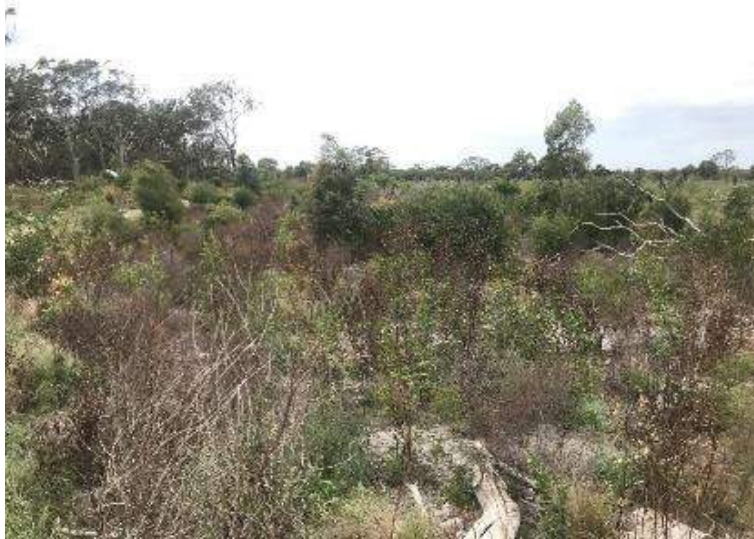
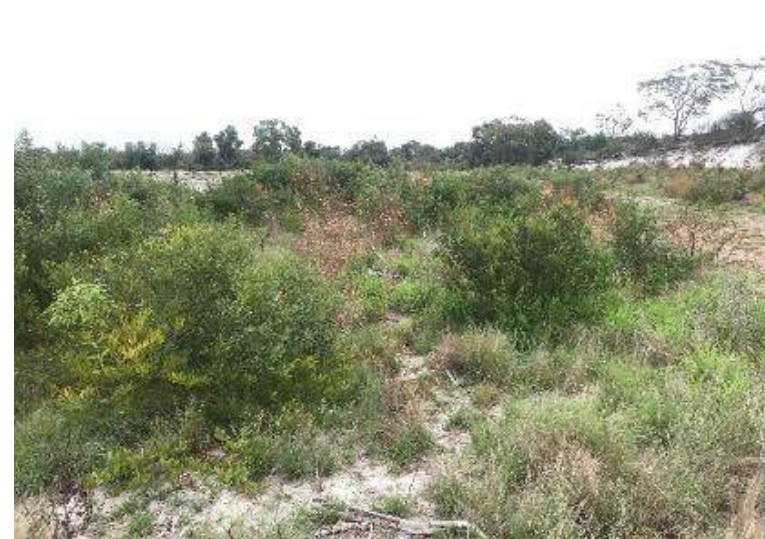
Plate 17: View of Block Q1 from PP1 looking East (left) and West (right) January 2020. Notice the dieback of shrub species and the height of the Eucalypt (left) and the prevalence of *Eragrostis curvula* (right)

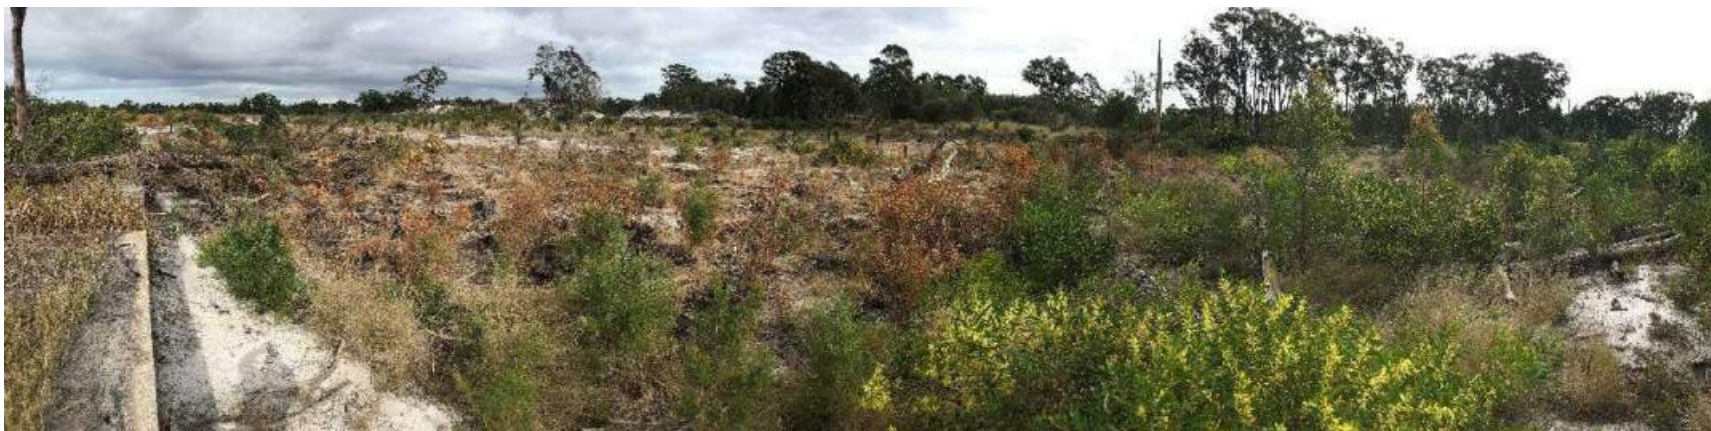
Plate 19: Block Q1 PP2 looking south - west – north, July 2020 just after controlled burns

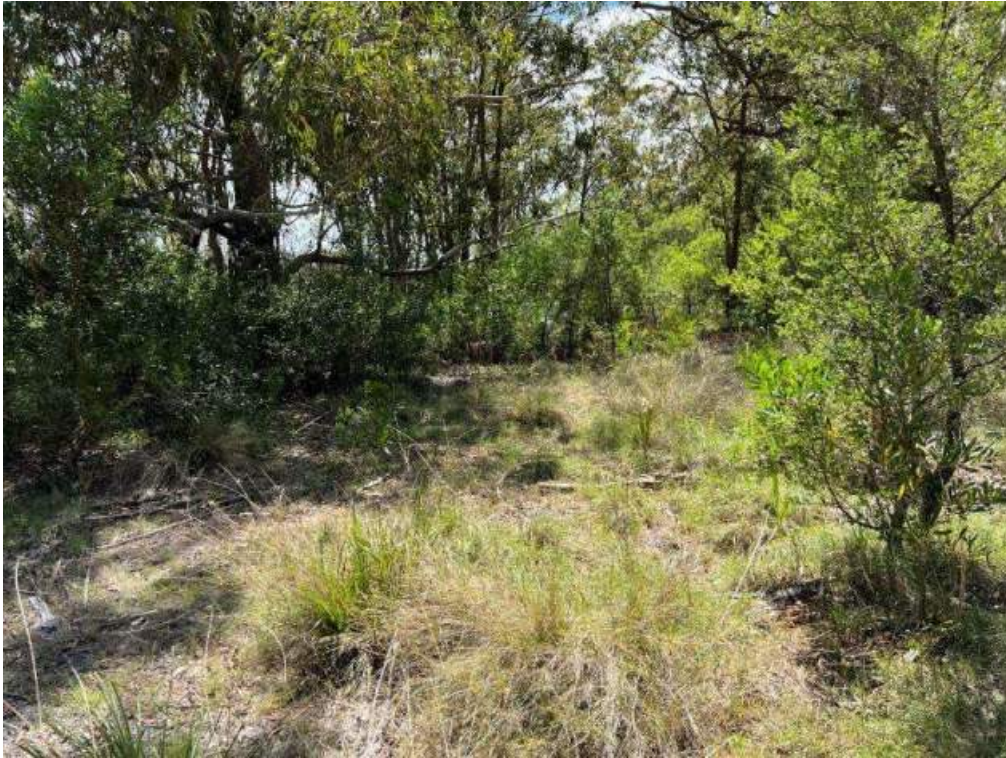
Plate 2: PP1 looking east showing poor condition (foreground) and better condition vegetation (background)

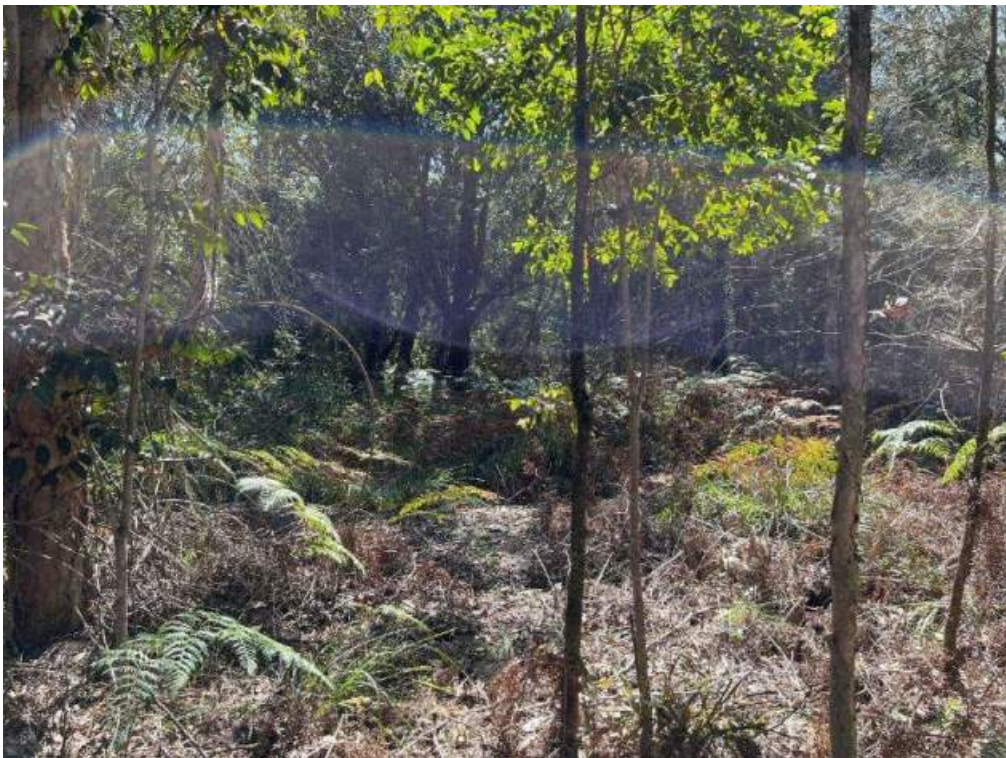
Plate 3: PP2 looking north showing dense Lantana and previous control works

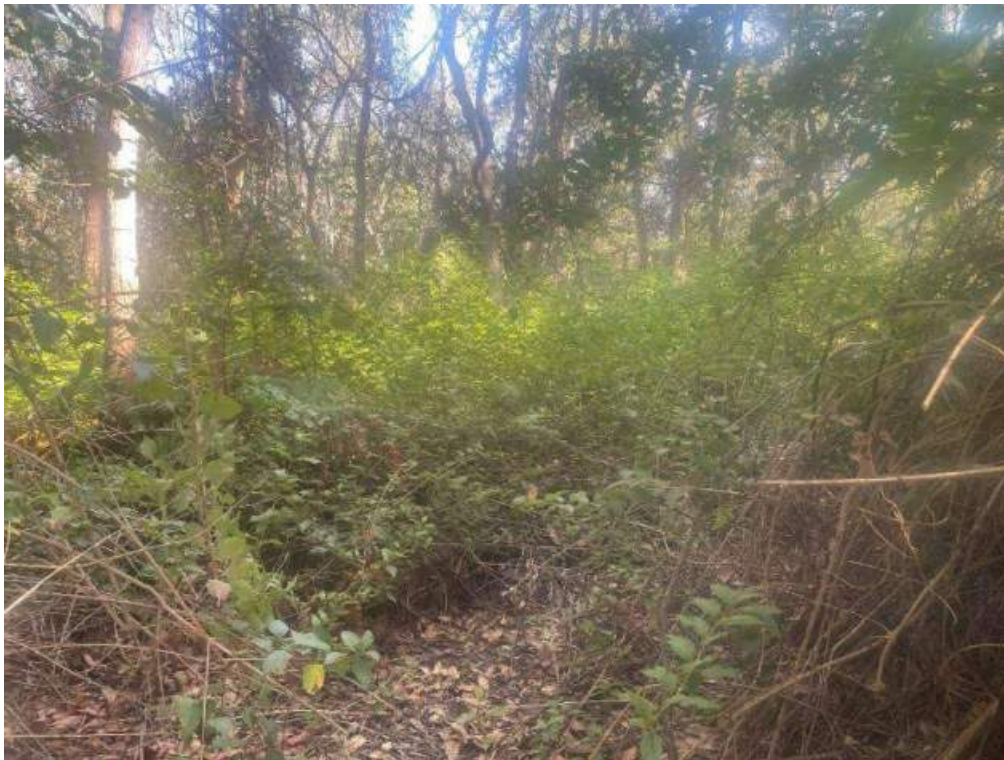
Lantana is the major threatening weed in the BOA, forming dense thickets at ground level and climbing into the mature tree canopies and covering a substantial portion of the BOA (**Figure 6**). The infestation density covers the full spectrum from isolated or scattered individuals to the dense thicket or belt referred to earlier (**Plate 12**). At its most dense, these thickets have the potential to hinder movement of koalas through the BOA and effectively divides the Swamp Mahogany – Paperbark Swamp Forest into two sections. The progress with the weed control works has greatly reduced this “wall” and opened up this area. This year’s weed mapping highlights the continued spread of this weed into the mature Swamp Mahogany – Paperbark Swamp Forest where scattered individuals are maturing and spreading into infestations.

Plate 9: Example of the dense Lantana that threatens to overwhelm native flora and restrict movement of native fauna.

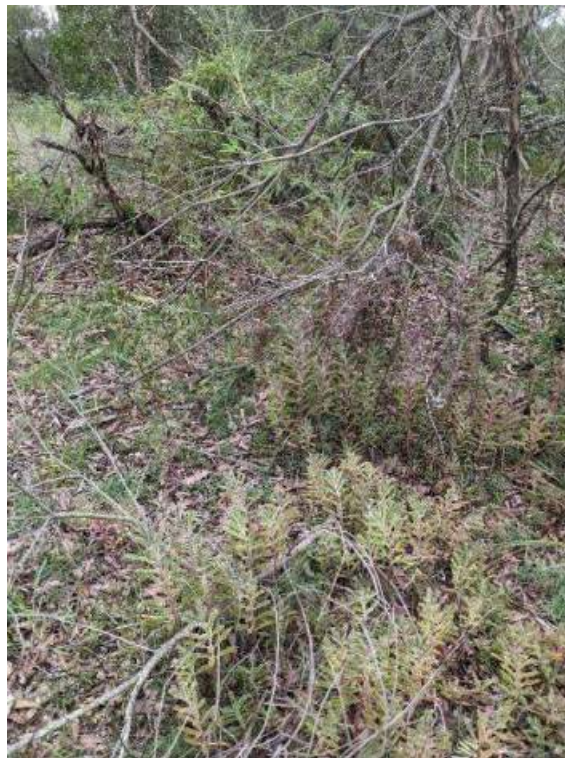
Plate 14: Mother of millions, foreground, bamboo, background.
