# 2019 Annual Environmental Management Report

## Tanilba Northern Dune

<b>Author:</b>	Kleinfelder Australia Pty Ltd
<b>Name of Site:</b>	Tanilba Northern Dune
<b>Name of Project:</b>	Annual Environmental Management Report
<b>Document Version:</b>	1.0

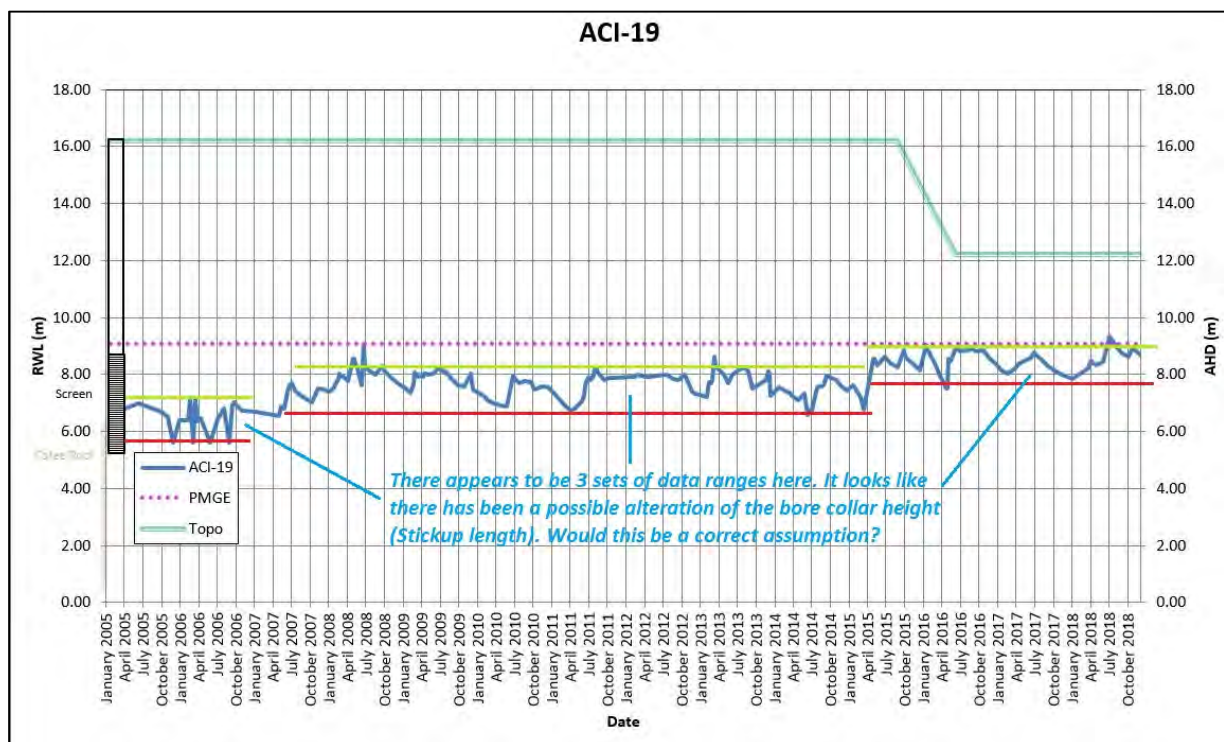
Observation for apparent water level exceedance in ACI-19

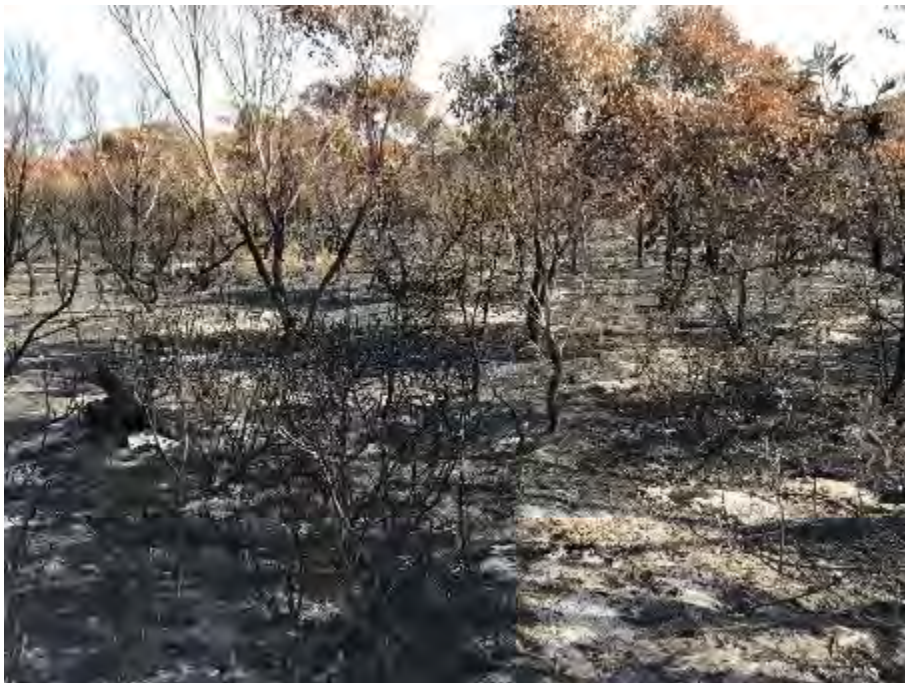
**Plate 1:** Block A1 showing the intensity of the fire and the extent of its effect upon the vegetation (PP1)

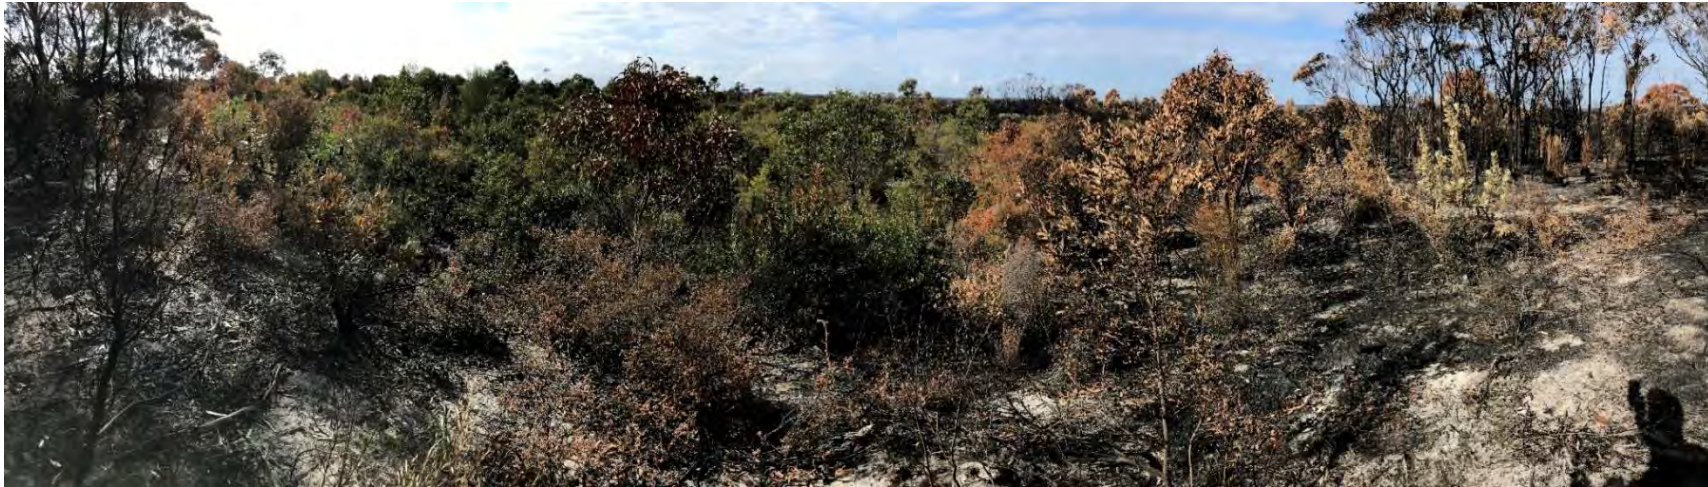
**Plate 2: BI A1 showing unburned section of vegetation which will act as seed source and increase the rate of natural revegetation (PP3)**

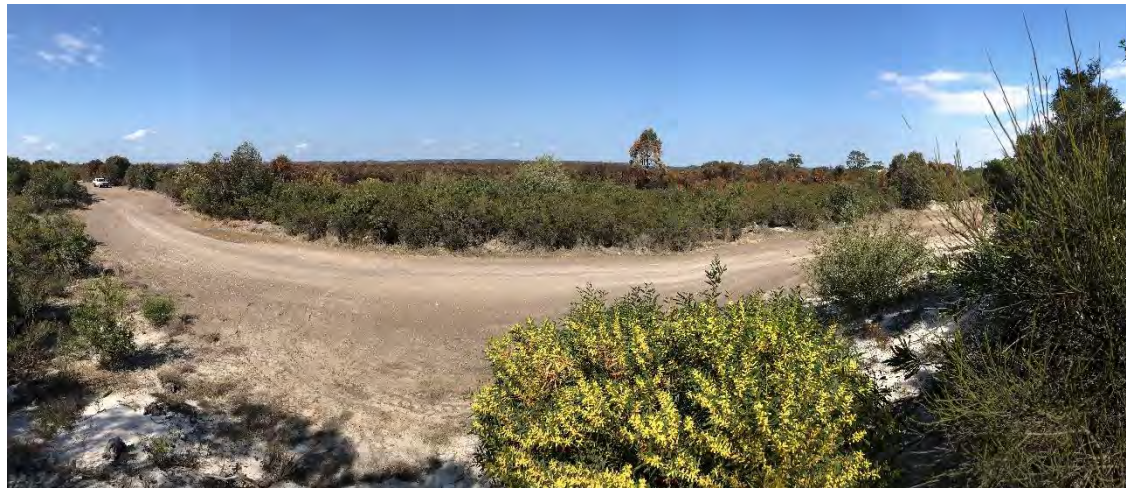
A thin strip of unburned vegetation has remained for much of the length of the haul road stretching from Block D to parts of Block E and will also act as a seed source in the future (**Plate 3**).

**Plate 3: BI D - looking south east from the haul road showing the unburned vegetation that runs parallel to the haul road with the burned areas visible in the background (PP13)**

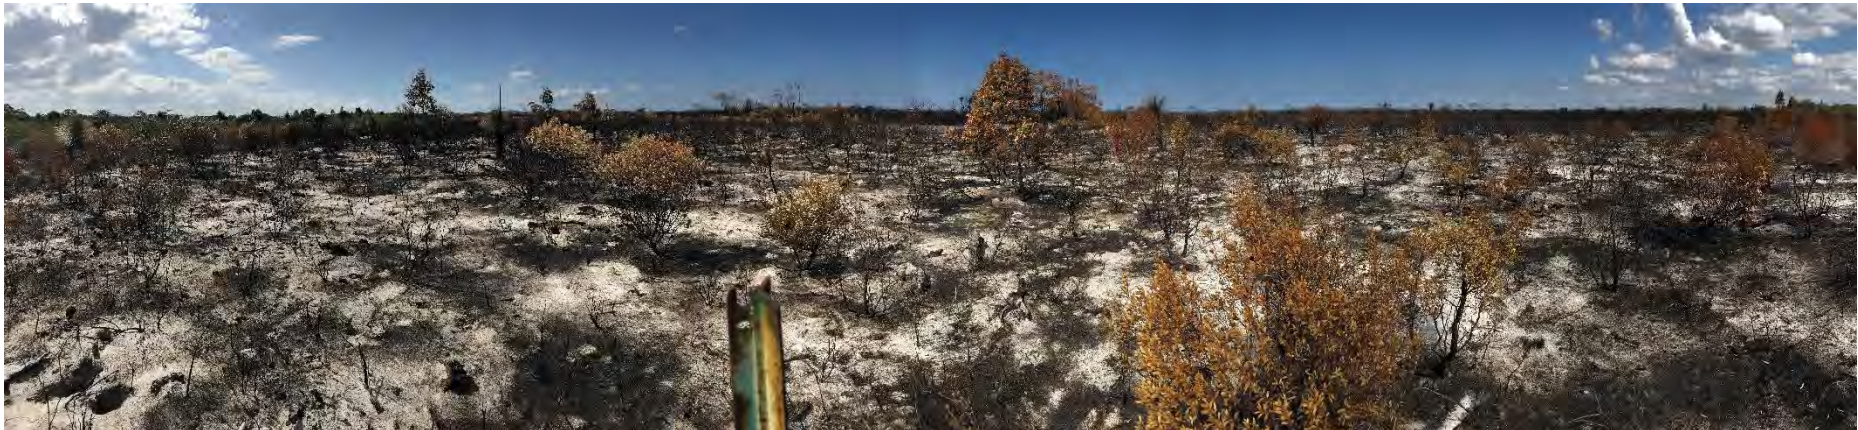
**Plate 4: Block I - looking south showing the extent and intensity of the fire on this block (PP12)**

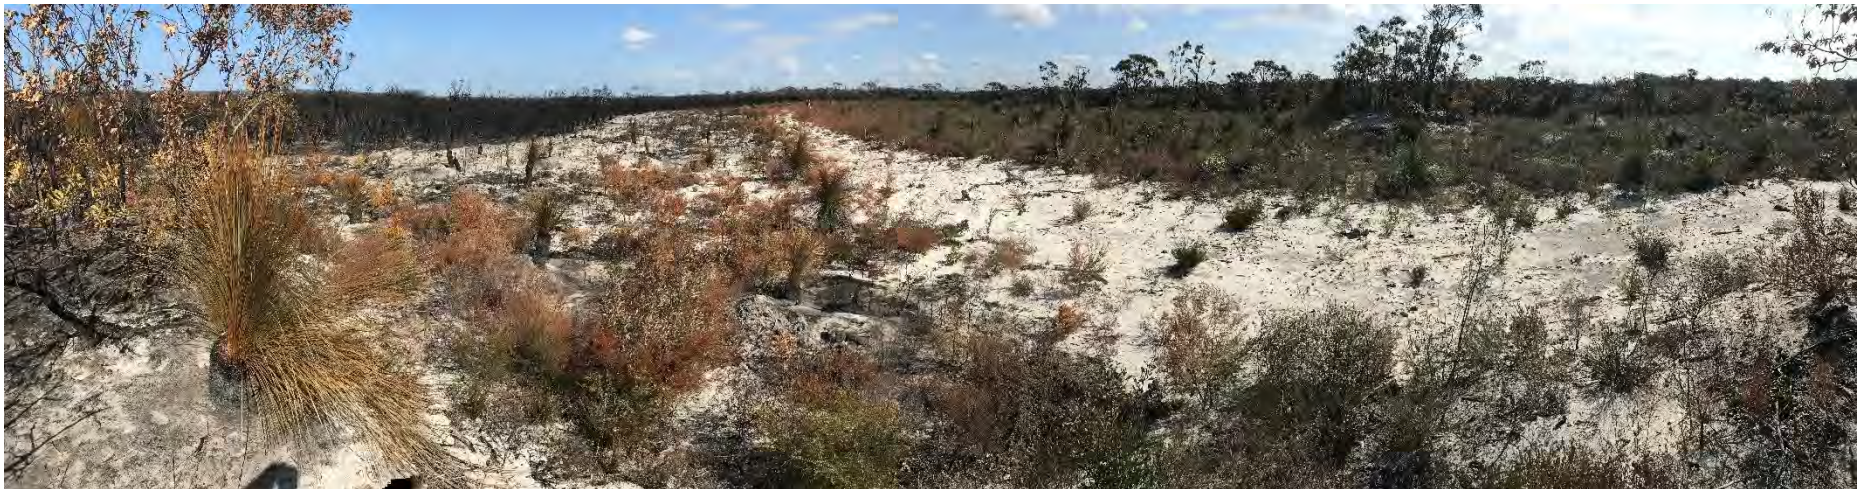
This is also a concern for the small portion of Block M that has been affected by fire (**Plate 5**). This area has only been rehabilitated for about 4 years. This is insufficient time for shrub and ground cover species to produce great quantities of seed, while the canopy species will have produced no seed. Additionally, the surrounding vegetation has been burned which will limit its ability to act as an immediate seed source – although it will recover eventually provided a sufficient period between fires occurs.

**Plate 5: Block M (south) looking east showing the extent of the fire damage (PP14)**
