Aboriginal Archaeological Due Diligence Report

COOMA ROAD QUARRY CONTINUED OPERATIONS PROJECT

Aboriginal Archaeology Due Diligence Report

Prepared by Umwelt (Australia) Pty Limited

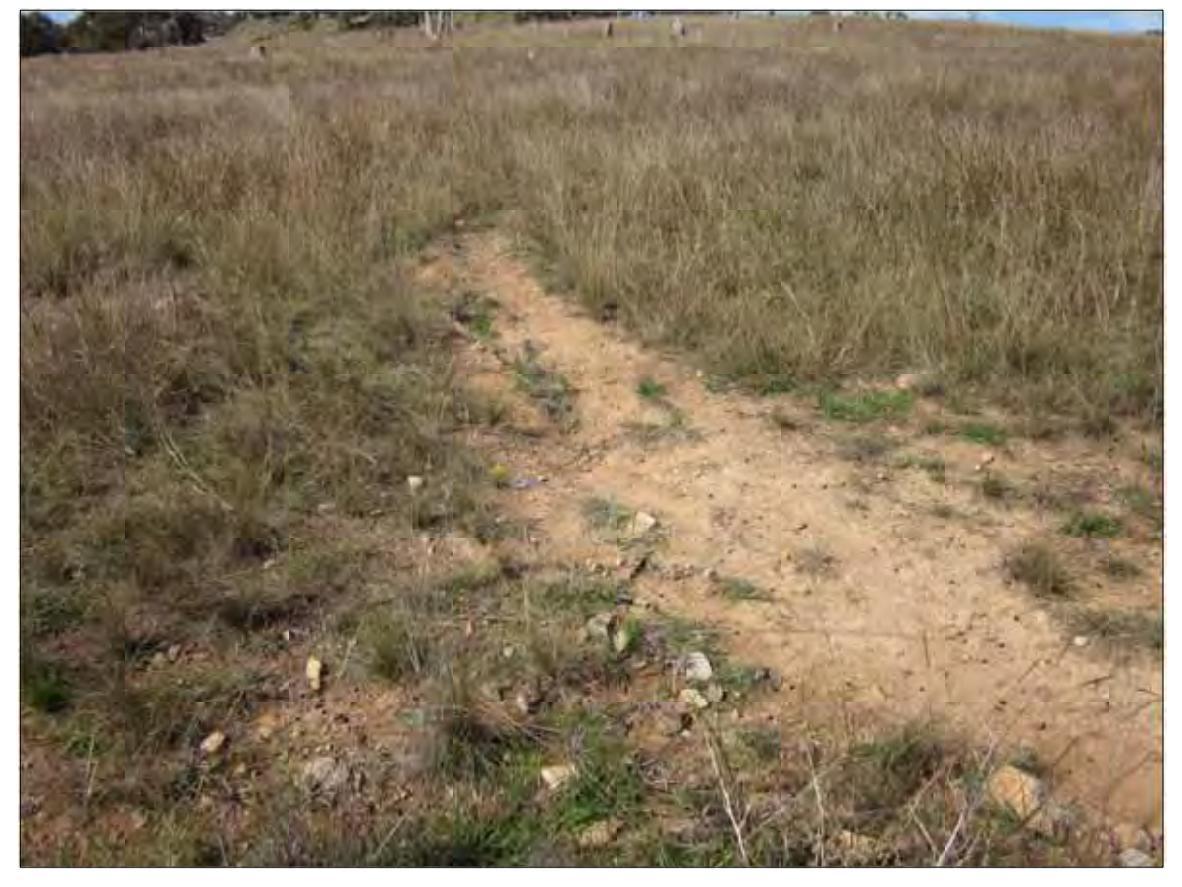
PLATE 1 Cooma Quarry 1 view to southeast

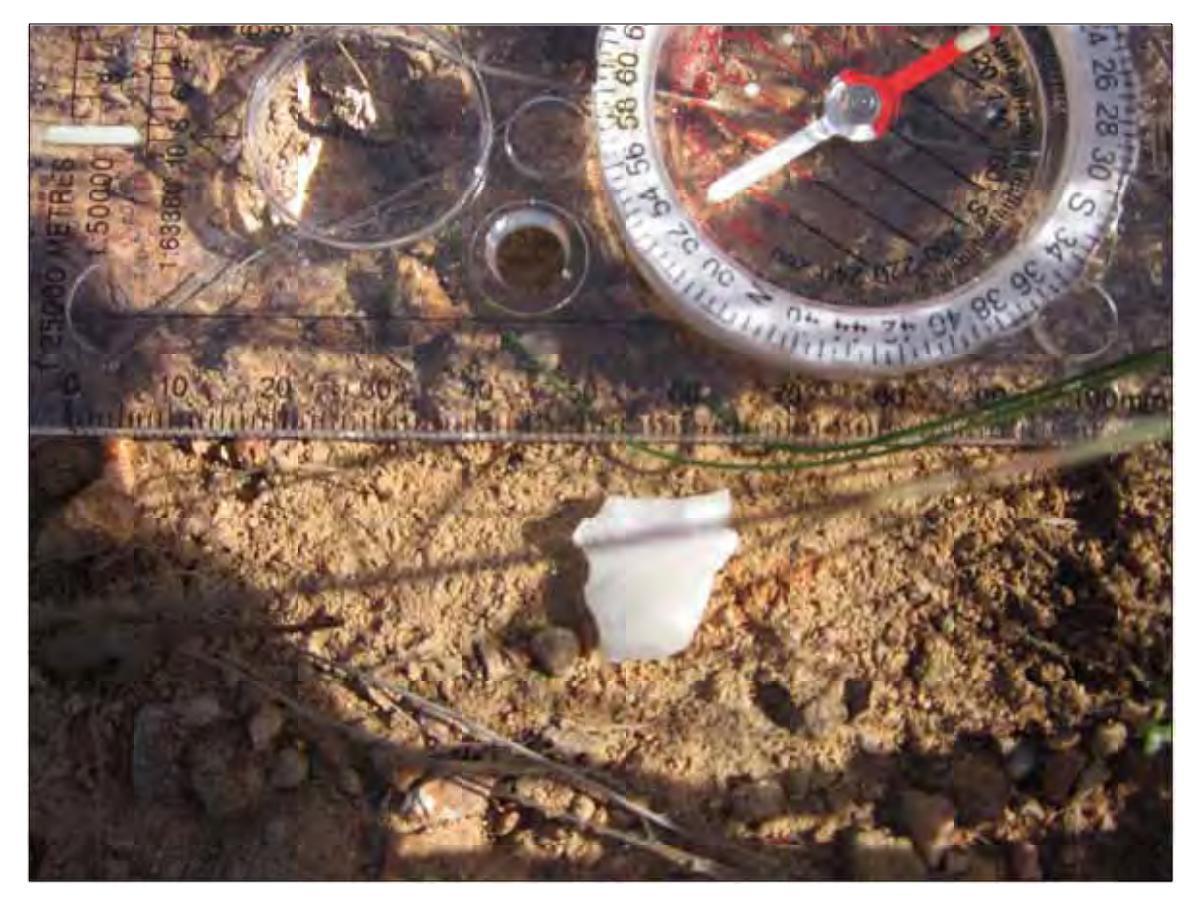
PLATE 2 Cooma Quarry 1 artefact detail

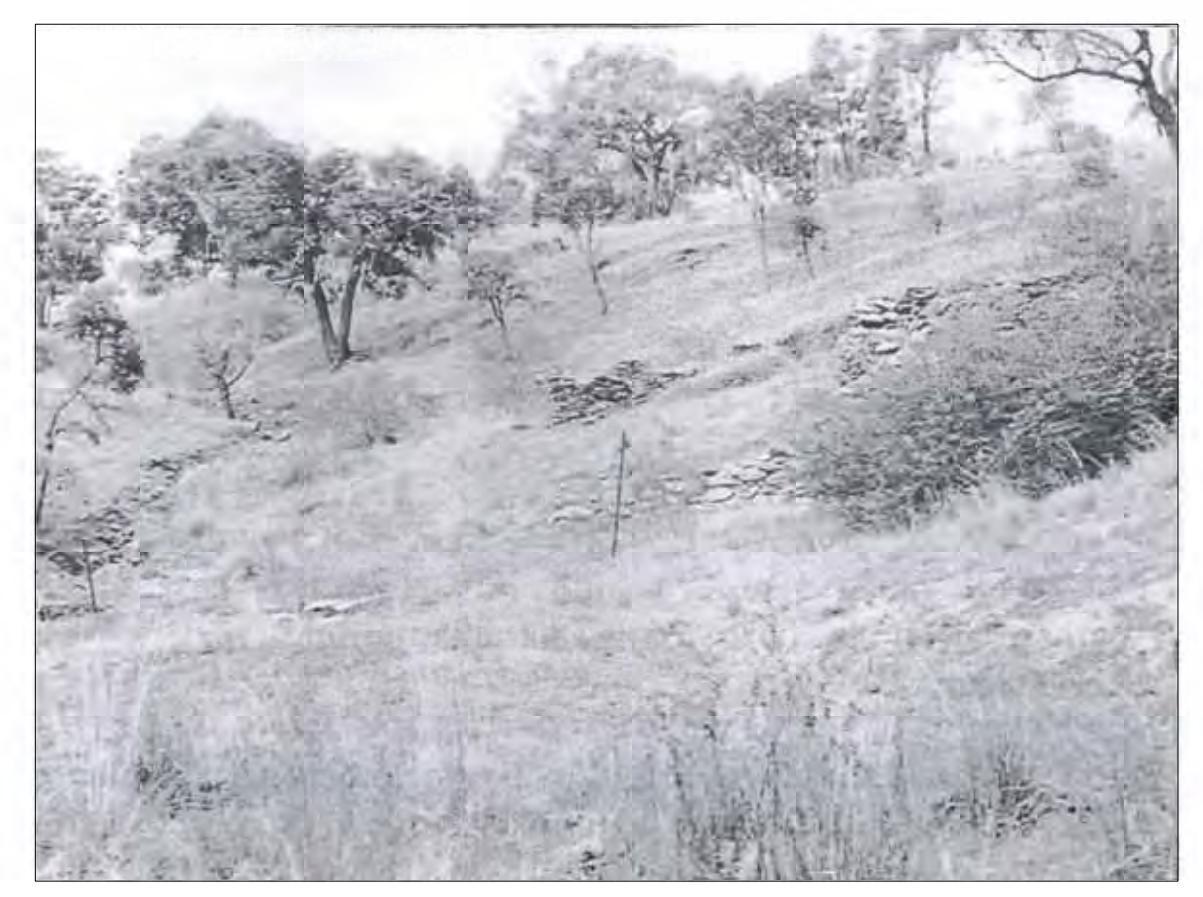
PLATE 3.1 1993 photograph of kiln site, general view to south

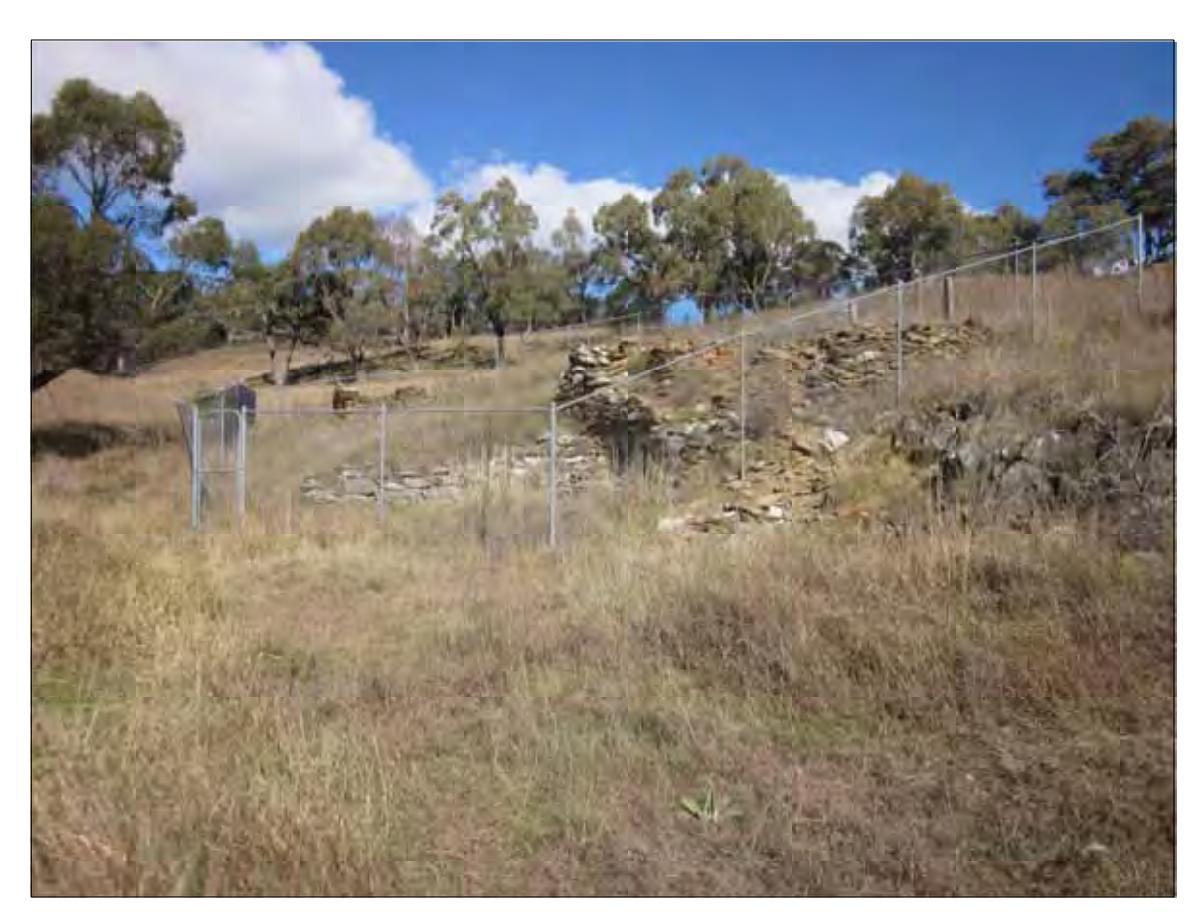
PLATE 3.2 May 2012 photograph of kiln site, general view to south

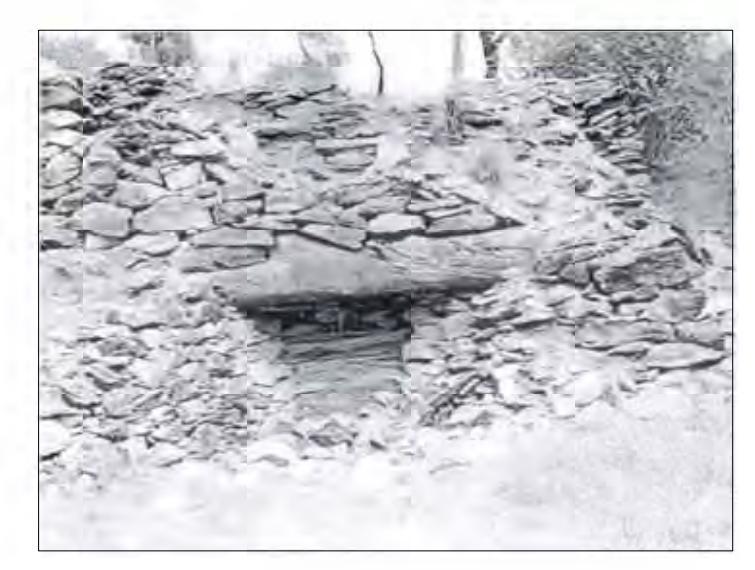
PLATE 3.3 1993 photograph of kiln structure, view to west

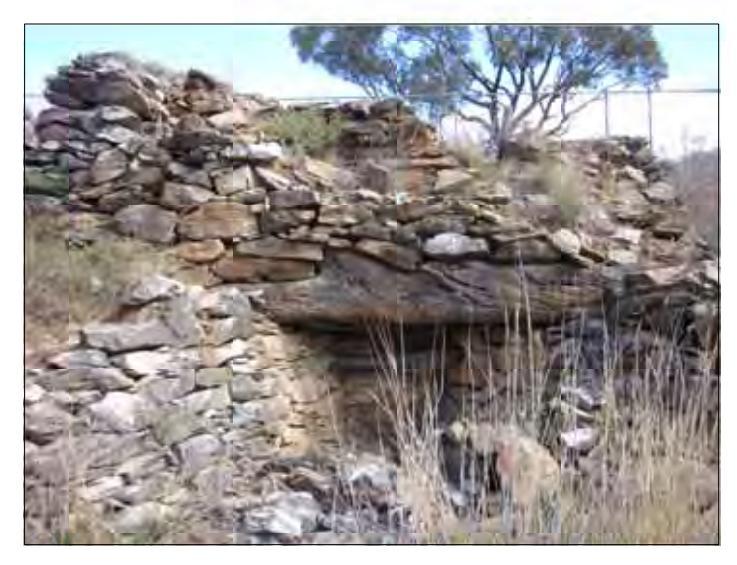
PLATE 3.4 May 2012 photograph of kiln structure, view to west

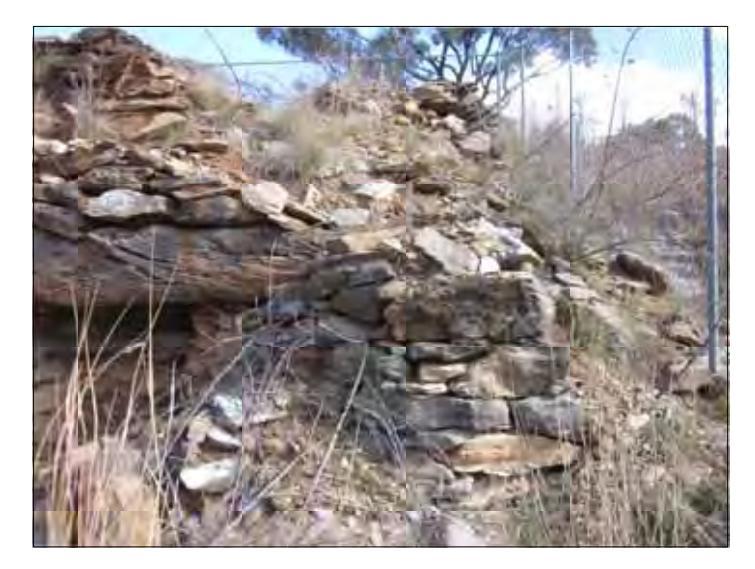
PLATE 3.5 May 2012 photograph of kiln structure, view to west

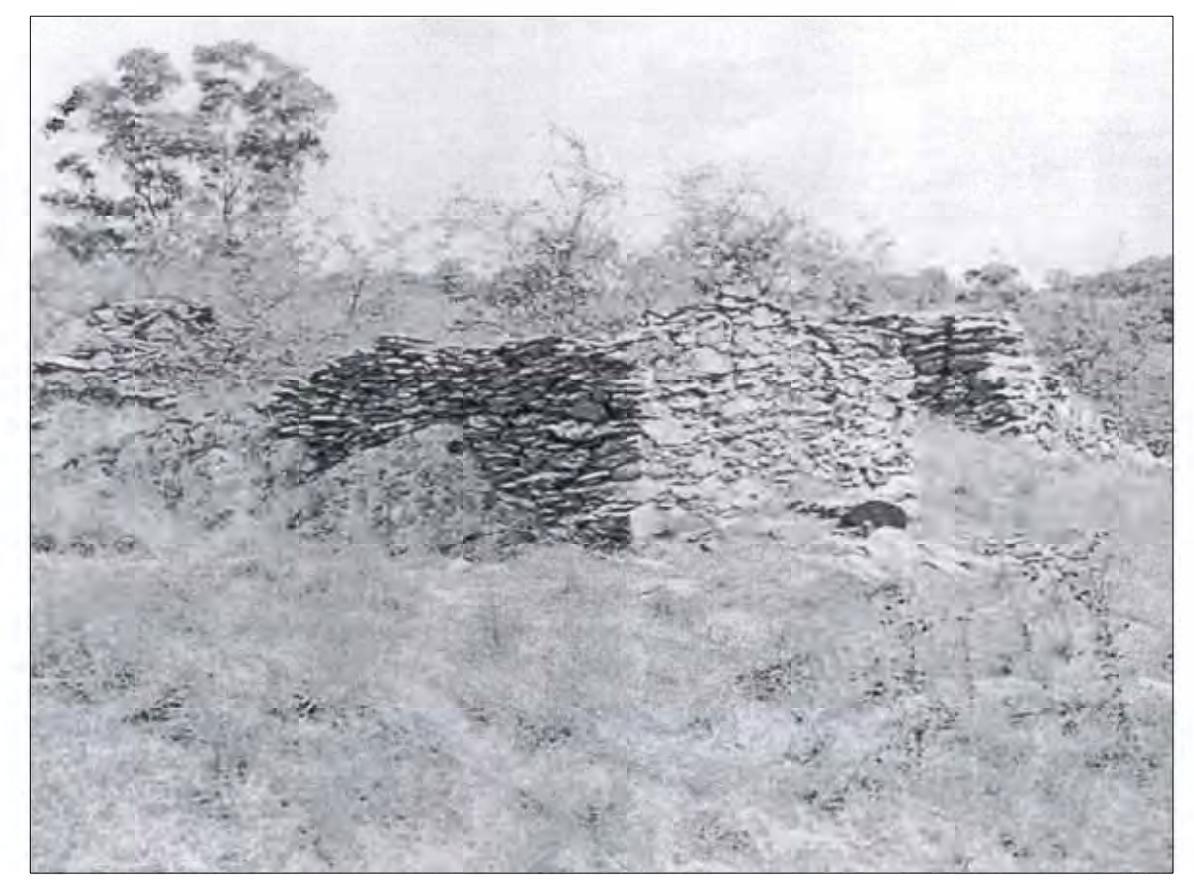
PLATE 3.6 1993 photograph of main stone structure, view to northwest

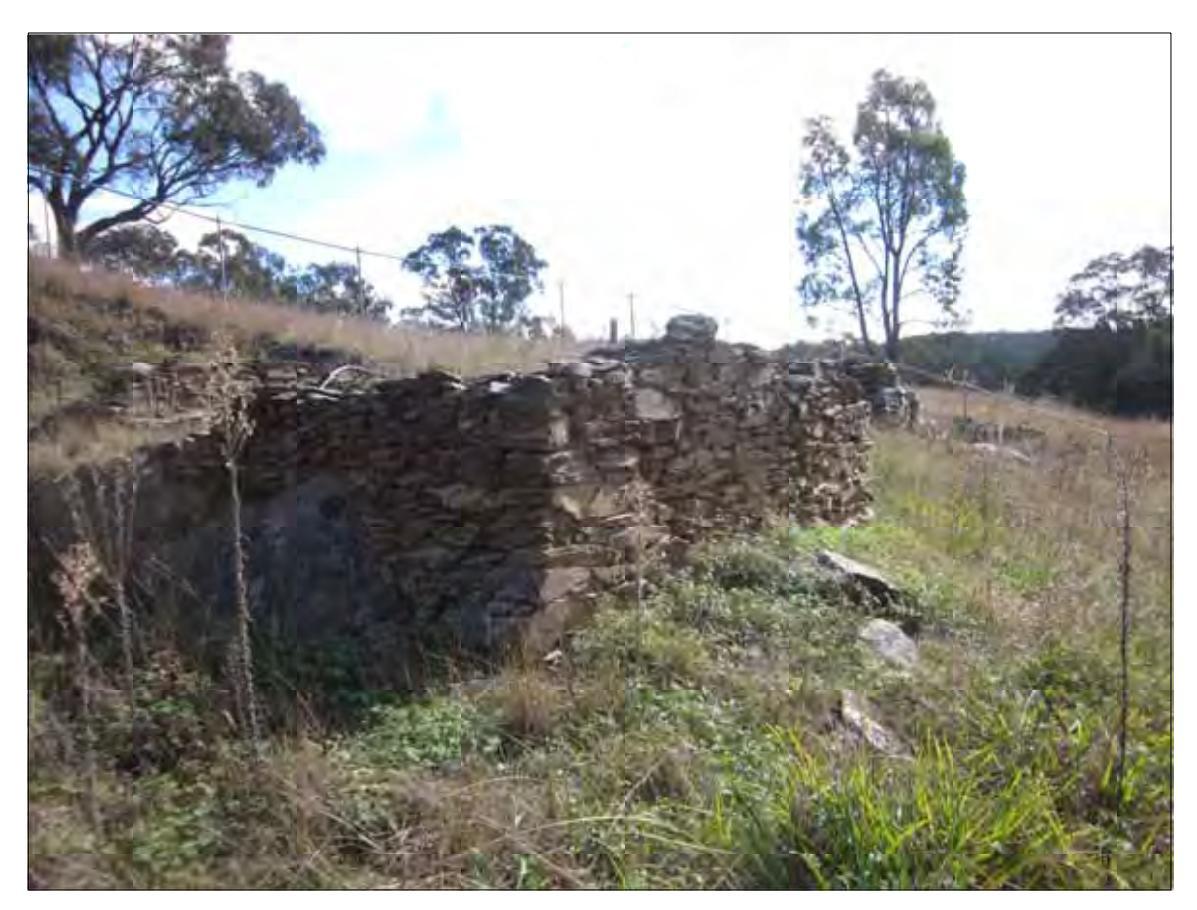
PLATE 3.7 May 2012 photograph of main stone structure, view to northwest

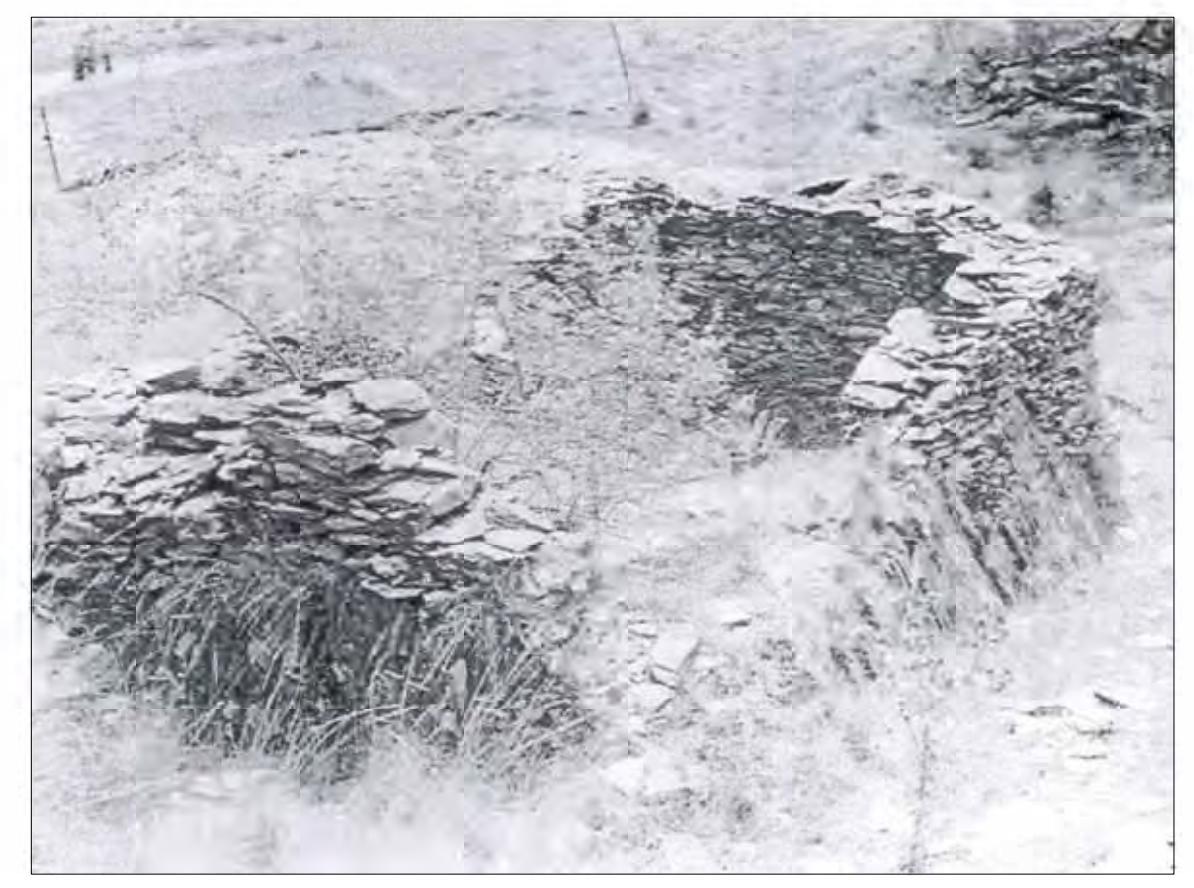
PLATE 3.8 1993 photograph of main stone structure, view to northeast

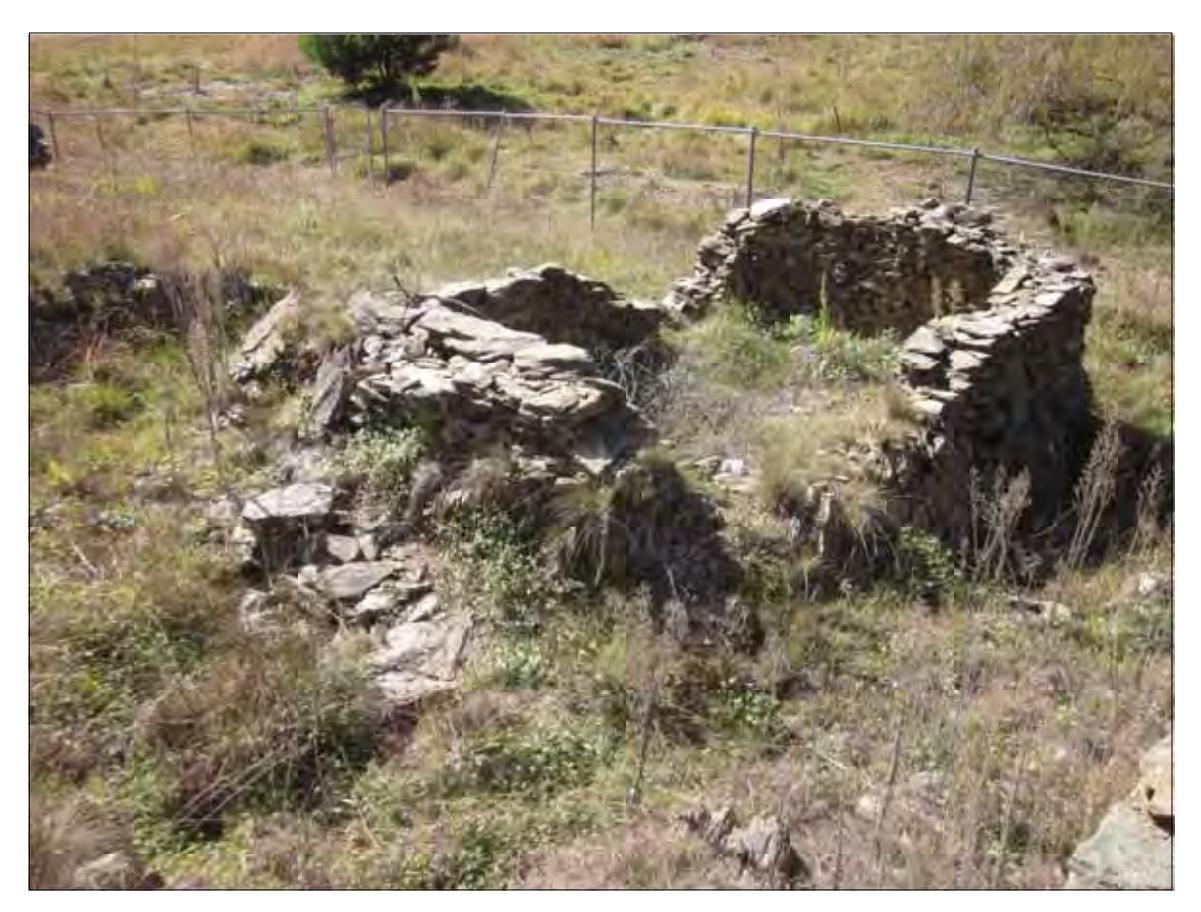
PLATE 3.9 May 2012 photograph of main stone structure, view to northeast

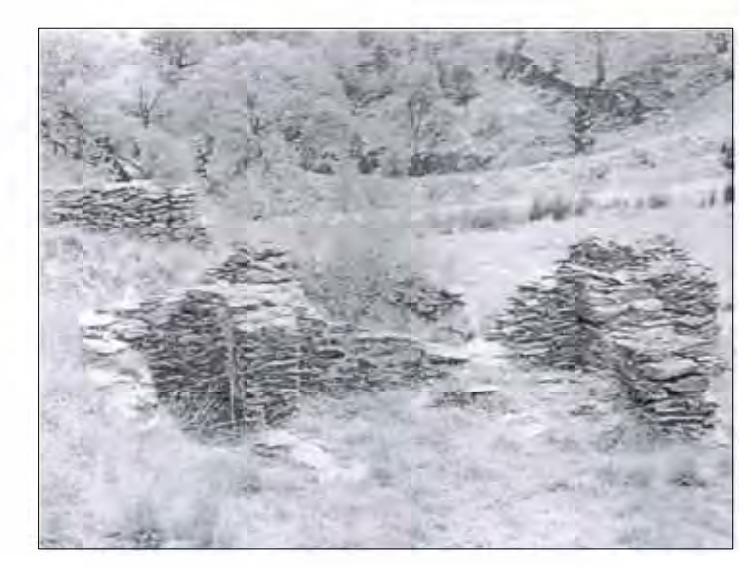
PLATE 3.10 1993 photograph of second stone structure, view to north

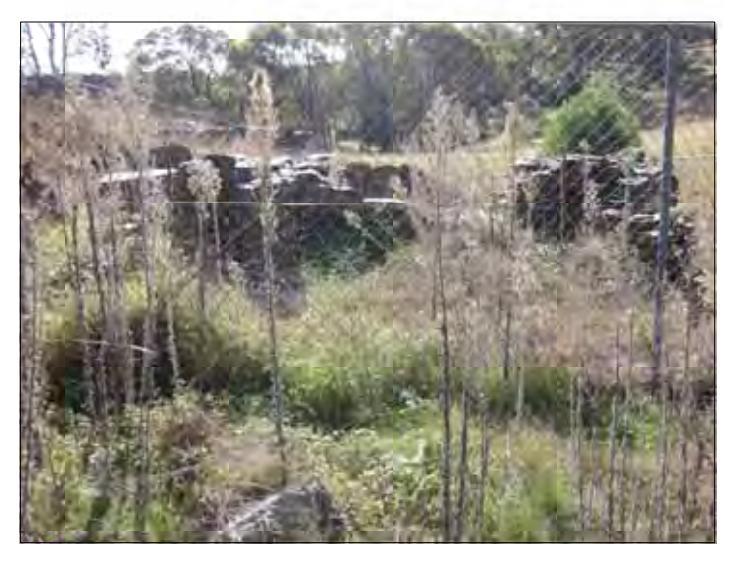
PLATE 3.11 May 2012 photograph of second stone structure, view to north

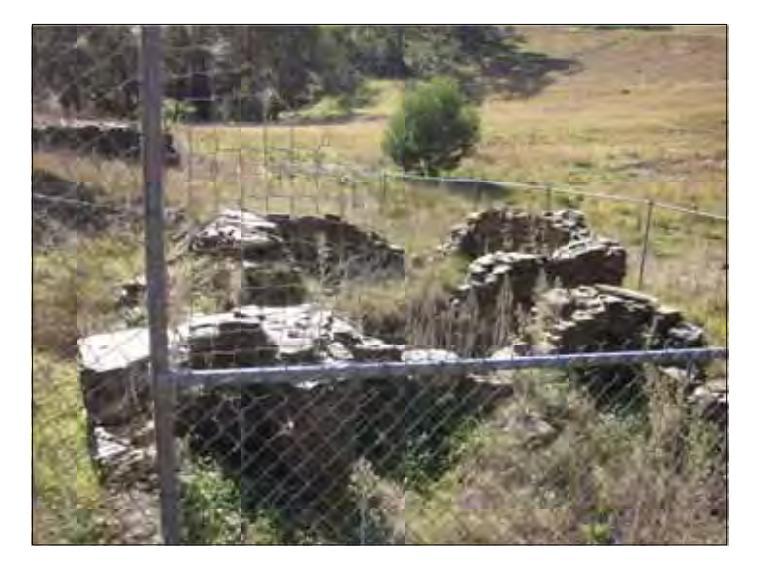
PLATE 3.12 May 2012 photograph of second stone structure, view to north

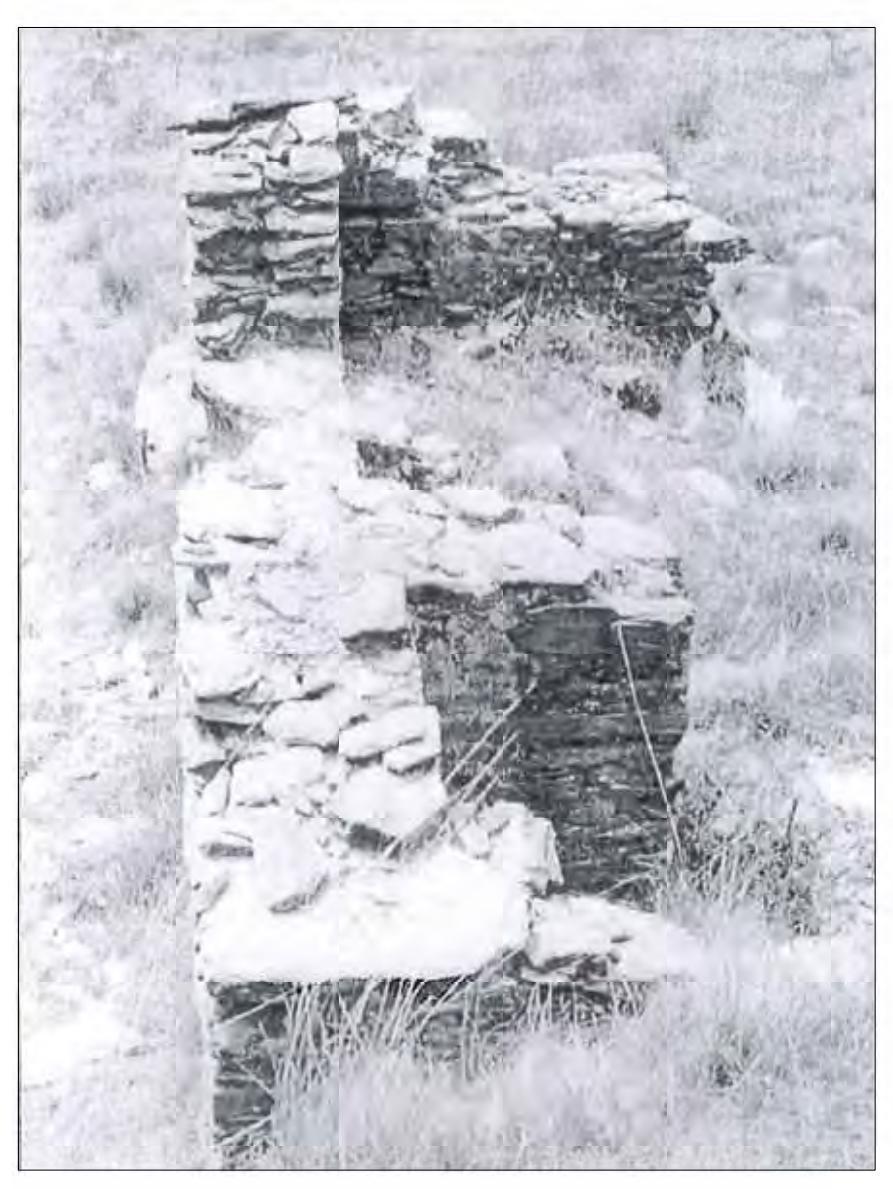
PLATE 3.13 1993 photograph of second stone structure, view to east

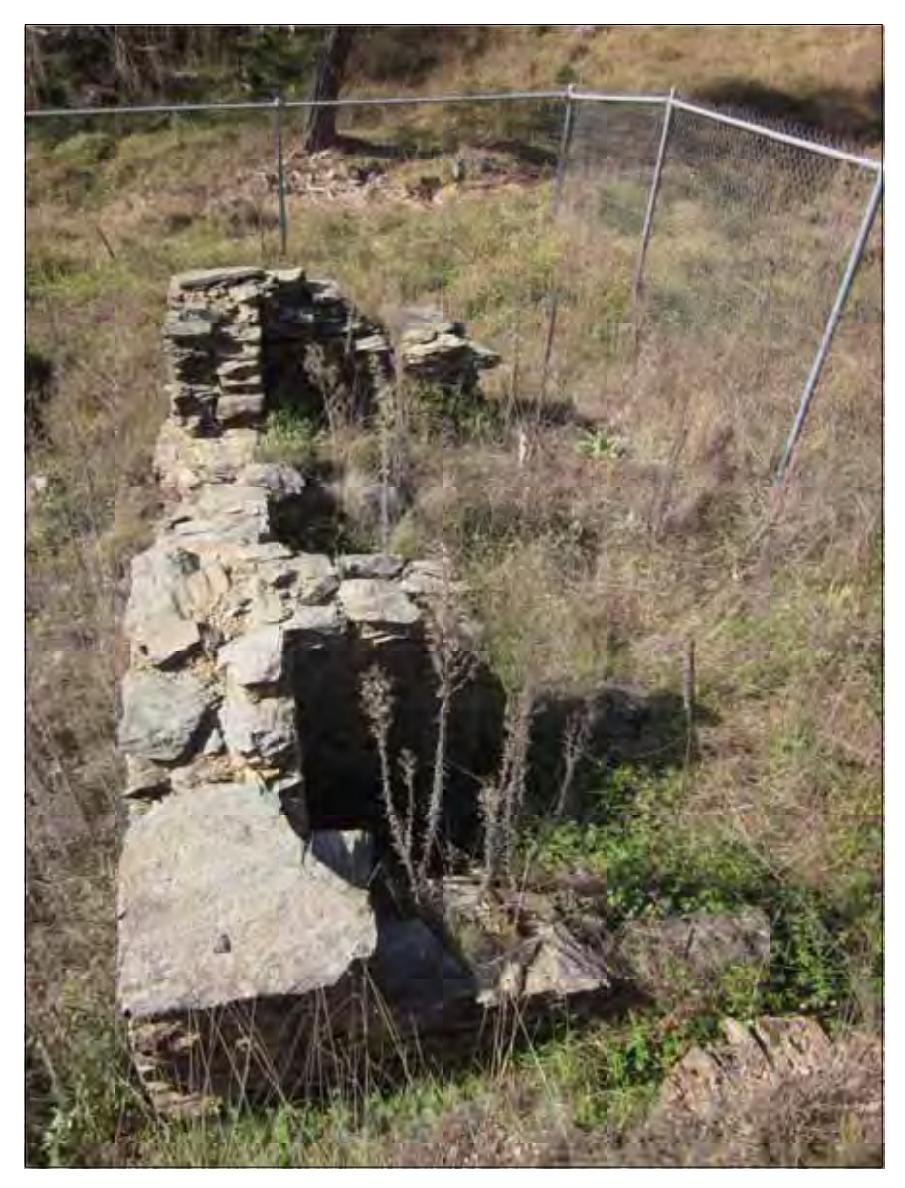
PLATE 3.14 May 2012 photograph of second stone structure, view to east
