### Historic Heritage Assessment

# **Non-Indigenous Archaeology Assessment Proposed Lynwood Quarry, Marulan**

May 2005

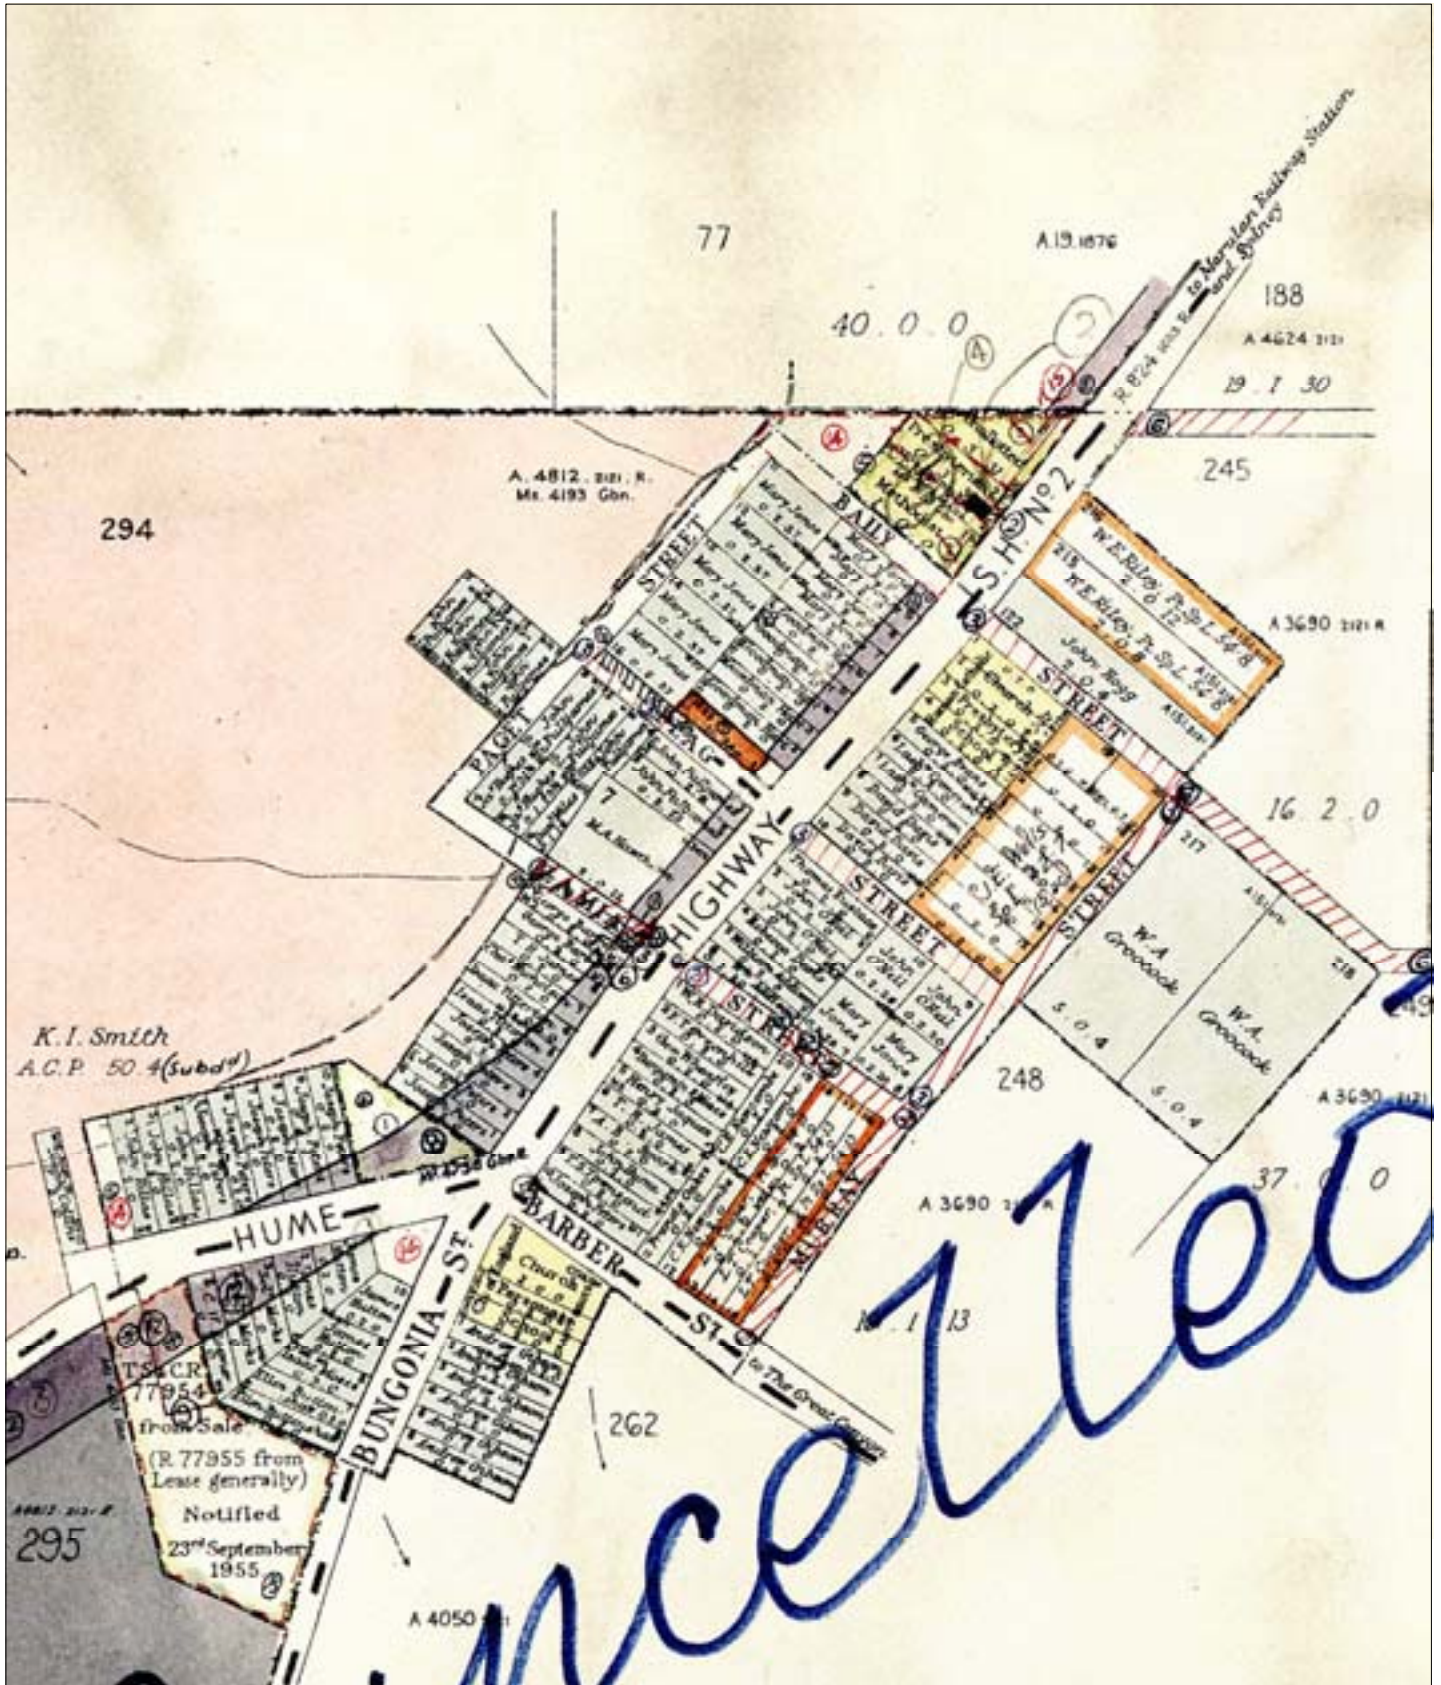
FIGURE 2.4  
1958 Parish Map

Source: LPI Parish Maps, Marulan Edition 9

Initially a single lane highway, the original concrete surface was laid in 1930 but was replaced with bitumen in subsequent years. The Parish Map of 1958 (refer to **Figure 2.4**) shows the widening and realignment of the highway through the old Marulan township, where land was reclaimed along the western side of the road. Duplication of the road occurred during the 1980s where further land was reclaimed along the eastern alignment of the road.

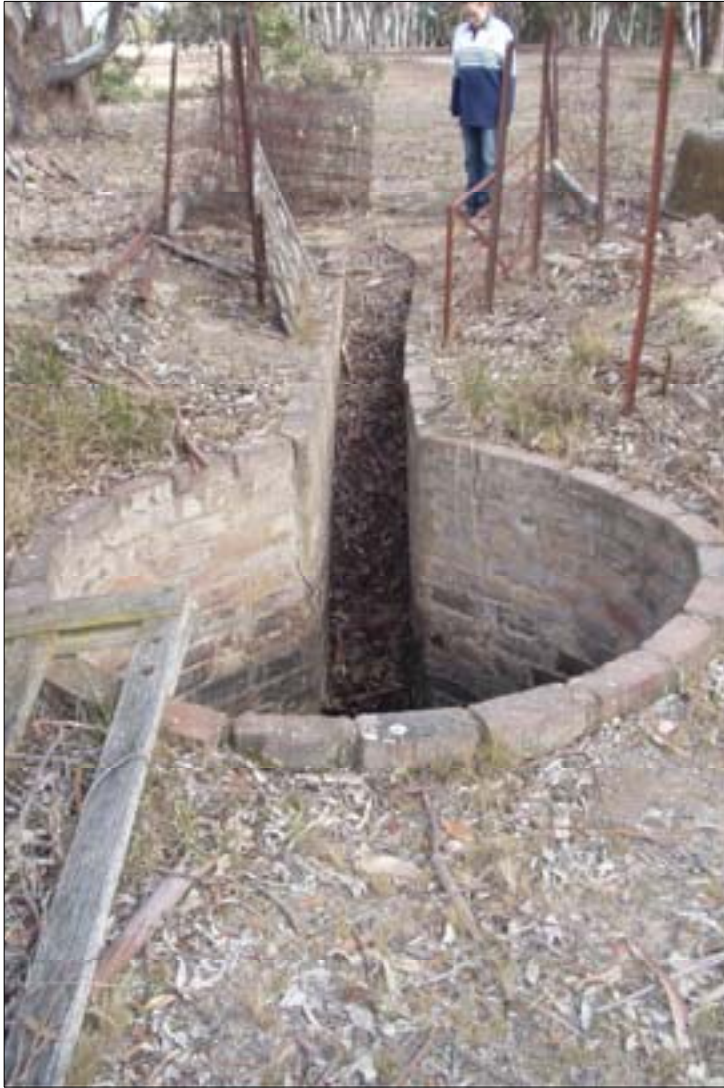
**PLATE 2.1**  
**Site MRNH1**  
**Sheep dip in July 2004, looking south.**

This site was first identified during the course of an ecological survey in July 2004. Digital photographs taken at the time show an intact race and circular sheep dip constructed of brick as shown in **Plate 2.1**. The remains of a draining pen with concrete floor and fencing were observed at the southern end of the dip. There was no evidence of a crush or plunge at the northern end of the dip.

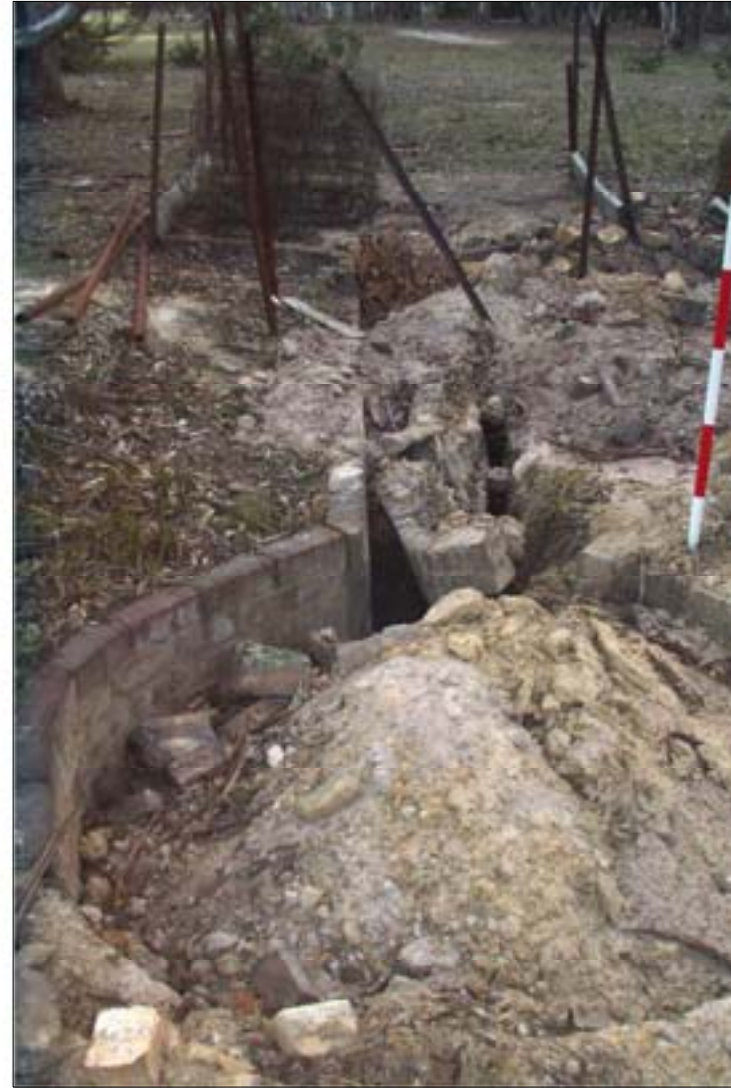
**PLATE 2.2**  
**Site MRNH1**  
**Sheep dip at survey September 2004, looking south. Scale 200mm**

Survey undertaken as part of the non-Indigenous archaeological investigations in September 2004 found this site had sustained some damage caused by earth moving machinery when dumping fill into the dip. A section of race wall had been collapsed, although remaining largely intact. **Plates 2.2** and **2.3** illustrate the damage as seen from the south and the north respectively.

Site Ref/Description	Recommendations
MRNH1 Circular Sheep Dip	<p>There is no direct impact anticipated at this site. However, this site has been impacted upon through recent vandalism. It is recommended that this site be repaired through the removal of fill and the re-instatement of collapsed brickwork. Any disturbance and/or excavation at this site is subject to an excavation permit under Section 57 of the NSW Heritage Act. However, as the excavation would involve only the removal of fill, this work would normally be exempt from such application. In order to allow for any additional excavation that may be involved in the repair, it is recommended that this site be incorporated into an application for an excavation permit as detailed in <b>Recommendation 3</b>.</p> <p>Once repaired, it is recommended that the site be fenced and/or covered as a safety measure and to prevent any inadvertent damage caused through the movement of machinery, vehicles and/or personnel. The site should also be clearly recorded on operational plans as a heritage site.</p>

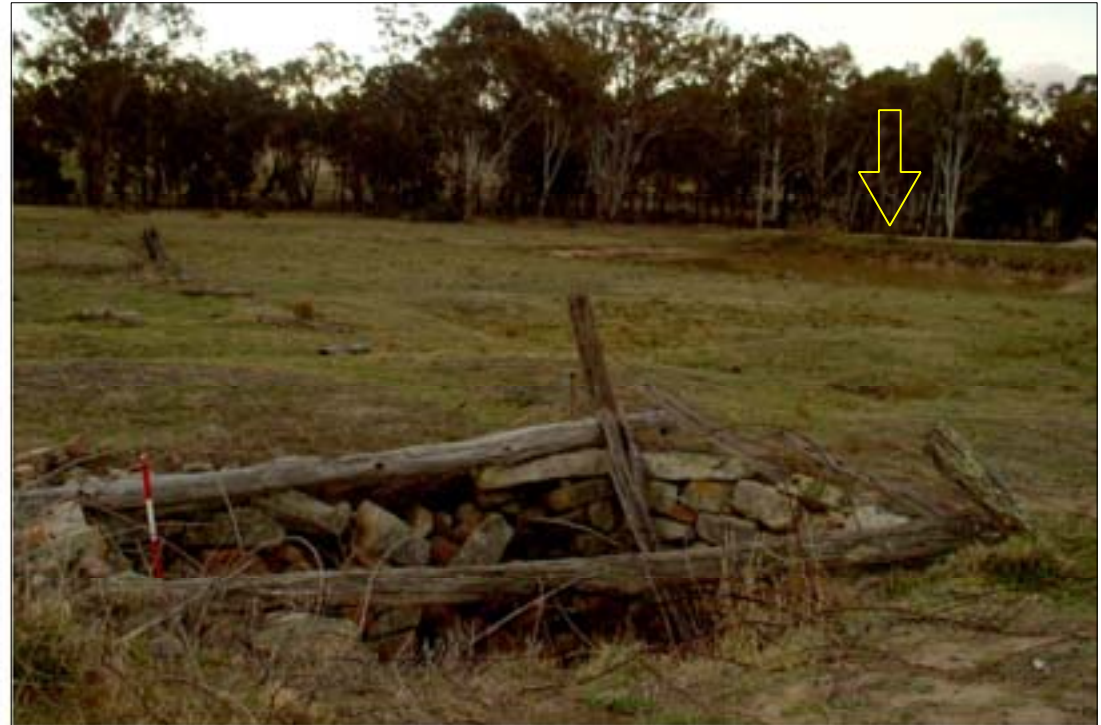
**PLATE 2.4**  
Site MRNH2  
View of stone lined cistern / well and remnant timbers. Location is shown in relation to site MRNH1 (as shown by arrow). Scale 200mm

Remnant timbers displaying rebates were observed at the pit head, however their purpose was unclear. The timbers are perhaps the remains of a former cover and are possibly not related to its historical use.

MRNH2 Stone lined cistern/well	<p>There is no direct impact anticipated at this site. However, it is recommended that the site be fenced and/or covered as a safety measure and to prevent any inadvertent damage caused through the movement of machinery, vehicles and/or personnel. The site should also be clearly recorded on operational plans as a heritage site</p>
MRNH3 Potential grave sites	<p>This site is located within the SHR boundary and any disturbance and/or excavation would be subject to an excavation permit under Section 57 of the <i>NSW Heritage Act 1977</i>. Management of exposed skeletal remains must be undertaken within guidelines published by the NSW Heritage Office in <i>Guidelines for the Management of Human Skeletal Remains</i> and the Public Health Regulation Act as detailed in <b>Section 5.1</b>.</p> <p>Construction of the proposed interchange will have no direct impact at this site. It is recommended that the site be fenced in order to prevent inadvertent disturbance/destruction.</p>

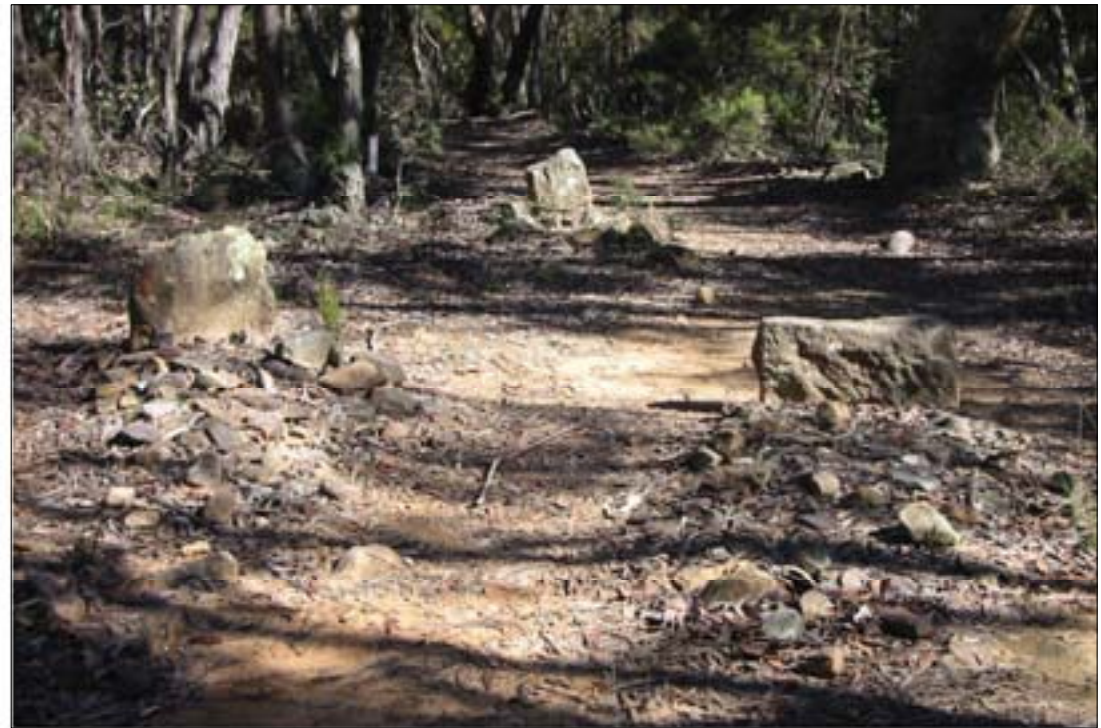
**PLATE 2.8**  
Known convict graves located at the Explorers Tree in the Blue Mountains  
(Source: Blue Mountains City Council)

As a comparative site, **Plate 2.8** depicts graves, thought to be convict graves, located on the Bathurst Road at Katoomba.

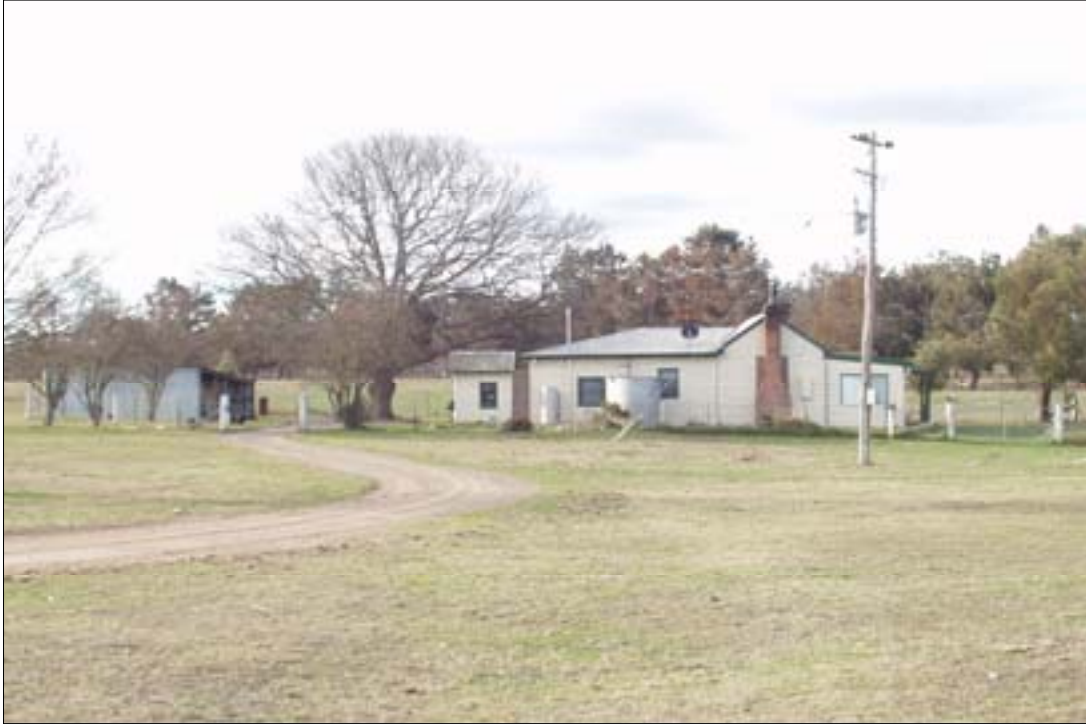
**PLATE 2.11**  
**Site MRNH5**  
**View of southern elevation of cottage and outbuildings facing north**

Item	Interpretation
Cottage	Local anecdotal information claims the cottage was constructed approximately 100 years ago. Within this time frame, the cottage is most likely associated with William Munday's ownership. It is possible the cottage was associated with earlier occupation and may provide evidence associated with earlier farming operations on the land. If constructed on or incorporating an earlier homestead site, the surface and subsurface context may contain further heritage material and information.
Shearing shed	Appears to have been constructed in the 1950s and consisted of one shearing stand. Based on size, the shed indicates management of a small flock of sheep, perhaps 500 head at most. The shed could have been constructed on the location of an earlier shearing shed and, if so, elements of the former shed could have been used in construction of the current shed, eg. vertical slab timbers.

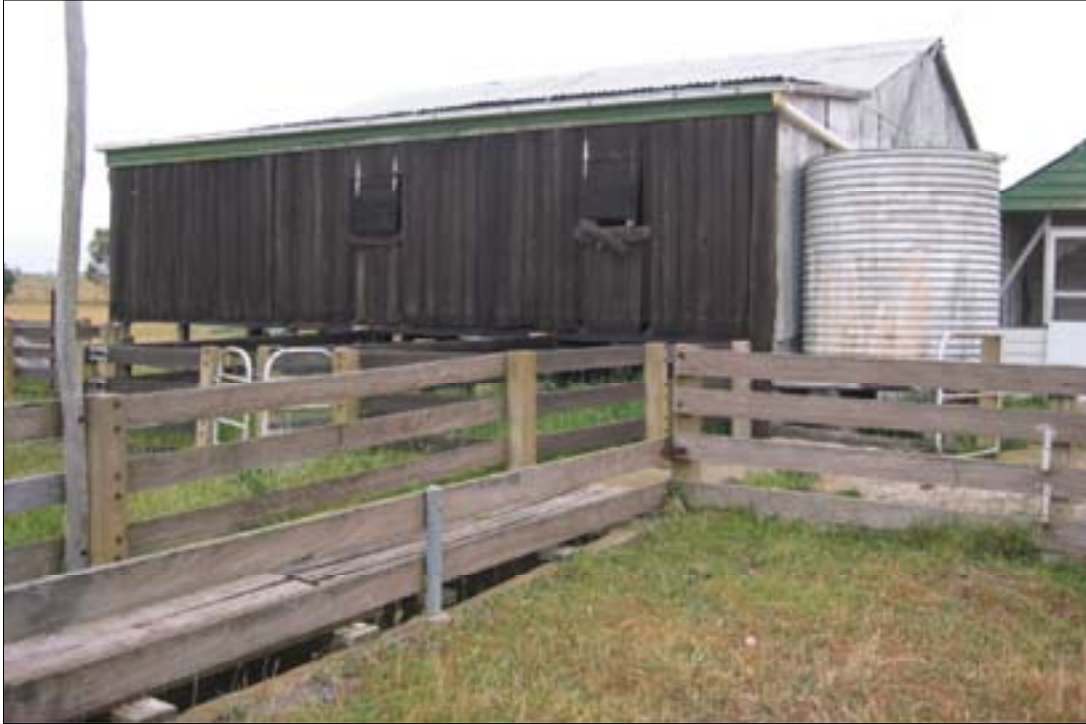
**PLATE 2.13**  
**Site MRNH5**

**Northern elevation of shearing shed showing vertical timber construction. Sheep dip is visible in foreground**

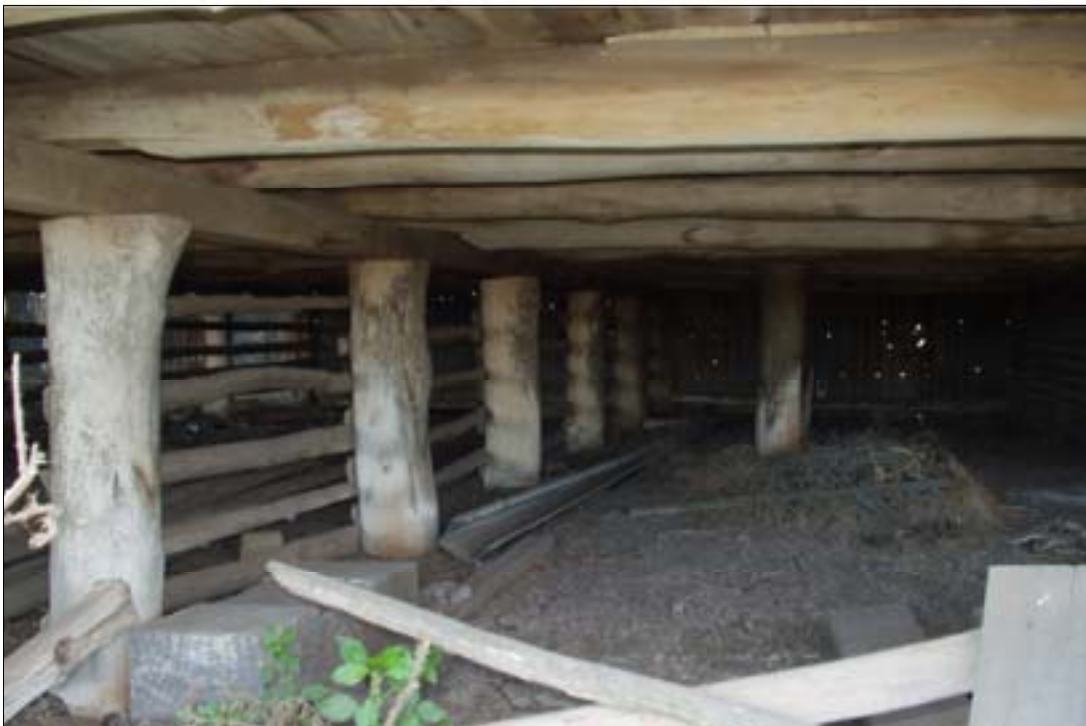
**PLATE 2.14**  
**Site MRNH5**

**View of holding pens constructed under the floor of the shearing shed**

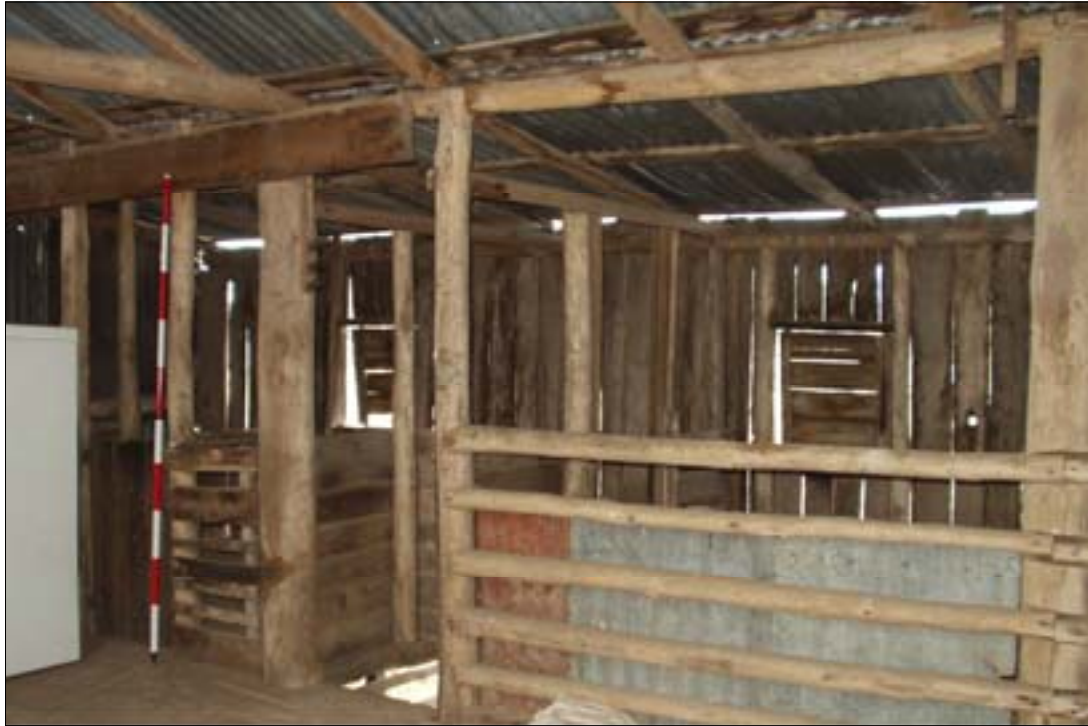
**PLATE 2.15**

**Internal view of shearing shed showing sweating pen at right and catching pen at left. Return chute is visible centre left. Scale 200mm**

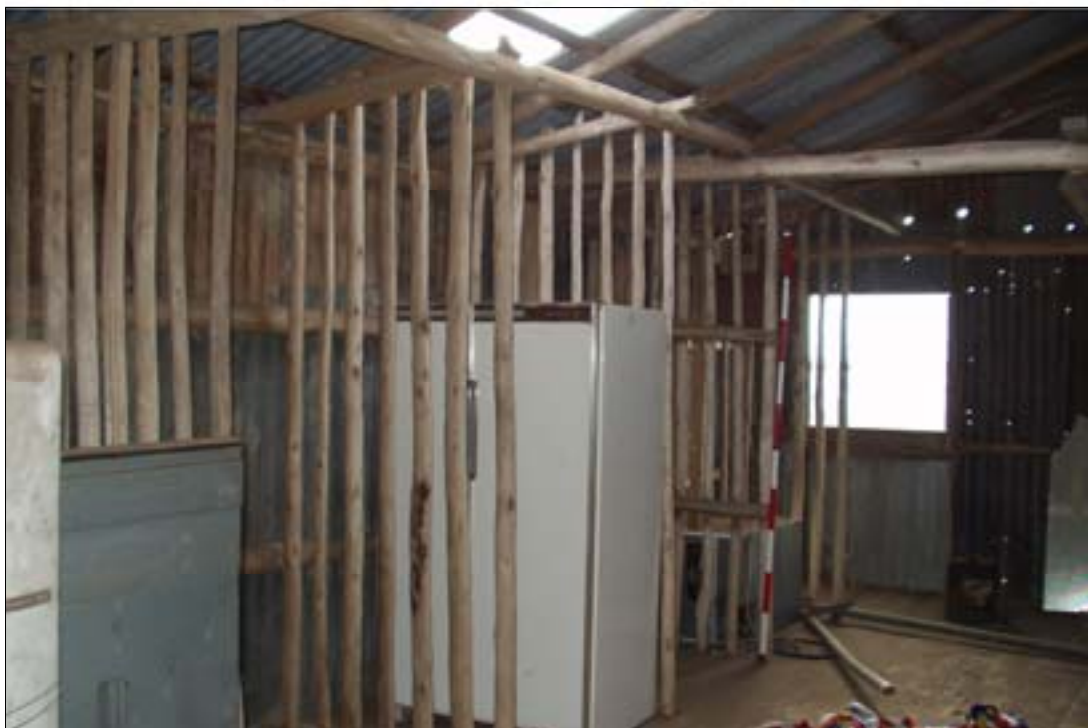
**PLATE 2.16**

**Site MRNH5**

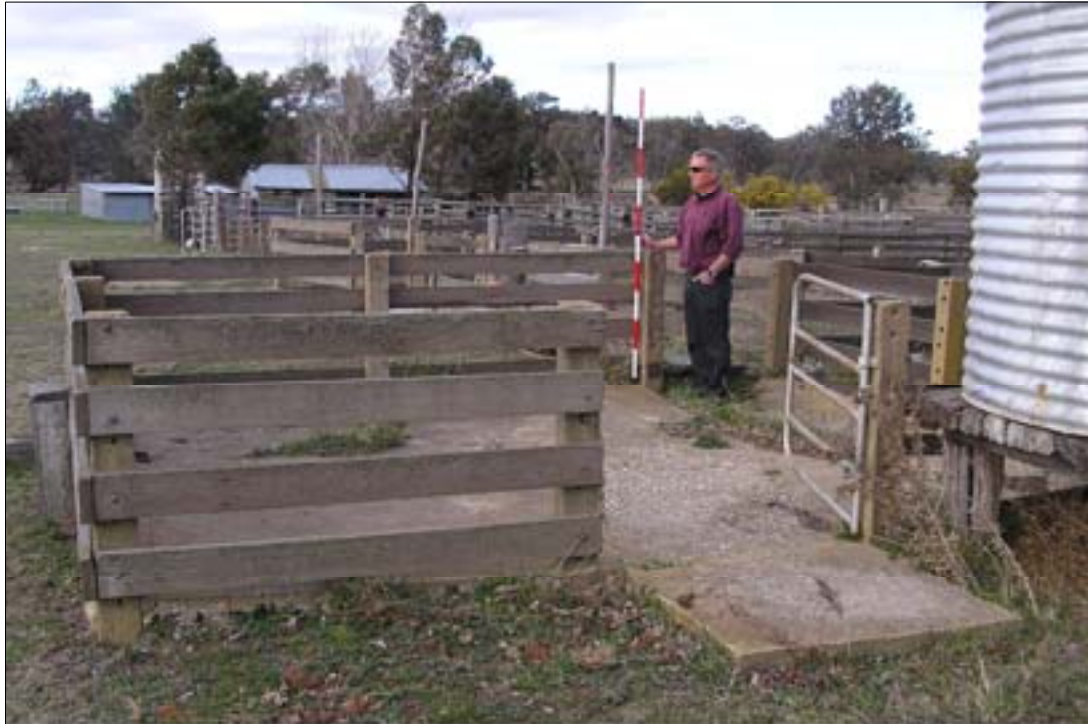
**PLATE 2.17**  
**Site MRNH5**

**View of sheep yards with draining pen in foreground. Facing north. Scale 200mm**

Yards	Most likely constructed at the same time as the shearing shed in the 1950s. Concrete posts gained popularity in the 1950s owing to a shortage of timber (Belschner, 1950:237) and were apparently locally made (W Croker, pers comm).
Sheep dip and foot bath	Sheep were managed from the western side of the dip where the pen was only two boards high. The removable timber cover may have been used for safety or to allow the secondary use of the dip as a race. Foot baths were used for the treatment and prevention of foot rot. Copper sulphate (bluestone) or formalin were the most widely used chemical for this purpose (Belschner, 1957: 453).
Meat house	This structure served as a place to carry out the butchering and hanging of meat. The meat house was most likely constructed prior to the shearing, perhaps as early as the 1930s.
Pisé building	Considering the style of construction, this structure could have been built as early as the 1850/1860s. It may have served as a dairy cool room or milk room for storage of perishable food. It is possible that a former cottage/house site exists within the vicinity of this structure although no surface evidence was observed. The corrugated iron roofing appears to have been replaced in circa 1920s.

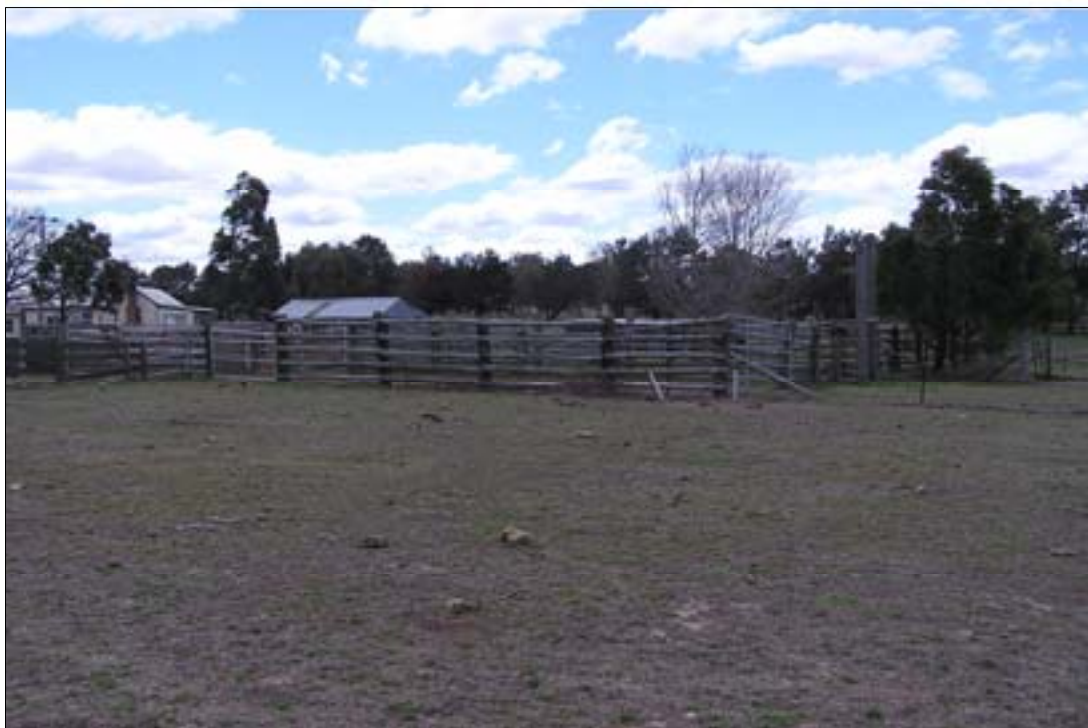
**PLATE 2.18**  
**Site MRNH5**

**View of cattle yards facing north west. Cottage is visible background left**

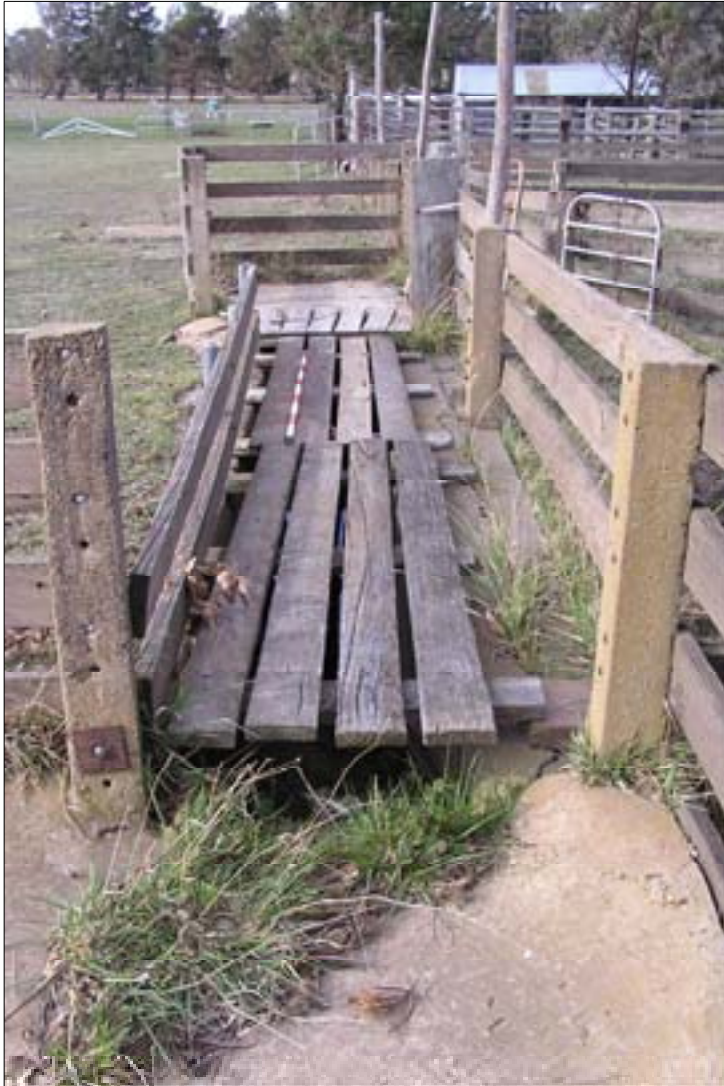
**PLATE 2.19**  
Site MRNH5  
View of sheep dip from draining pen. Facing north. Scale 200mm

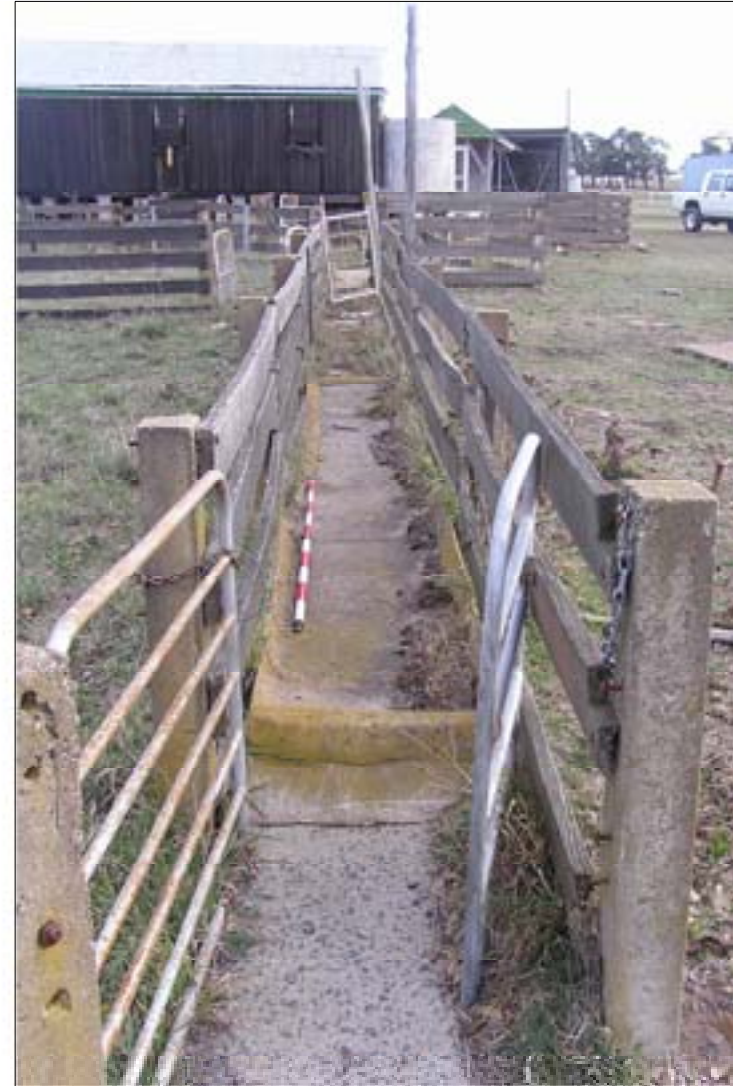
**PLATE 2.20**  
View of foot bath. Facing south. Scale 200mm

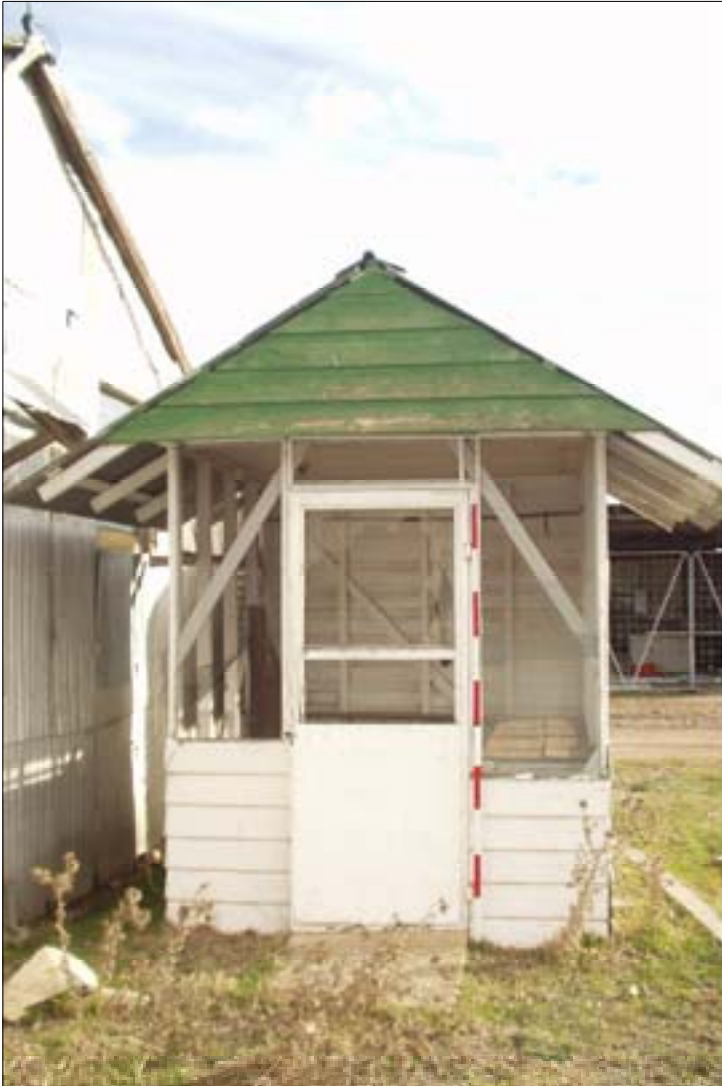
**PLATE 2.21**  
Site MRNH5  
View of northern elevation of meat house. Shearing shed at left. Scale 200mm

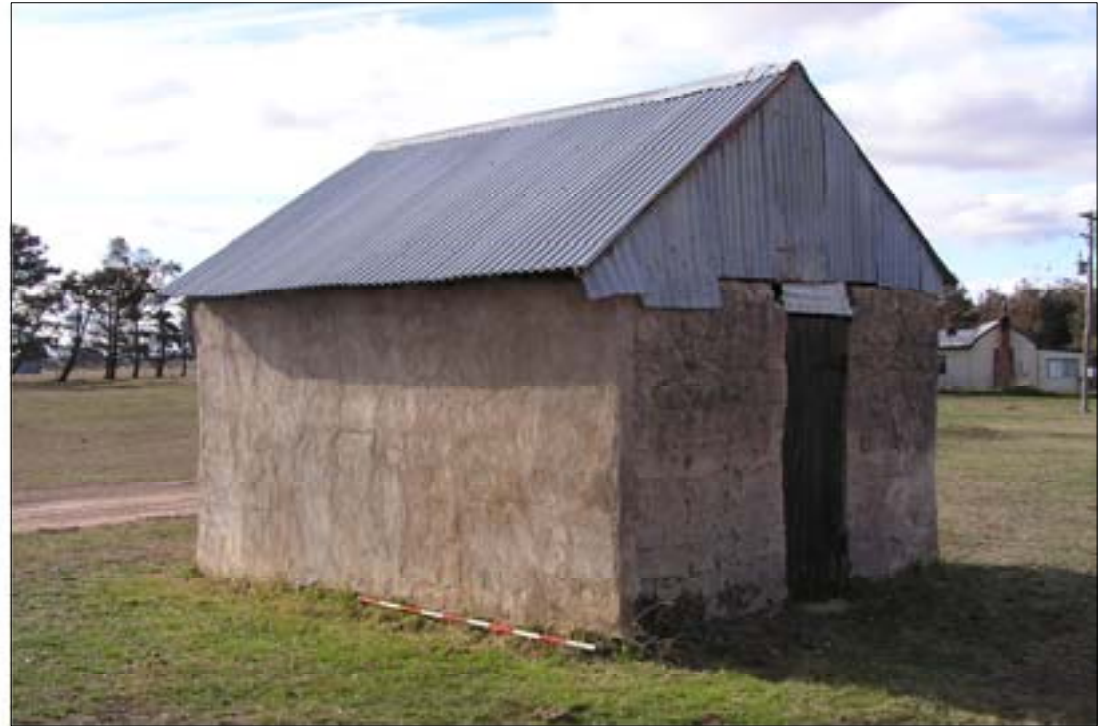
**PLATE 2.22**  
Site MRNH5  
External view of southern and eastern elevation of pisé building. Facing NNW. Scale 200mm

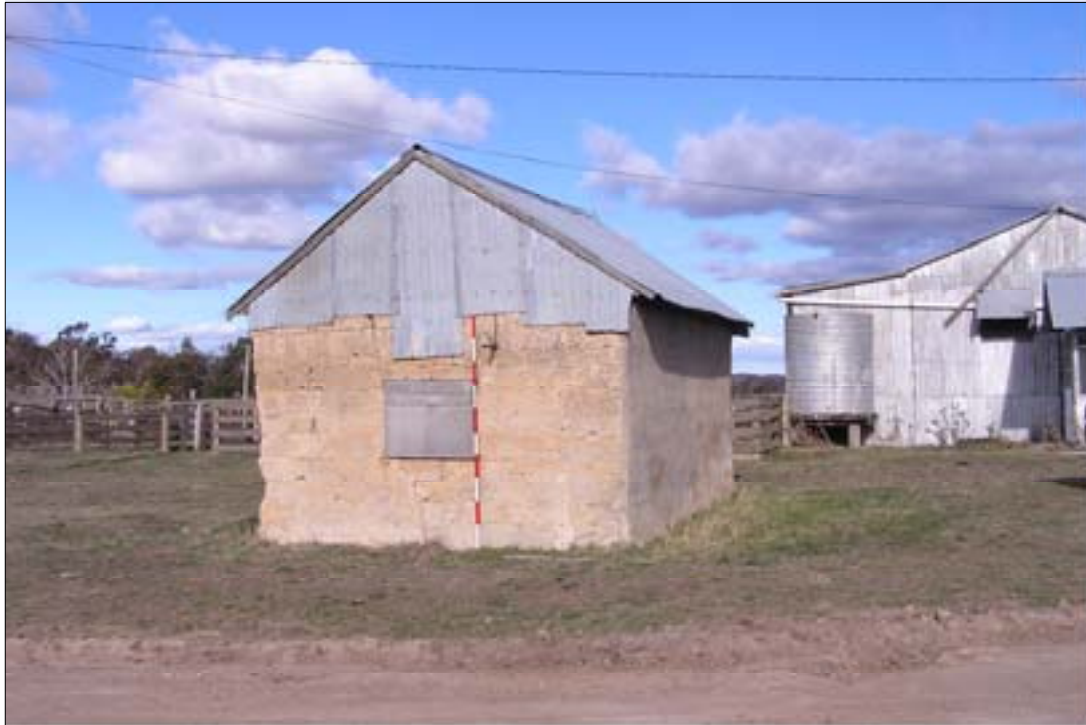
**PLATE 2.23**  
Site MRNH5  
External view of western and southern elevation of pisé building.  
Facing east. Shearing shed visible background right. Scale 200mm

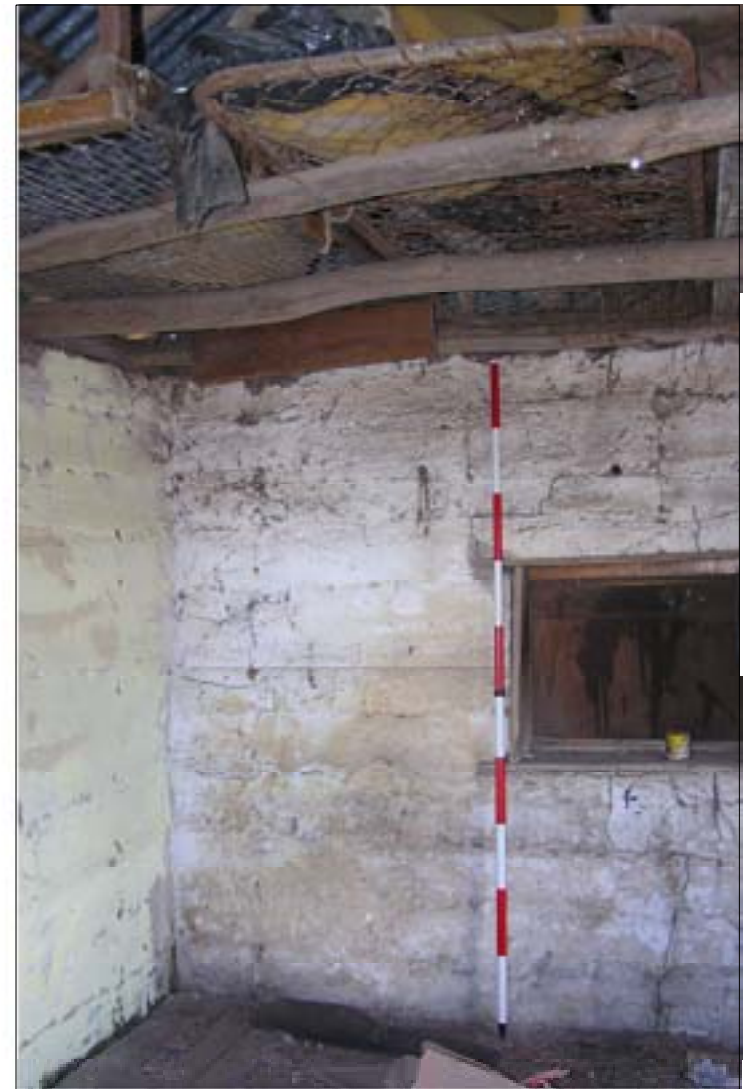
**PLATE 2.24**  
Site MRNH5  
Internal view of western wall of pisé building. Scale 200mm

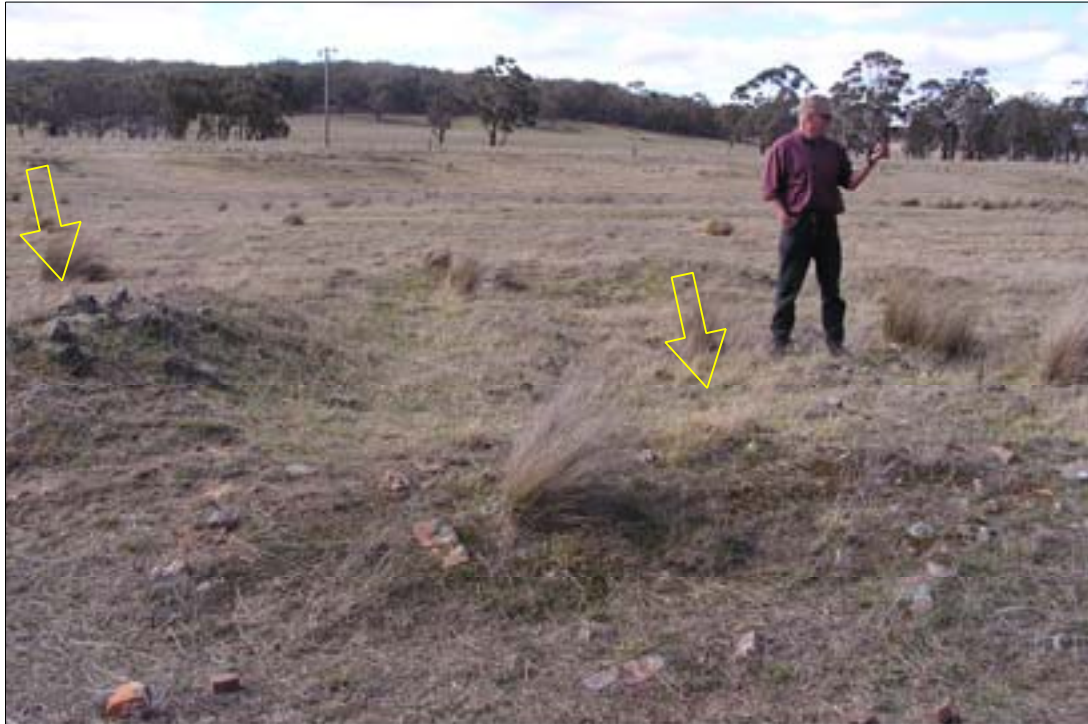
**PLATE 2.25**  
**Site MRNH6**

Bricks observed on the surface were clearly hand pressed with a rectangular frog mark. There is a marked variation in the colour of bricks, from deep brown to yellow, an indication of uneven heat distribution during firing, which is consistent with clamp firing.

**Mounds of brick benches of former brick clamp as indicated by arrows. Facing north east**

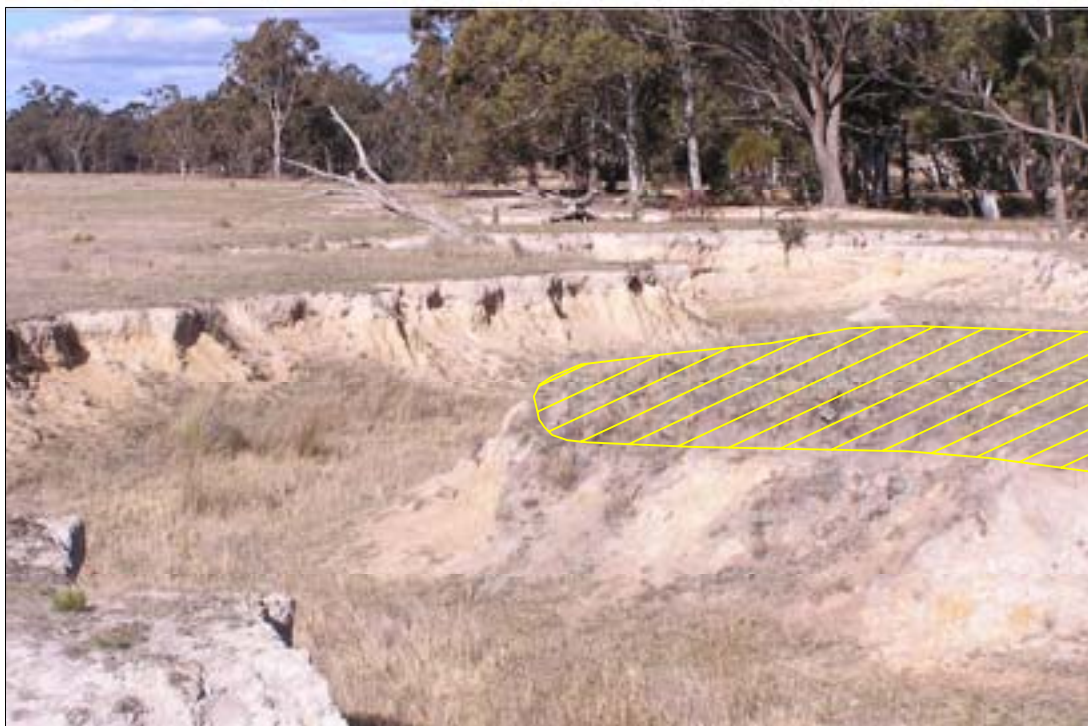
**PLATE 2.26**  
**Site MRNH6**

**View along drainage line showing possible brick discard pile on southern bank as indicated by hatching. Facing east**

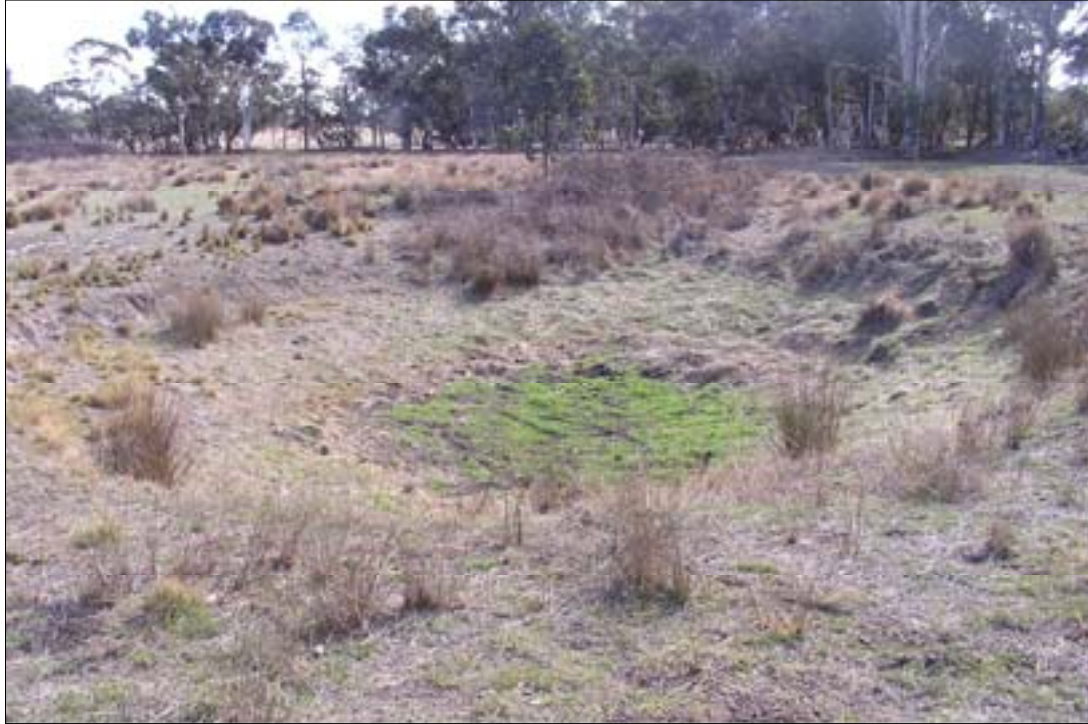
**PLATE 2.27**  
**Site MRNH7**

**View of possible claypit, thought to be associated with brick clamp. Facing south.**

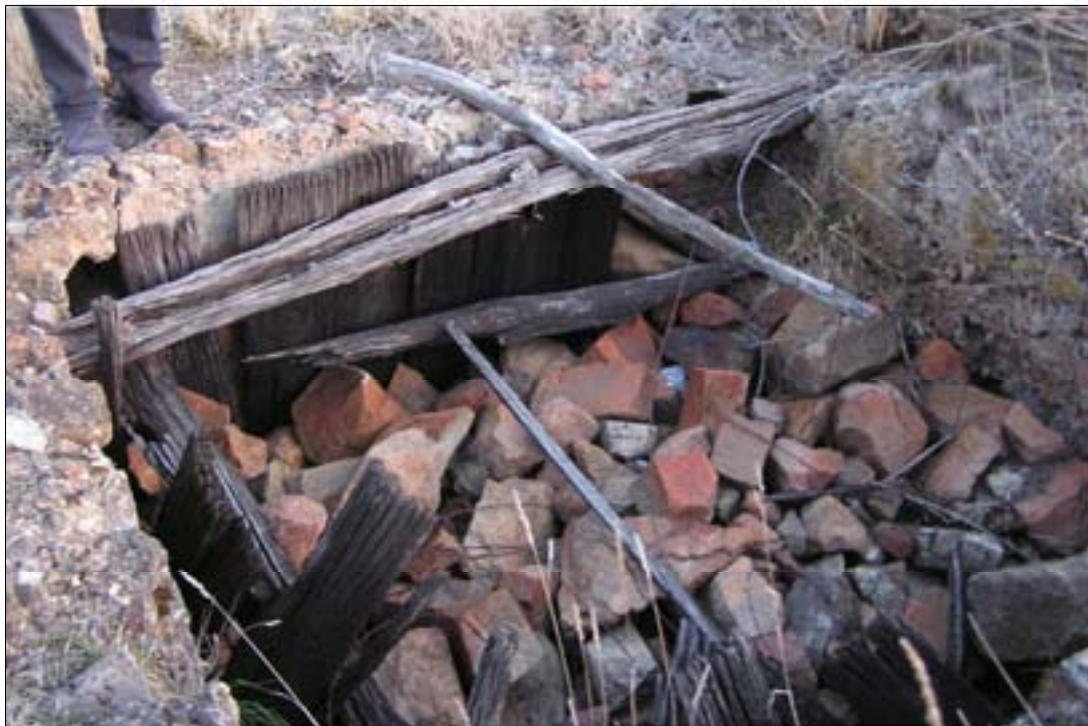
**PLATE 2.28**  
**Site MRNH8**

This site was located in the road reserve along the eastern alignment of the Hume Highway. It consisted of an approximately 2.5 metre square cistern/well lined with concrete and timber. **Plate 2.28** provides a view of the item which appears to have been filled with rubble, possibly at the time of the highway duplication in the 1980s.

**Cistern/well located in RTA easement along eastern side of Hume Highway.**

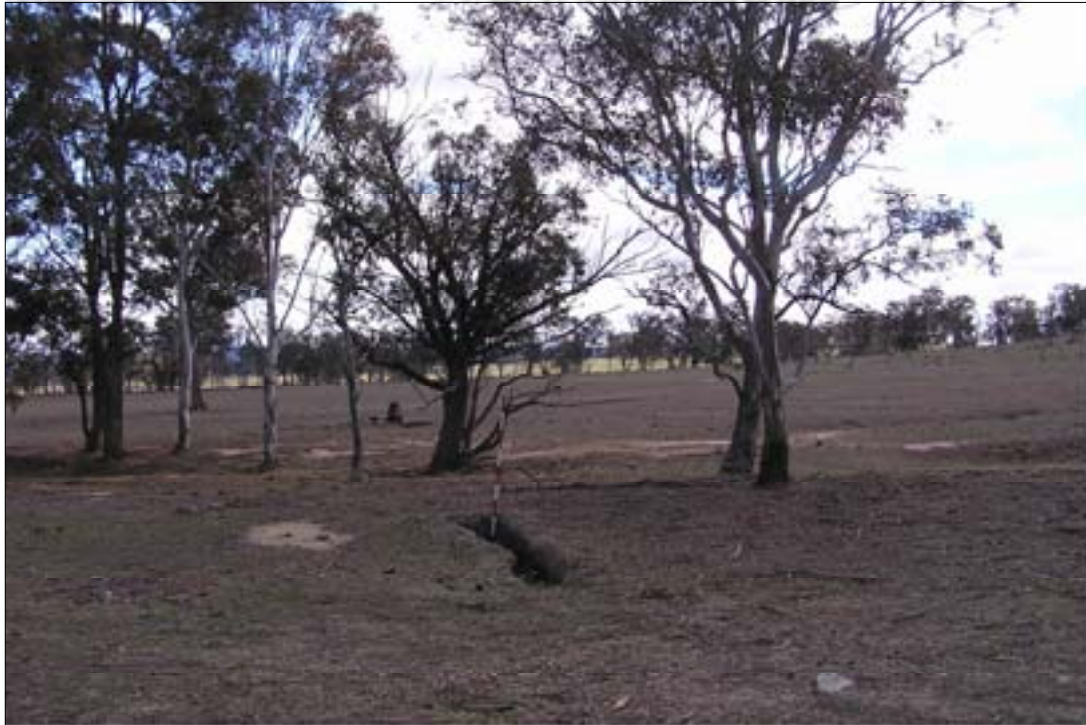
**PLATE 2.29**  
Site MRNH9  
Concrete sheep dip in its context. Facing north west. Scale 200mm
