### Historic Heritage Assessment

# **Non-Indigenous Archaeology Assessment Proposed Lynwood Quarry, Marulan**

May 2005

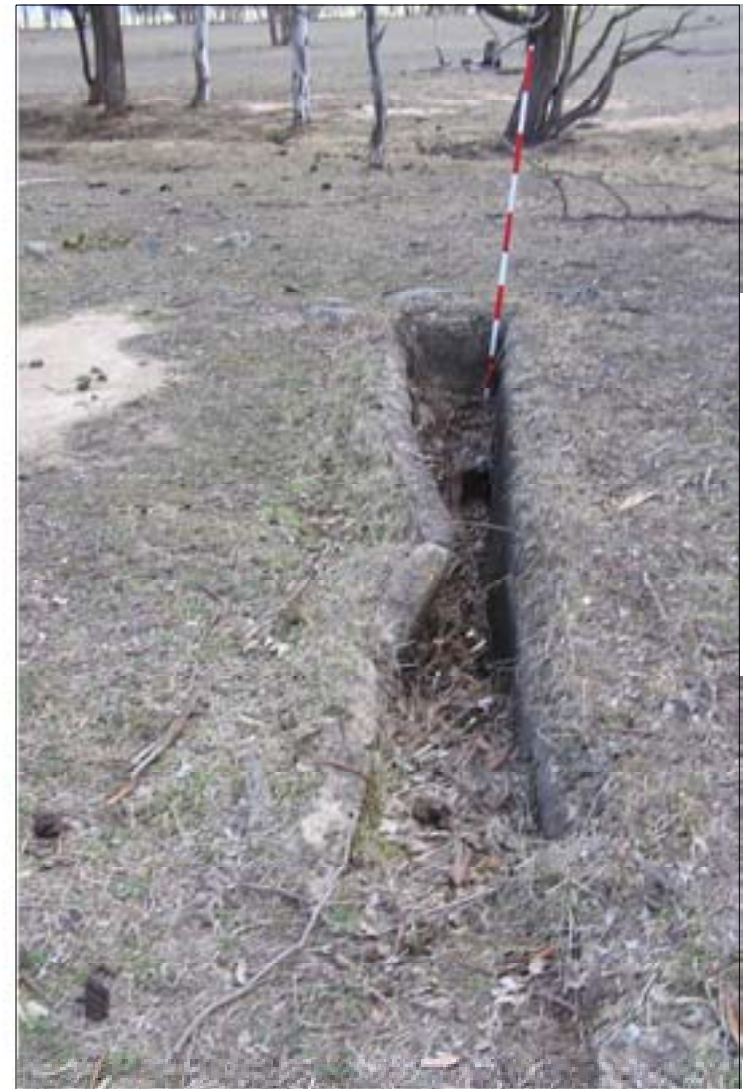
**PLATE 2.30**  
Site MRNH9  
Detail view of sheep dip. Facing north west. Scale 200mm

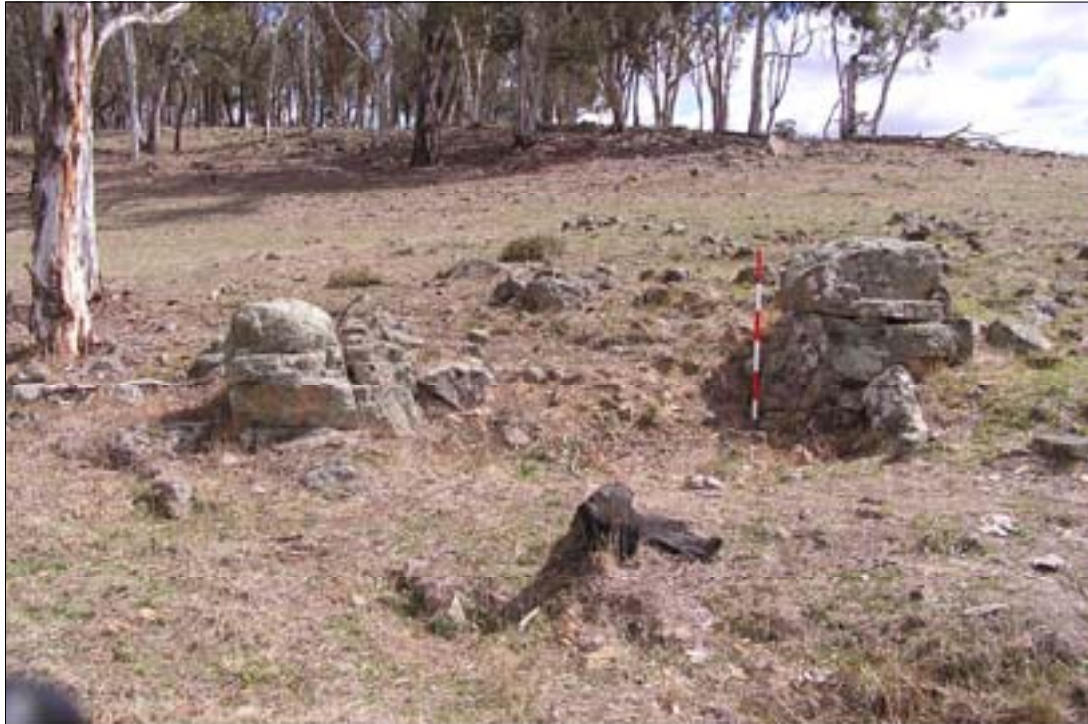
**PLATE 2.31**

The surface geology at this location consisted of isolated outcrops of porphyritic rock which typically fracture along horizontal and vertical joints, facilitated by water and ice action in cold climates. There is evidence of this type of weathering at this location causing blocks of rock to break away from the outcrops. There is no visible evidence to support the breaking or removal of rock by quarrying activities.

**View of the rock outcrop in its context. Facing north. Local folklore maintains this site to be a convict stone quarry. Scale 200mm**

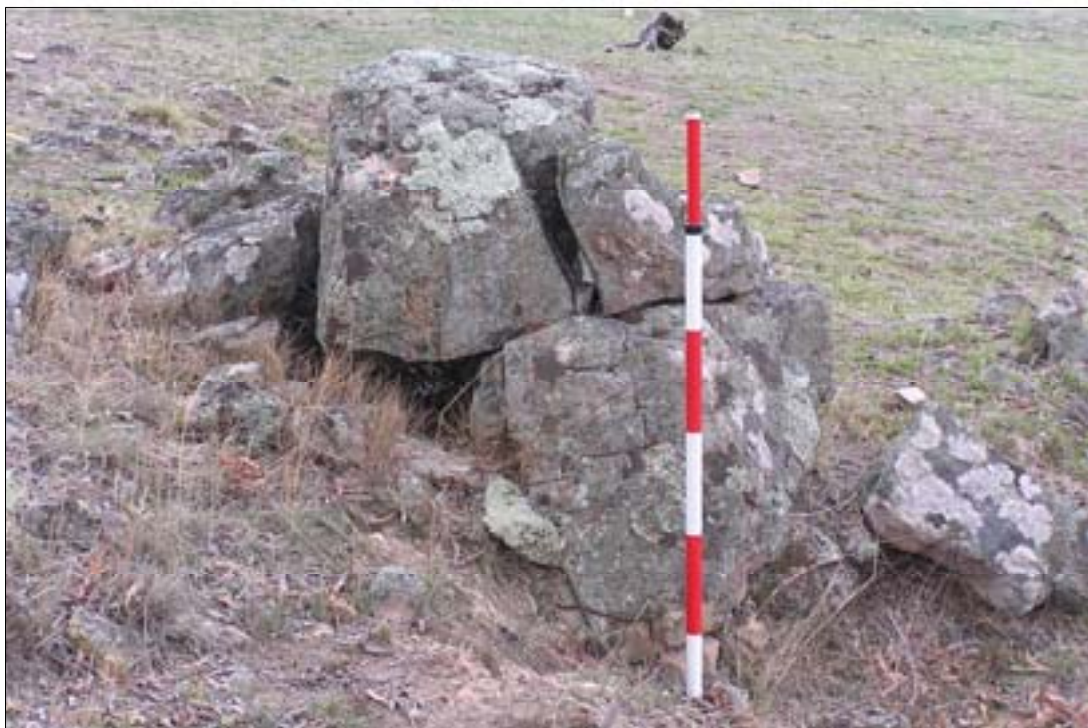
**PLATE 2.32**

**Detail view of rock outcrop showing fractures and weathering**
