# Corangamite Water Skink Management Plan - Stage 5 and Stage 6

Colac Quarry Extension (WA158), Victoria

1 February 2021

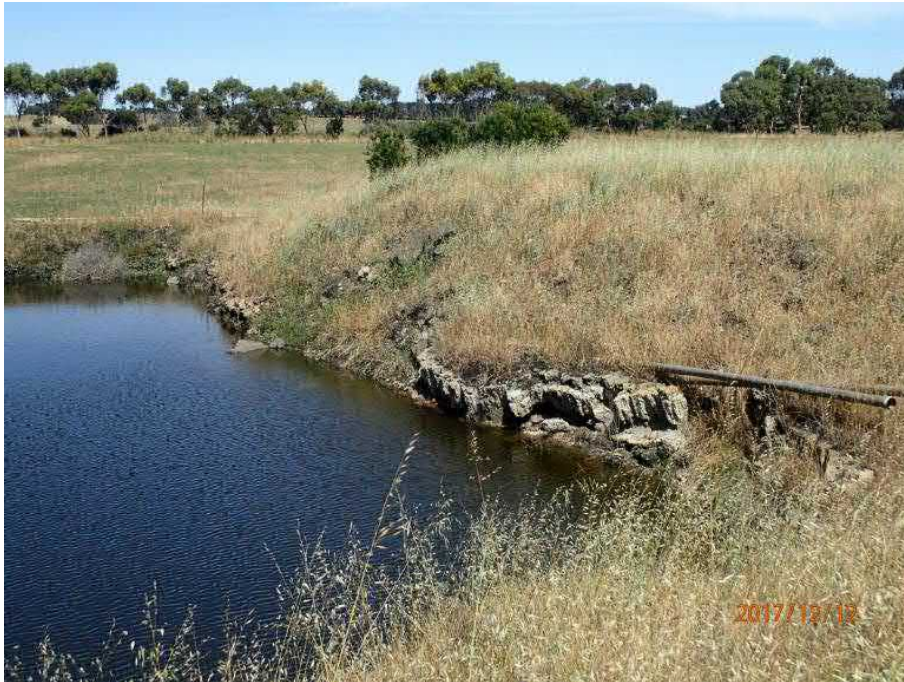
A small dam within Stage 5 supports optimal habitat features for Corangamite Water Skink with an open body of water fringed with rocks and earth cavities (Plate 1). The dam is fed with water pumped from the active quarry (quarry manager, Holcim, pers. comm.) through a pipe into a short section of open rock-lined channel leading into the dam. The dam is surrounded by mounded earth and rocks which are mostly embedded rather than on the surface. One Corangamite Water Skink was observed at this location in December 2017 (AECOM 2020) and again in early 2020 (Biosis 2020).

**Plate 1- Habitat occupied by Corangamite Water Skink in Stage 5 expansion area**

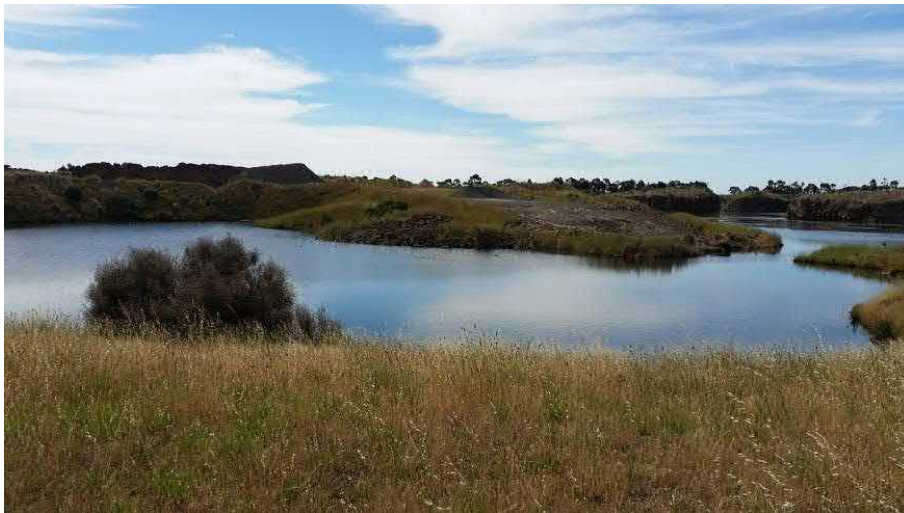
To the immediate west of Stage 5 is an area of the former quarry pit (Basin 6) which was the site chosen for creation of Corangamite Water Skink habitat as part of the implementation of the SDA management plan. Corangamite Water Skink have been recorded in the created habitat since 2015/16 (Biosis 2018, 2020; AECOM 2020).

**Plate 2- Corangamite Water Skink habitat in Basin 6 to the west of the Stage 5 extension area**

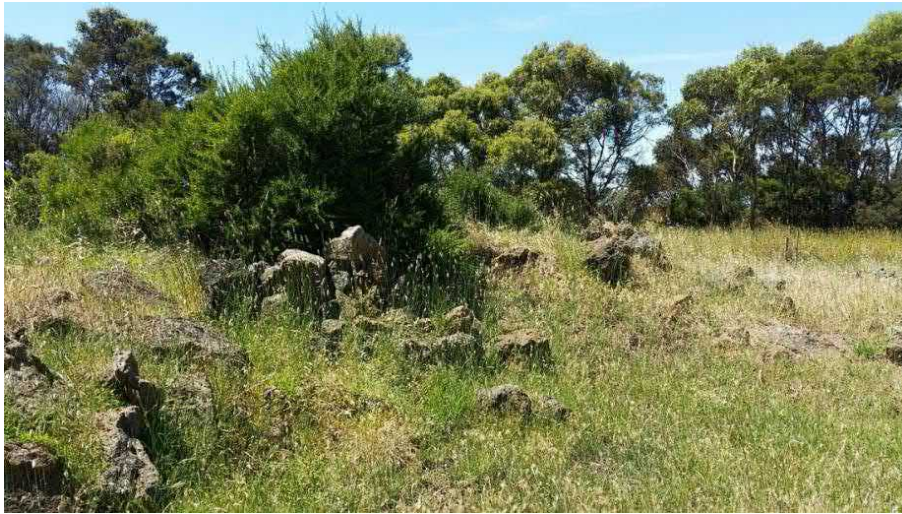
One structurally complex stony knoll occurs in Stage 6 (Figure 2- Appendix A) however it is not adjacent to water and is therefore considered to be sub-optimal habitat for Corangamite Water Skink on the basis of the findings of previous monitoring (Biosis 2017; 2018).

**Plate 3- More complex stony knoll habitat (Stage 6) - sub-optimal habitat as it is not adjacent to water**

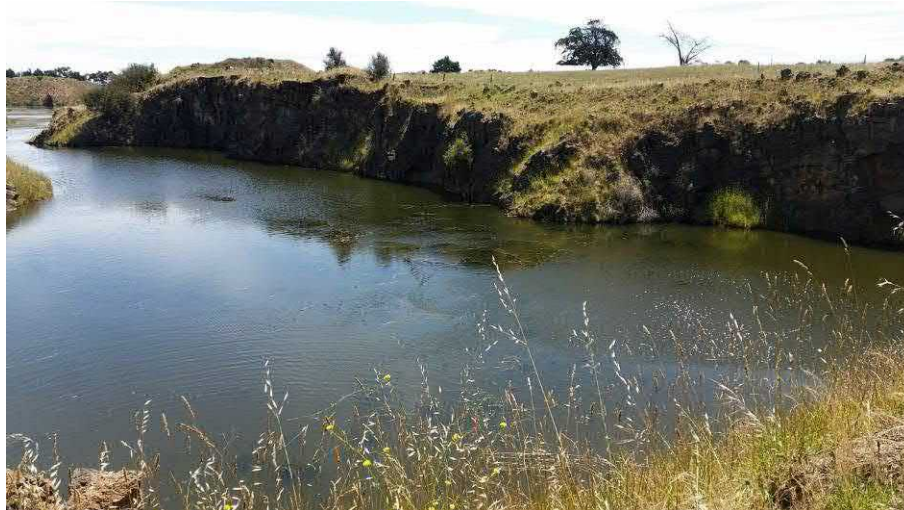
Corangamite Water Skinks within the former quarry pit have typically been observed either in jumbles of rocks in the base of pits, adjacent to the bottom of pit walls or on dissected rocky faces of walls. The plateau above the pit walls does not generally provide suitable microhabitat (I. Smales, Biosis, pers comm.).

**Plate 4- Corangamite Water Skink habitat on northern wall of Basin 5 (southern edge of Stage 6).**

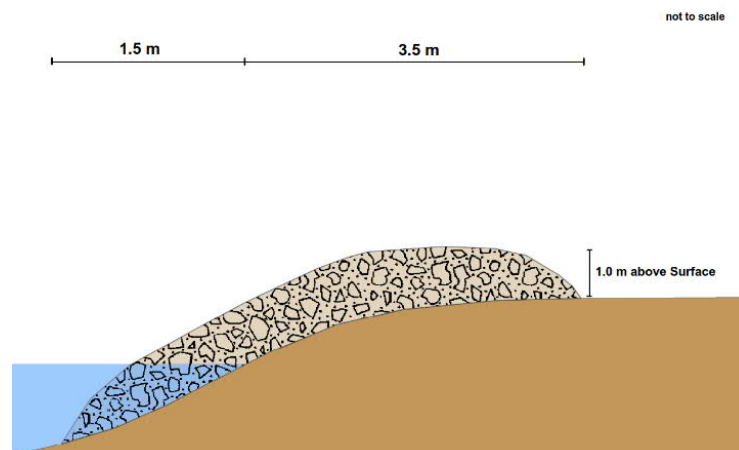
Figure 5 Conceptual drawing of habitat creation

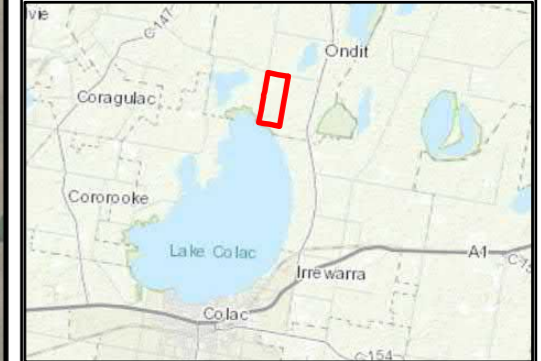
**SITE LAYOUT**

- Work Authority Area - WA158
- Stages 5 and 6 Extraction Areas
- Haul Road
- Bund/ water control barrier RL120
- Stockpile Area
- Approved Limit of Extraction
- Approved Disturbance Boundary
- Contours mAHD
- Watercourse
- Waterbody

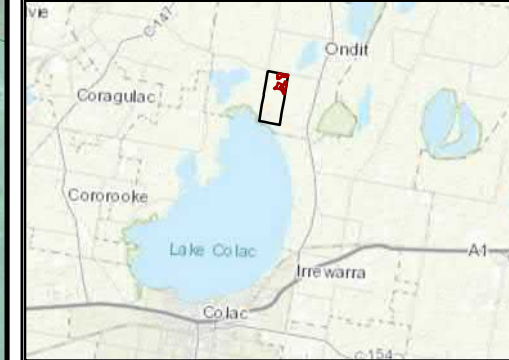
**CORANGAMITE WATER SKINK RECORDS**

- Work Authority Area - WA158
  - Stages 5 and 6
  - Assessment Area
  - Haul Road
  - Proposed Bund RL120
  - Approved Limit of Extraction
  - Approved Disturbance Boundary
  - Contours mAHD
  - Contour 118mAHD
  - Watercourse
  - MapshareVIC Current Mapped Wetland
- Corangamite Water Skink Records**
- Biosis Post-2016/17 Observations (Biosis 2018; 2020)
  - Biosis pre-2016/17 Observations (Biosis 2005; 2018; 2020)
  - AECOM 2017 Assessment
- Corangamite Water Skink Habitat**
- Optimal Habitat
  - Sub-Optimal Habitat

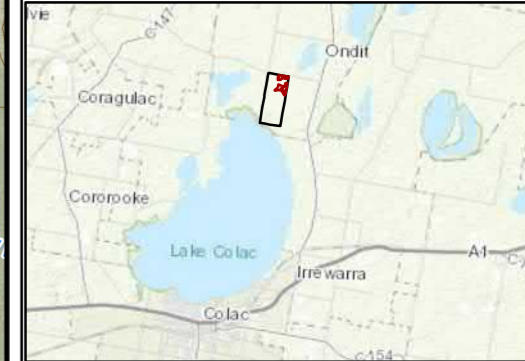
**CORANGAMITE WATER SKINK  
 POTENTIAL IMPACT  
 AND MITIGATION**

- Work Authority Area - WA158
  - Stages 5 and 6
  - Haul Road
  - Proposed Bund RL120
  - Approved Limit of Extraction
  - Approved Disturbance Boundary
  - Contours mAHD
  - Contour 118mAHD
  - Watercourse
- Corangamite Water Skink**
- Suitable Habitat (Stage 5 & 6)
  - Sub-optimal Habitat with historic record (Stage 5&6)
  - Pre-2016 Occupied Habitat (with buffer on CWS record)
  - Post-2016 Occupied Habitat (with buffer on CWS record)
  - Habitat Created 2008 for SDA
  - Habitat Offset created for habitat loss (to extent above 118mAHD)
  - Habitat Offset to be created during rehabilitation (indicative)
  - Supplementary Habitat Created to mitigate Water Level Increase
