Annual Environmental Management Review (AEMR)

Dunloe Sands Quarry 2016 – Revision

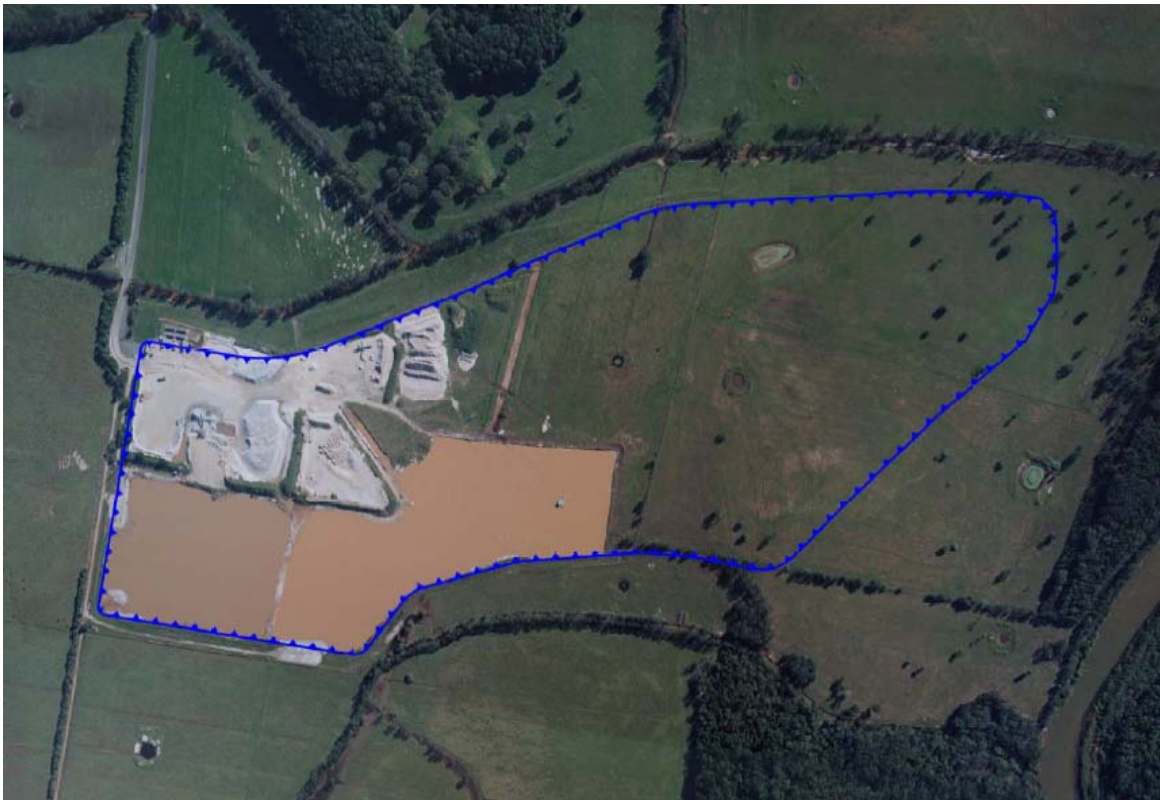
Figure 1 Extraction boundary and extraction activity

Figure 1 shows the extraction boundary with the site extraction activities in late 2017. Figure 2.1 is the site location within a regional context as well as the site plan.

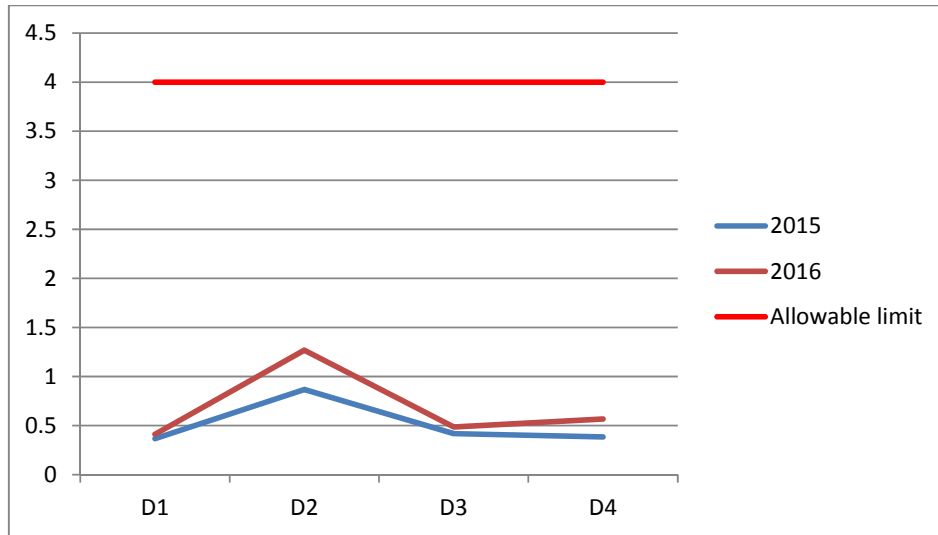
Figure 2 Historical comparison of DDG annual average data

Holcim only has access to the dust deposition data from 2015 and 2016 for historical comparisons. As can be seen in Figure 2 and Figure 3 below, the data shows consistently low levels of dust being contributed across all monitoring locations.

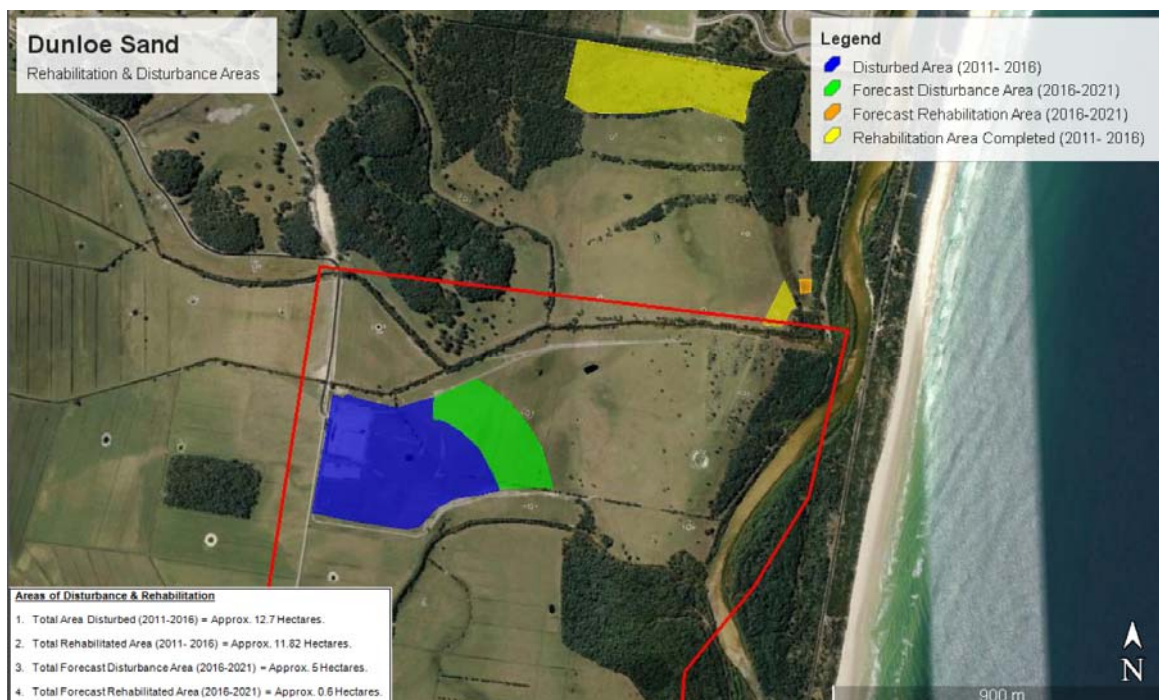
Figure 4 Rehabilitation and disturbance area

At the time of reporting, there was not enough information from previous data sets to show any trends or significant changes in the revegetated areas. Further to this, when Holcim began managing the site and reviewed the monitoring record sheets, concerns the Department have regarding the quality of the detail were shared. This was to be addressed with Ramtech in 2017 with performance to be reviewed.

In 2018 or 2019, there is expected to be enough information to determine how progressive the rehabilitation is, whether it is as expected and what improvements, if any, can be made to ensure success in these areas. The data analysis will be provided in future annual returns.
