Cooma Road Quarry Annual Review 2017

Holcim (Australia) Pty Ltd

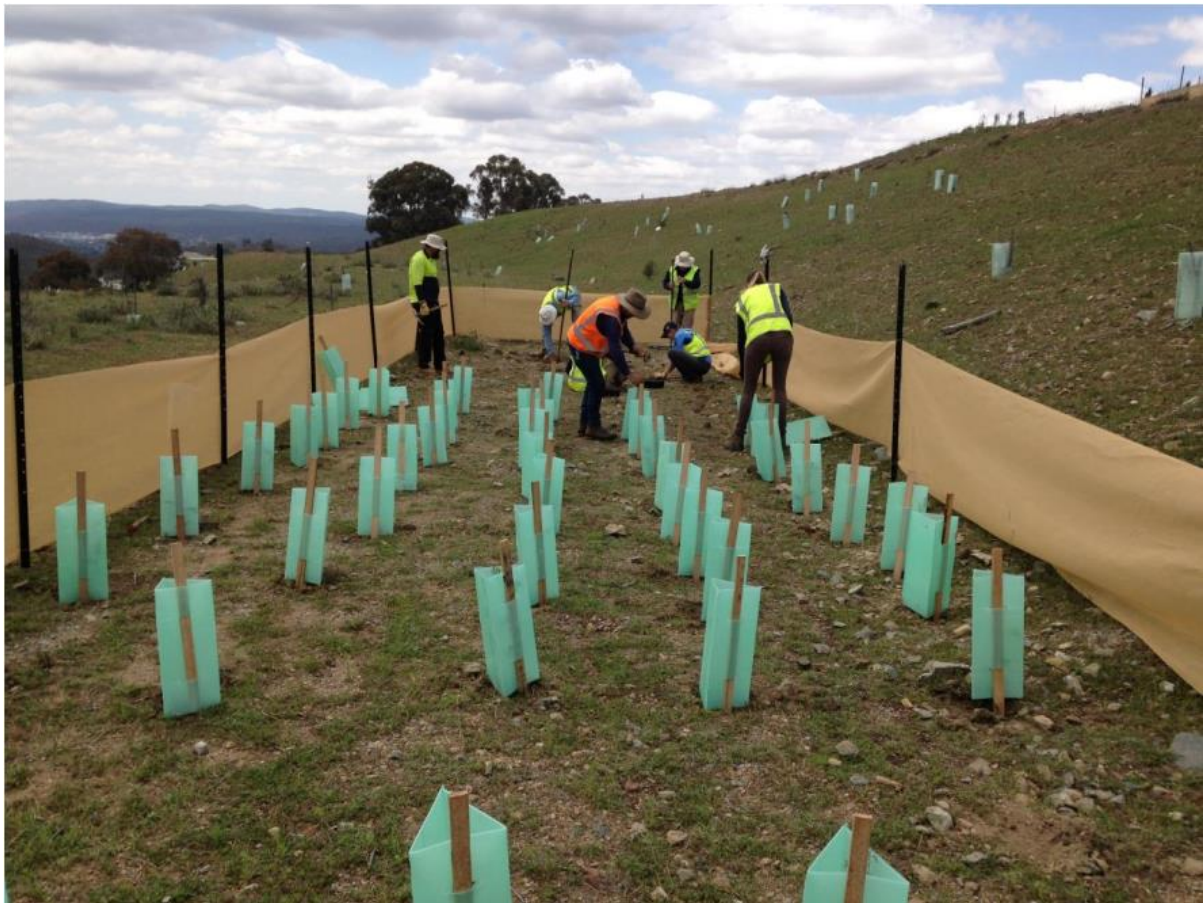
Figure 3: Seedling planting with CVA at the Cooma Road Quarry in 2017

During 2017 Holcim partnered with CVA with the planting of native seedlings at the Cooma Road Quarry. This re-vegetation project is ongoing with CVA volunteers planting native trees on and around the Quarry site in 2017. Further planting is proposed in 2018. This area equated to a planting area of 200m² (0.02Ha)

The 2017 IEA observed that progressive rehabilitation appears to have been maximised at the Cooma Road Quarry with topsoil application and revegetation occurring for the majority of non-operational areas. All areas that are finalised have been stabilised, however some not to the final land-use state, and others requiring some re-vegetation. Holcim will continue to work towards achieving all rehabilitation objectives at the quarry in 2018 through rehabilitation maintenance.

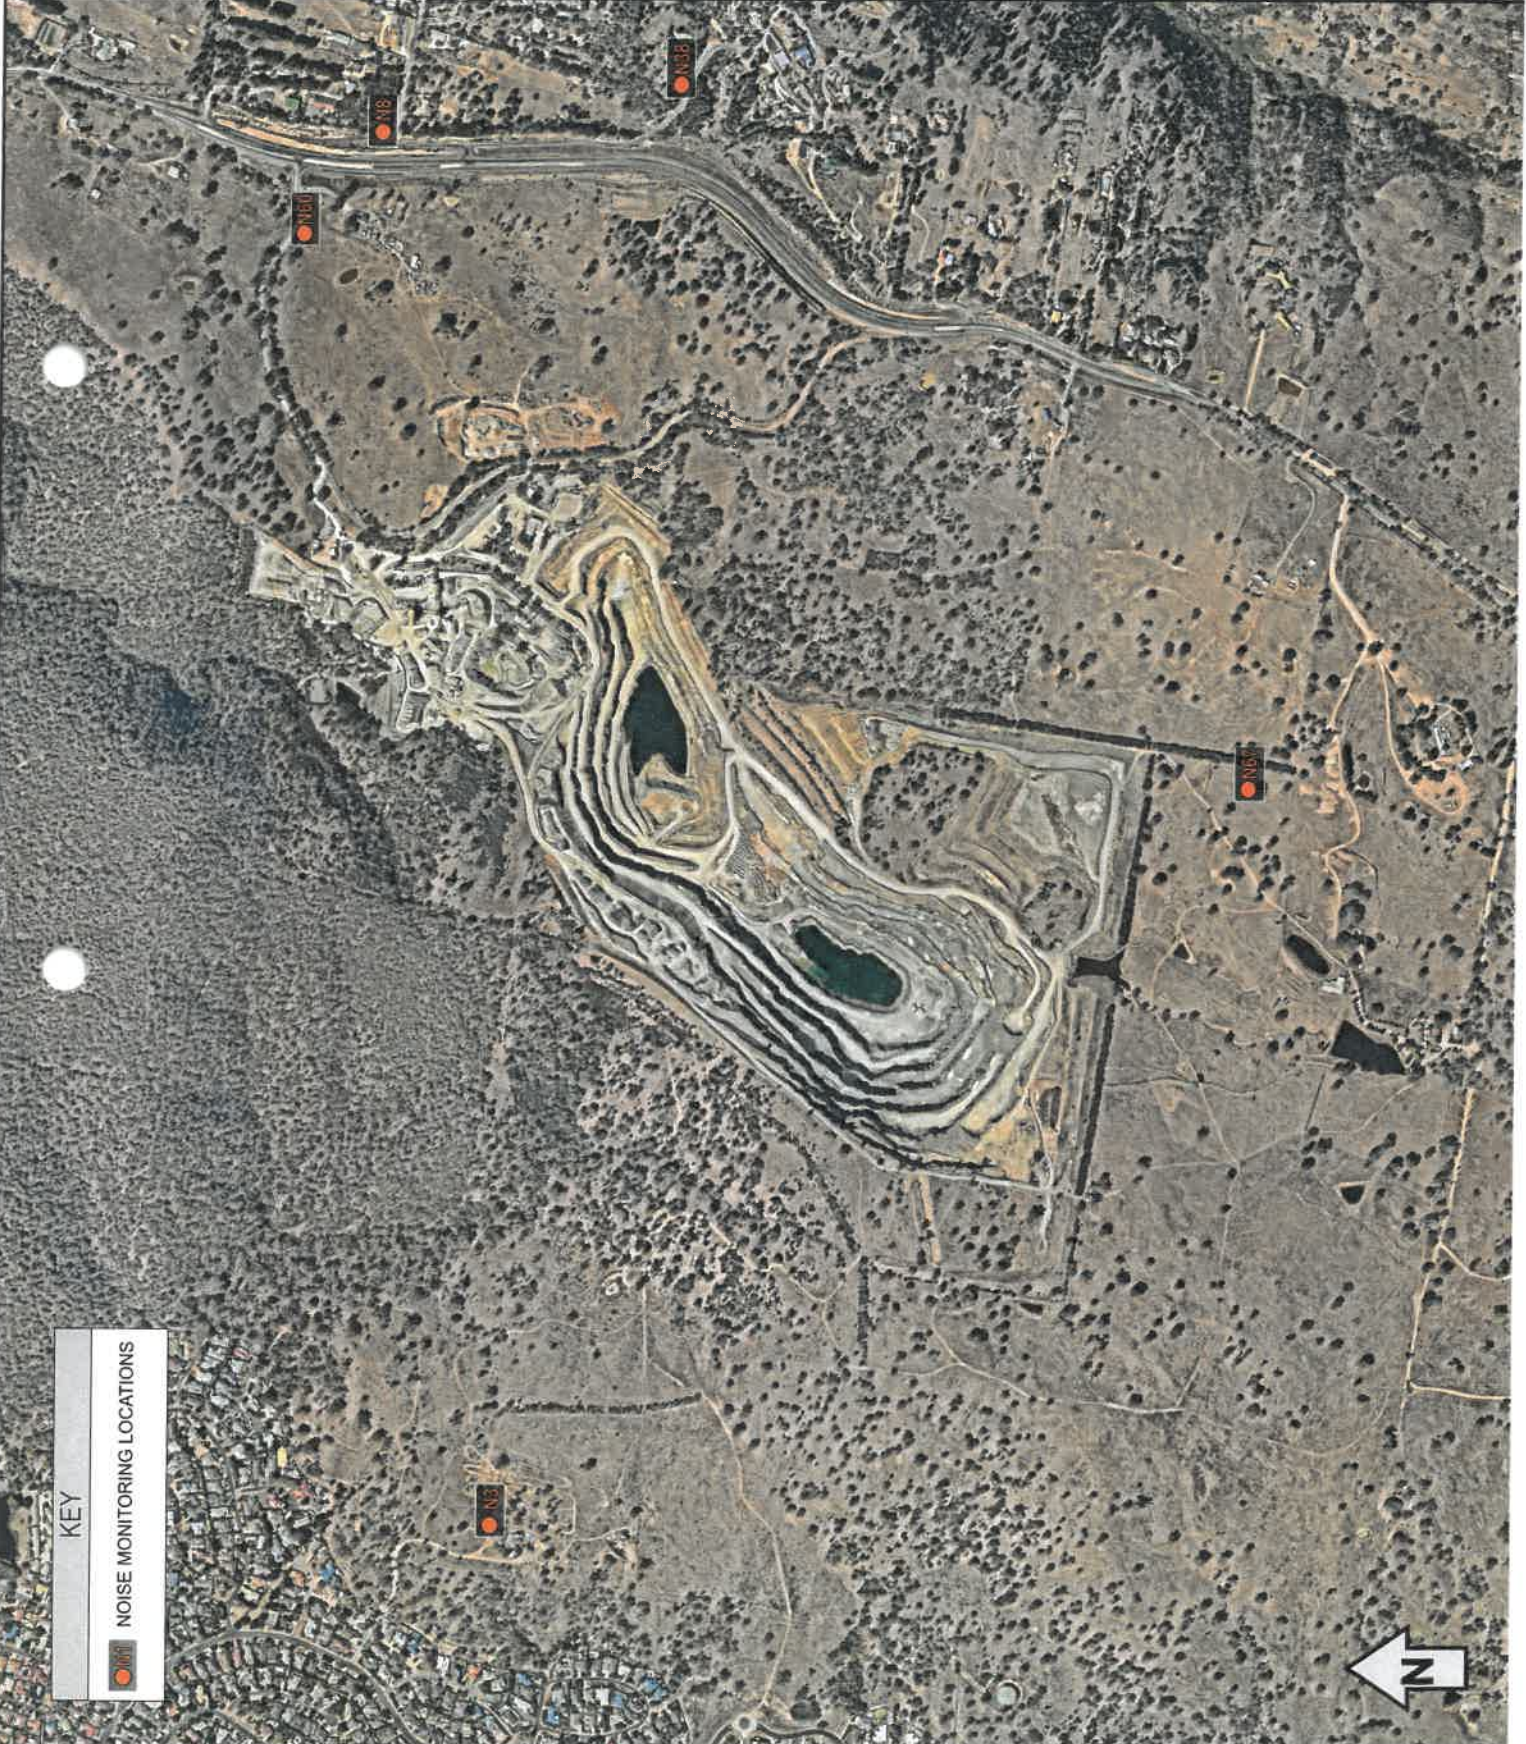
LOCALITY PLAN

NOISE MONITORING LOCATIONS

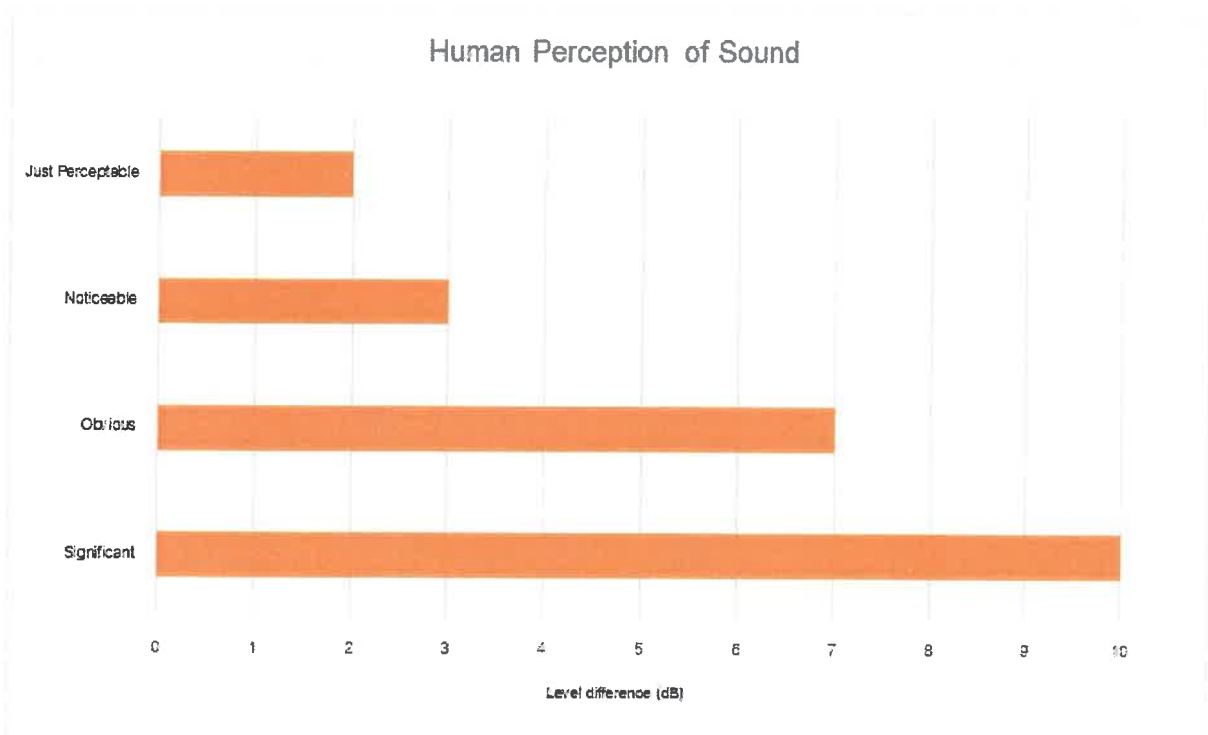
Figure A1 – Human Perception of Sound

Table A2 Common Noise Sources and Their Typical Sound Pressure Levels (SPL), dBA	
Source	Typical Sound Level
Threshold of pain	140
Jet engine	130
Hydraulic hammer	120
Chainsaw	110
Industrial workshop	100
Lawn-mower (operator position)	90
Heavy traffic (footpath)	80
Elevated speech	70
Typical conversation	60
Ambient suburban environment	40
Ambient rural environment	30
Bedroom (night with windows closed)	20
Threshold of hearing	0

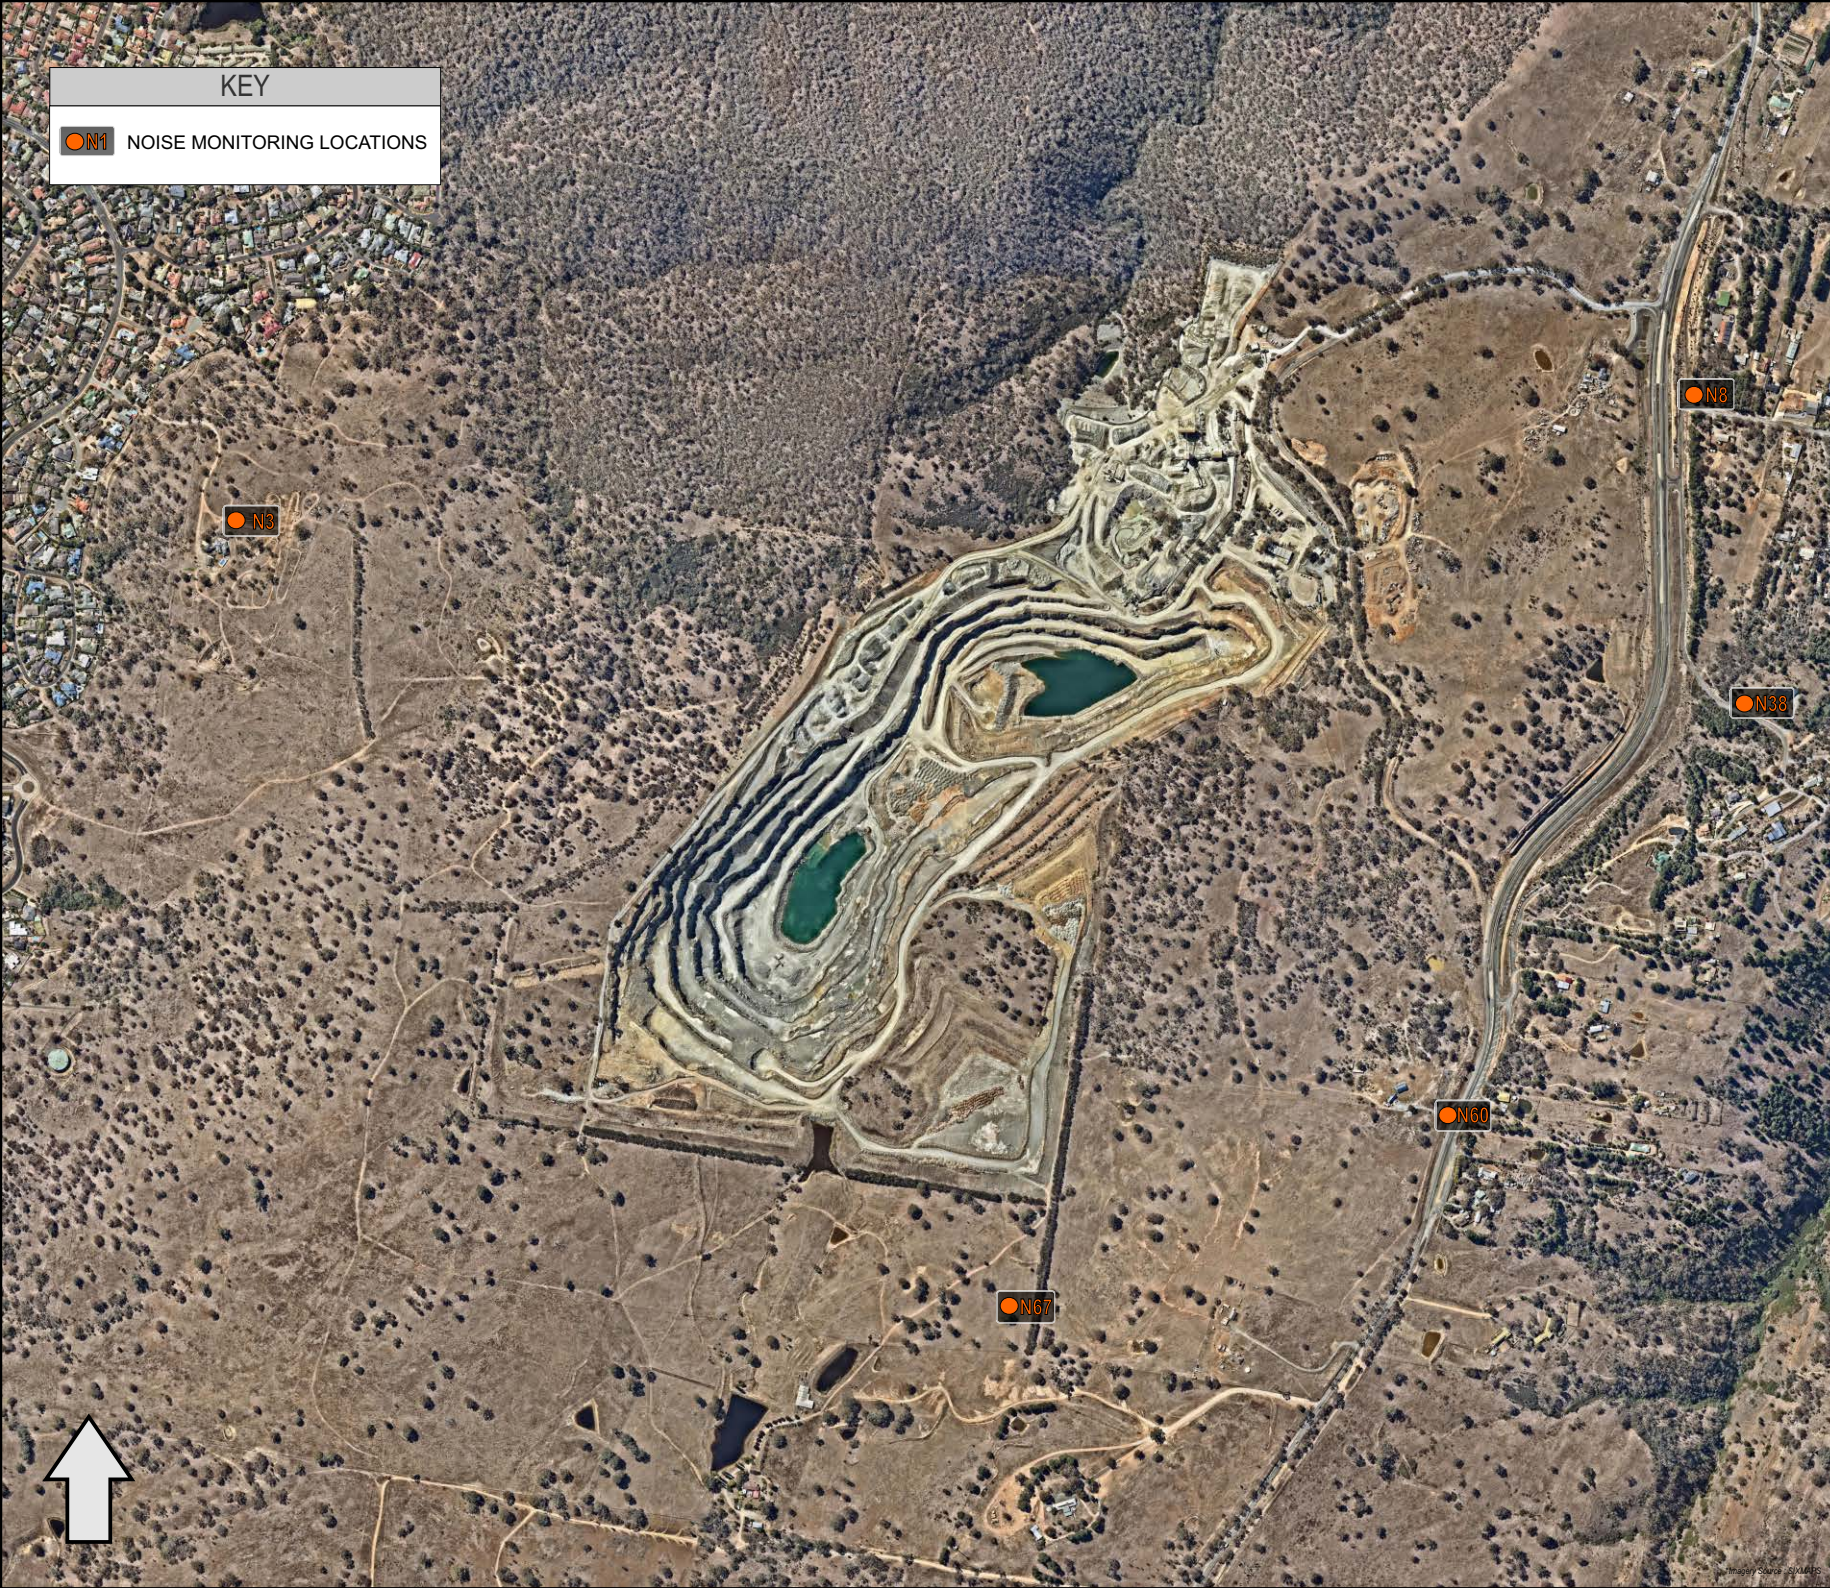
● N1 NOISE MONITORING LOCATIONS

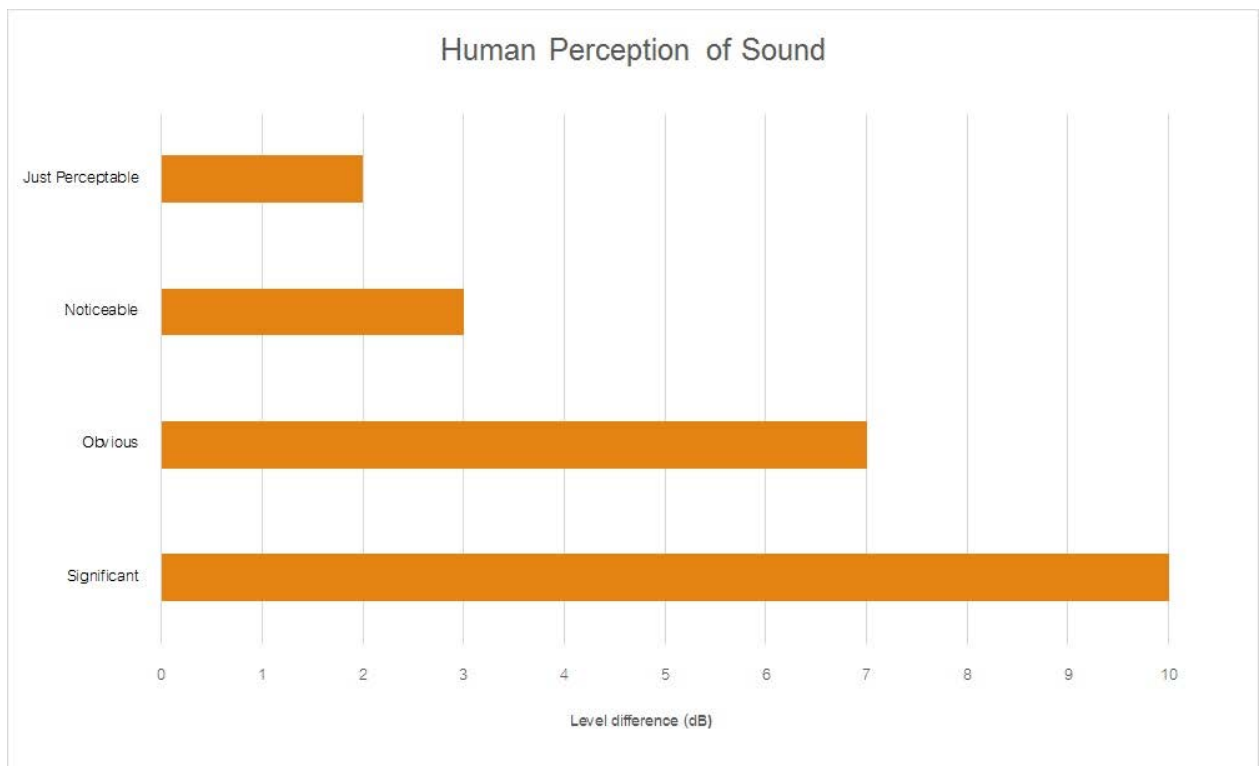
Figure A1 – Human Perception of Sound

Table A2 Common Noise Sources and Their Typical Sound Pressure Levels (SPL), dBA	
Source	Typical Sound Level
Threshold of pain	140
Jet engine	130
Hydraulic hammer	120
Chainsaw	110
Industrial workshop	100
Lawn-mower (operator position)	90
Heavy traffic (footpath)	80
Elevated speech	70
Typical conversation	60
Ambient suburban environment	40
Ambient rural environment	30
Bedroom (night with windows closed)	20
Threshold of hearing	0

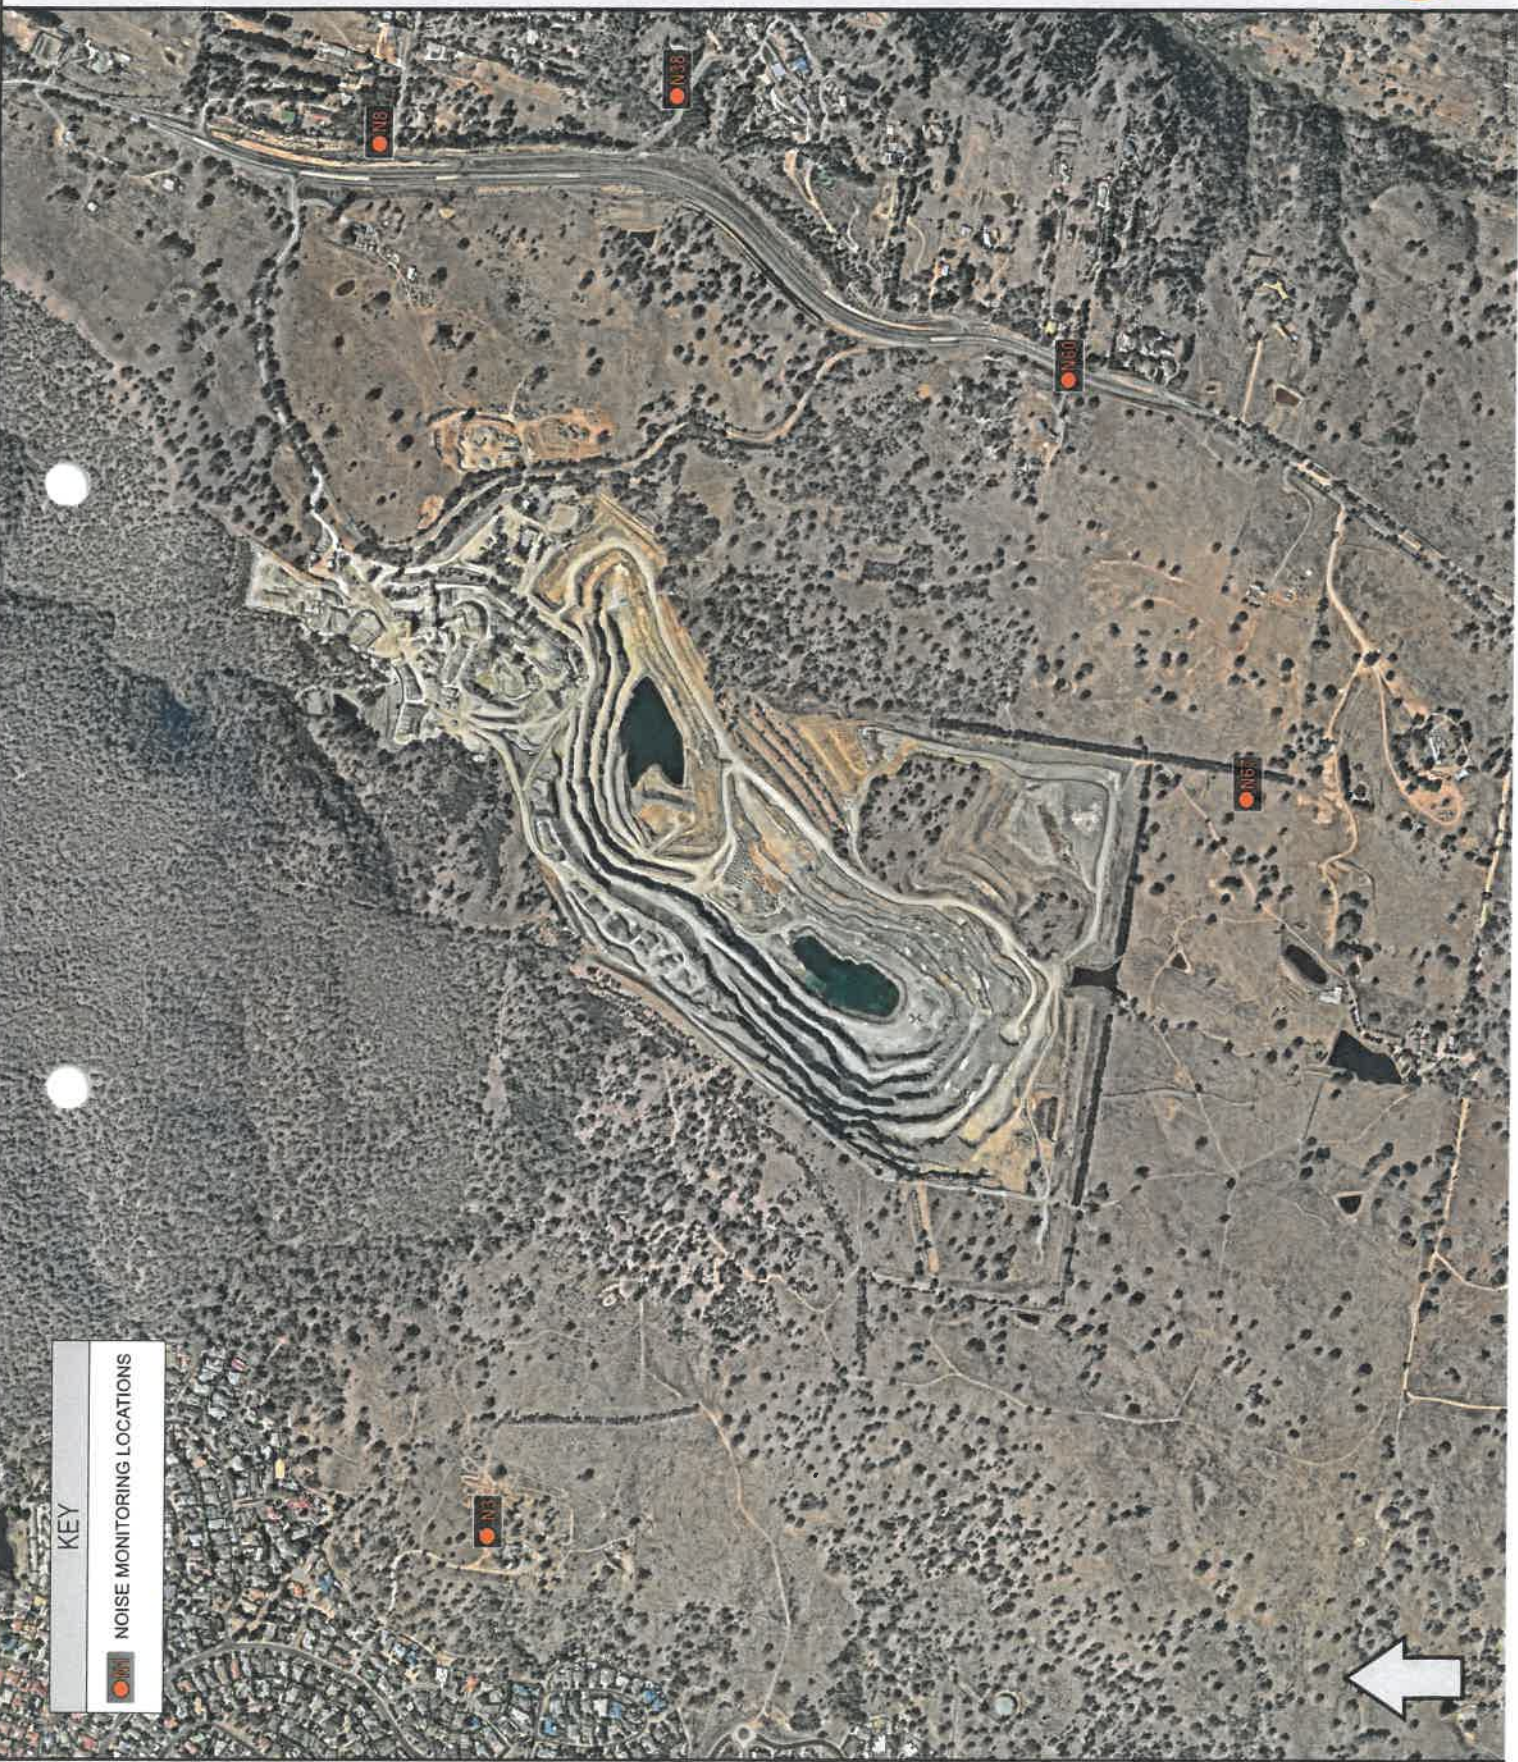
NOISE MONITORING LOCATIONS

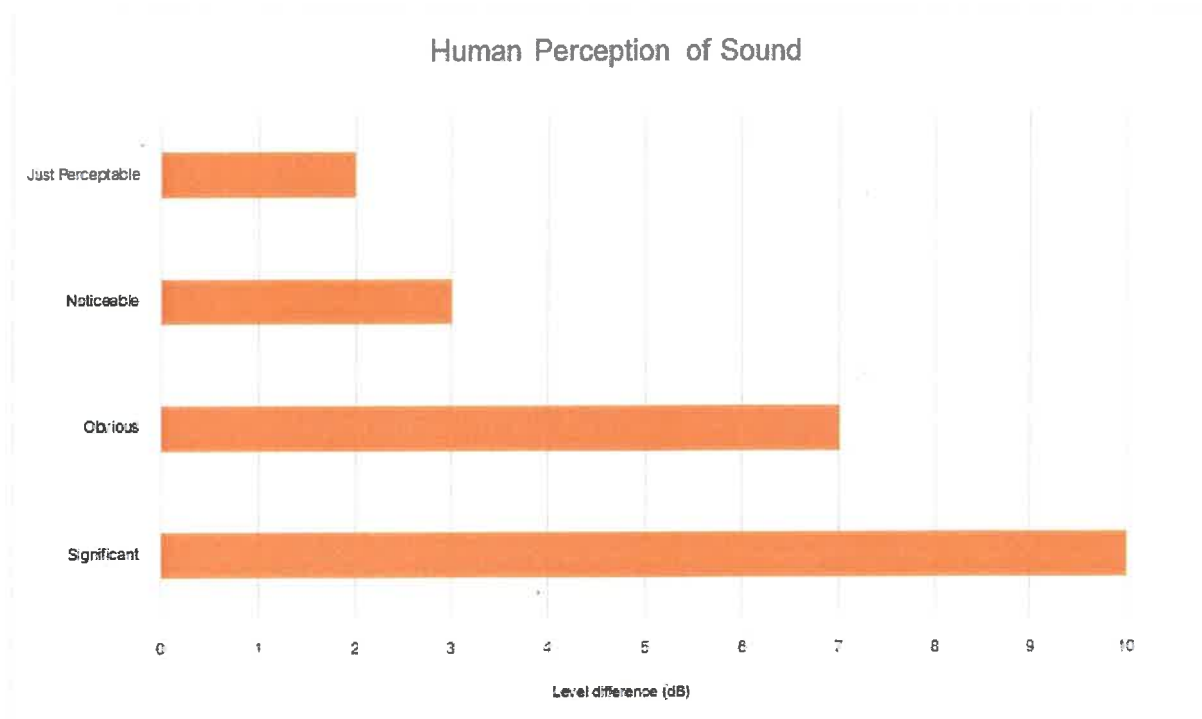
Figure A1 – Human Perception of Sound

Table A2 Common Noise Sources and Their Typical Sound Pressure Levels (SPL), dBA	
Source	Typical Sound Level
Threshold of pain	140
Jet engine	130
Hydraulic hammer	120
Chainsaw	110
Industrial workshop	100
Lawn-mower (operator position)	90
Heavy traffic (footpath)	80
Elevated speech	70
Typical conversation	60
Ambient suburban environment	40
Ambient rural environment	30
Bedroom (night with windows closed)	20
Threshold of hearing	0

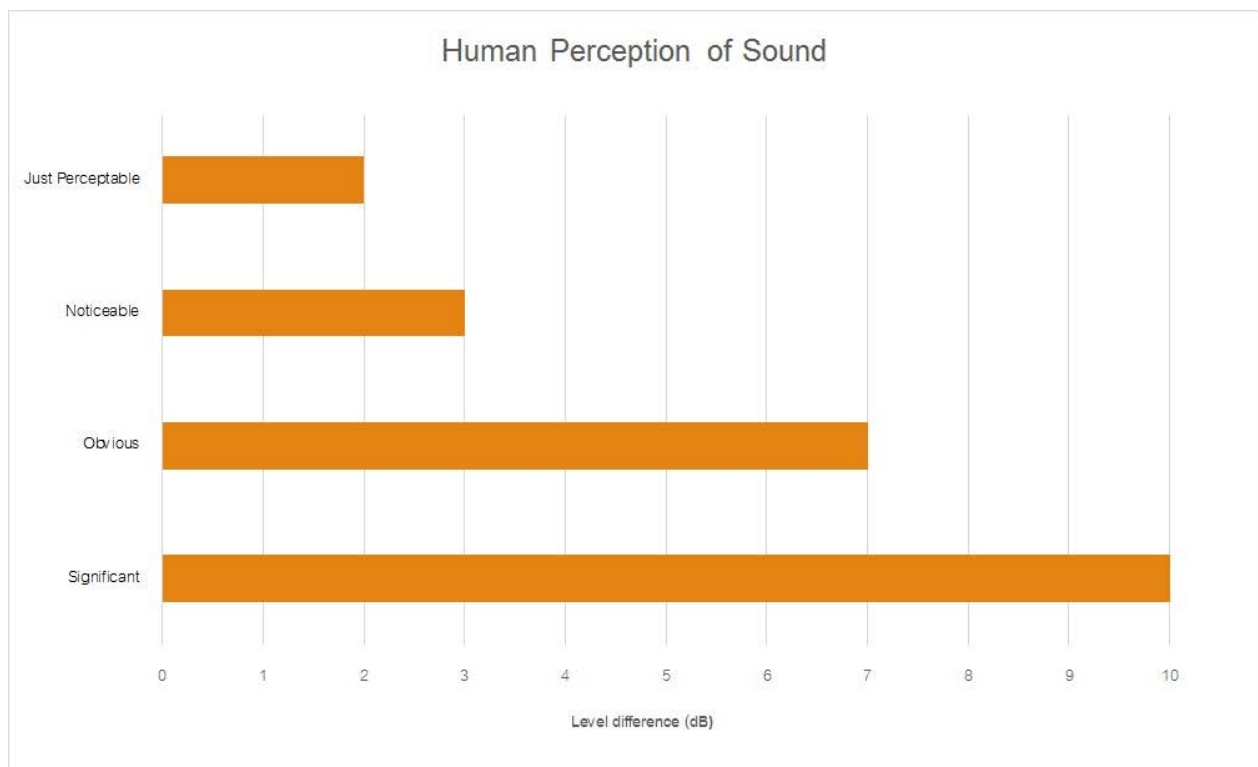
Figure A1 – Human Perception of Sound

Table A2 Common Noise Sources and Their Typical Sound Pressure Levels (SPL), dBA	
Source	Typical Sound Level
Threshold of pain	140
Jet engine	130
Hydraulic hammer	120
Chainsaw	110
Industrial workshop	100
Lawn-mower (operator position)	90
Heavy traffic (footpath)	80
Elevated speech	70
Typical conversation	60
Ambient suburban environment	40
Ambient rural environment	30
Bedroom (night with windows closed)	20
Threshold of hearing	0
