ANNUAL REVIEW

1 January 2020 – 31 December 2020

Cooma Road Quarry

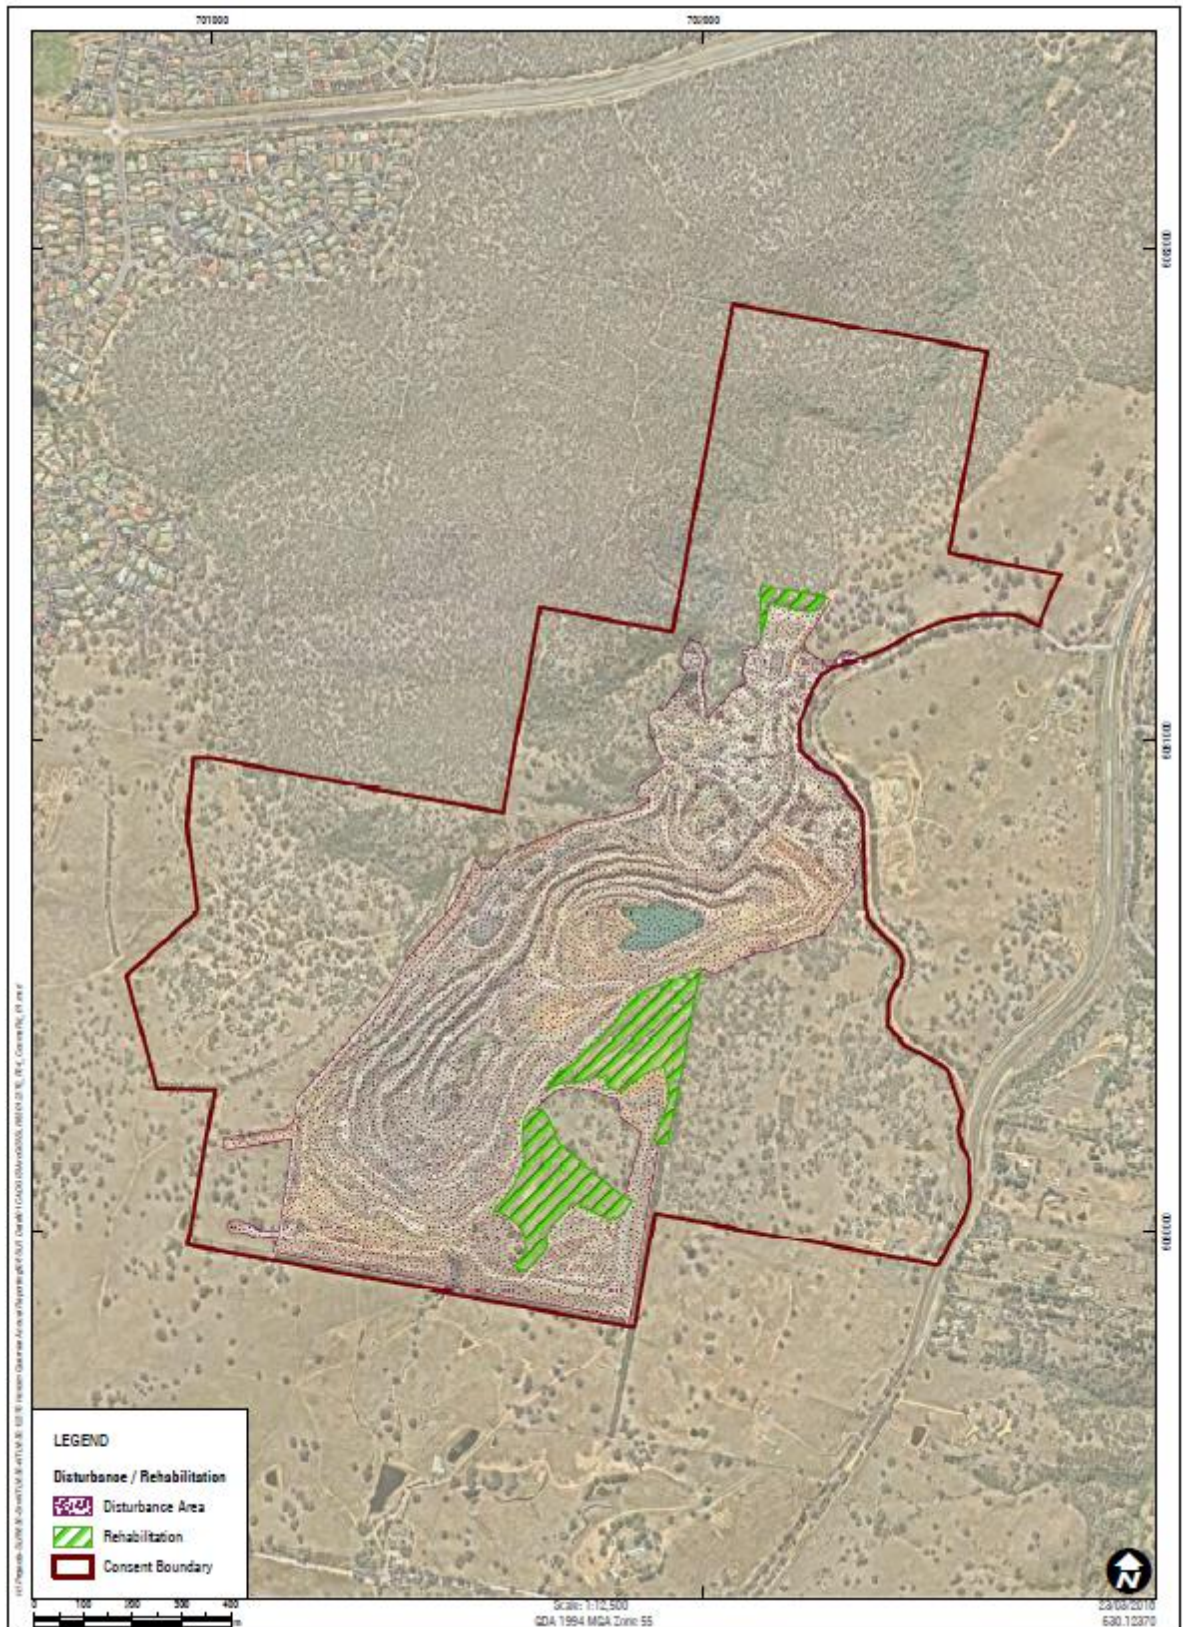
Figure 3: Current Disturbance and Rehabilitation

At the end of 2020 there was approximately 71.5 Ha of active disturbance and 7.6 Ha of active rehabilitation. There was no further disturbance or rehabilitation preparation activities done in 2020 which was primarily due to meteorological conditions including lack of rainfall. Cooma Road Quarry is proposing to prepare 0.5 ha for rehabilitation for the next reporting period. Continuous rehabilitation maintenance will be maintained into 2021.
