DUNLOE SANDS

Environmental Monitoring Report
November 2010 to April 2011

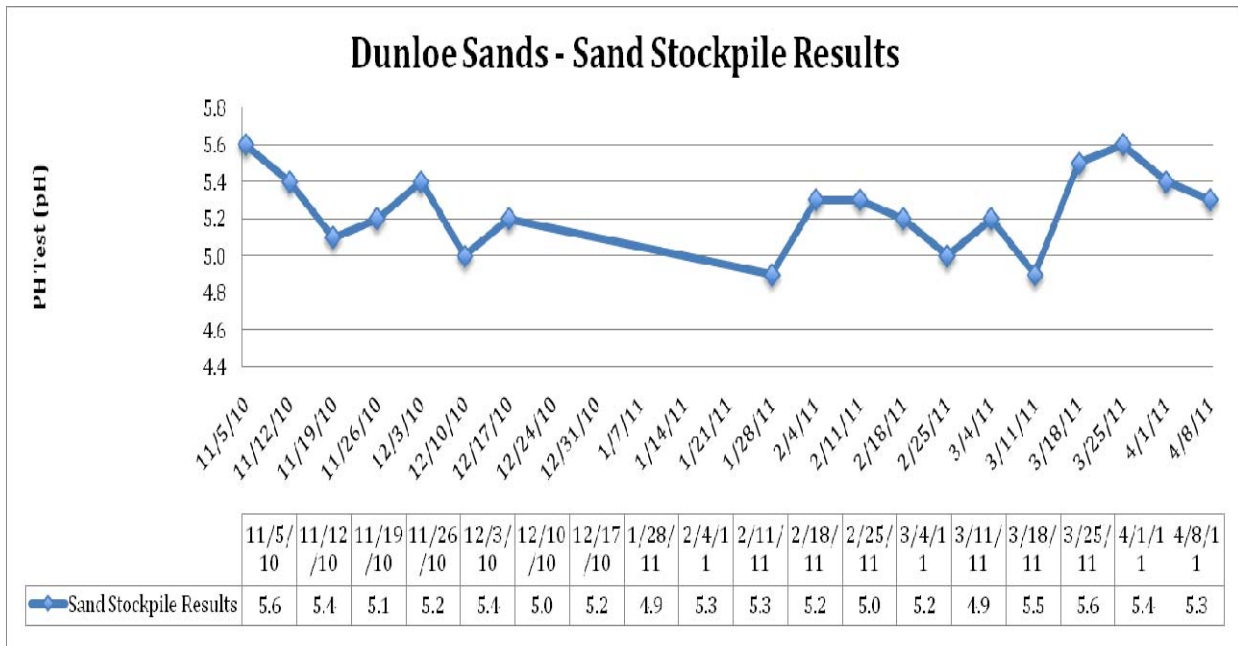
Figure 1: Dunloe Sands - Sand Stockpile (pH Test) Results November 2010 to April 2011

Figure 1 displays the results for November 2010 to April 2011. Results are displayed in pH levels at a weekly monitoring rate.

The results displayed show pH levels within the sand stockpile to be generally consistent. Over the six month monitoring period pH levels ranged between 4.9pH and 5.6pH. Analysing this graph against the total rainfall on site shows direct correlations illustrating that increased rainfall in the vicinity produce lower pH levels within the lake. This correlation explains the varied pH level results as rainfall over December and January are considerably higher than that of the other months within the monitoring period, although considerable rainfall was also experienced within the low peak noticeable in March.

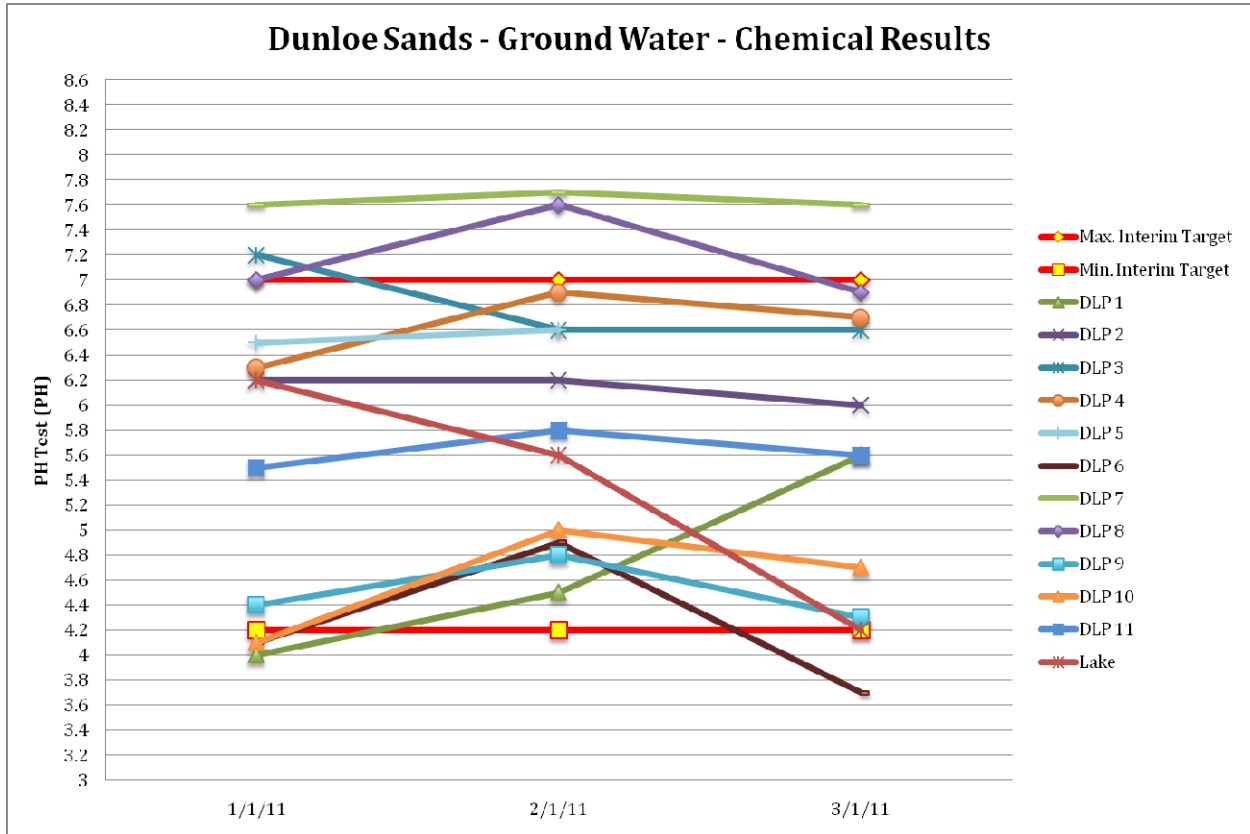
Figure 2: Dunloe Sands - Ground Water - Chemical (pH Test) Results January to March 2011

The EMP provided the interim target range regarding the pH levels of ground water sampling. The majority of the results displayed are between the minimum of 4.2pH and maximum of 7.0pH.

DLP 7 constantly sits outside the maximum levels by between .6 and .7pH presenting a lower (more alkaline) acidity level than that of the target level, whilst DLP 8 also lifted above the target level in February. This is not unexpected given that similar levels were experienced prior to construction within background testing.

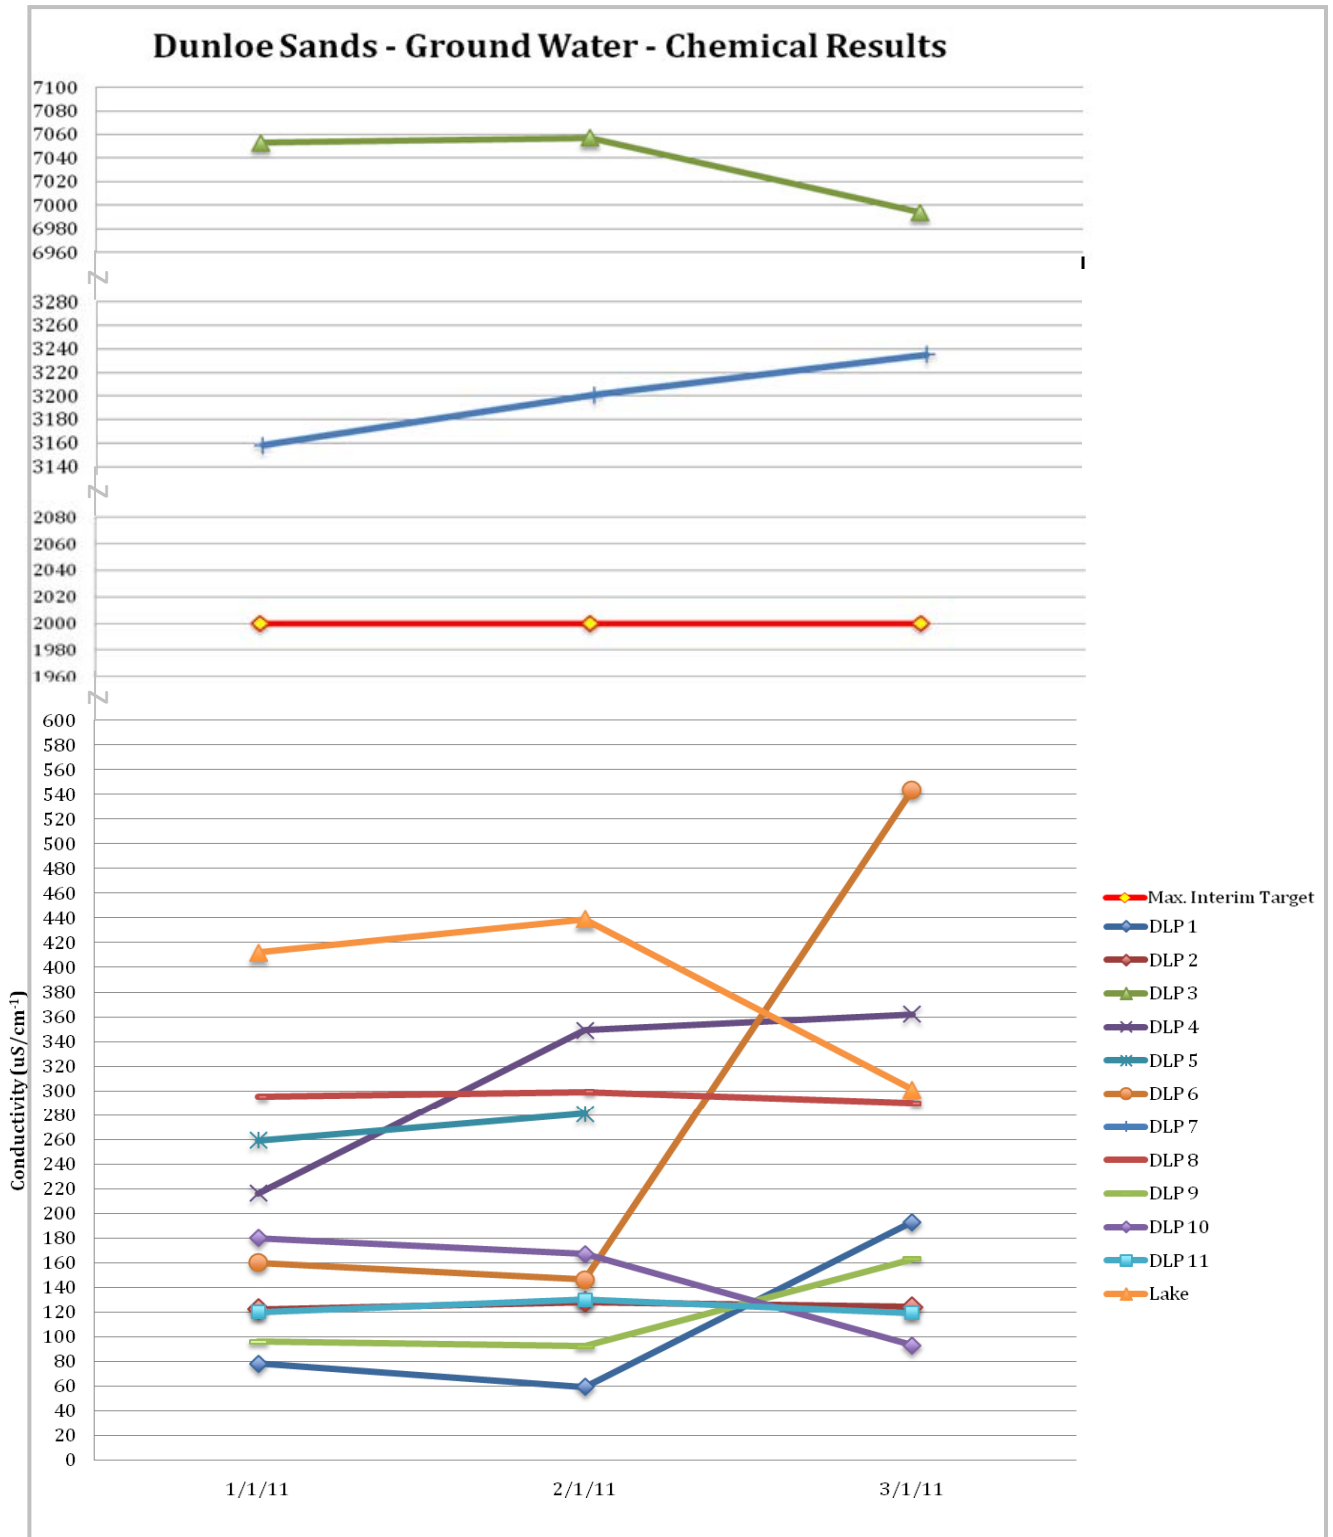
Figure 3: Dunloe Sands - Ground Water - Chemical (EC Test) Results January to March 2011

The majority of the samples taken produce considerably low EC levels when compared to the EMP maximum interim target.

Two samples sites; DLP3 and DLP7 present conductivity levels well above the maximum interim target of 2,000uS/cm⁻¹ stated within the EMP, each of which also expressed similar levels of EC within background testing. This is quite easily explained in respect of DLP 3 as DLP3 was installed in the low-lying portion of the floodplain adjacent to the sections of Mooball Creek and the main agricultural drainage line that are subject to tidal influences. It is therefore considered likely that some localised salinisation of surficial groundwaters has occurred within the vicinity of monitoring location DLP3 due to tidal influences within these nearby waterways.

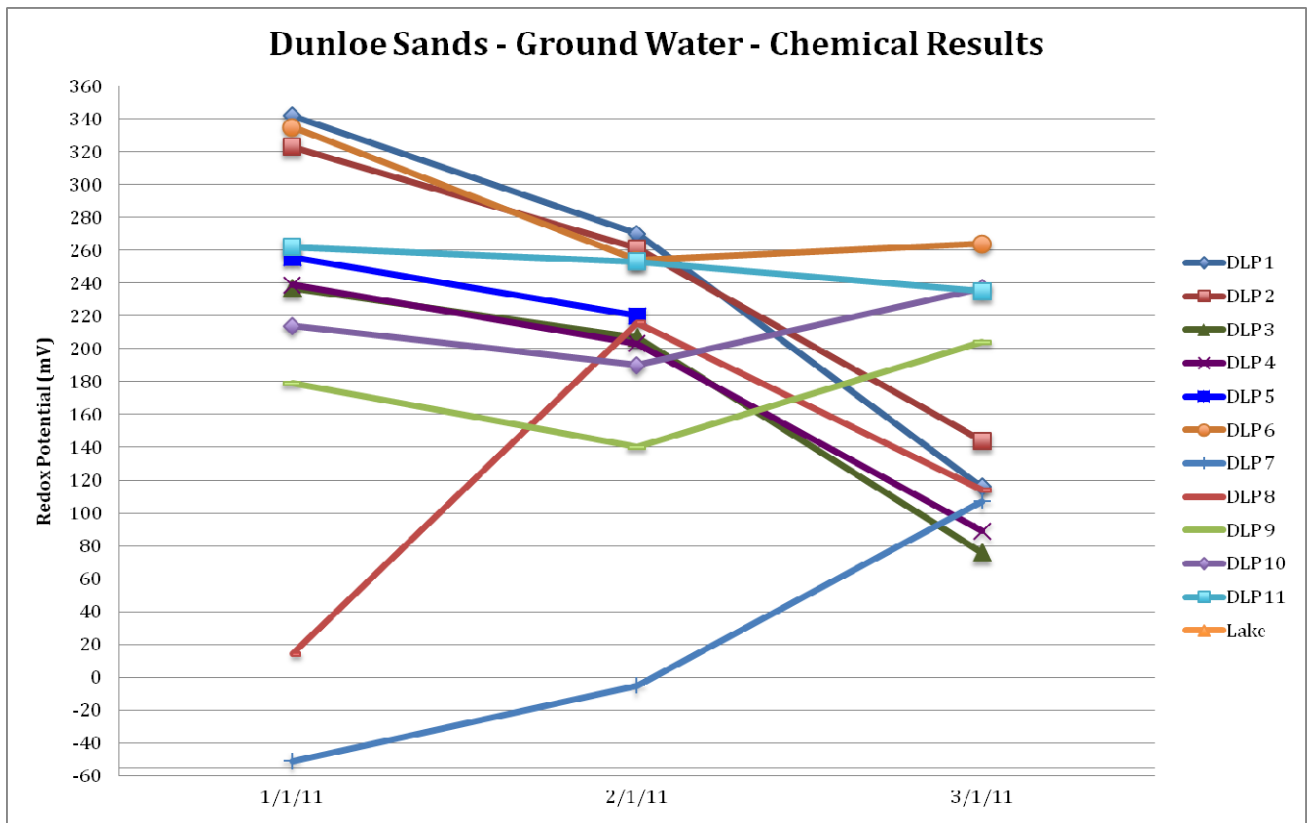
Figure 4: Dunloe Sands - Ground Water - Chemical (Redox Potential Test) Results January to March 2011

The EMP does not provide an exact interim target level for Redox Potential but instead states 'MAXIMUM'. The results are split with half the locations (generally locations DLP 1 to DLP 5) presenting a higher to lower Redox Potential rate and the locations DLP 6, DLP 9, DLP 10 and DLP 11 producing a steady or higher - lower - higher Redox Potential rate. DLP 7 depicts an extremely low Redox Potential level of -51 in January that increases rather rapidly to +105 during March, this is difficult to explain but is likely to be related to the decomposition of sub surface organic matter given its location immediately proximate to the adjacent wetland.

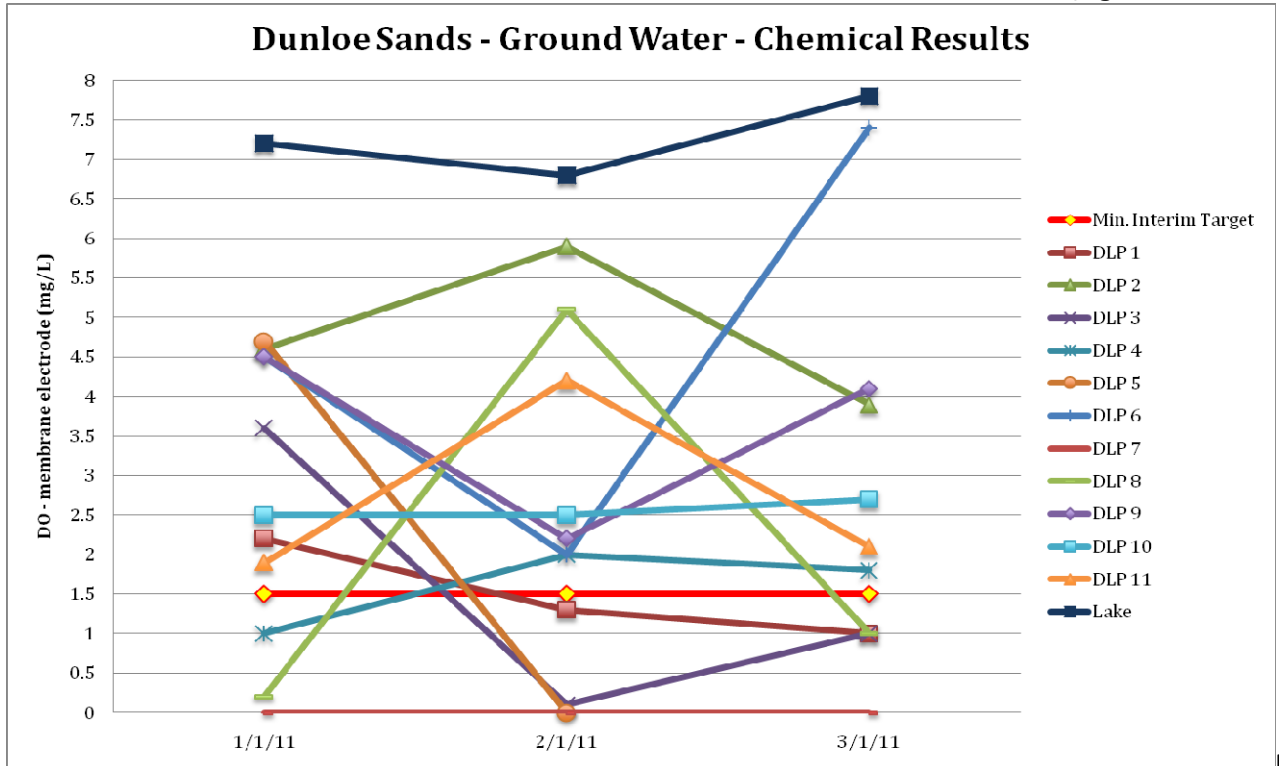
Figure 5: Dunloe Sands - Ground Water - Chemical (DO Test) Results January to March 2011

The minimum DO level provided within the EMP is 1.5mg/mL. The results vary in DO levels considerably with the majority not presenting or conforming to a pattern over the three month monitoring period.

The majority of groundwater samples collected is above the minimum interim target however ten samples collected from varied locations present levels below the target. The lake sample presents the highest level and remains above 6.5mg/ML.

Whilst background testing indicated generally low DO levels inherently across the site, the results for DLP 7, 1, 3 & 5 require some further consideration, particularly with respect to the temperature of samples at these locations as exceedingly warm samples will automatically generate a low DO reading. Low results may also be related to excessive faecal matter and nutrients associated with livestock use. Each of these potential reasons should be considered in the context of future sample results so as to look towards potential ameliorative measures.

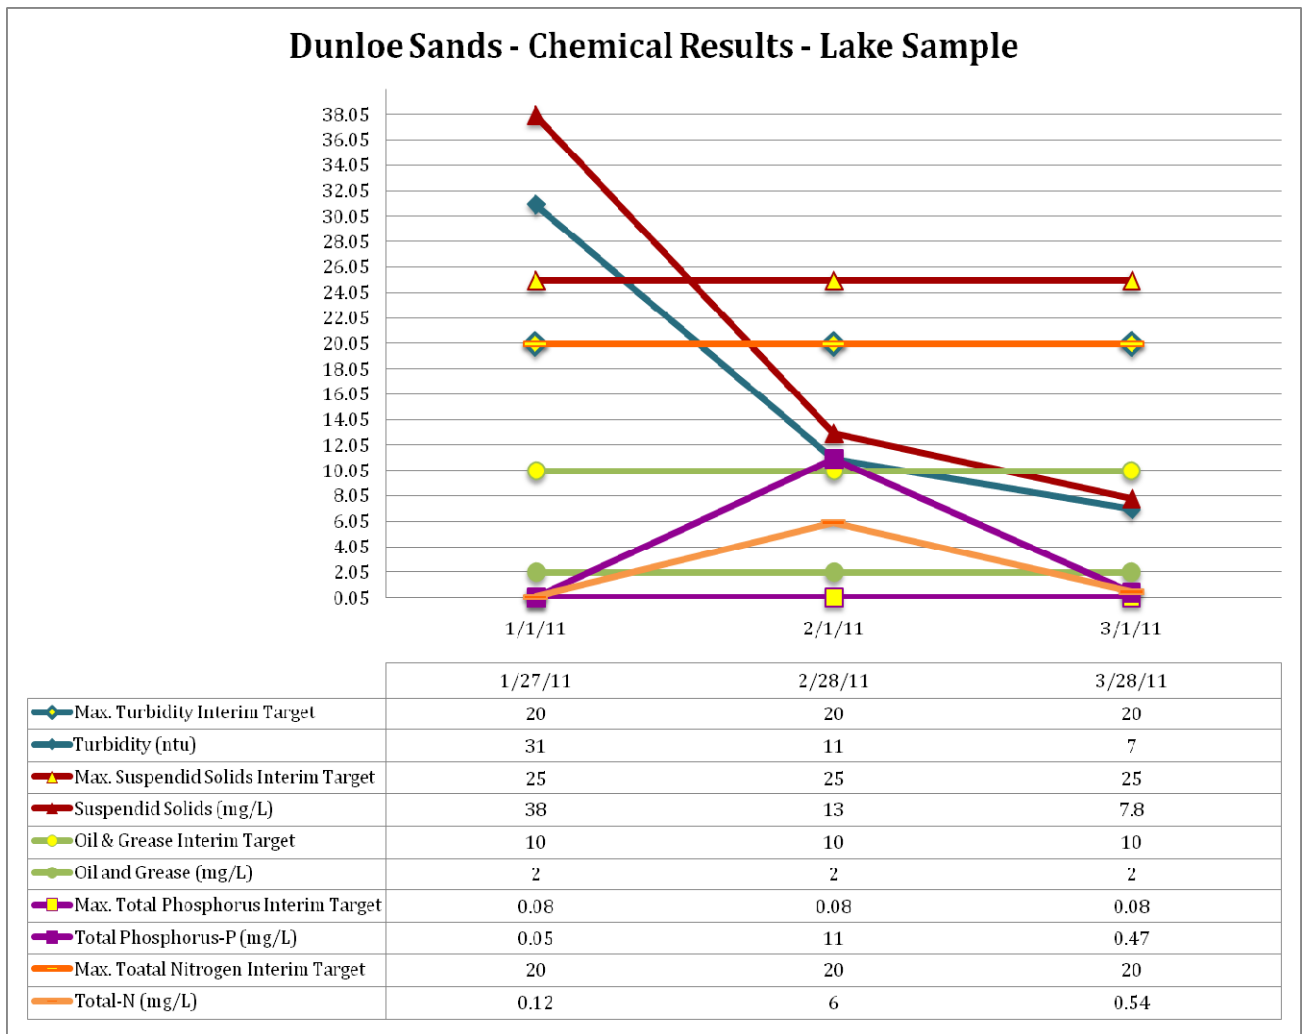
Figure 6: Dunloe Sands - Lake - Chemical Results January to March 2011

Results for tests of turbidity, suspended solids, oil and grease, total phosphorus and total nitrogen were only collected within the lake sample site. **Figure 6** presents the sample levels compared to the EMP interim target levels.

Interim target levels for turbidity present a maximum level of 20ntu within the EMP. The levels recorded over the three month monitoring period show levels above the maximum during January however levels are decreased to below maximum levels during the February and March monitoring. This could be generally explained by the high rainfall experienced in January, however it also warrants consideration of the effectiveness of ensuring that surface water inflows do not flow into the lake from external sources (inclusive of the plant area).

The maximum interim target level for the suspended solids within the EMP is 25mg/L. Results present a level above the maximum during January and levels below this target during February and March. Again this result is likely due to the excessively high rainfall experienced in January. It should be noted that generally a maximum level of 50 ntu is applied to discharge levels from development sites, indicating that generally levels are and remain quite low across the site.

The EMP states a maximum level of 10mg/L in regard to oil and grease. Levels of oil and grease within the samples are consistent over the three month monitoring period at 2mg/L.

Total phosphorus levels are generally higher than the maximum interim target levels contained within the EMP. January results present lower than target levels of phosphorus however the results of February sampling presents a sharp increase well above the target levels. During March the level of phosphorus decreased considerably producing a level only slightly higher than the target rate. It is difficult to explain

the elevated reading in February as Suspended Solids (often concurrently high with phosphorous readings) were quite low at the equivalent time.

Total nitrogen levels remain consistently lower than the interim target of 20mg/L with a maximum result of 6mg/L.

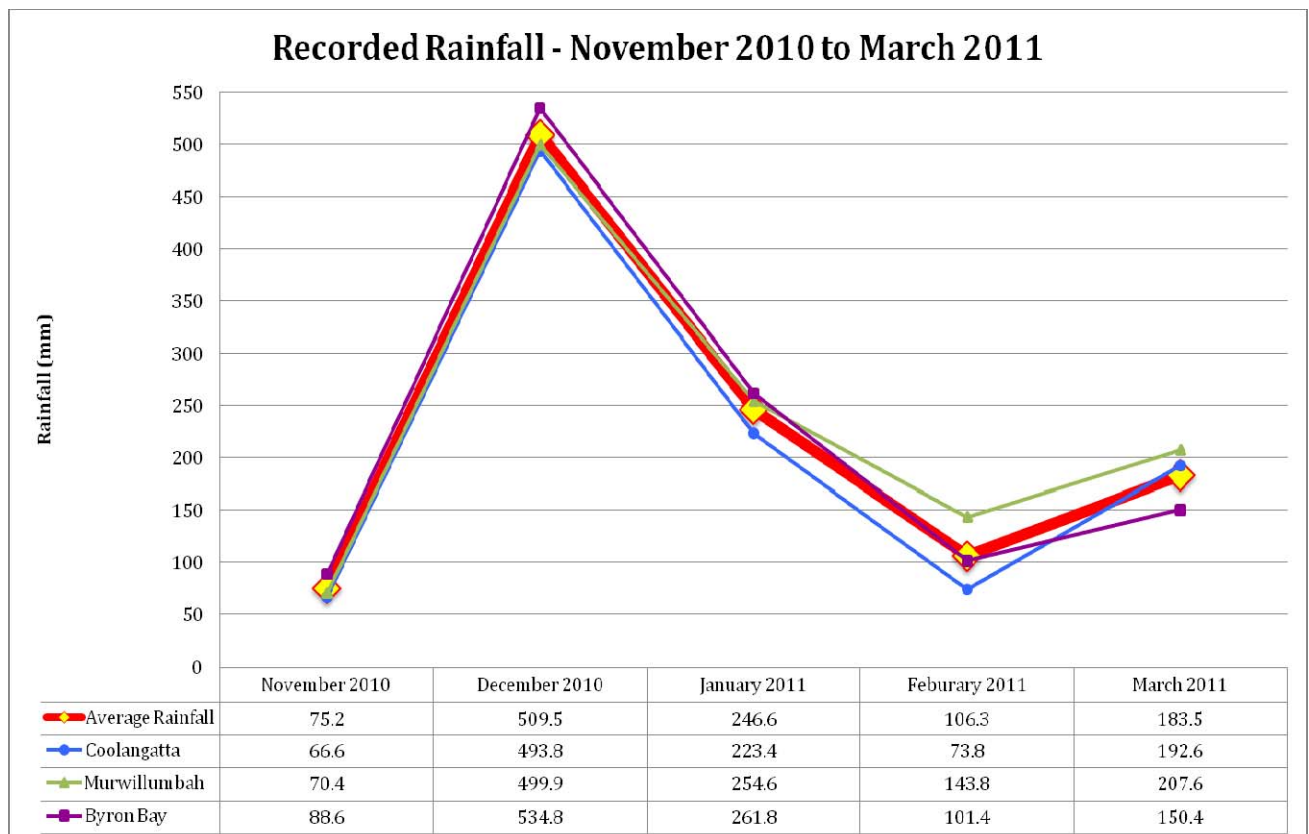
Figure 7: Recorded Rainfall November 2010 to March 2011

The BOM have recorded rainfall within the surrounding areas of Pottsville; including Coolangatta (24.3km from Pottsville), Murwillumbah - Bray Park (18.9km from Pottsville) and Byron Bay (28.5km from Pottsville). The results are illustrated within Figure 7 along with the recorded rainfall average.

The recorded rainfall of the three suburbs surrounding Pottsville has been averaged to produce an approximate on site rainfall. December 2010 presented a high level of rain with approximately 509.5mm of rain being recorded. In total over the five month period approximately 1,121.1mm of rain was recorded on site.

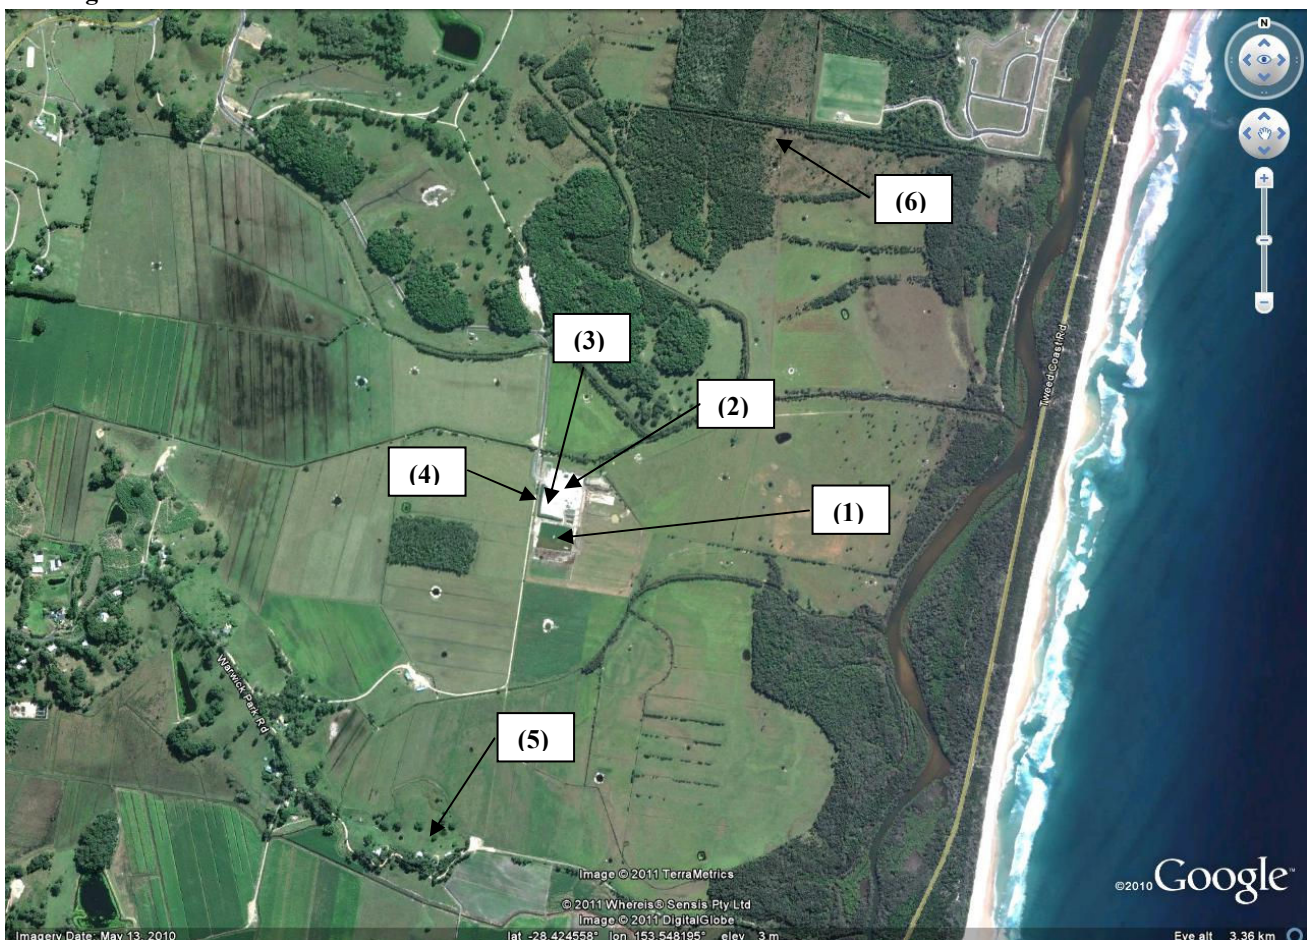
Figure 1: Aerial of Sand Mine and Measurement Locations

(1): Refer to Figure 1 below for measurement locations.
