Corangamite Water Skink EPBC Act Offset Strategy & Management Plan

Colac Quarry Extension – Stage 5 and Stage 6 (WA158)

Colac Quarry Extension, WA158, 75-95 Potters Road, Ondit, Victoria

Client: Holcim (Australia) Pty Ltd

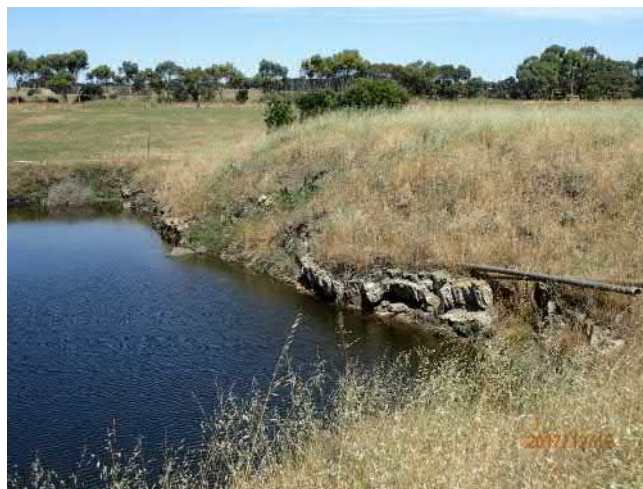
Plate 1- Habitat occupied by Corangamite Water Skink in Stage 5 expansion area (dam)

- Approximately 100 lineal metres of suitable habitat on the margin of a small dam in Stage 5.
- Approximately 50 lineal metres of suitable habitat on the northern wall of Basin 5 of the former northern quarry pits¹ Although the habitat is in an area with an existing approval to extract, the removal of the wall to gain access to the resources in Stage 6 will be undertaken as part of the Stage 6 works. Habitat on the northern wall of Basin 5 is therefore accounted for as part of the Stage 6 losses.

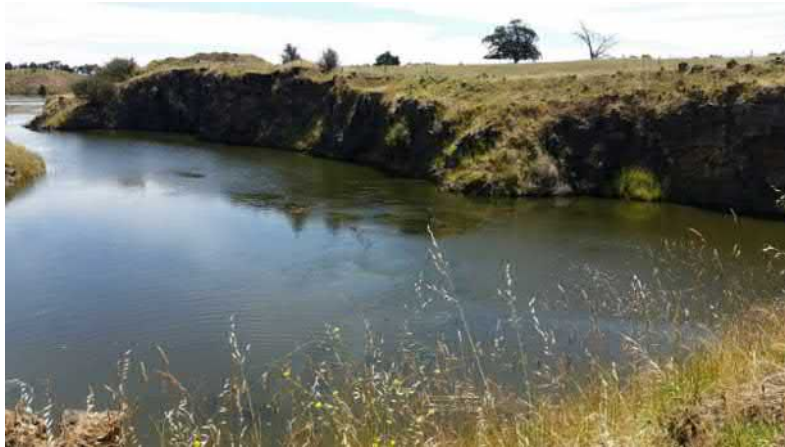
Plate 2- Stage 6: view of Corangamite Water Skink habitat on southern edge (northern wall of Basin 5)

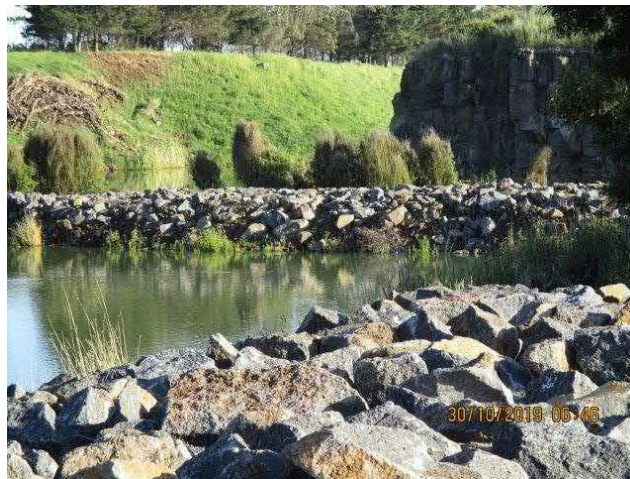
Plate 3- Habitat creation on Basin 1, view north from eastern bank (foreground) to the northern bank (background)

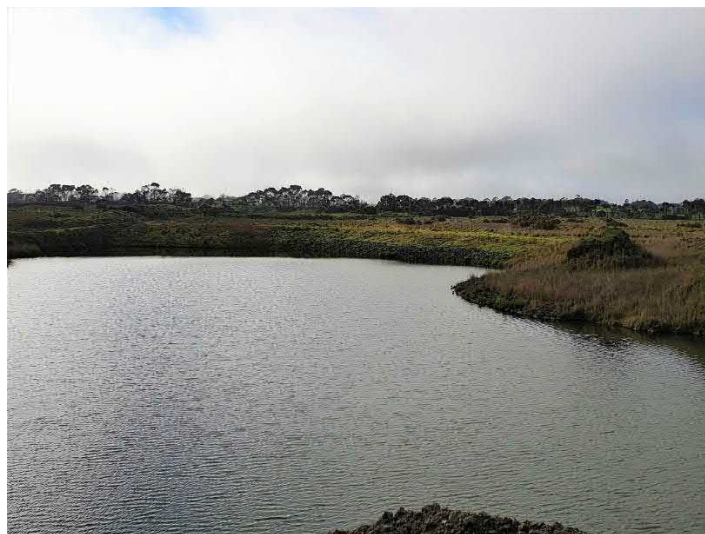
Plate 4- Habitat creation area on east side of Basin 6 to the north of area of habitat created along the southern margin in 2008 (viewed from the western side of Basin 6)

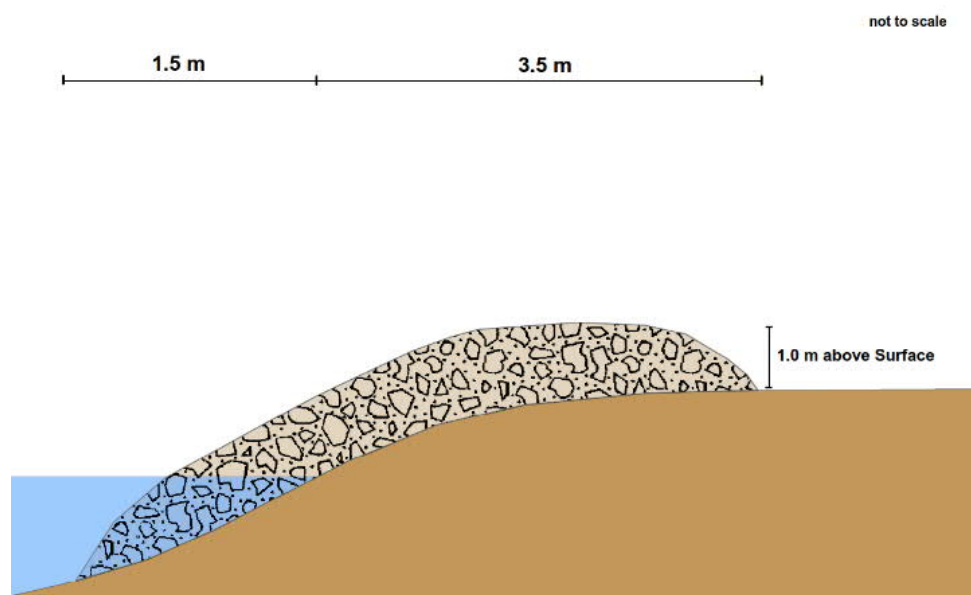
Figure 3 Conceptual drawing of habitat creation

- Use rock overburden from quarry operation (mix of some soil and mostly rock)
- Create piles that are:
 - Minimum 25 lineal metre sections along the water edge spaced intermittently.
 - Minimum width of 5 metres:
 - Extending approximately 1.5 metres into the water.
 - Extending approximately 3.5 metres out of the water (Basin 4, Basin 6, Stage 6 rehabilitation) or approximately 1 metre above the 118mAHD water level on the bund between Basin 1 and Basin 3.
 - Average of 1 metre height of rock pile above ground surface level.
 - Comprised of a variety of rock sizes to create a high proportion of rock crevices as refugia for the skinks
- Revegetate water body margins adjacent to the created outcrop with appropriate semi-aquatic plants including:
 - Marsh Club-rush *Bolboschoenus medianus*
 - Common Reed *Phragmites australis*

- Sharp Club-sedge *Schoenoplectus pungens*
- Water Ribbon *Triglochin procerum*
- Southern Water-ribbons *Cycnogeton alcockiae*
- Revegetate inland margins of created habitat with appropriate shrub species at:
 - a rate of 400 plants per hectare and
 - a ratio of 3 Tree Violets *Melicytus dentatus* s.s. to 0.5 Black Wattle *Acacia mearnsii* and Blackwood *A. melanoxylon* to 0.5 Sweet Bursaria *Bursaria spinosa*.

- Allow for the maximum predicted water levels of the former quarry pit environment following bunding and dewatering of Basin 5 and dewatering Stage 5 and 6 during operation.

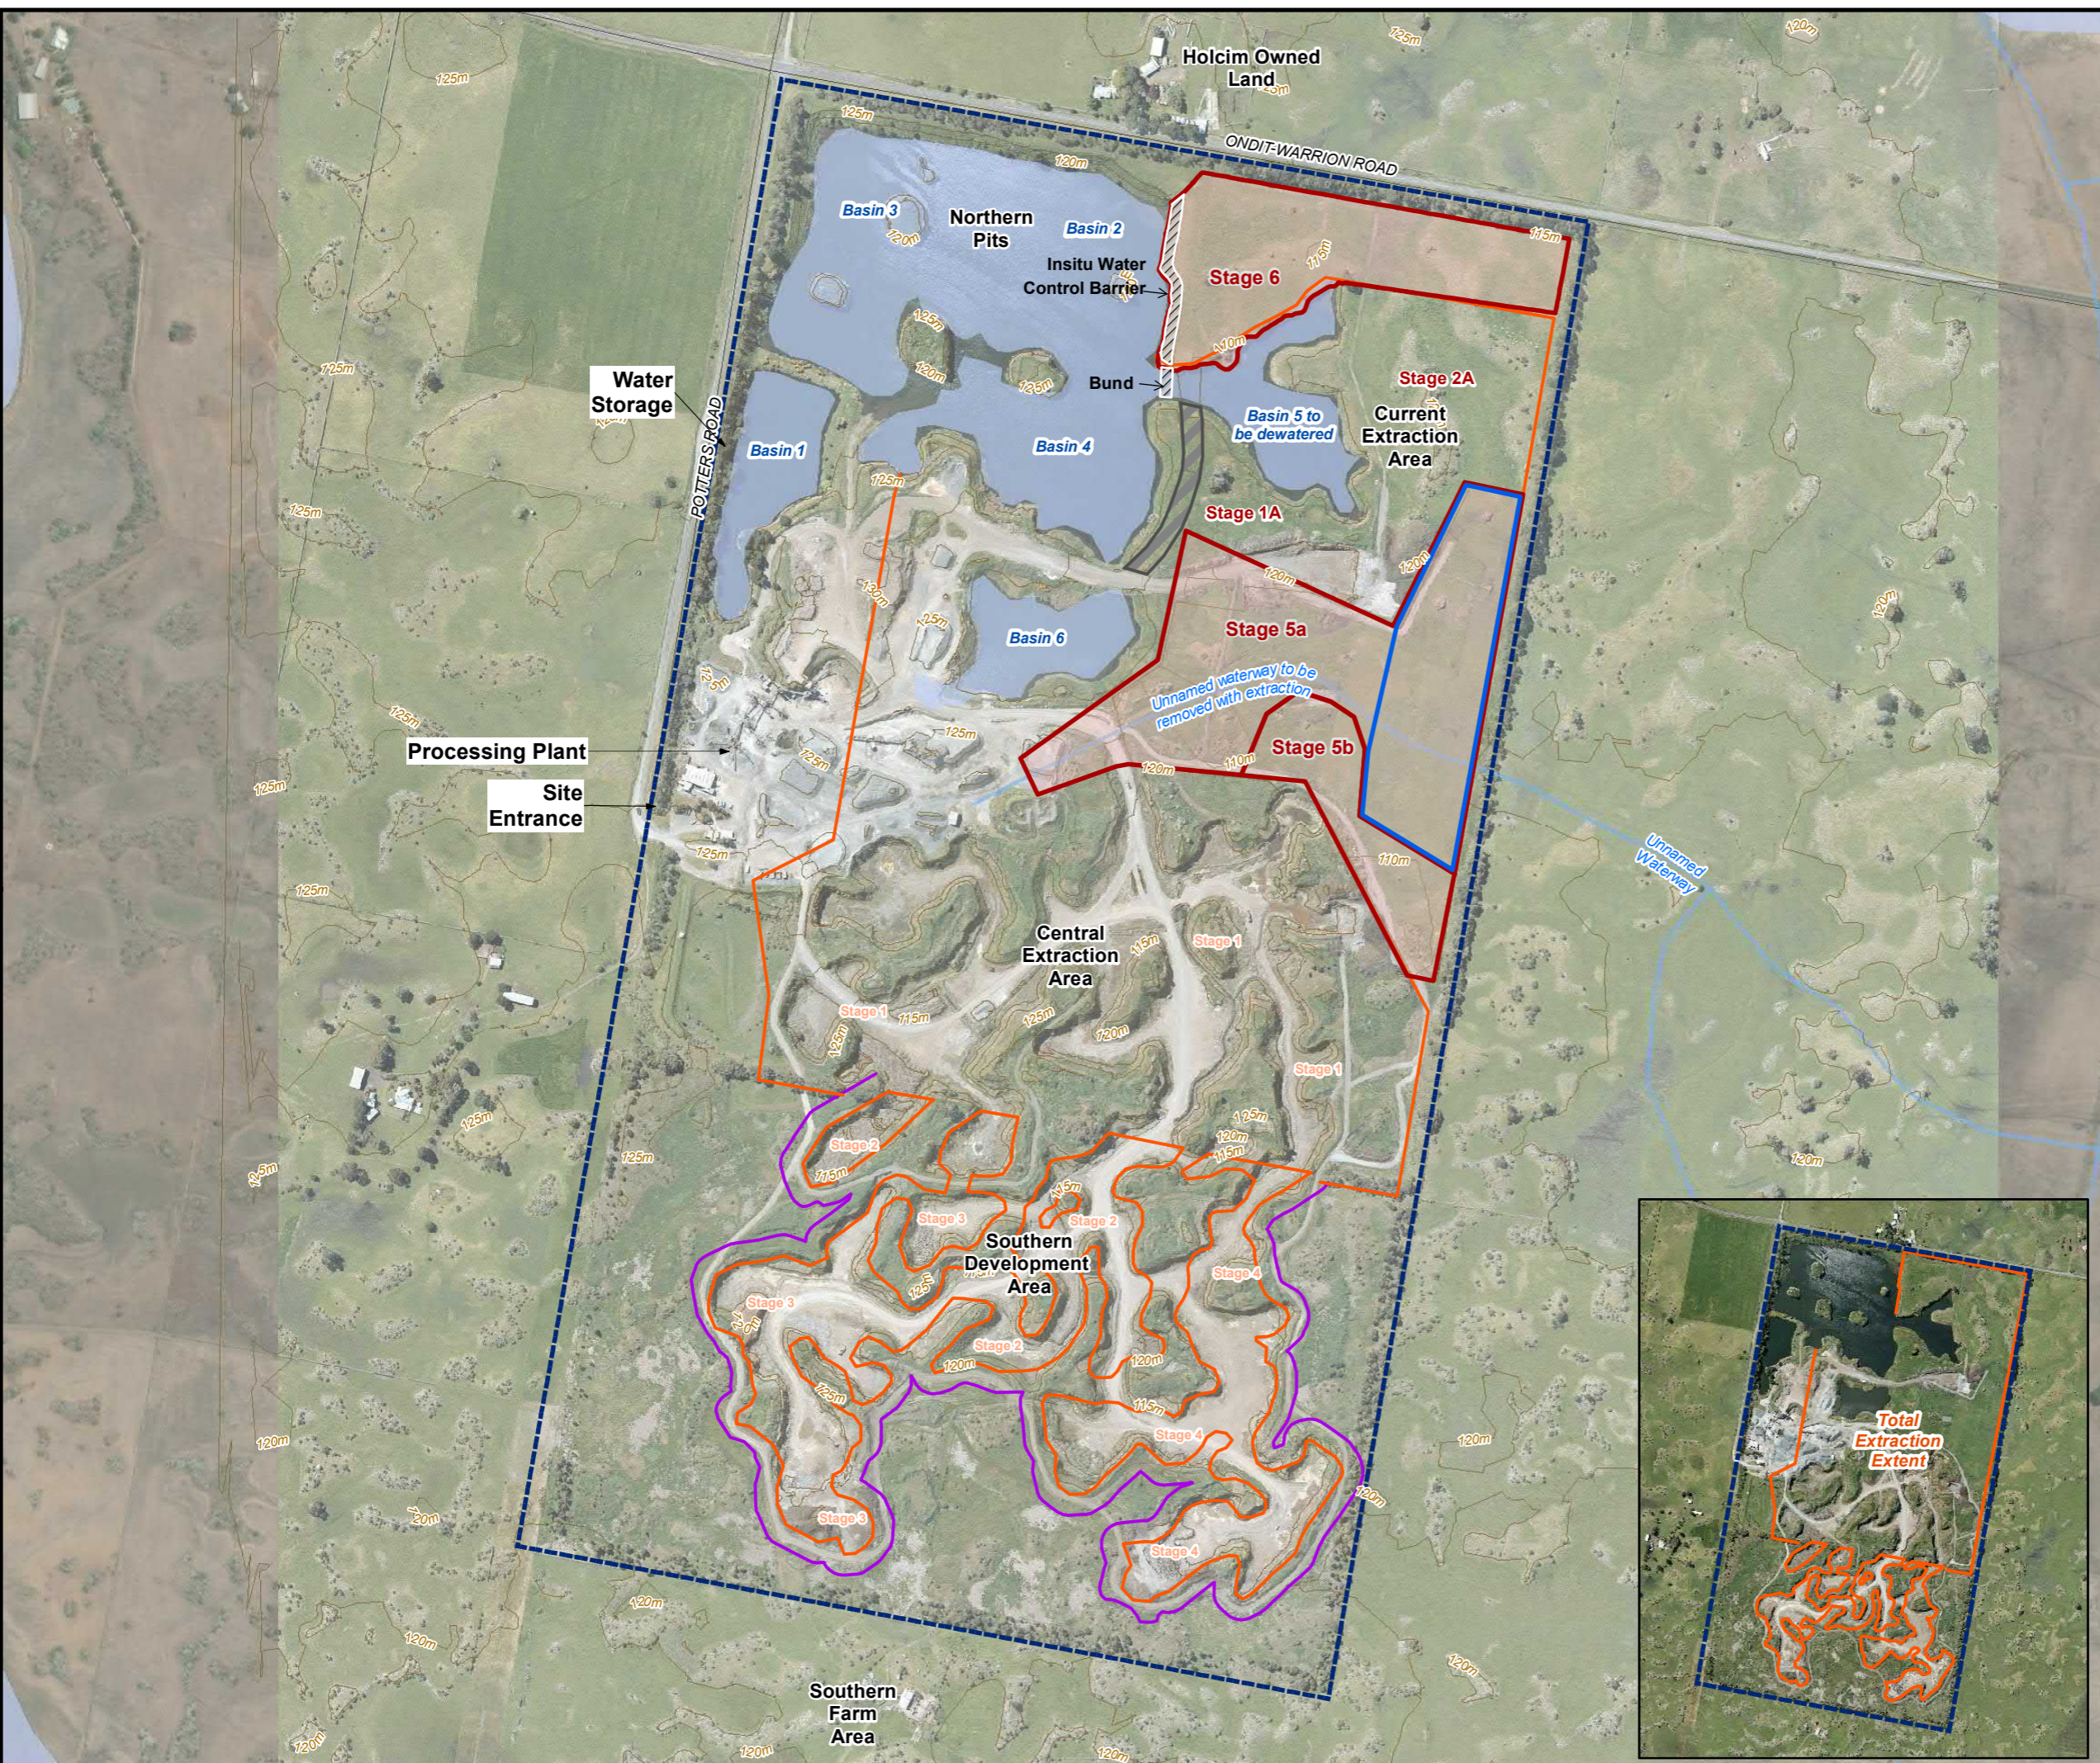
Figure
F1

SITE LAYOUT

Colac Quarry is located at 75 – 95 Potters Road, Ondit, approximately 1.5 kilometres north of Lake Colac, Victoria (**Figure 1 - Appendix A**). The site has been in operation as a basalt quarry since 1972. Currently Holcim (Australia) Pty Ltd (Holcim) are the site operator and owner and are extracting basalt rock from the approved extraction limit within Work Authority 158 (WA158). Holcim plan to expand its quarry operations under WA158 into two additional areas referred to as Stage 5 (including two sub areas- Stage 5a and Stage 5b) and Stage 6 (see **Figure 2 - Appendix A**). These areas are in an unquarried portion of the property east of the former quarry pit and will allow for a contiguous extraction area with the other approved extractions areas within the quarry.

The northern pits refer to Basins 1 – 4 and Basin 6 (**Figure 1 – Appendix A**). Basins 1- 4 were the original quarry extraction area approved under Extractive Industry Licences (EIL39, EIL 680) granted in 1972 and 1974 respectively, and subsequently consolidated under the quarry work authority WA158. Basin 6 was formed during extraction of an area approved in 1997 under EIL 1607. The northern pits flooded once extraction was completed and the basins now function as water storage for the quarry.
