Overview & Summary of the Archaeological Program

1.0 An overview of the volume

Old Marulan 2007 archaeological investigations – Volume 3 – Archival recording

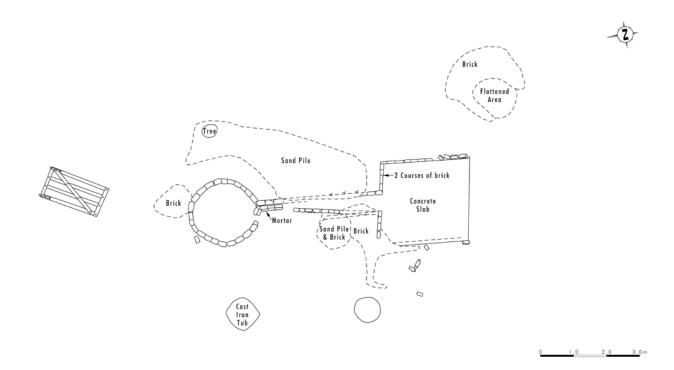
Figure 4.2 - MRNH1 Circular Sheep Dip [Denis Gojak].

The damage to the structure was likely caused by fill that has been poured into the channel and washing chamber, bringing them up to near ground level. The fill consists of a mixture of clean soil fill, broken brick fragments and natural stone.

Several edges of the structure have been cracked and dislodged in the damage.

- MRNH 1 the circular sheep-dip was damaged by farm machinery prior to the commencement of the Lynwood Quarry development Project and this archaeological investigation. The project committed to the Heritage Branch to stabilise the structure. It has now been archivally recorded, and a specification for the stabilisation and protection during development works has been implemented [refer to Volume 1 Attachments 6 and 10 of this report series].

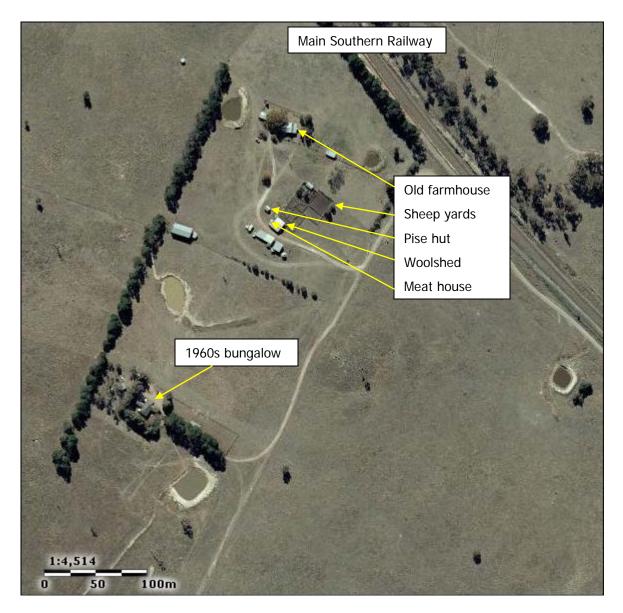
Figure 4.3 - Layout of Lynwood Homestead, and elements recorded archivally [NSW Dept of Lands 2012].

Only specific features of the Homestead complex are archivally recorded here. These are shown in Figure 4.3.

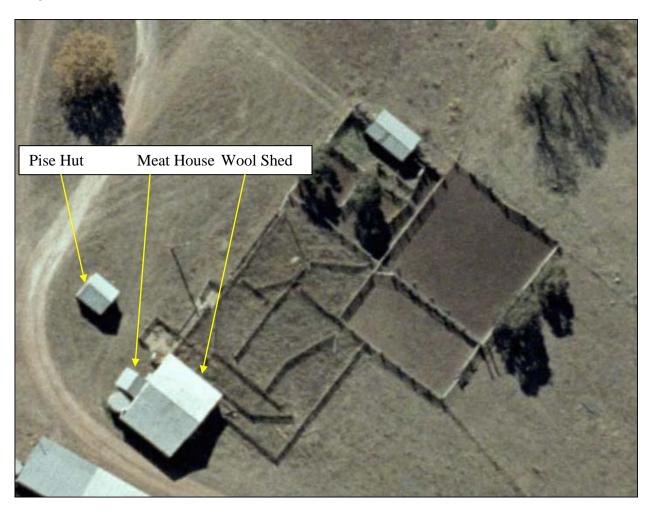
Figure 4.4 - The woolshed and sheep yards [NSW Dept of Lands 2012]

The sheep yards extend into a series of races allowing the separation of sheep from flocks and their feeding into the woolshed. At the northeastern end there are two yards with taller square posts; up to 1.7 metres [5'] tall 6" x 10" squared posts. These have 6 adzed and slightly flattened saplings as rails, all attached with coach bolts, making an area for the management of horses or cattle. There is a ram shed at the northern end of the sheep yard complex consisting of a small structure clad in corrugated iron.

The concrete posts are trapezoidal in section measuring 125 millimetres between opposite faces, which are 115 and 130 millimetres long. They support hardwood rails measuring 140 millimetres wide x 30 millimetres thick, bevelled at the edges and fastened to the concrete post with two coach bolts. Where posts have been broken they have been replaced mainly with short sections of railway rail cemented into place. All of the gates are made of 1.5" tubular steel welded together, with home-made hinges.

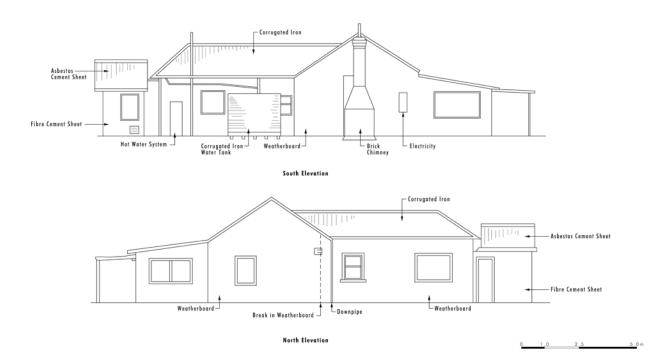
Figure 4.5 - MRNH5 - Old Farmhouse [Denis Gojak].

The house has 10 interior spaces, generally coming off a centrally placed front door and hallway. It was originally built as a symmetrical farmhouse, probably with four main spaces and integrated kitchen and wet area at the rear. Spaces [1] to [4] represent the surviving evidence of this structure, although even wall cladding and possibly framing has been replaced to open up the structure.

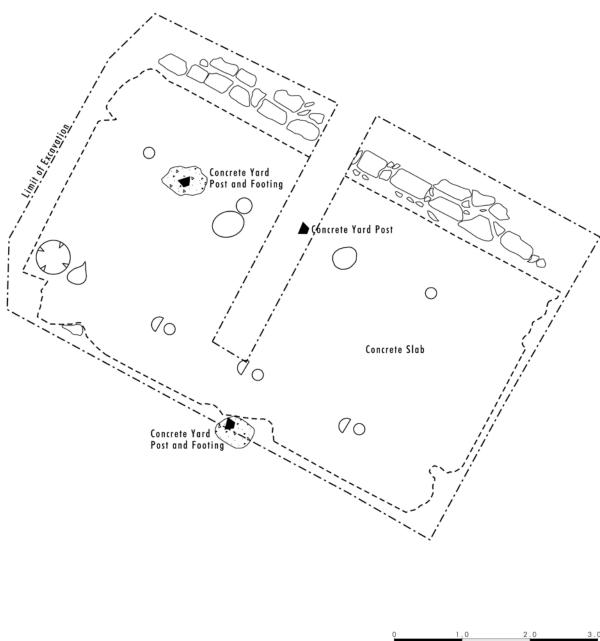
Figure 4.11 - MRNH5 - Sheep Yards Detail [Denis Gojak, Umwelt].

The second possible feature was confirmed to be loose natural stone, probably cleared from elsewhere on the site.

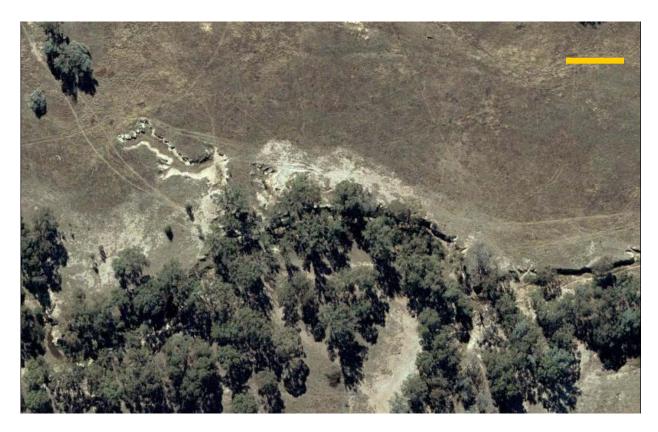
Figure 4.12 - The scars of the clay pits clearly evident along the northern bank of Jaorimin Creek. Scale bar 20 metres [NSW Dept Lands 2013].

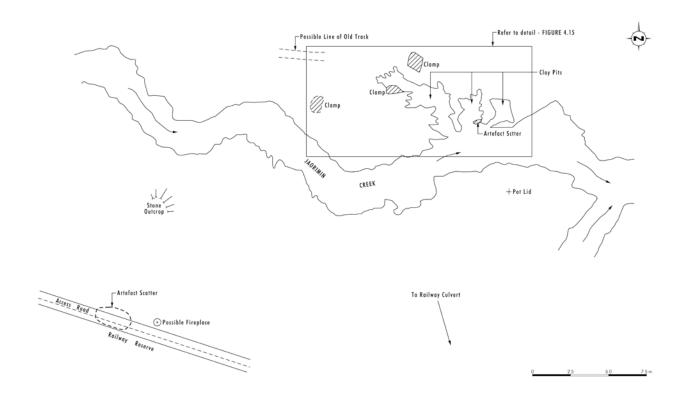
Figure 4.14 - MRNH 6 & 7 - Brick Clamps and Clay Pits [Denis Gojak].

MRNH 6A is the southwestern clamp comprising a single pile of bricks and brick fragments in an elliptical scatter, mainly at the prevailing ground level with a shallow single central high point. The mound measures about 16 metres north to south by about 12 metres east to west. The visible bricks are all broken, with no intact examples observed. Brick fragments were generally 0.2 to 0.6 of whole brick size with all of the fractures appearing to be old. Most had some visible imperfection, including glazing, exploded inclusions in the clay, distortion and uneven firing. The bricks examined in situ did not appear to be systematically stacked or otherwise arrayed, although visibility was not ideal.

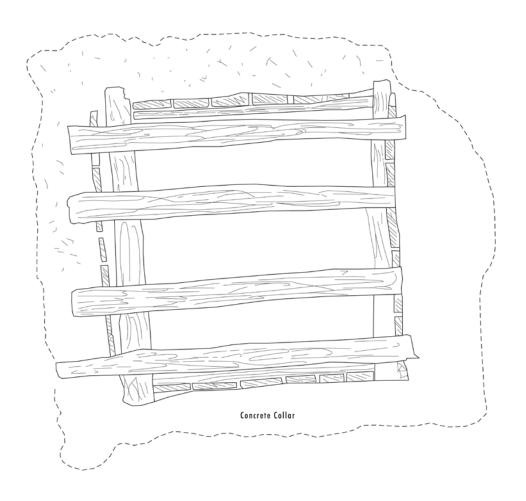
Figure 4.17 - MRNH8 - Timber Lined Well [Denis Gojak].

The timber-lined well [MRNH8] sits in the natural collection point for drainage along the southern side of the Hume Highway and presumably the Great Southern Road before that.

- MRNH 8 the timber-lined well is in the location of a maintenance road beside the southbound up-ramp of the interchange. A specification was prepared and endorsed by the Heritage Branch, detailing how the well was to be documented, then backfilled prior to construction of the interchange [refer to Volume 1 Attachments 7 and 9 of this report series]. The recording and in situ conservation of the well, through careful filling and burial, have been undertaken.

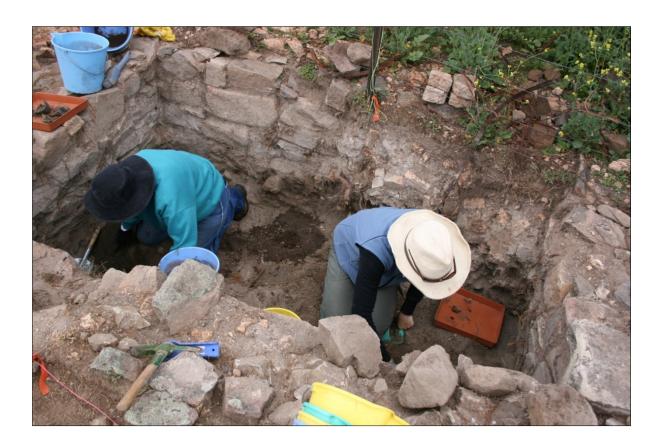
Figure 4.19 - Excavation of OMF 46 - Cesspit

Cesspit OMF 46 was the only structural element of the Woolpack Inn that fell within the Old Marulan SHR area excavated during the Old Marulan 2007 archaeological investigation [refer to Figure 4.1 and Figure 4.19]. The remainder of the Woolpack Inn building was formerly located to the south of and outside the archaeological investigation area, and was likely removed during the widening of the Hume Highway in the late 1960s and 1970s. No evidence of the Woolpack Inn building was found during the excavation of the Hume Highway road reserve alongside the main 2007 archaeological investigation area [refer to Volume 2 Section 6.7.5 of this report series].

Following excavation and prior to any works associated with the construction of the transport interchange that may impact the cesspit, the cesspit was filled and protected in accordance with a methodology endorsed by the Heritage Branch [refer to Volume 1 Attachments 7 and 9 of this report series]. This consisted of lining the cesspit with geofabric and filling with clean sand. A second layer of geo fabric was laid over the filled cesspit, extending out around the exposed remains, and topped with approximately 500 millimetres of clean sand.

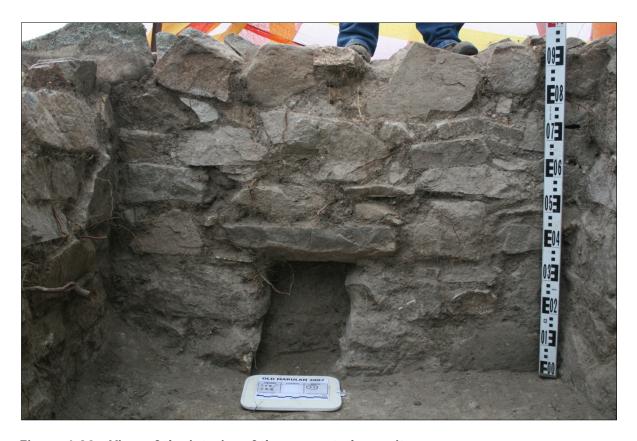
Figure 4.20 - View of the interior of the excavated cesspit

The cesspit is detailed within Volume 2 Section 6.7.7 of this report series. It comprised a rectangular pit, lined with roughly squared porphyryite field stone boulders set in random courses. There was no mortar present between the stones. It was oriented roughly east to west along its long axis and appeared to be parallel to the lot boundary. The cesspit measured 2.60 by 1.78 metres, and was about 0.85 metres deep internally. The walls were about 300 millimetres thick and consisted of a single thickness of stone. The top of the cesspit was level, and there was a residual course of bricks set in mortar remaining along the top, representing the superstructure. In the east wall, at the base, there was an opening measuring 250 millimetres across by 320 millimetres high. This penetrated the wall thickness. It did not appear to continue naturally into a channel, and probably acted as a natural seep, although it would have discharged into quite dense decayed bedrock with negligible permeability [refer to Figure 4.20].
