Teven Quarry Annual Review 2017

Holcim (Australia) Pty Ltd

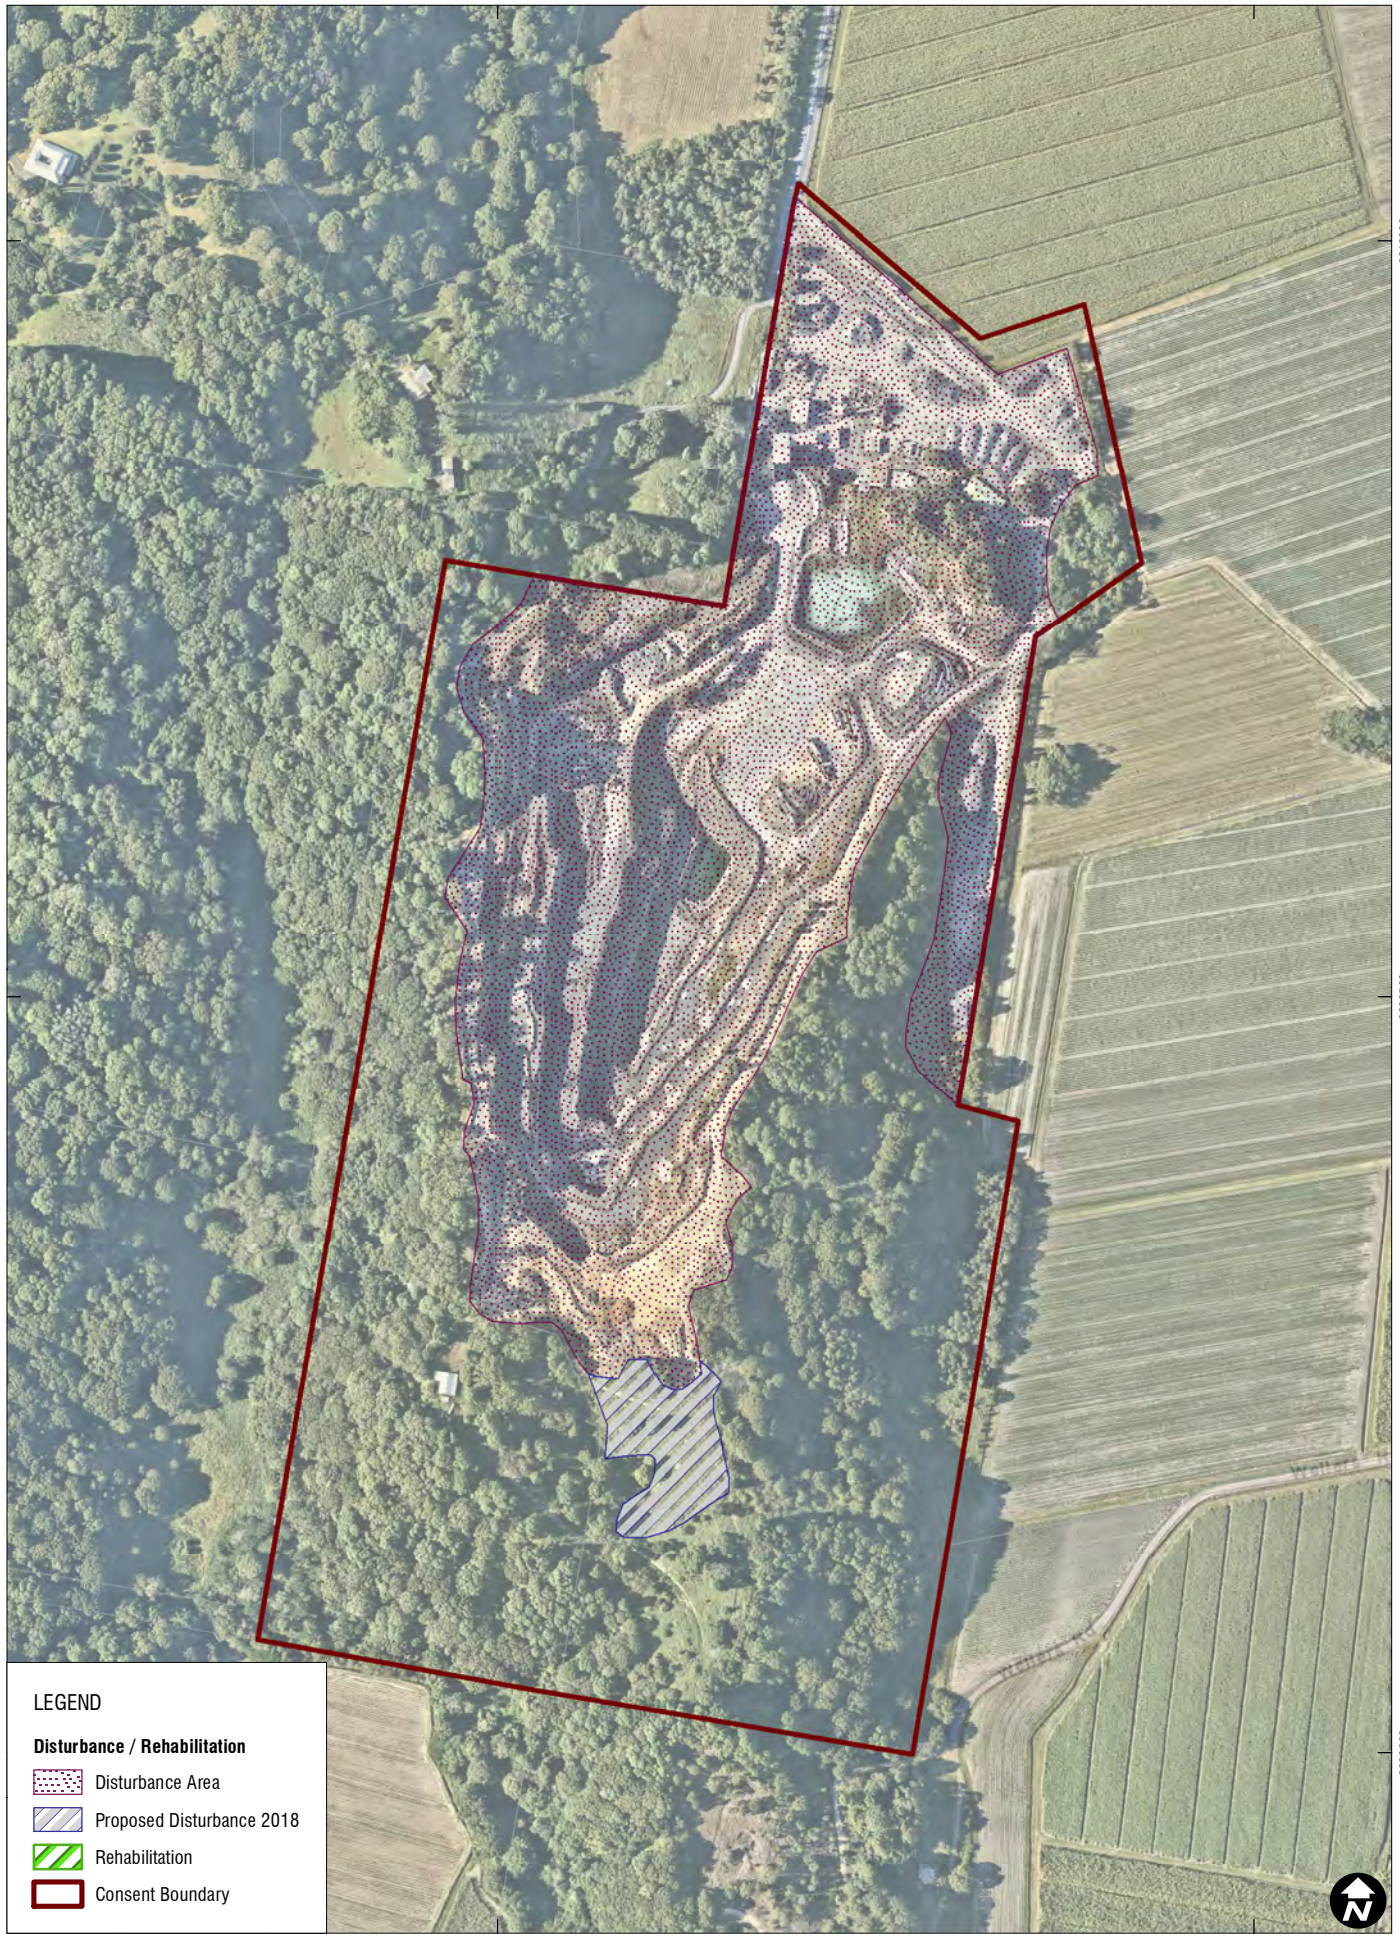
At the end of 2017 there was approximately 17.1 Ha of active disturbance. There is proposed to be 0.7 Ha of additional disturbance in 2018 at Teven Quarry. There is no active rehabilitation at Teven Quarry, and none proposed in 2018.

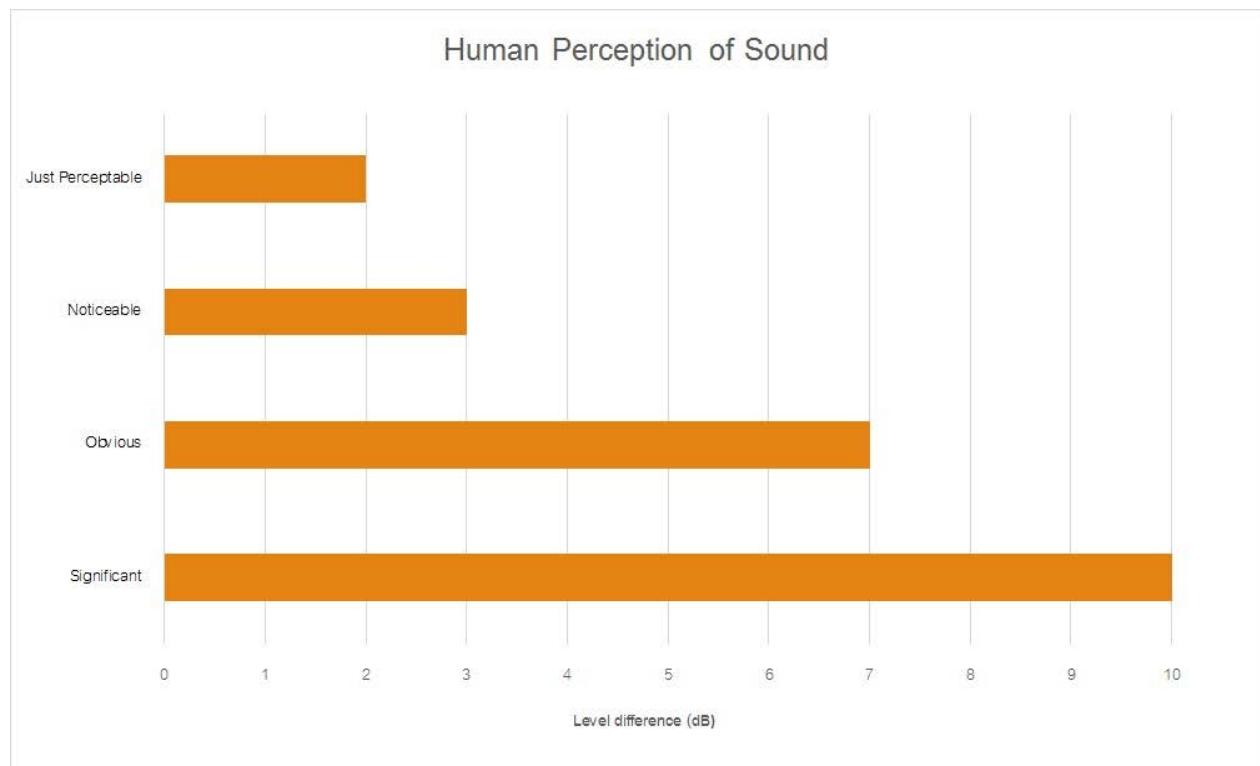
Figure A1 – Human Perception of Sound

Table A2 Common Noise Sources and Their Typical Sound Pressure Levels (SPL), dBA	
Source	Typical Sound Level
Threshold of pain	140
Jet engine	130
Hydraulic hammer	120
Chainsaw	110
Industrial workshop	100
Lawn-mower (operator position)	90
Heavy traffic (footpath)	80
Elevated speech	70
Typical conversation	60
Ambient suburban environment	40
Ambient rural environment	30
Bedroom (night with windows closed)	20
Threshold of hearing	0

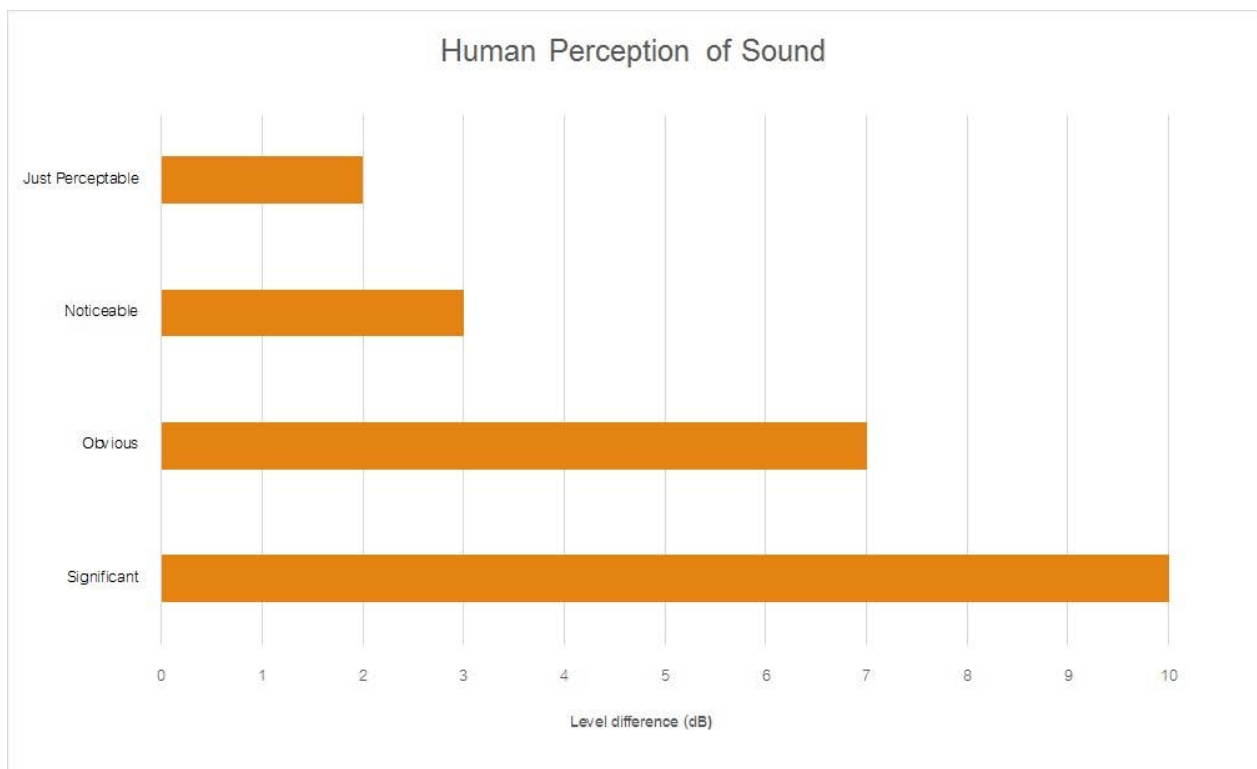
Figure A1 – Human Perception of Sound

Table A2 Common Noise Sources and Their Typical Sound Pressure Levels (SPL), dBA	
Source	Typical Sound Level
Threshold of pain	140
Jet engine	130
Hydraulic hammer	120
Chainsaw	110
Industrial workshop	100
Lawn-mower (operator position)	90
Heavy traffic (footpath)	80
Elevated speech	70
Typical conversation	60
Ambient suburban environment	40
Ambient rural environment	30
Bedroom (night with windows closed)	20
Threshold of hearing	0

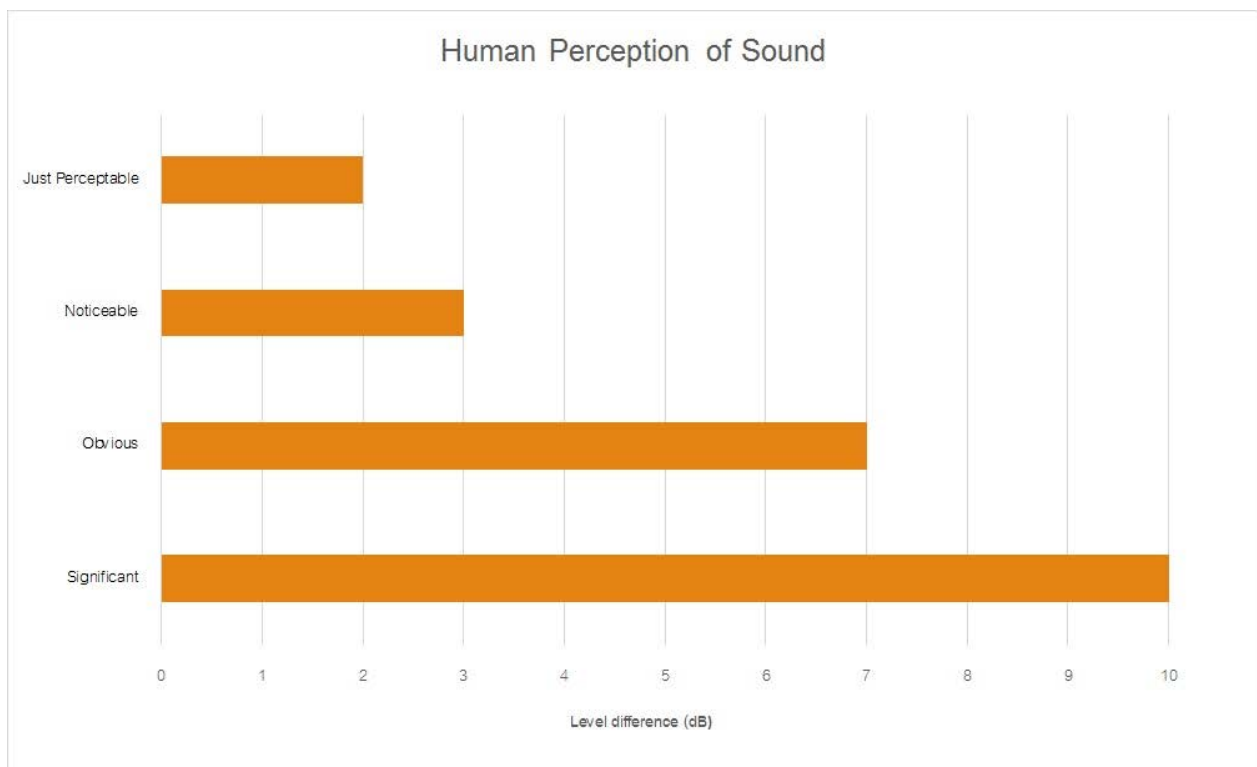
Figure A1 – Human Perception of Sound

Table A2 Common Noise Sources and Their Typical Sound Pressure Levels (SPL), dBA	
Source	Typical Sound Level
Threshold of pain	140
Jet engine	130
Hydraulic hammer	120
Chainsaw	110
Industrial workshop	100
Lawn-mower (operator position)	90
Heavy traffic (footpath)	80
Elevated speech	70
Typical conversation	60
Ambient suburban environment	40
Ambient rural environment	30
Bedroom (night with windows closed)	20
Threshold of hearing	0

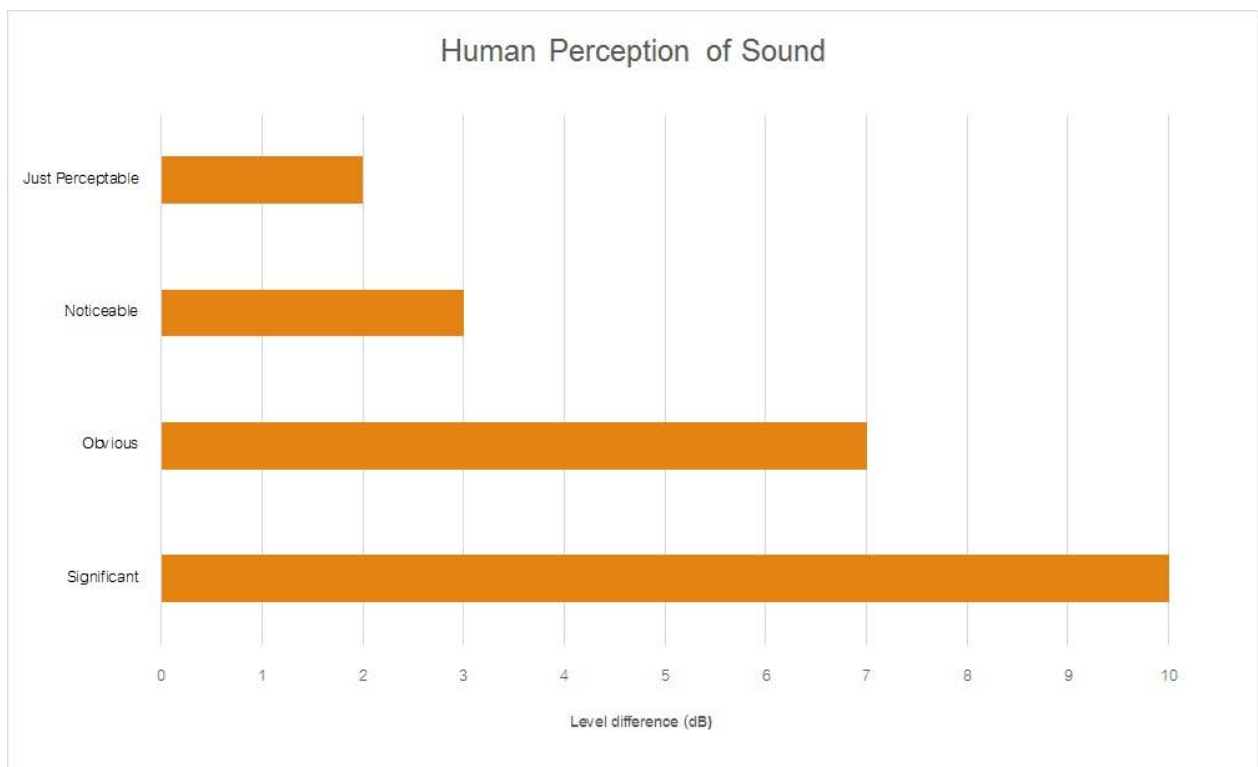
Figure A1 – Human Perception of Sound

Table A2 Common Noise Sources and Their Typical Sound Pressure Levels (SPL), dBA	
Source	Typical Sound Level
Threshold of pain	140
Jet engine	130
Hydraulic hammer	120
Chainsaw	110
Industrial workshop	100
Lawn-mower (operator position)	90
Heavy traffic (footpath)	80
Elevated speech	70
Typical conversation	60
Ambient suburban environment	40
Ambient rural environment	30
Bedroom (night with windows closed)	20
Threshold of hearing	0
