# HOLCIM Australia Rooty Hill Environmental Monitoring Program

2009 Annual Report

**Report Title:** 2009 Annual Report **Document Status:** Final  
**Document No:** MN211173-2010-001 **Date of Issue:** 05.10.10  
**Project Title:** Rooty Hill Environmental Monitoring Program **Client:** HOLCIM Australia  
**Comments:**

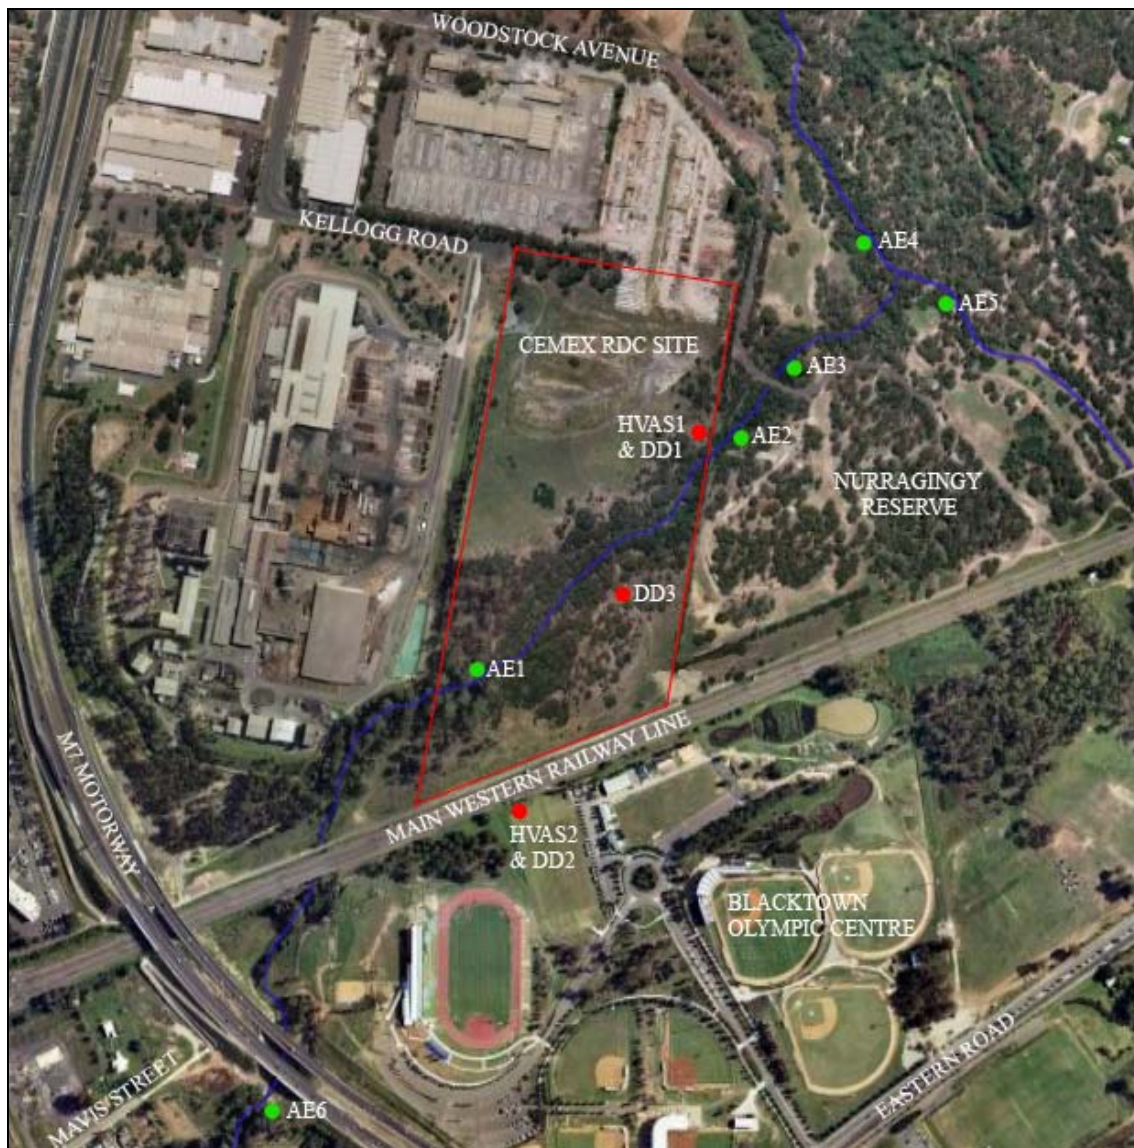
Figure 4 – Air, water and ecology sample locations map (modified from Google Earth)

Figure 4 below illustrates the sampling locations for air, water and ecological parameters. Sites were selected after a feasibility assessment was conducted in late 2008 (Ecowise, 2008), having originally been specified by HOLCIM.

A total of six sites were located along local watercourses (site names preceded by 'AE'). Four of these sites were located on Angus Creek and two were located on Eastern Creek. Three sites were positioned upstream of potential impacts from the proposed RDC development (two on Angus Creek and one on Eastern Creek) and three sites were positioned in downstream locations.

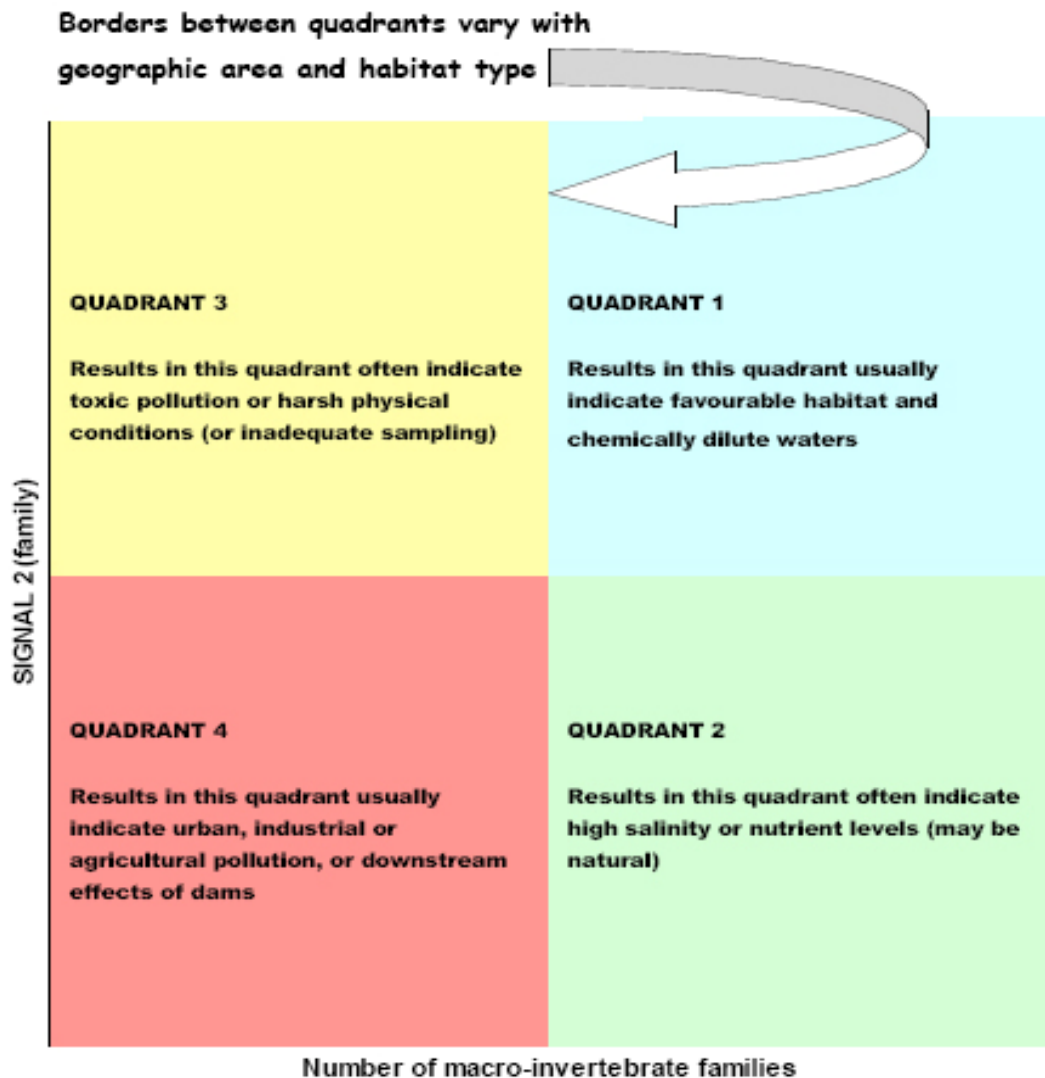
**Figure 5 – SIGNAL2 biplot for the assessment of outputs (Chessman, 2003)**

For easier interpretation, SIGNAL 2 scores and the number of macroinvertebrate taxa have been graphed using a biplot (Figure 5). The resulting biplot is placed into context using a quadrat diagram that divides the results into four general realms described in Figure 5.

The quadrat boundaries have been set at a SIGNAL2 score of 4 and at 20 for the number of macroinvertebrate families, after consideration of suggested NSW interim SIGNAL2 boundaries.

All SIGNAL2 outputs from samples collected in spring and autumn 2009 are within quadrant 4, (see Figure 5 in section 3.4.4) indicating some form urban, industrial or agricultural water pollution. This observation is supported by water quality results from all sites, recording elevated concentrations of common pollutants (Table 7).

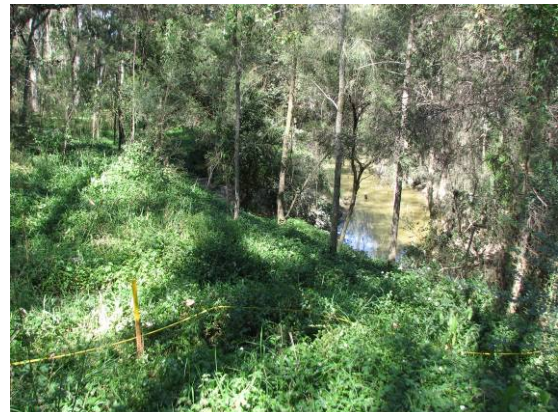
Photo 1 – Transect marker post and tape

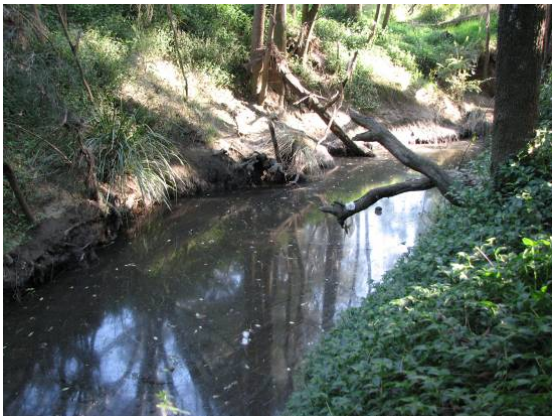
The natural aquatic habitat in Angus Creek appeared severely restricted by the stress of a heavily urbanised catchment. Large amounts of gross pollutants exist within the stream and on riparian vegetation and snags, including general litter, car batteries and vehicle parts. Anoxic sediment odour and the presence of algae blooms are indicative of poor submerged habitat conditions. Iron precipitate was observed in several areas seeping out of banks, and as build-up in slow moving water.

**Photo 2 – Typical Angus Creek habitat**

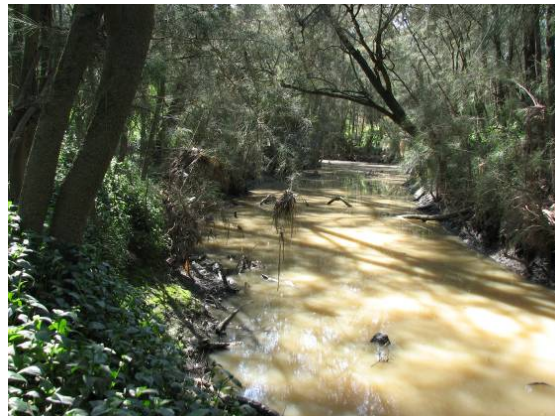
The aquatic habitat in Eastern Creek was similarly disturbed by the impacts of urbanisation. Large amounts of gross pollutants were observed, as well as significant algae blooms, covering large sections of the waterway. The most obvious difference between the two creeks was the consistently low water visibility in Eastern Creek and a larger quantity of large woody debris.

High peak flows and some erosion was evident, with little vegetation present with 1m of the waterline. Large woody debris has generally been retained in the channel, as well as a thick layer of Casuarina needles in some areas. No submerged macrophytes were observed in the creek and are likely to be sparse because of limited light penetration of the waters surface.

The substrate in Eastern Creek was difficult to observe due to high turbidity, yet high silt/clay content was evident from sediment plumes during macroinvertebrate sampling. Some large boulders were also noted protruding from the water at various places in the channel.

The channel width in this section of the Eastern Creek was about 6 -12 m, with an average of approximately 10 m. The banks were higher and steeper than those of Angus Creek, being closer to 4 m high.

**Photo 3 – Typical Eastern Creek habitat**

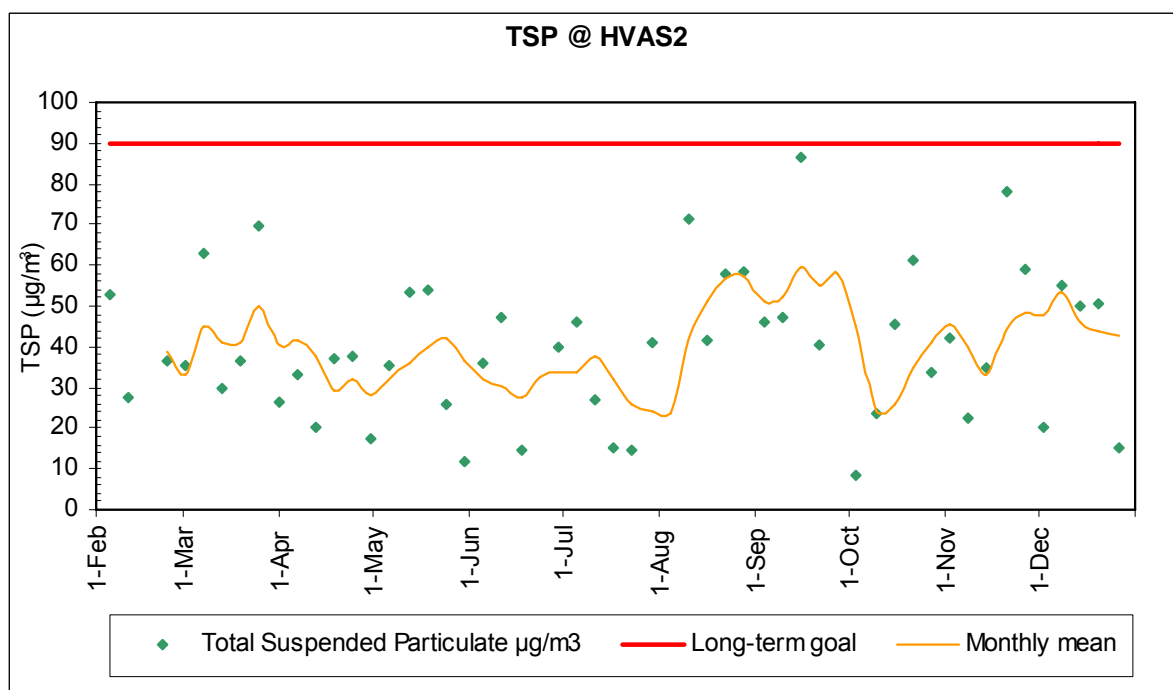
**Figure 6 – TSP results at HVAS2 site, February to December 2009**

TSP results from the HVAS2 site between February and December 2009 (Figure 6) shows no measurements exceeding the  $90 \mu\text{g}/\text{m}^3$  threshold, with the maximum level recorded on the 15<sup>th</sup> of September ( $86.5 \mu\text{g}/\text{m}^3$ ). The monthly mean, calculated from the preceding four weeks, stays within the range of  $25$  to  $60 \mu\text{g}/\text{m}^3$ . The average value for all measurements throughout the monitoring period depicted is  $39.9 \mu\text{g}/\text{m}^3$ , well below the annual target<sup>1</sup> of  $90 \mu\text{g}/\text{m}^3$ .

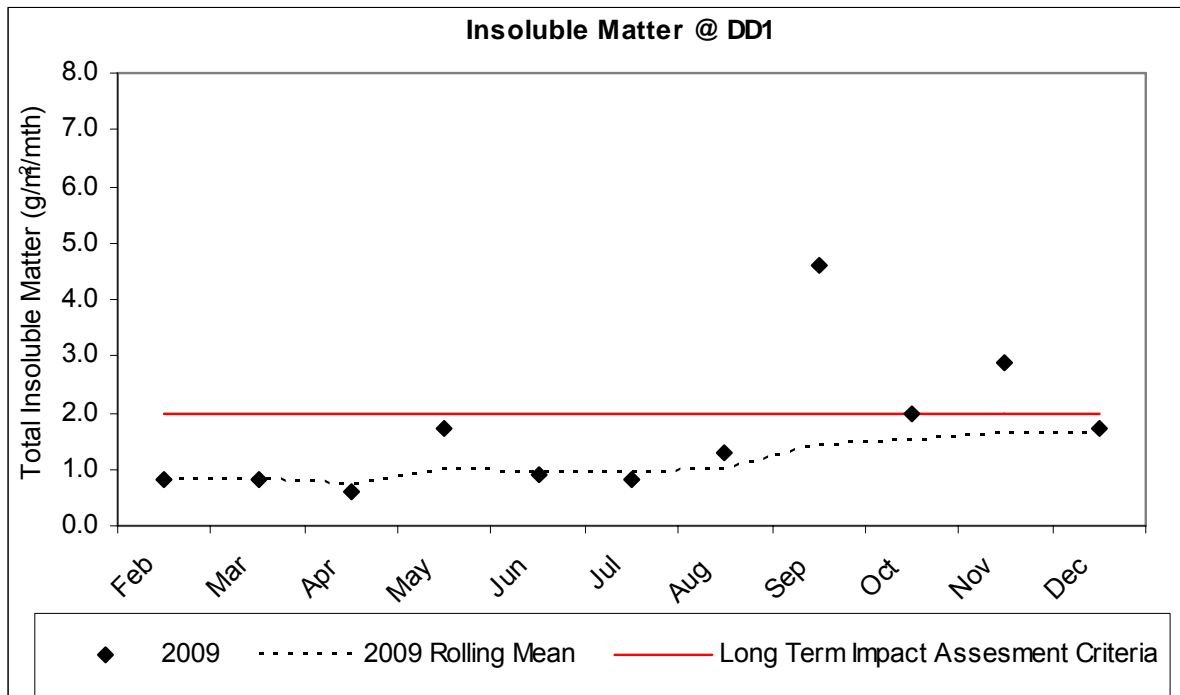
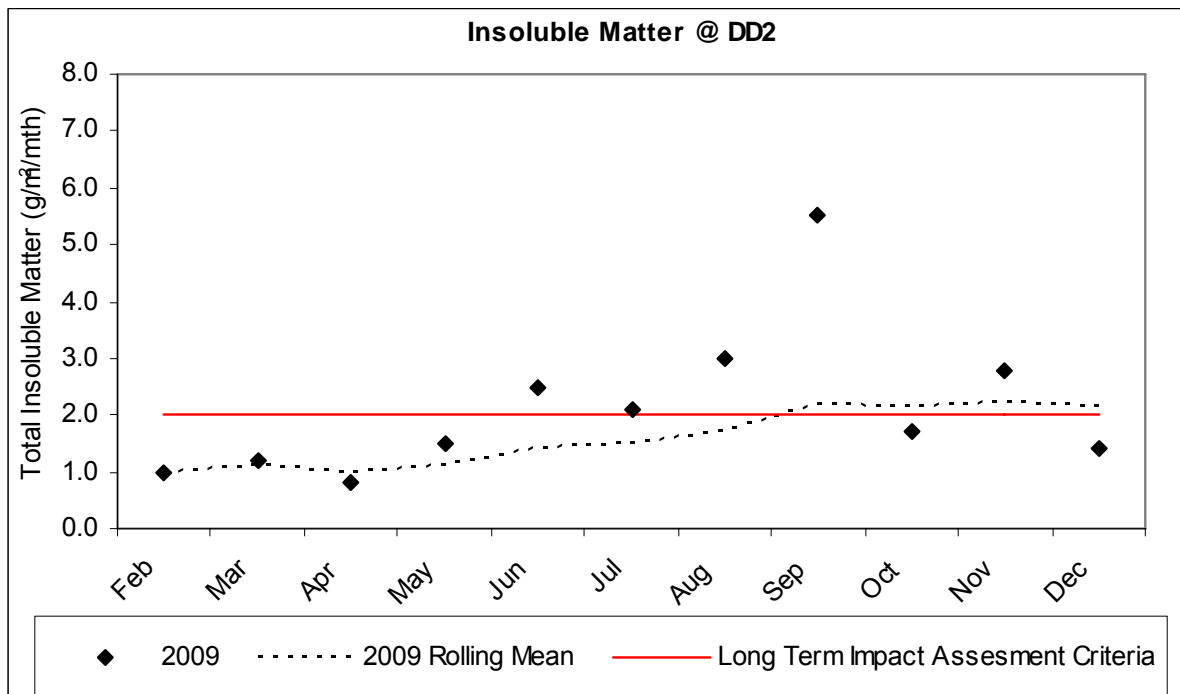
Figure 7 – Total insoluble matter at DD1 site, February to December 2009

Figure 8 – Total insoluble matter at DD2 site, February to December 2009

Figure 9 – Total insoluble matter at DD3 site, February to December 2009

Total Insoluble Matter results from the three depositional dust gauges are displayed in Figure 7, Figure 8 and Figure 9 above. The results from all three sites show a general increase in values throughout the year, and the associated increase in the rolling average. Site DD2 and DD3 (Figure 8 and Figure 9) show the rolling average exceeding the LTIAC (Long Term Impact Assessment Criteria) after the high reading in September. This exceptionally high reading at all sites in September was due to a dust storm that swept across Sydney that month.

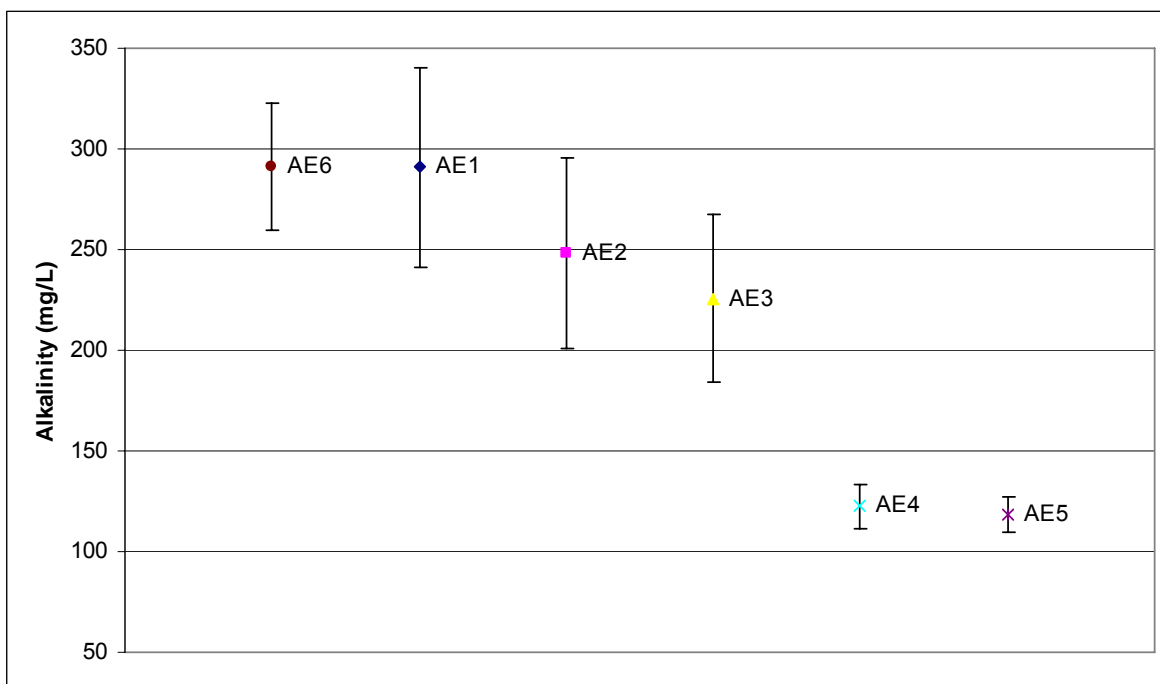
Figure 10 – Mean total alkalinity at water quality sample sites, with standard error bars

Total alkalinity (bicarbonate dominated) in the Angus Creek sites generally decreased, moving downstream (Sites AE6, AE1, AE2 and AE3 in Figure 10). In contrast, total alkalinity was much lower and less varied at the Eastern Creek sites (Sites AE4 and AE5 in Figure 10).

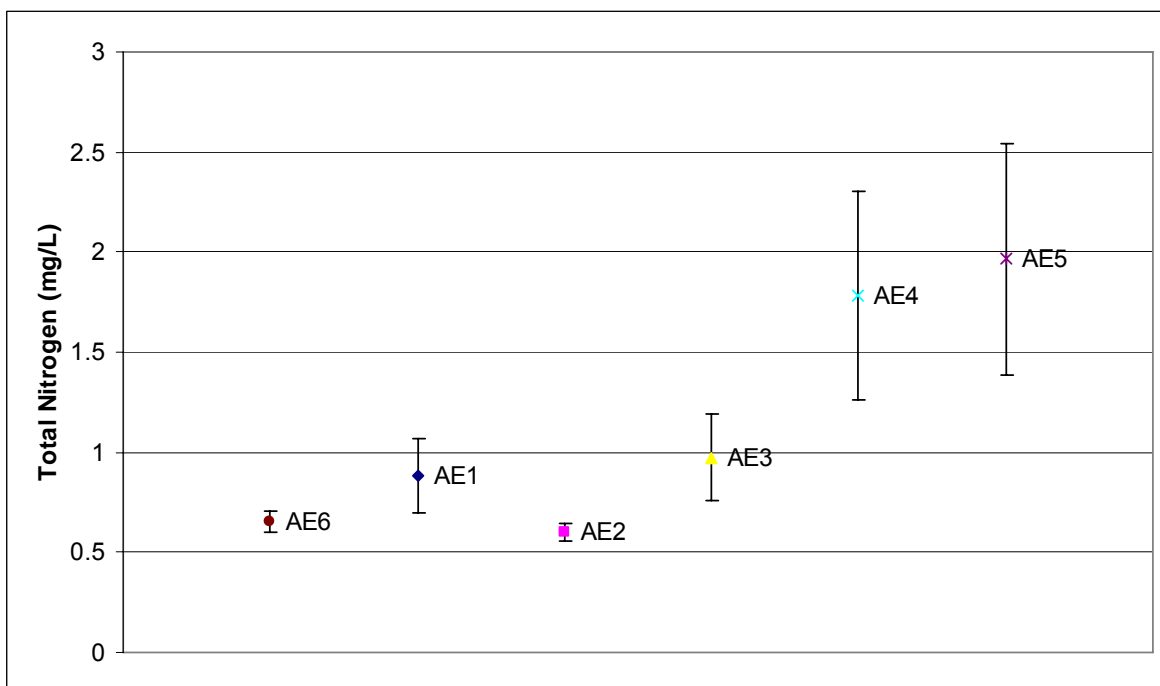
**Figure 12 – Mean total nitrogen at water quality sample sites, with standard error bars**

Total nitrogen concentrations at the Angus Creek sites (Sites AE6, AE1, AE2 and AE3) were generally lower and less variable than in those collected from the Eastern Creek sites (Sites AE4 and AE5). All mean values were above the ANZECC (2000) guidelines for total nitrogen.

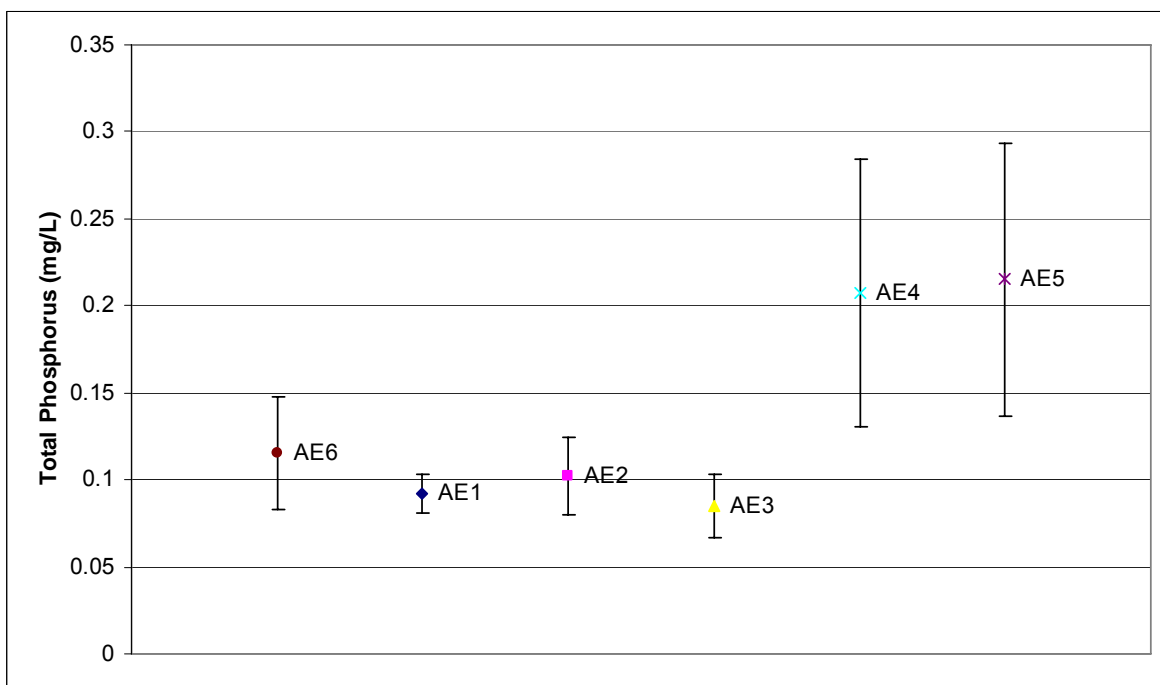
**Figure 13 – Mean total phosphorus at water quality sample sites, with standard error bars**

Total phosphorus concentrations were similarly higher and more variable at the Eastern Creek sites than in the Angus Creek. Concentrations in both creeks were well in excess of the ANZECC (2000) guidelines for TP.

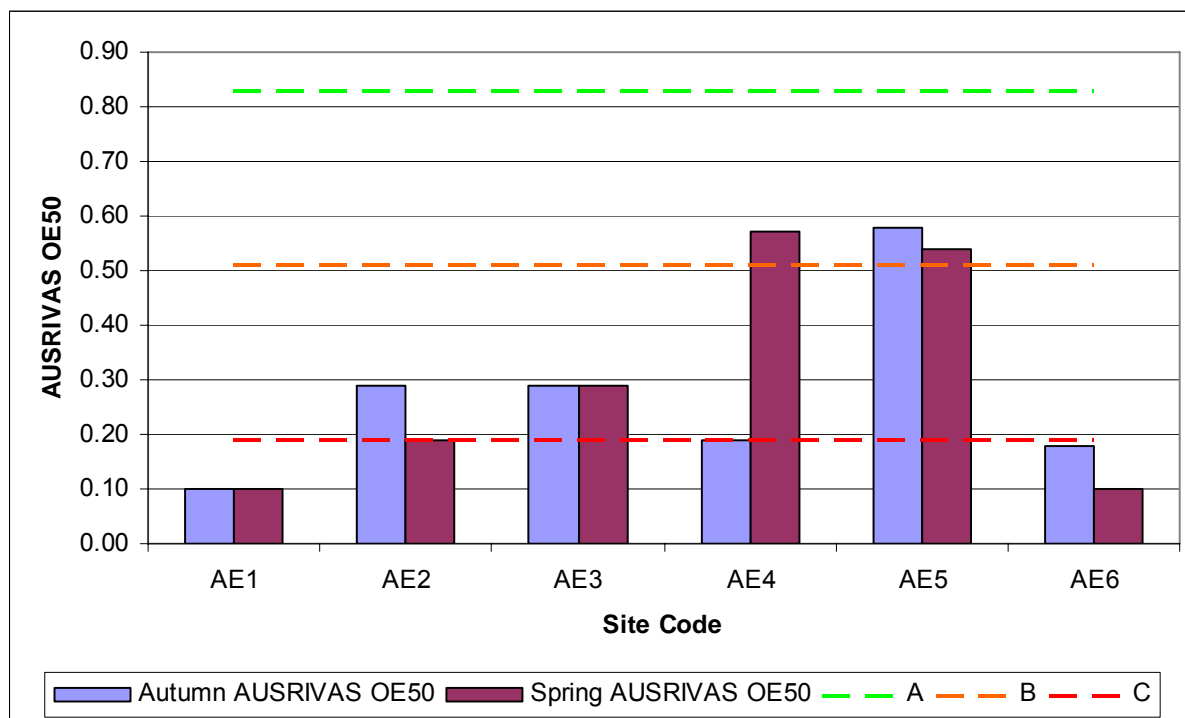
**Figure 14 – AUSRIVAS OE50 Scores for 2009 spring and autumn sampling events**

AUSRIVAS OE50 outputs for all sites (Figure 14) indicate significant to extreme aquatic ecosystem degradation (AUSRIVAS grades B to D, see Table 6 in section 3.4.4 for more information). This output is based on the ratio of number of macroinvertebrate families observed in the samples, to the number that are predicted to occur by the AUSRIVAS model, based on the input variables (given in Table 5, section 3.4.4).

Most of the macroinvertebrate taxa expected to occur in Angus Creek sites (AE1 and AE6) were not observed in the samples collected, with OE50 scores indicating as little as 10% of the families predicted, actually occurring. Moving downstream on Angus Creek, sites AE2 and AE3 show slightly more families present than the upstream sites.

In terms of the number of expected taxa observed, the Eastern Creek sites (AE4 and AE5) appeared less degraded than the Angus Creek sites, with the exception of the sample from AE4 in autumn 2009. This is likely to be a reflection of differences in water quality, as explained below, although it may also be due to subtle differences in micro-habitat characteristics.

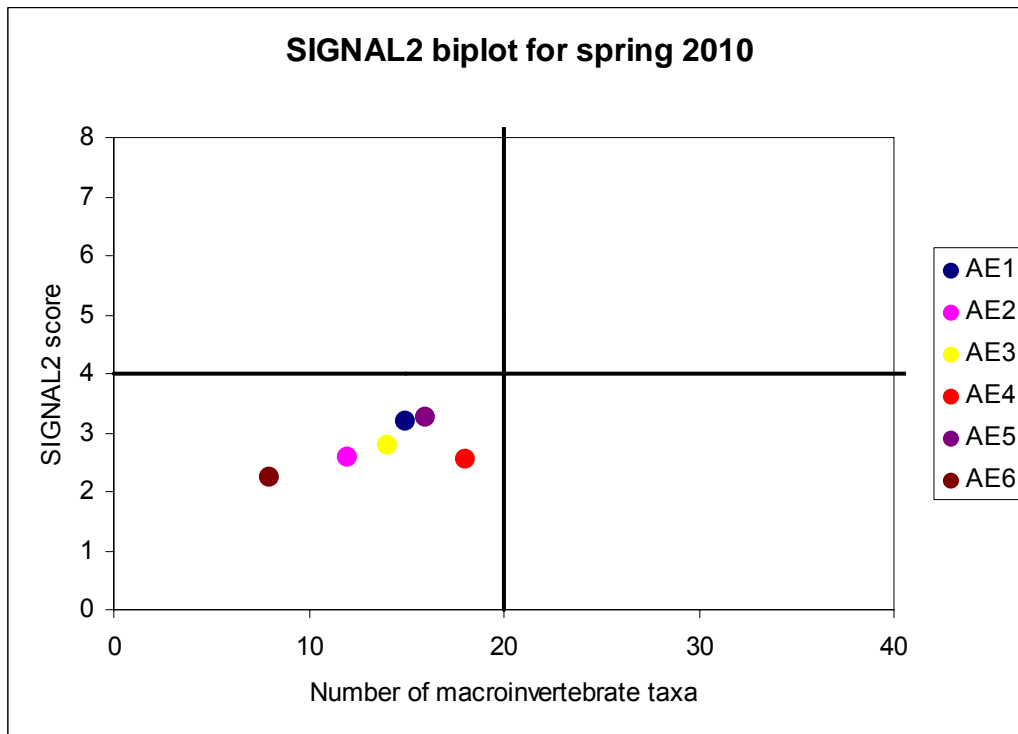
Figure 15 – Autumn 2009 SIGNAL2 outputs for aquatic sample sites

Figure 16 – Spring 2009 SIGNAL2 outputs for aquatic sample sites

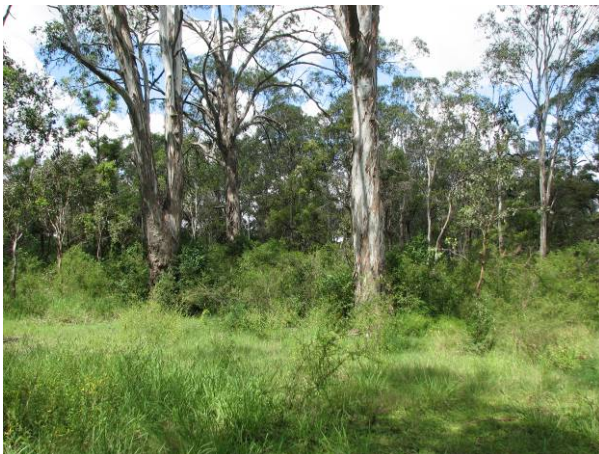
**Photo 4 – Cumberland Plain Woodland within the RDC site**

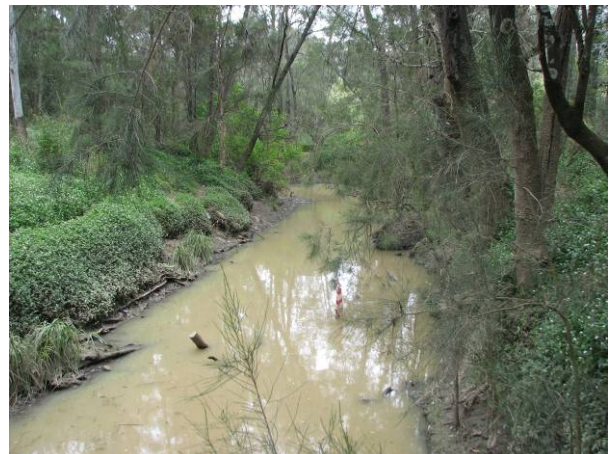
The upper and lower riparian vegetation found at all sites is heavily degraded from the originally existing River Flat Eucalypt Forest community. This ecological community is listed as endangered under the *NSW Threatened Species Conservation Act 1995*.

However, the quality of the community was determined as low; because of the dominance of the understorey by intrusive, exotic species (e.g. Wandering Jew - *Tradescantia fluminensis* and Privets - *Ligustrum* spp.).

**Photo 5 – Degraded River Flat Forest along the banks of Eastern Creek**

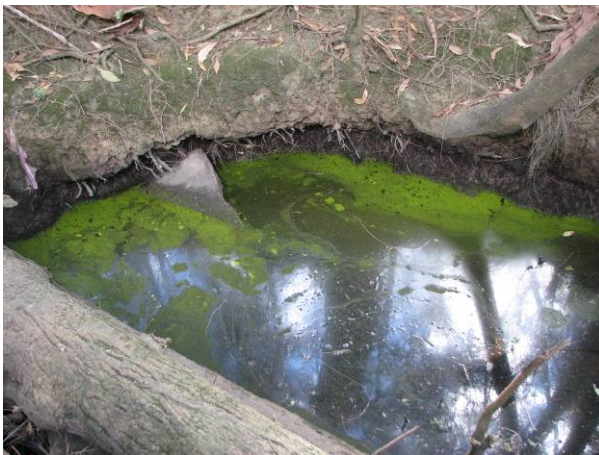
- Aquatic Vegetation – No submerged macrophytes were noted at this site and a significant bloom of microscopic algae (possibly blue-green algae) was observed on the waters surface. Emergent vegetation was not observed, with banks being heavily scoured and devoid of plants other than larger trees.

**Photo 6 - Algae bloom in Angus Creek**

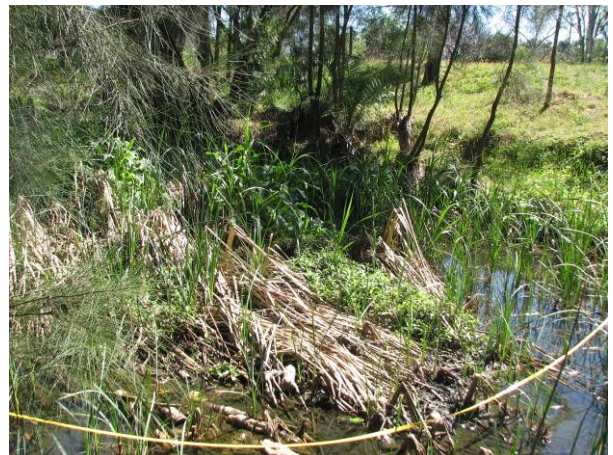
- Aquatic Vegetation – *Typha* sp., *Persicaria* sp. and *Baumea articulata* were the main emergent macrophytes present at this site. The submerged *Potamogeton pectinatus* and *Vallisneria* sp. were also observed in the stream. Macrophytes were also present further upstream of the transect, within the swamp area, and further downstream towards the M7 overpass.

**Photo 7 – Emergent vegetation at site AE6**
