Rooty Hill Regional Distribution Centre

Annual Environmental Monitoring Report 2013 - 2014

Document title: Annual environmental monitoring report 2013-14

Document no. EN03250 280115

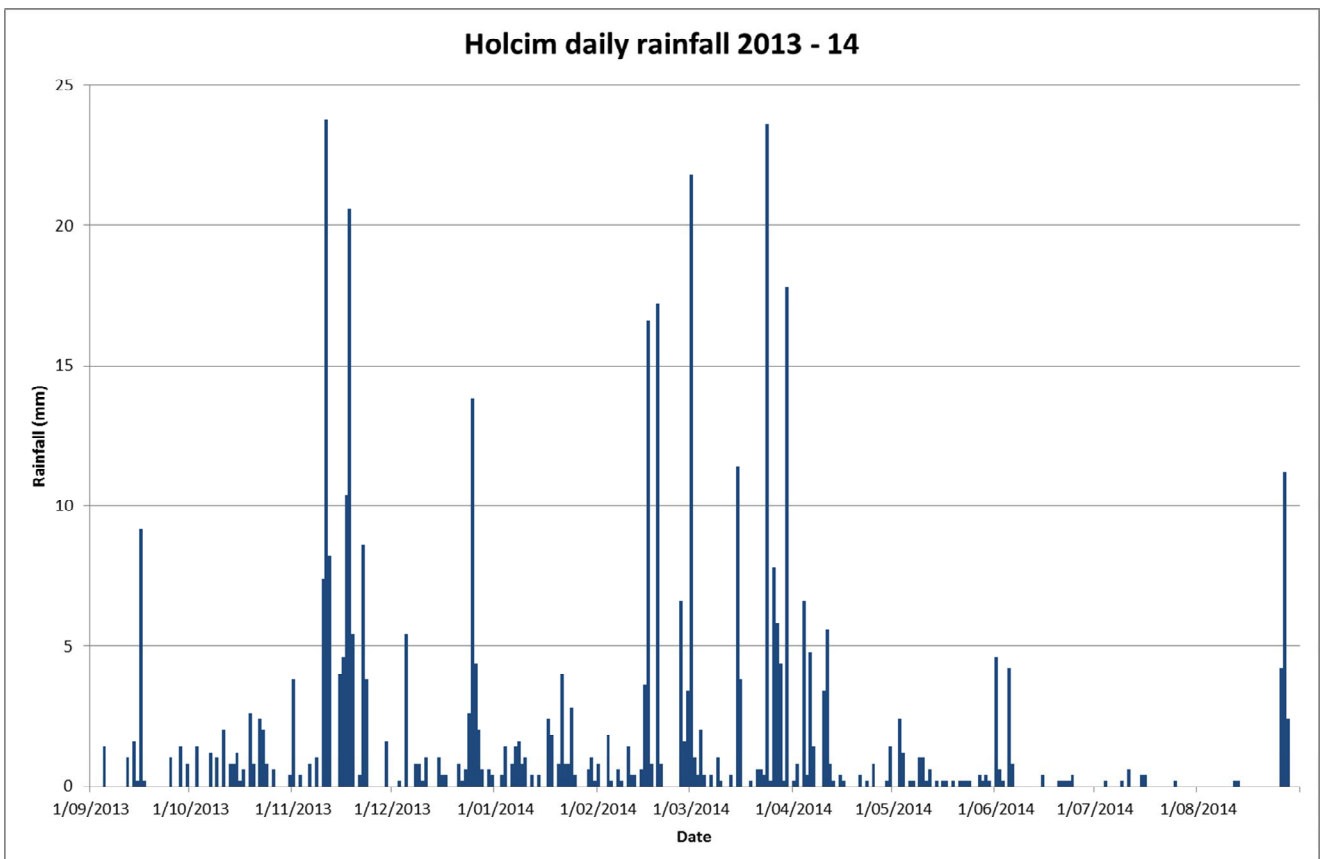
Figure 2-4 Daily rainfall

Results of rainfall observations are summarised in Figure 2-4. Total rainfall in the period was 445 mm over 197 rain days, lower than the nearby Prospect Reservoir, which was around 900 mm. The timing and rainfall for the majority of observed rain days are similar for each site. This difference is relatively large and may indicate localised storm activity or that the Rooty Hill monitoring station is less sensitive to some rainfall events.

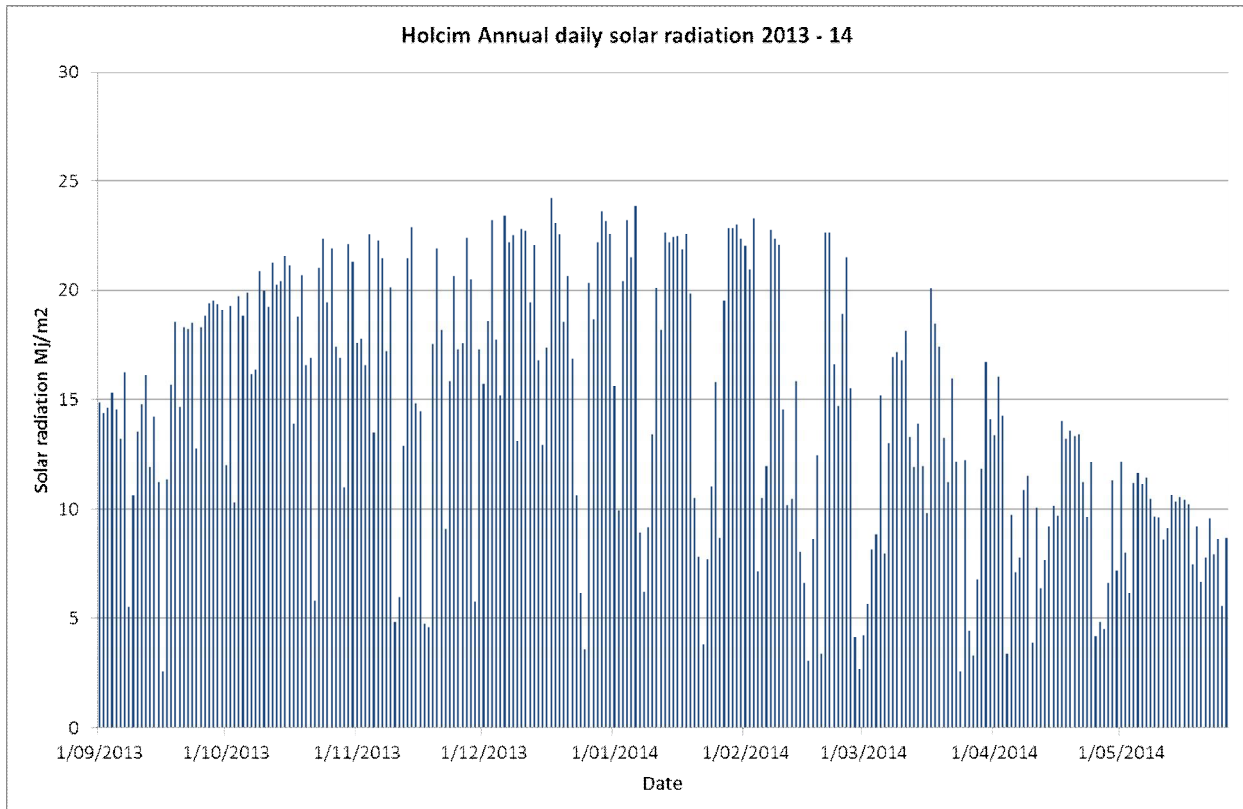
Figure 2-6 Solar radiation

Average daily solar radiation is summarised in Figure 2-6. The trend in solar radiation follows the UV index, with highest levels experienced in summer.

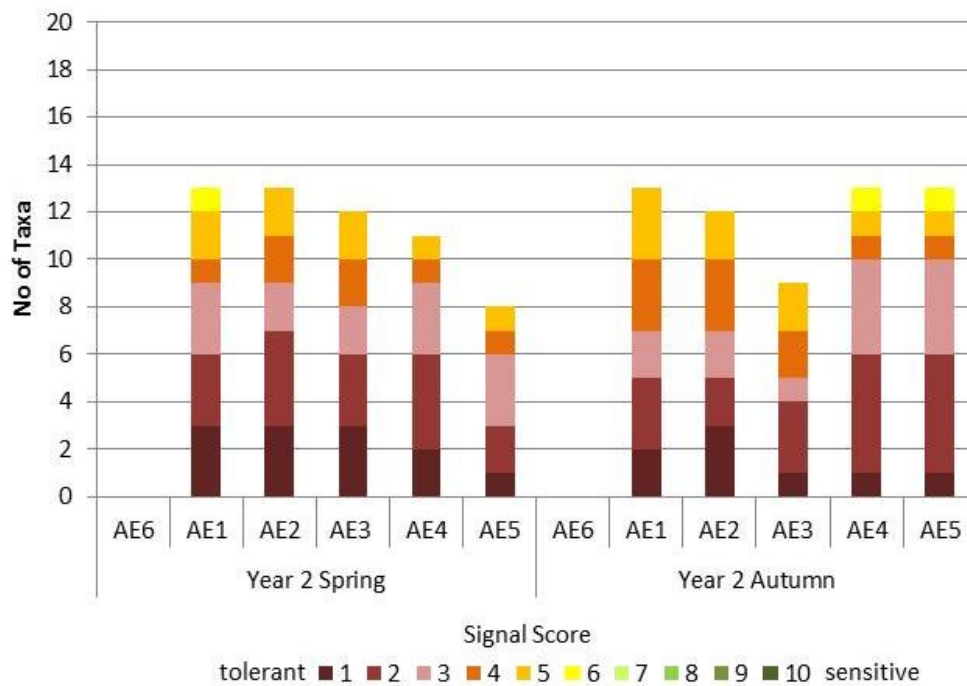
Figure 3-3 Contribution of macroinvertebrate taxa to SIGNAL scores (2013-14).

Site SIGNAL scores indicated that all sites contained taxa tolerant and moderately tolerant to a range of environmental conditions (Table 3-3). The number of taxa in each SIGNAL grade contributing to overall site SIGNAL scores are displayed Figure 3-3.

A large proportion of taxa were tolerant and moderately tolerant, from SIGNAL grades 1, 2 and 3. Generally over 70% of taxa were from the SIGNAL grades 4 and below. Taxa sensitive to most forms of pollution or disturbance were not found at any of the sites in either season.

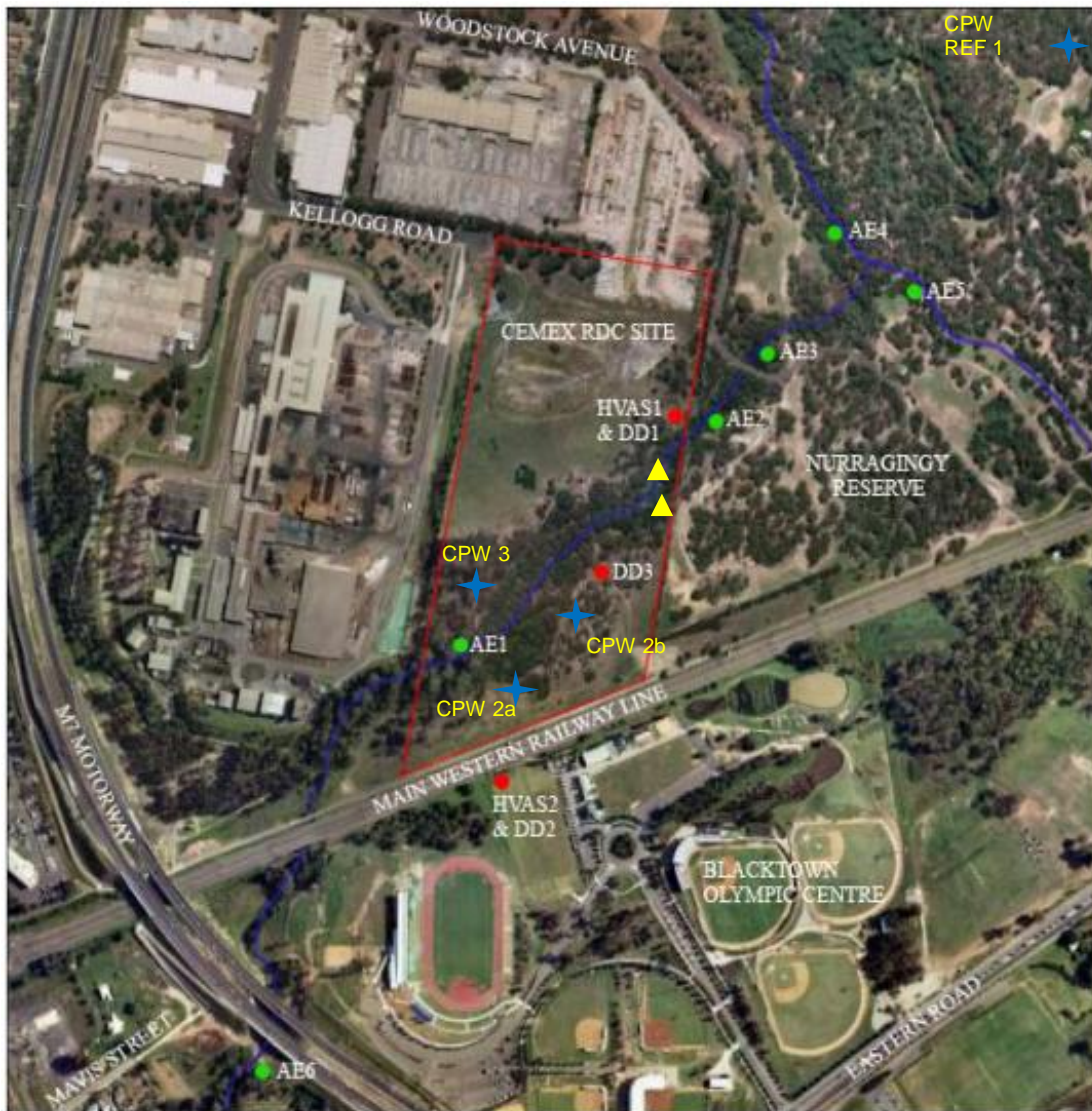
Figure 4-1 Monitoring locations

Monitoring locations included the following, which are illustrated in Figure 4-1.

- Juniper-leaved Grevillea populations - North and South of Angus Creek
- Riparian health assessment - AE1 to AE6
- Cumberland Plain Woodland CEEC- Rooty Hill RDC site and Nurragingy Nature Reserve (CPW 2a, CPW 2b, CPW 3, CPW Ref)

Table 4-1 identifies the dates monitoring was undertaken at the Rooty Hill RDC site. Monitoring locations are illustrated in Figure 4-1.

Riparian health and condition monitoring was conducted at the six established monitoring sites quarterly during dry weather (refer Figure 4-1).

Cumberland Plain Woodland (CPW) was monitored as a baseline assessment (pre-Stage 2 construction) of the three zones (or conditions) of the woodland on the Rooty Hill RDC site and an assessment of one external reference CPW site in close proximity to the site (refer Figure 4-1). The field methodology aligns with current industry best practice for describing vegetation condition in relation to biodiversity offsets. This methodology will provide a useful baseline upon which to describe improvements resulting from bushland regeneration efforts that are required at the site as part of the conditions of approval for the project as well as identifying any condition changes as a result of the project.

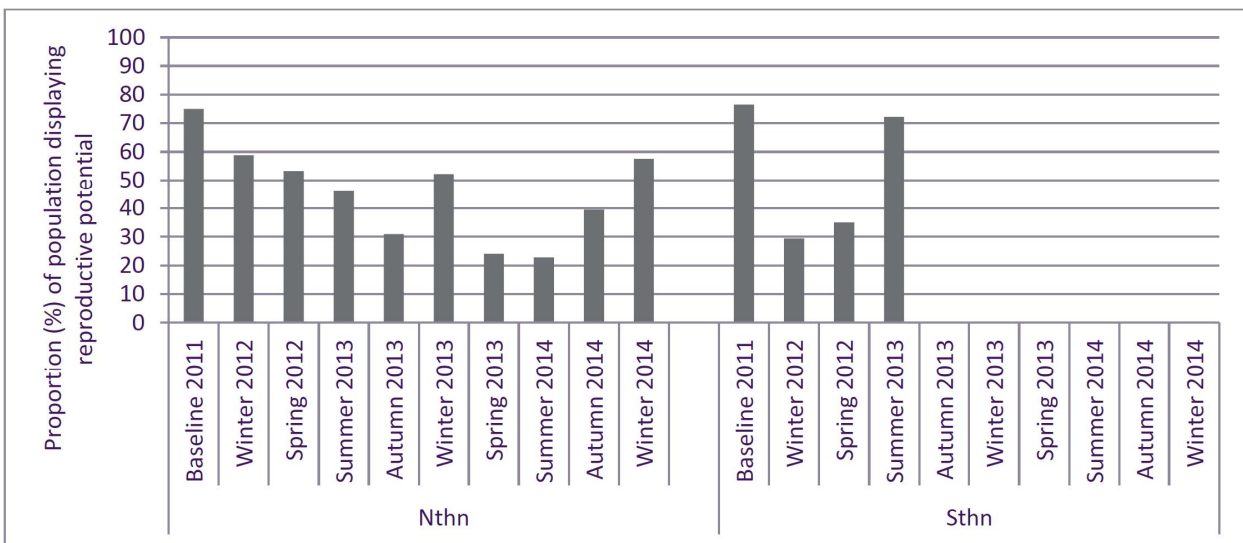
Figure 4.4 : Reproductive potential of each population of the Juniper-leaved Grevillea over four seasons

Figure 4.4 illustrates the proportion of the northern and southern grevillea population that has reproductive potential. The reproductive potential of the northern population remains stable due to juvenile individuals exhibiting flowering and fruiting almost all year round. The reproductive potential of the southern population was eliminated from the site in the wildfire in January 2013, and it is anticipated that seedlings in that population will become reproductively mature in two or three years.

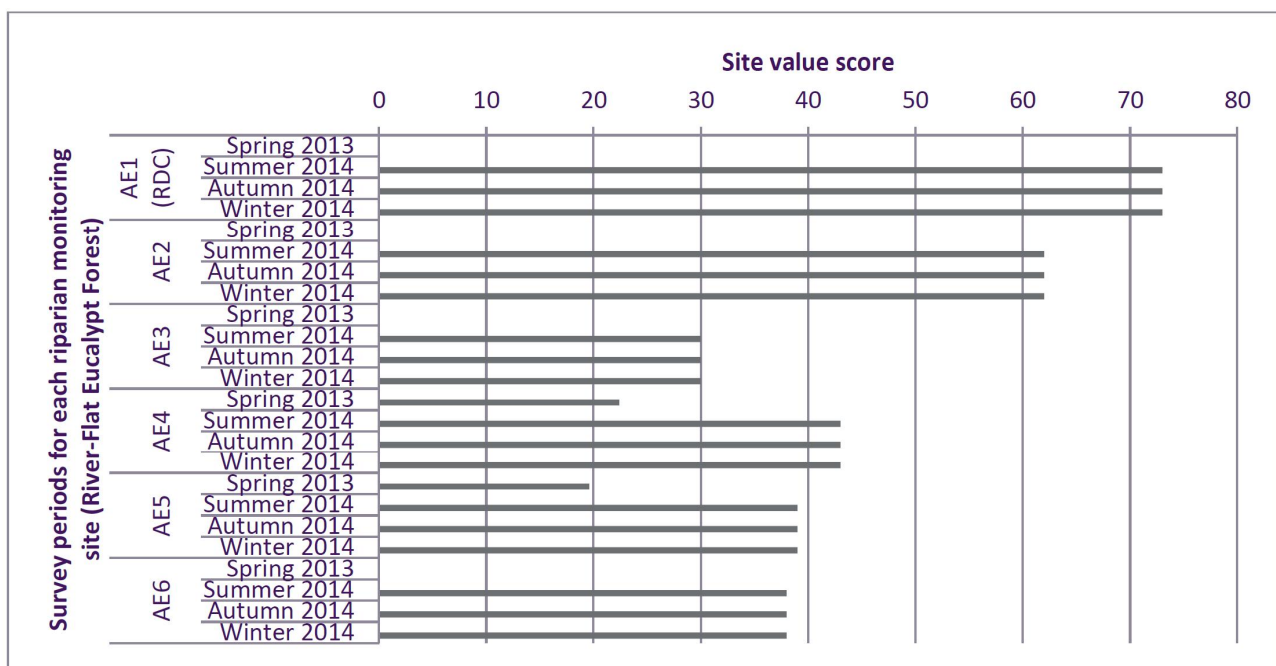
Figure 4-5 Site value scores for each riparian monitoring site across 4 seasonal survey periods

This temporary decrease in the conditions of the riparian monitoring sites is the result of localised flooding and topsoil removal. AE1 on the Rooty Hill RDC site consistently has the highest site value score; however this is likely because the site has a large number of fallen logs and two trees with hollows, characteristics that are favourably weighted in the site value scores.

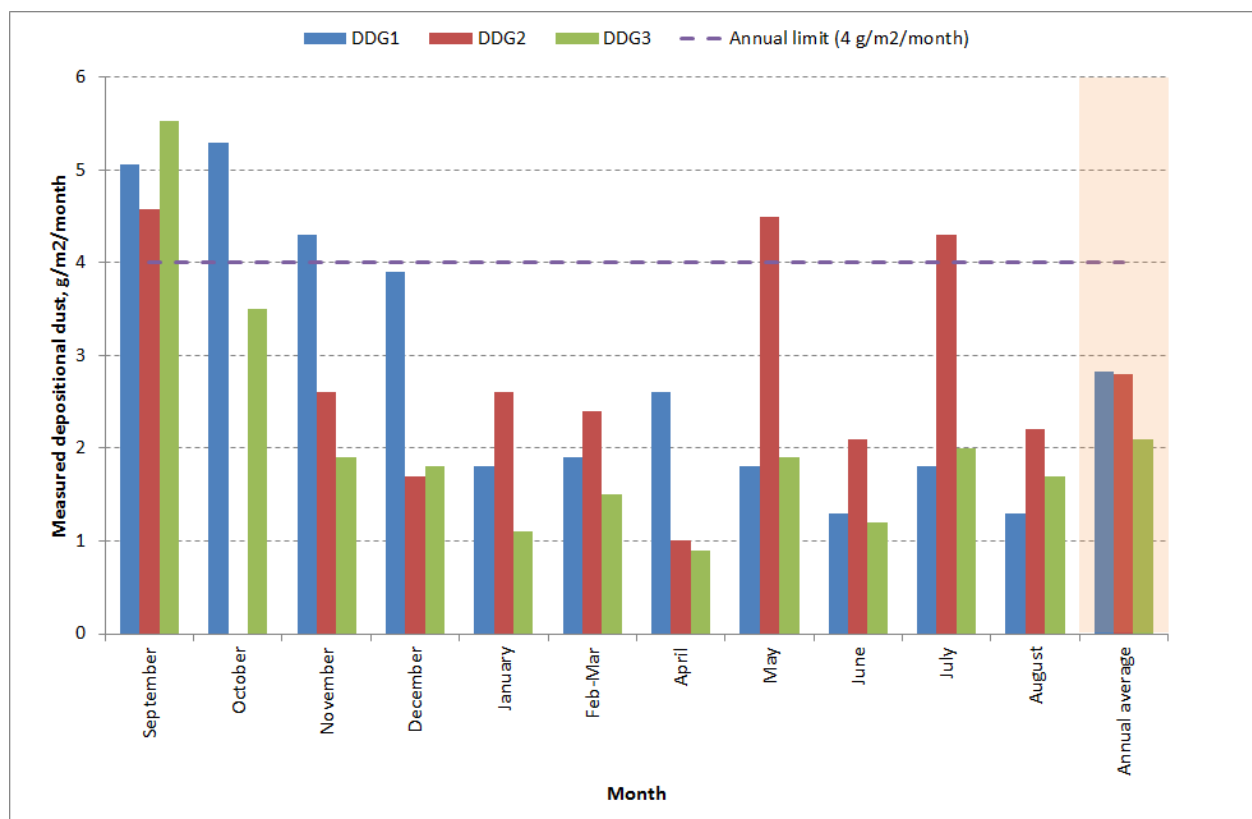
Figure 6-4 Depositional dust results

Results for monthly depositional dust sampling are summarised graphically in Figure 6-4. It is evident that the annual average values for each of the three monitoring locations are less than the annual limit of 4 g/m²/month.

DDG2 recorded the highest concentrations of depositional dust between May and July 2014, trending to increased levels by the end of the annual monitoring period.
