Teven Quarry Biodiversity & Rehabilitation Management

Holcim Australia
November 2021 Update

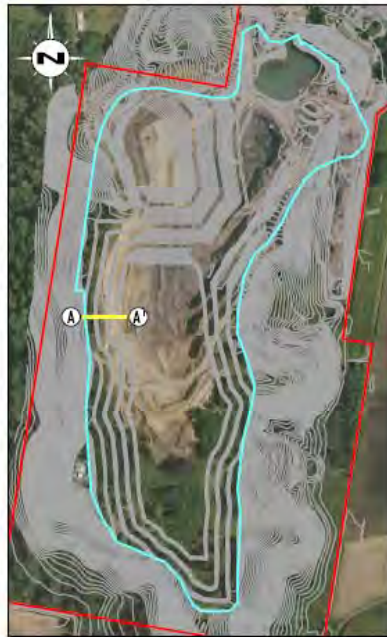
Plan

Section A - A'
