Appendix 3

Community Information Sheets

Cooma Road Quarry - Continuation Project Community Information Sheet No.1

Groundwater Assessment

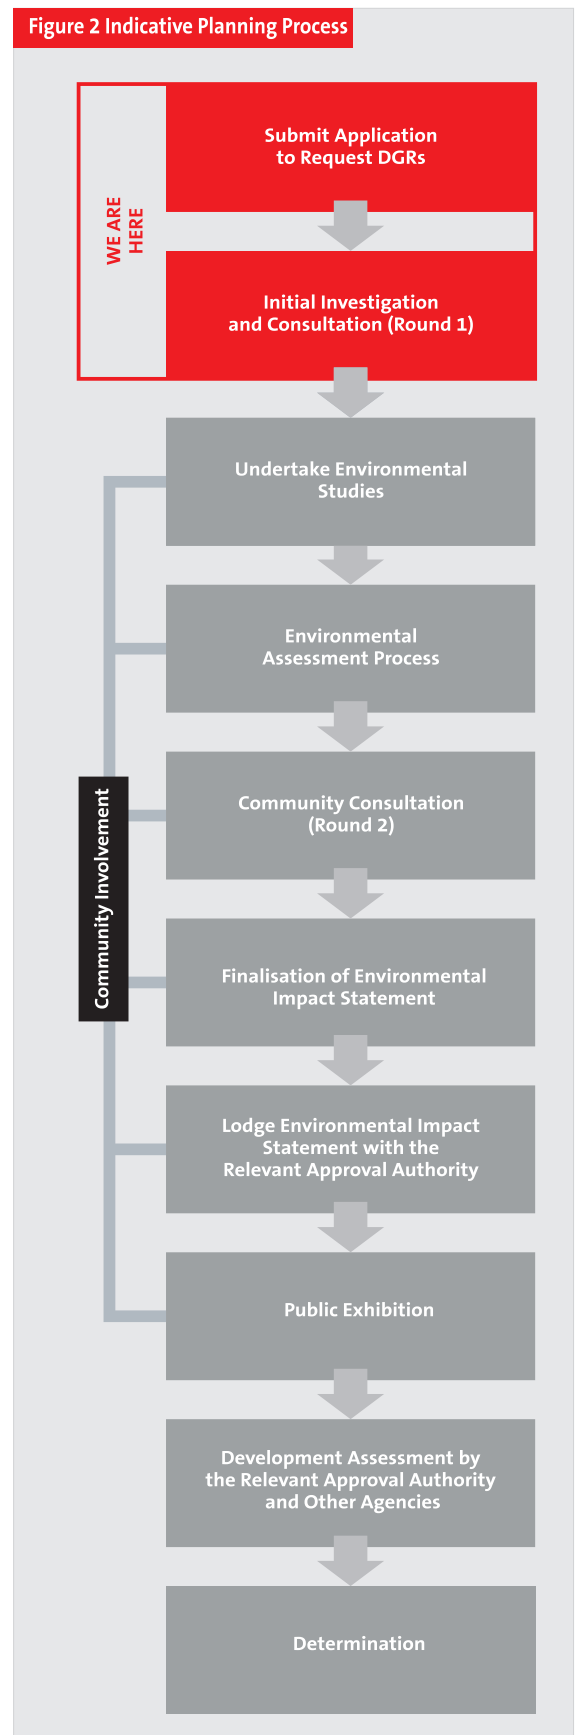
Figure 2 Indicative Planning Process

Umwelt (Australia) Pty Limited (Umwelt), an Environmental Consultant, has been engaged by Holcim Australia to assist with conducting environmental studies and preparation of the EIS. An outline of the indicative planning and approvals process is provided in Figure 2.

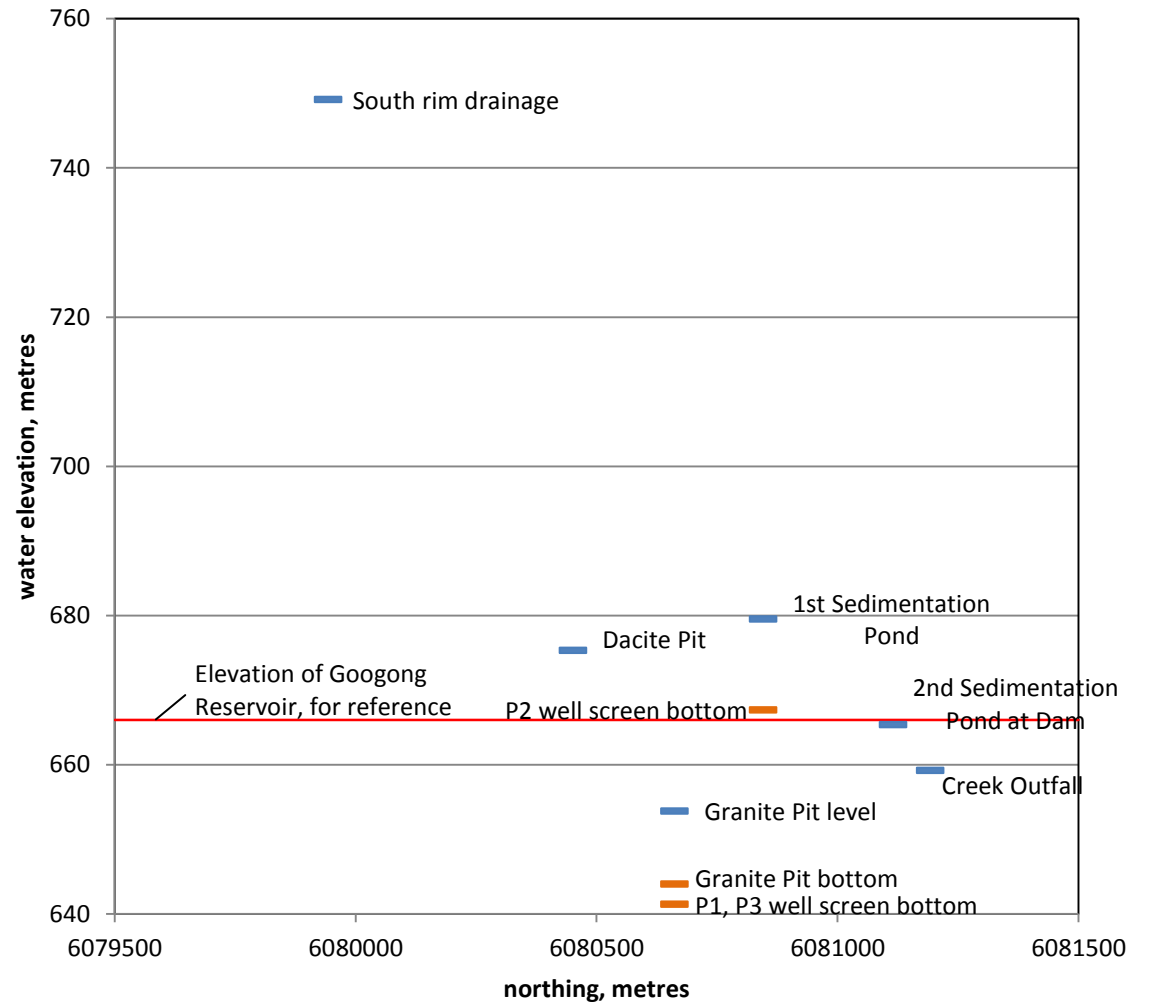
client:	Umwelt (Australia)	
project:	Cooma Road Quarry	
title:	Surface water elevation	
project no:	GEOTNEWS21034AA	figure no: FIGURE 2

Surface Water Elevations at Cooma Road Quarry

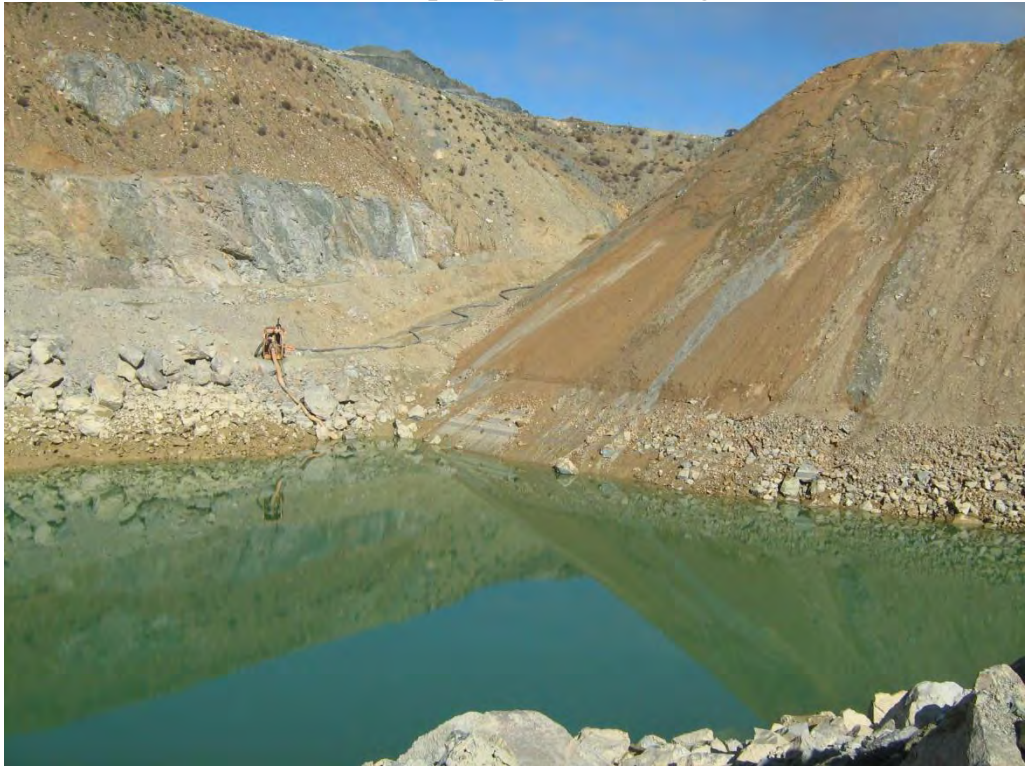
a Granite Lake with pump in the back ground

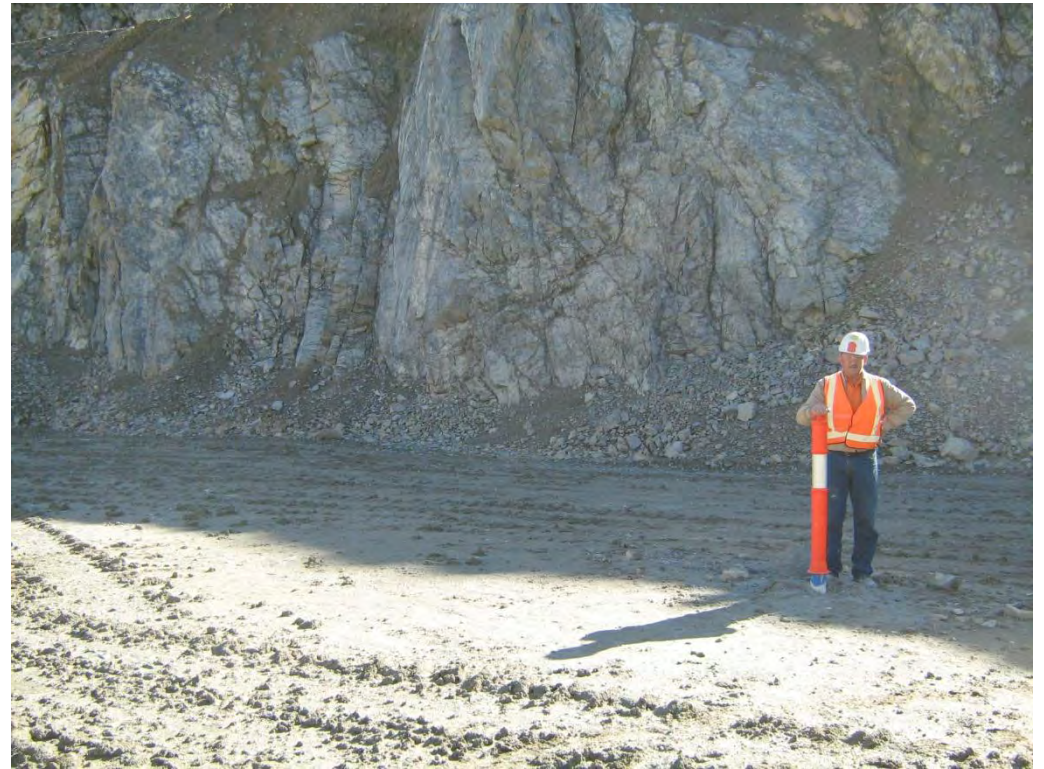
b Well P3 on bench 2 at the Granite Pit

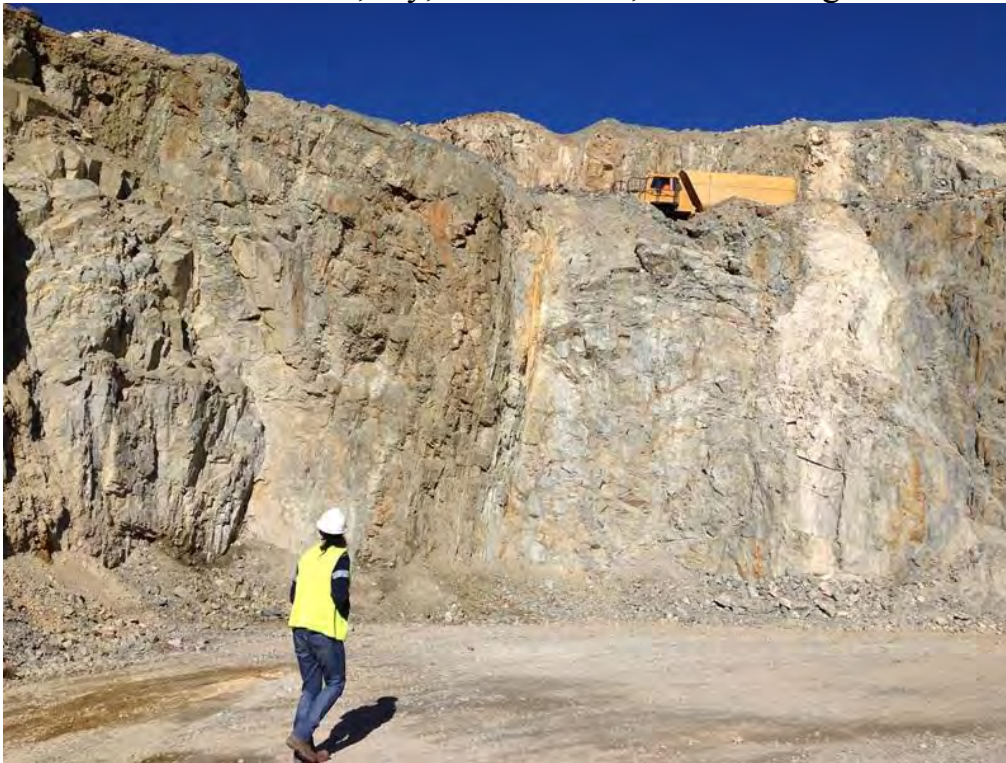
c Bench 3 rock face, dry, in Dacite Pit, southern edge

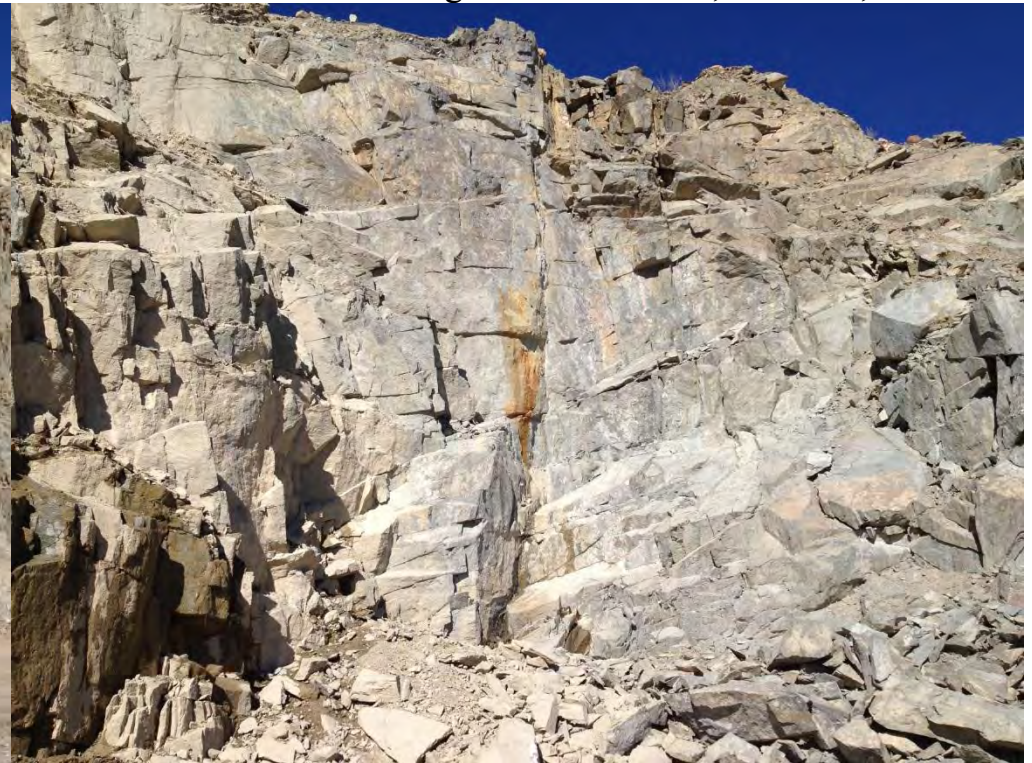
d Minimal traces of groundwater flow, fresh cut, Dacite Pit
