ANNUAL REVIEW
1 April 2021 – 31 March 2022

Northern Dune Extension

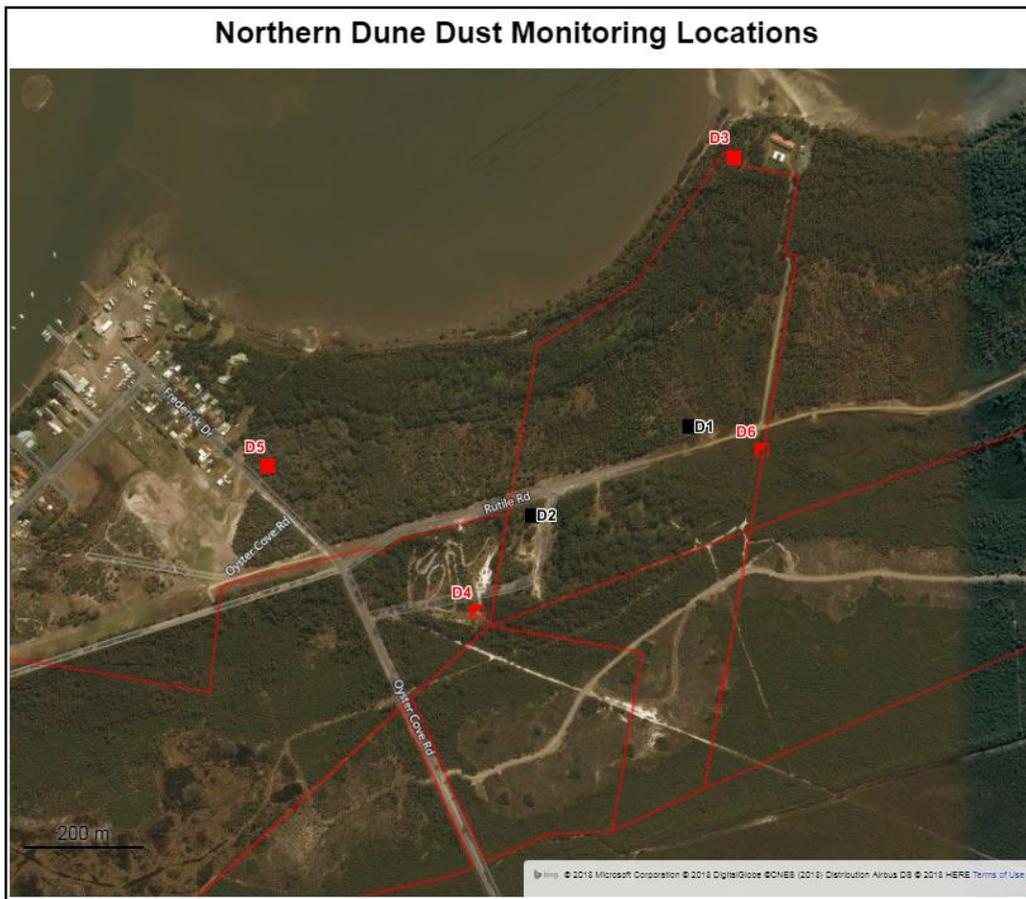
Figure 4: Dust Sampling Locations

Depositional dust was monitored monthly over the AR reporting period and analysis conducted by ALS Laboratory Services (NATA accredited) for insoluble solids in accordance with AS 3580.10-1 - 2003.

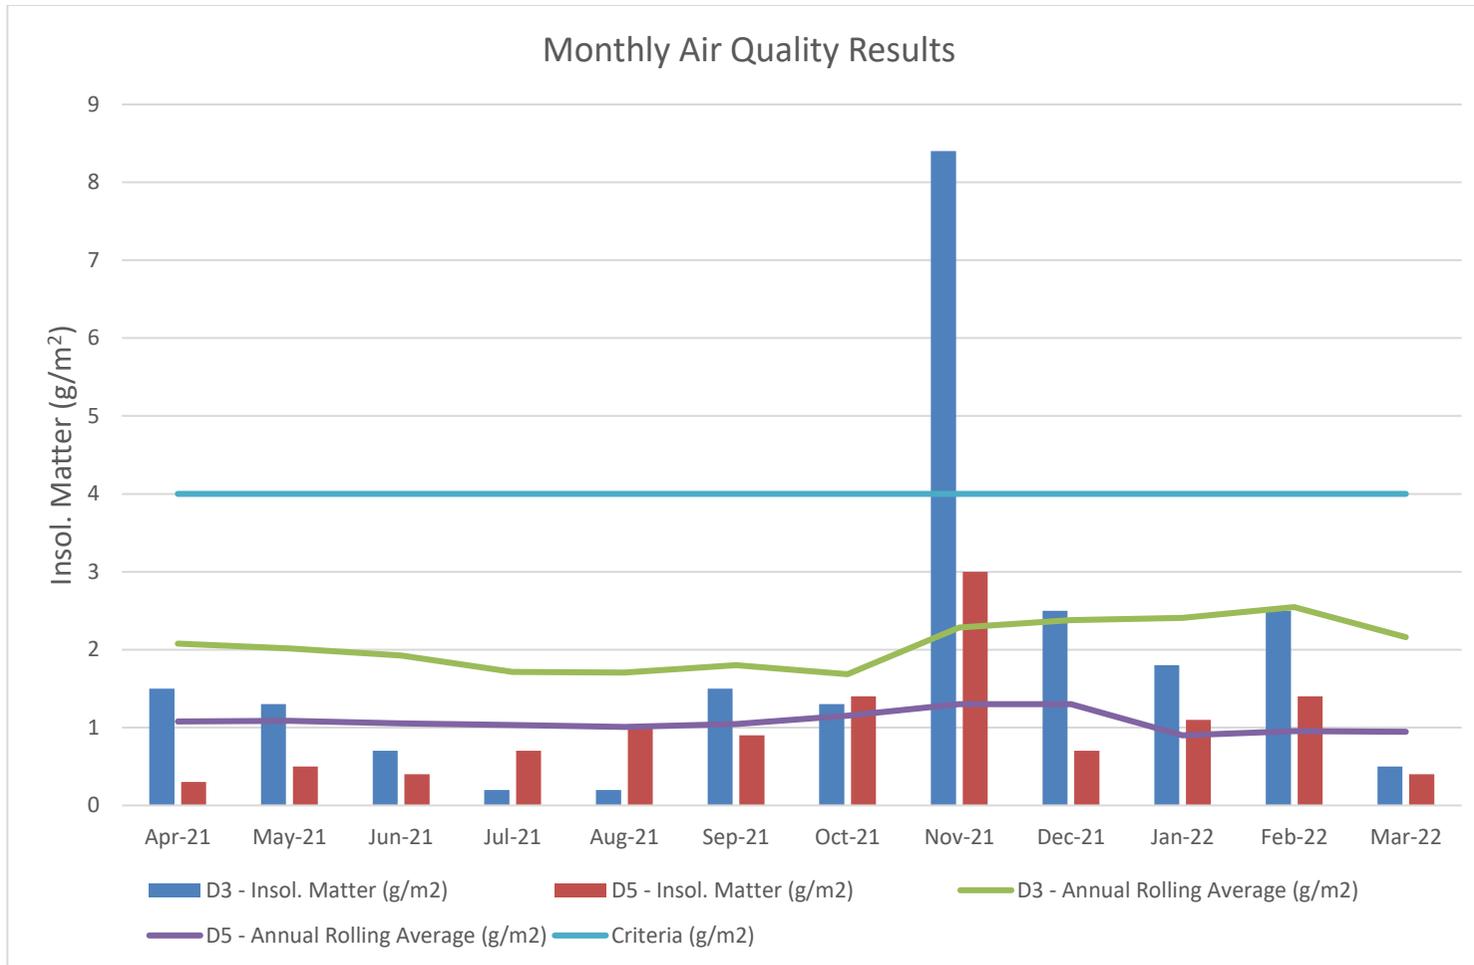
Figure 5: Insoluble Matter (g/m²) Monitoring results for the D5 / TB3 Monitoring Station and D3 / TB4 Monitoring Station

- November 2021 (8.4 g/m²). It was noted in the EPA portal at the time of receiving this result that construction work had been carried out on the private property where eD3 / TB4 is located. This construction work included ground disturbing activities. And is suspected as being the source of the elevated November 2021 result.

The annual rolling average for both D3 / TB 4 and D5 / TB3 are below the trigger threshold under Schedule 3, Clause 6 of the conditions of approval for all months within the monitoring period.

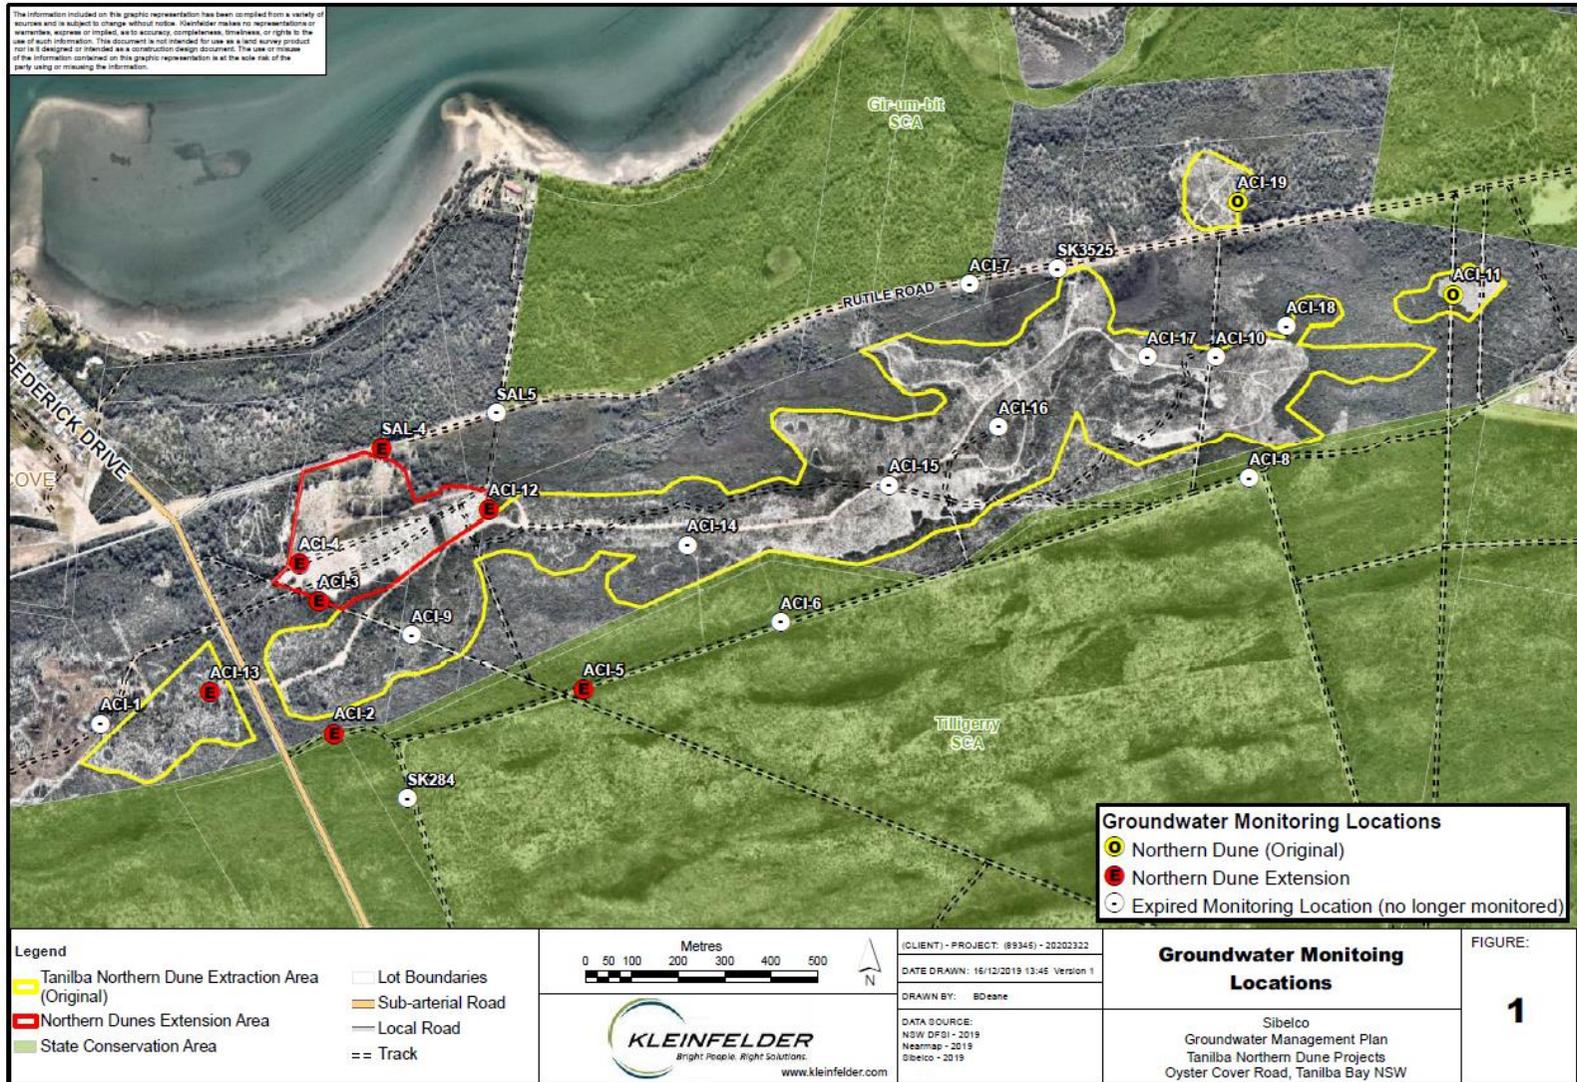
Figure 6: Location of the Tanilba Northern Dune Projects and Associated Current Monitoring Locations

During the reporting period, the 2021 updated plan was not yet approved or therefore being implemented. This resulted in the groundwater quality monitoring locations and frequencies listed in Table 14 remaining for the reporting period. The locations of these bores are shown in Figure 6.

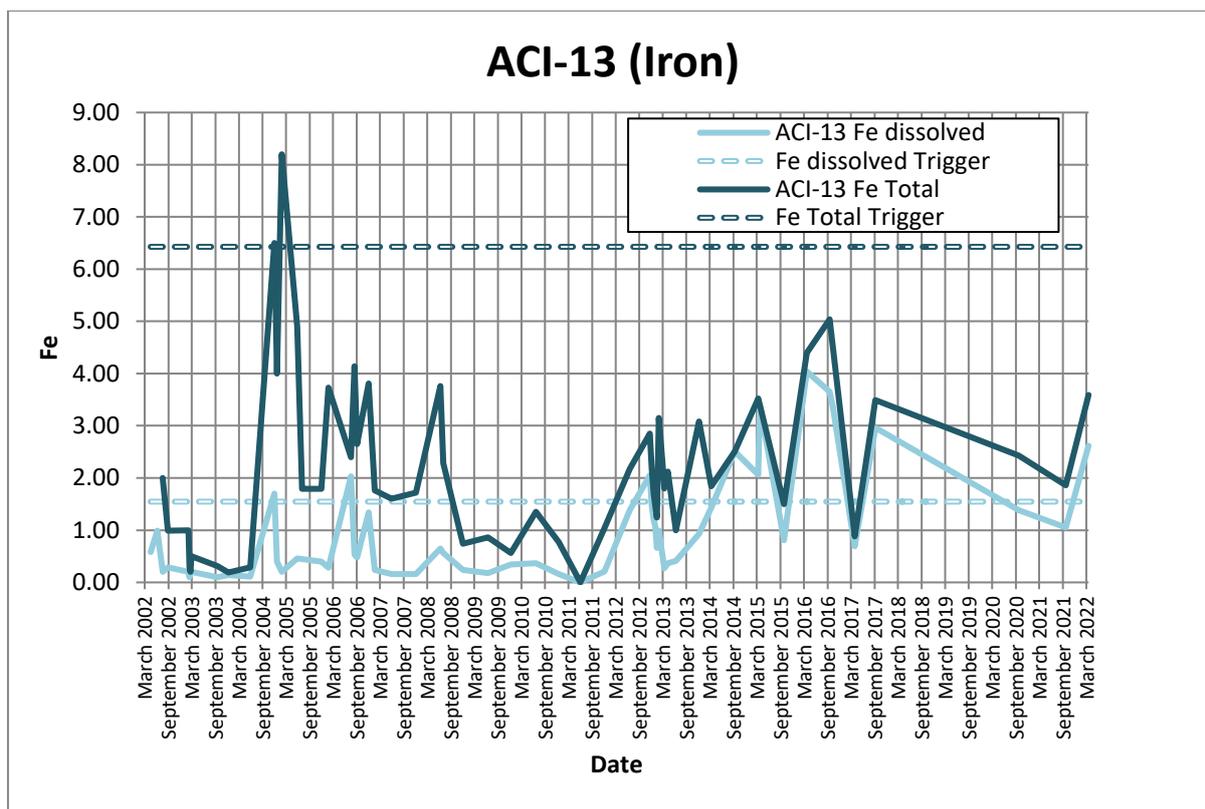
Figure 10: ACI-13 Iron Results Trend History

Groundwater quality at Northern Dune is driven by the nature of rainfall and properties of the unsaturated zone. Rainfall entering the soil zone undergoes significant changes in chemical composition and pH by processes such as root respiration and decomposition of organic matter via chemical reactions such as sorption and redox. The chemical constituency of infiltrating water in turn modifies groundwater chemistry by processes such as leaching, dilution but not concentration (which is protected against by licence conditions limiting depth to groundwater) as well as dissolution/precipitation. The effect of multiple processes on groundwater quality parameters and therefore setting Trigger Values is that water quality data is often multiple-modal (non-normal distribution) and so simple statistical analysis using mean and standard deviation may not adequately represent processes leading to water quality change. Water quality is dependent upon the nature of rainfall (ie. timing, intensity, duration...etc.) which determines whether infiltration provides a diluting effect and/or a leaching effect on ions and/or metals. Water quality can improve or deteriorate with rainfall and therefore timing of a small, limited sample set strongly influences the calculated trigger value.

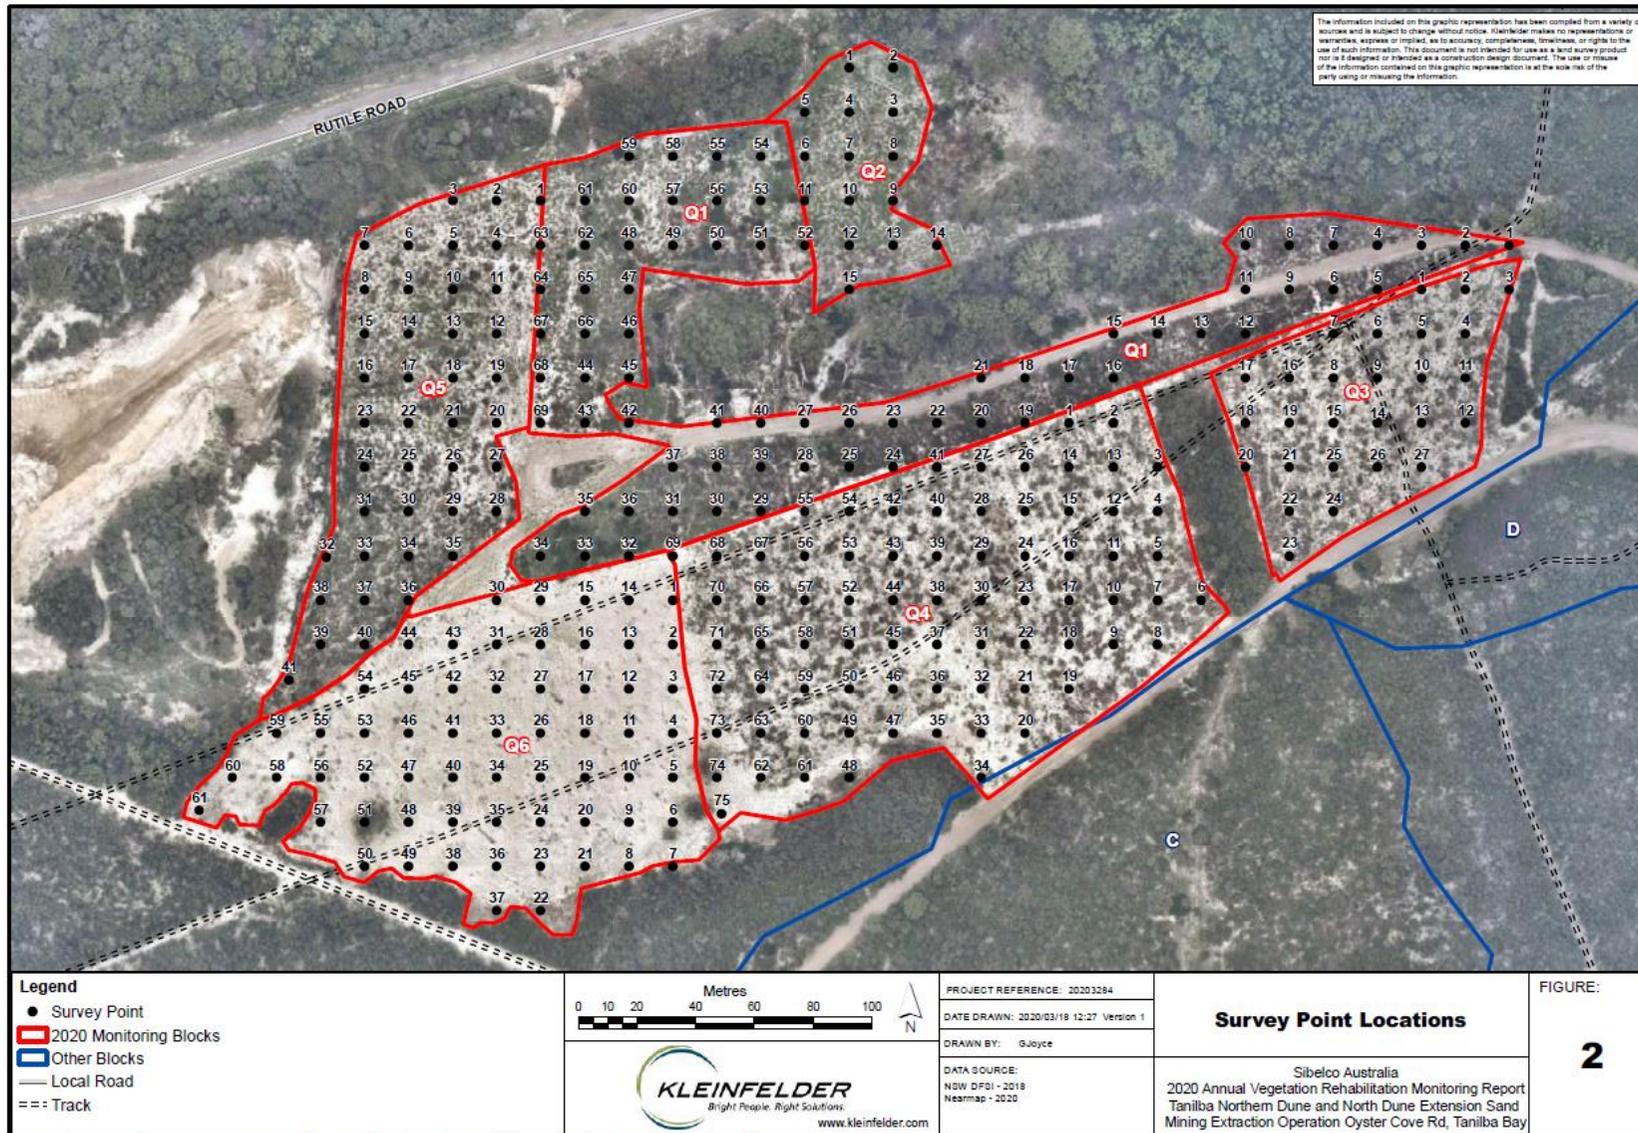
Figure 11: Locations of Blocks Q1 to Q6

The monitoring plan has been designed in accordance with principles of the EMP and will facilitate the stated aim of the EMP (Section 7.1) to re-establish stable and sustainable native vegetation cover in-line with the original vegetation community types pre-extraction, including similar structural components and species composition at similar elevations.

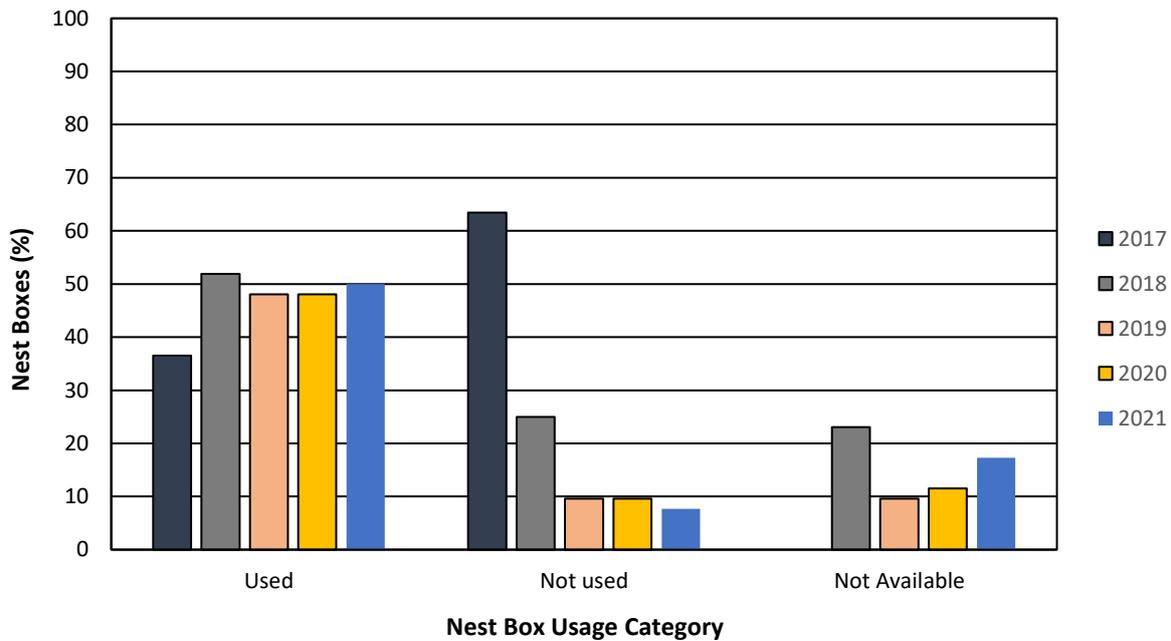
Chart 1 General usage rates of nest boxes in 2021 and comparison to previous surveys

In 2021, the percentage of all nest boxes exhibiting any sign of use was 50% (26) (**Chart 1**). Seventeen percent (17) of the total number of nest boxes were determined to be unavailable for use resulting from occupation by pest species such as wasps, bees or the box was found to missing from its location on the site. Nest boxes 44 (Glider), 45 (Bat), 46 (Glider) and 47 (Glider) were missing. This reduces the number of available boxes to 43, but the remaining statistics regarding usage are based upon the original number (52) to provide a more accurate comparison. Use of nest boxes by insects is generally a temporary feature, and as the insects move on, the box becomes available for use by vertebrates.

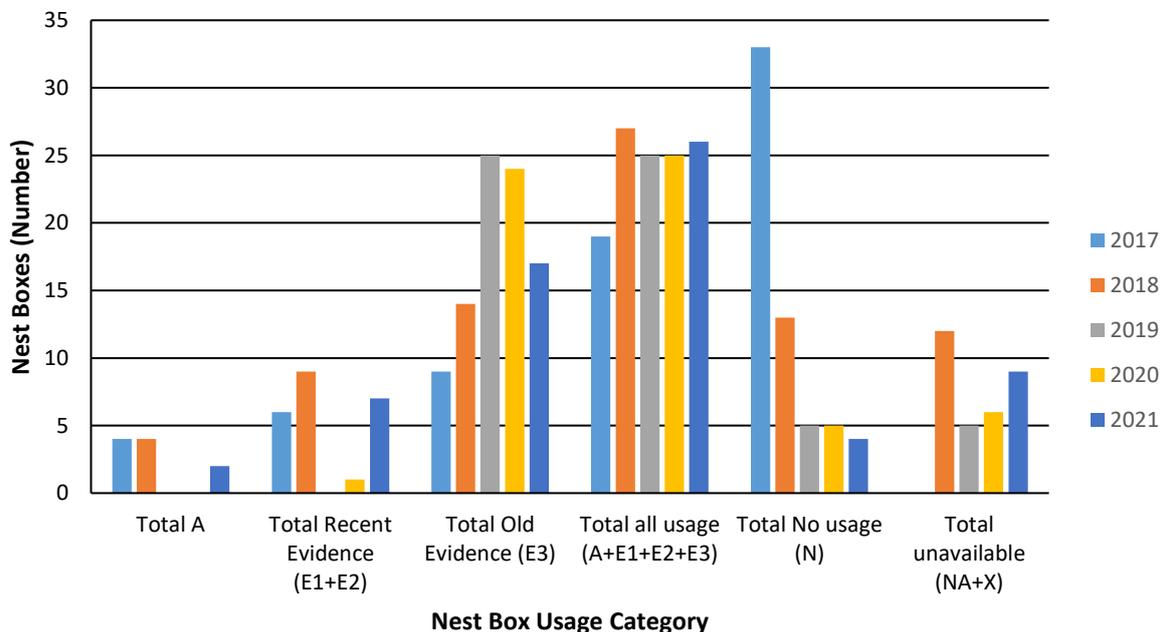
Chart 2 Detailed usage by category of nest boxes for the 2020 survey and comparison to the previous surveys

In 2021, two boxes (4%) were observed to have animals present (A). There were three boxes showing recent evidence of use with four boxes within the “moderately fresh” category, and the total number of boxes showing old evidence was 17 boxes, or 33% (**Chart 2**). A total of nine boxes were categorised as either NA – not available due to insects as noted above, but four boxes were noted to be missing, believed stolen. This brought the total number of nest boxes available for fauna use to 43, three less than the 2021 survey.

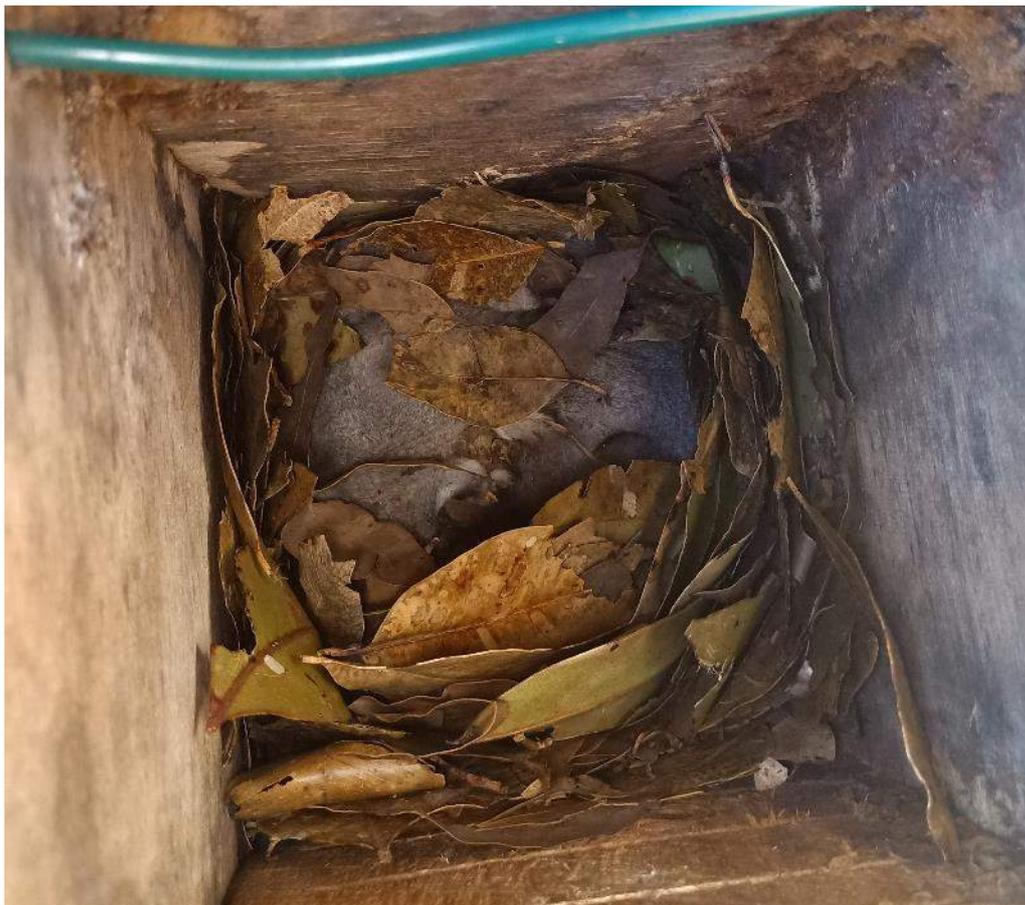
Plate 4: Nest box 41 with four Sugar Gliders in residence

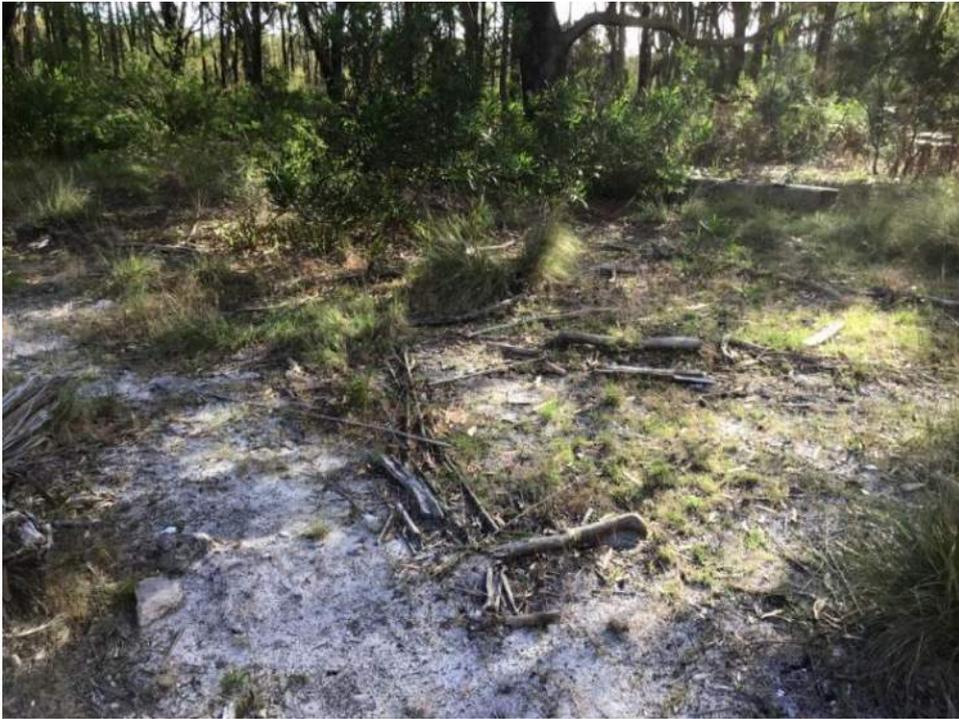
South of Rutile Rd, a small section of the NBOA abuts the extraction zone. Most of this area was affected by the 2018 fires but has recovered with increased rainfall in late 2020 and early 2021. The condition improves moving east from Coastal Sand Apple Blackbutt Forest that fringes the extraction zone and Block Q2 which is quite weed infested until good condition Swamp Mahogany – Paperbark Forest is encountered. This area has some scattered Fishpole Bamboo (*Phyllostachys aurea*), and Bugle Lily (*Watsonia meriana*). The 50m buffer zone of vegetation along Rutile Rd is quite weedy with exotic grasses, *Lantana* (*Lantana camara*) and some minor Blackberry (*Rubus fruticosus* spp. agg.), Glory Lilly (*Gloriosa superba*), *W. meriana* and *Pinus elliotii* (Slash Pine) as well as others. Regeneration of the *E. robusta* within this “regenerating” area was assessed by measuring the health and size of *E. robusta* trees within 1 m of a transect running East to West across the NBOA (Figure 6). The individual trees were divided into five height classes (<1m, 1-2m, 2-10m, 10-15m and >15m or mature trees) for determination of age. Trees <1m in height were classified as seedlings/saplings, trees 1-2m in height were classified as saplings, trees between 2 and 10m were classified as immature trees, trees 10-15m were classified as intermediate, while trees estimated to be over 15m in height were classified as mature. This year, a total of 114 trees (81 trees last survey) were assessed along the transect that was approximately 400m long. The assessment found that there were two saplings <1m, only 11 were estimated to be between 1-2m in height, with 76 trees estimated to be between 2-10m, 25 trees between 10-15m tall and no trees assessed as mature. The majority of the *E. robusta* – 92 trees - were located in the eastern section of Swamp Mahogany – Paperbark Swamp Forest. Two areas at the western end of the NBOA are classified as regenerating grassland where the density of trees and shrubs is greatly reduced. Since the initial survey in 2013, natural regeneration has occurred, with many shrubs and some midstorey species self-seeding. The northern most section of the NBOA has been classified as mature Swamp Mahogany – Paperbark Swamp Forest. This area contains mature *E. robusta* and *Melaleuca quinquenervia* trees with an understorey of Tall Saw-sedge (*Gahnia clarkei*) and other swamp flora. *Lantana* has colonised this section of the BOA with infestation levels varying from scattered individuals to very heavy (<75% cover), with a belt of dense *Lantana* acting to separate this section from the southern regenerating section of the NBOA. Evidence of previous control works conducted by Kleinfelder is visible.

Plate 5: PP1 looking east showing poor condition (foreground) and better condition vegetation (background)

a modest weed control program, and Holcim (Australia) have continued this program. Further on-going and more intense weed control efforts will be required to improve the condition of the NBOA.

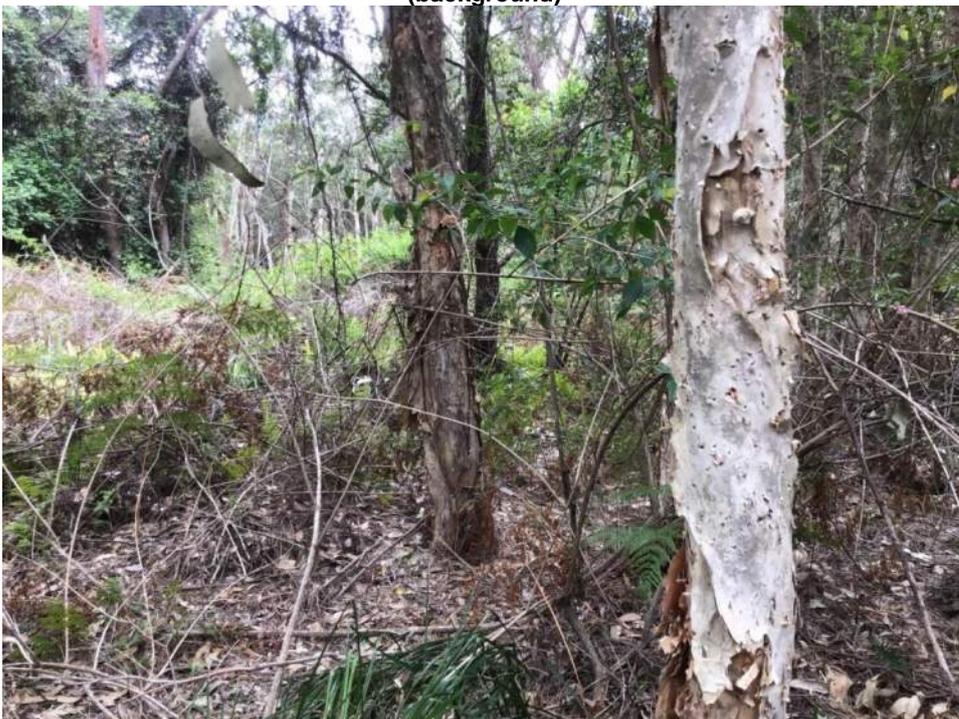
Plate 6: PP2 looking north showing dense Lantana and previous control works

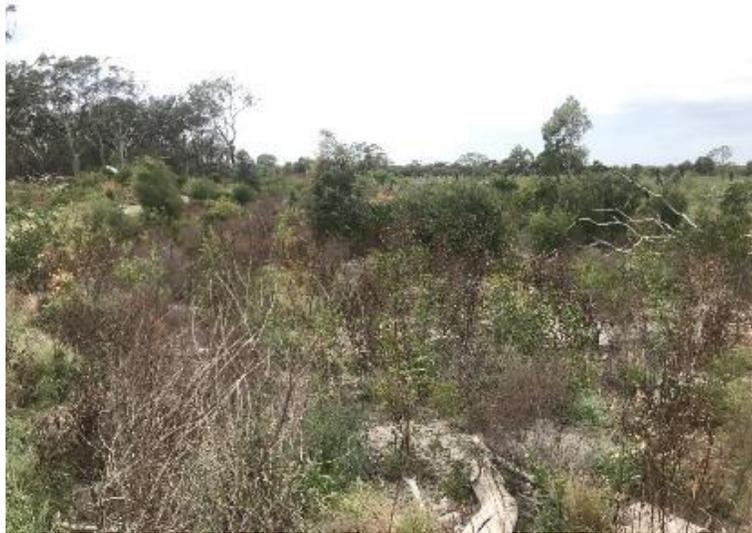
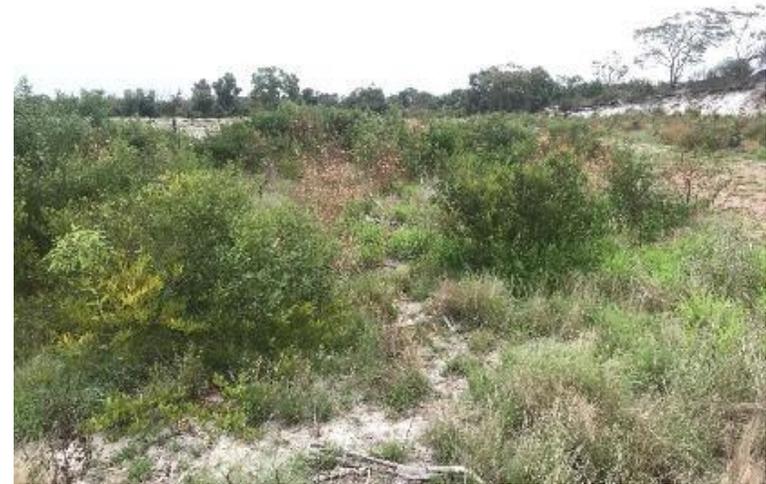
Plate 9: View of Block Q1 from PP1 looking East (left) and West (right) January 2020. Notice the dieback of shrub species and the height of the Eucalypt (left) and the prevalence of *Eragrostis curvula* (right)

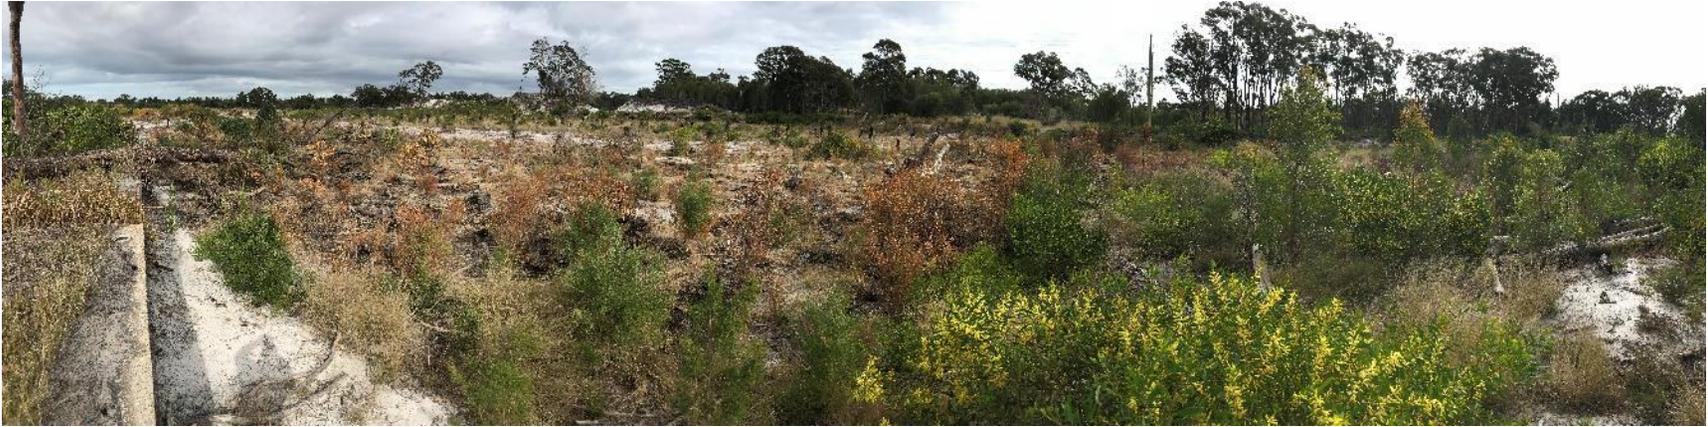
Plate 11: Block Q1 PP2 looking south - west – north, July 2020 just after controlled burns

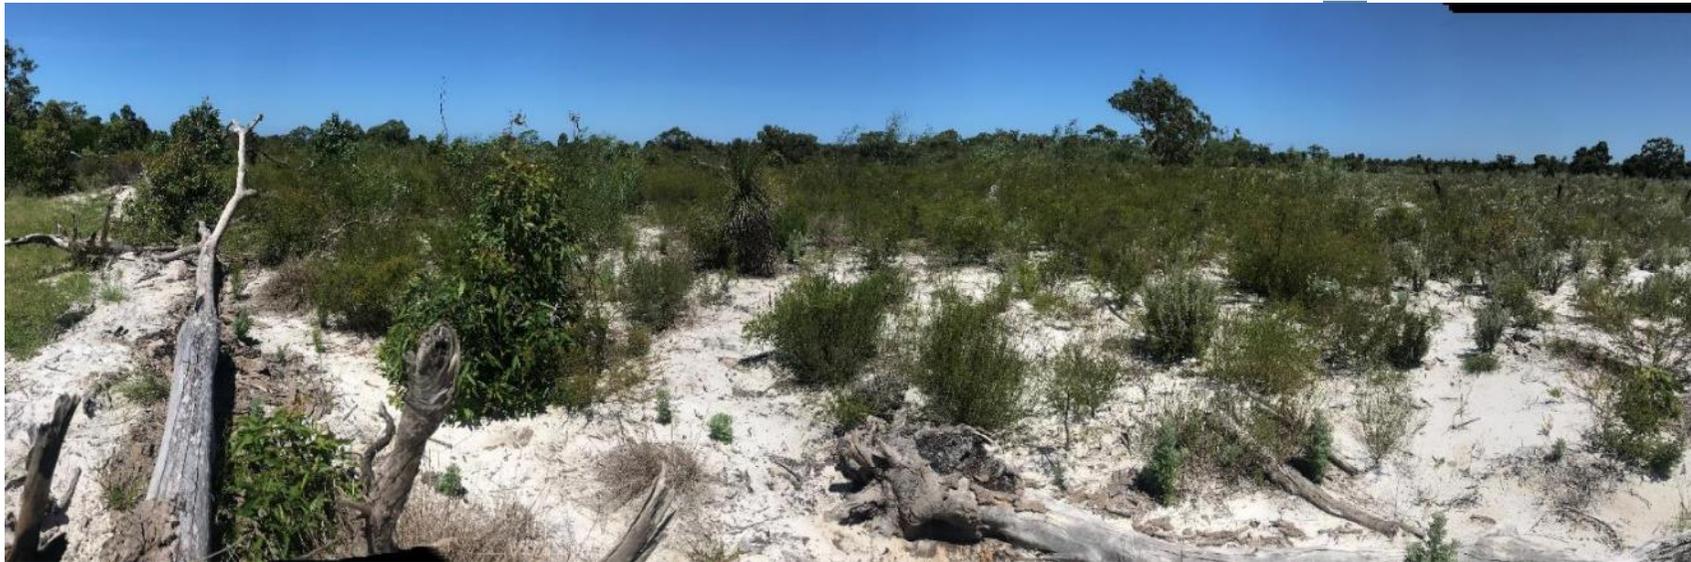
Plate 41: Block Q4 west (looking east) January 2021. Note the dense weedy grass infestation in Block Q1 (left of photo) and the encroachment into this block.

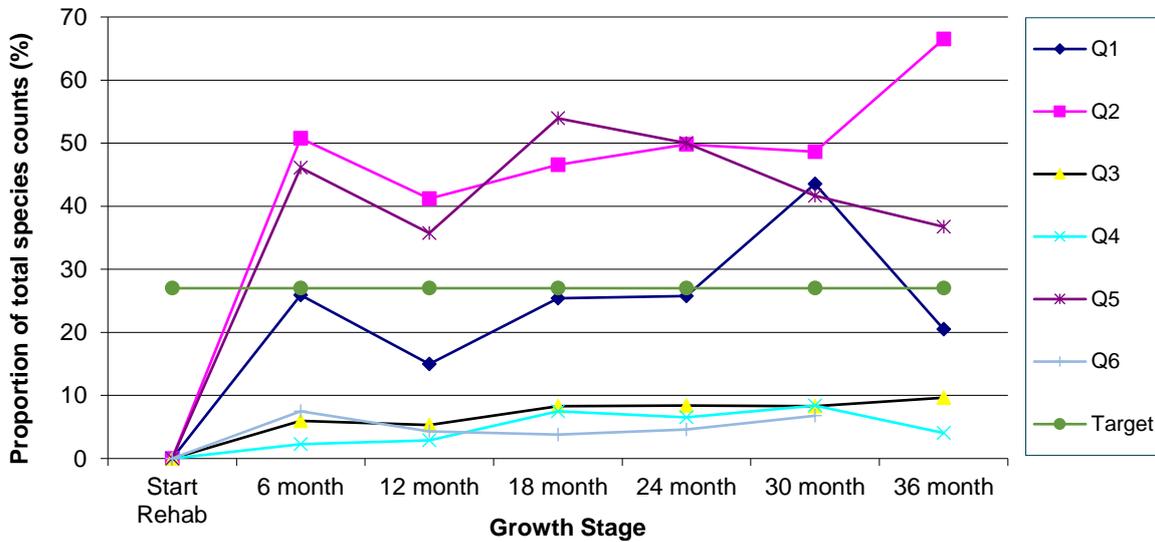
Chart 16: Comparison of the average proportion of ground species recorded per plot

Chart 16 shows the number of ground stratum species as a proportion of the total number of species per plot. The three blocks with high numbers of weeds have the highest proportion of ground stratum species – this being the most common stratum of weeds. The target of 27% of ground stratum species has never been achieved across any of the rehabilitation in the sand extraction complex, not just the NDE. The lack of other species in the remaining stratum increases the relative proportion of the species in this stratum.

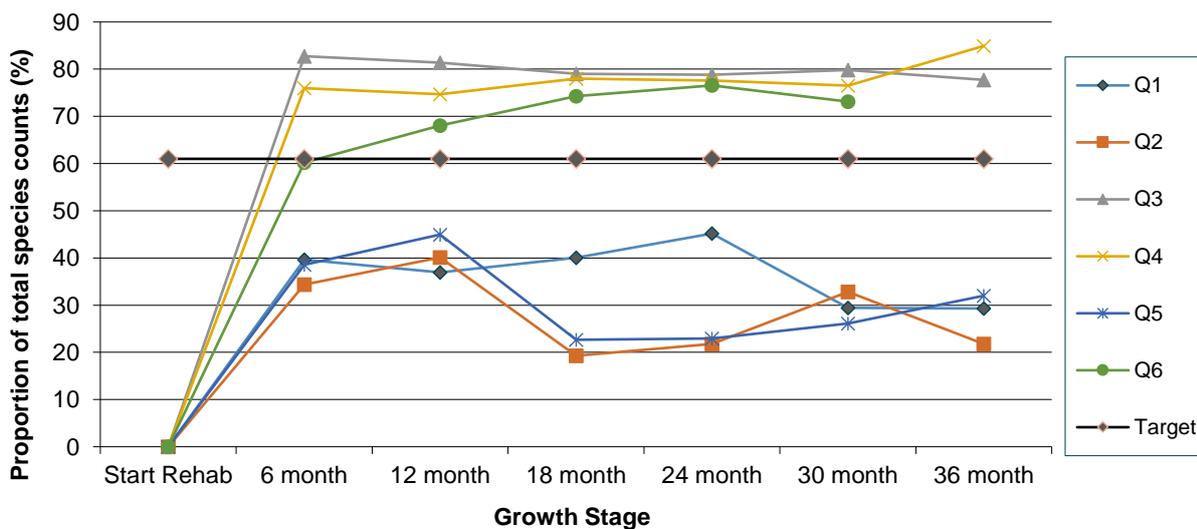
Chart 17: Comparison of the average proportion of shrub species recorded per plot

Chart 17 shows the number of shrub stratum species as a proportion of the total number of species per plot. This stratum dominates the native revegetation, with most of this stratum self-germinating from the topsoil seed bank that is respread over the target area. A high proportion of shrubs indicates topsoil sourced from good quality native vegetation that has been rapidly respread and not allowed to degrade in stockpiling. Again, this highlights the difference between the two areas, with the poorer quality blocks, having a much lower proportion of shrub species from the start of rehabilitation.

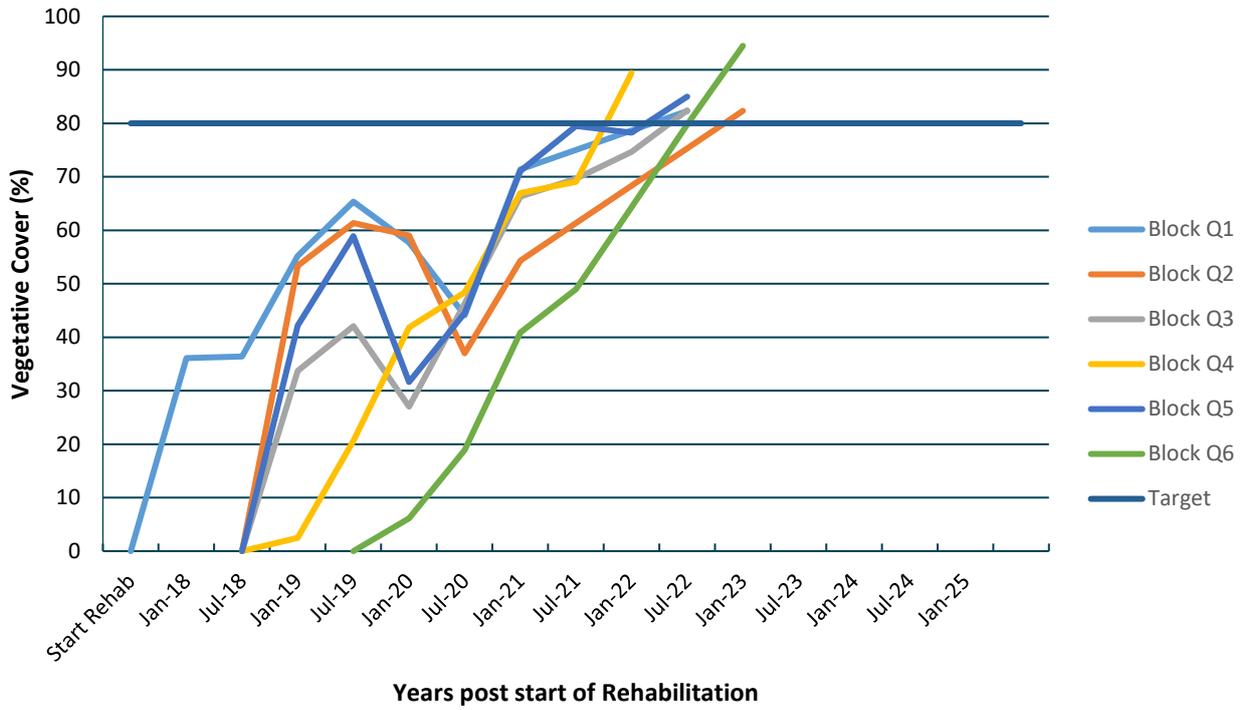
Chart 20: The predicted dates since the commencement of rehabilitation for Blocks Q1 to Q6 to reach 80% foliage cover. Data for Block Q1 is based on seven surveys, Blocks Q2 – Q5 based on six surveys, Block Q6 based on five surveys

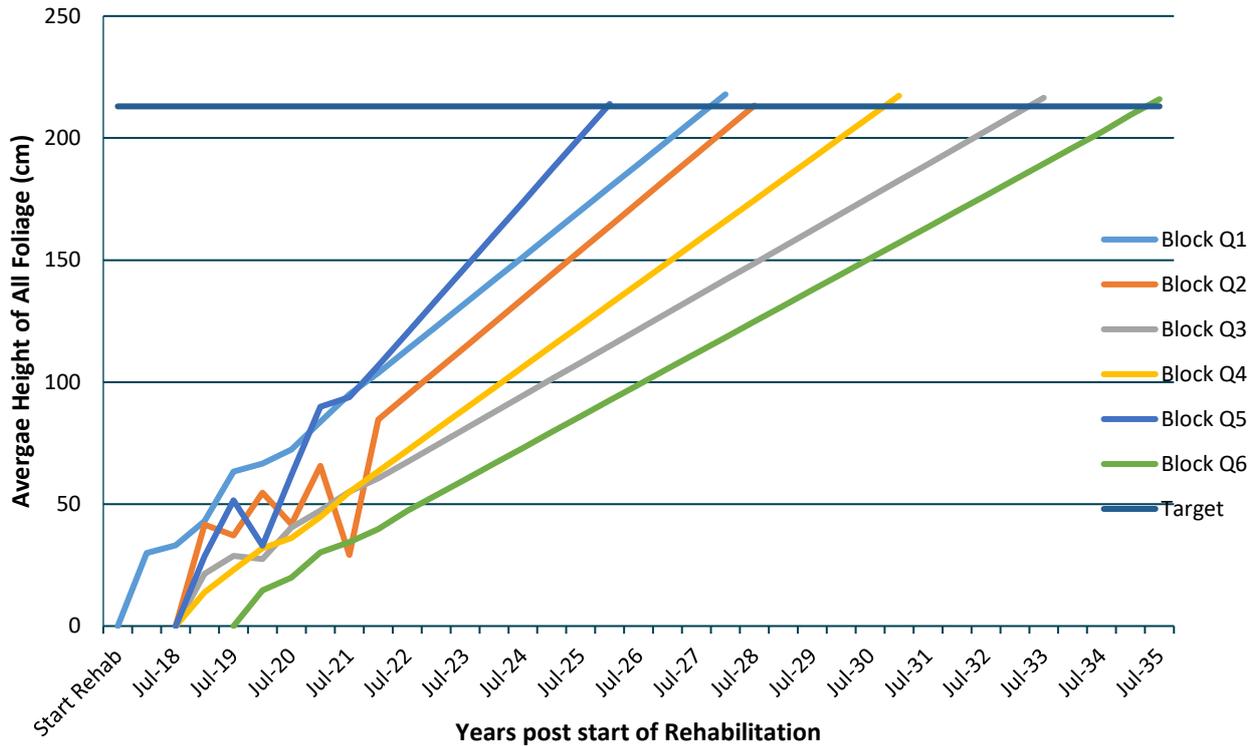
Chart 21: The predicted dates since the commencement of rehabilitation for Blocks Q1 to Q6 to reach target average height (213 cm). Data for Block Q1 is based on seven surveys, Blocks Q2 – Q5 based on six surveys, Block Q6 based on five surveys
