# Rehabilitation and Landscape Management Strategy

Dubbo Quarry Continuation Project

Prepared for Holcim (Australia) Pty Ltd  
January 2021

# HOLCIM QUARRY DUBBO: LAND AND SOIL CAPABILITY ASSESSMENT

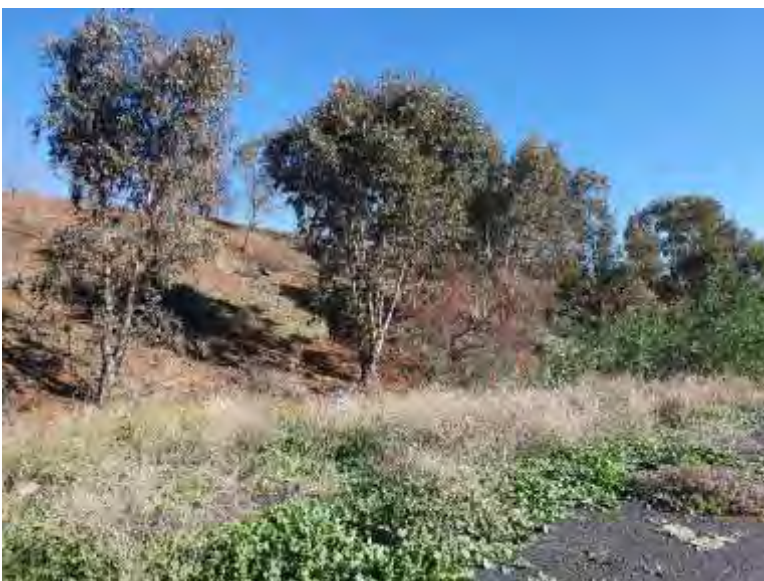
**Photograph 3.1** Existing rehabilitation west pit

During rehabilitation, completed pit faces will be blasted to form an overall slope gradient of 1(v) to 3(h) or 32° which is consistent with rehabilitation practices currently undertaken on site (Photograph 3.1).

There is no evidence of slope failure or erosion on the existing rehabilitation areas on site that have been in place since 2010.

Based on observations of existing rehabilitation works in the west pit and the lack of rill erosion, annual average erosion rates of less than 2 tonnes per hectare per year (t/ha/y) and a peak erosion rate of less than 5t/ha/y should be achieved on the pit walls essentially reducing the erosion hazard to very low using a combination of rock/soil matrices and hydromulching.

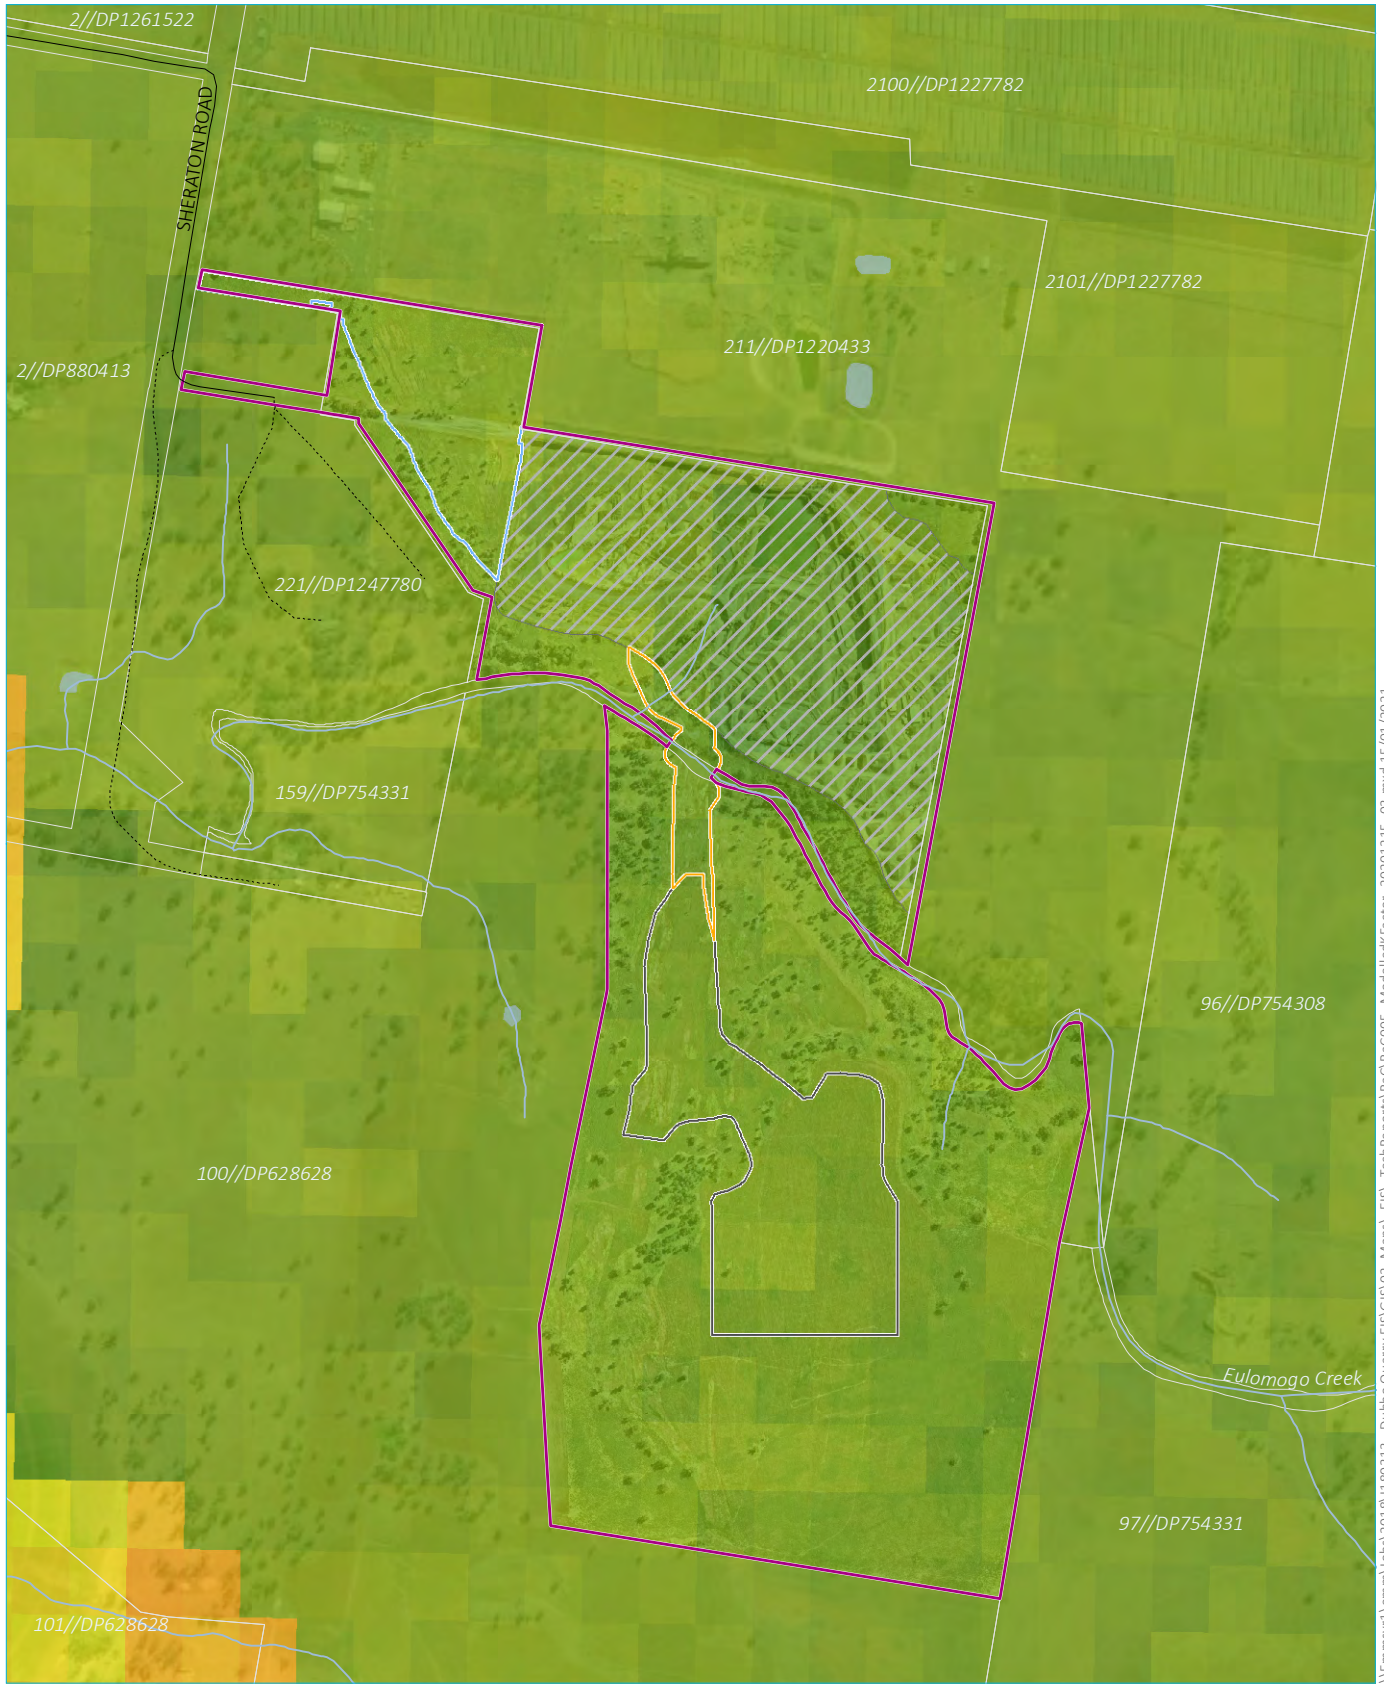
Dubbo Quarry Continuation Project  
Rehabilitation and Landscape Management Strategy  
Figure 3.4

Loch (1998) recommends a minimum K-factor of 0.06 for dispersive soils which does not align with the modelled K-factors for the project area which range from 0.03 to 0.04 (Figure 3.4, OEH 2016).

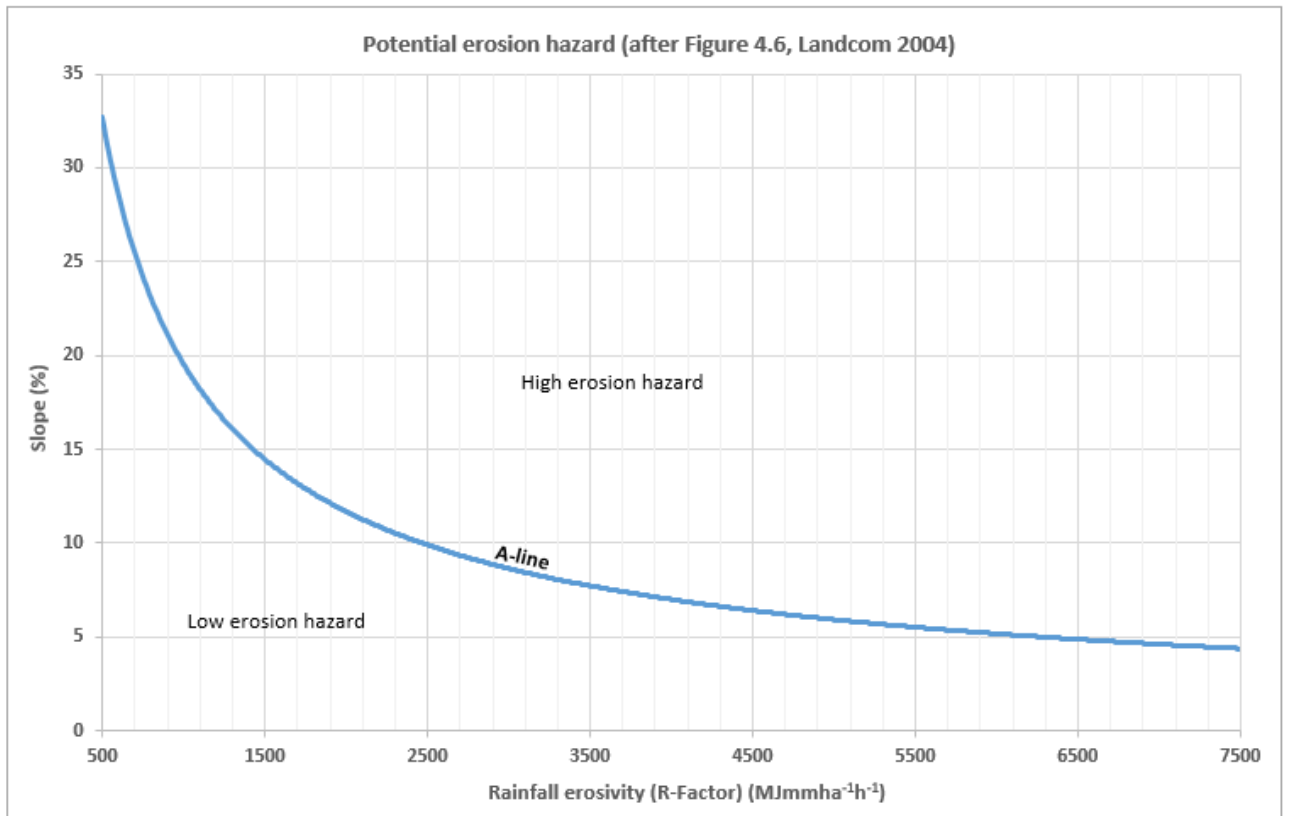
**Figure 3.5 Assessment of potential erosion hazard (Figure 4.6 Landcom 2004)**

The erosion hazard for the project area has been determined using the procedure described in section 4.4.1 of Landcom 2004. The first step in the hazard assessment is a simple process using Figure 4.6 from Landcom 2004 (reproduced as Figure 3.5) that considers slope of the land and the Rainfall Erosivity or R factor.

For the project, the slope gradient of planned disturbed areas ranges from less than 1% to 10% in the proposed quarry pits with isolated areas between 10 to 20% where the haul road crosses Eulomogo Creek (Figure 3.6). The rainfall erosivity factor (R factor) is 1,300 MJ.mm ha<sup>-1</sup> h<sup>-1</sup> (Appendix B Landcom 2004). Applying these parameters to the erosion hazard nomograph results in an erosion hazard of low for the proposed extraction areas and high where the haul road crosses over Eulomogo Creek. A high erosion hazard requires further detailed assessment in accordance with section 4.4.2 of Landcom 2004 to determine soil loss classes (3.6).

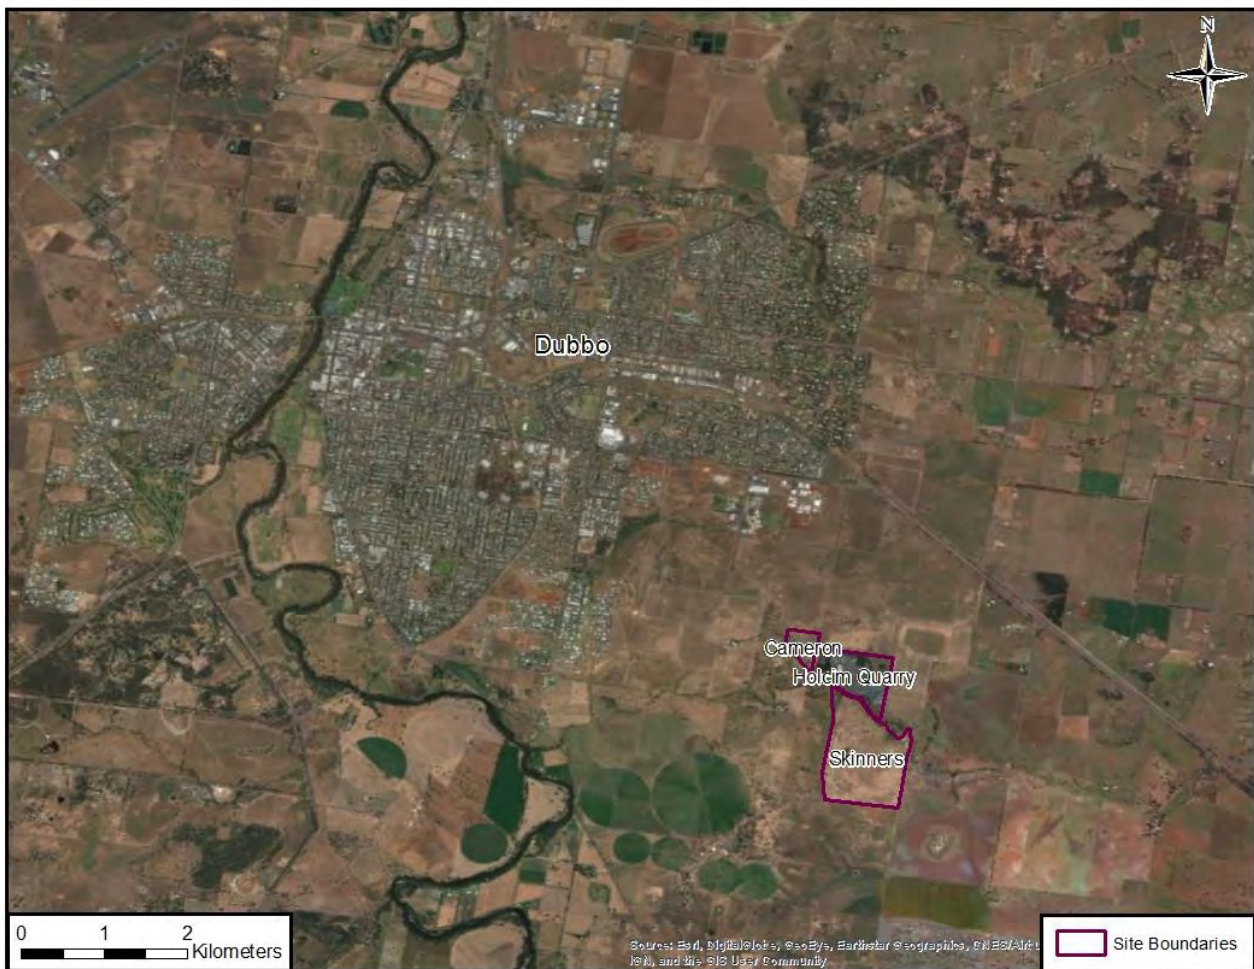
Figure 1. The study area is located approximately 5 km southeast of Dubbo.

Holcim Quarry is located at 20L Sheraton Road, approximately 5 km southeast from the centre of Dubbo (Figure 1). The study area includes two (2) parcels of land referred to as 'Skinners' and 'Cameron'. Skinners is approximately 88 ha and is situated to the south of the existing quarry. Cameron is approximately 10 ha and is located to the west of the existing quarry.

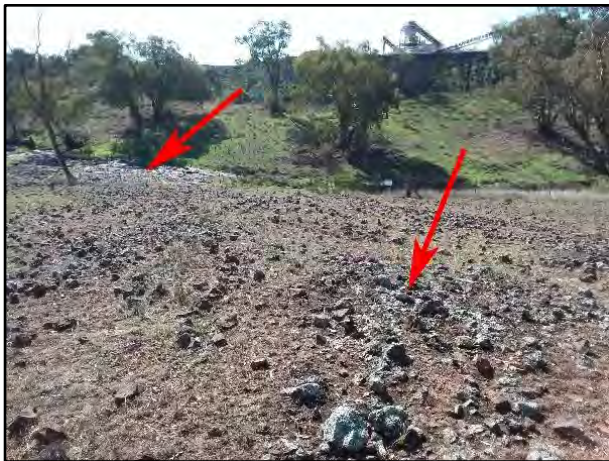
Photograph 1a. Basalt outcropping within the Eulomogo Creek and adjacent slopes (red arrows).

In justification of this statement, the quarry is mining basalt and not alluvium. Furthermore, the field study identified basalt outcrops along Eulomogo Creek and adjacent slopes (Photographs 1a and 1b).

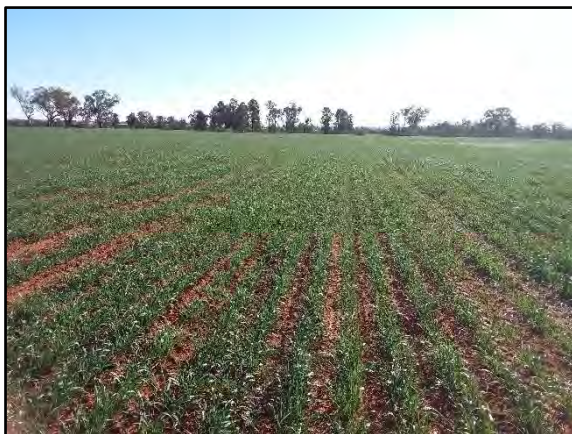
**Photograph 2a.** Site TP6 (facing north). This area is on the flat plateau and has been cleared and cultivated for pasture.

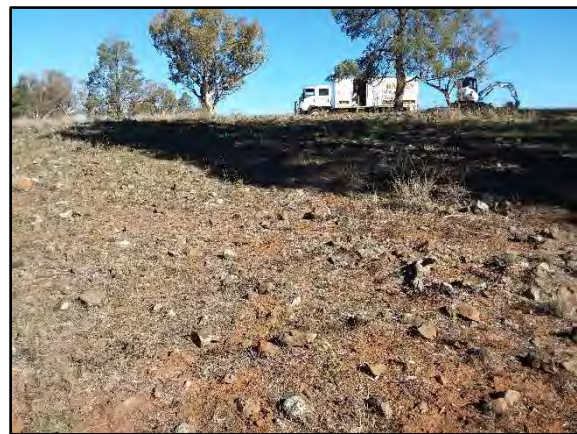
**Photograph 2b.** Site TP1 (facing south). Upper slopes adjacent to Eulomogo Creek.

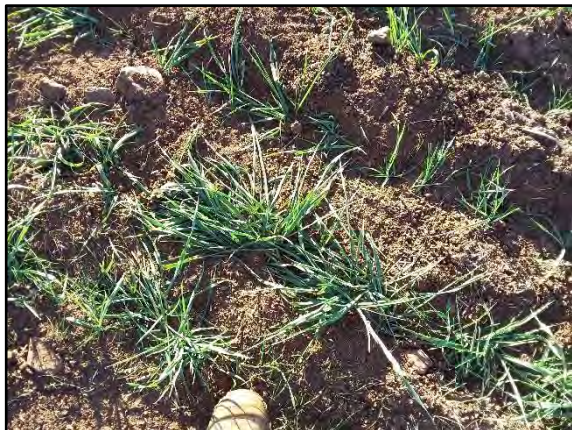
**Photograph 3a.** Surface at Site TP6.

A 0–50 mm	Reddish brown (moist 5YR 4/3) light clay. Structure moderate with polyhedral peds < 10 mm diameter. Coarse fragments 2–10 %, sub-angular cobbles < 200 mm. Laboratory pH 5.7. Roots many. Clear boundary to –
B21 50–250 mm	Reddish brown (moist 5YR 4/3) medium heavy clay. Structure strong with polyhedral peds < 50 mm. Coarse fragments 2–10 %, sub-angular cobbles < 200 mm. Laboratory pH 8.3. Roots many. Gradual boundary to –

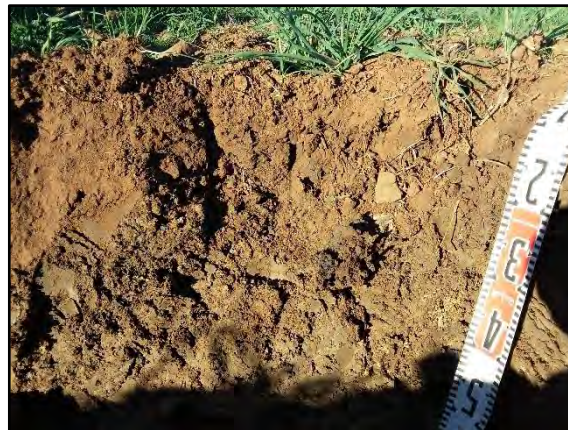
**Photograph 3b.** Profile at Site TP6.

B22 250–600 mm	Brown (moist 7.5YR 4/3) medium heavy clay. Structure strong with prismatic peds <50 mm. Coarse fragments 10–20 %, sub-angular cobbles < 200 mm. Laboratory pH 9.2. Roots few. Gradual boundary to –
B3/C > 800 mm	Light clay and weathered basalt. Refusal at 800 mm.

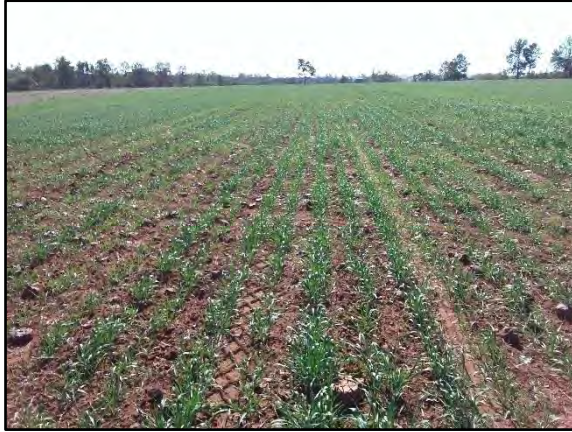
**Photograph 4a.** Site TP3 (facing north). This area is on the upper slope and has been cleared and cultivated for pasture.

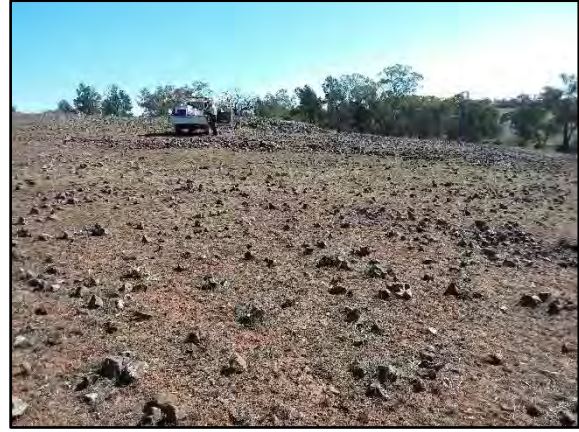
**Photograph 4b.** Site TP2 (facing west). Upper slopes adjacent to Eulomogo Creek.

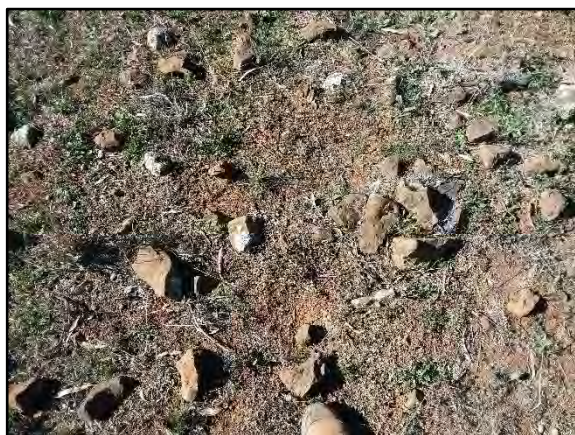
**Photograph 5a.** Surface at Site TP1.

Site TP1 (Photograph 5a and 5b) is classified as a Brown Ferrosol and is an example of a representative profile for a Shallow Ferrosol. Its description follows:

A 0–100 mm	Dark brown (moist 7.5YR 3/4) clay loam. Structure weak with polyhedral peds < 20 mm diameter. Coarse fragments 40–60 %, sub-angular cobbles < 200 mm. Laboratory pH 6.4. Roots many. Gradual boundary to –
B 100–500 mm	Dark brown (moist 7.5YR 3/4) clay loam. Structure weak with polyhedral peds <20 mm. Coarse fragments 60–80 %, sub-angular cobbles < 200 mm. Roots many. Clear boundary to –
C > 500 mm	Weathered basalt. Refusal at 500 mm.

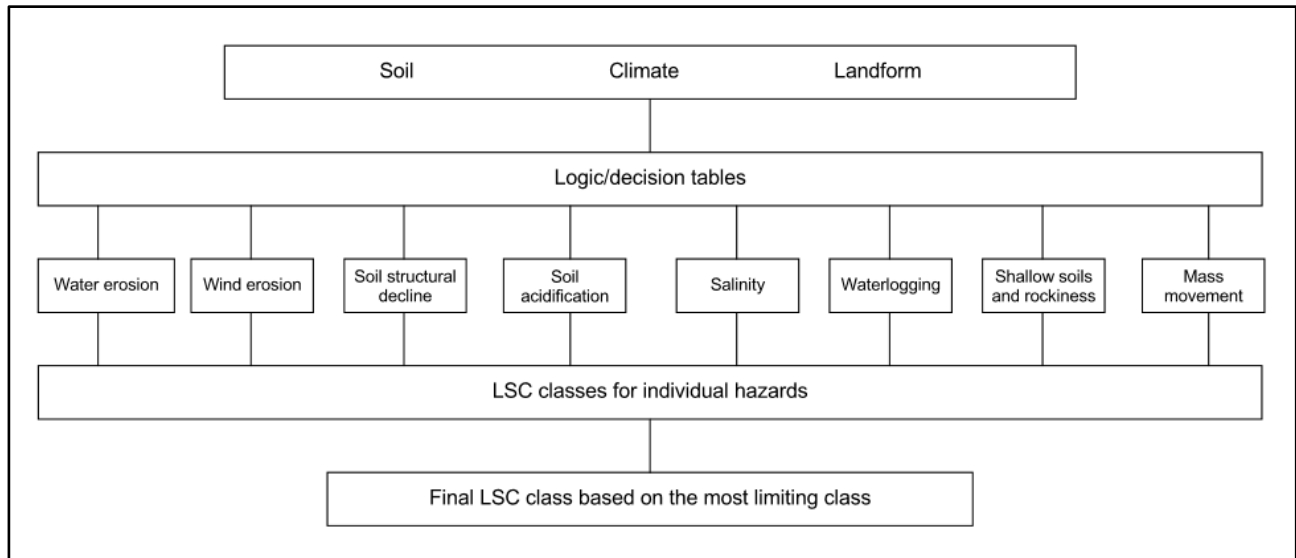
Figure 11. Biophysical information used to determine the LSC class.

The LSC assessment was undertaken with reference to *The Land and Soil Capability Assessment Scheme* (NSW OEH, 2012). The LSC framework is based on the evaluation of eight (8) main hazards and limitations for each soil mapping unit. The rating of the most limiting hazard or limitation is then used to determine the final LSC class for the land (Figure 11).
