# Noise Monitoring Assessment

Cooma Road Quarry, Googong, NSW Quarter 1 Ending March 2021.

**Noise Monitoring Assessment**

Document ID	Status	Date	Prepared By	Signed	Reviewed By	Signed
MAC180611-03RP11	Final	12 March 2021	Kristian Allen	Kller	Rod Linnett	RMLSH

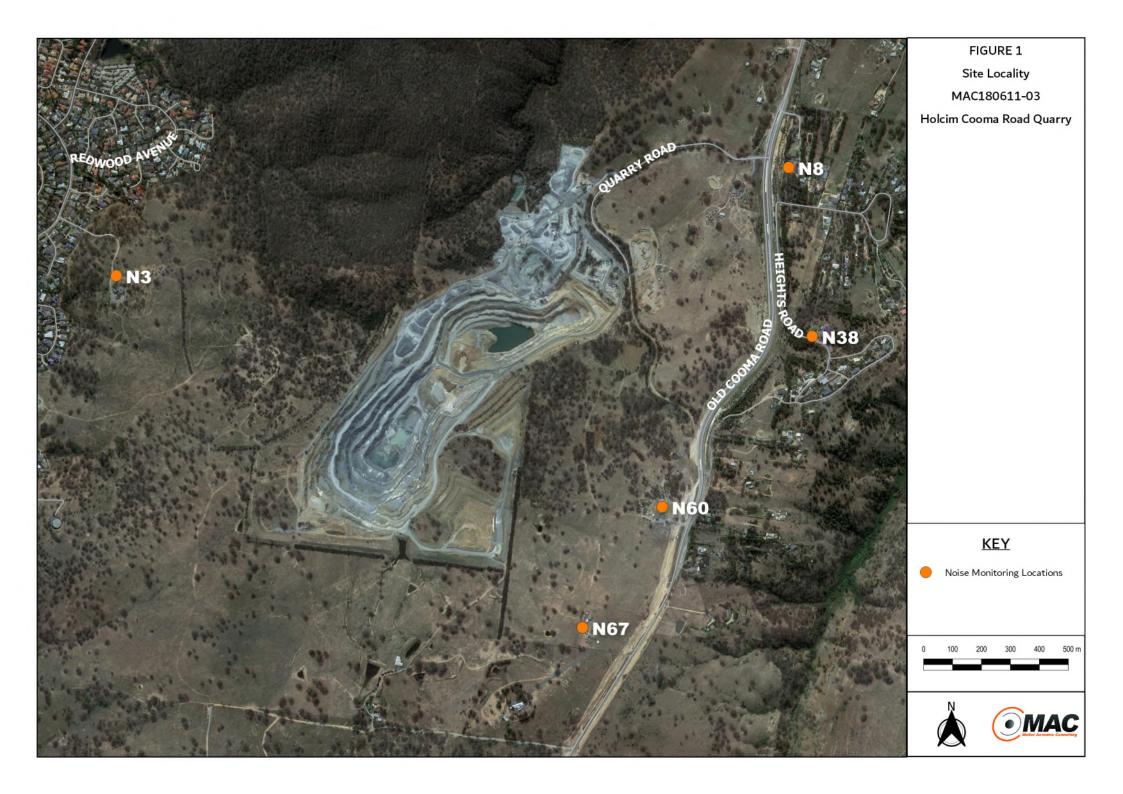
The quarry is located in Googong, NSW approximately 13km south east of Canberra, ACT. The quarry is bounded primarily by rural and residential properties in all directions, with noise from passing road traffic on Old Cooma Road dominating the acoustic environment for receivers to the east of the quarry. The monitoring locations with respect to the quarry and assessed receivers are presented in the locality plan shown in **Figure 1**.
