Noise Monitoring Assessment

Cooma Road Quarry, Googong, NSW Quarter 4 Ending December 2019.

Prepared for: Holcim (Australia) Pty Ltd December 2019 MAC180611-03RP6

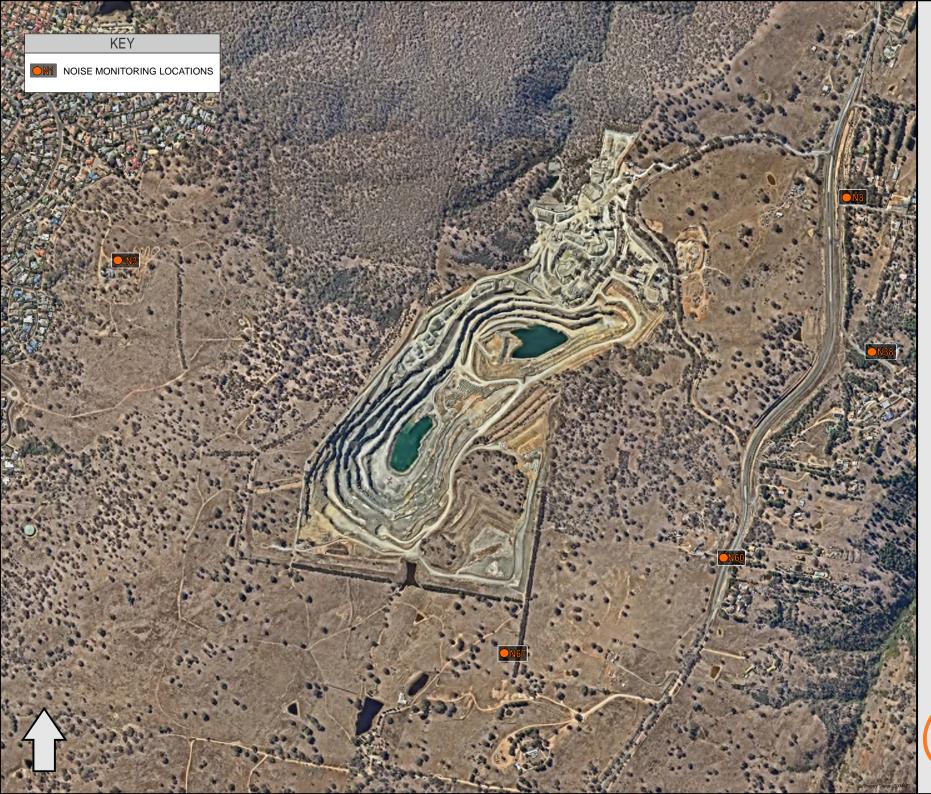
The quarry is located in Googong, NSW approximately 13km south east of Canberra, ACT. The quarry is bounded primarily by rural and residential properties in all directions, with noise from passing road traffic on Old Cooma Road dominating the acoustic environment for receivers to the east of the quarry. The monitoring locations with respect to the quarry and assessed receivers are presented in the locality plan shown in **Figure 1**.

Five monitoring locations have been selected as part of the NMA and in accordance with the Development Consent.

Location N3 is to the west of the quarry situated on a rural property off Copperfield Place. This location represents residential and rural receivers to the west of the quarry.

Location N8 is to the north east of the quarry along Tempe Crescent and is representative of residential receivers in that area.

Location N38 is on Heights Road and is representative of the elevated residential receivers to the east of the quarry.

Location N60 is at 501 Old Cooma Road and represents the residence adjacent to the quarry access road.

Location N67 is situated on a rural property at 732 Old Cooma Road to the south of the quarry. This is representative of rural and residential receivers to the south, with direct line of site into the quarry pit.
