DUNLOE SANDS QUARRY

Ramtech Pty Ltd
Pottsville Mooball Rd,
Pottsville NSW

Annual Environmental Monitoring Report
November 2012 - October 2013

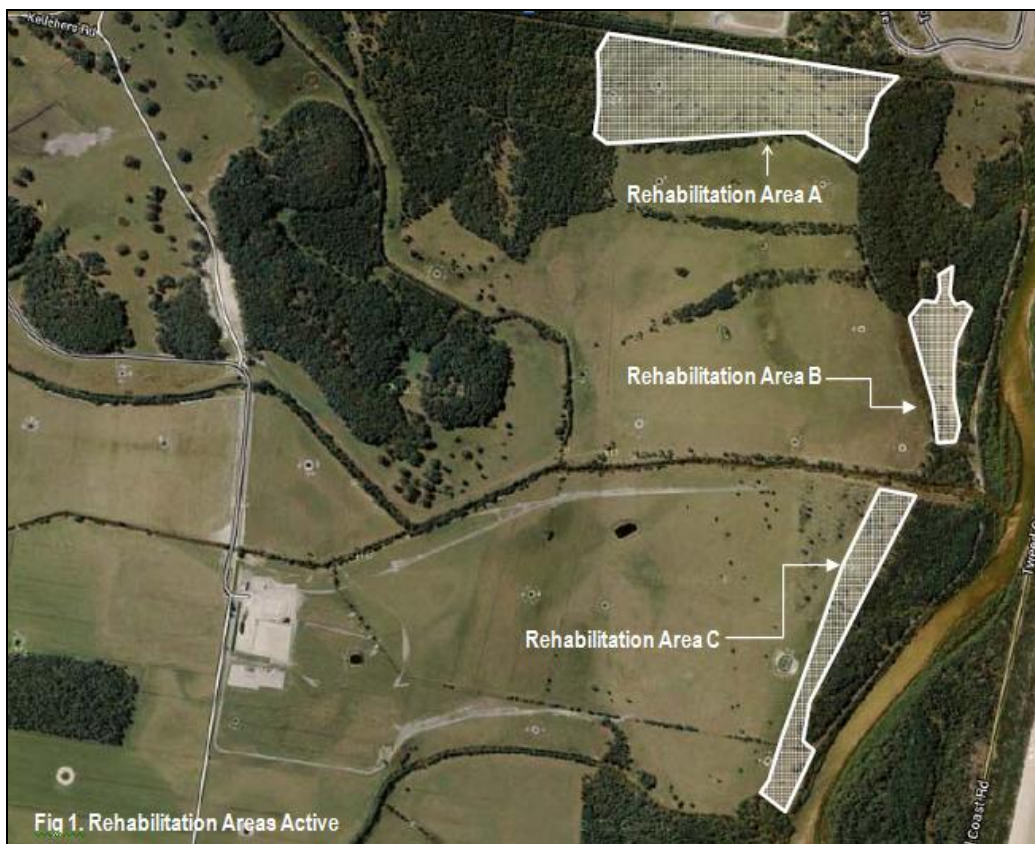
The regenerative works have been undertaken via a combination of assisted and natural regrowth and all areas have been fenced so as to limit the intrusion of cattle. In this regard, depending on soil types, each of the areas has been very successful in establishing quality regrowth. The only limiting factors have been some cattle getting in and around existing fences (primarily at low tide where they have been able to traverse the creek lines). There are also some areas of extensive grass intrusion that will be subject to ongoing spray control so as to allow for further natural regrowth to occur. The works have been successful to date as shown within the photo plates at **Appendix D**.

As part of the Dunloe Sand Quarry's approved Environmental Management Plan, revegetation and regenerative landscaping is required (Appendix C of the EMP). Ongoing management of the surrounding vegetation is being carried out by Ramtech P/L over the lifetime of the Dunloe Quarry operations. As such, progress photographs have been included within this report to allow for the ongoing monitoring of the vegetation works (**Appendix D**).

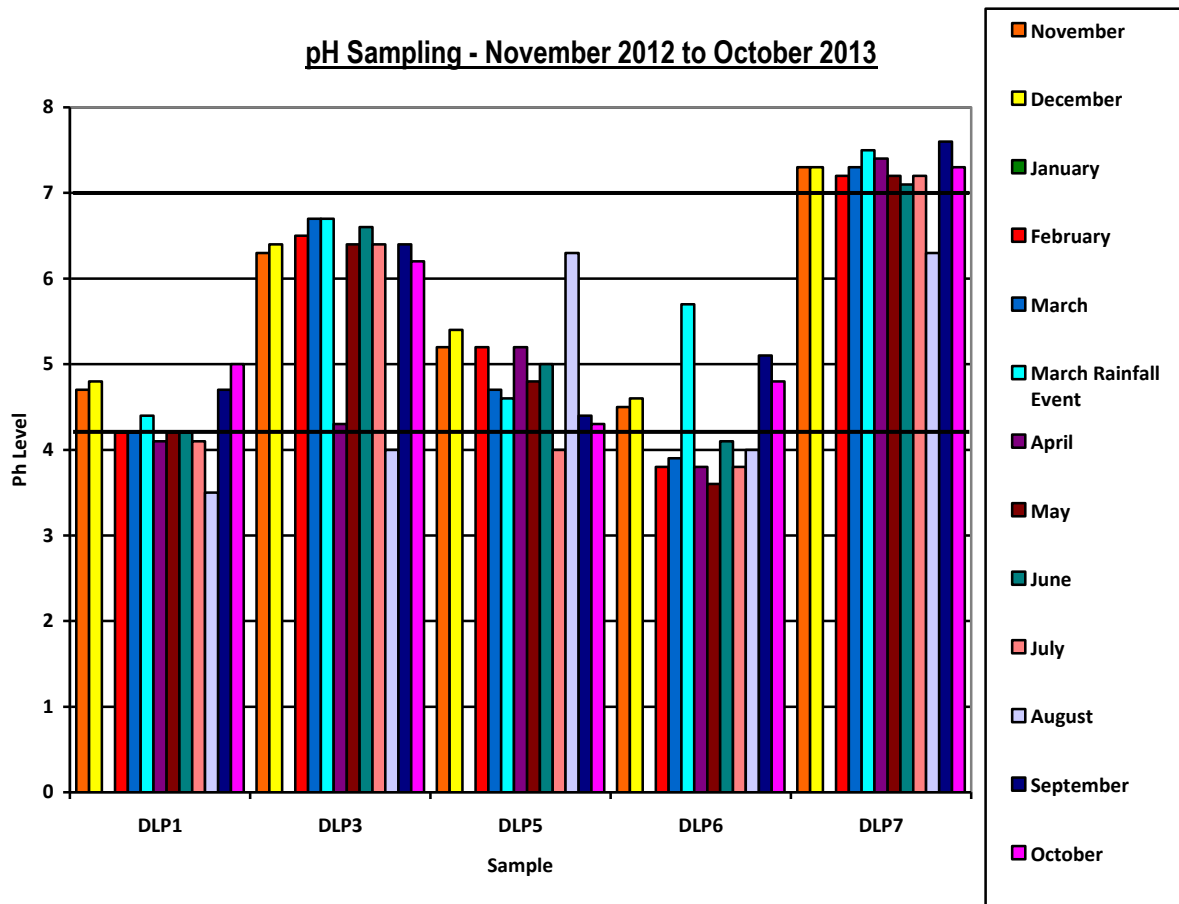
Figure 1: Dunloe Sands - Ground Water - Chemical (pH Test) Results November 2012 to October 2013

The EMP provides the interim target range regarding the pH levels of ground water sampling. The majority of the results displayed are between the minimum of 4.2pH and maximum of 7.0pH (shown as black lines). DLP 7 shows some samples outside of the maximum interim target levels by between 0.1 and 0.6pH. This presents a more alkaline pH level than the target range. These minimal exceedances of pH at DLP7 are not considered to be of any significance as small fluctuations in groundwater pH is common within regions which experience both high and low levels of rainfall and are consistent with background levels which were consistently acidic before operations commenced (particularly DLP7). DLP1, 3, 5 and 6 record samples below the 4.2pH interim target. This presents a more acidic pH level than the target range. This is considered to have been caused by high levels of rainfall following dry periods. The majority of results present within the target range and therefore the sampling for the year in considered to be generally consistent with the EMP requirements.

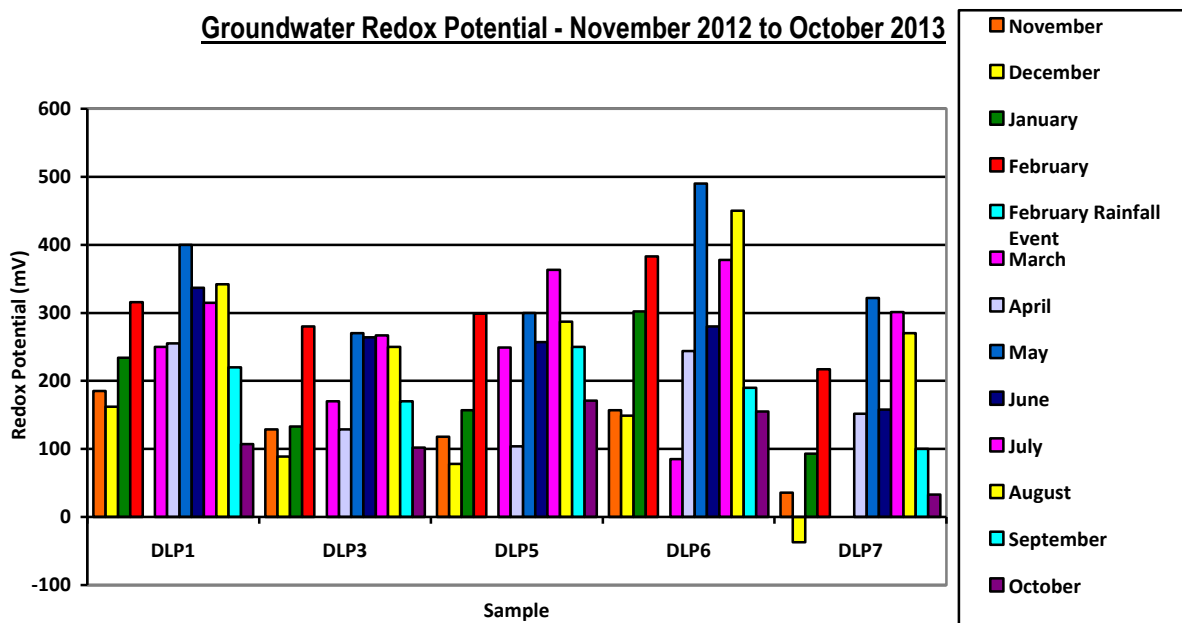
Figure 3: Dunloe Sands - Ground Water - Chemical (Redox Potential Test) Results November 2012 to October 2013

The EMP does not provide an interim target level for Redox Potential but instead states that results should be monitored for outlier samples. All samples present in a uniform manner, with no outliers present.

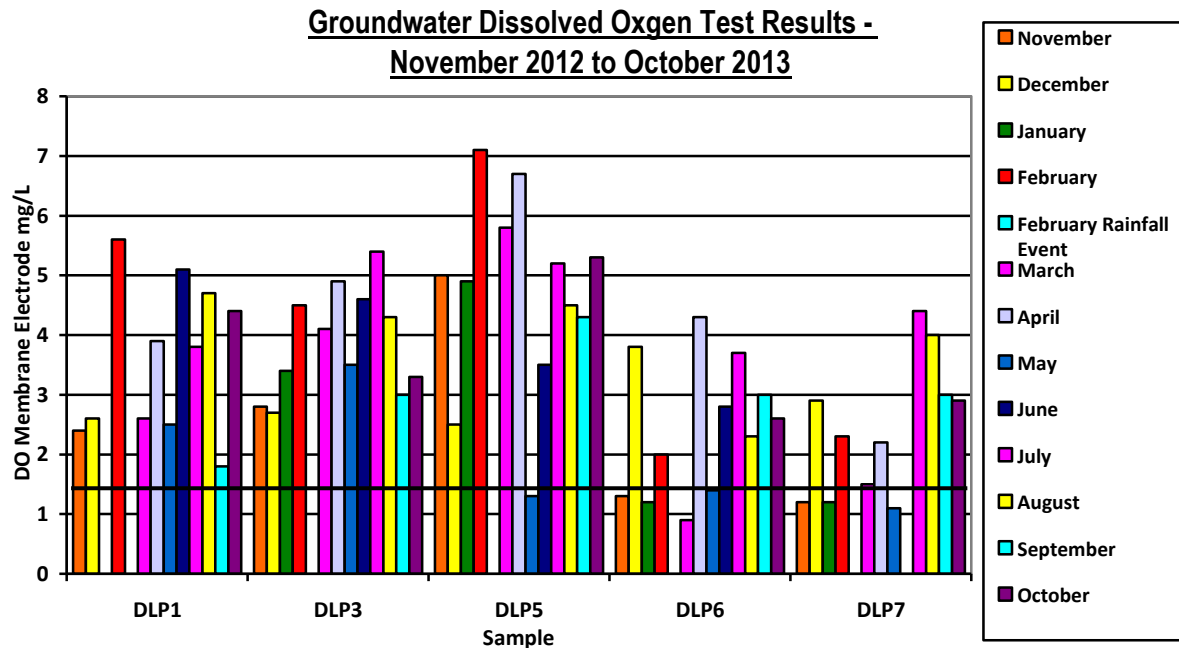
Figure 4: Dunloe Sands - Ground Water - Chemical (DO Test) Results November 2012 to October 2013

The minimum DO level provided within the EMP is 1.5mg/mL (shown as a black line). The results vary in DO levels considerably with the majority not presenting or conforming to a pattern over the twelve (12) month monitoring period. The majority of the groundwater samples that were collected are above the minimum interim target however samples collected from varied locations present levels below the target. Whilst background testing indicated generally low DO levels inherently across the site, the results for DLP 6 and 7 require some further consideration; particularly with respect to the temperature of samples at these locations as exceedingly warm samples will automatically generate a low DO reading. Low results may also be related to excessive faecal matter and nutrients associated with livestock use. Each of these potential reasons should be considered in the context of future sample results so as to look towards potential ameliorative measures, however in the main results at DLP 3 and 7 remain generally low due to proximity to saline environments (Mooball Creek).
