**COOMA ROAD QUARRY
ANNUAL REVIEW 2013**

March 2014

Prepared by
Umwelt (Australia) Pty Limited

on behalf of
Holcim Australia Pty Ltd

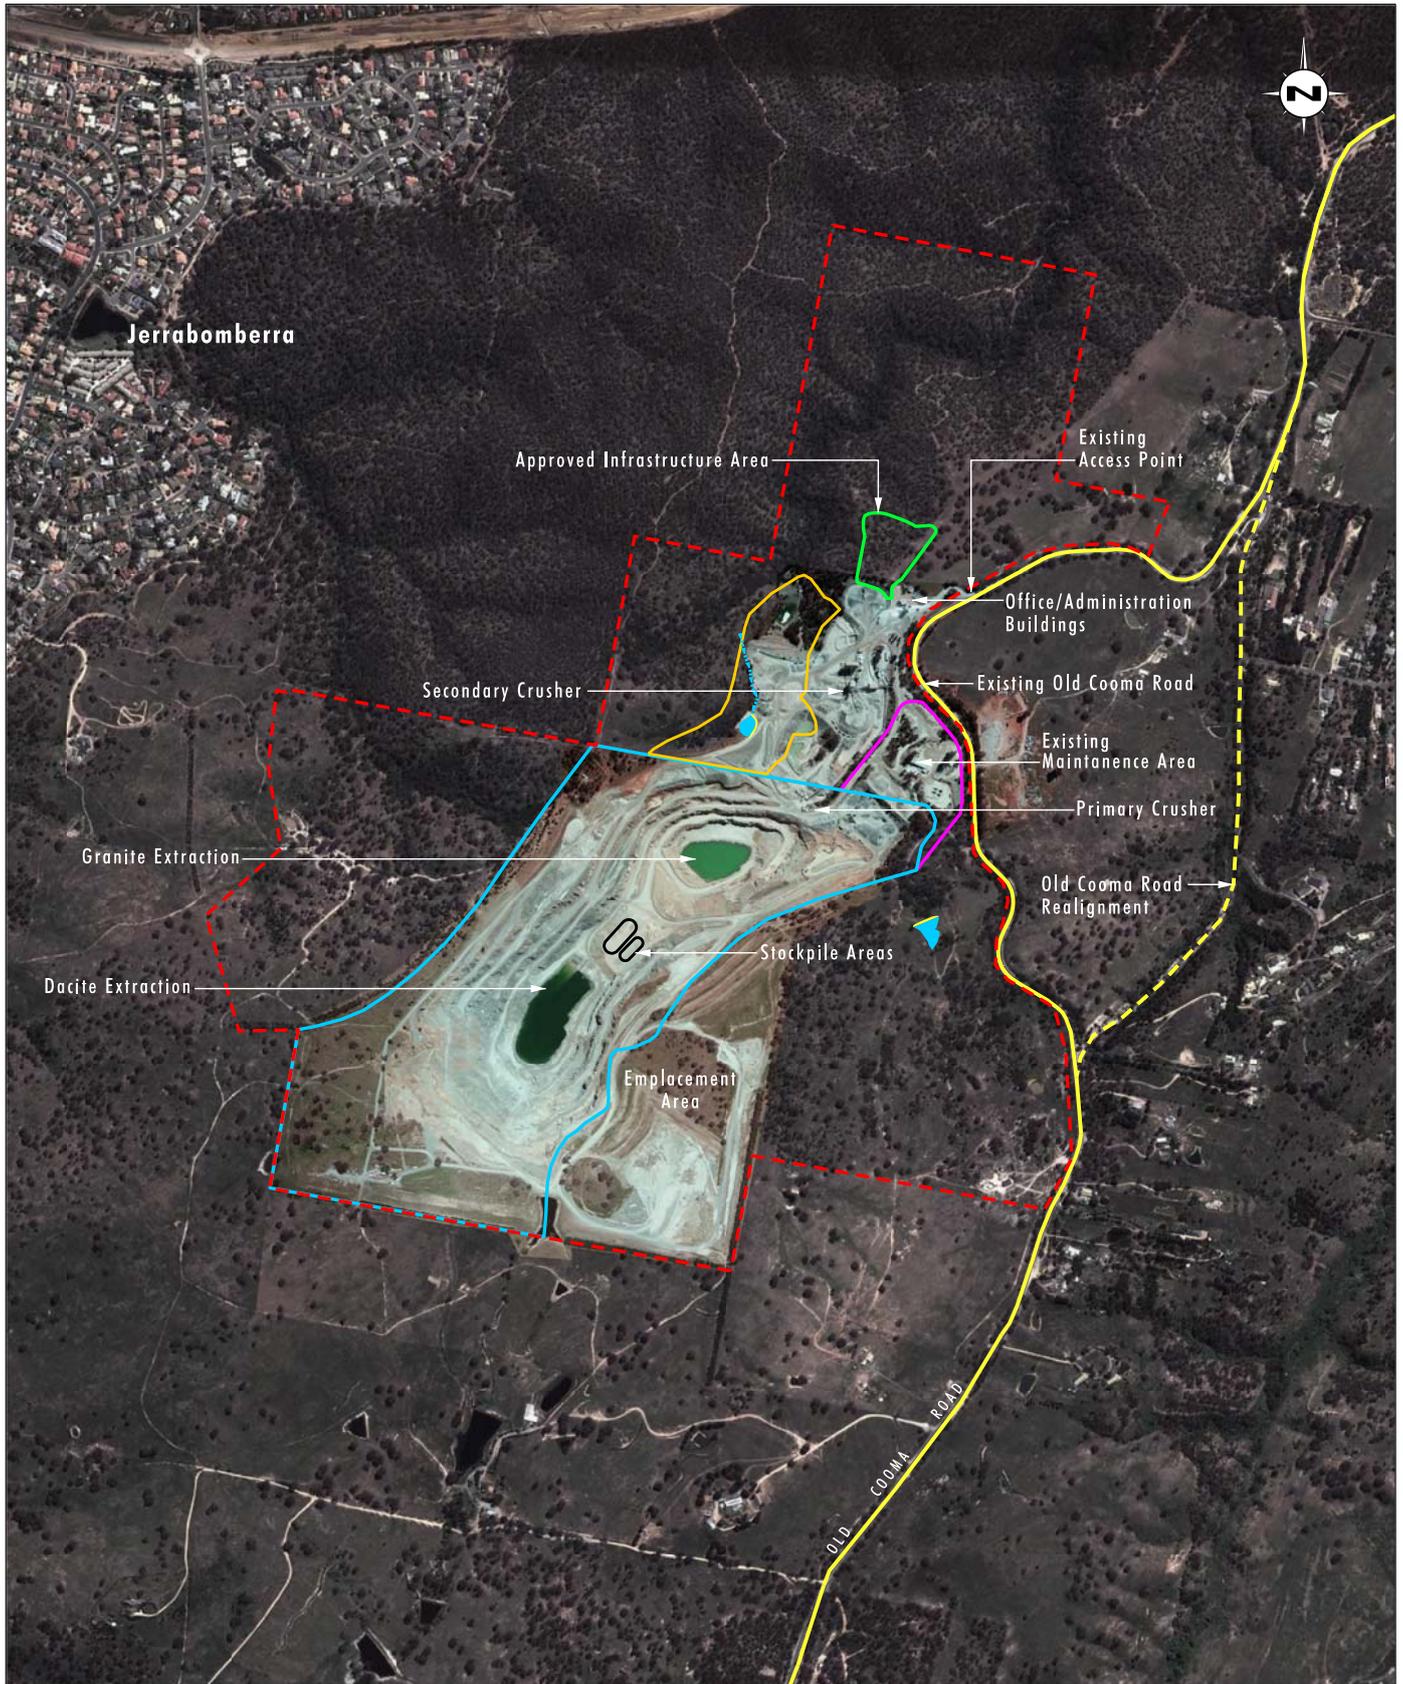
FIGURE 1.2

**Cooma Road Quarry
 Continued Operations Project**

Figure 1.2 shows the key project components of the Cooma Road Quarry Continued Operations Project.

The crushing and screening process passes rock through a series of crushers to produce quarry products of various sizes and shapes to meet customer specifications. A series of screens and conveyors are used following each crusher to sort the crushed rock into various size categories. The location of the crushing and screening plant is shown on **Figure 1.2**.

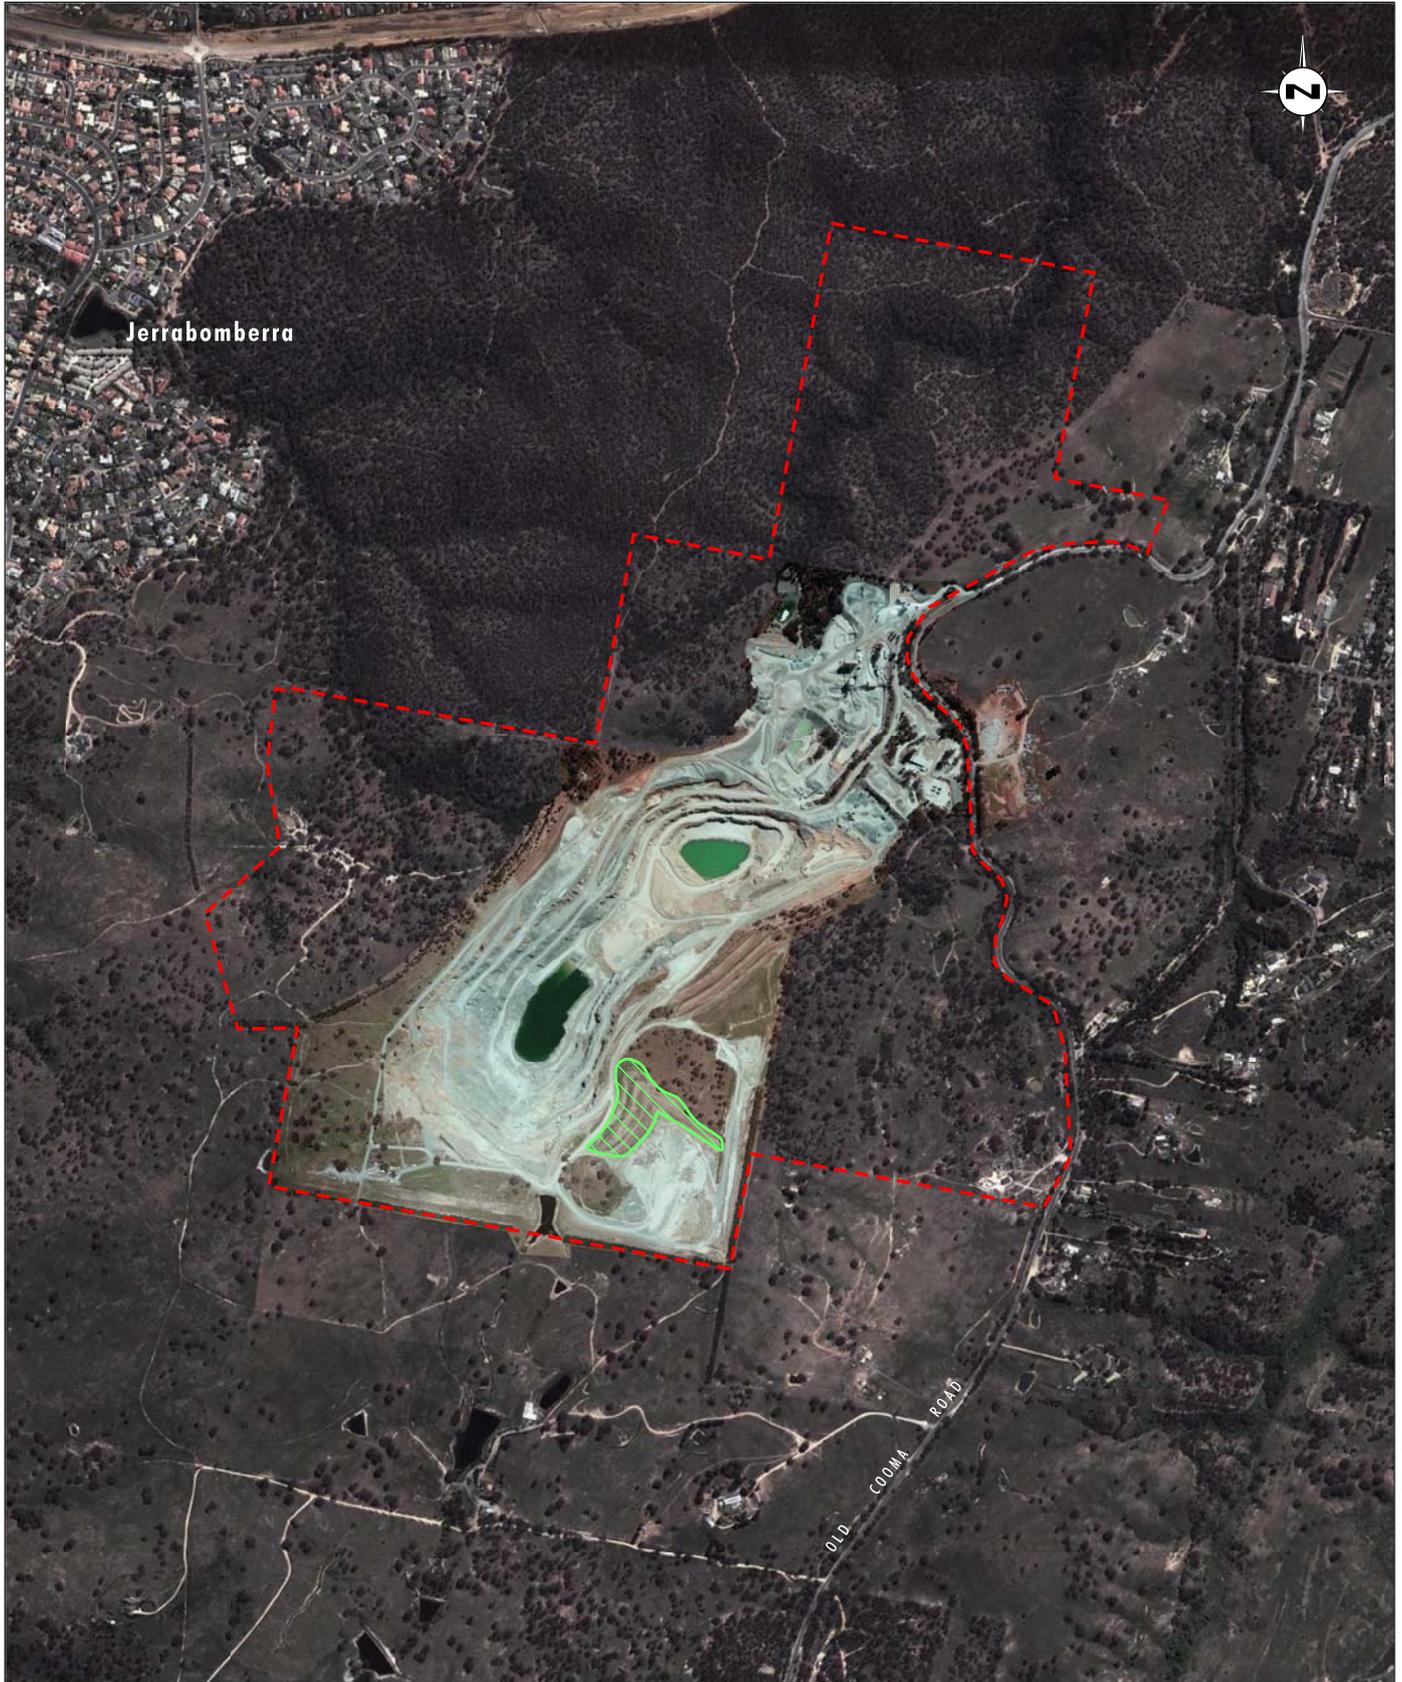
FIGURE 2.1
Rehabilitation During 2013

The program of rehabilitation for 2013 included a small area of overburden emplacement in the northern part of the quarry. The area of land rehabilitation included approximately 2.12 hectares of land. The area of land rehabilitated is shown on **Figure 2.1**.

The slopes of the overburden dump were battered to an average of 10 degrees to minimise erosion risk and constructed to provide variability in local relief to prevent ponding of surface water.

The overburden area was covered with topsoil and planted with native tree species relevant to the rehabilitation plan for the site. Holcim also developed native fauna habitat as part of rehabilitation program.

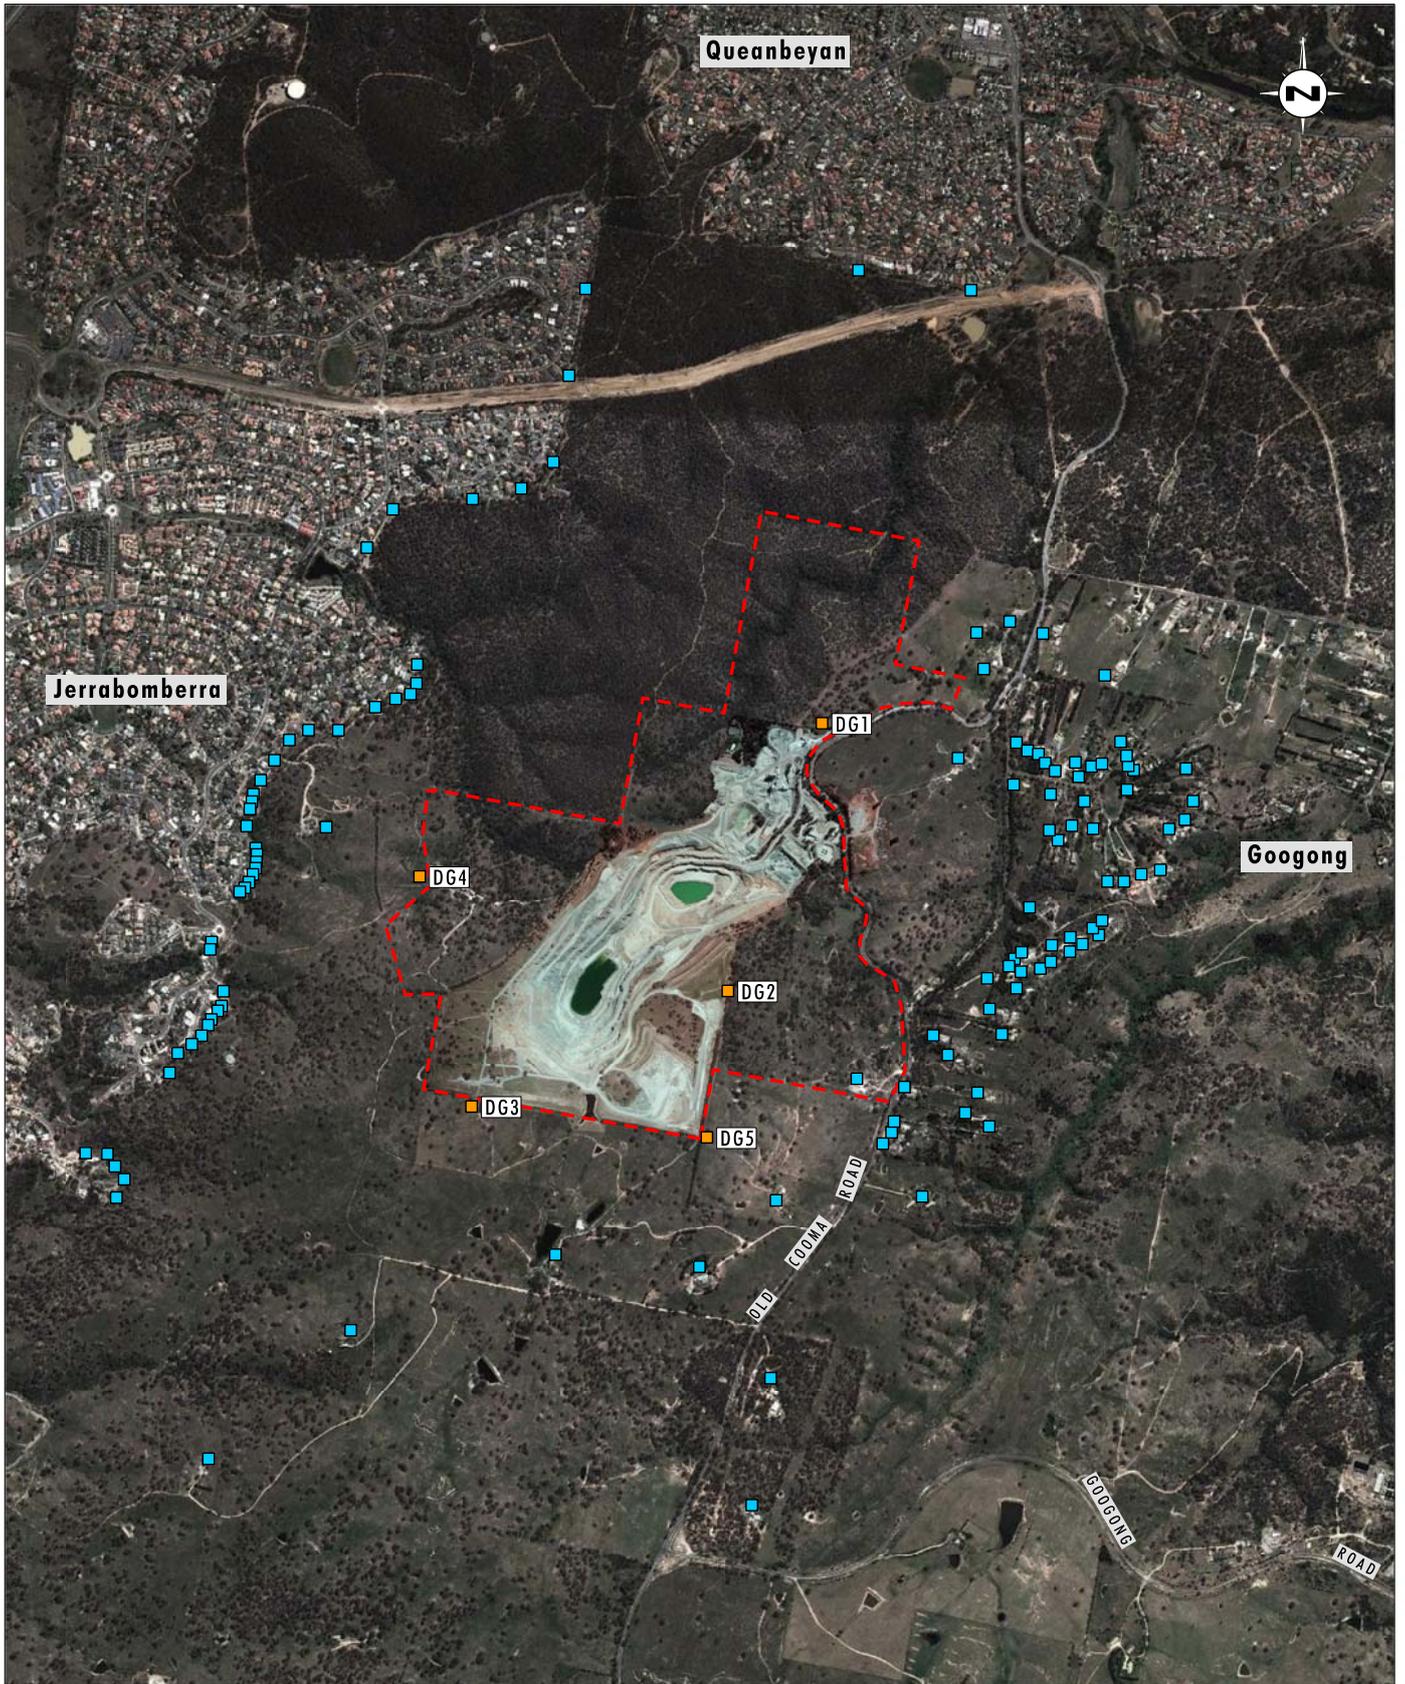
FIGURE 3.1

Dust deposition monitoring is undertaken on a monthly basis at five locations within the Project Area (refer to **Figure 3.1**). Holcim continued to monitor dust deposition during 2013.

Air Quality Monitoring Locations

Dust Deposition monitoring was undertaken throughout 2013 at five sites. The monitoring sites are shown on **Figure 3.1**. Results of the dust deposition gauges are analysed on a monthly basis for insoluble solids. The results from each monitor are provided below in **Table 3.2**.

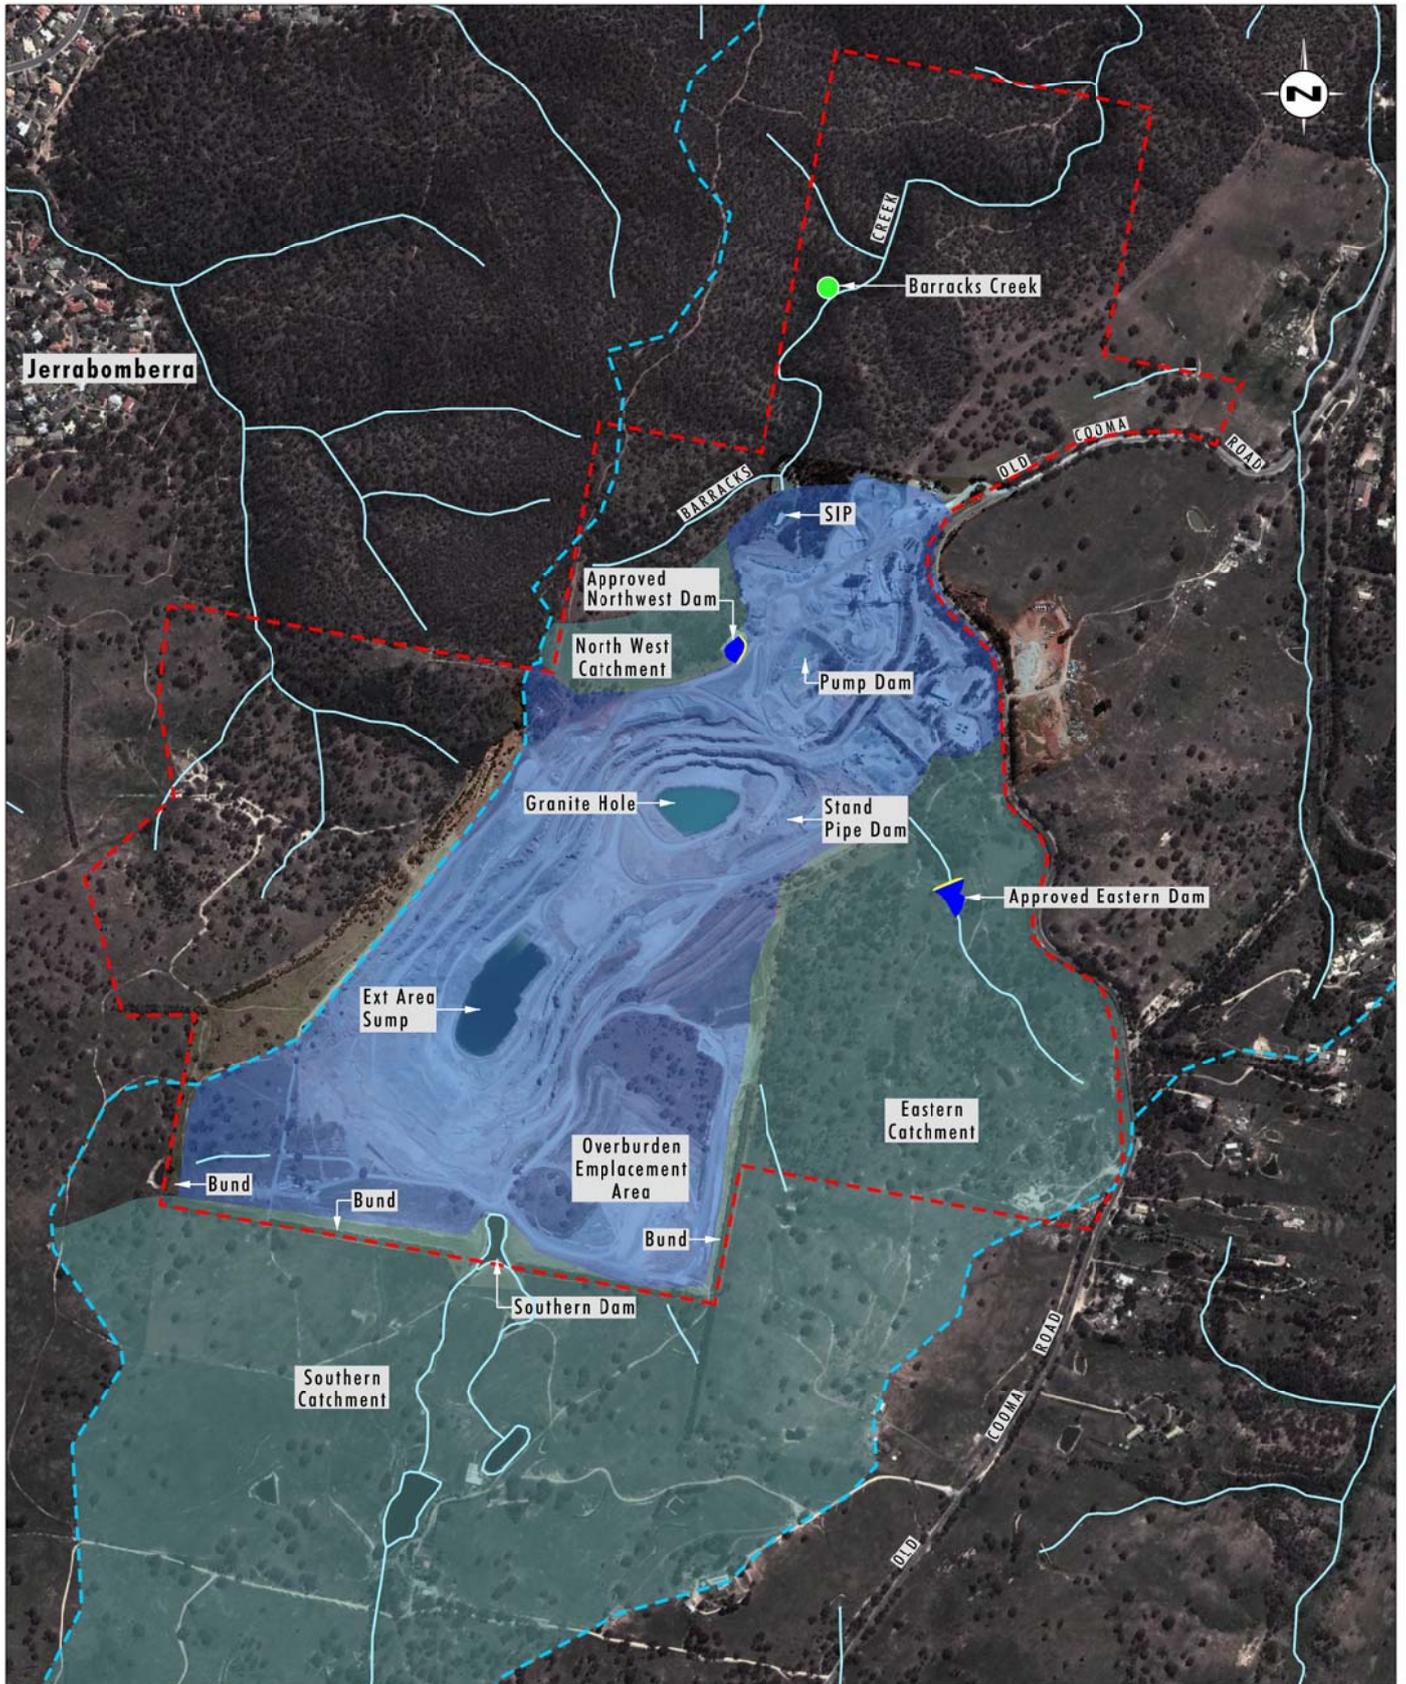
FIGURE 3.2

All dirty water runoff from the overburden emplacement areas and the workshop is directed into the quarry pit. Water is collected in either the extraction area sump or granite hole and used for dust suppression on site, in the processing plant, or transferred to the Pump Dam (refer to **Figure 3.2**).

Dirty water runoff from the processing plant, and stockpile areas drains directly to the Pump Dam. Stormwater runoff from the upslope portion of the north-west catchment of the quarry also drains to the Pump Dam (refer to **Figure 3.2**). Water is sourced from the Pump Dam for use in the processing plant and other dust suppression activities on site.

Cooma Road Quarry
Water Management System

Holcim is currently preparing a revised Water Management Plan (WMP) in accordance with Condition 20 of Schedule 3 of the development consent. The revised WMP will be generally consistent with the current EMP. As part of the continued operations project, the following improvements to the WMS are proposed:

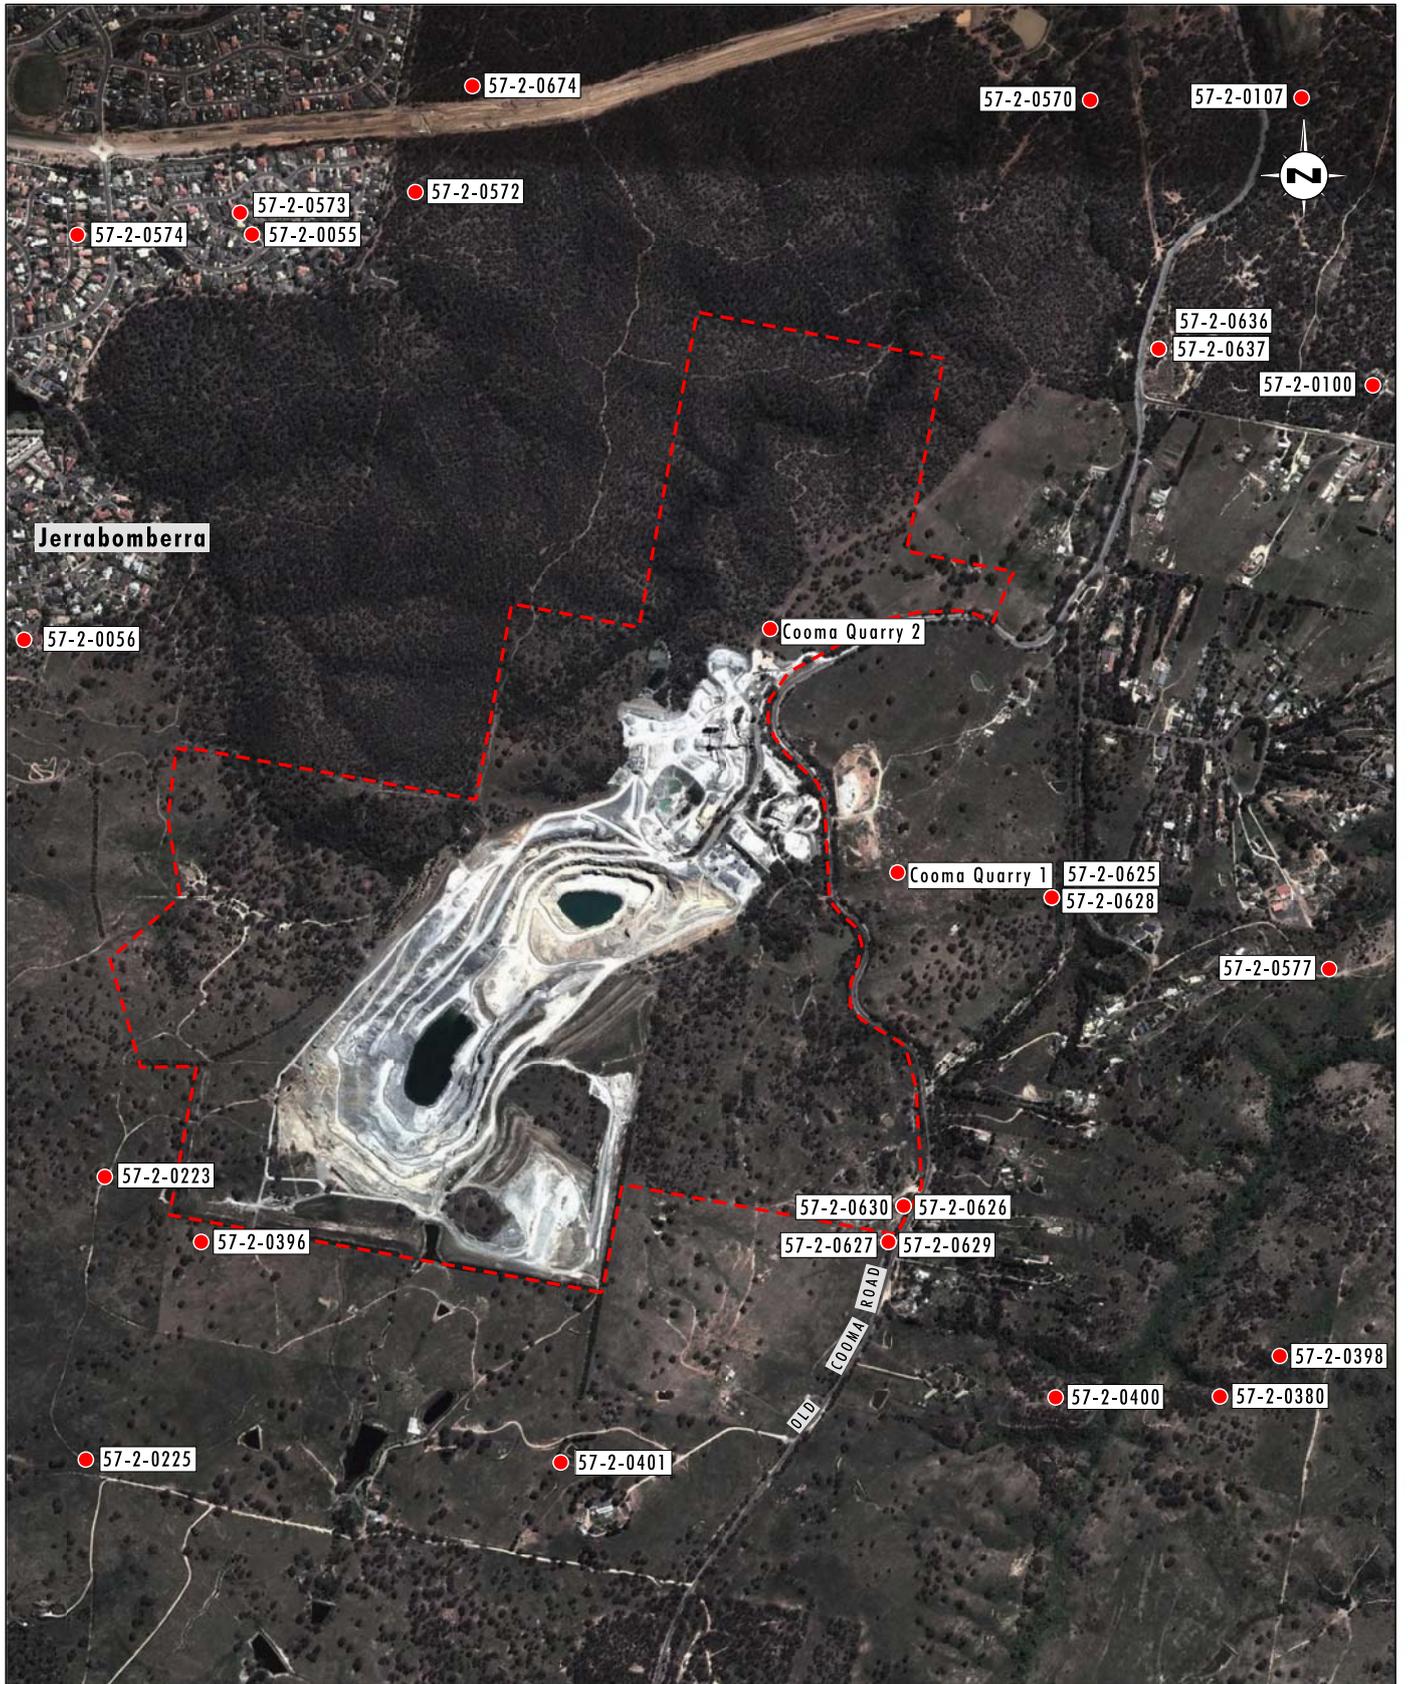
FIGURE 3.4

A number of Aboriginal archaeological sites surround Cooma Road Quarry however no known sites are located within the disturbance areas for the existing and future quarry operations. **Figure 3.4** shows the known Aboriginal archaeology sites identified by the EIS.

No additional Aboriginal archaeology sites were identified during 2013.
