Cooma Road Quarry Annual Review: 2014

Dan Lidbetter
daniel.lidbetter@lafargeholcim.com
April 15, 2016
Cooma Road Quarry Annual Review
Holcim Australia (Cooma Road Quarry)
Attn: Katrina O'Reilly
On behalf of the Secretary NSW Department of Planning & Environment
Adam Bertram, Peter Hewson & Ian Shenton

Appendix 1: Independent Road Noise Survey (Rudd Acoustics 2014)

Road Traffic Nose Assessment Report

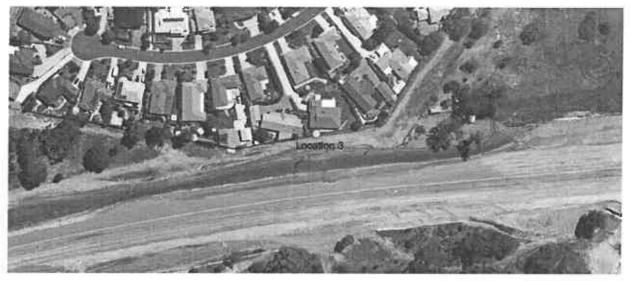
FIGURE 2 MONITORING LOCATION 3

Figure 1 and Figure 2 show the monitoring location with the background aerial photo obtained from a government website.

(Source: www.actmapi.act.gov.au)

Operator attended noise monitoring was conducted on Tuesday 13 May 2014 besides the Edwin Land Parkway. The measurement location is about 8 metres from the road line mark on the north side where the road is generally slope up from east to west.
