## Cooma Road Quarry Annual Review: 2015

<b>Author:</b>	Dan Lidbetter  <a href="mailto:daniel.lidbetter@lafargeholcim.com">daniel.lidbetter@lafargeholcim.com</a>
<b>Date:</b>	April 21, 2016
<b>Title:</b>	Cooma Road Quarry Annual Review
<b>Company:</b>	Holcim Australia (Cooma Road Quarry)
<b>Copies to external:</b>	Attn: Katrina O'Reilly  On behalf of the Secretary NSW Department of Planning & Environment
<b>Copies to internal:</b>	Adam Bertram, Peter Hewson & Ian Shenton

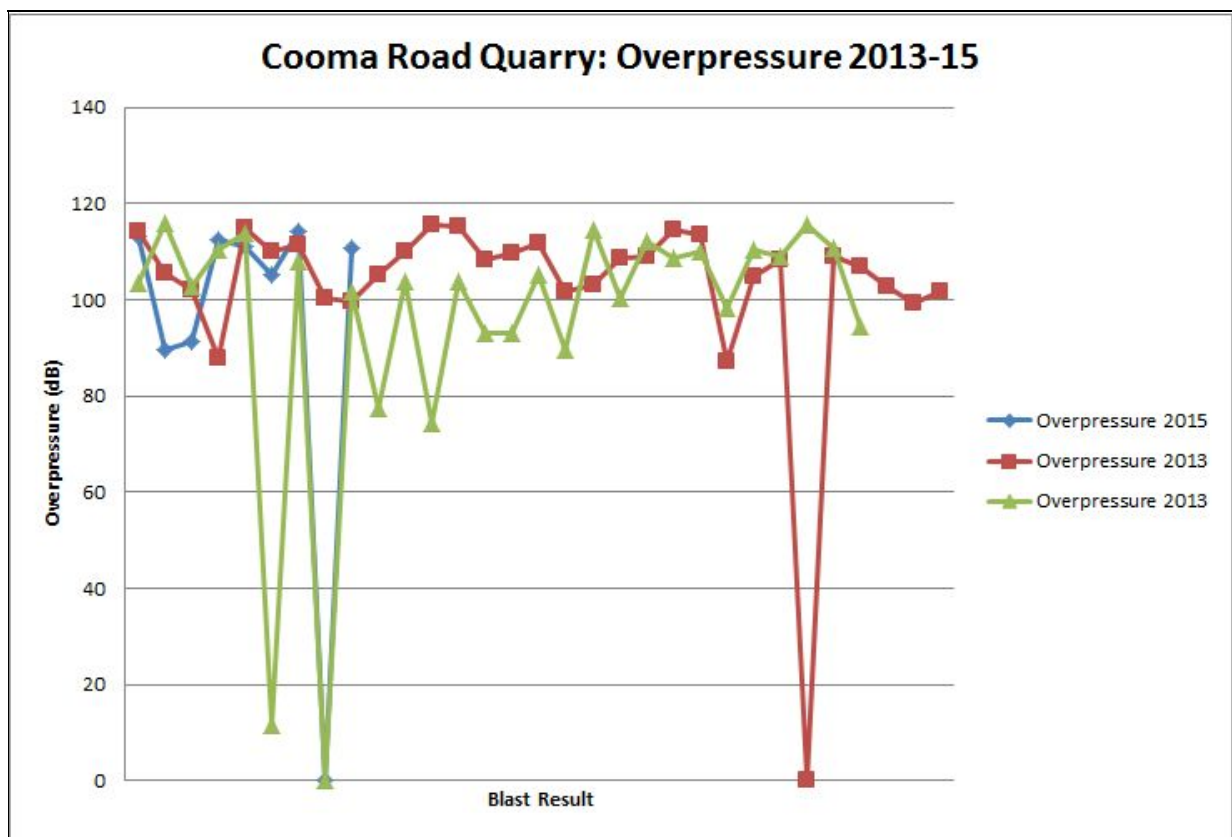
Figure 7: Cooma Road Blast Monitoring (Overpressure Results 2013-15).

Overpressure results show a consistent trend over the past 12 months with no trend established over the 2013-15 period. All results in 2015 complied with the criteria listed in the EPL.

This data is consistent with the predictions of the EIS as well as data collected in 2013. All data is consistent with the results that were predicted in 2012 with similar results expected in 2016.

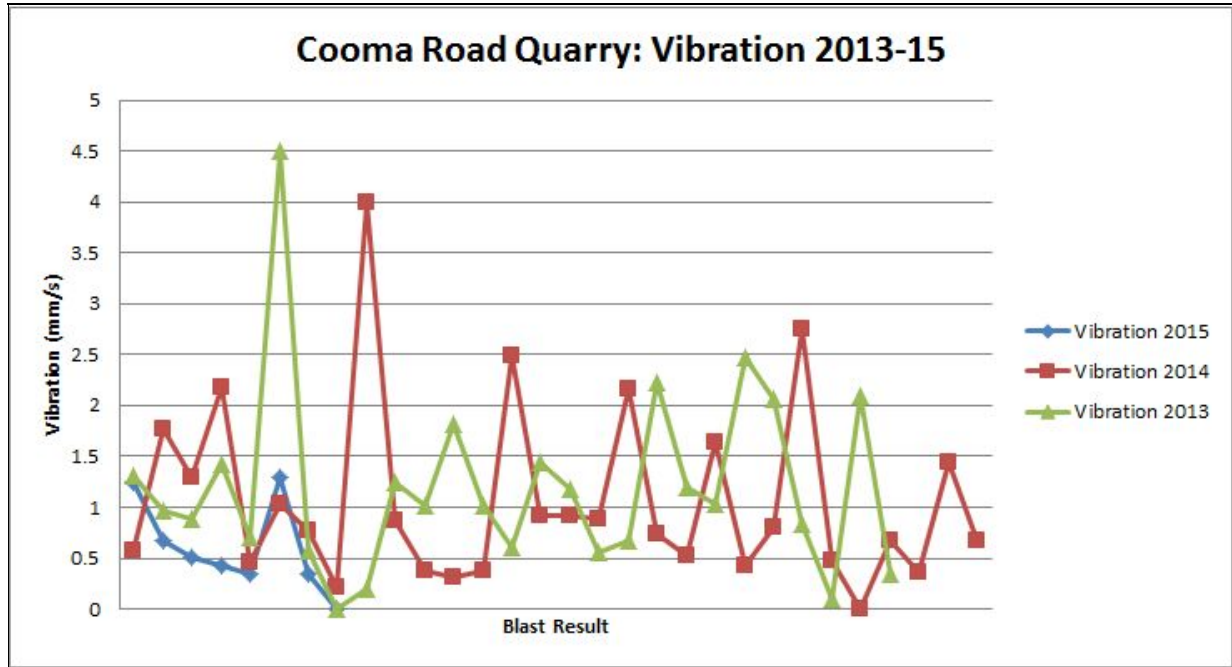
Figure 8: Cooma Road Blast Monitoring (Vibration Results 2013-15).

Vibration results in 2015 show no significant trends from results undertaken in the previous 12 months. The site has not registered a non-conformance against vibration criteria during the 2013-15 period.

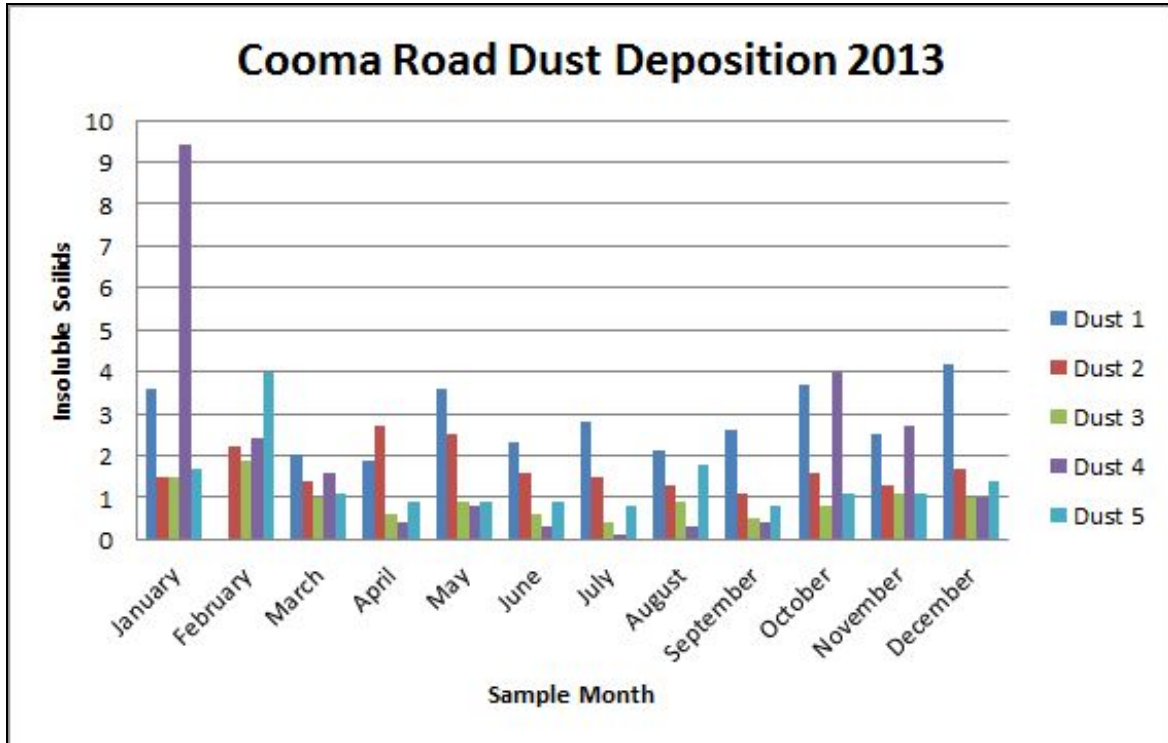
Figure 9: Cooma Road Dust Deposition Results 2013.

Air monitoring data has shown a consistent trend in 2015, with results not deviating substantially (refer to air quality monitoring results graph below) between monitoring dates.

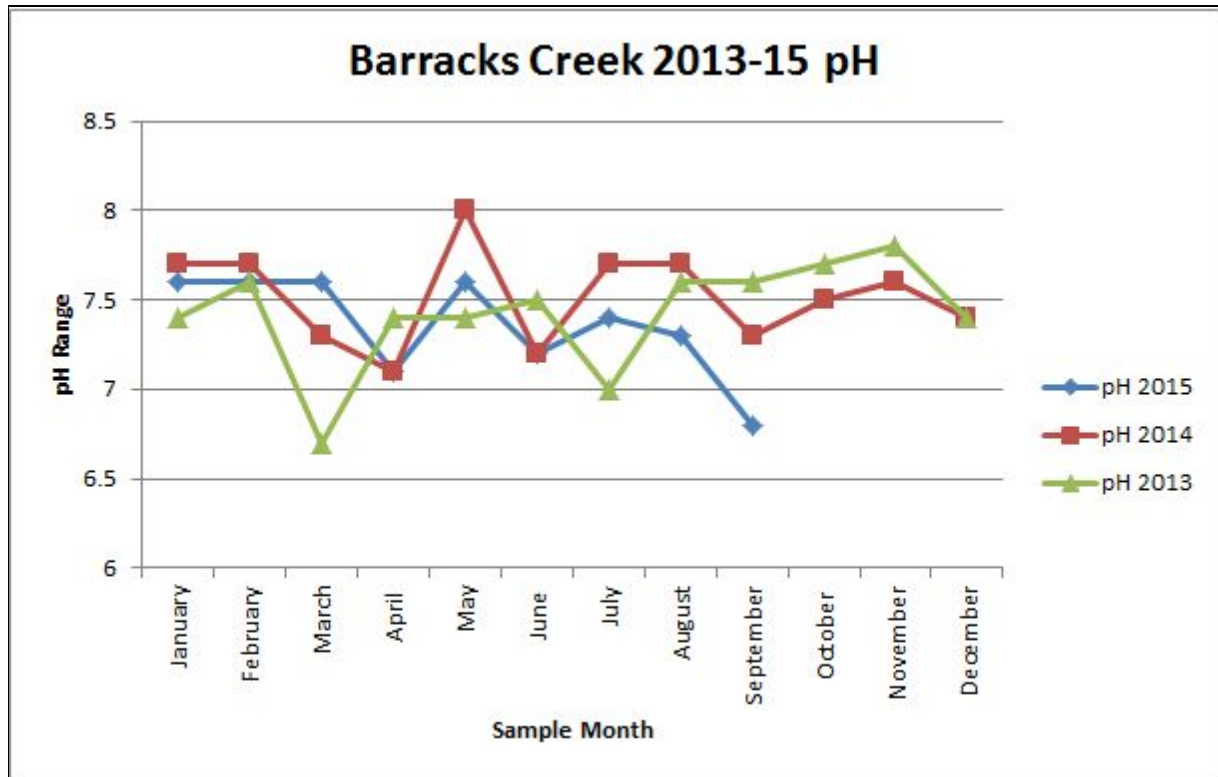
Figure 12: Cooma Road Water Monitoring (Barracks Creek pH 2013-15).

The range for pH has remained steady within the 6.5-8 pH range since monitoring was undertaken in accordance with the new Development Consent. The trend in data over this period has shown no change in the expected pH range in Barracks Creek. Measurements could not be undertaken from October-December 2015 due to Barracks Creek running dry during this period.

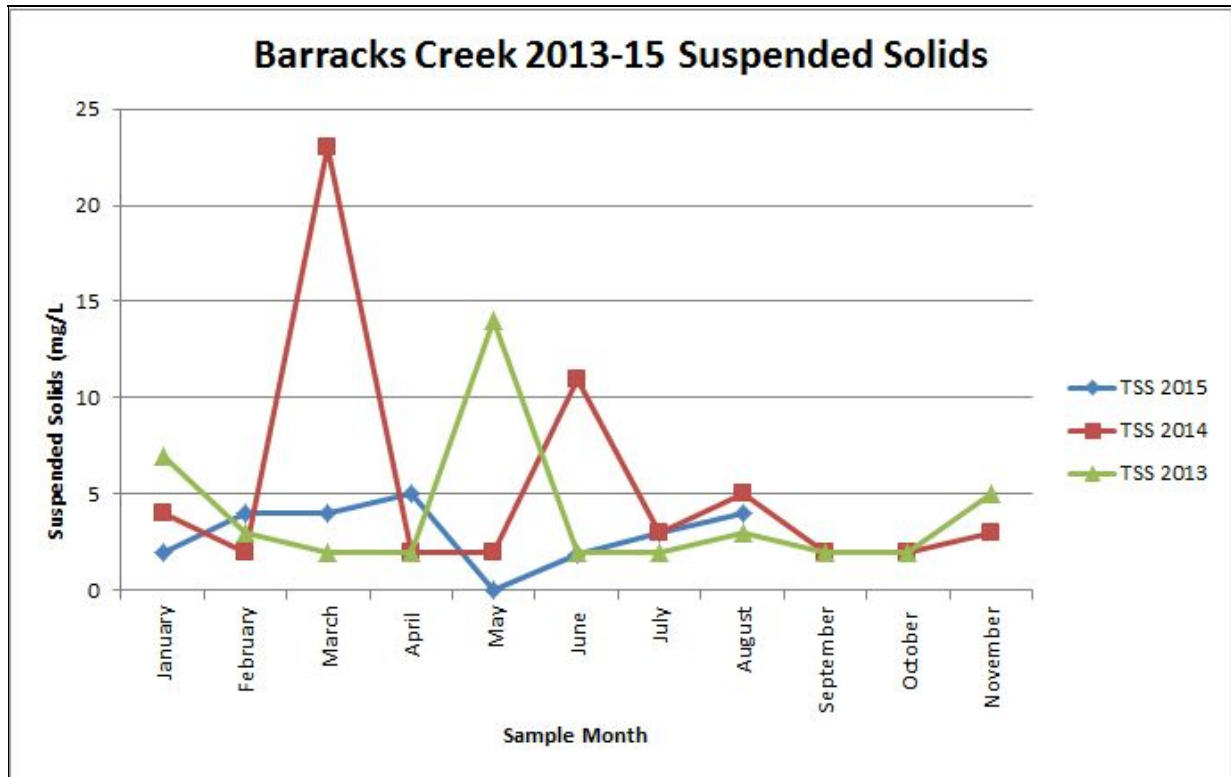
Figure 13: Cooma Road Water Monitoring (Barracks Creek Suspended Solids 2013-15).

Data collected for Suspended Solids in Barracks Creek showed a consistent trend from 2013 to 2015. All results collected for this period (see graph below) found no exceedances in criteria with the creek found to be dry and unable to be monitored from October to December 2015.

No discharges occurred during 2015 with all water was contained onsite within the Quarry at the SIP dam, Granite pit and Dacite pits.

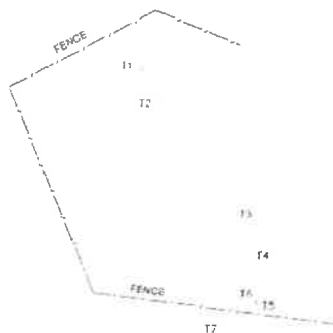
Diagram of Survey Marks

Mark	Easting	Northing	Elevation
T1	974.919	996.063	101.312
T2	976.108	993.964	102.142
T3	983.133	986.175	102.205
T4	984.463	983.314	102.637
T5	983.356	979.866	103.251
T6	983.204	979.943	102.985
T7	980.625	978.824	103.216

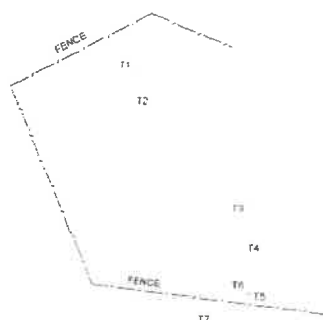
Diagram of Survey Marks

Mark	Easting	Northing	Elevation
T1	974.919	996.063	101.312
T2	976.108	993.964	102.142
T3	983.133	986.175	102.205
T4	984.463	983.314	102.637
T5	983.356	979.866	103.251
T6	983.204	979.943	102.985
T7	980.625	978.824	103.216
