ANNUAL REVIEW

1 January 2018 – 31 December 2018

Cooma Road Quarry

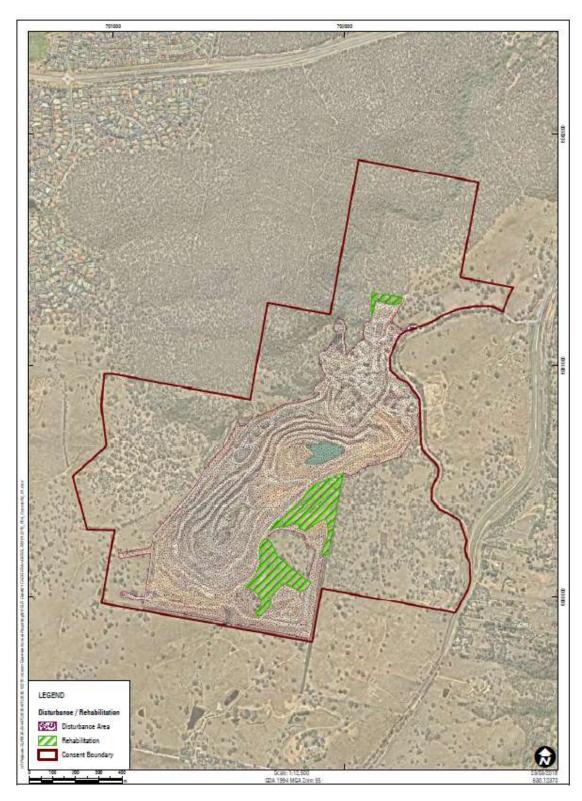
Figure 3 Current Disturbance and Rehabilitation

³ Rehabilitation that is being shaped in a phase of decommissioning, landform establishment and growth medium development.

⁴ rehabilitation under a phase of ecosystem and land use establishment or ecosystem and land use sustainability 5 This refers to rehabilitation that has been signed off from the DRG.

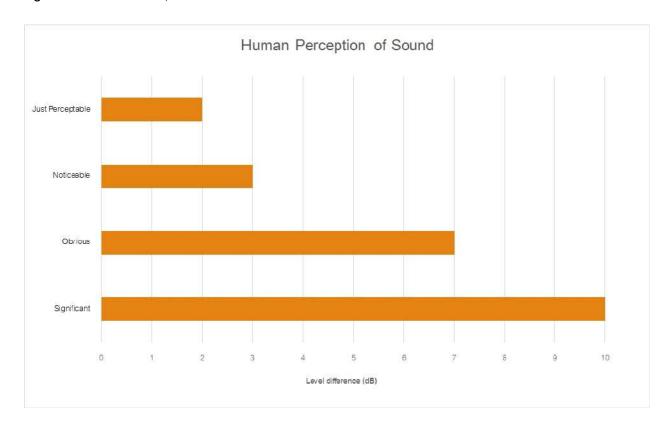
Figure A1 – Human Perception of Sound

Table A2 Common Noise Sources and Their Typical Sound F	Pressure Levels (SPL), dBA
Source	Typical Sound Level
Threshold of pain	140
Jet engine	130
Hydraulic hammer	120
Chainsaw	110
Industrial workshop	100
Lawn-mower (operator position)	90
Heavy traffic (footpath)	80
Elevated speech	70
Typical conversation	60
Ambient suburban environment	40
Ambient rural environment	30
Bedroom (night with windows closed)	20
Threshold of hearing	0

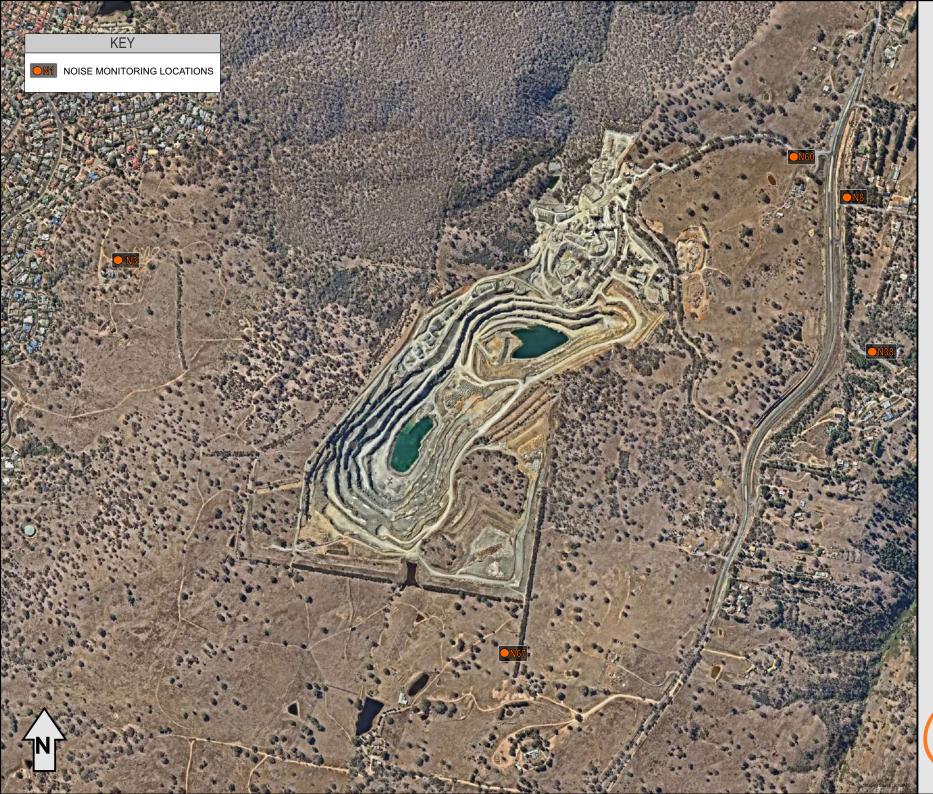
FIGURE 1

The quarry is located in Googong, NSW approximately 13km south east of Canberra, ACT. The quarry is bounded primarily by rural/residential properties in all directions, with noise from passing road traffic on Old Cooma Road dominating the acoustic environment for receivers to the east of the quarry. The monitoring locations with respect to the quarry and assessed receivers are presented in the locality plan shown in **Figure 1**.

LOCALITY PLAN

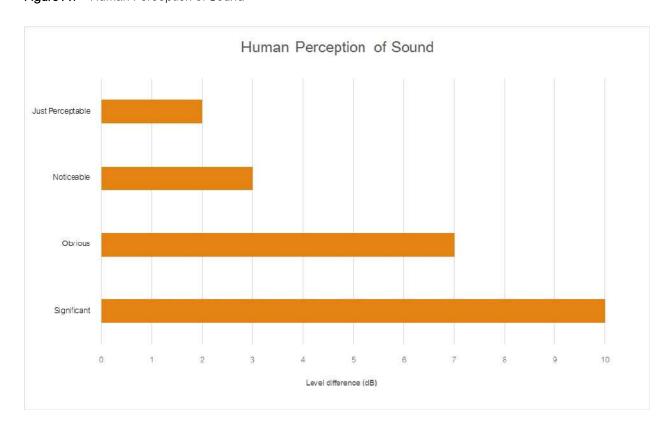
Figure A1 – Human Perception of Sound

able A2 Common Noise Sources and Their Typical Sound Pressure Levels (SPL), dBA					
Source	Typical Sound Level				
Threshold of pain	140				
Jet engine	130				
Hydraulic hammer	120				
Chainsaw	110				
Industrial workshop	100				
Lawn-mower (operator position)	90				
Heavy traffic (footpath)	80				
Elevated speech	70				
Typical conversation	60				
Ambient suburban environment	40				
Ambient rural environment	30				
Bedroom (night with windows closed)	20				
Threshold of hearing	0

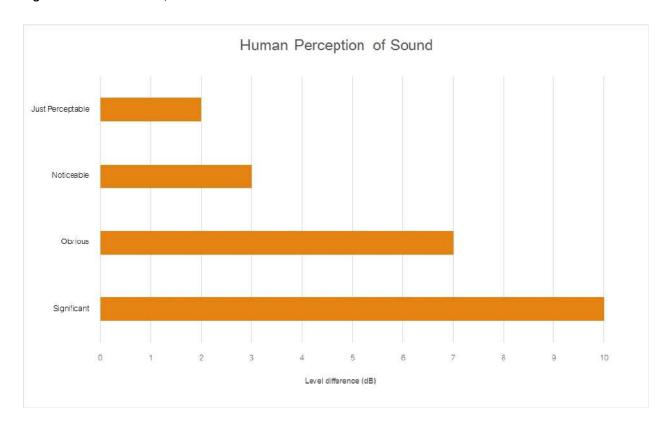
Figure A1 – Human Perception of Sound

Table A2 Common Noise Sources and Their Typical Sound Pressure Levels (SPL), dBA			
Source	Typical Sound Level		
Threshold of pain	140		
Jet engine	130		
Hydraulic hammer	120		
Chainsaw	110		
Industrial workshop	100		
Lawn-mower (operator position)	90		
Heavy traffic (footpath)	80		
Elevated speech	70		
Typical conversation	60		
Ambient suburban environment	40		
Ambient rural environment	30		
Bedroom (night with windows closed)	20		
Threshold of hearing	0

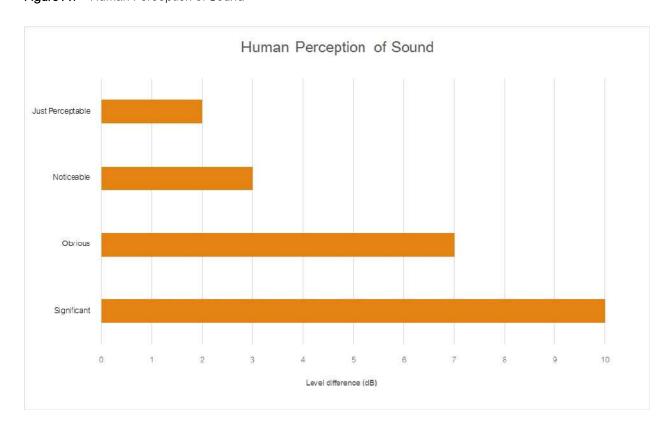
Figure A1 – Human Perception of Sound

Table A2 Common Noise Sources and Their Typical Sound P	ble A2 Common Noise Sources and Their Typical Sound Pressure Levels (SPL), dBA				
Source	Typical Sound Level				
Threshold of pain	140				
Jet engine	130				
Hydraulic hammer	120				
Chainsaw	110				
Industrial workshop	100				
Lawn-mower (operator position)	90				
Heavy traffic (footpath)	80				
Elevated speech	70				
Typical conversation	60				
Ambient suburban environment	40				
Ambient rural environment	30				
Bedroom (night with windows closed)	20				
Threshold of hearing	0
