**ANNUAL REVIEW**

**1 January 2022 – 31 December 2022**

**Cooma Road Quarry**

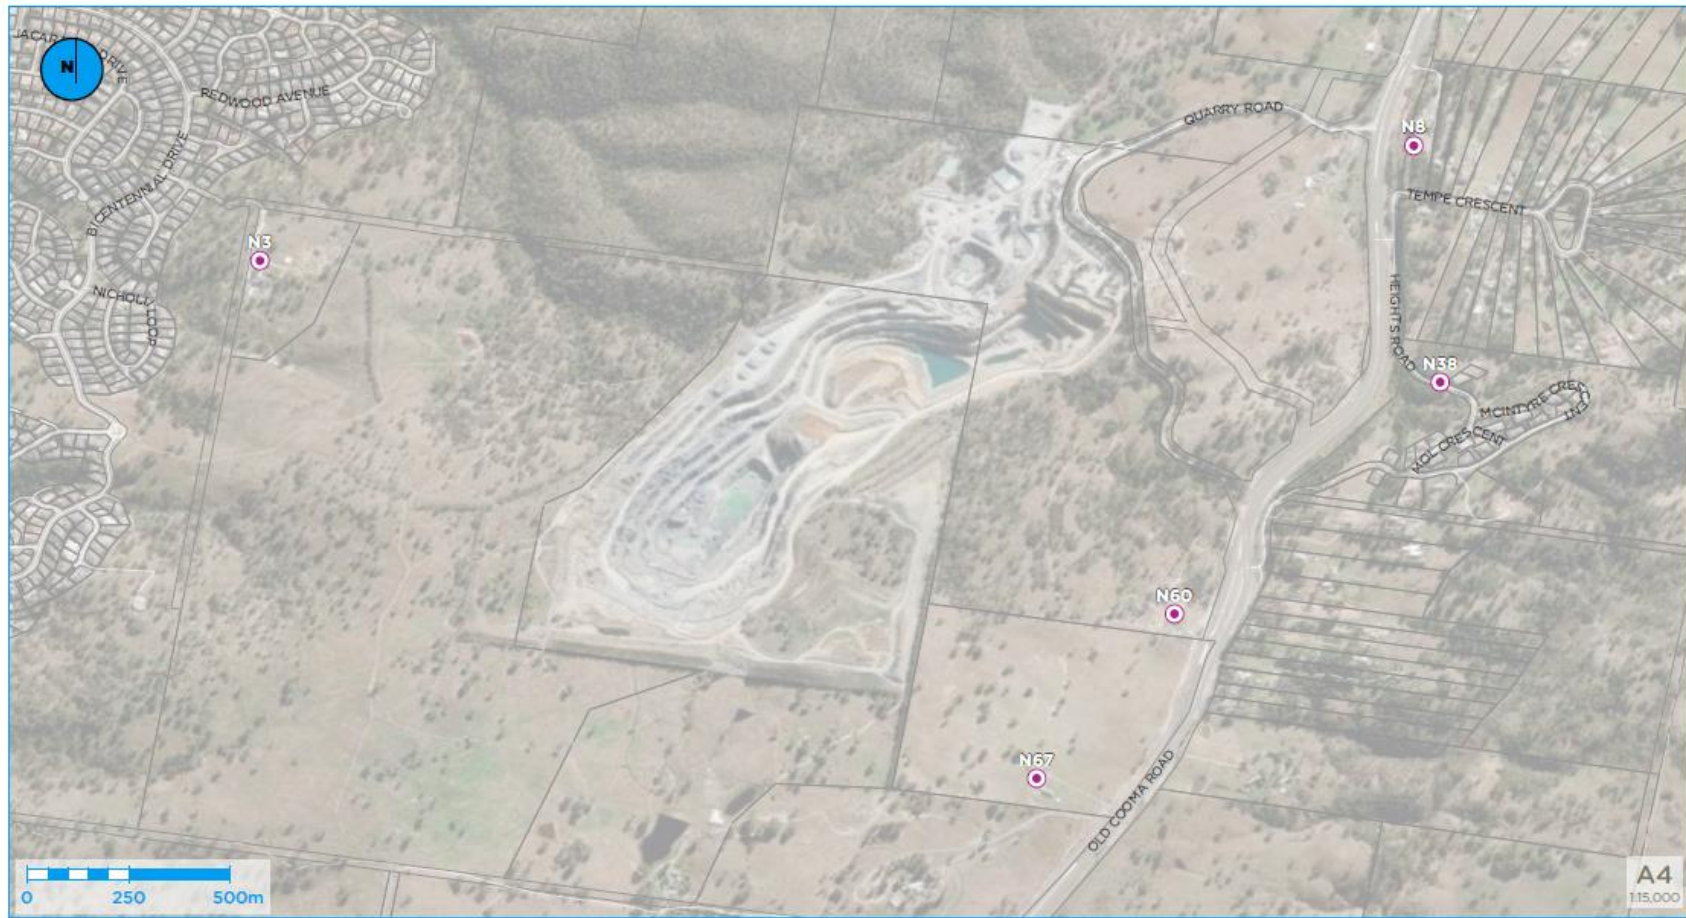
Monitoring Locations	Locality and Sensitive Receptors
N3	West of the quarry situated on a rural property off Copperfield Place. This location represents residential and rural receivers to the west of the quarry.
N8	Northeast of the quarry along Tempe Crescent and is representative of residential receivers in that area.
N38	On Heights Road and is representative of the elevated residential receivers to the east of the quarry.
N60	At 501 Old Cooma Road and represents the residence adjacent to the quarry access road.
N67	Situated on a rural property at 732 Old Cooma Road to the south of the quarry. This is representative of rural and residential receivers to the south, with direct line of site into the quarry pit

The monitoring locations with respect to the quarry and assessed receivers are presented in the locality plan shown in **Figure 1**.

- Noise monitoring location

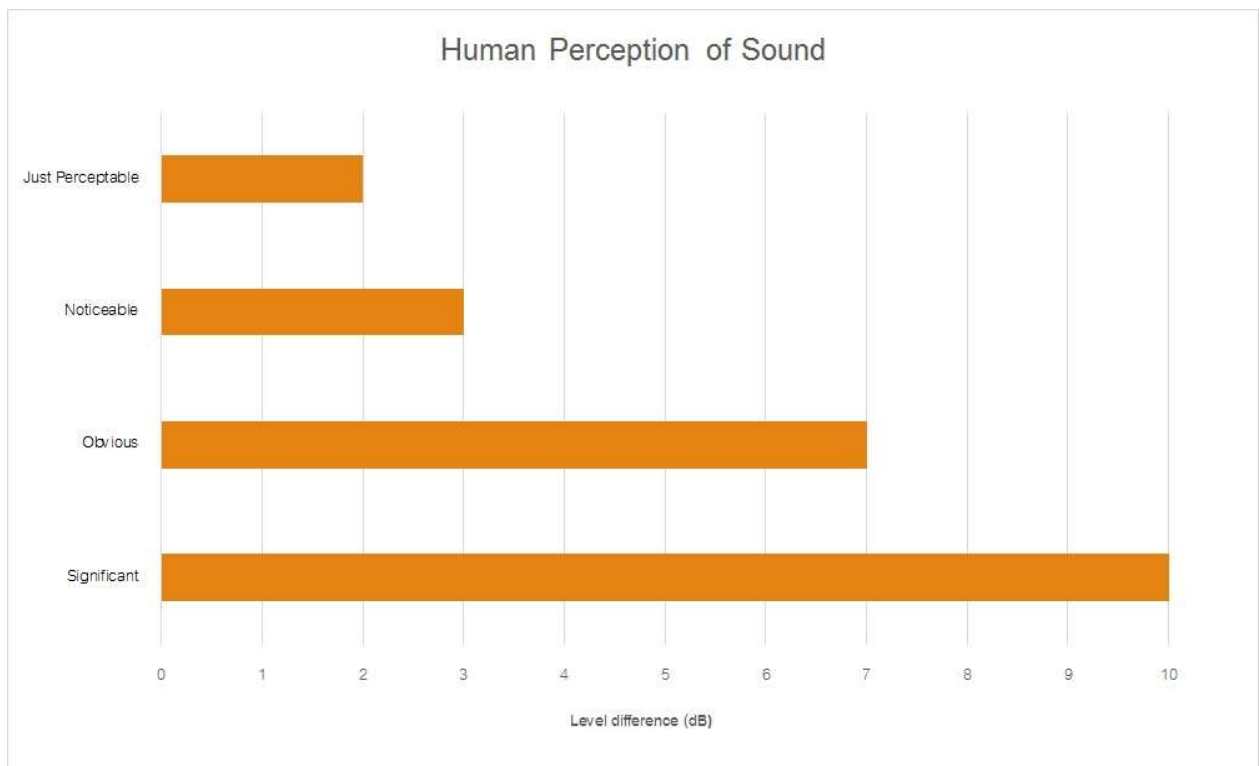
Figure A1 – Human Perception of Sound

Table A2 Common Noise Sources and Their Typical Sound Pressure Levels (SPL), dBA	
Source	Typical Sound Level
Threshold of pain	140
Jet engine	130
Hydraulic hammer	120
Chainsaw	110
Industrial workshop	100
Lawn-mower (operator position)	90
Heavy traffic (footpath)	80
Elevated speech	70
Typical conversation	60
Ambient suburban environment	40
Ambient rural environment	30
Bedroom (night with windows closed)	20
Threshold of hearing	0

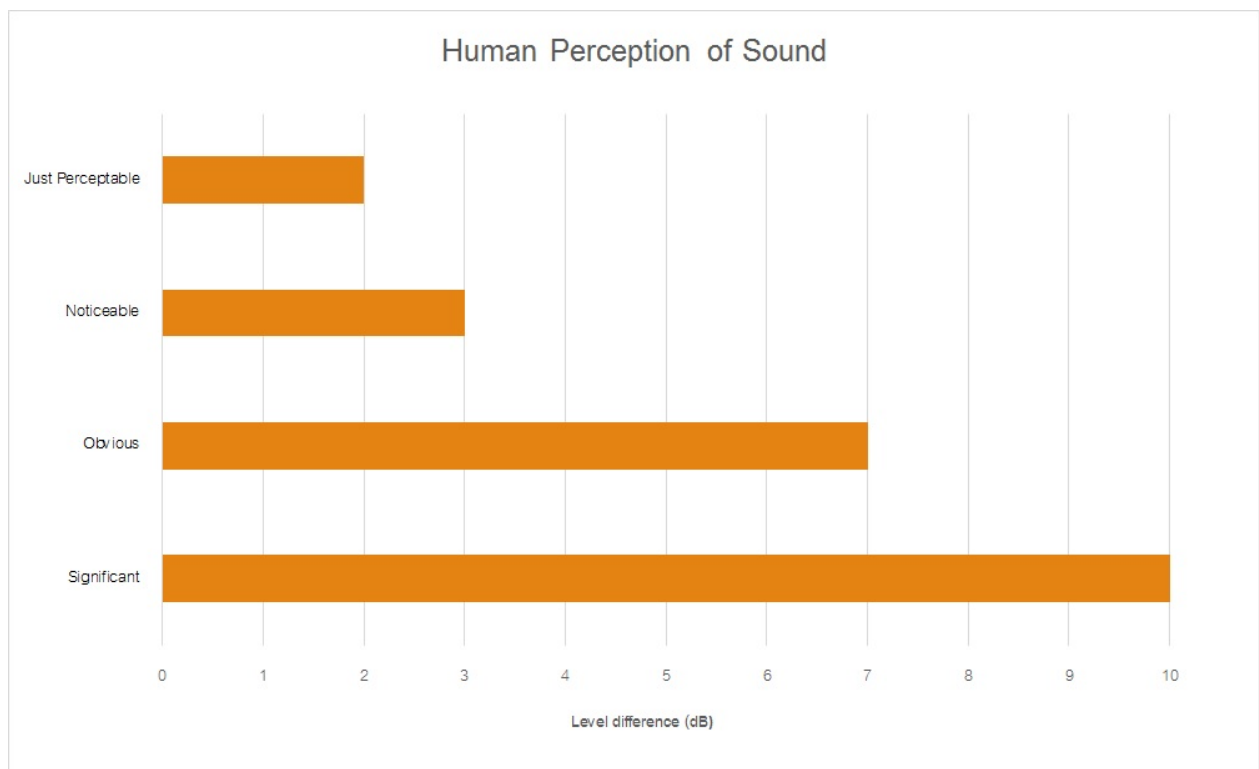
Figure A1 – Human Perception of Sound

Table A2 Common Noise Sources and Their Typical Sound Pressure Levels (SPL), dBA	
Source	Typical Sound Level
Threshold of pain	140
Jet engine	130
Hydraulic hammer	120
Chainsaw	110
Industrial workshop	100
Lawn-mower (operator position)	90
Heavy traffic (footpath)	80
Elevated speech	70
Typical conversation	60
Ambient suburban environment	40
Ambient rural environment	30
Bedroom (night with windows closed)	20
Threshold of hearing	0
