ANNUAL REVIEW

1 January 2023 – 31 December 2023

Cooma Road Quarry

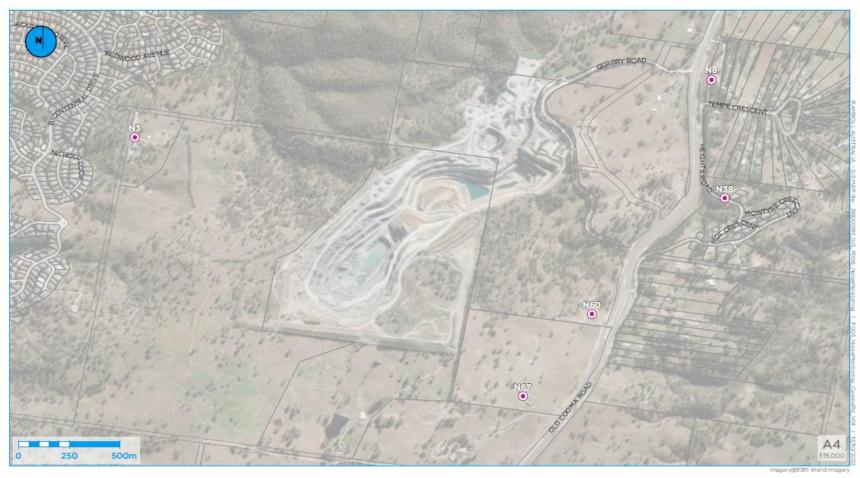
The monitoring locations with respect to the quarry and assessed receivers are presented in the locality plan shown in **Figure 1**.

Noise monitoring location

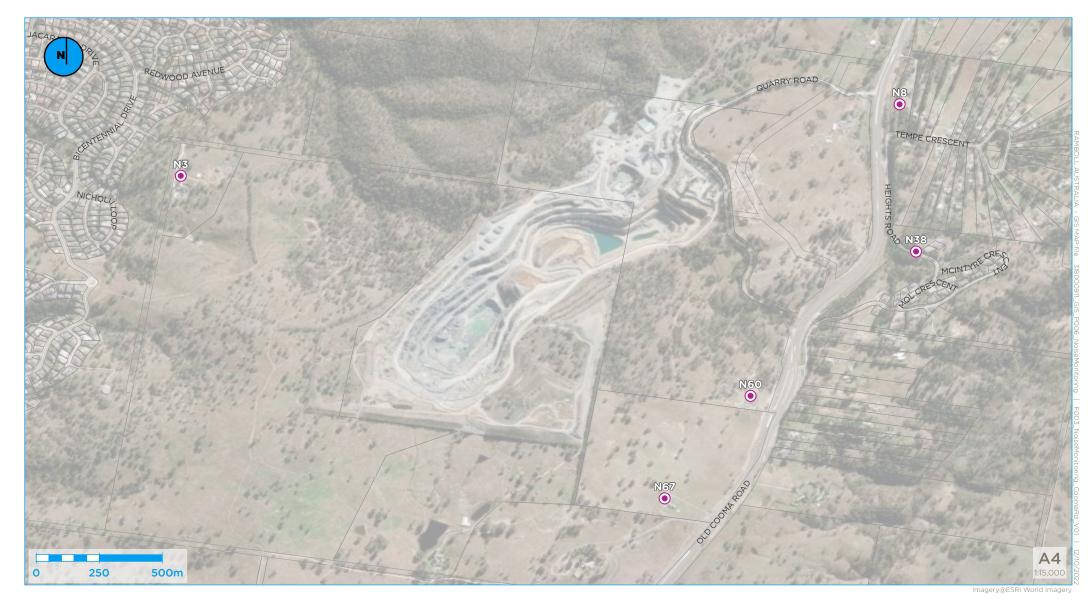
The monitoring locations with respect to the quarry and assessed receivers are presented in the locality plan shown in **Figure 1**.

• Noise monitoring location

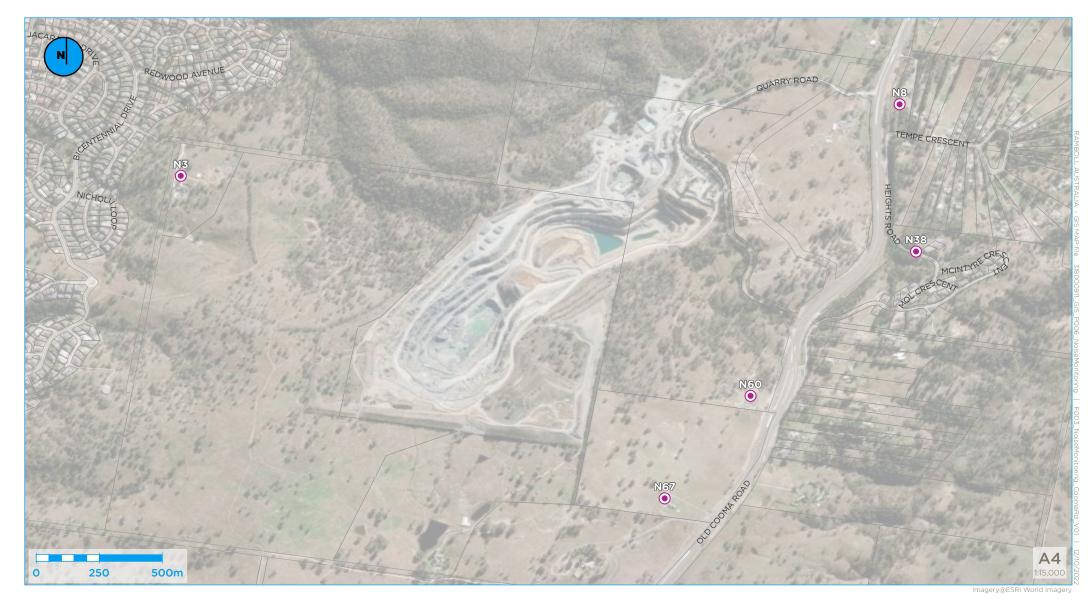
The monitoring locations with respect to the quarry and assessed receivers are presented in the locality plan shown in **Figure 1**.

• Noise monitoring location
