**INDEPENDENT AUDIT OF COMPLIANCE
WITH EPBC 2019/8530**

**Holcim Colac Quarry,
75 – 95 Potters Road, Ondit VIC**

August 2025

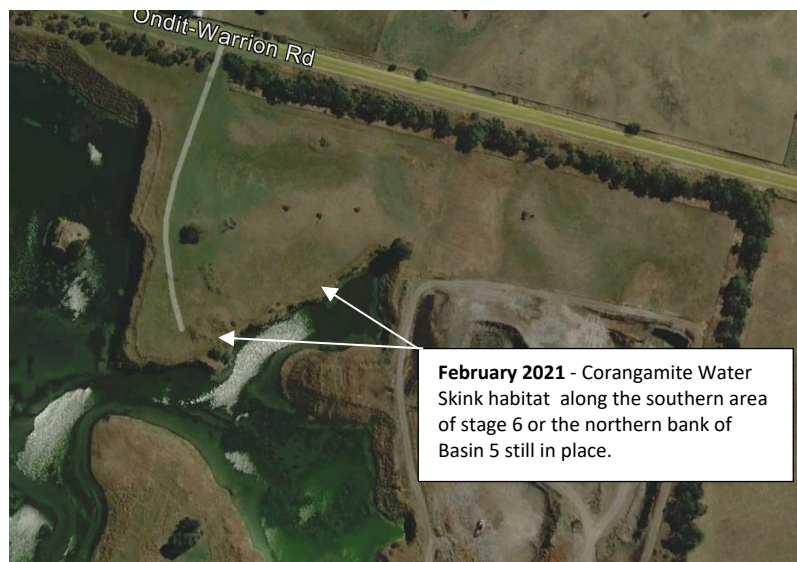
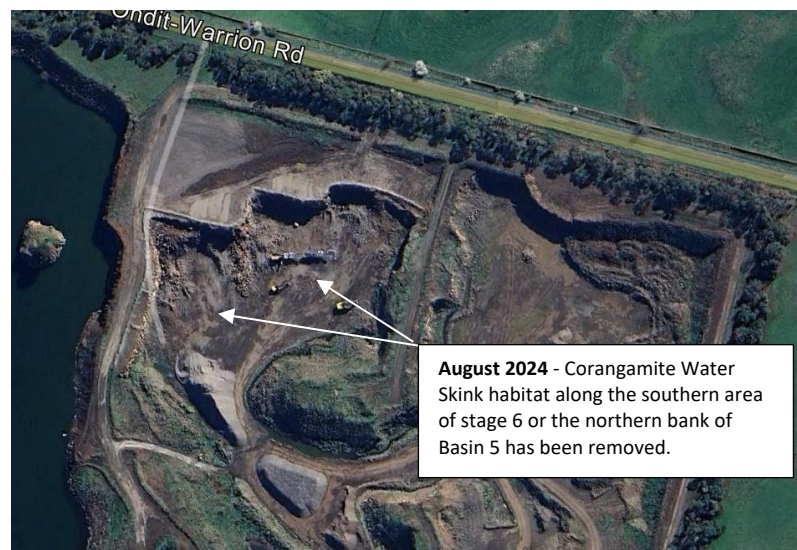
FIGURE 1: CORANGAMITE WATER SKINK HABITAT REMOVED OUTSIDE OF THE ACTION AREA (i.e. ALONG THE SOUTHERN AREA OF STAGE 6 OR THE NORTHERN BANK OF BASIN 5

The visual inspection of existing habitat areas during the site inspection revealed that in the main, areas of existing habitat have been appropriately fenced off or had a bund constructed to protect the retained habitat from inadvertent damage. However, it was also observed that there were some areas of existing habitat around the central dam area (within Stage 5) and within the central extraction area (CEA), whilst located within a larger fenced off area, that have not been appropriately demarcated to protect retained habitat from inadvertent damage should operational activities progress into those areas in the future.

EPBC Approval - 2019/8530 A-15	mNC	Notify the department of any non-compliances with conditions of the approval as soon as practicable and no later than 2 business days after becoming aware of the non-compliance.
EPBC Approval - 2019/8530 A-16	mNC	Provide the department with details of any non-compliances with conditions of the approval as soon as practicable and no later than 10 business days after becoming aware of the non-compliance.
EPBC Approval - 2019/8530 A-18	mNC	Provide to DCCEE the name and qualifications of the proposed independent auditor and the draft audit criteria before the end of any recurring subject three year period.
CWS Mgt Plan 3.2	C-OFI	To ensure that retained habitat is protected (i.e. in the southern development area and at the central dam area within Stage 5), place demarcation pegs around these habitat areas to ensure that they are clearly identified and will be protected from inadvertent damage should new works be planned in this area in the future.

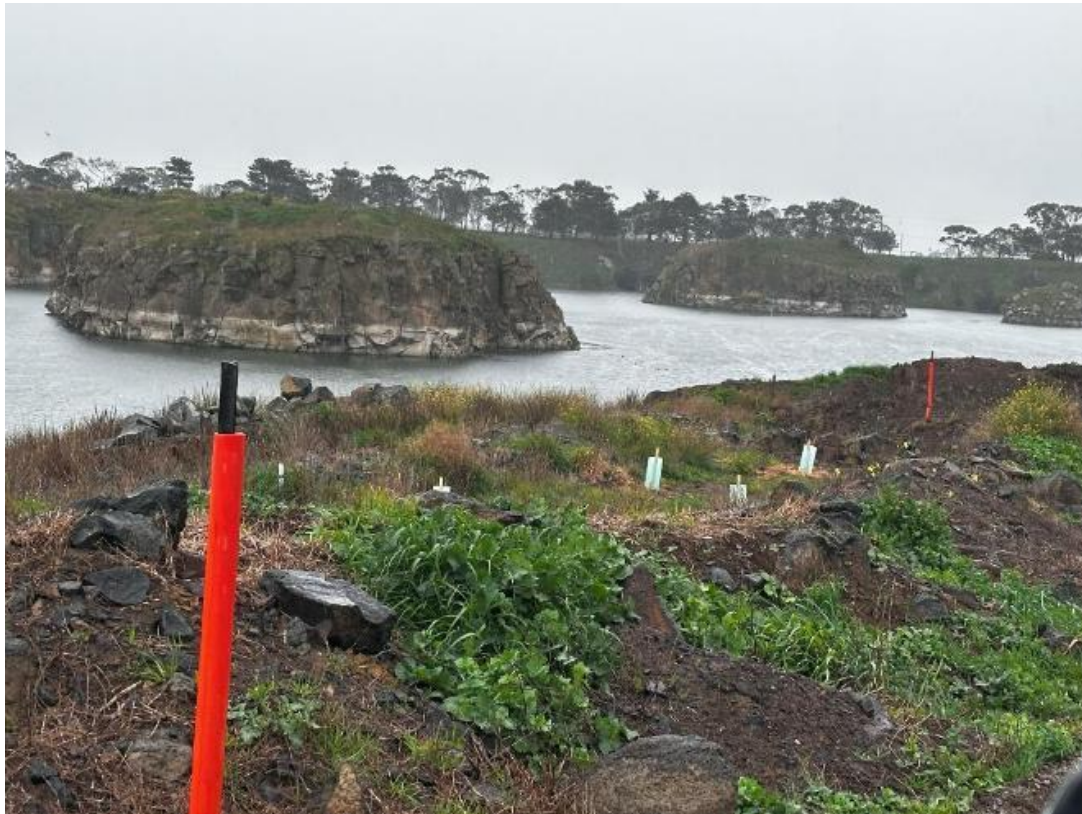
FIGURE 3: BUND WALL OBSERVED AT THE CREST OF CLIFF FACE ON WESTERN EDGE OF STAGE 6

A bund wall was observed at the crest of the cliff face on the western edge of Stage 6 to prevent rocks/earth from falling down the cliff face (**Figure 3**).

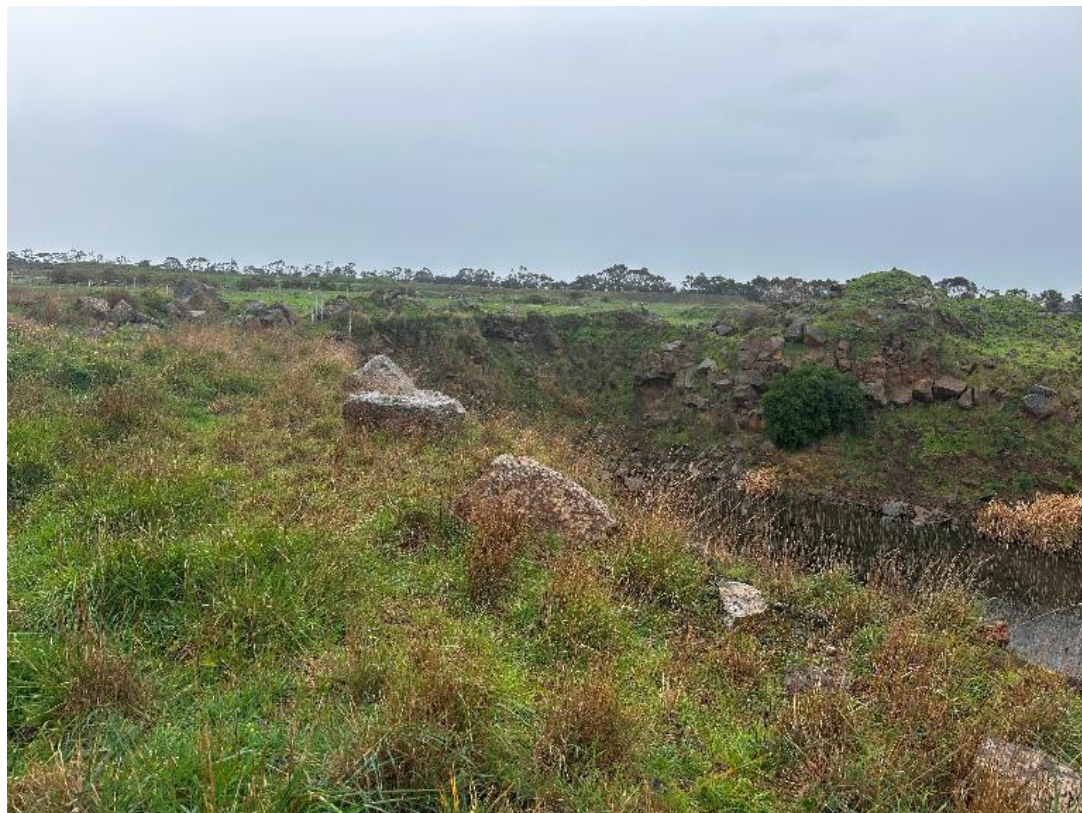
FIGURE 4: EXAMPLE OF HABITAT AREA IN THE CENTRAL EXTRACTION AREA (CEA) NOT CLEARLY DEMARCATED

However, it was also noted that not all habitat areas were clearly demarcated (e.g. the central dam in Stage 5a, whilst part of a fenced off area, the habitat within the fenced off area has not been demarcated). Also, some habitat areas in the central extraction area (CEA) have not been cleared demarcated (**Figure 4**).

CWS Mgt Plan 3.2	C-OFI	To ensure that retained habitat is protected (i.e. in the southern development area and at the central dam area within Stage 5), place demarcation pegs around these habitat areas to ensure that they are clearly identified and will be protected from inadvertent damage should new works be planned in this area in the future.
CWS Mgt Plan 4.2.4, 8-12, 8-14, 8-16, 9 (Implementation Schedule), OMP 5.2.4, 5.7-6, 5.7-8, 5.7-11	mNC	Maintain 10% cover of native shrubs and implement revegetation recommendations as specified in the AECOM (25 May 2023), Biosis (20 September 2023), Biosis (29 May 2024) and Biosis (10 March 2025) reports.
CWS Mgt Plan 4.2.5, 8-15, 8-17, 9 (Implementation Schedule) OMP 5.3.3, 5.7-9, 5.7-12	C-OFI	Request that the contractor managing weeds and pest animals provide a formal report of the control measures and works that that have been implemented.
CWS Mgt Plan 4.2.5, 8-15, 8-17, 9 (Implementation Schedule) OMP 5.3.3, 5.7-9, 5.7-12	mNC	Obtain from the contractor managing weeds and pest animals, copies of applicable licences to demonstrate that they are appropriately licenced to undertake the work and keep these files on record.

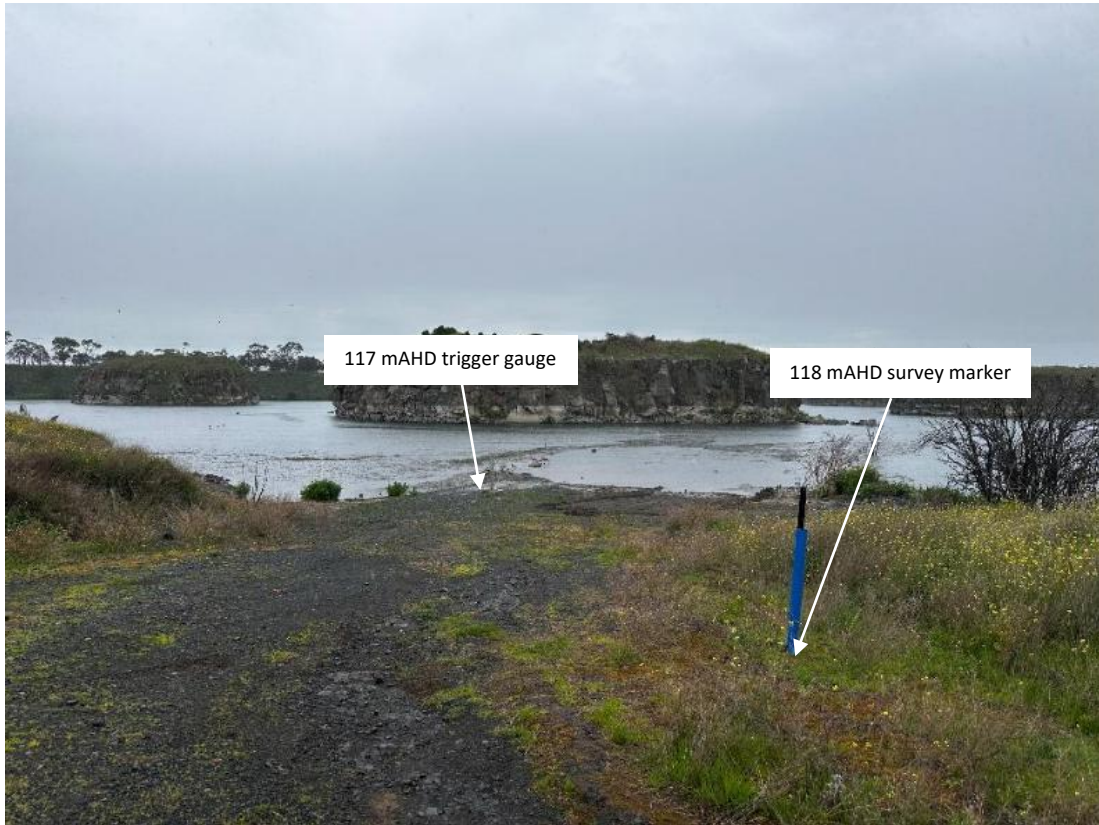
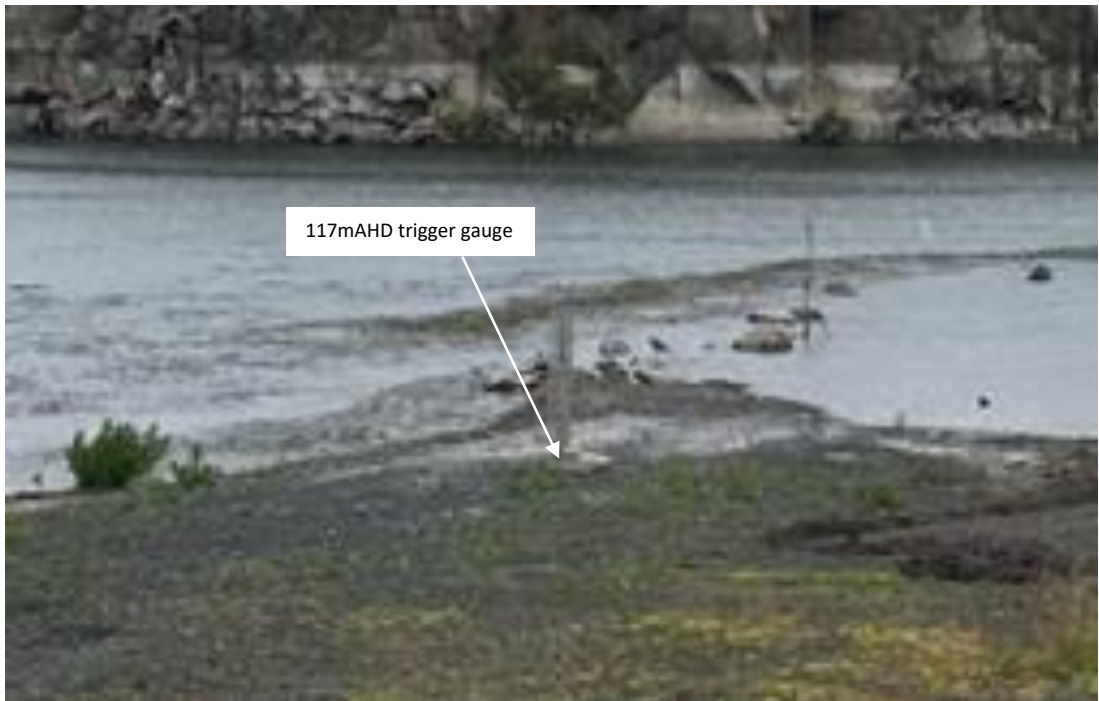
FIGURE 5: WATER LEVEL SURVEY MARKERS IN NORTHERN PITS

Holcim have placed two survey markers within the northern pits to assist in determining water levels. One marker is placed at 116.8 mAHD and another at 118 mAHD (**Figure 5**). As such water levels can be measured to determine whether they are approaching the 117 mAHD trigger level and whether they are below the 118 mAHD level as specified in the CWS Management Plan.

The auditor observed during the quarry inspection on Tuesday 26 August 2025 that the water level within the northern pit was below the 117 mAHD survey marker and below the 118 mAHD specified level in the 2021 CWS Management Plan.

<p>CWS Mgt Plan 4.2.4, 8-12, 8-14, 8-16, 9 (Implementation Schedule), OMP 5.2.4, 5.7-6, 5.7-8, 5.7-11</p>	<p>mNC</p>	<p>Maintain 10% cover of native shrubs and implement revegetation recommendations as specified in the AECOM (25 May 2023), Biosis (20 September 2023), Biosis (29 May 2024) and Biosis (10 March 2025) reports.</p>
<p>CWS Mgt Plan 4.2.5, 8-15, 8-17, 9 (Implementation Schedule) OMP 5.3.3, 5.7-9, 5.7-12</p>	<p>C-OFI</p>	<p>Request that the contractor managing weeds and pest animals provide a formal report of the control measures and works that that have been implemented.</p>
<p>CWS Mgt Plan 4.2.5, 8-15, 8-17, 9 (Implementation Schedule) OMP 5.3.3, 5.7-9, 5.7-12</p>	<p>mNC</p>	<p>Obtain from the contractor managing weeds and pest animals, copies of applicable licences to demonstrate that they are appropriately licenced to undertake the work and keep these files on record.</p>
<p>CWS Mgt Plan 4.2.5, OMP 5.3.2</p>	<p>mNC</p>	<p>Continue conducting monthly monitoring of water levels based on the water level gauge in the northern pits and keep records of the monthly monitoring.</p>

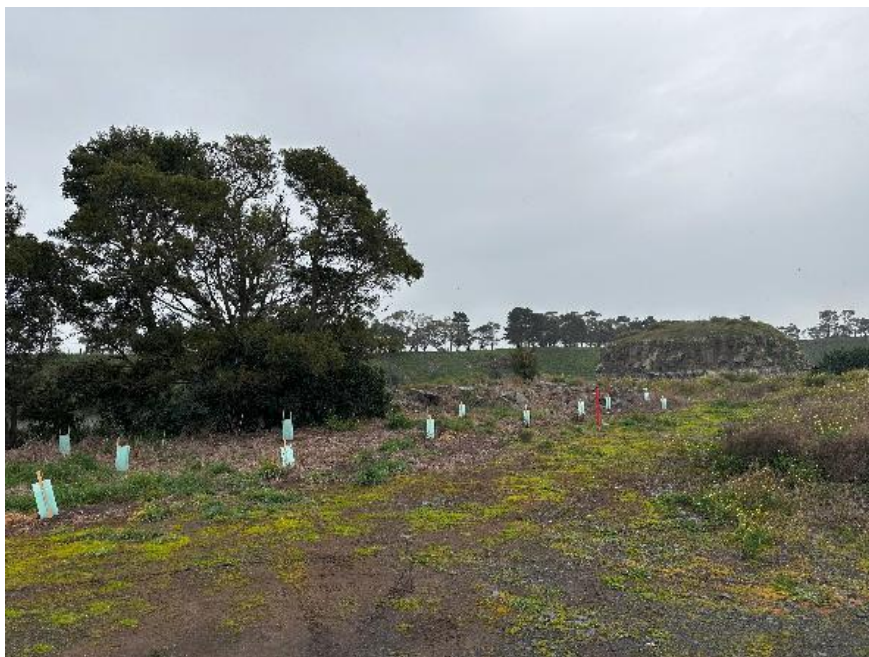
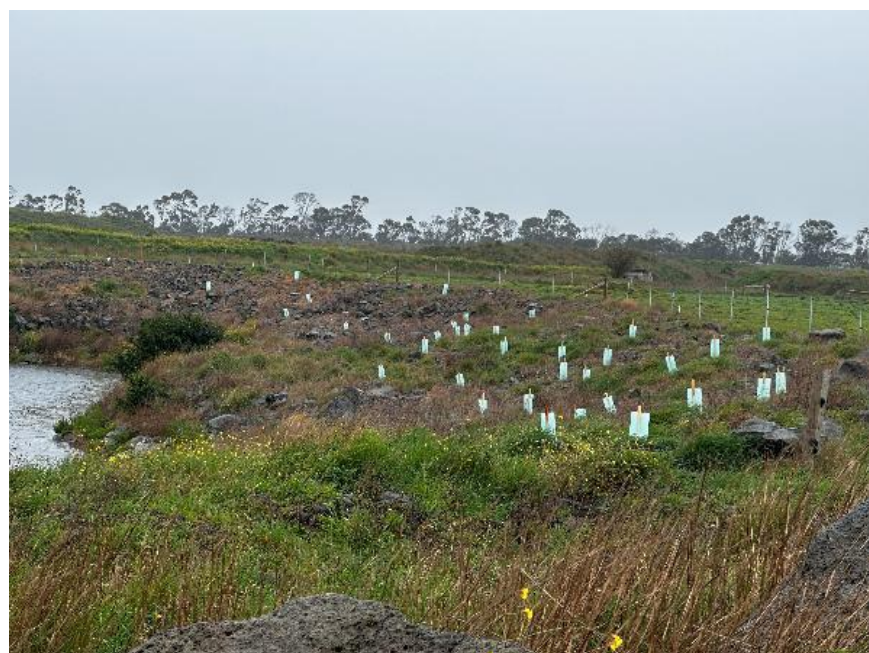
FIGURE 6: REVEGETATION AREAS

Revegetation plantings of inland margins of created habitat were evident from the visual inspection undertaken during the audit (**Figure 6**). However the 2023, 2024 and 2025 Biosis monitoring reports have identified that further work is needed to improve revegetation in created habitat. A 10% cover of native shrub cover was only partially observed during the 2022/23, 2023/24 and 2024/25 monitoring seasons.

Weed management targets are reported by suitably qualified ecologists (i.e. Biosis) to have been met during the 2022/23 monitoring season, only partially met during the 2023/24 monitoring season and fully met during the 2024/25 monitoring season.

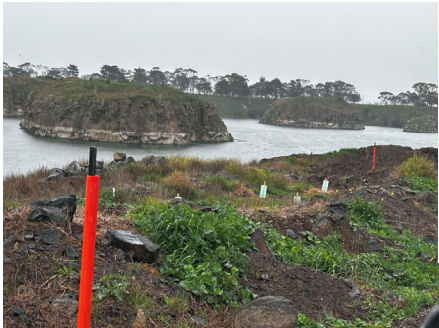
- Install measures to prevent rocks/earth from falling down the cliff face of the western edge of Stage 6 and covering areas of habitat which, although currently covered by water, may provide habitat again if the water level recedes.	Visual Inspection	A bund wall was observed at crest of the cliff face on the western edge of Stage 6 to prevent rocks/earth from falling down the cliff face.	C

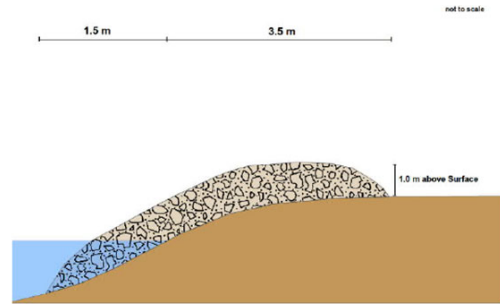
Figure 5 Conceptual drawing of habitat creation

4.2.4 Design					
	<p>Follow the description in Section 3.3.2 of Biosis Research (2007) and schematic in Figure 5 below which includes:</p>	Visual Inspection	Areas of created habitat were visually inspected on Tuesday 16 August 2025 as part of the audit and appeared to generally follow the description in section 3.3.2 of Biosis Research 2007 and schematic in Figure 5 (an example is shown in the photo below located on the northern bank of Basin 6).

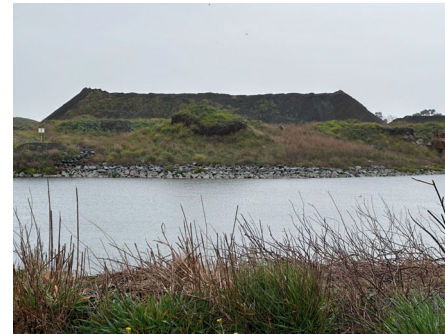
Use rock overburden from quarry operation (mix of some soil and mostly rock)	Visual Inspection	Rock overburden from the quarry operation was observed to have been used for habitat creation and was comprised of mostly rock.	C	
Create piles that are:	Visual Inspection	Piles appeared to be a minimum 25 lineal metres along the water edge	C	
<ul style="list-style-type: none"> - Minimum 25 lineal metre sections along the water edge spaced intermittently. - Minimum width of 5 metres: - Extending approximately 1.5 metres into the water. - Extending approximately 3.5 metres out of the water (Basin 4, Basin 6, Stage 6 rehabilitation) or approximately 1 metre above the 118m AHD water level on the bund between Basin 1 and Basin 3. - Average of 1 metre height of rock pile above ground surface level. - Comprised of a variety of rock sizes to create a high proportion of rock crevices as refugia for the skinks 	Visual Inspection	Piles appeared to have a minimum width of 5 metres, extended 1.5m into the water (noting that the water level was low during the visual inspection) and extending approximately 3.5m out of the water and approximately 1m above the 118 m AHD water level on the bund between Basin 1 and Basin 3. The piles also appeared to have an average height of 1m above ground surface and were comprised of a variety of rock sizes.	C

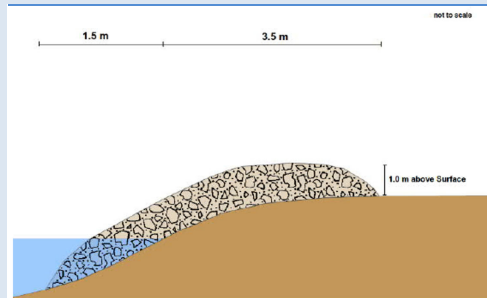
Figure 3 Conceptual drawing of habitat creation

Created habitat design will follow the description in Biosis Research (2007) and schematic in Figure 3 below which includes:

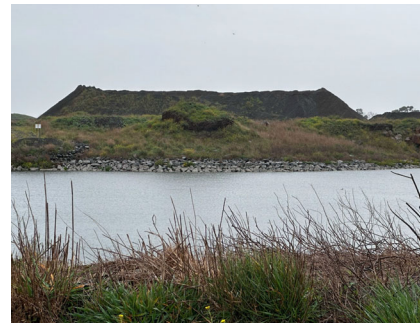
Areas of created habitat were visually inspected on Tuesday 16 August 2025 as part of the audit and appeared to generally follow the description in section 3.3.2 of Biosis Research 2007 and schematic in Figure 5 (an example is shown in the photo below located on the northern bank of Basin 6).

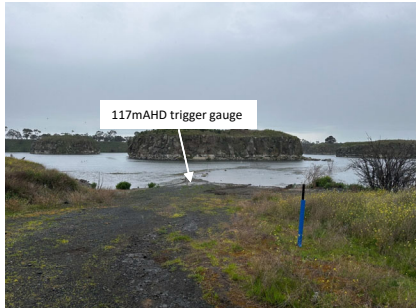
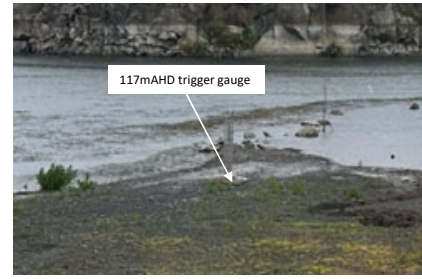
<p>5.3.2 Water Levels</p>			
<p>Water levels in the northern pits will be monitored to ensure they do not exceed the predicted maximum of 118 mAHD. The following measures will be implemented:</p>	<p>WSP - Surface water and Groundwater Monitoring Reports - March 2023, Sept 2023, March 2024, September 2024, March 2025</p>	<p>The March 2023, Sept 2023, March 2024 and Sept 2024 water monitoring reports revealed water levels in Basins 1, 2 and 3 of >116.4 mAHD, >116 mAHD and >116 mAHD respectively (except for Basin 3 in March and Sept 2024 which had a recorded water level of between 116 to <116.8 mAHD).</p> <p>The March 2025 water monitoring report revealed water levels in Basins 1, 2 and 3 of 116.3 mAHD, >116 mAHD and between 116 to <116.8 mAHD respectively).</p> <p>Whilst water levels in the northern pit are being recorded on a biannual basis, it is considered that the current reporting approach applied by the consultant is predominantly for the purpose of determining water volumes within the northern pit. As such additional records should be included in the biannual reports to clearly specify whether the water in the northern pits has reached the 117 mAHD trigger level and if the water is below the 118 mAHD specified level in the 2021 CWS Management Plan.</p>	<p>Request that the consultant undertaking the biannual water level monitoring in the northern pits, clearly specify whether the water in the northern pits has reached the 117 mAHD trigger level and/or if the water is below the 118 mAHD specified level in the 2021 CWS Management Plan.</p> <p>mnc</p>

<ul style="list-style-type: none"> • Monthly monitoring of water levels based on the water level gauge in the northern pits during Stage 5 and Stage 6 operations. 		<p>It is acknowledged that in February 2025, Holcim also commenced its own monthly recording of water levels in the northern pit, however monthly water level monitoring was not undertaken throughout the entire audit period.</p>	<p>Continue conducting monthly monitoring of water levels based on the water level gauge in the northern pits and keep records of the monthly monitoring.</p> <p>mnc</p>
<ul style="list-style-type: none"> • Setting of a trigger level of 117 mAHD for the Quarry Operator to initiate an evaluation of the rate of groundwater dewatering and remaining pit life of Stage 5 and Stage 6. 	<p>Visual inspection</p>	<p>A trigger gauge of 117 mAHD was observed in the northern pits (refer to photo below) during the visual inspection</p>
