ENVIRONMENTAL MANAGEMENT PLAN ANNUAL AUDIT REPORT

**Holcim Pakenham Quarry,
95 Mt Shamrock Road, Pakenham, VIC**

March 2024

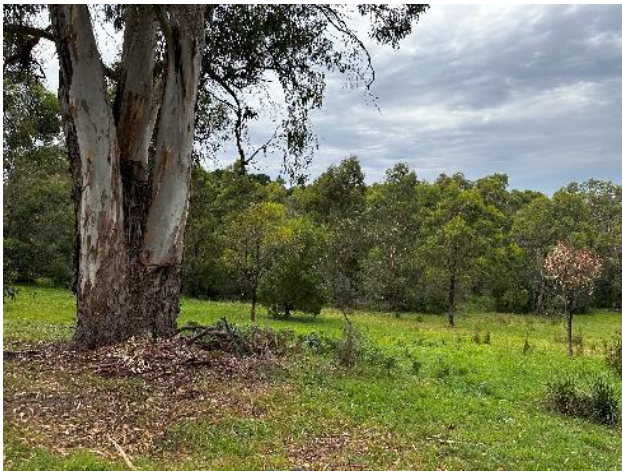
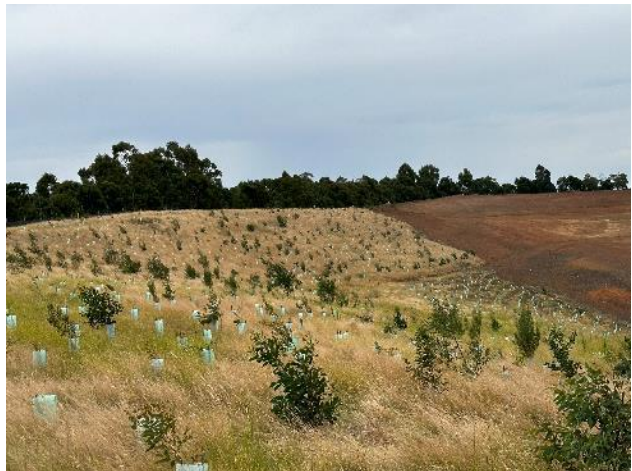
FIGURE 1: ESTABLISHED AND NEW PROGRESSIVE REHABILITATION AREAS ON SOUTH WESTERN FACE

- Excellent management, engagement and awareness of Env issues and risks at the quarry across all levels (i.e. Quarry Mgr, Quarry Supervisor, Plant operator)
- No environmentally related and justified complaints were received/recorded;
- Recommendations from the previous audits have been actioned, or appropriately deferred for future action as required;
- Rehabilitation areas within the quarry, on the outside western and southern slopes, and in the Net Gain Offset areas are progressing well. Vegetation management has responded and adapted appropriately to site conditions through species selection (use of more dry resistant species) and planting strategy (timing, spacing on slope) (**Figure 1**);

Holcim is to be commended for its progressive rehabilitation efforts and associated management program undertaken by Naturelinks. Progressive rehabilitation in many areas is now well established (**Figure 1**). It is recommended that Holcim progress the recommendations provided in the 2023 Naturelinks report.

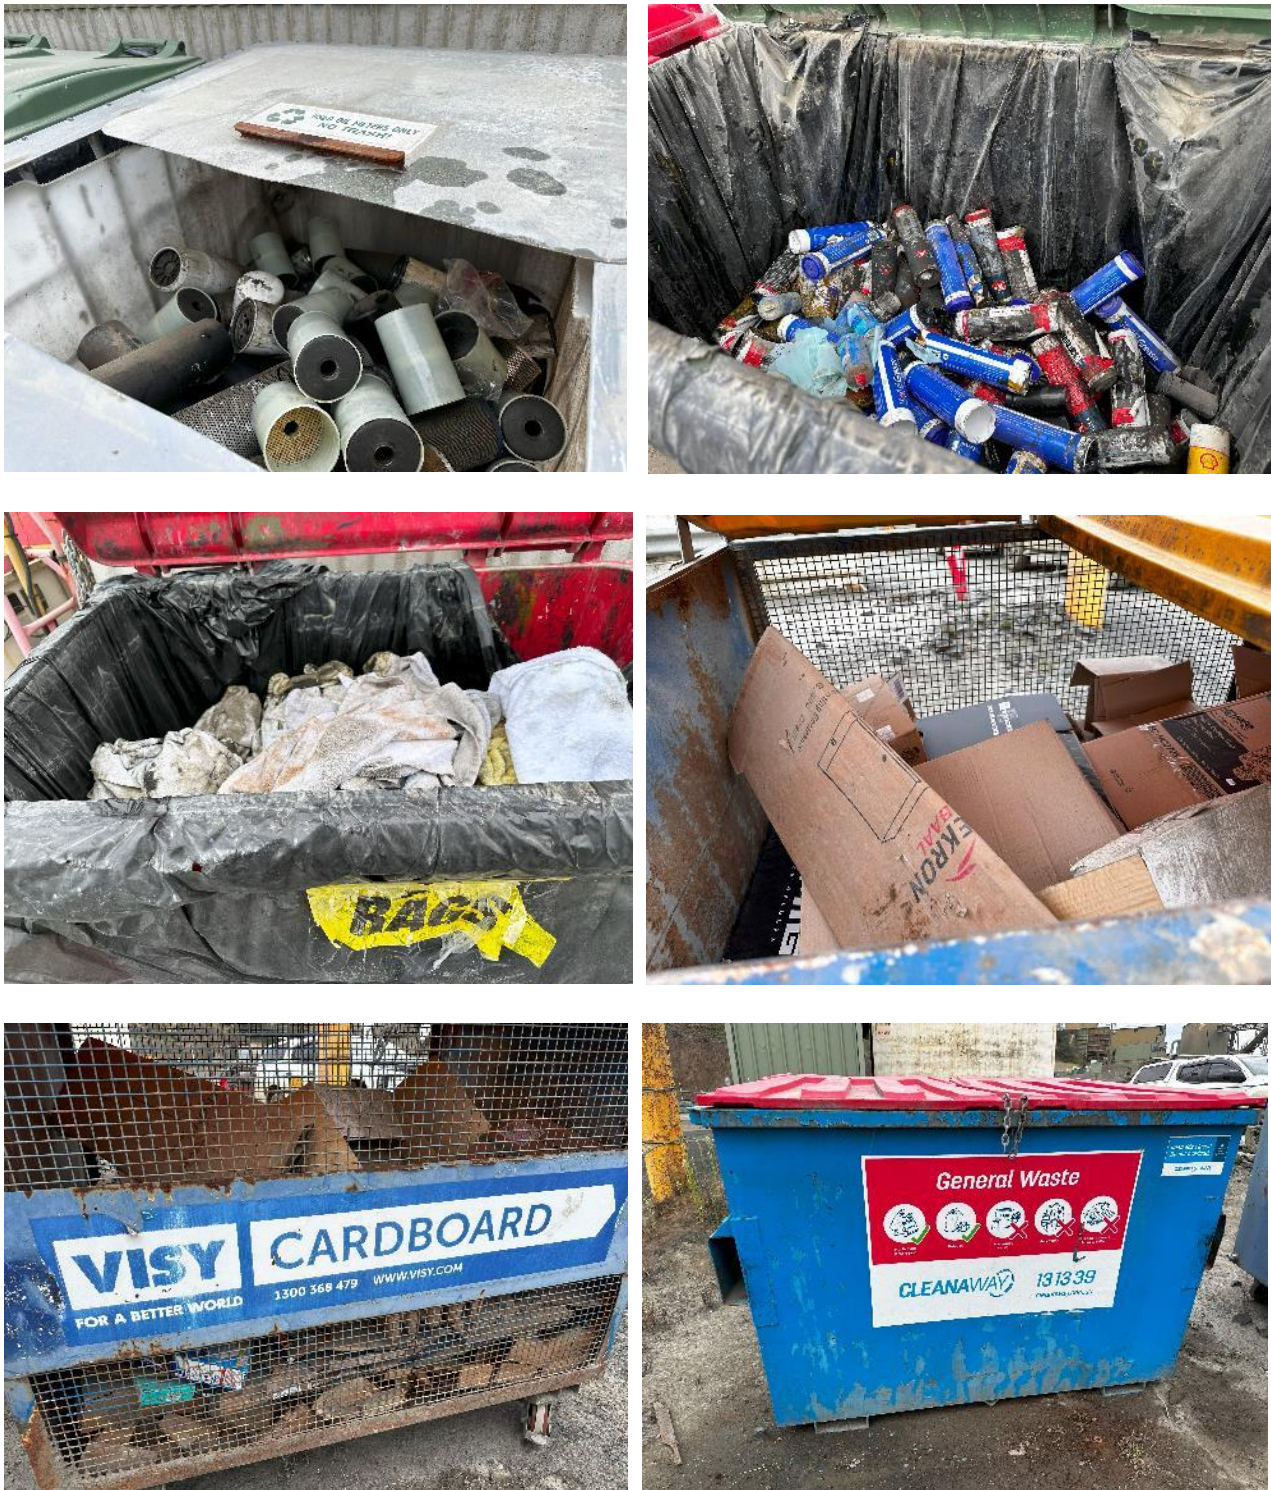
FIGURE 2: EXAMPLES OF GOOD WASTE MANAGEMENT PRACTICE AND SEGREGATION

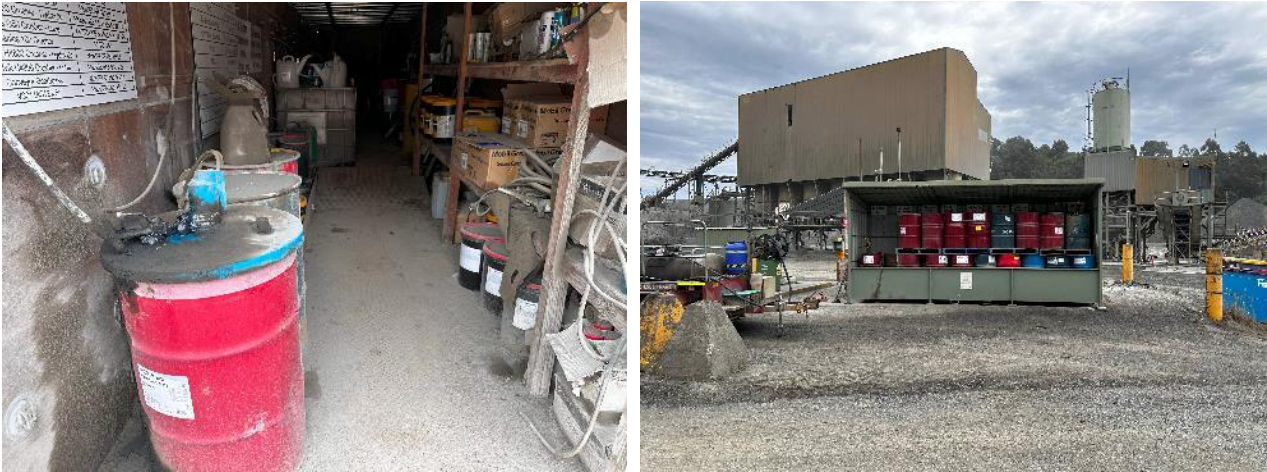
FIGURE 3: GOOD CHEMICAL, FUEL AND OIL STORAGE PRACTICES

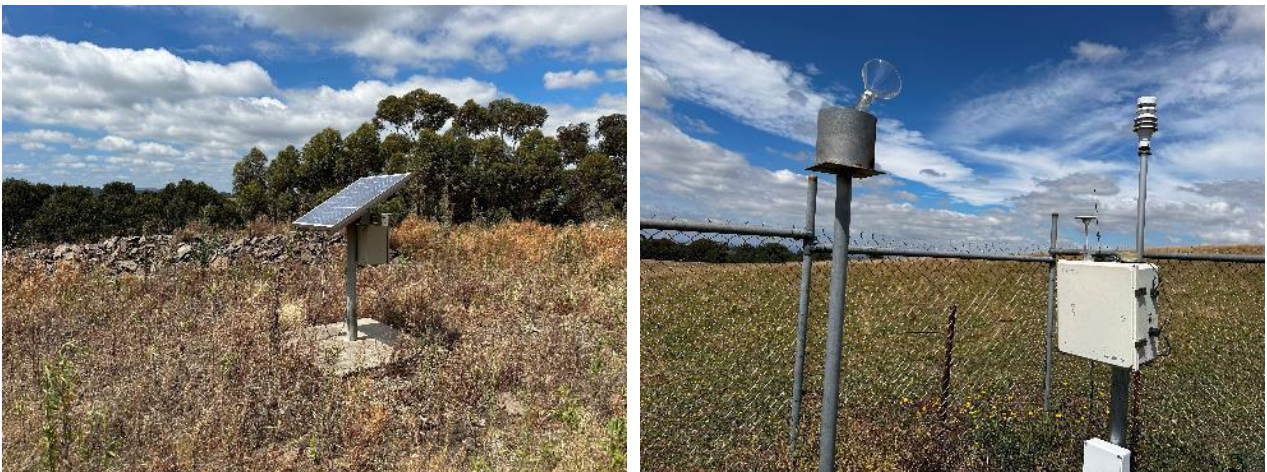
- Progressive replacement and update of the dust particulate monitoring equipment which showed significant 'outages' and data gaps during the audit period (**Figure 4**);

FIGURE 4: UPDATE OF WEATHER STATION AND MONITORING EQUIPMENT

Holcim experienced some technical problems with its air quality monitoring network, particularly operability problems were experienced with reactive monitors leading to PM10 data gaps in January, February, March and July 2023 at the A4 Pony Club, A3 Farmhouse and A6 Waterhouse property respectively. Quarry management have progressively replaced the continuous dust monitoring equipment (**Figure 4**) throughout the audit period resulting in accurate data now being recorded and there appeared to be no further loss of monitoring data through the remainder of the audit period.

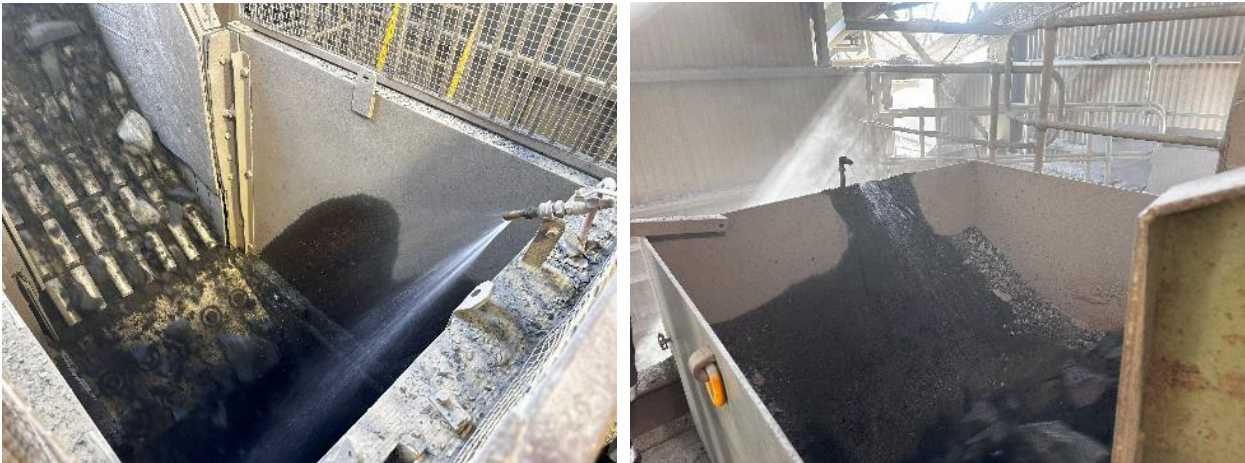
FIGURE 5: WATER SPRAYS OPERATING ON CRUSHING PLANT

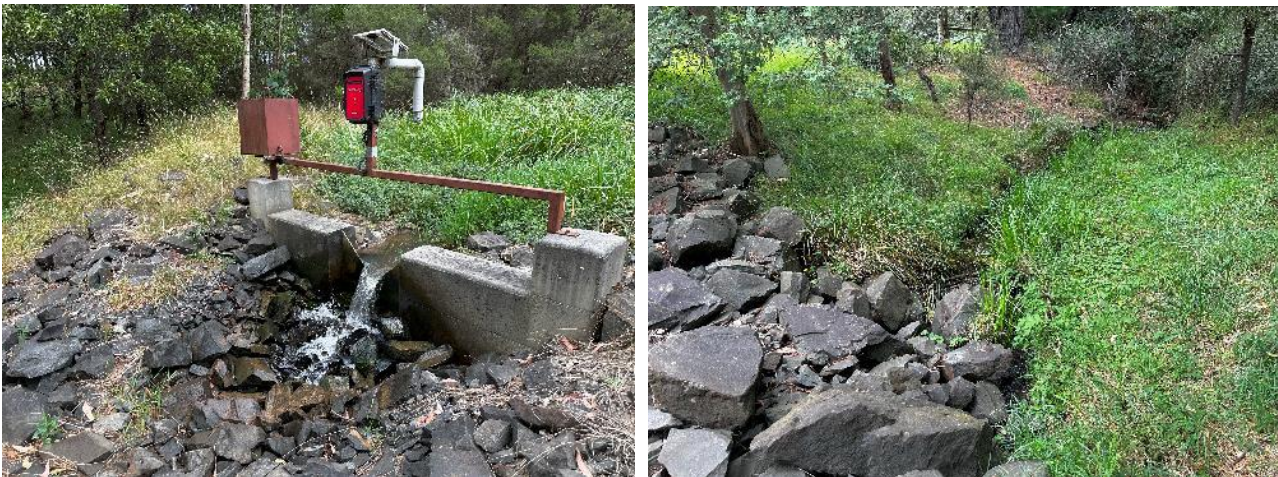
Surface water run-off from the quarry discharges to the environment via a licenced discharge point (under EPA Operating licence #OL000000544) located at the V-notch weir downstream of Donnazan's Dam (Monitoring Station W, Figure 1, *Environmental Monitoring Stations*, EMP Appendix 11) (**Figure 6**). The surface water comprised run off from adjacent farm paddocks and vegetated land and quarry run off water discharged from Donnazan's Dam.

FIGURE 6: SURFACE WATER EPA LICENCED DISCHARGE POINT

As such, it is recommended that Holcim progress the feasibility investigation for the installing of the larger pump including an assessment on what impacts that would have on the integrity of Donnazan's Dam and also consider undertaking a Hydrological Assessment to better understand catchments volumes within the quarry and capacity needed to allow for

To assist in the management of surface water run-off during significant rain events it is also recommended that Holcim include a process for the activation of pumps to manage water discharge from dams in a severe weather event to the site specific work procedure 'Management of severe weather event PAKSWP87 Rev2 Reviewed 06/10/22'.

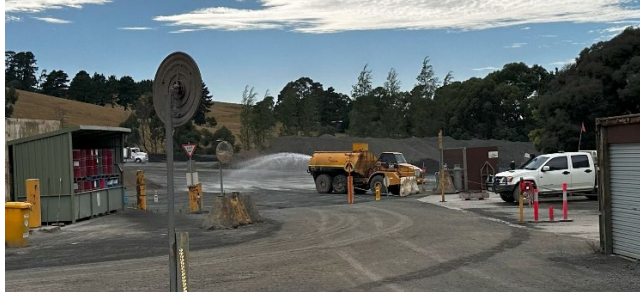
2.1.3	Management Measures - Actions Dust emissions from unpaved surfaces are to be controlled using the following measures: Wet suppression - all dust generating areas such as site roads will be watered, as required, to suppress dust during operation.	Observation – truck observed in action.	Sighted use of water cart during quarry operations (Photo 1). PHOTO 1: WATER CART IN USE

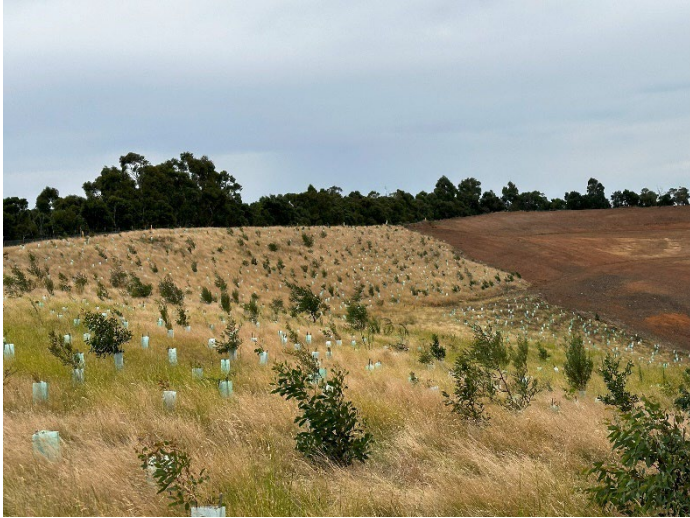
EMP SECTION	EMP REQUIREMENT – SUMMARY	AUDIT EVIDENCE	AUDITOR'S FINDINGS & COMMENTS	COMPLY*	RECOMMENDATION
During clearing	Revegetation of exposed surfaces, including the following measures:	Observation; photographs 2023 Holcim Mt Shamrock Rehabilitation Report	See LRMP (Appendix 6) Sighted results of topsoil stripping from the NW face to the SW face ready for next stage of progressive rehabilitation (Photo 4)	C	
All times	▪ Vegetation and topsoil removal will be limited to the smallest practicable area and revegetated as soon as possible following clearance;		PHOTO 4: TOPSOIL PLACEMENT (BACKGROUND) READY FOR NEXT STAGE OF PROGRESSIVE REHABILITATION		
All times	▪ Soil stockpiles will be allowed to self-seed when left for extended periods of time;

LRMP	▪ The extent of areas prone to erosion will be restricted wherever possible;		Windrow of topsoil along rim of quarry. Vegetated naturally.

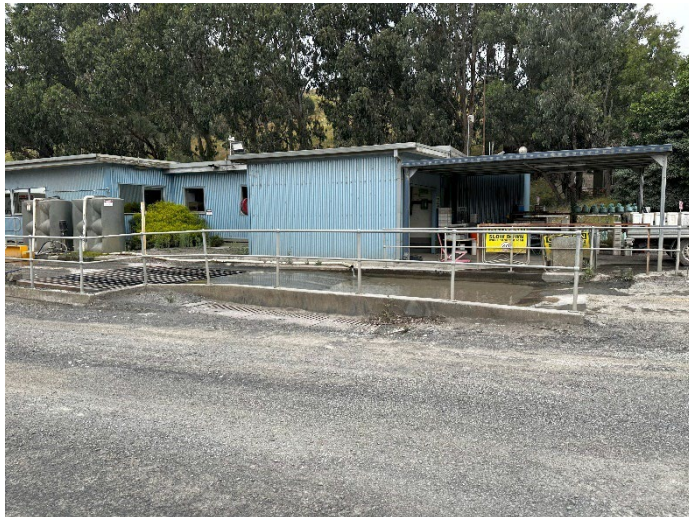
All times	All road registered vehicles that cart quarried materials shall be covered by suitable tarpaulins or enclosed blinds prior to leaving the quarry and entering public roadways.	Observation; Quarterly Report to ERC (tarping checks)	Periodic checks are made of vehicles.	C	
All times	All road registered vehicles delivering quarry products or additives to or from the site, will pass through the wheel wash facility prior to leaving the quarry and entering public roadways.	Observation	Wheel wash was observed to be in operation during the audit (Photo 5). PHOTO 5: WHEEL WASH IN USE

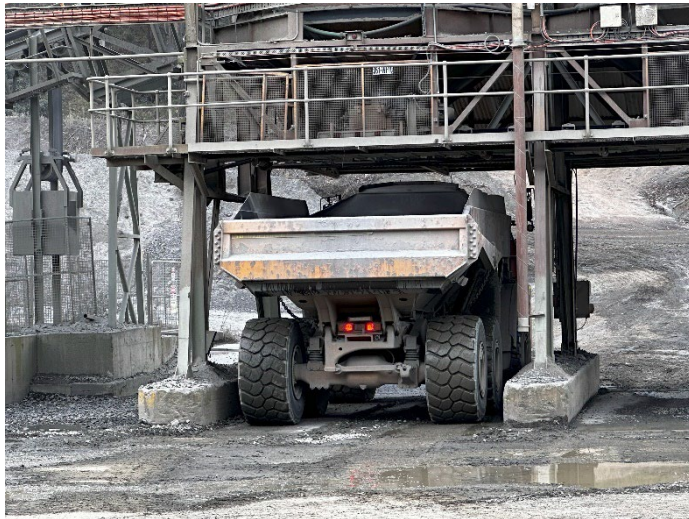
All times	Dust emissions from conveyors will be minimised by: <ul style="list-style-type: none"> Minimising drop heights; and Appropriate design of hopper load systems to ensure a good fit with trucks, and use of appropriate enclosures for hoppers. 	Observation; Monthly sprinkler inspection records (sample); Weekly Running Inspections – sample sighted.	Monthly inspections of sprinklers conducted. Weekly running inspection of primary-secondary crusher plant includes spray function. Auditor attended at control room and discussed the issue with controller. Dust generation is visualised on screens and sprays activated when dust is excessive. Crushing and transfer activities are closely monitored at all times.	C	Refer to above recommendation on tertiary crusher conveyor.
All times	Dust emissions during material handling will be minimised by: <ul style="list-style-type: none"> Minimising drop heights; Regularly cleaning up any spillages; and Appropriate design of hopper load systems to ensure a good fit with trucks, and use of appropriate enclosures for hoppers. 	Observations; photographs.	<p>Loading observed – minimal dust emissions occurred (Photo 6).</p> <p>PHOTO 6: LOADING WITH MINIMAL DUST DUE TO USE OF RING SPRAYS</p>

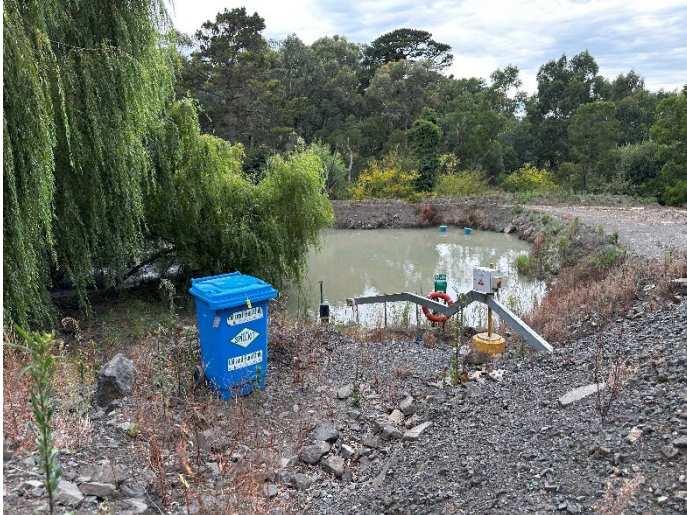
EMP SECTION	EMP REQUIREMENT – SUMMARY	AUDIT EVIDENCE	AUDITOR'S FINDINGS & COMMENTS	COMPLY*	RECOMMENDATION
Every 12 months	Sediment in the settlement ponds is removed at least once every 12 months and stockpiled within other areas of the quarry.	Invoice, MC Earthmoving	<p>Sediment was removed from 'dam' (this was clarified to mean one or other of the settlement ponds, not Donazzan's Dam) in March 2022 (Photo 7).</p> <p>PHOTO 7: SEDIMENT REMOVED FROM DAM</p>

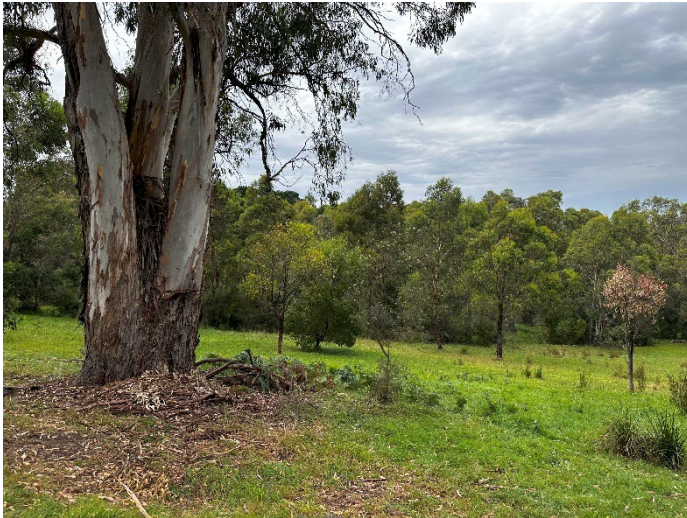
2.8.2	Target Establishment of vegetation in accordance with the Native Vegetation Management Framework and the Net Gain Offset Management Plan (NGOMP, Biosis Research, September 2007 – Appendix 13) by January 2009 (as specified in the s.173 Agreement)		<p>NGO areas have been established and are being well maintained by Naturelinks (Photo 8). Weeding and maintenance has continued.</p> <p>PHOTO 8: NET GAIN OFFSET AREA WELL ESTABLISHED</p>

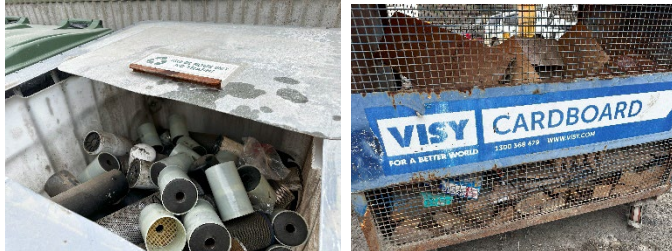
2.12.3	Management Measures				
Timing	Action				
June 2008	Characterise all waste streams and develop measures to: <ul style="list-style-type: none"> minimise site waste generation; segregate waste groups; and direct landfilled wastes to recycle/re-use wherever possible 		Sighted segregation of waste groups during the audit and use of designated bins for various types of wastes (Photo 9). Sighted bins for recycled materials e.g. cardboard etc PHOTO 9: GOOD SEGREGATION OF WASTES

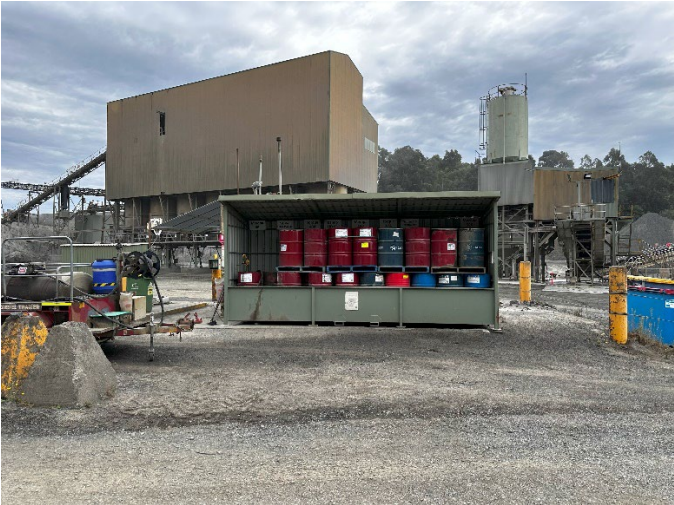
2.14.3	Management Measures				
All times	Signage will be maintained around bunded fuel tanks describing the filling procedure to be followed.	Observation		C	
All times	All fuels and chemicals in containers over 100 litres will be bunded when stored or in use.	Observation; Photograph	Measure met at maintenance depot and contractor’s container in quarry (Photo 10). PHOTO 10: EXAMPLE OF BUNDED STORAGE OF FUEL, OILS AND CHEMICALS	C

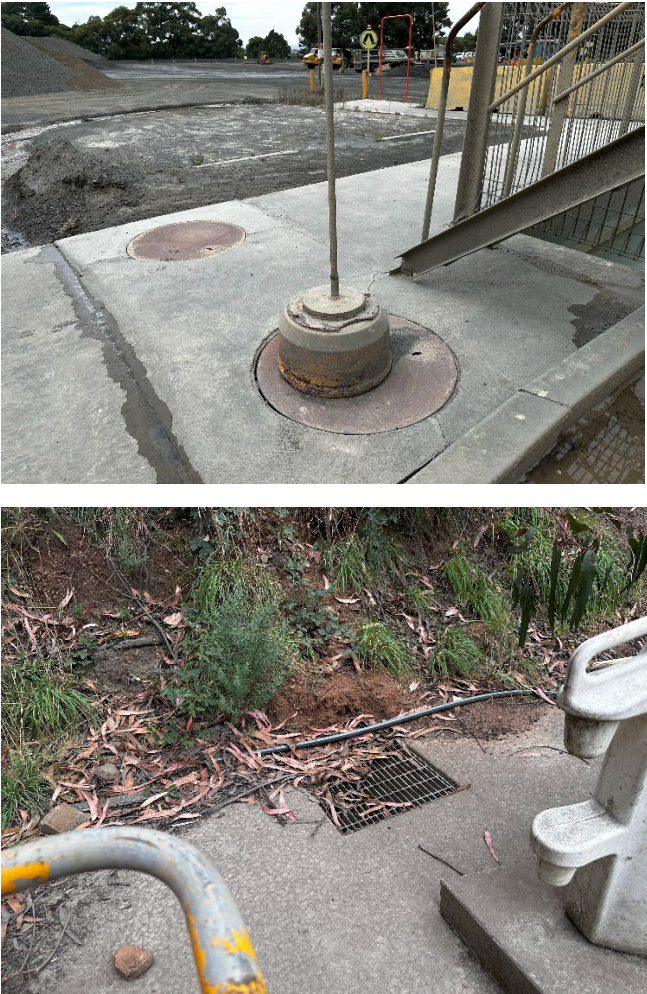
EMP SECTION	EMP REQUIREMENT – SUMMARY	AUDIT EVIDENCE	AUDITOR'S FINDINGS & COMMENTS	COMPLY*	RECOMMENDATION
As required	Captured rainwater within fuel/oil storage bunds will be released through triple interceptor prior to release to the stormwater system.	Observation	<p>Advised that bunded fuel trailer collects water that is manually discharged through T.I.T (Photo 11). Bunds are enclosed or roofed.</p> <p>PHOTO 11: TRIPLE INTERCEPTORS USED AT SITE</p>

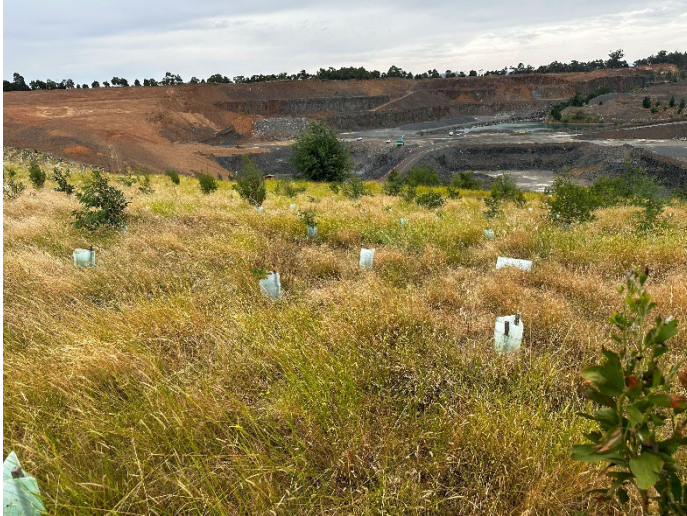
1.2	Targets Successful establishment and maintenance of landscape screening and rehabilitation in accordance with the Work Plan attachment <i>Landscape and Rehabilitation Report, ERM</i> (January 2005) and the <i>Landscape & Rehabilitation Management Plan, 2007</i> , (LRMP) to the satisfaction of the ERR and the Responsible Authority. Maintenance of existing vegetation where practicable.	Observation - Photographs; Mt Shamrock Rehabilitation Report, 2023 (Naturelinks)	Targets have been met – quarry rehabilitation planting is progressing as planned (Photo 12). LRMP has been reviewed and revised as specified below. PHOTO 12: EXAMPLE OF QUARRY REHABILITATION PLANTING

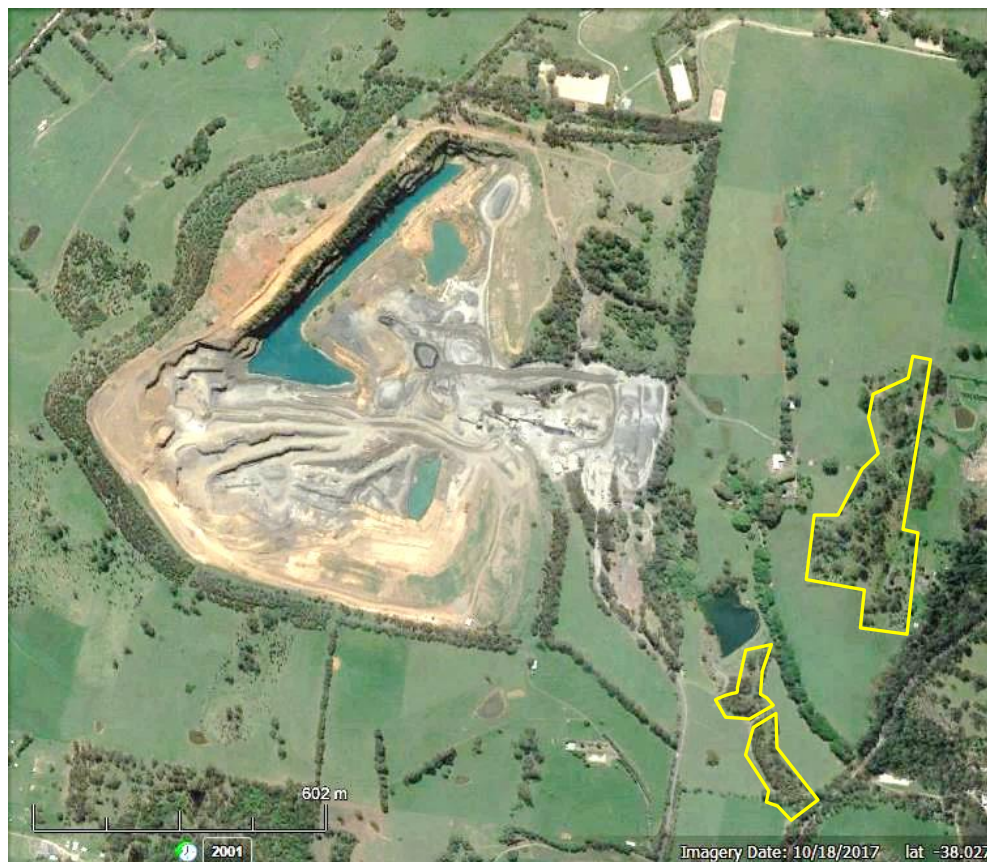
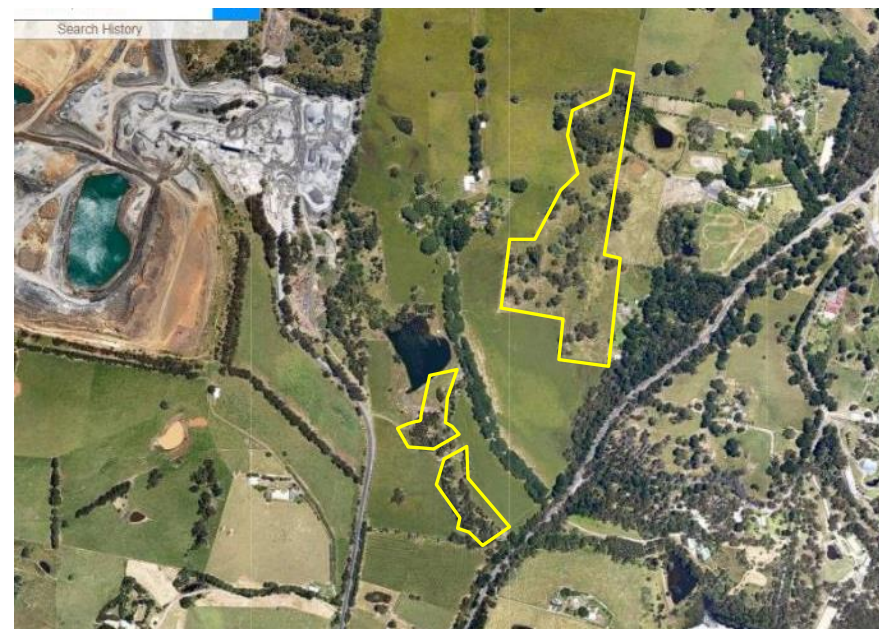
PHOTOGRAPH 7: OCTOBER 2017 (ABOVE). NET GAIN OFFSET AREAS ARE SHOWN OUTLINED IN YELLOW. FOR COMPARISON, THE PHOTO OPPOSITE IS FROM JAN 2014.

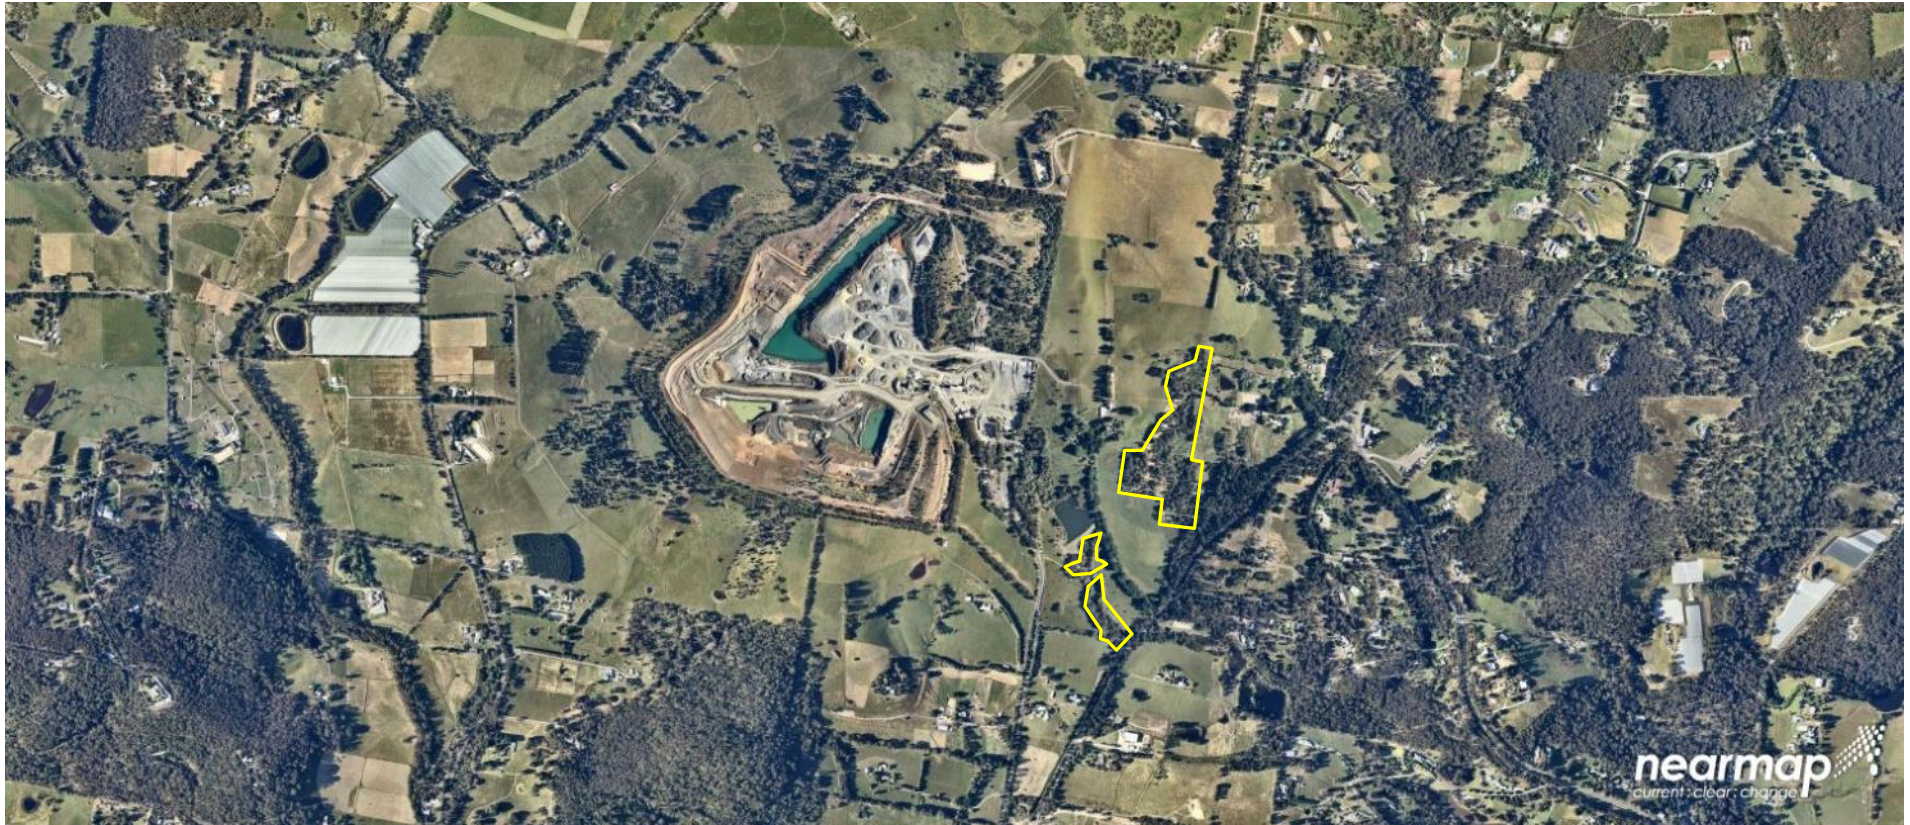
PHOTOGRAPH 10: DECEMBER 2020 (NET GAIN OFFSET AREAS SHOWN WITH YELLOW BORDERING)

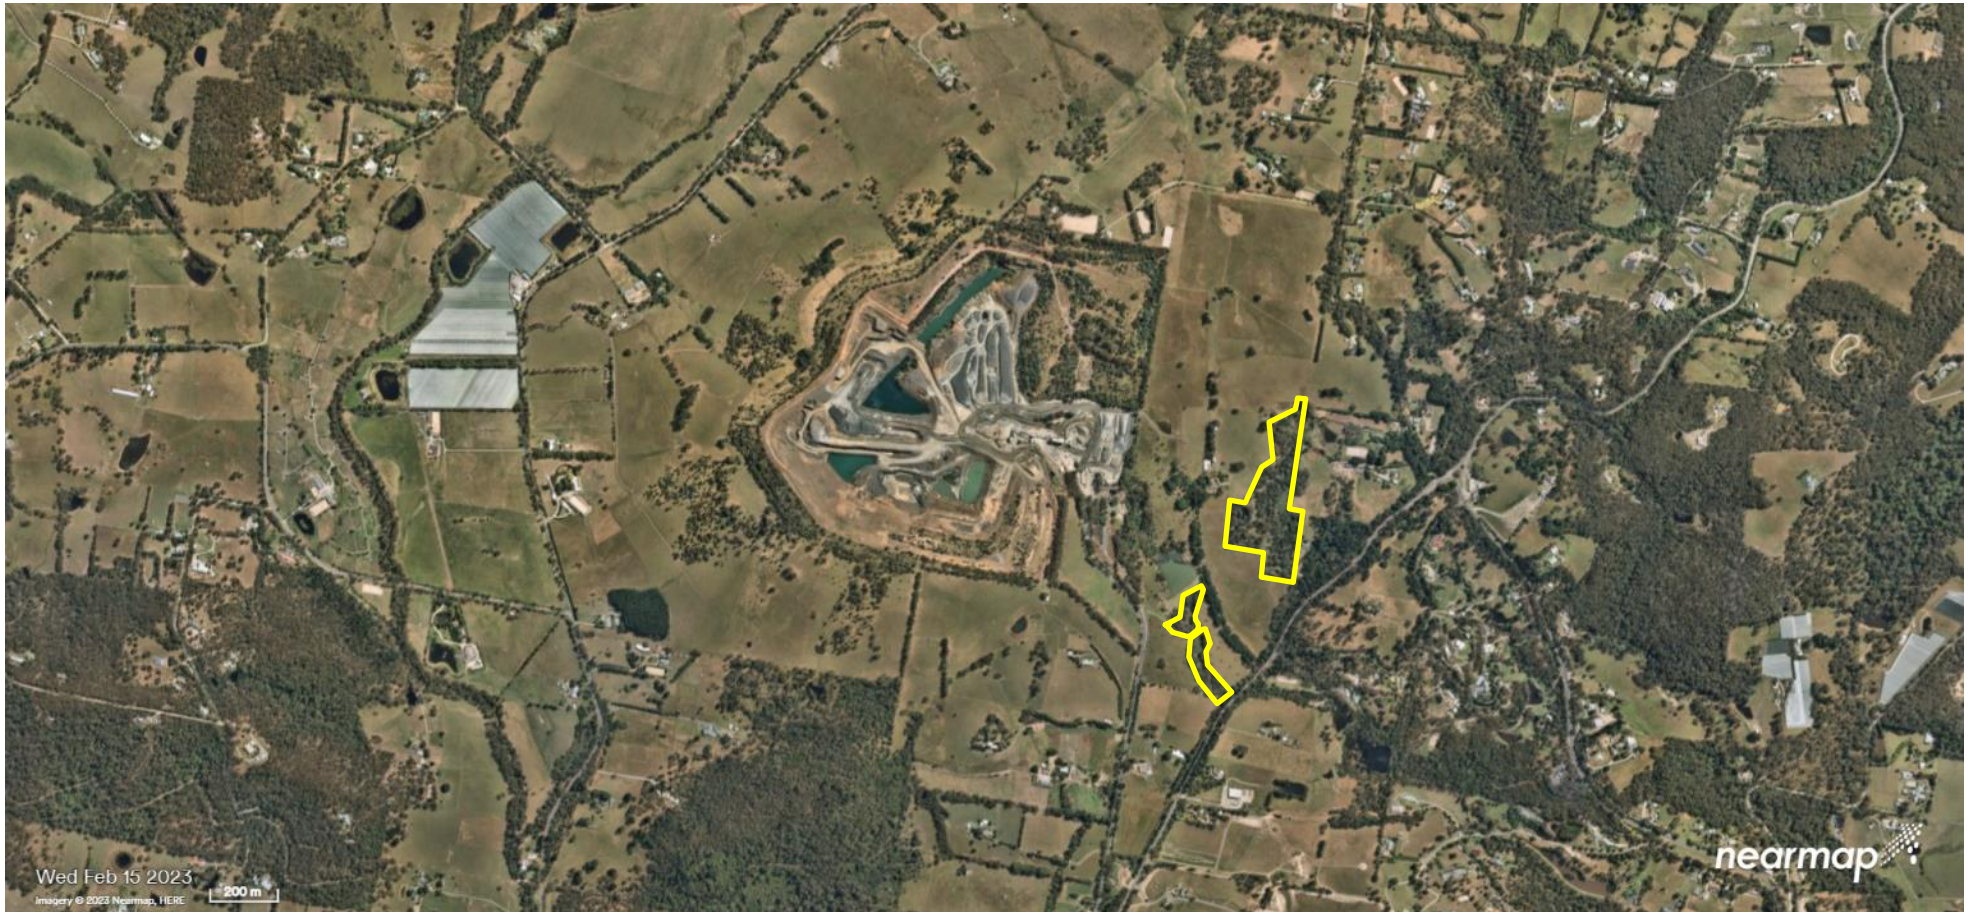
PHOTOGRAPH 11: DECEMBER 2021 (NET GAIN OFFSET AREAS SHOWN WITH YELLOW BORDERING).

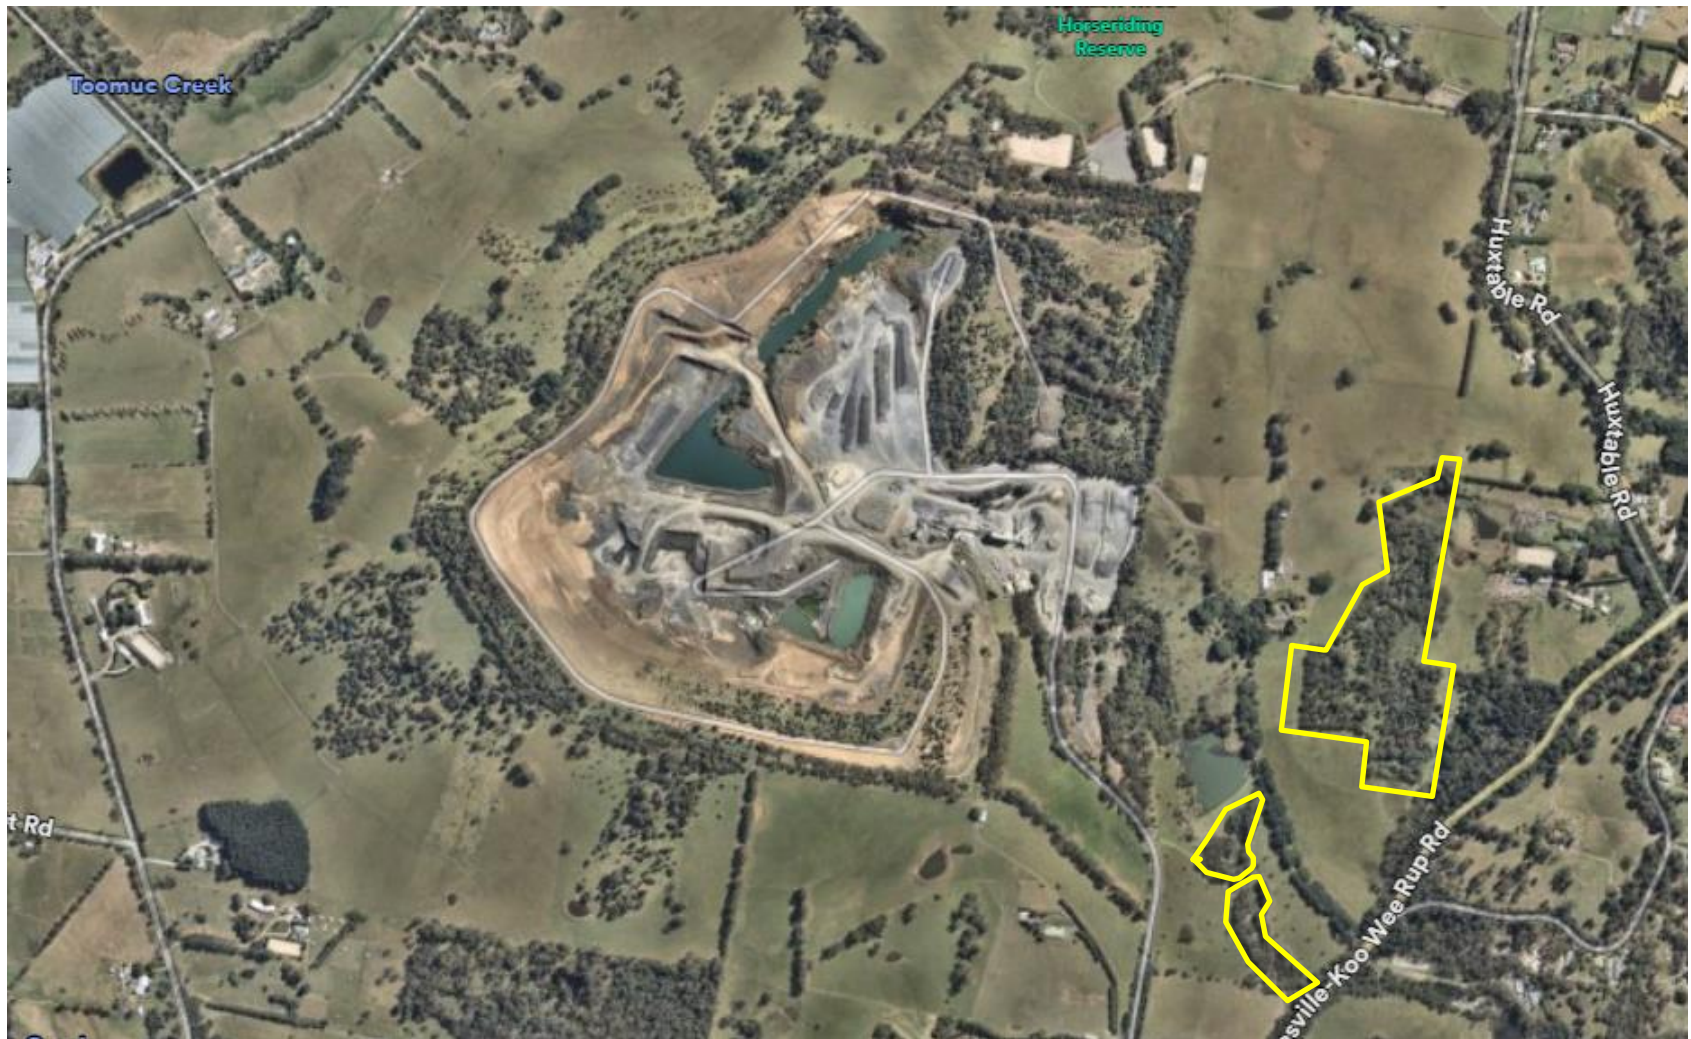
PHOTOGRAPH 12: FEBRUARY 2023 (NET GAIN OFFSET AREAS SHOWN WITH YELLOW BORDERING).

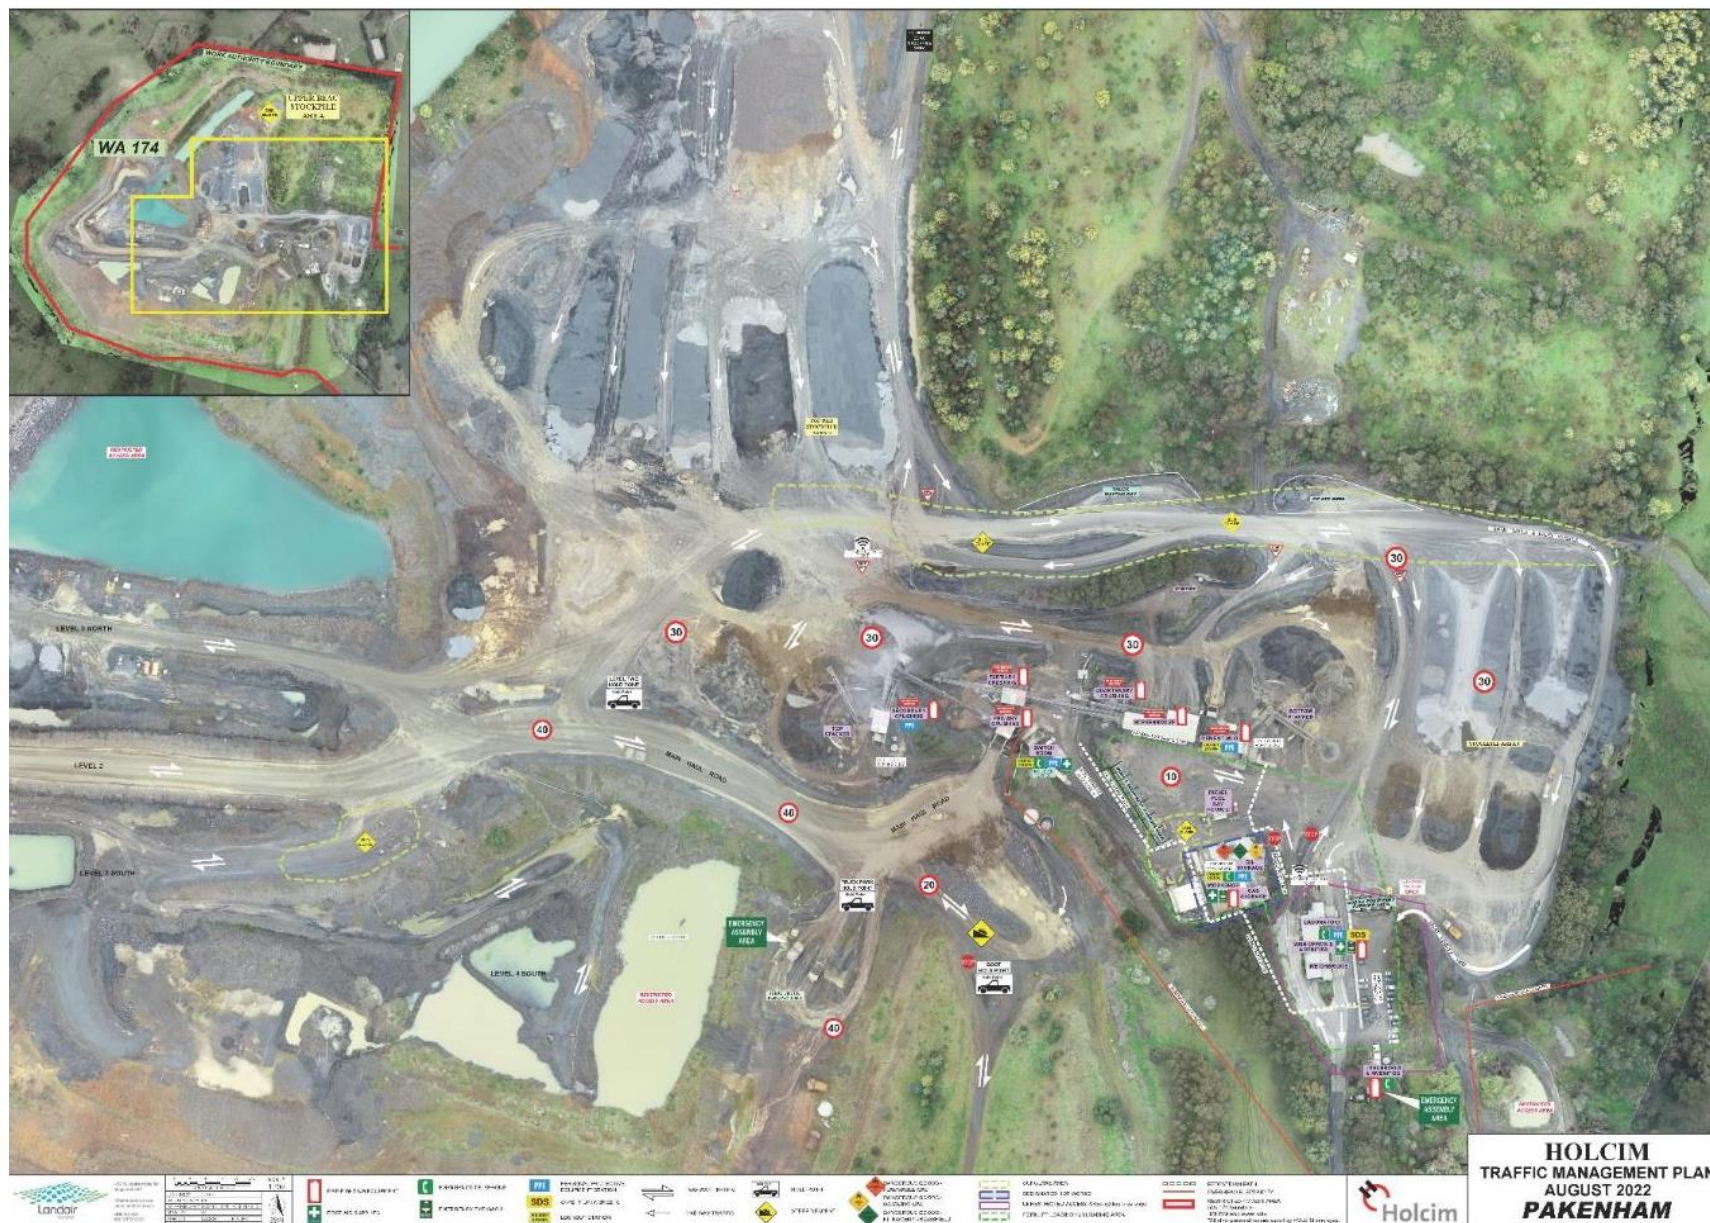
PHOTOGRAPH 13: FEBRUARY 2024: NET GAIN OFFSET AREAS SHOWN WITH YELLOW BORDERING
