ENVIRONMENTAL MANAGEMENT PLAN ANNUAL AUDIT REPORT

**Holcim Pakenham Quarry,
95 Mt Shamrock Road, Pakenham, VIC**

February 2025

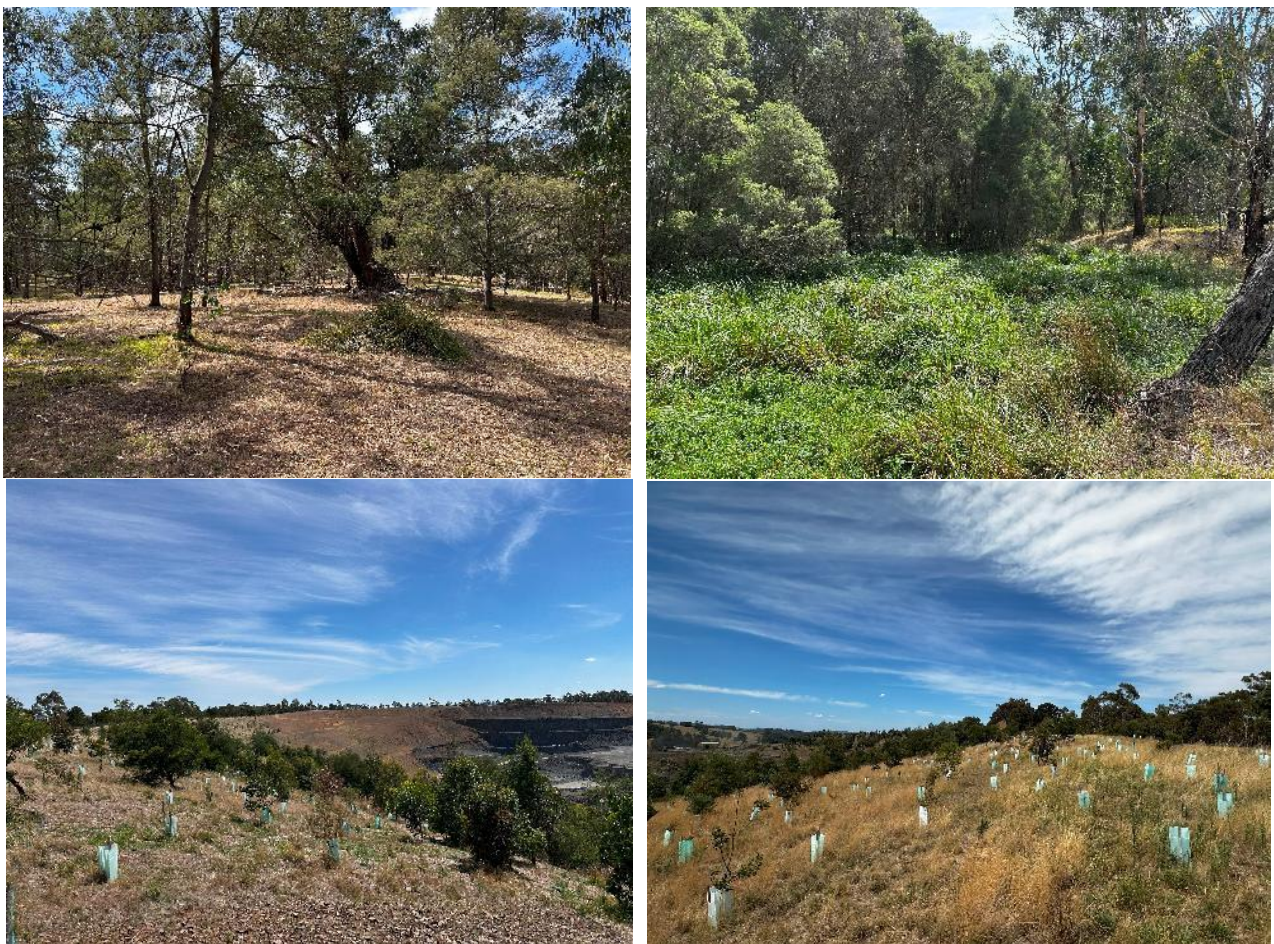
FIGURE 1: ESTABLISHED AND NEW PROGRESSIVE REHABILITATION AREAS ON SOUTH WESTERN FACE

Holcim is to be commended for its progressive rehabilitation efforts and associated management program undertaken by Naturelinks. Progressive rehabilitation in many areas is now well established (**Figure 1**). It is recommended that Holcim progress the recommendations provided in the 2024 Naturelinks report.

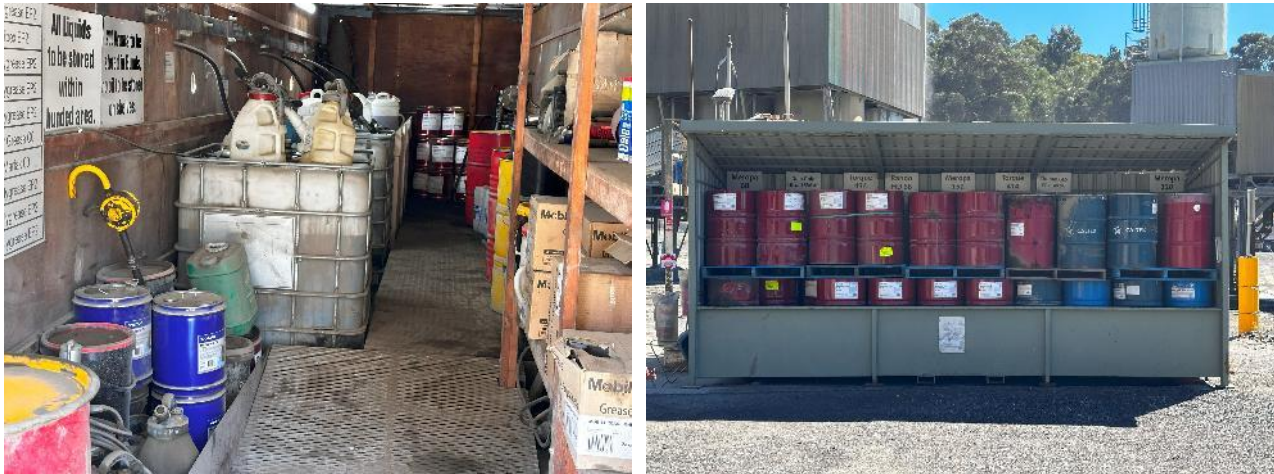
FIGURE 3: GOOD CHEMICAL, FUEL AND OIL STORAGE PRACTICES

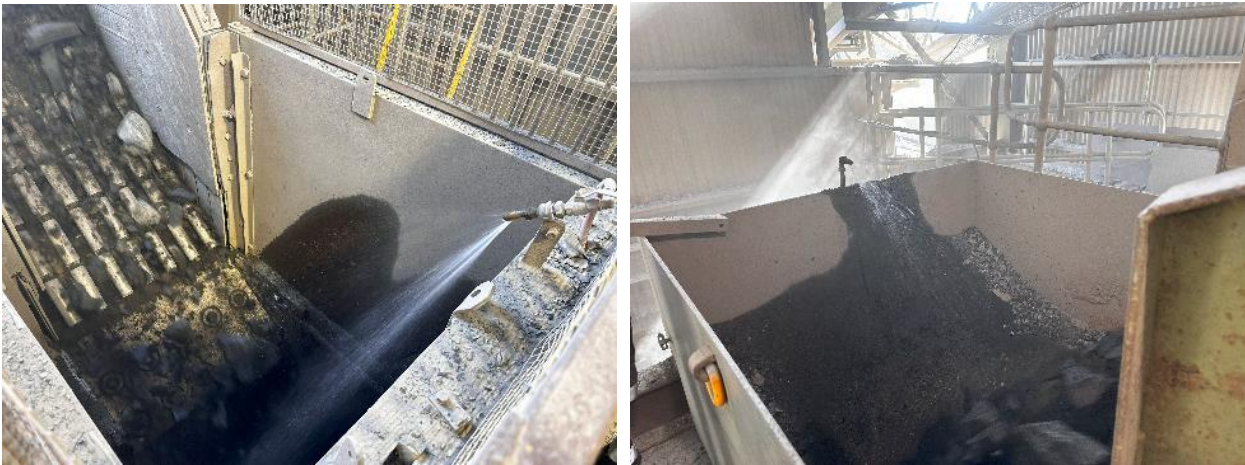
Commendably, a system continues to be in place whereby the quarry manager now receives real time notification should the continuous monitoring equipment record an exceedance for PM10 of $64 \mu\text{g}/\text{m}^3$. The quarry plant operator also indicated that they maintain a visual check of visible dust levels during crushing operations. Water sprays were also observed to be readily applied during the audit to assist with nuisance dust mitigation (**Figure 4**).

FIGURE 4: WATER SPRAYS OPERATING ON CRUSHING PLANT

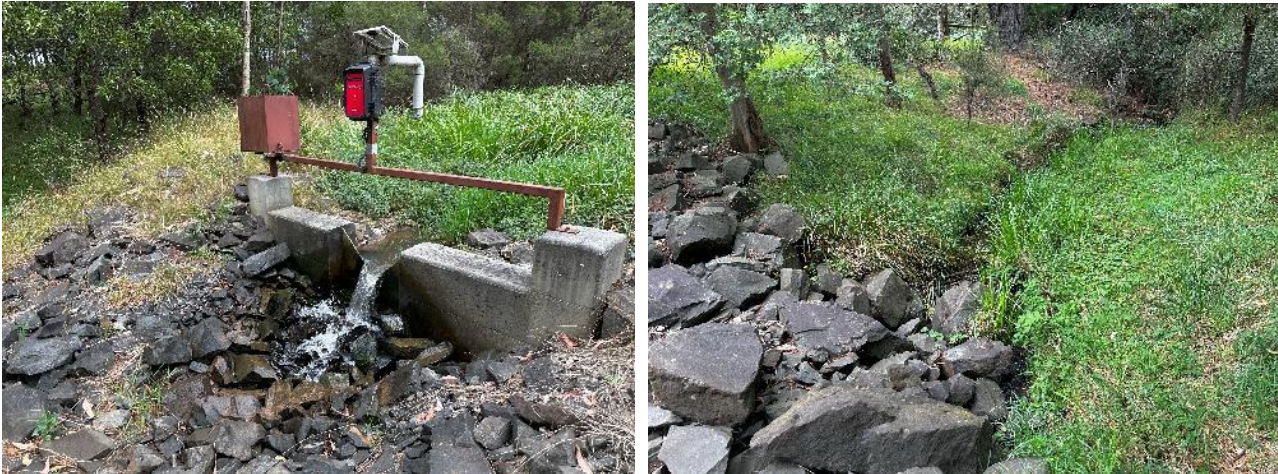
Surface water run-off from the quarry discharges to the environment via a licenced discharge point (under EPA Operating licence #OL000000544) located at the V-notch weir downstream of Donnazan's Dam (Monitoring Station W, Figure 1, *Environmental Monitoring Stations*, EMP Appendix 11) (**Figure 5**). The surface water comprised run off from adjacent farm paddocks and vegetated land and quarry run off water discharged from Donnazan's Dam.

FIGURE 5: SURFACE WATER EPA LICENCED DISCHARGE POINT

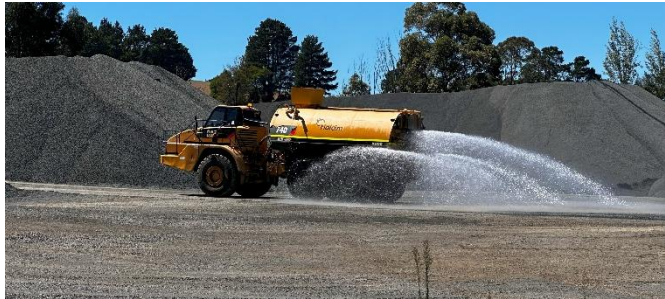
2.1.3	Management Measures - Actions Dust emissions from unpaved surfaces are to be controlled using the following measures: Wet suppression - all dust generating areas such as site roads will be watered, as required, to suppress dust during operation.	Observation – water truck observed in action.	Sighted use of water cart during quarry operations (Photo 1). PHOTO 1: WATER CART IN USE

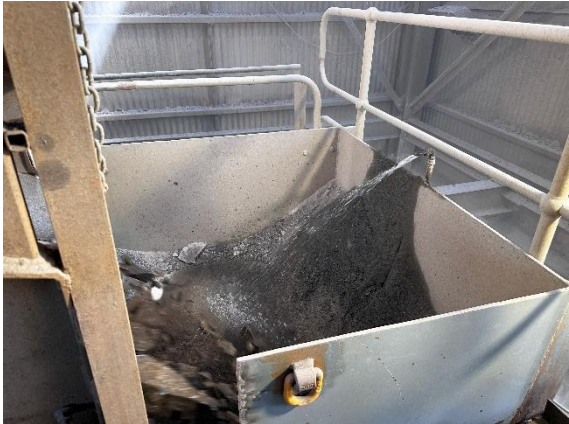
EMP SECTION	EMP REQUIREMENT – SUMMARY	AUDIT EVIDENCE	AUDITOR’S FINDINGS & COMMENTS	COMPLY*	RECOMMENDATION
			<p>There was visibly significant process dust observed during the audit from the crushing and screening plant (Photo 3) but in the main was localised and considered reasonably managed well.</p> <p>PHOTO 2: WATER SPRAYS IN USE ON CRUSHER PLANT</p>

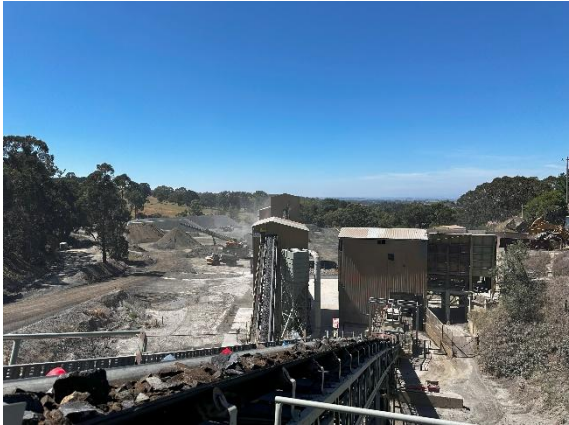
<p>PHOTO 3: FUGITIVE DUST VISIBLE FROM QUARRY PLANT</p>

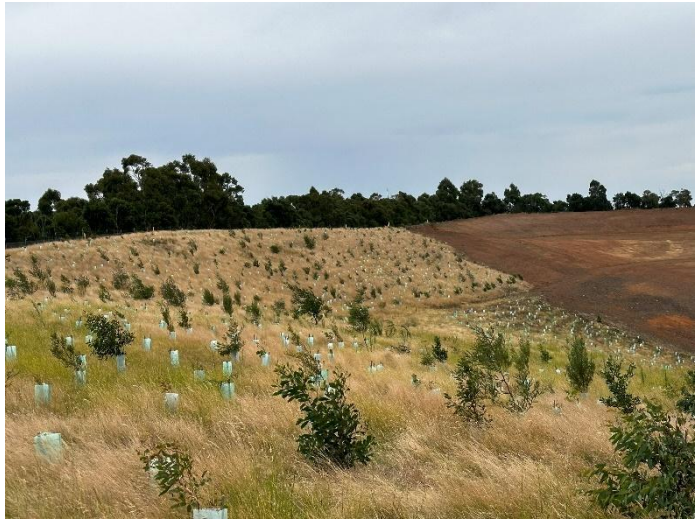
During clearing	Revegetation of exposed surfaces, including the following measures:	Observation; photographs 2024 Holcim Mt Shamrock Rehabilitation Report	<p>See LRMP (Appendix 6)</p> <p>Revegetation of rehabilitated areas continues to be in good condition and well established (Photo 4)</p>	C

EMP SECTION	EMP REQUIREMENT – SUMMARY	AUDIT EVIDENCE	AUDITOR'S FINDINGS & COMMENTS	COMPLY*	RECOMMENDATION
All times	<ul style="list-style-type: none"> Vegetation and topsoil removal will be limited to the smallest practicable area and revegetated as soon as possible following clearance; 		<p>PHOTO 4: REVEGETATION OF REHABILITATED AREA IS WELL ESTABLISHED</p>

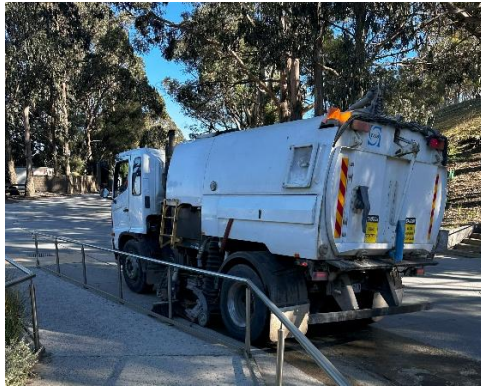
EMP SECTION	EMP REQUIREMENT – SUMMARY	AUDIT EVIDENCE	AUDITOR'S FINDINGS & COMMENTS	COMPLY*	RECOMMENDATION
All times	Speed limits will be defined and communicated to all machinery operators. Where necessary speed limits will be enforced by quarry management.	Observation Induction Records	Speed limits are specified in the site induction. Sighted Speed Limit Signs on site and in the Traffic Management Plan. No obvious speeding vehicles were observed during the audit. Holcim advises some quarry vehicles have speed detectors that can alarm when limit is exceeded. Reportedly there have been no instances of speeding.	C	
As necessary	Paved/sealed roadways within the quarry will be maintained in a clean state to minimise dust from vehicle movement.	Sweeper invoices – sample sighted.	Street sweeper comes to site weekly on a Wednesday afternoon – sealed surfaces swept only (inside quarry and down Mt Shamrock Rd to corner). Sighted the street sweeper (Aligned Asset Services) being used during the audit (Photo 5) PHOTO 5: STREET SWEEPER IN OPERATION ON PAVED AREAS

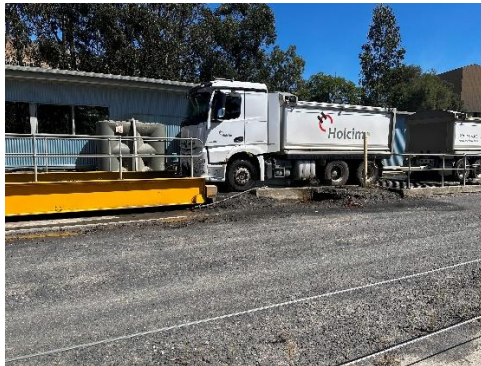
All times	All road registered vehicles that cart quarried materials shall be covered by suitable tarpaulins or enclosed blinds prior to leaving the quarry and entering public roadways.	Observation; Quarterly Report to ERC (tarping checks)	Periodic checks are made of vehicles. Visually observed tarping area being used during the audit.	C	
All times	All road registered vehicles delivering quarry products or additives to or from the site, will pass through the wheel wash facility prior to leaving the quarry and entering public roadways.	Observation	Wheel wash was observed to be in operation during the audit (Photo 6). PHOTO 6: WHEEL WASH IN USE

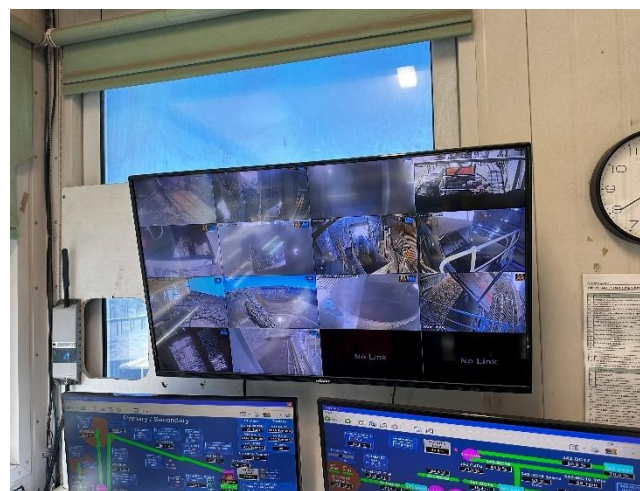
PHOTO 7: VISUAL MONITORING OF DUST FROM PLANT CONTROL ROOM

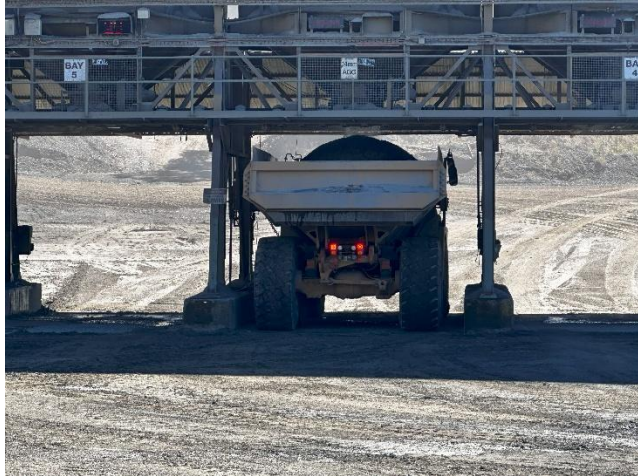
EMP SECTION	EMP REQUIREMENT – SUMMARY	AUDIT EVIDENCE	AUDITOR'S FINDINGS & COMMENTS	COMPLY*	RECOMMENDATION
All times	Dust emissions during material handling will be minimised by: <ul style="list-style-type: none"> Minimising drop heights; Regularly cleaning up any spillages; and Appropriate design of hopper load systems to ensure a good fit with trucks, and use of appropriate enclosures for hoppers. 	Observations; photographs.	<p>Loading observed – minimal dust emissions occurred due to operation of Ring Sprays during loading (Photo 6).</p> <p>PHOTO 8: LOADING WITH MINIMAL DUST DUE TO USE OF RING SPRAYS</p>

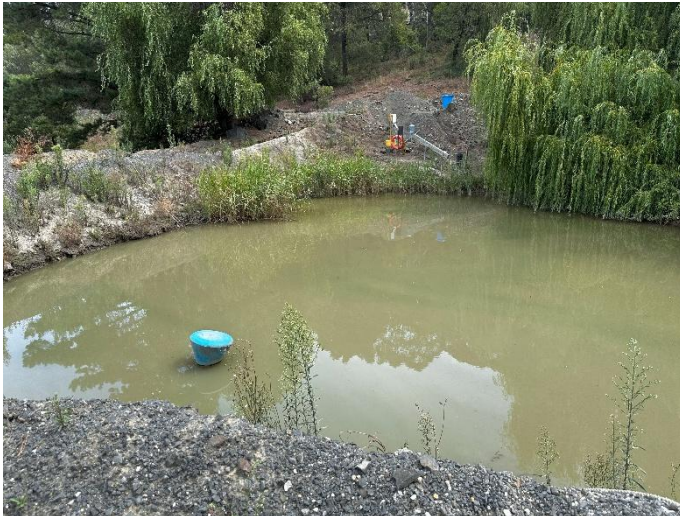
EMP SECTION	EMP REQUIREMENT – SUMMARY	AUDIT EVIDENCE	AUDITOR'S FINDINGS & COMMENTS	COMPLY*	RECOMMENDATION
			PHOTO 9: SEDIMENT REMOVED FROM DAM

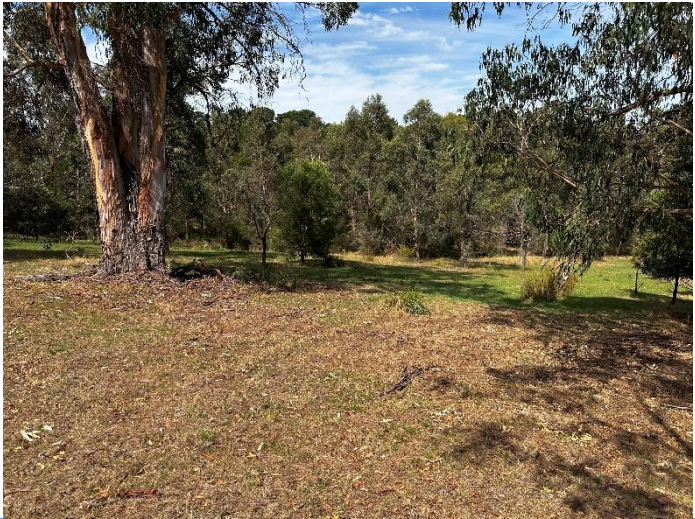
EMP SECTION	EMP REQUIREMENT – SUMMARY	AUDIT EVIDENCE	AUDITOR'S FINDINGS & COMMENTS	COMPLY*	RECOMMENDATION
	Offset Management Plan (NGOMP, Biosis Research, September 2007 – Appendix 13) by January 2009 (as specified in the s.173 Agreement)		PHOTO 10: NET GAIN OFFSET AREA WELL ESTABLISHED

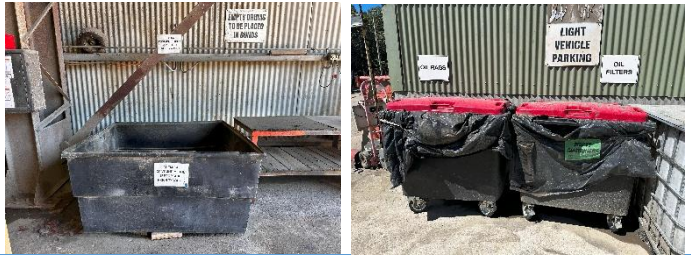
2.12.3	Management Measures				
Timing	Action				
June 2008	Characterise all waste streams and develop measures to: <ul style="list-style-type: none"> ▪ minimise site waste generation; ▪ segregate waste groups; and ▪ direct landfilled wastes to recycle/re-use wherever possible 		Sighted good segregation of waste groups during the audit and use of designated bins for various types of wastes (Photo 11). Sighted bins for recycled materials e.g. cardboard, scrap metal etc PHOTO 11: GOOD SEGREGATION OF WASTES

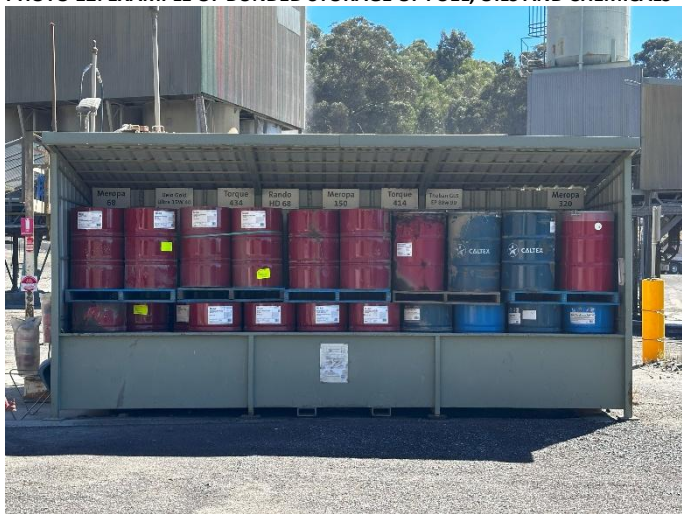
2.14.3	Management Measures				
All times	Signage will be maintained around bunded fuel tanks describing the filling procedure to be followed.	Observation	Sighted Work procedure PAKJSA35 – Refuelling at hardstand Fuel Tank (11/10/22) and sighted work procedure sign off sheet. However there is no signage at fuel tanks describing filling procedures	C-OFI	Display the Fuel Filling Procedure at the fixed and mobile fuel tanks.
All times	All fuels and chemicals in containers over 100 litres will be bunded when stored or in use.	Observation; Photograph	Measure met at maintenance depot and contractor's container in quarry (Photo 12). PHOTO 12: EXAMPLE OF BUNDED STORAGE OF FUEL, OILS AND CHEMICALS	C

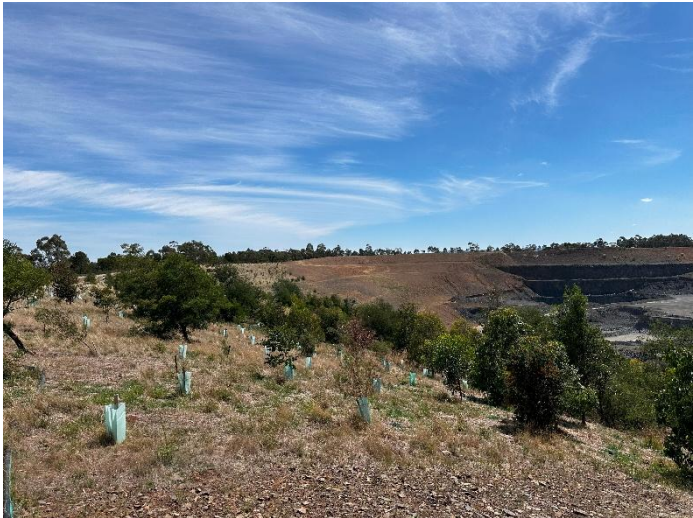
EMP SECTION	EMP REQUIREMENT – SUMMARY	AUDIT EVIDENCE	AUDITOR’S FINDINGS & COMMENTS	COMPLY*	RECOMMENDATION
			<div> <div>PHOTO 14: EXAMPLE OF QUARRY REHABILITATION PLANTING</div>
